# **PRESERVATION PLAN**

## **ACEQUIA AND COMPUERTA**

### **TUMACÁCORI NATIONAL HISTORICAL PARK**

In conjunction with:  
Desert Southwest Cooperative Ecosystem Studies Unit (DS-CESU)  
June 2014

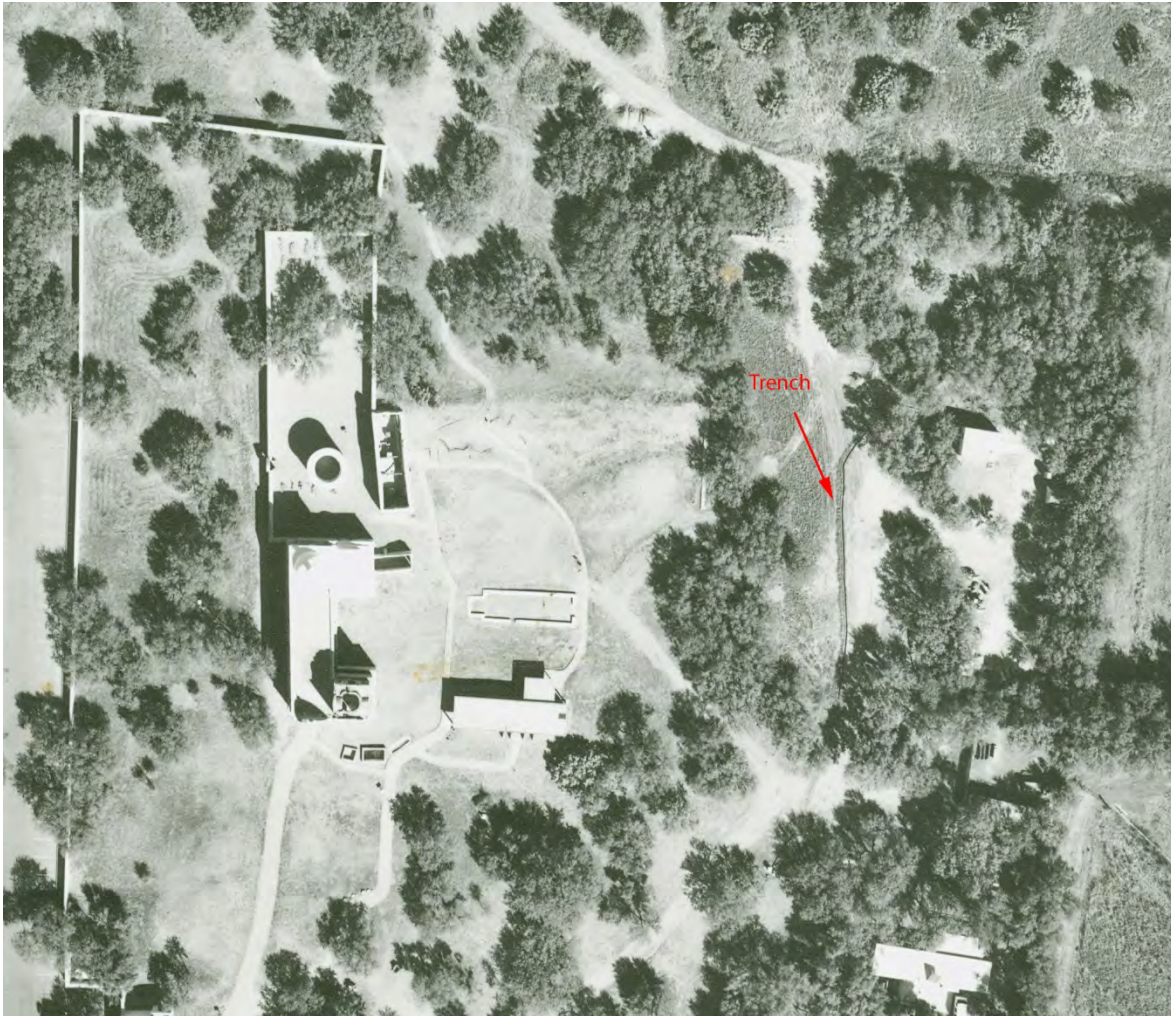
Conditions within the vicinity of the acequia appeared to stabilize in the 1980s as there are few visible changes between aerial photos including the feature taken in 1983 (Figure 2.8) and 1993 (Figure 2.9). However, in 1994, a utility line was excavated through a section of the acequia alignment (Figure 2.10). The installation of additional utility lines over time may have damaged or removed sections of the buried channel.

Figure 2.10. 1994 aerial photograph illustrating the location of an excavated utility-line trench within the acequia alignment (NPS TNHP Archives).

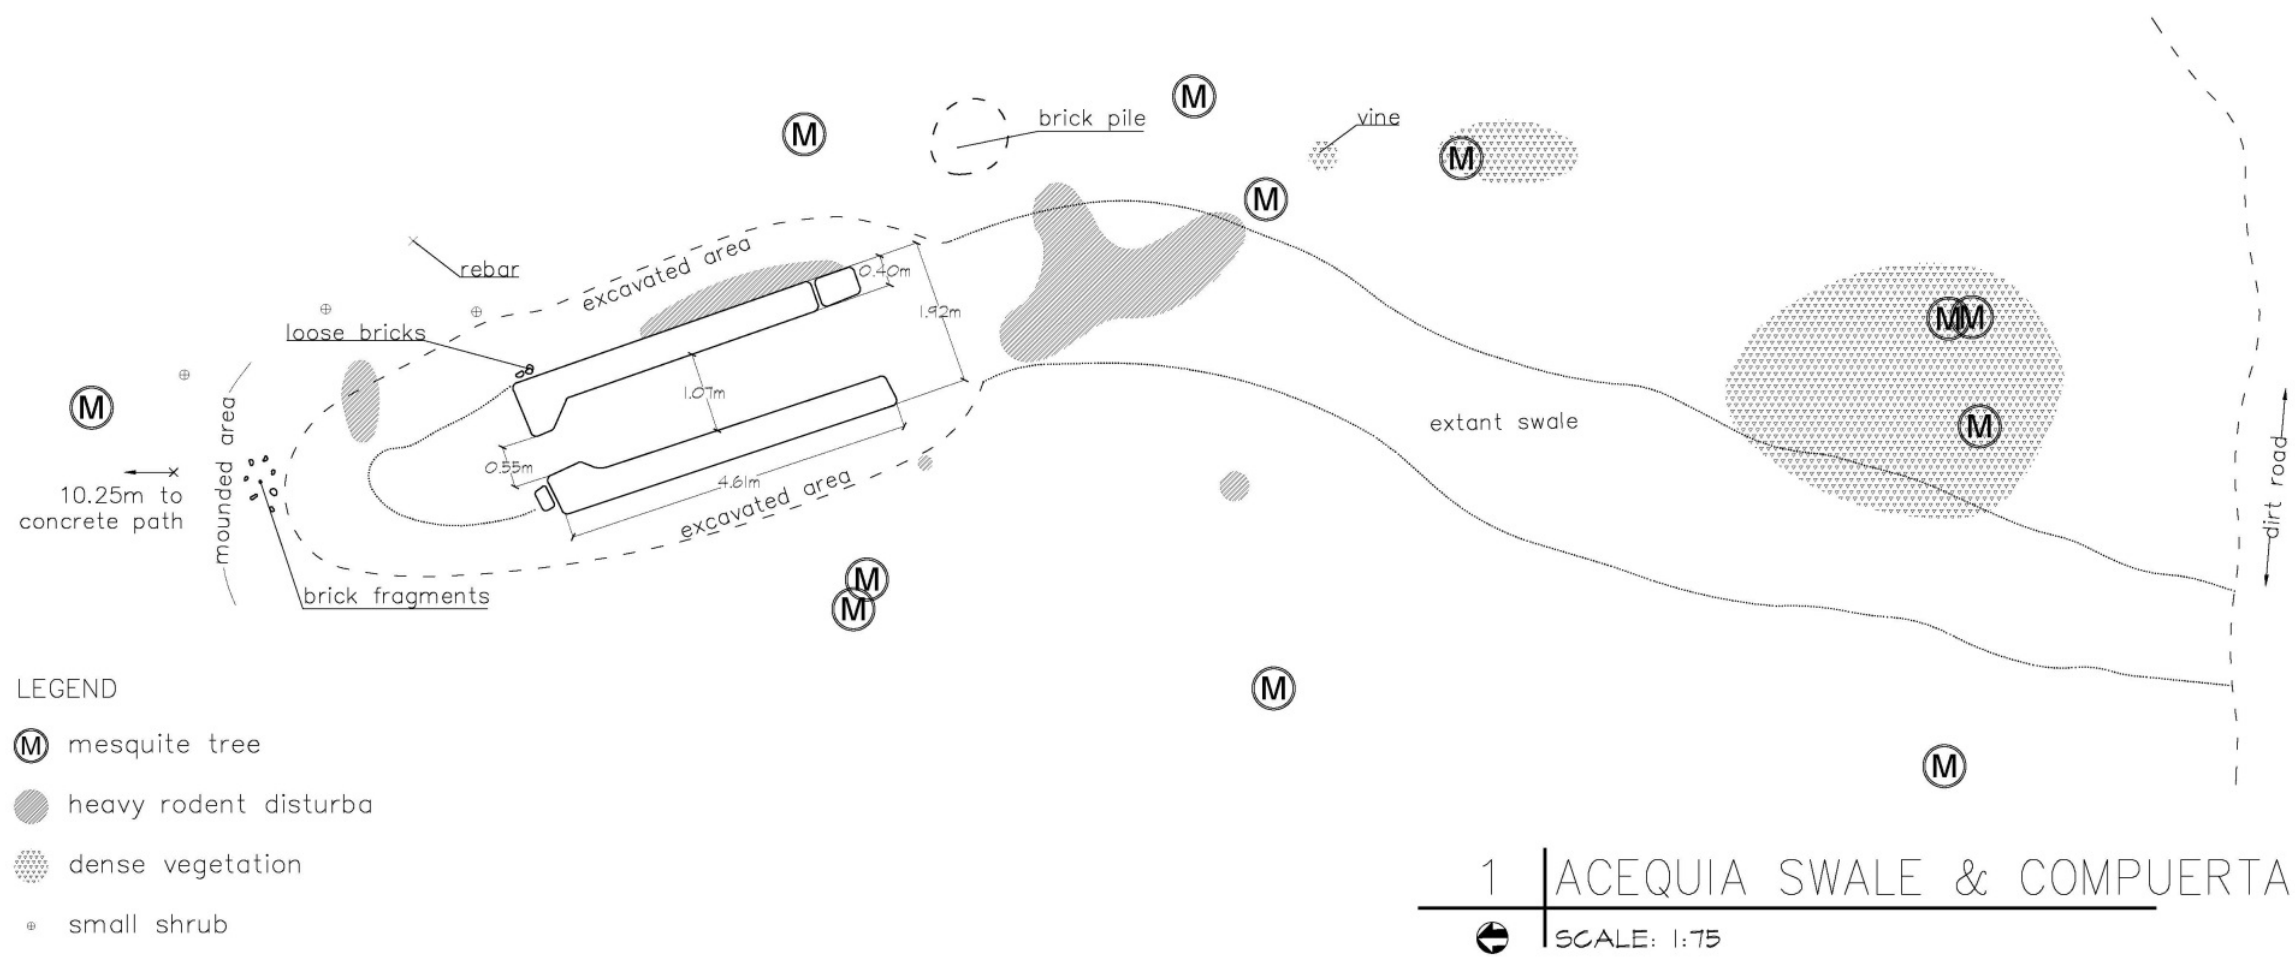
Figure 3.2. Schematic plan map of compuerta and visible swale. Deficiencies and preservation issues associated with the swale are outlined.

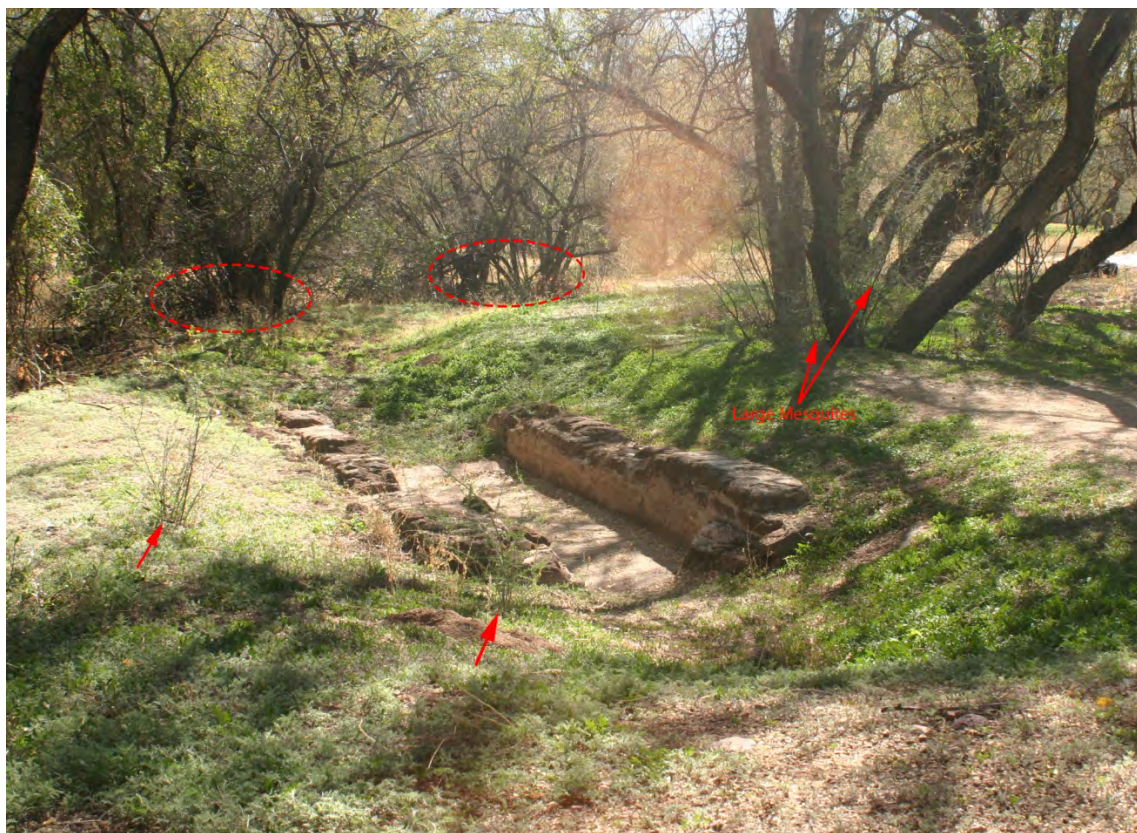
Figure 3.3. Overview of vegetation encroachment: areas of heavy vegetation circled in dashed line; looking south (photographed January 29, 2014).

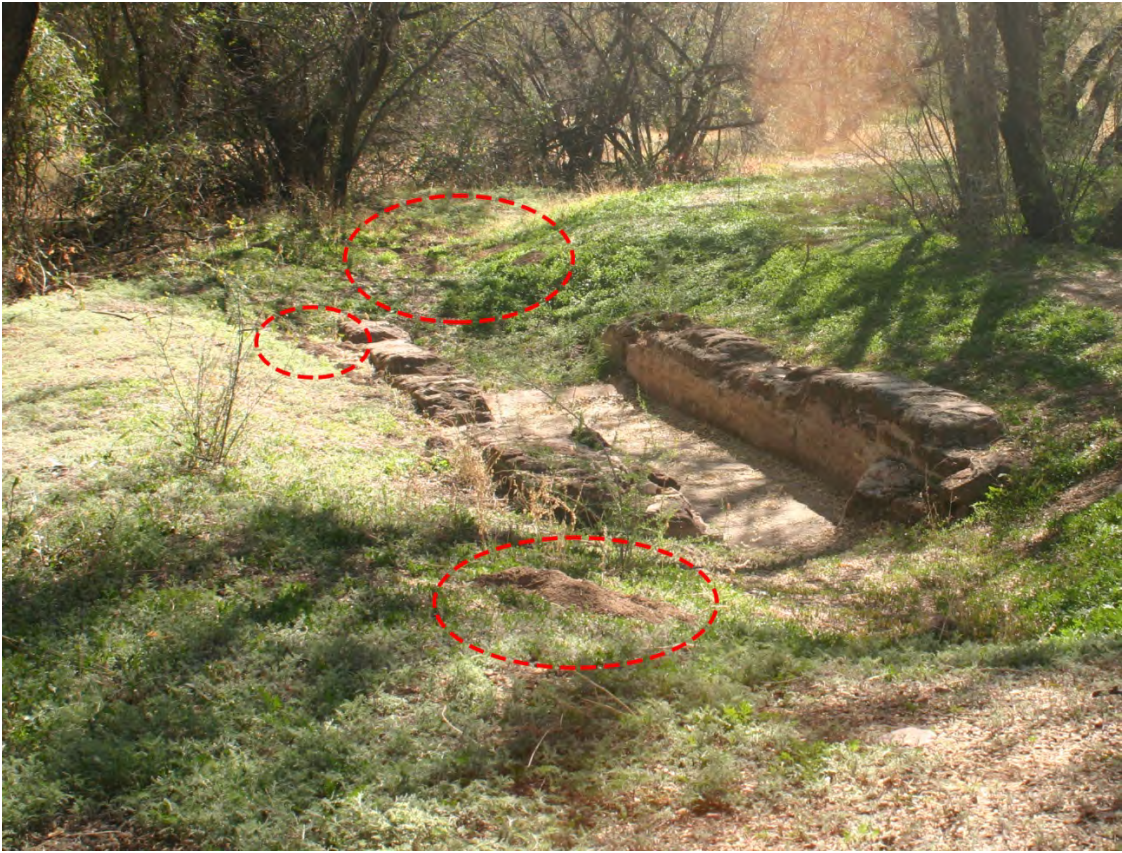
Figure 3.4. Overview of rodent disturbance; areas of fresh or significant activity outlined in red (photographed January 29, 2014).

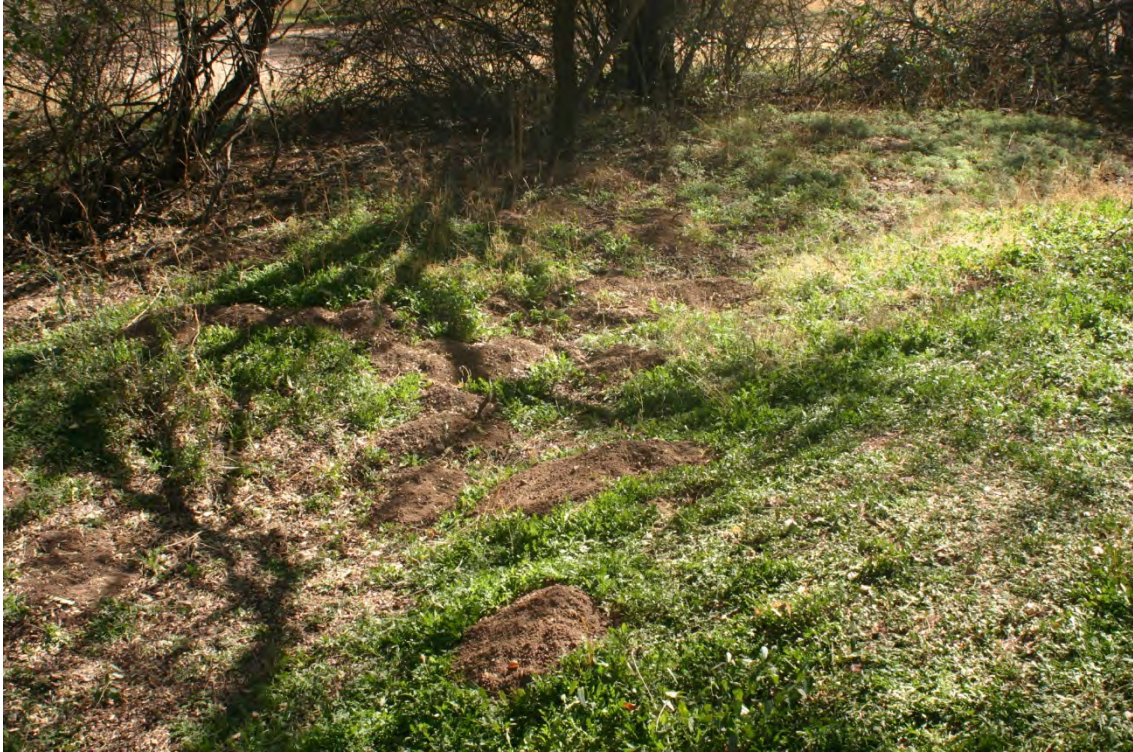
Figure 3.5. Heavy concentration of rodent disturbance south within the swale south of the compuerta (photographed January 29, 2014).

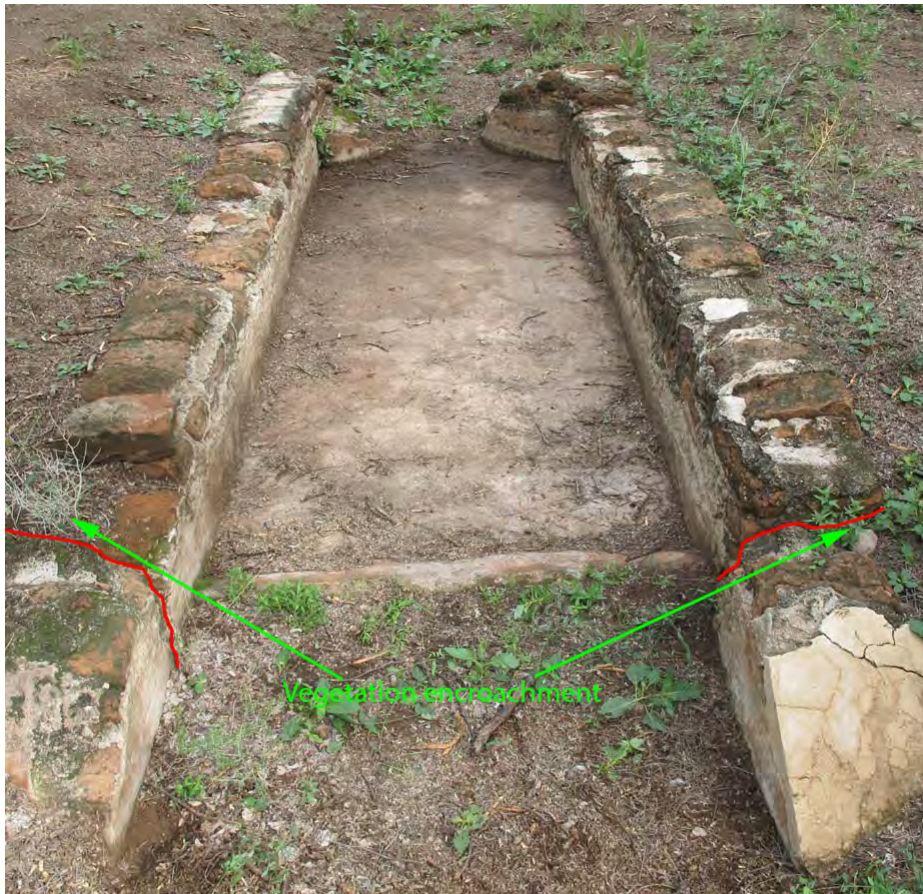
Figure 3.10. Structural cracks in southern ends of both east and west compuerta walls (traced in red); note vegetation encroachment in cracks (see detail in Figure 3.9) (photographed November 19, 2013).

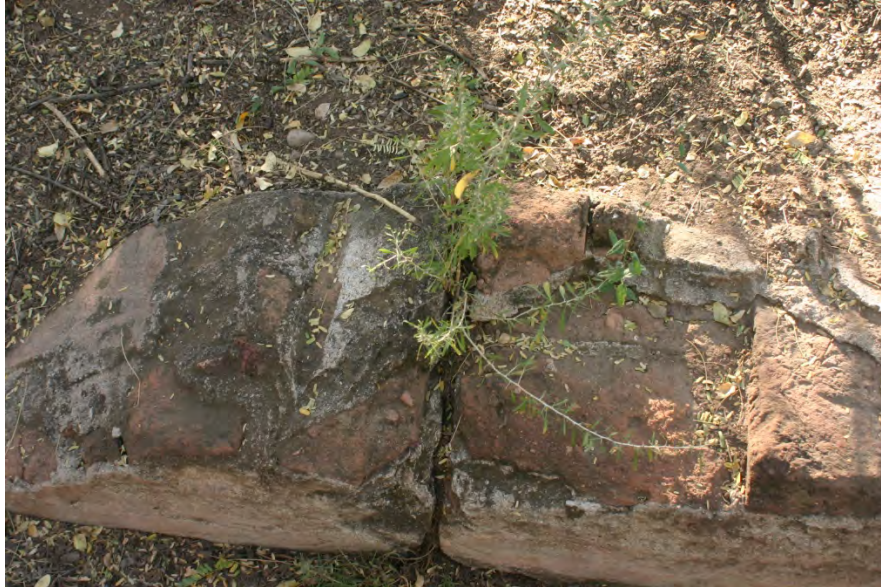
Figure 3.11. Structural crack in southern end of west wall; vegetation encroachment within crack (photographed November 19, 2014).

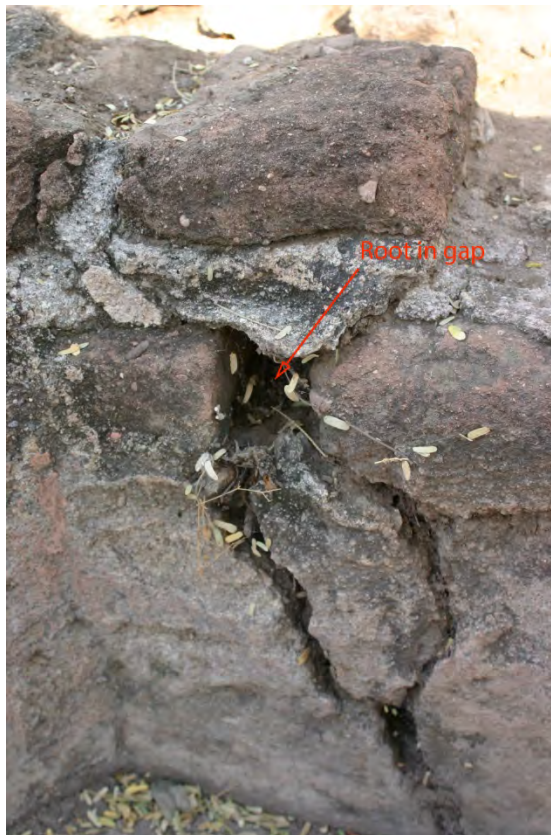
Figure 3.12. Structural crack in north east corner of compuerta. Note root in the gap of the bedding mortar (photographed November 19, 2014).

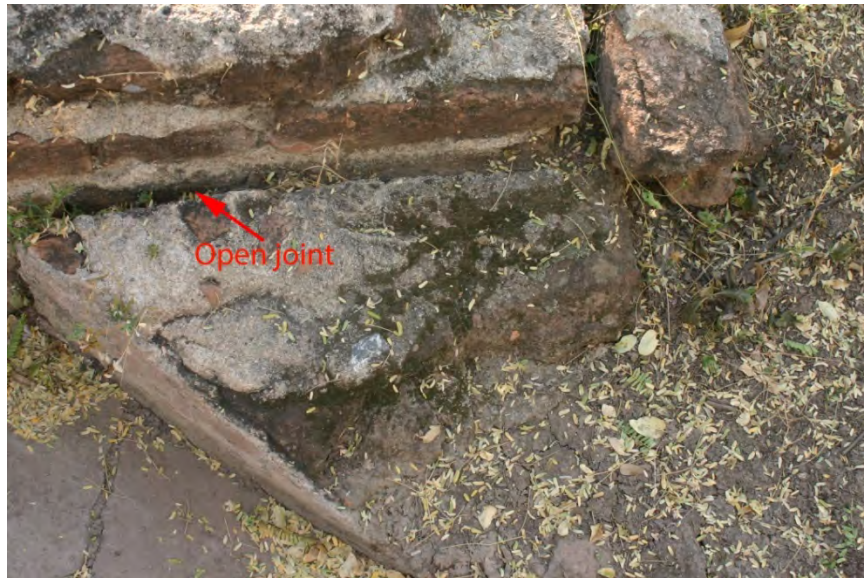
Figure 3.13. Detail of open joint between the west wall of the compuerta and the west half of the weir at the northern end of the feature. Note vegetation encroachment within gap (photographed November 19, 2013).

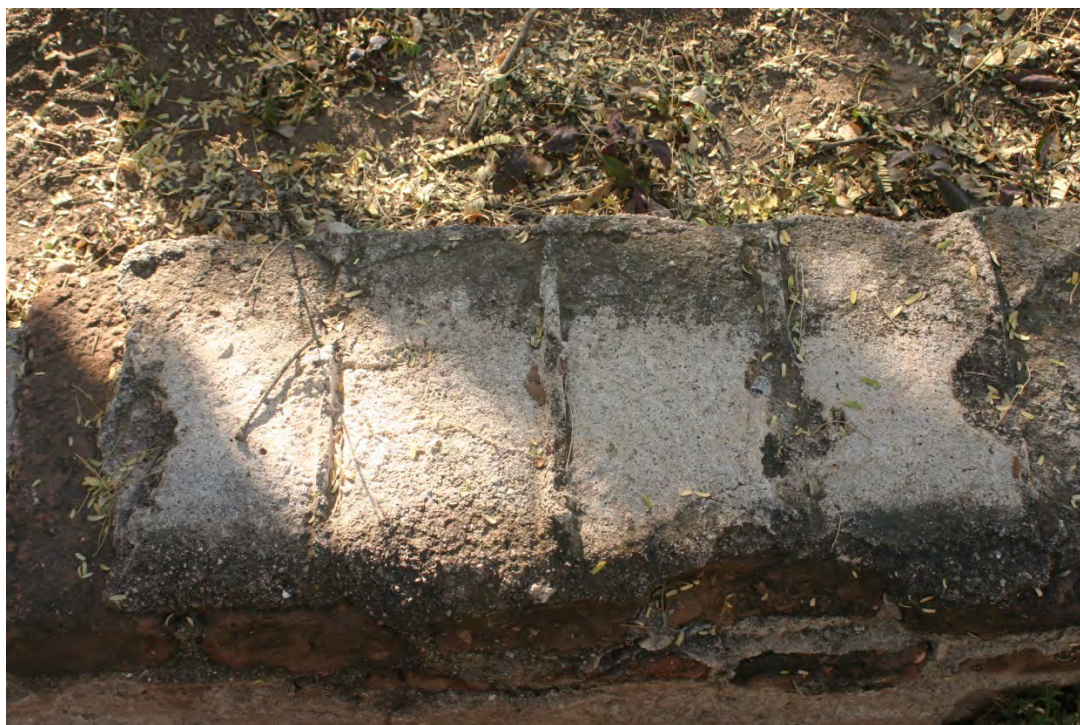
Figure 3.15. Evidence of lost course of bricks at top of compuerta walls, indicated by brick impressions in bedding mortar (photographed November 19, 2014).

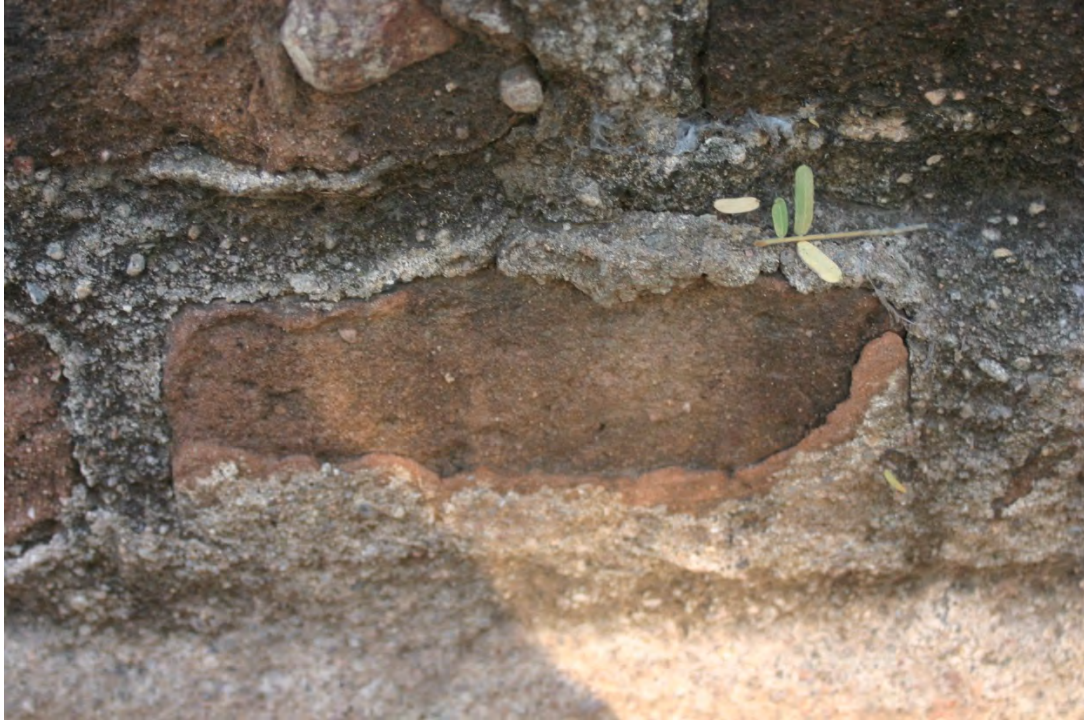
Figure 3.16. Detail of spalled surface on brick, east wall of compuerta (photographed November 19, 2013).

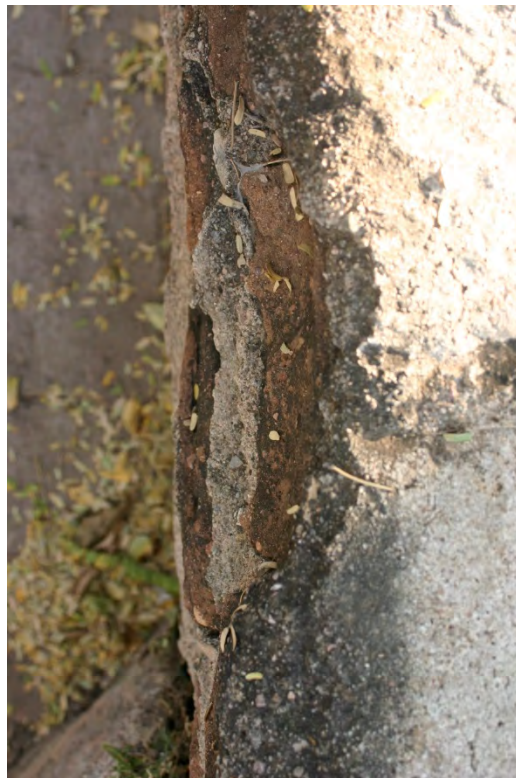
Figure 3.17. Plan view of spalled brick, showing extent of material loss (photographed November 19, 2013).

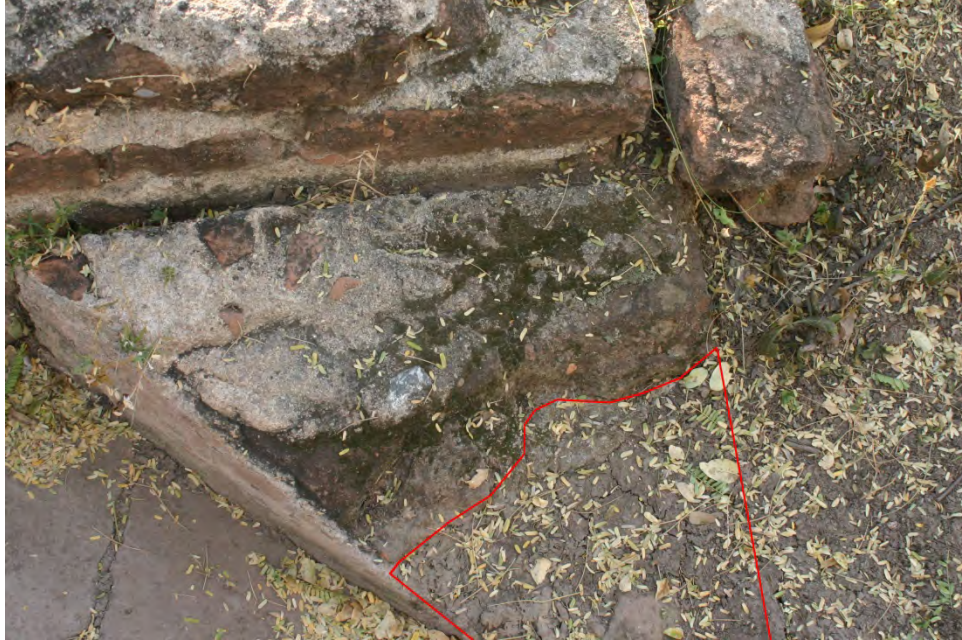
Figure 3.18. Material loss on western portion of weir at northern end of compuerta. Estimated extant of original material lost outlined in red (photographed facing west, November 19, 2013).

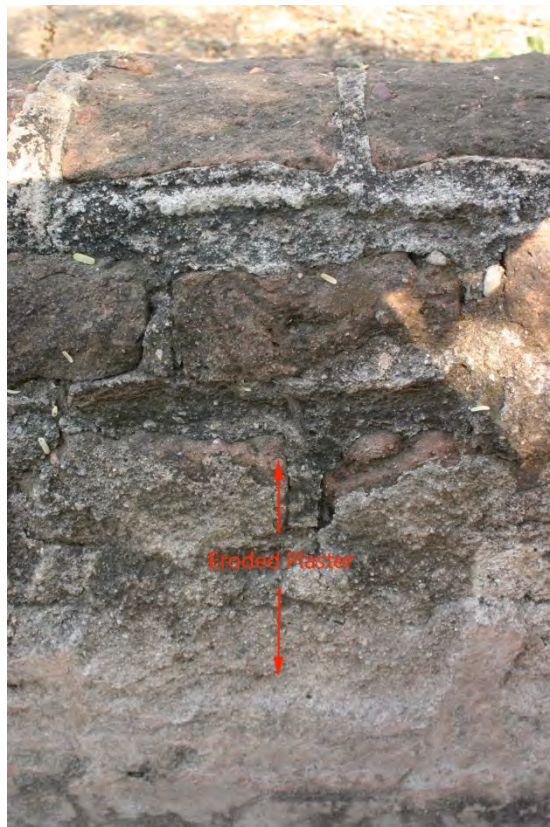
Figure 3.19. Plaster finish on the interior surface of the compuerta has spalled and eroded (photographed November 19, 2013).

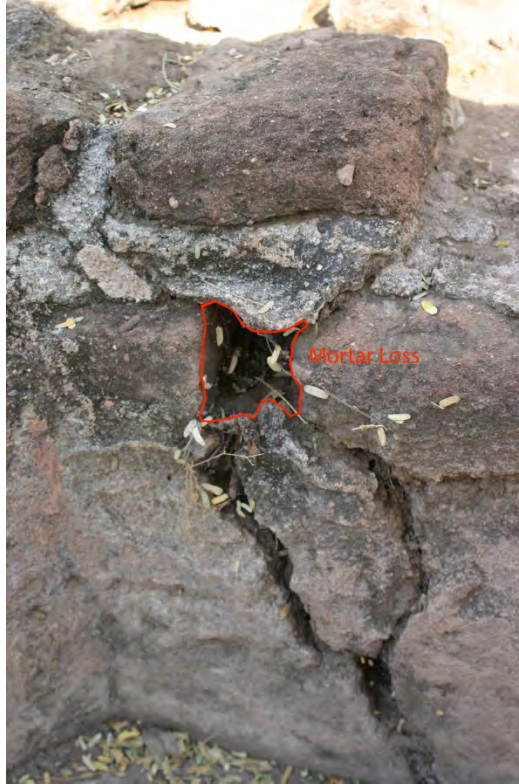
Figure 3.20. North end of east compuerta wall showing mortar loss within brick joints, outlined in red (photograph facing northeast, November 19, 2013).

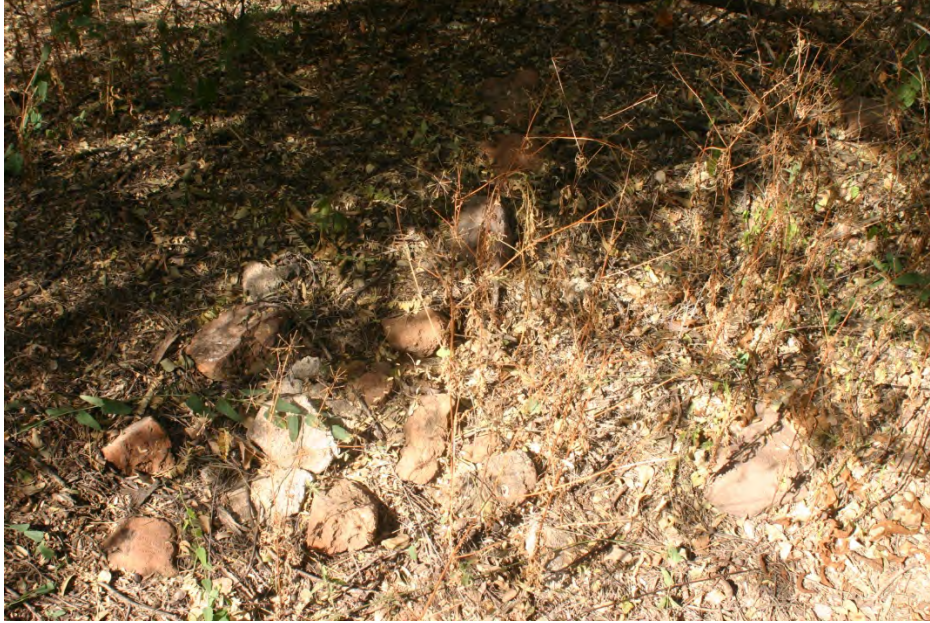
Figure 3.22. Brick and bedding mortar fragments piled to the southeast of the compuerta (photograph facing east, November 19, 2013).

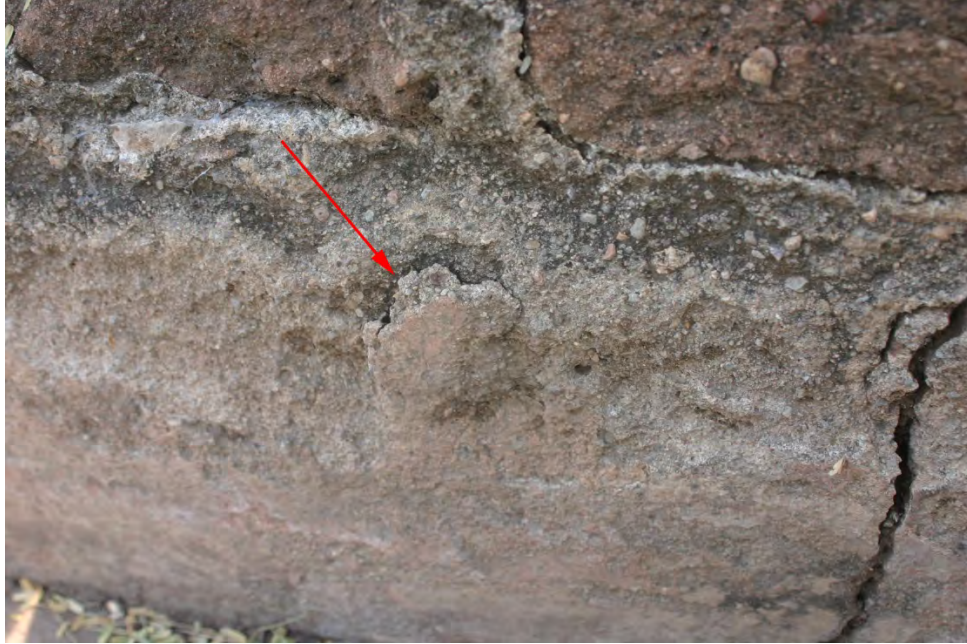
Figure 3.23. Spalling plaster near center of the east compuerta wall (photograph facing east, November 19, 2013).

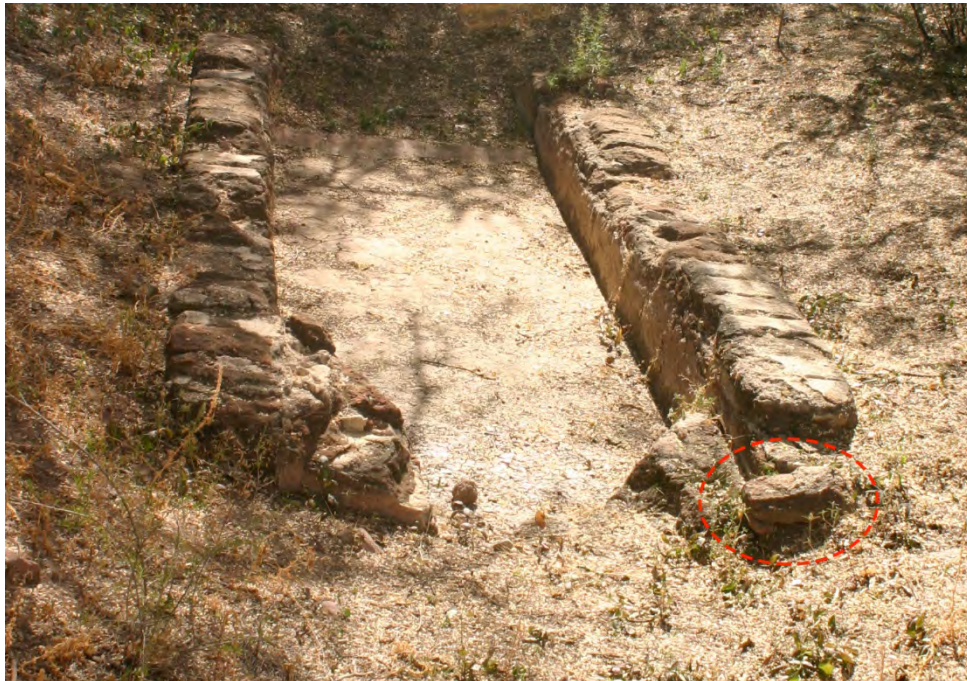
Figure 3.24. Loose brick at northwest corner of compuerta, outlined in red (photograph facing southeast, November 19, 2013).

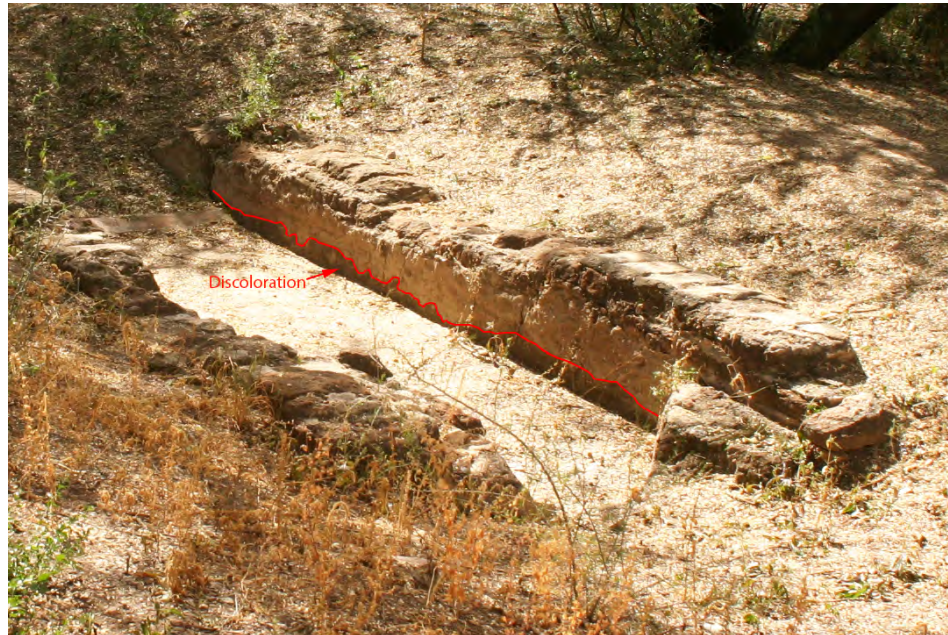
Figure 3.25. Overview of discoloration at base of west wall highlighted in red (photograph looking south, November 19, 2013)

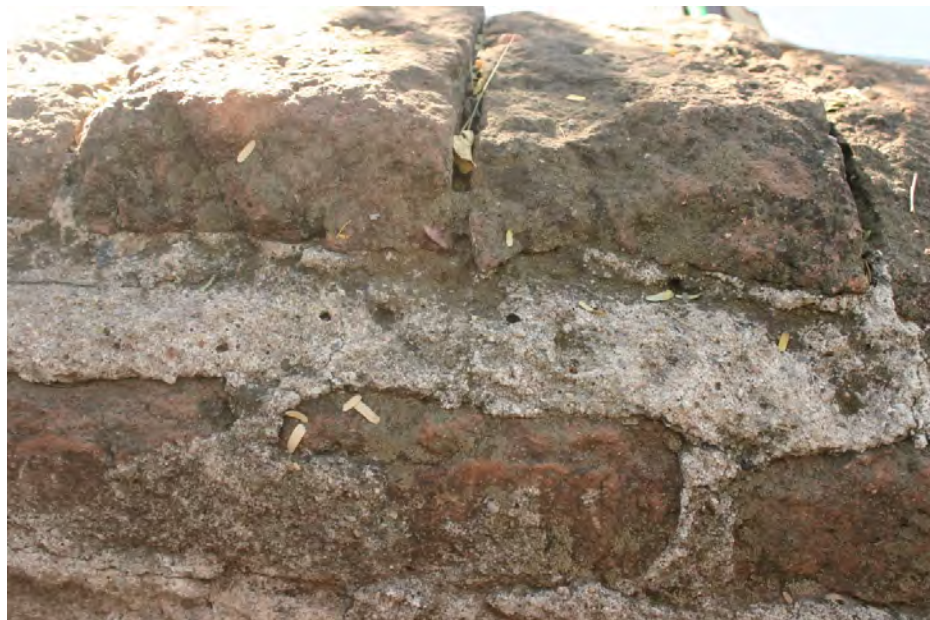
Figure 3.26. Detail of bio-organic growth on the surface of brick and bedding mortar of west wall (photograph November 19, 2013).

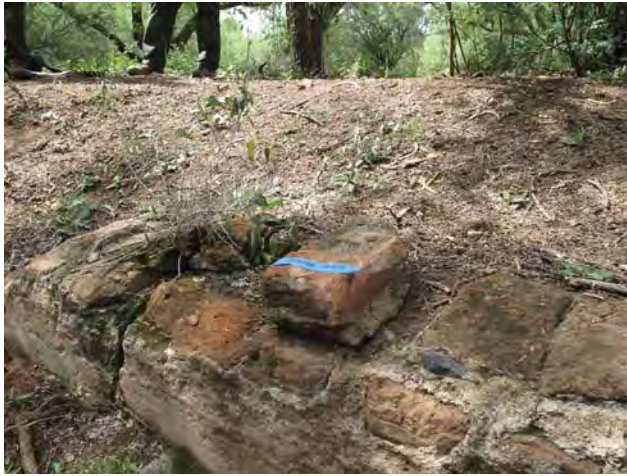
**Figure 4:** Photo of loose brick and plaster sample prior to removal.
