**HERMIT'S REST
GRAND CANYON NATIONAL PARK**

THE UNIVERSITY OF ARIZONA
PRESERVATION STUDIES PROGRAM
COLLEGE OF ARCHITECTURE AND
LANDSCAPE ARCHITECTURE

DECEMBER 2007

ROOF PLAN
DEFICIENCIES

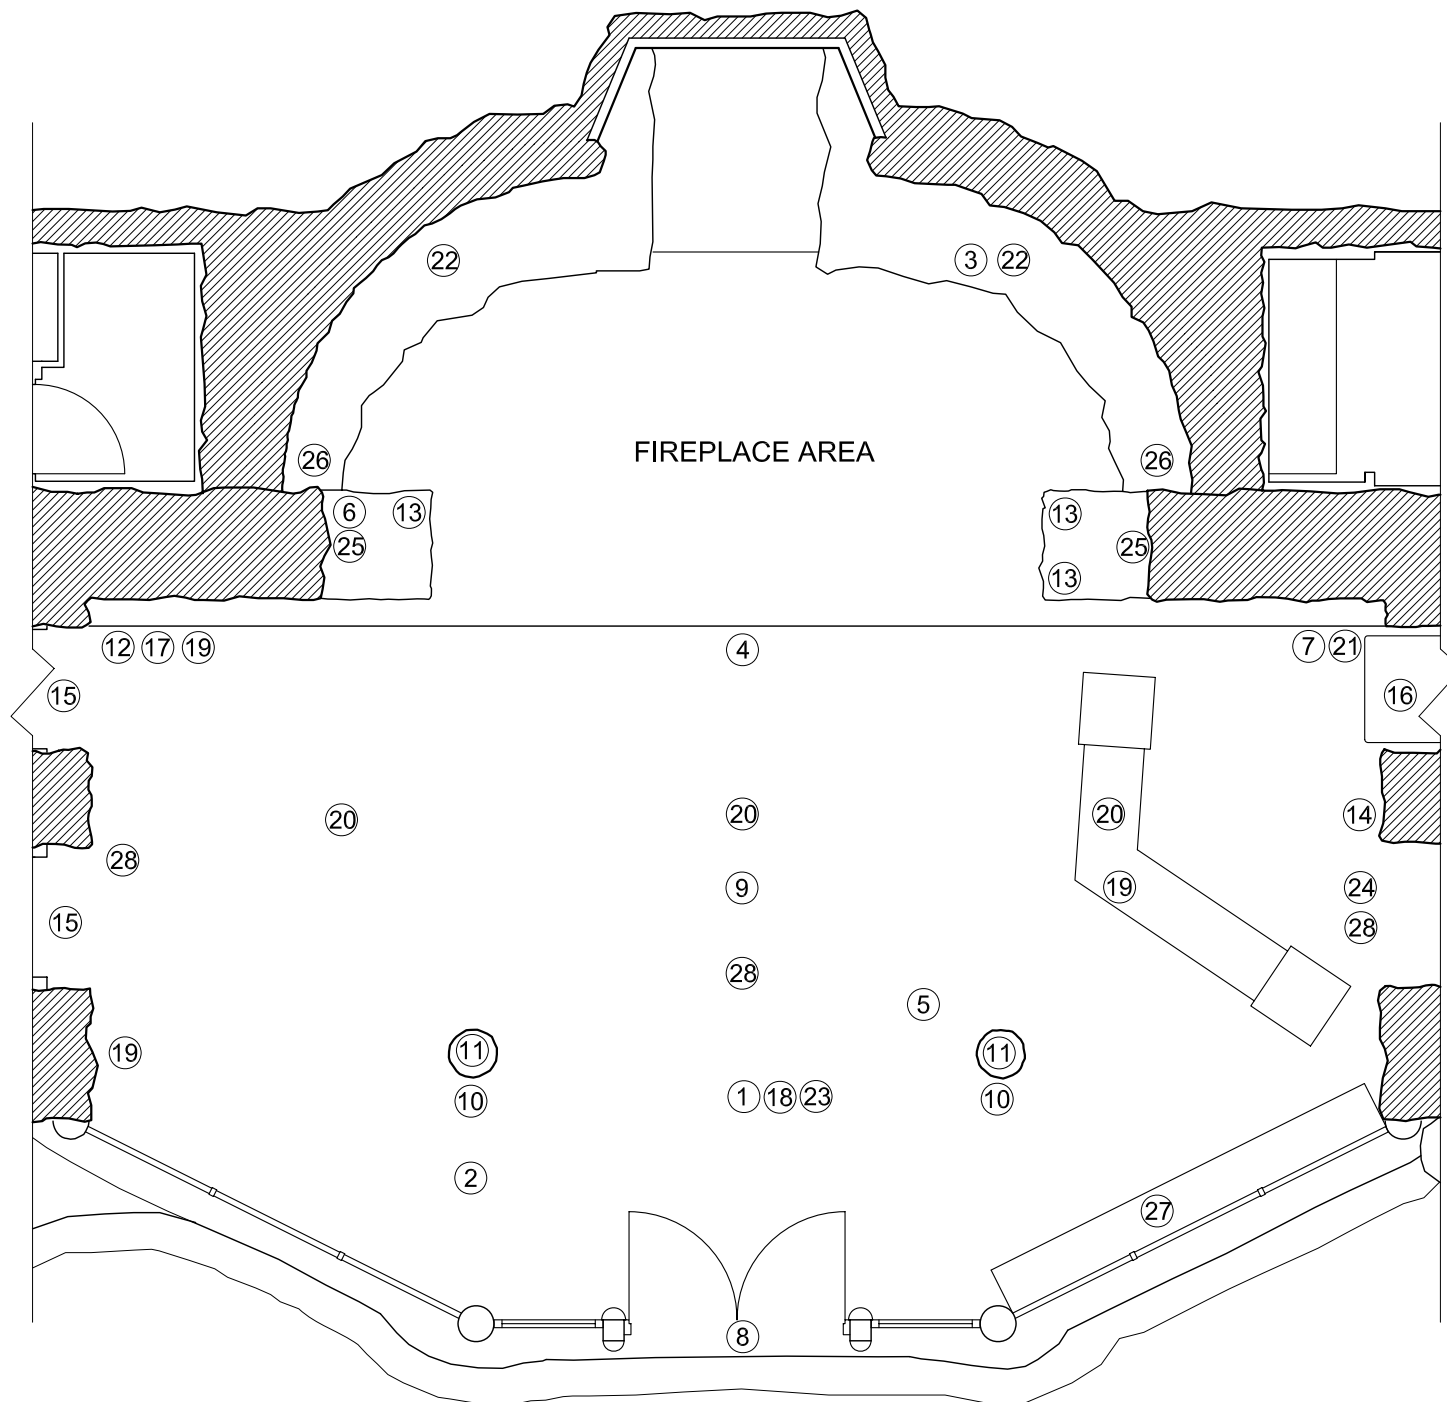
①	Log slab ceiling at entrance damaged by rodents. See FIGS. GR8, GR9.
②	Trash left by rodents visible in ceiling. See FIGS. GR8, GR9.
③	Loose stone on integrated bench. See FIG. GR12.
④	White painted stripe at level change visually distracting. See FIGS. GR1, GR2.
⑤	Table/chair missing seat. See FIG. GR19.
⑥	Incompatible mortar applied on built-in stone bench. See FIG. GR11.
⑦	Electrical conduit and propane pipe installed through window frame. See FIG. E53 in Exterior section.
⑧	Level change from exterior. See FIG. GR1.
⑨	Floor regularly waxed giving it a shiny appearance. See FIGS. GR1-GR4.
⑩	Holes in posts from removed candelabra. See FIG. GR14.
⑪	Decorative paint faded on wood posts. See FIGS. GR13, GR14.

⑫	Rodent access at location of removed propane heater. See FIG. GR7.
⑬	Three iron firewood holders missing. See FIG. GR11.
⑭	Historic light fixture missing shade covering. See FIG. GR26.
⑮	Doors to Secondary Room missing. See FIG. GR4.

⑩	Archway blocked with non-original safe and burlap. See FIGS. GR3, GR16.
⑪	Modern steel C-channel present for removed propane heater in southeast corner. See FIG. GR7.
⑫	Modern log slab ceiling at entrance. See FIGS. GR6, GR8, GR9, CD11, CD12 in Chronology of Development section
⑬	Modern merchandise displays obscure character-defining features. See FIGS. GR3, GR4, GR13.
⑭	Modern ceiling fans with hanging light fixtures. See FIG. GR5.
⑮	Modern propane heater mounted on steel C-channel. See FIG. GR27.
⑯	Candelabras relocated to fireplace wall from posts. See FIGS. GR2, GR14, GR15, CD8 in Chronology of Development section.
⑰	Modern track lighting installed. See FIGS. GR3, GR4, GR6, GR9.
⑱	Modern speakers installed on west wall and cords draped between them. See FIG. GR3.
⑲	Historic lamp fixtures electrified. See FIG. GR24.
⑳	Modern electrical outlets at fireplace. See FIGS. GR24, GR25.
㉑	Modern shelves below west windows and between west windows and Kitchen archway. See FIG. GR28.

㉒	Modern conduit on north, east and west walls. See FIG. GR7.

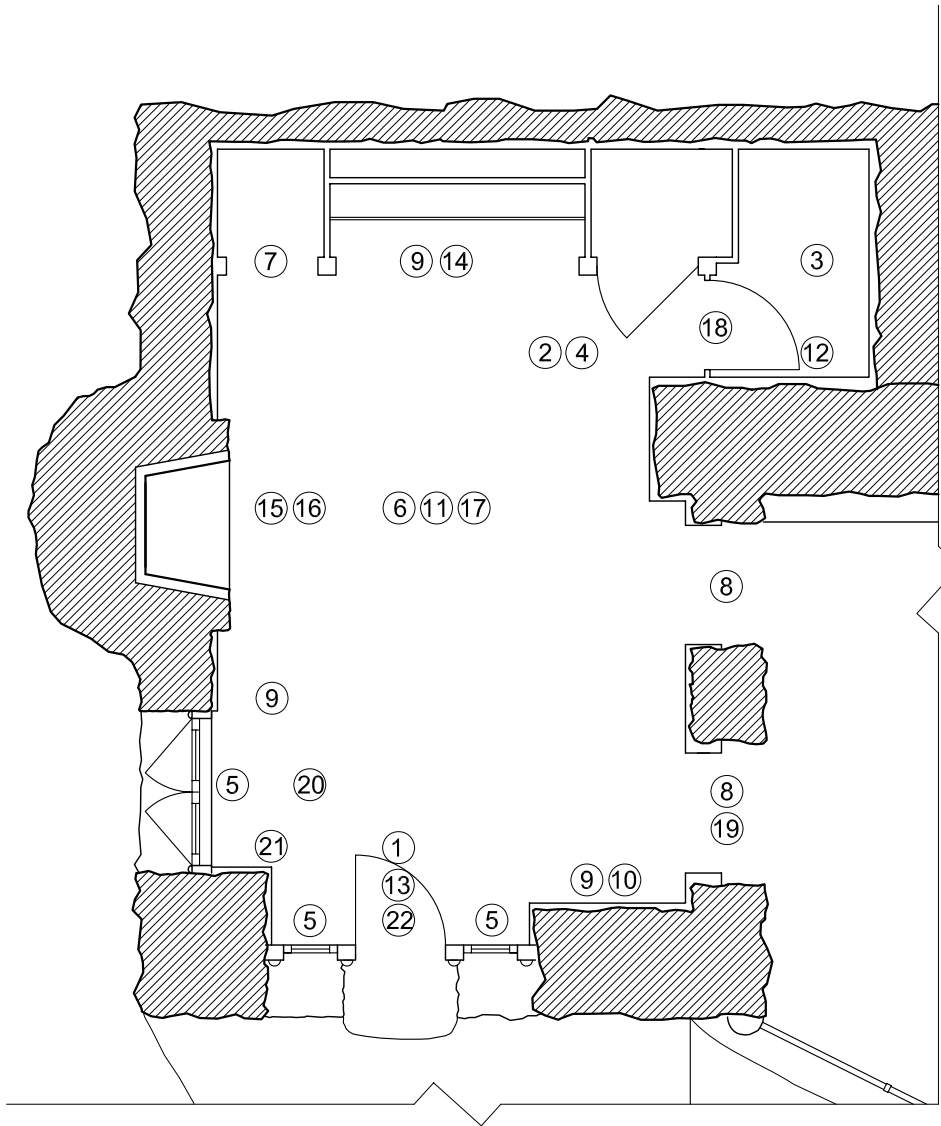
SECONDARY ROOM
DEFICIENCIES

①	Exterior door blocked by merchandise. See FIG. SR8.
②	Rodent access gained through gaps between wall boards, ceiling boards, and connections between wall and ceiling. See FIGS. SR13, SR14.
③	Water damage on closet ceiling. See FIG. SR13.
④	Rodent footprints on ceiling logs. See FIG. SR17.
⑤	Daylight blocked by display in windows. See FIGS. SR2, SR8.
⑥	Room temperature is warm in the summer.

⑦	Closet door missing. (Located in storage trailer) See FIG. SR5.
⑧	Doors to Great Room missing. See FIGS. SR9, SR10.

⑨	Modern merchandise displays. See FIGS. SR2, SR3, SR5, SR8, SR20.
⑩	Slat board installed on north wall. See FIG. SR8.

⑪	Carpet installed over concrete floor. See FIGS. SR11, SR12.
⑫	Missing battens in closet. See FIG. SR18.
⑬	White board on ceiling near north door. See FIG. SR19.
⑭	False wall installed on south wall for display. See FIG. SR3.
⑮	Stone fireplace reconfigured. See FIGS. SR1, CD13 in Chronology of Development section.
⑯	Fireplace plugged.
⑰	Modern track light fixtures installed. See FIGS. SR2, SR17.
⑱	Reversed door to west wall closet. See FIG. SR7.
⑲	Modern trim over north arch on west wall. See FIG. SR10.
⑳	Modern battens where original battens missing. See FIG. SR15.
㉑	Security camera installed in northwest corner with cord draped across north wall. See FIG. SR16.
㉒	Modern dutch door. See FIG. SR19.

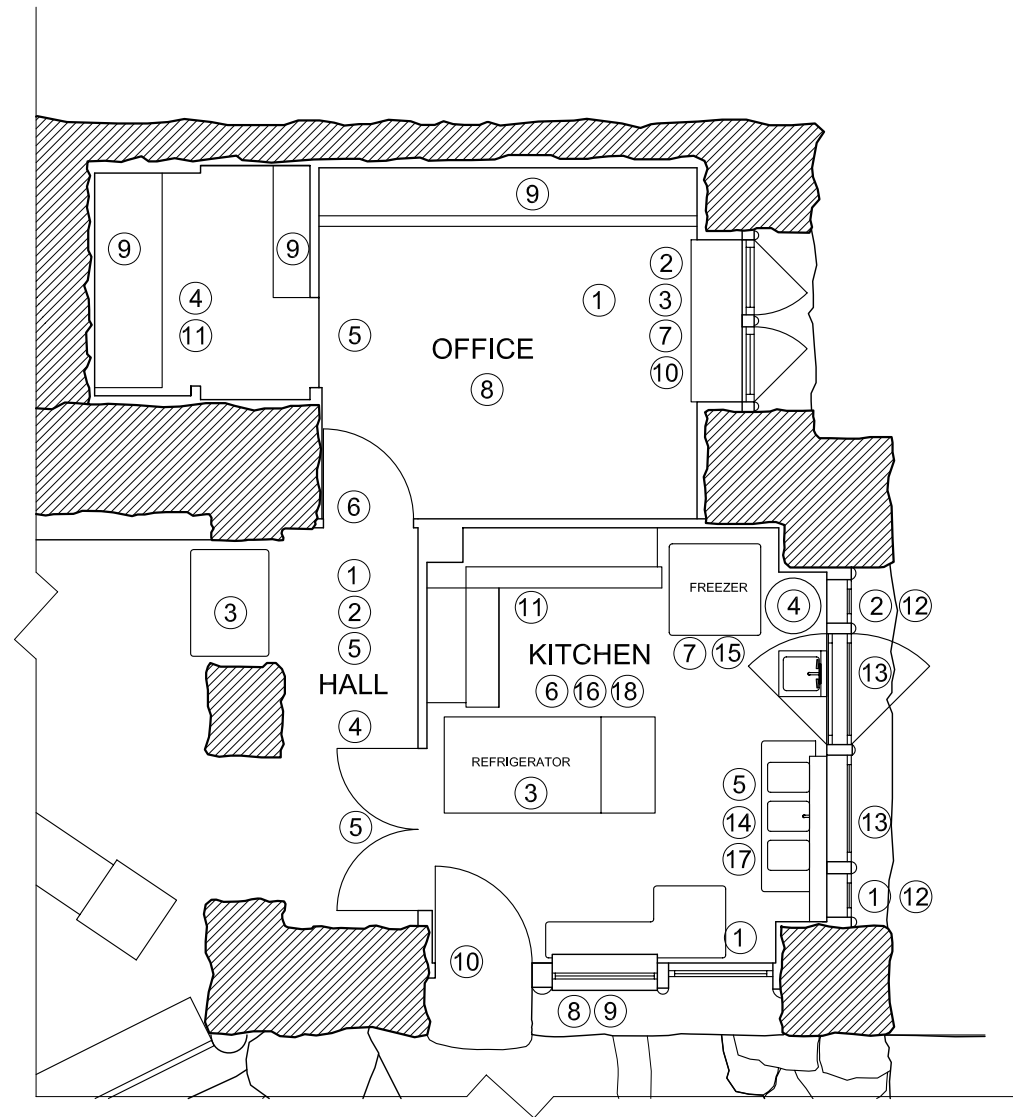
KITCHEN, OFFICE & HALL
DEFICIENCIES

- ① Daylight blocked by food storage and display in windows. See FIGS. K1, K12.
- ② Septic pipe installed through window frame. See FIG. K10.
- ③ Loud refrigerator impairs employee hearing. See FIG. K4.
- ④ Inefficient hot water for coffee and tea machines. See FIG. K9.
- ⑤ Frequent clogging and overflowing of sink. See FIG. K11.

- ⑥ Original sink, wall treatments and most cabinets removed. See FIG. CD14 in Chronology of Development section.

- ⑦ Oven wiring interferes with access to corner fire extinguisher. See FIG. K9.
- ⑧ Modern counter installed under north window. See FIG. K2.
- ⑨ Replaced wood window with aluminum on north wall. See FIG. K2.
- ⑩ Replaced Dutch door window with aluminum-framed window. See FIG. K3.
- ⑪ Modern cabinets, counters and backsplashes. See FIGS. K5, K6.
- ⑫ Exhaust fans and louvered vents installed in side windows on west wall. See FIGS. K10, K12.
- ⑬ Window covered with improperly adhered reflective film. See FIG. K12.
- ⑭ Modern shelves installed in front of sink window. See FIG. K12.
- ⑮ Wall configuration modified by removal of original pantry. See FIG. CD14 in Chronology of Development section and original drawings in Appendix B.
- ⑯ Vinyl tile installed over concrete floor. See FIG. K4.
- ⑰ Window replacements on west wall. See FIG. K12.
- ⑱ Modern fluorescent ceiling fixtures.

- ① Water damage on ceiling. See FIG. O8.
- ② Rodent access gained through gaps between wall boards. See FIG. O9.
- ③ Electrical conduit installed through window frame. See FIG. O2.
- ④ Lead-based paint present in Office closet. See FIG. O10.

- ⑤ Closet door missing. See FIG. O1.
- ⑥ Office door missing part of wood latch. See FIG. O6.

- ⑦ Security wire installed over window. See FIG. O2.
- ⑧ Modern fluorescent lighting installed on ceiling. See FIG. O1.
- ⑨ Modern shelving installed in Office and closet for merchandise storage. See FIGS. O2-O5.
- ⑩ Baseboard heater installed on west wall. See FIG. O2.
- ⑪ Partition wall removed and original toilet room and storage area combined into single closet. See FIG. O10.

- ① Water damage on ceiling. See FIG. H4.

- ② Exposed wiring haphazardly mounted. See FIGS. H2, H4, H6, H7.
- ③ Archway to Great Room blocked with safe and burlap. See FIG. GR16 in Great Room section.
- ④ Partition wall removed. See FIG. H1.
- ⑤ Modern fluorescent ceiling fixtures. See FIGS. H3, H4.
