HISTORIC STRUCTURE REPORT

UTAH PARKS COMPANY SERVICE STATION BRYCE CANYON NATIONAL PARK

A Service Learning Project of the
Preservation Studies Program
College of Architecture and Landscape Architecture
The University of Arizona

November 2005

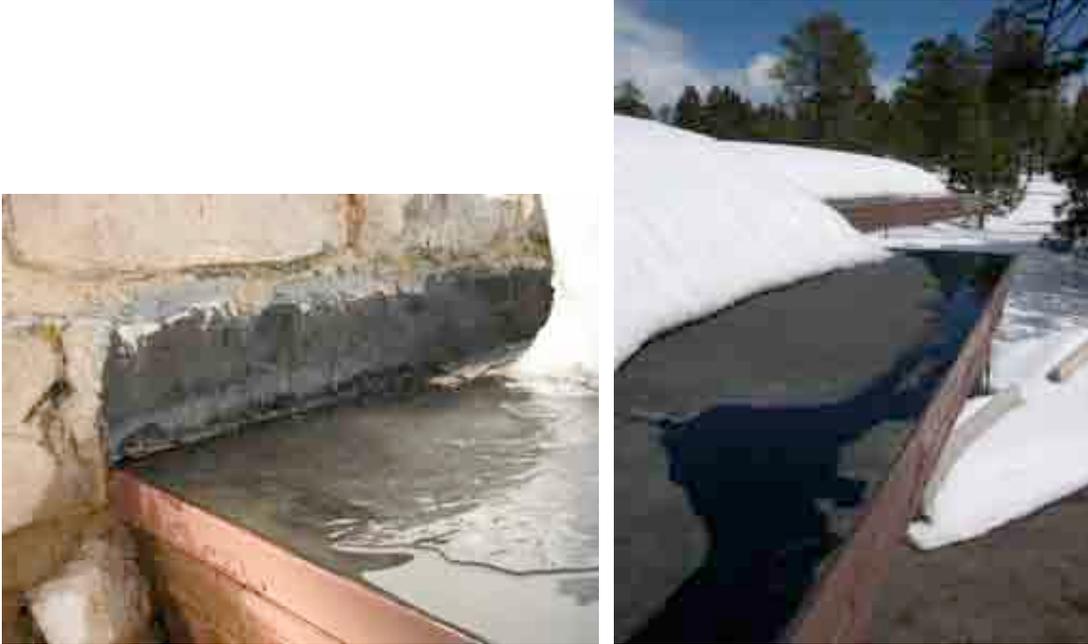
damage caused by water leakage and roof run-off, especially efflorescence¹⁷ and erosion of the stone on the north and south ends of the stone wall, the water damage to the roof joists and ceilings (see *Structural* below), and the exterior corners of the roofline are major preservation issues for the Service Station and require immediate attention.

Figure 5 & Figure 6 - Water ponding on the roof causing damage to the stone wall and at the roof's edge adjacent to the fascia.

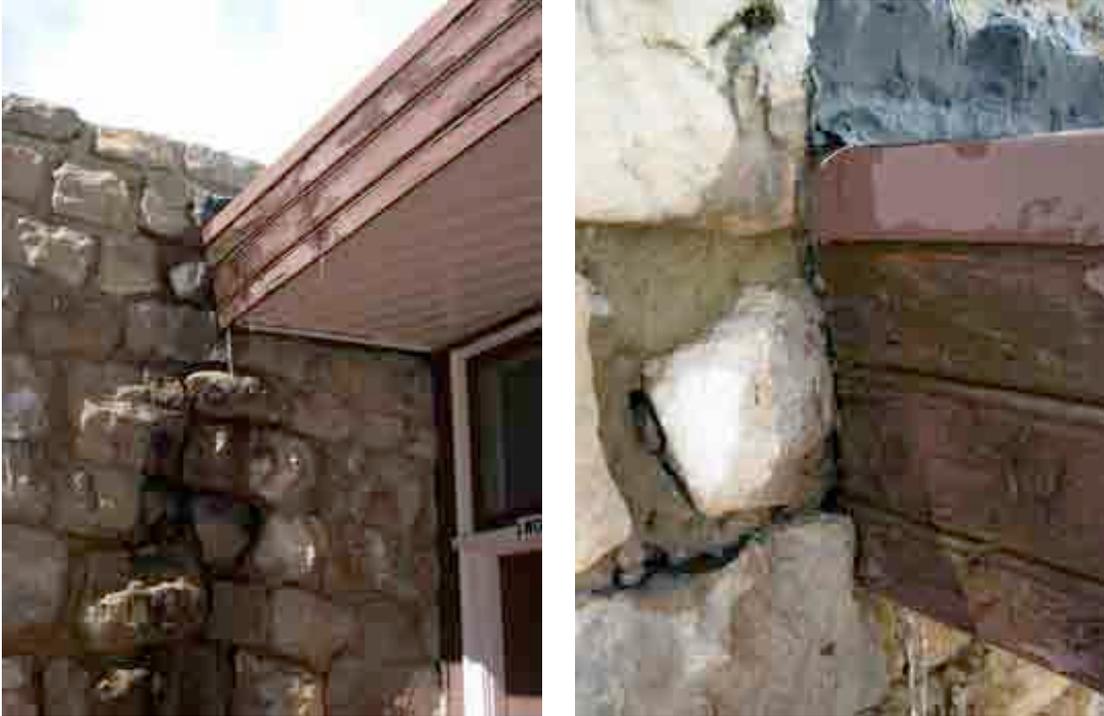
Figure 7 & Figure 8 - Poor drainage at the southwest corner of the building showing water damage to the stone wall and the fascia.

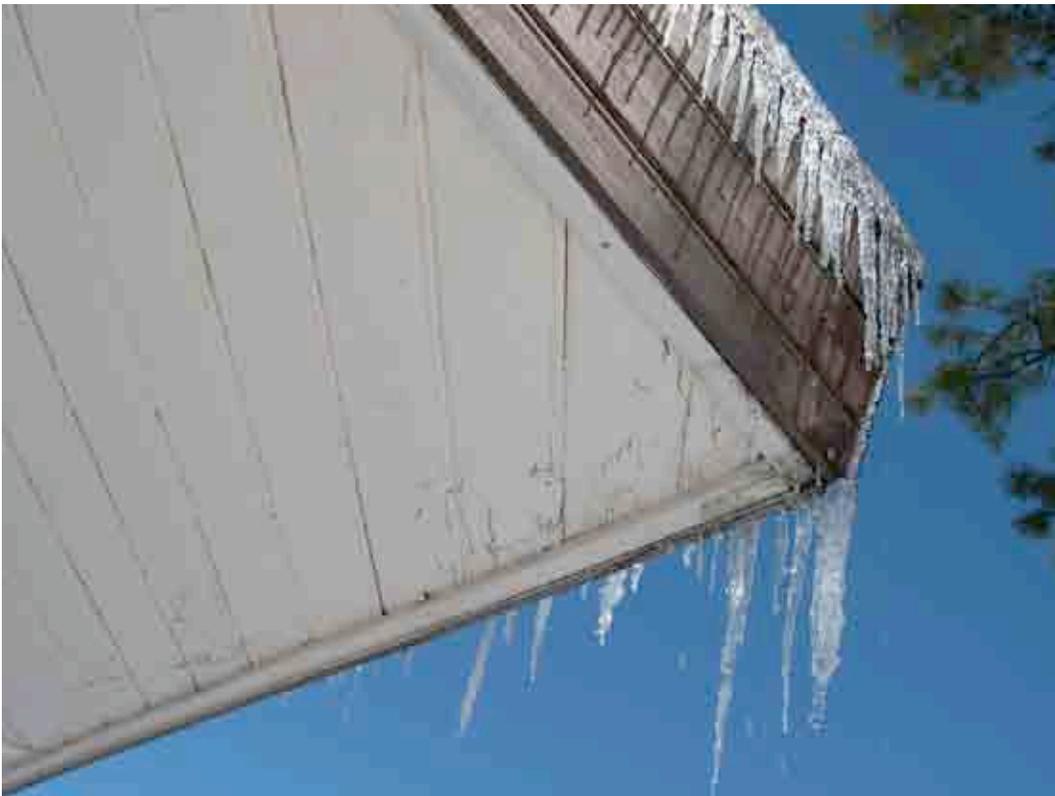
Figure 9 - Water drainage occurring at the fascia of the Pump Canopy causing damage to the wood fascia members due to an unintentional drainage system.

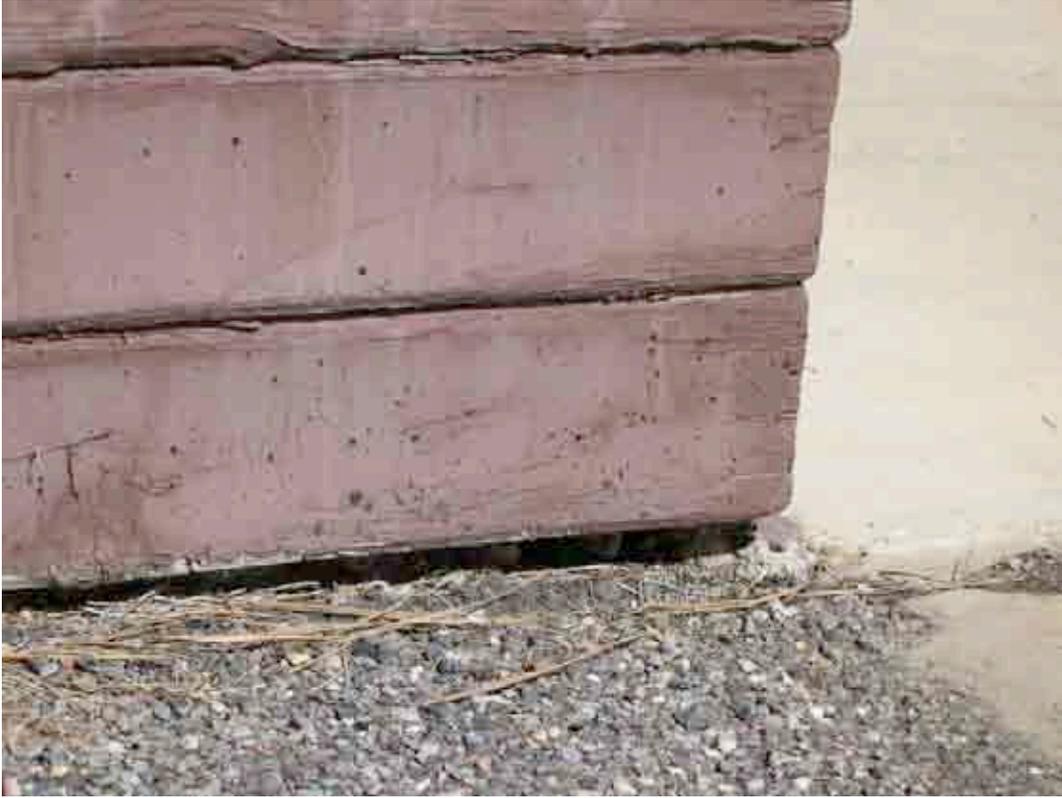
Figure 10 - Undercutting at the SE corner of the Sales Office, caused by poor site drainage.

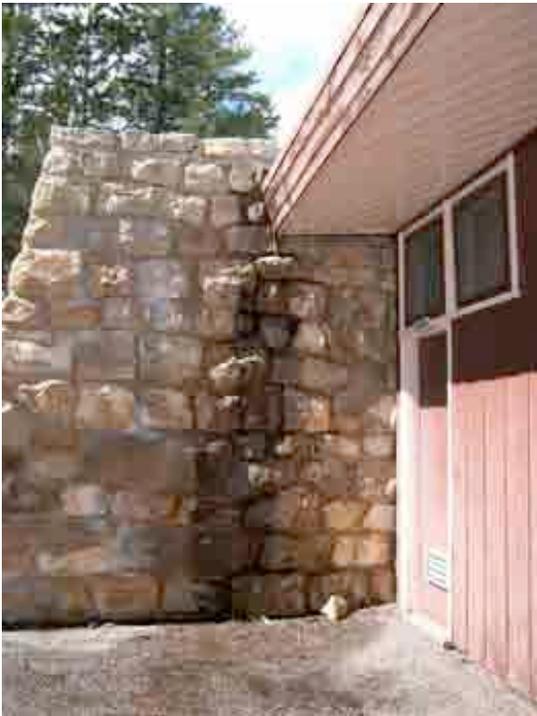
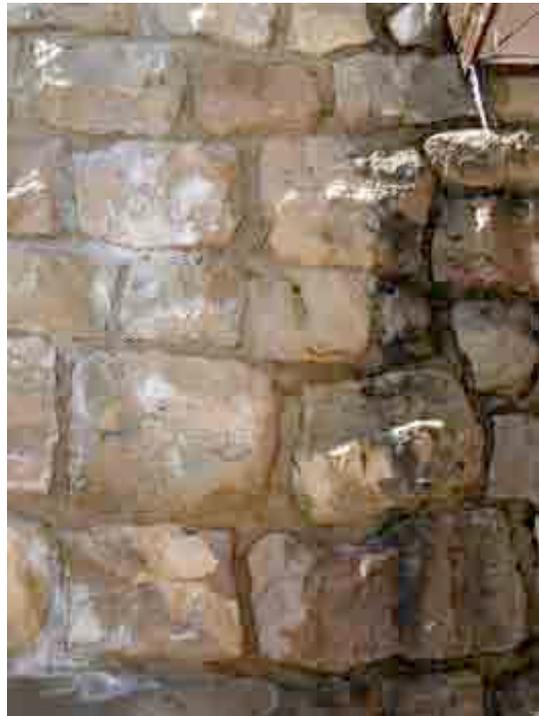
Figure 11 & Figure 12 - Efflorescence and erosion caused by poor drainage.

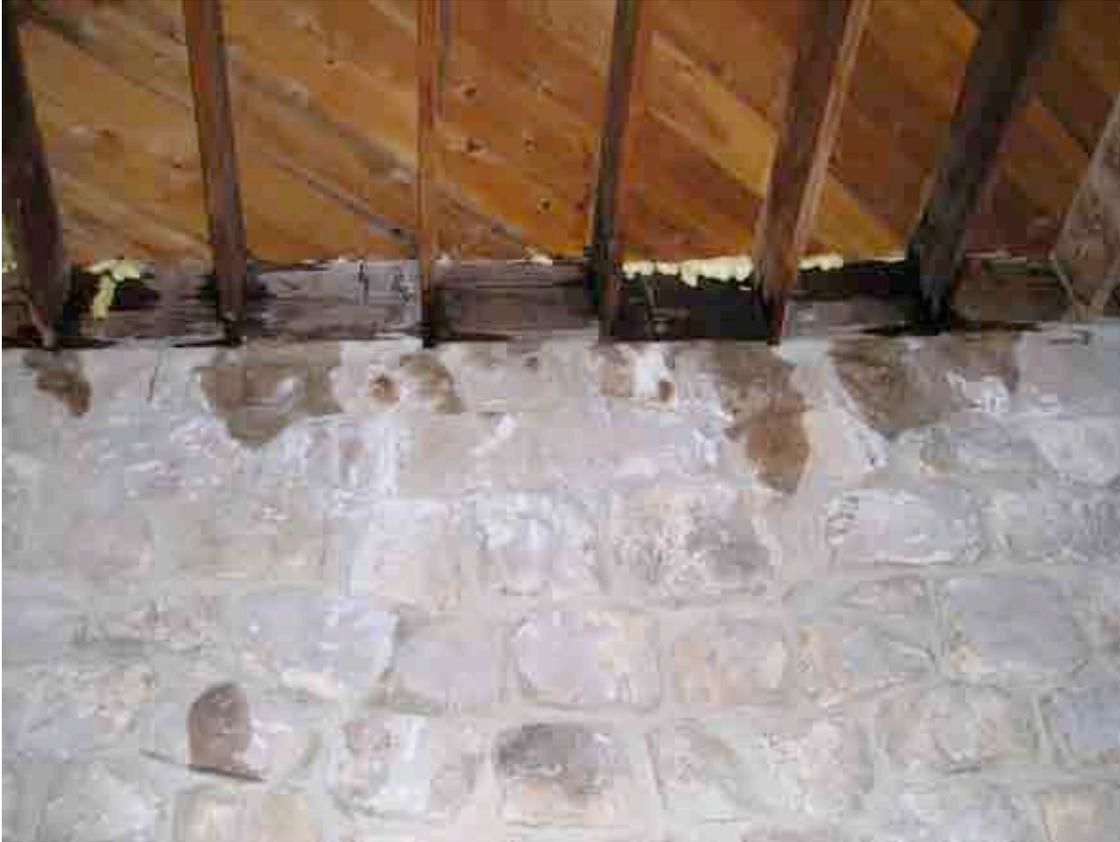
Figure 13 - Water leakage in the interior of the Utility Room between the stone wall and roof plane caused by poor water drainage and inappropriate flashing at connection between stone wall and built-up roofing membrane.

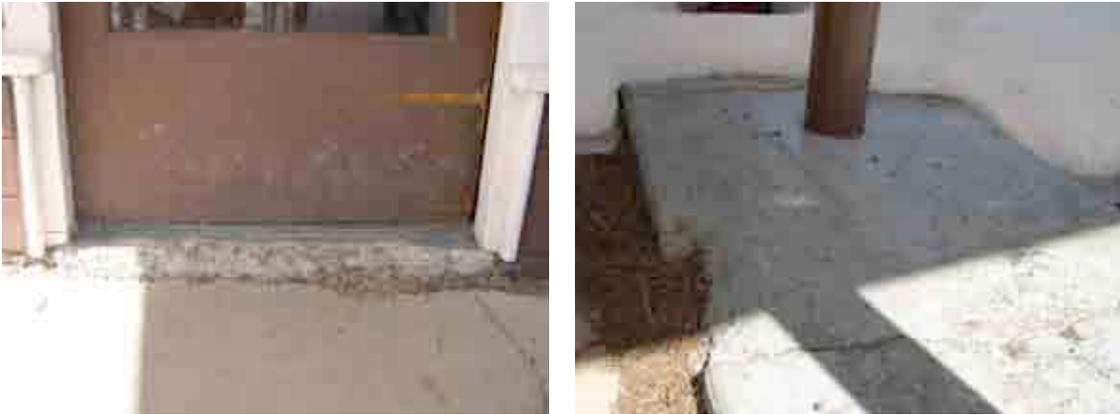
Despite some minor cracking and isolated areas of fragmentary loss due to weathering and wear, the foundation footings and floor slab are in good condition. The concrete foundation was not accessible, but holds the potential for loss of structural integrity due to insufficient drainage from roof that is visibly affecting the stone wall and the wood paneling (see *Drainage* above). The wood frame walls are in good condition, but the abutted joint between the wood frame and the stone masonry needs attention in many places where the interior walls are beginning to separate from the rear stone wall (see *Building Interior* below). The stone masonry is generally in fair condition with areas of efflorescence and biological growth. There are two cracks in the stone wall. The most significant crack is located in the Women’s Restroom and is clearly visible on the exterior façade in this area most likely caused by a small earthquake. The second crack begins at the flue in the Repair Shop and extends down at an angle into the Utility Room. This second crack, most likely caused by drilling to install new utility conduit in the Utility Room, is less severe and not visible on the exterior. The roof joists are in fair condition with water damage identified at the connection between the roof and the rear stone wall caused by poor drainage (see *Drainage* above). This water damage, however, has not compromised the structural integrity of the roof joists, but could in the future if the drainage deficiency is not resolved. In some areas, expanding foam has been inserted to prevent further water damage, but this is not an adequate solution. At the Pump Island canopy, a slight deflection was observed when that span was covered with snow.

Figure 15 & Figure 16 - Areas of concrete slab cracking and minor loss around the building exterior.

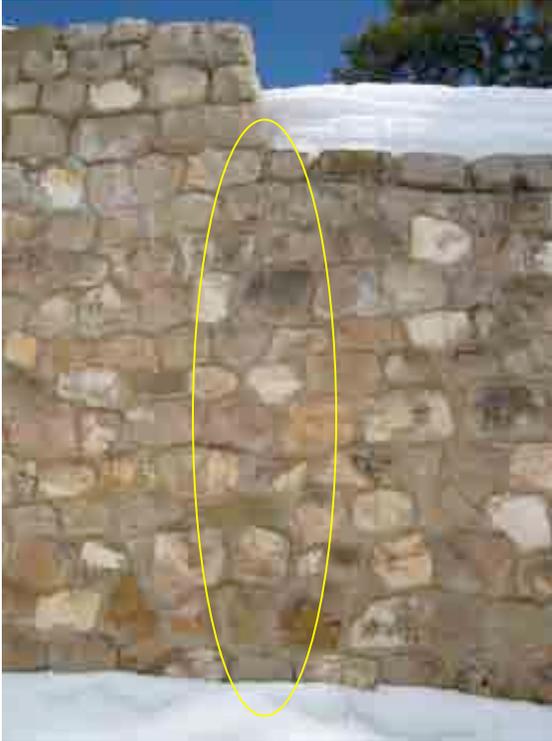
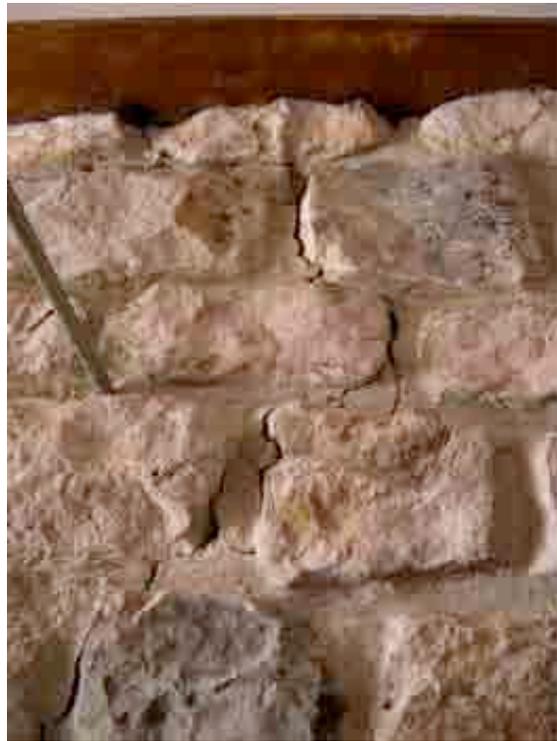
Figure 17 & Figure 18 - Large crack in rear stone wall, exterior (left) and interior (right, in Women's Restroom).

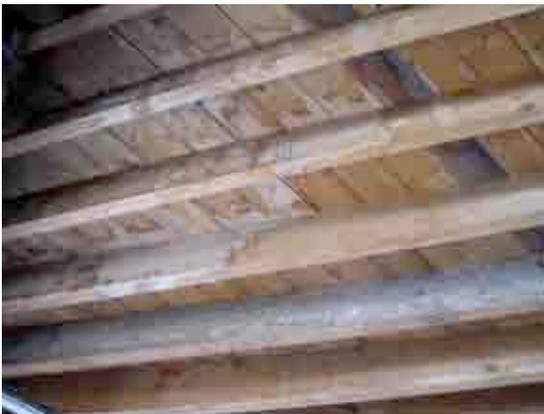
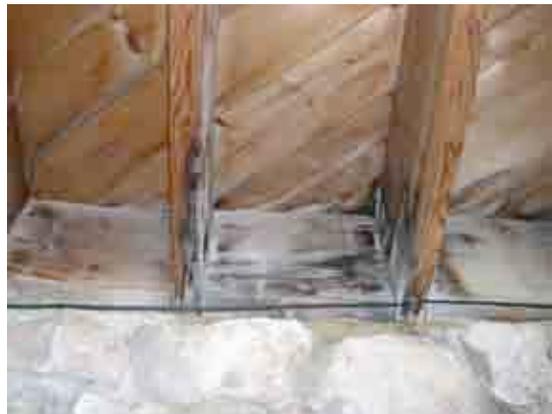
Figure 19 & Figure 20 - Areas of water damage to roof joists in Repair Shop (left) and Utility Room (right).

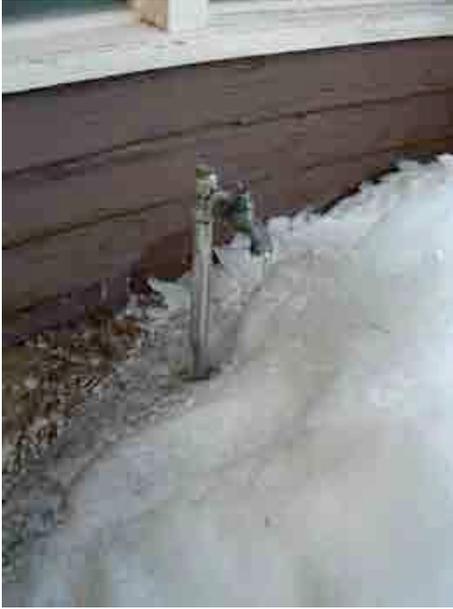
Figure 26 - Exterior water spigot, no longer functional.

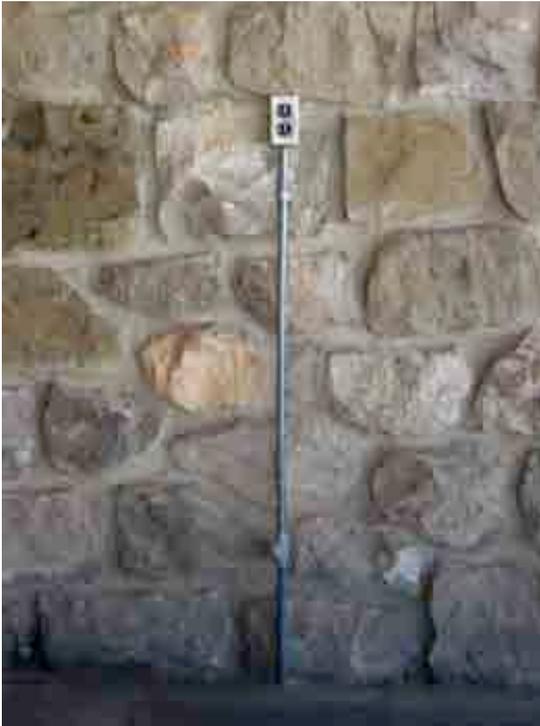
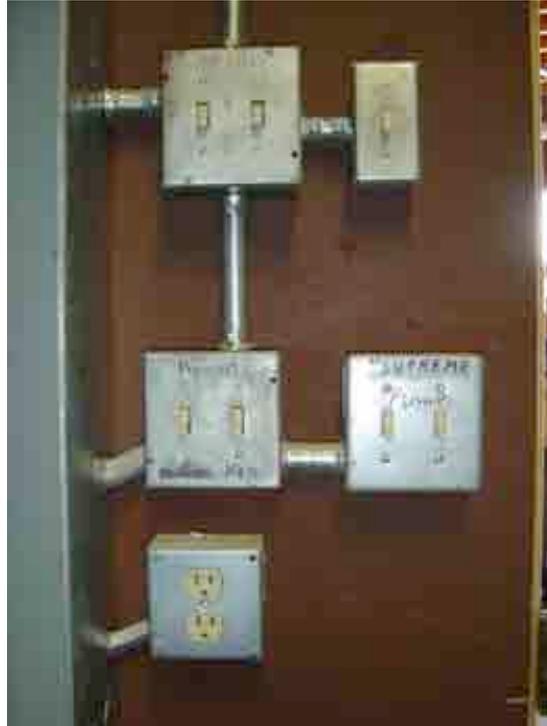
Figure 30 & Figure 31 – Original electrical outlet in Repair Shop using conduit embedded in concrete slab (left) and non-functioning switch boxes in Utility Room (right).

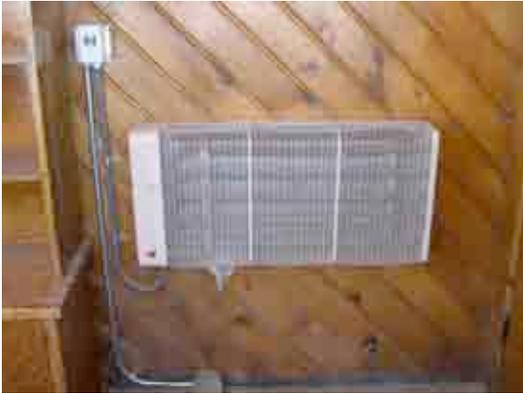
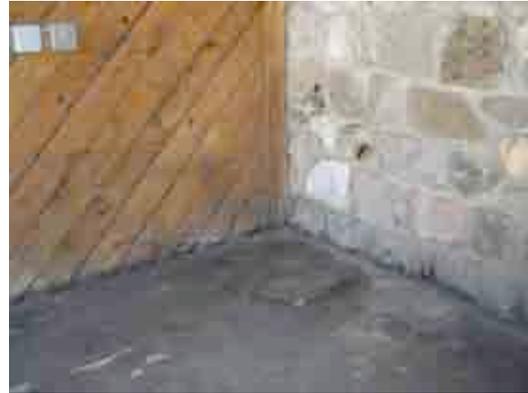
The heating, ventilation, and cooling (HVAC) systems at the Service Station are limited to a wall-mounted electric heater located in the Sales Office whose placement detracts from the visual quality of the wood paneling. The original heating system for the building was an oil-fired circulating unit that sat in the southwest corner of the Repair Shop. It has been removed, but oil residues remain on the floor and walls. The interior flue hole from this original heater remains in the rear stone wall above the location of the original heater and connects with a chimney that protrudes beyond the west façade. This flue opening is historically significant, and its original location should be maintained in the future use of the building.

Figure 34 & Figure 35 - Current wall-mounted electric heater in Sales Office (left) and location of original oil heater in the Repair Shop.

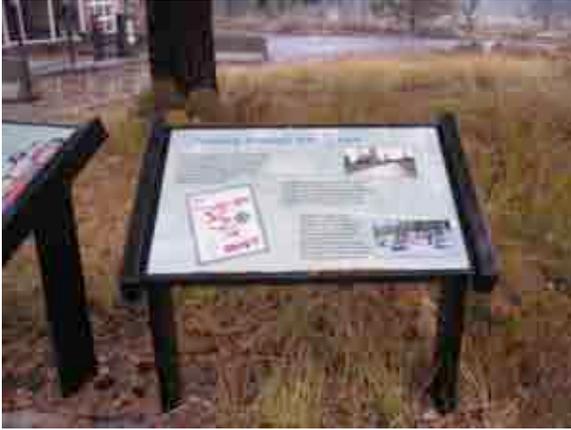
Figure 47 – Interpretive panels located in the island detracts from the visual quality of the site.

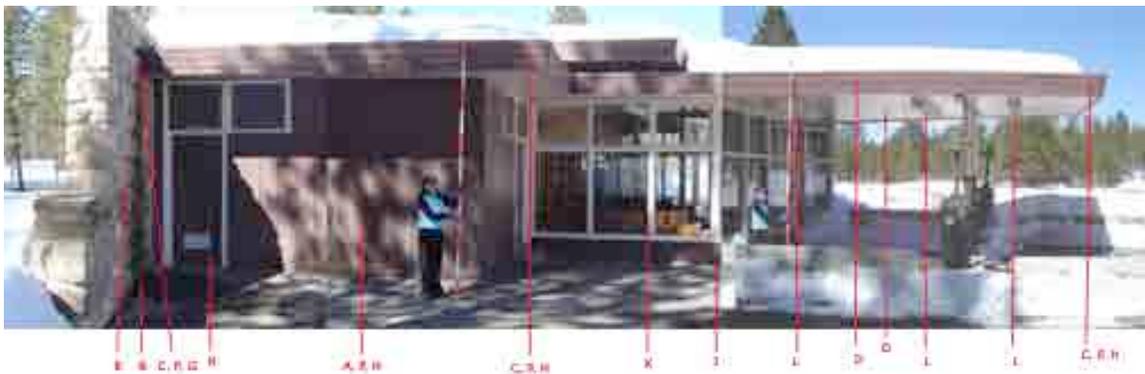
Figure 50 - South façade composite documentation photograph (letters refer to notes in condition assessment table below).

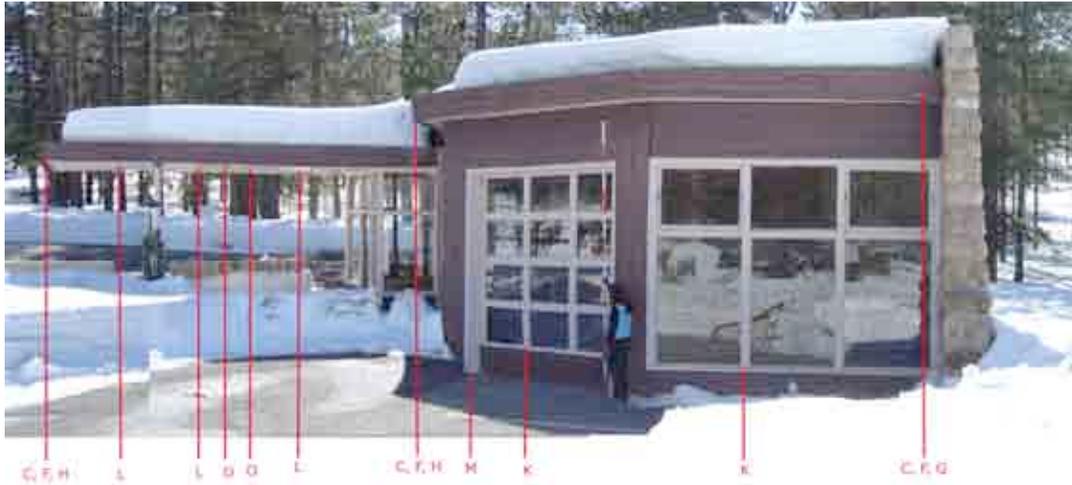
Figure 51 - North façade composite documentation photograph (letters refer to notes in condition assessment table below).

L. Rusting on exterior fluorescent light fixtures.	Replace with lighting system appropriate for period of significance and future use.	Serious
M. Cracking and loss of concrete slab at base of main entrance, garage door, and around Pump Island.	Repair with like materials	Minor
N. Scuffing/scarring of front and restroom doors.	Repair and refinish.	Minor
O. High profile vehicle damage in the form of scraped beaded board paneling on both north and south sides of the underside, fascia and metal flashing of Pump Island canopy	Repair and repaint. Replace concrete barricades with deterrent less visually intrusive and more appropriate to future use (e.g. outdoor seating). Replace metal flashing where necessary and repaint to match original.	Serious

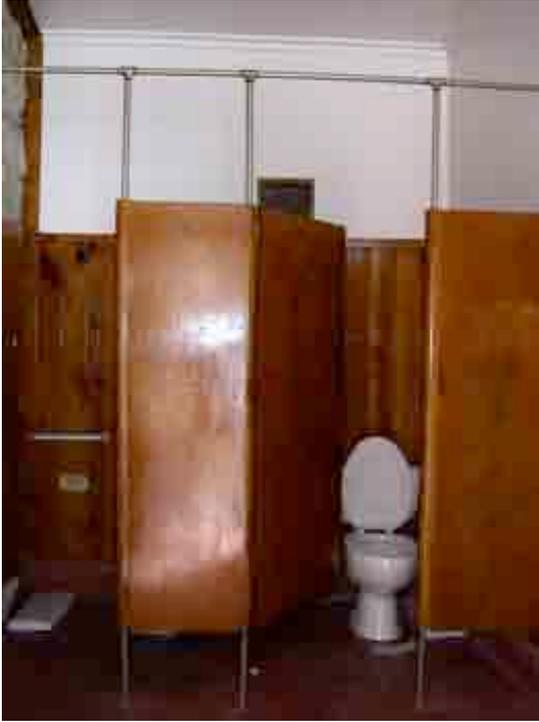
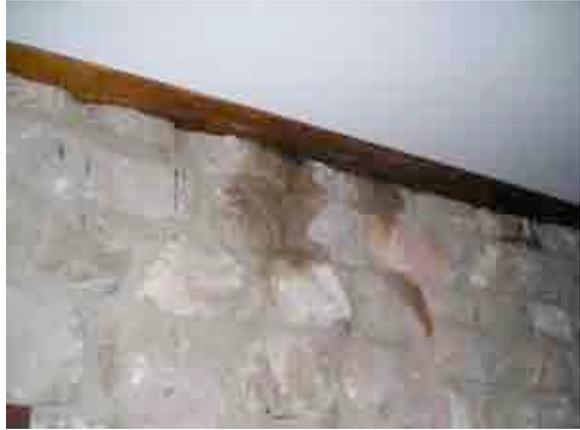
Figure 54 & Figure 55 - Wooden toilet stall partitions (left) and water damage from poor connection between stone wall and roof in Women's Restroom (right).

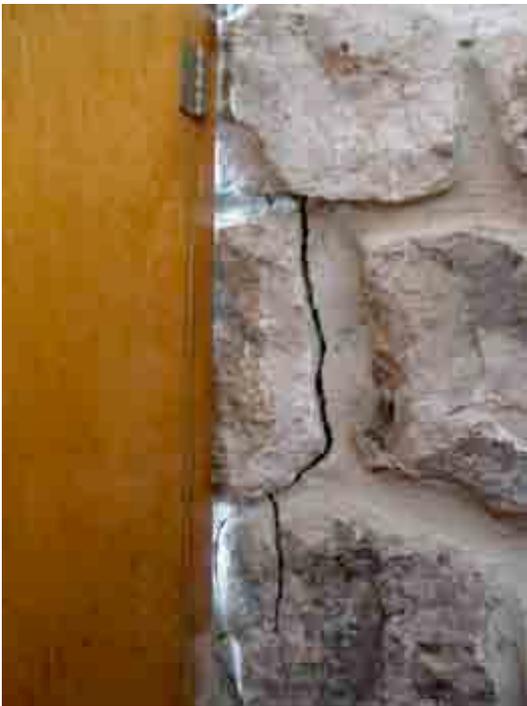
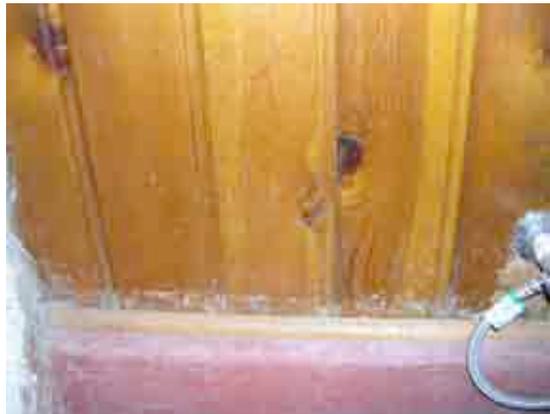
Figure 56 & Figure 57 - Vertical crack in stone wall visible on interior of restroom (left) and residue along the base of the north wall (right).

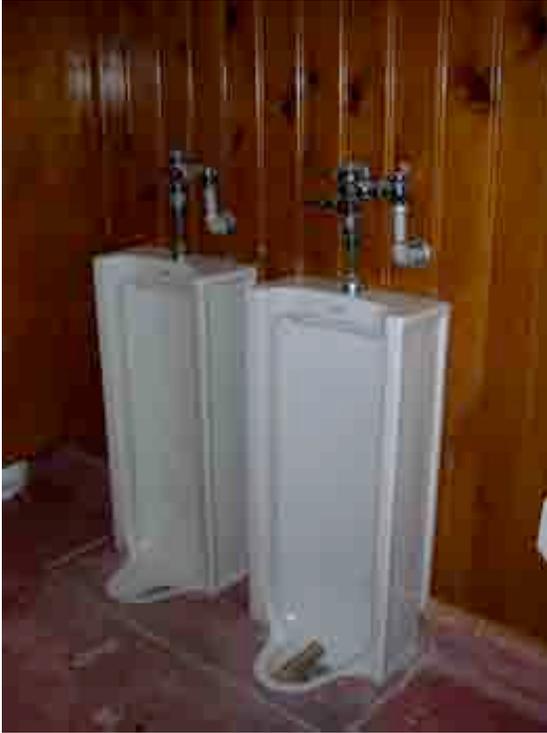
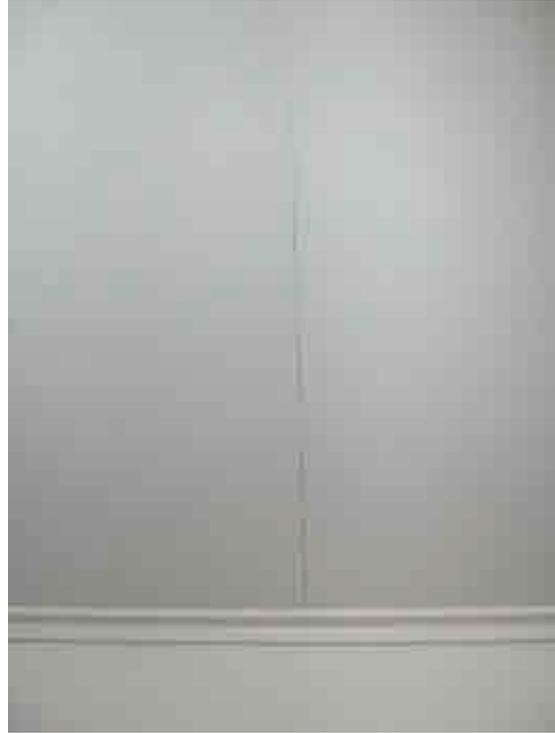
Figure 59 & Figure 60 - Original urinals showing integrated concrete floor slab and base molding (left) and crack in ceiling plasterboard, visible in both Men's and Women's Restrooms (right).

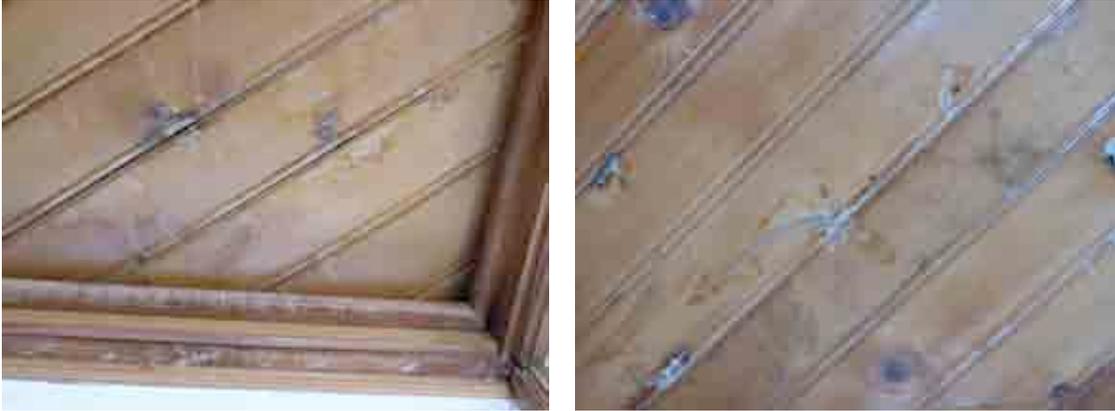
There is water damage to the pine bead-board ceiling, including staining and cracking as well as to the trim along the north wall. This damage is particularly noticeable in the northeast corner of the ceiling. There is a small area of loss to the bead-board near the fluorescent light fixture that is located in the center of the ceiling. There is also some soiling along the base of the west wall paneling, especially in the northwest corner.

Figure 62 & Figure 63 - Water damage to paneled ceiling and wood trim.

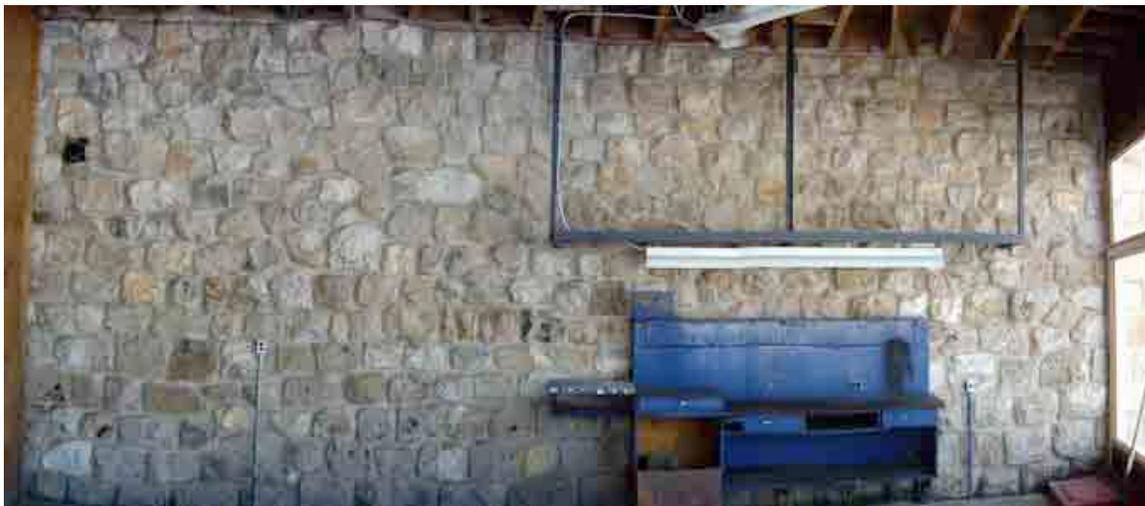
Figure 67 - Composite photograph of west stone wall from the Utility Room (far left) to the window wall (far right) showing the visually intrusive workbench.

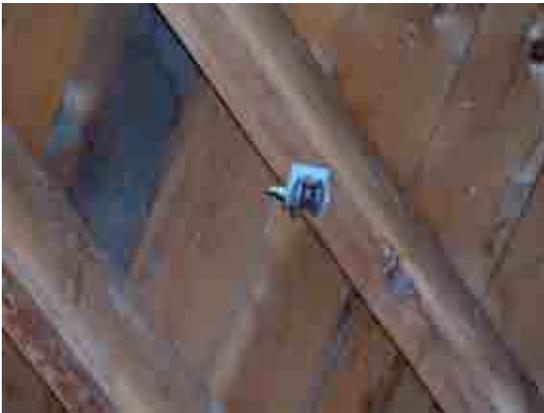
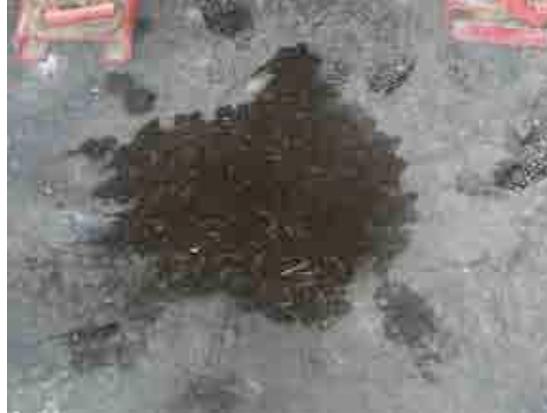
Figure 70 & Figure 71 - Abandoned pulley from garage door mechanism attached to roof joist (left) and fresh oil stains on concrete slab floor from automobile lift.

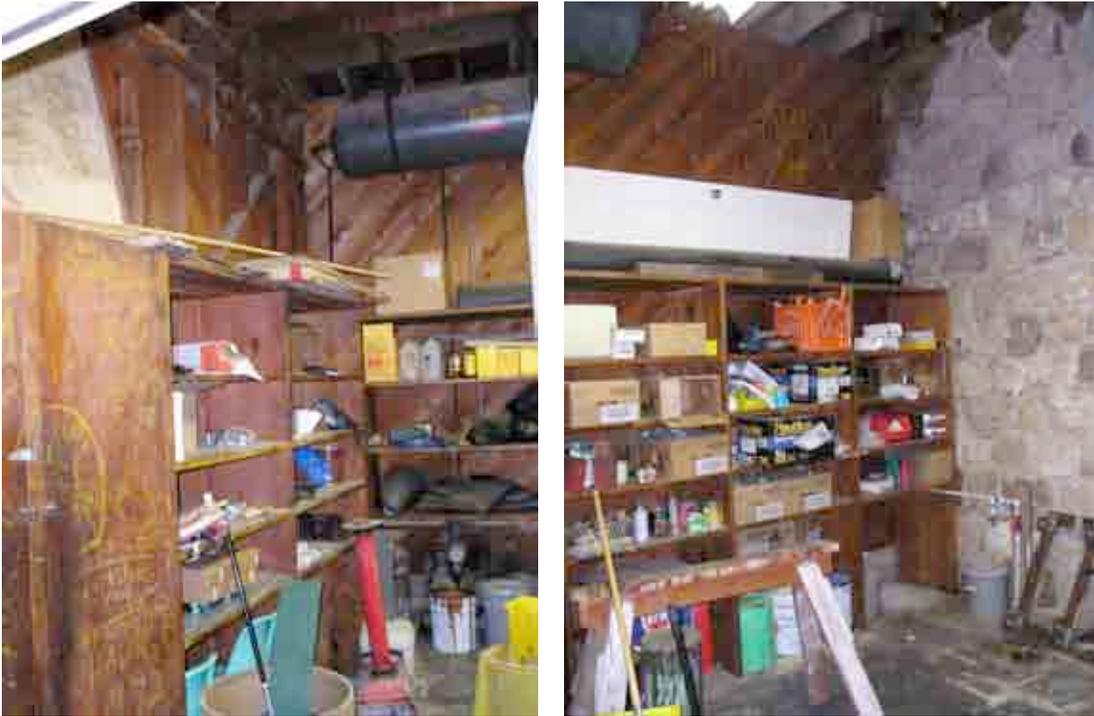
Figure 73 & Figure 74 - Cabinets on east and south walls showing the compressed air tank, exposed framing of the east wall, diagonal wood paneling of the south wall and the water stains at the connection between the stone wall and roof joists.

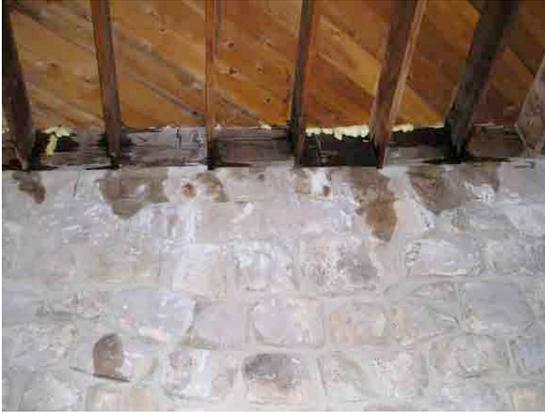
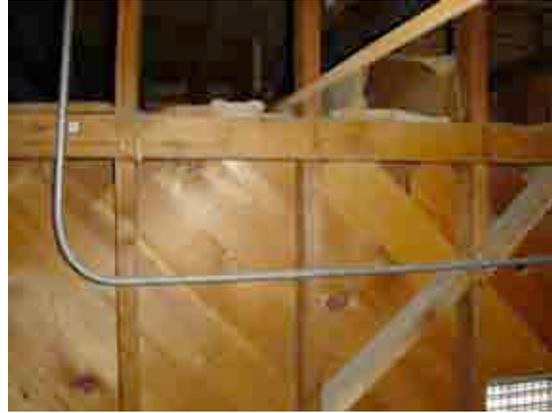
Figure 75 & Figure 76 - West stone wall showing the water stains at the connection between the stone wall and roof joist, the dripping foam used to unsuccessfully seal the joint (left) and the east exposed wood frame wall with the intersticiary space above (right).

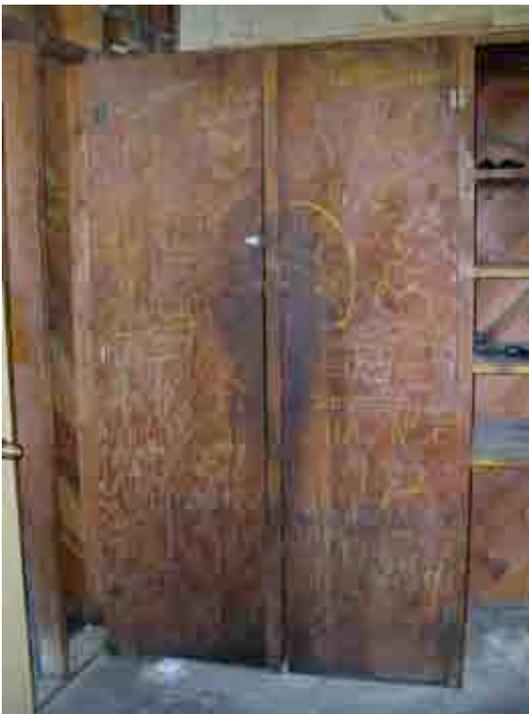
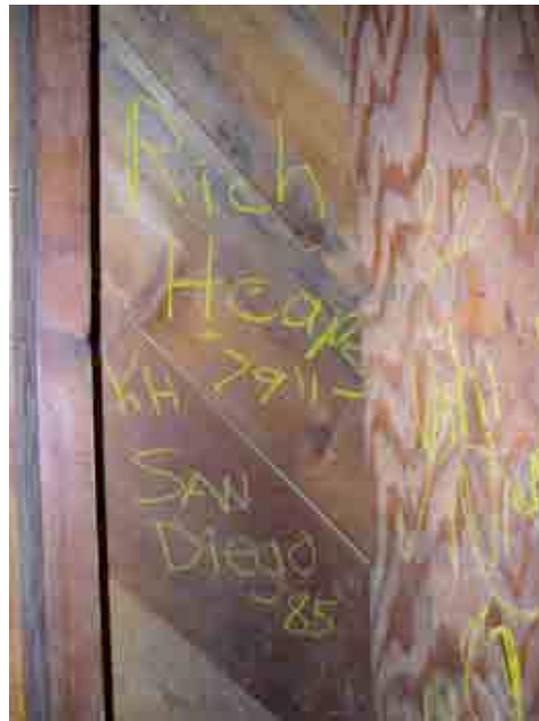
Figure 77 & Figure 78 - Yellow chalk graffiti on cabinetry and walls.
