# HISTORIC STRUCTURES REPORT

## **BATES WELL RANCH ORGAN PIPE NATIONAL MONUMENT**

A Service Learning Project of the  
Preservation Studies Program  
College of Architecture and Landscape Architecture  
The University of Arizona

May 2006

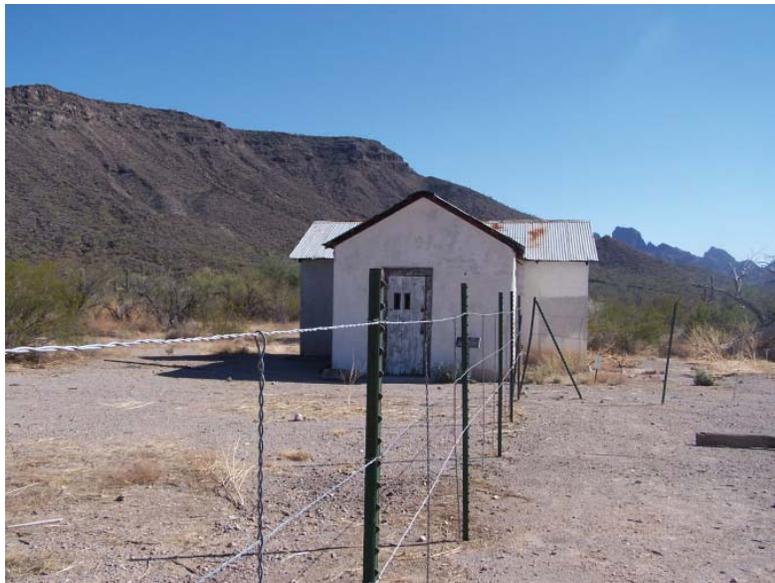
*Fig. 1 - View of the north elevation of the Main Residence.*

The main house is in the best shape of all the buildings on the site. The exterior is in good shape with small cracks in the stucco surface. The corrugated steel roof is in need of some attention with many holes from previous nails and rusting from age. The window openings have been boarded up from the outside with smaller 1 foot by 2 foot openings cut into the plywood and screened with quarter inch steel mesh. The glazing is gone and many of the frames are missing as well. The ceiling material has all but fallen down and there are several pieces of the wall material missing as well. The kitchen cabinets and the stove are intact. The linoleum flooring is peeling back and revealing the wood floor below. The interior is weathered from the leaking roof but there is no evidence of mold.

At the very least the roof should be sealed to prevent further infiltration of water into the exterior.

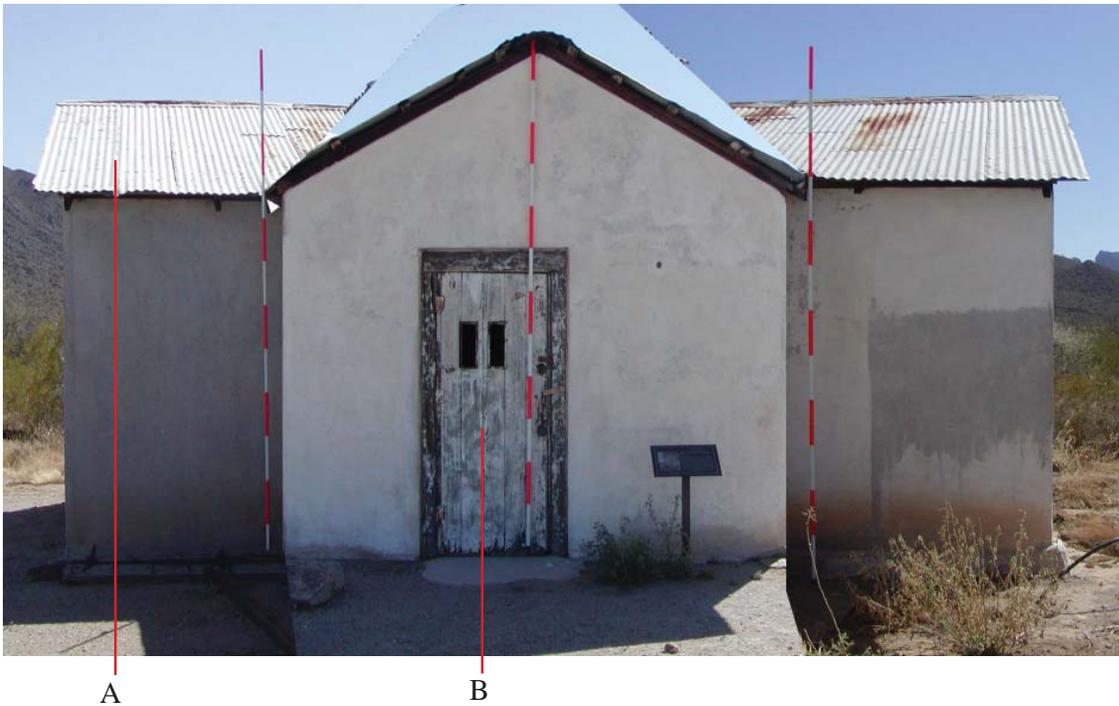
*Fig. 2 - North elevation of the Main Residence (letters refer to notes in condition assessment table below)*

<b>Deficiencies</b>	<b>Recommended Treatments</b>	<b>Priority</b>
A	Corrugated Steel rusted through	Replace or seal roof from further water damage	Serious
B	Rotted/termite infested Wood	Application of biocides where severe damage.	Critical
C	Missing Components	Replace lost components	Serious
D	Water Damage	Repair/repalce roof and reinstall damaged material.	Serious
E	Broken Window Framing/ glazing	Replace and repair as needed	Serious
F	Items added after period of significance	Remove and return to original state	Critical

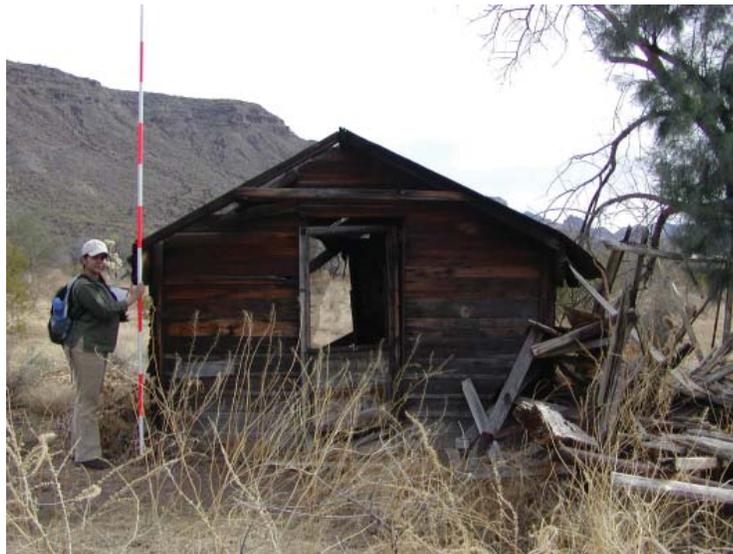
*Fig. 1 - View of the north elevation of the Small Residence.*

The building was in poor condition in 1986 when the nomination was made and has continued to deteriorate. The southeast corner of the building has failed and the building is leaning in this direction. It is only a matter of time before the balance of the building fails as well. It is strongly recommended that building be shored up until a final determination can be made.

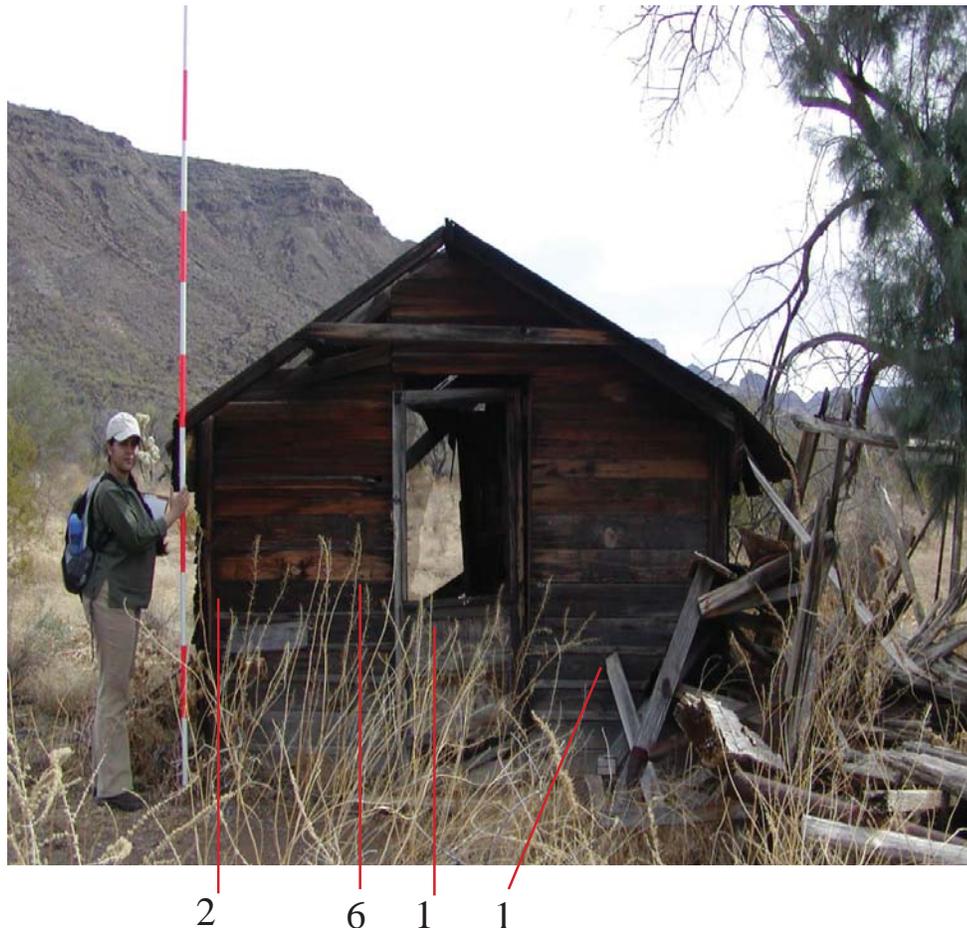
*Fig. 2 - North elevation of the Small Residence (letters refer to notes in condition assessment table below)*

<b>Deficiencies</b>	<b>Recommended Treatments</b>	<b>Priority</b>
A	Corrugated Steel rusted through	Replace or seal roof from further water damage	Serious
B	Rotted/termite infested Wood	Application of biocides where severe damage.	Critical
C	Missing Components	Replace lost components	Serious
D	Water Damage	Repair/repalce roof and reinstall damaged material.	Serious
E	Broken Window Framing/ glazing	Replace and repair as needed	Serious
F	Structural Failure	Repair structural damage	Critical

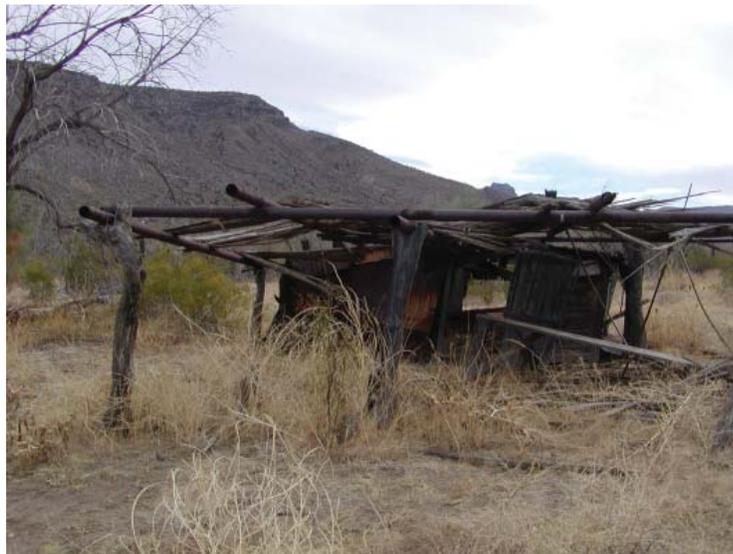
*Fig. 1 - View of the north elevation of the Blacksmith Shop with Ramada located in front of shop building.*

The Blacksmith shop, like many of the buildings on site appears to be built from found materials. The materials such as dimensional lumber, railroad ties, corrugated steel panels, and steel pipe were more than likely taken from buildings nearby-possibly Growler Mine. The materials have extraneous nails and nail holes inconsistent with the present use. There is also the use of mesquite branches and trunks for structural members and saguaro ribs for sheathing of the ramada roof. The most interesting feature of the building is the use of cedar shakes for the roof material. This material was not found anywhere else on site. The height of both structures is also interesting and believed to be the result of the size of the material used specifically the length of a railroad ties which are commonly 8' in length. Ballast 3 feet into the ground and there is 5 feet remaining-the height of the ramada and the ridge peak of the shop.

Overall condition of each structure is very poor and without proper intervention the structures should be expected to collapse. Shoring up the southwest corner of the building and elements of the ramada should be undertaken until a final determination is made on the site. Additionally, trees and grasses growing in, under and within 20 feet of the building should be removed to prevent possible fire damage.

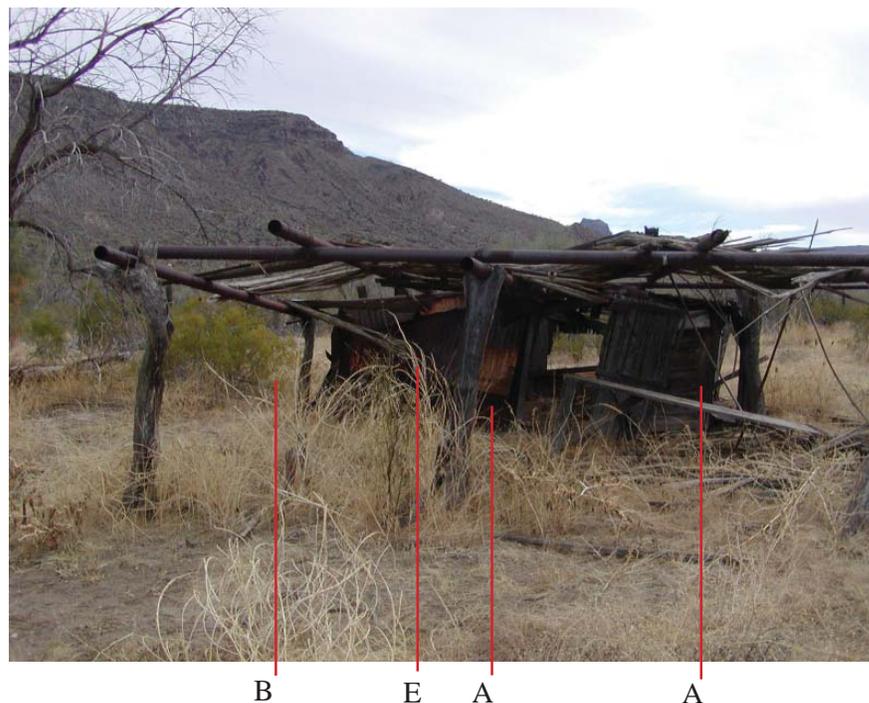
*Fig. 2 - North Elevation of Blacksmith Shop (letters refer to notes in condition assessment table below)*

<b>Deficiencies</b>	<b>Recommended Treatments</b>	<b>Priority</b>
A	Corrugated Steel rusted through	Replace rusted material	Serious
B	Rotted/termite infested Wood	Application of biocides where severe damage.	Critical
C	Missing Components	Replace lost components	Serious
D	Water Damage	Repair/repalce roof and reinstall damaged material.	Serious
E	Broken Window Framing/ glazing	Replace and repair as needed	Serious
F	Structural Failure	Repair structural damage	Critical

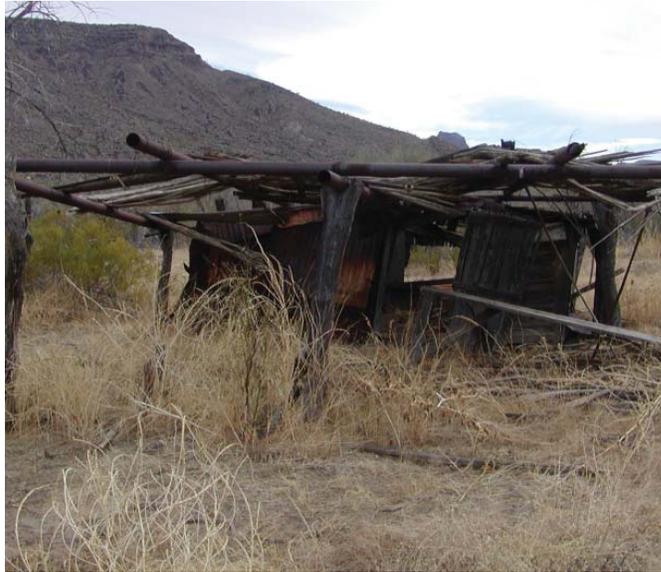
*Fig. 6 -North Elevation of the Ramada with Blacksmith Shop behind.*

The Ramada is intact but it is difficult to complete an evaluation of the structure because we do not know the original intent of the builder. The material placed on top is composed of dimensional lumber, saguara ribs, and more steel pipe. There is many pieces of this material laying on the ground below the structure and it is assumed that this material at one time sat on top of the ramada. Structurally the ramada is ridge possibly having more to do with being tied on a grid system with the steel piping than the columns' foundations.

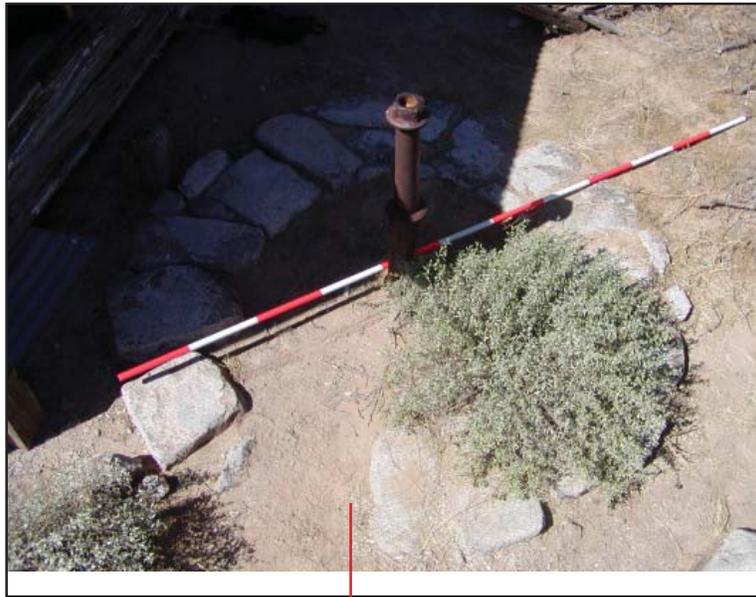
*Fig. 2 - View of Arrastra from the South (letters refer to notes in condition assessment table below)*

<b>Deficiencies</b>	<b>Recommended Treatments</b>	<b>Priority</b>
A	Missing Granite Stones	Replace with same	Serious
B	Missing arm and wheel	Replace if period becomes part of significance.	None

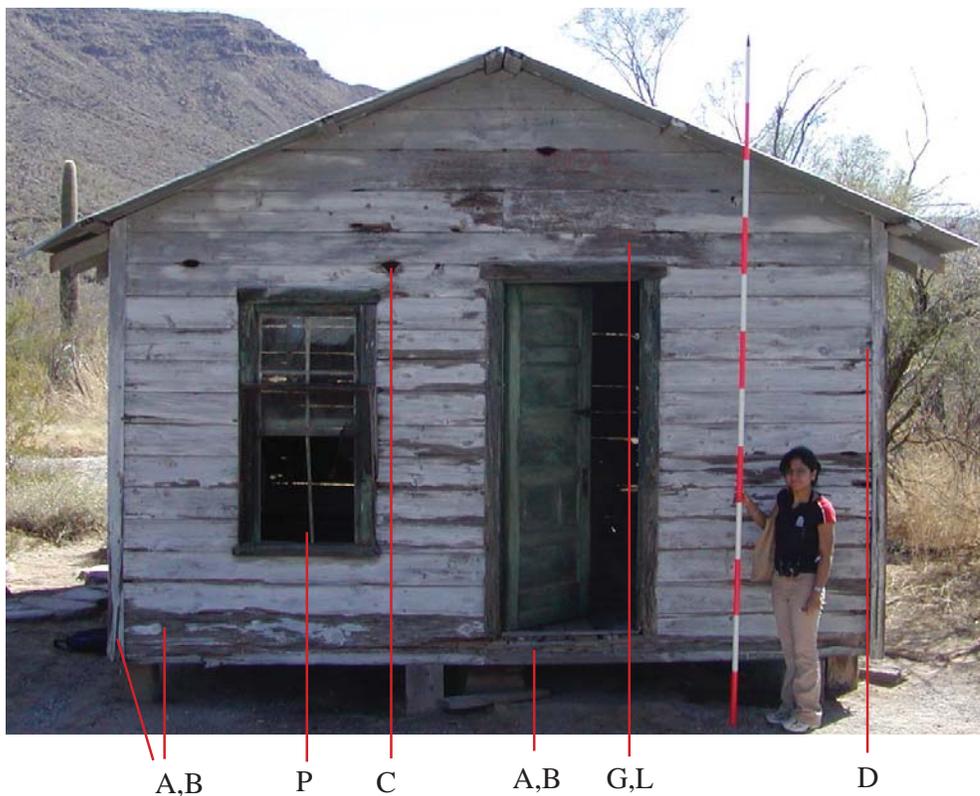
*Fig. 3 - East elevation of the Bunkhouse  
(Letters refer to notes in condition assessment table ahead)*

<b>Deficiencies</b>	<b>Recommended Treatments</b>	<b>Priority</b>
A	Water damage to wood paneling and facia including warping and splintering.	Correction of the source of water Replace the wooden planks where severely damaged; match the size & type of wood to existing.	Serious
B	Rotting of wood due to microorganisms/ pests (also termite) infestation.	Application of biocides where severe damage.	Serious
C	Missing parts from wood planks	Replace entire plank where substantial parts missing or structural stability is endangered.	Critical
D	Corrosion and deterioration of wood around iron nails on edges.	Apply anti-rust coating on nails before replacement planks are installed.	Serious
F	Falling apart of the metal sheets on the roof	Replace/reattach the portions that are coming apart. Use identical sheeting for replacement	Critical
G	Staining of wood due to water damage.	Correction of the source of water; pay attention to roof leaks & holes in wall panels.	Serious

I	Tilting of the structural wooden posts leading to de-stability & bending of the shed sideways.	Stabilise the structure by realigning the main structural posts. If necessary reassess the condition of the tie-beam and strengthen it to bind the structure	Critical
J	Falling apart of the wooden planks near the base of the structure.	These pieces should be nailed back to the structure.	Critical
K	Sagging of the floor.	The cause of the problem should be addressed , for e.g. the whole floor should be repaired.	Critical
L	Missing Paint coat	Reapply paint on the facades. It should exactly match the old one in appearance & properties.	Serious
M	New window frames nailed onto original facade	New parts should be removed after being well documented	Serious
N	Missing pieces from the Gypsum board paneling & false ceiling in the interior	The paneling should be replaced if too severely damaged	Serious
O	Water damage on the Gyp-board	Address source of seepage & replace board if extensively damaged	Serious

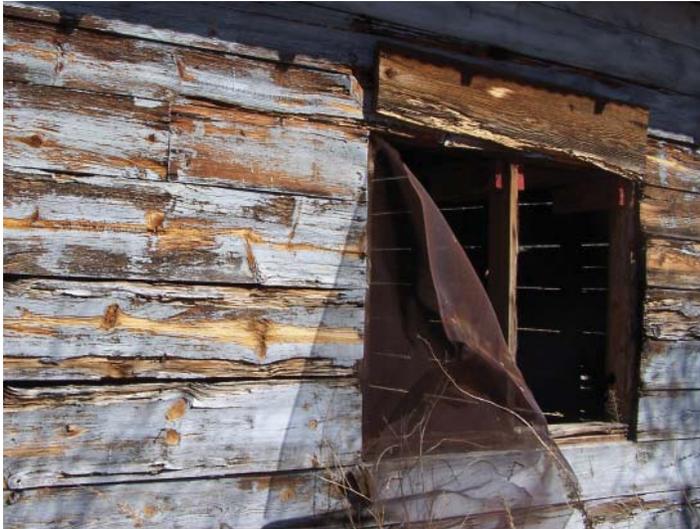
*M, A, B. Detail view of window on west elevation. Note the wire mesh screen coming off & new board above*

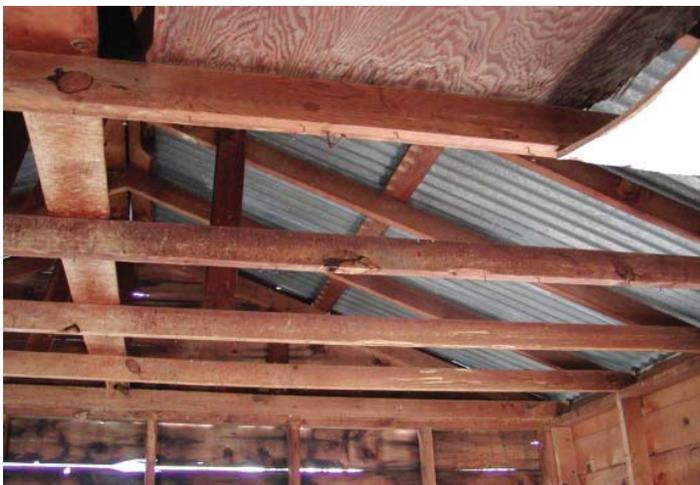
*View of the roof trusses. Note the relatively new metal sheeting on the roof*

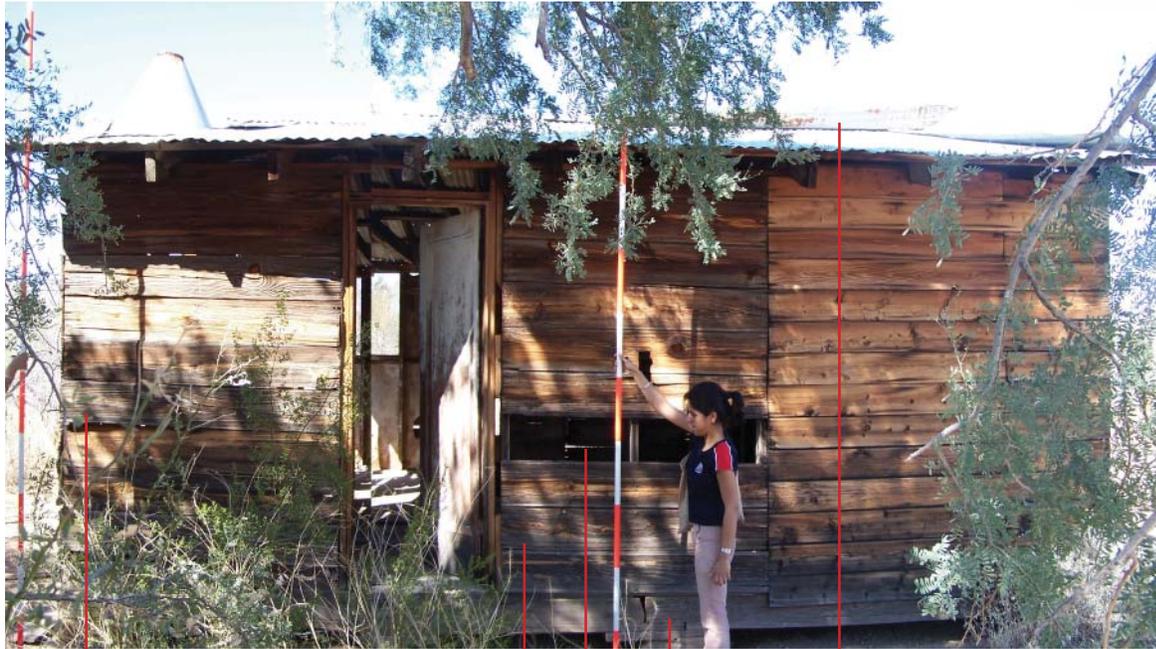
Fig. - West elevation of the Hay Barn  
(Letters refer to notes in condition assessment table ahead)

<b>Deficiencies</b>	<b>Recommended Treatments</b>	<b>Priority</b>
A	Water damage to wood paneling and fascia including warping and splintering.	Correction of the source of water Replace the wooden planks where severely damaged; match the size & type of wood to existing.	Serious
B	Rotting of wood due to microorganisms/ pests (also termite) infestation.	Application of biocides where severe damage.	Serious
C	Missing parts from wood planks	Replace entire plank where substantial parts missing or structural stability is endangered.	Critical
D	Corrosion and deterioration of wood around iron nails on edges.	Apply anti-rust coating on nails before replacement planks are installed.	Serious
E	Rusting of the corrugated metal roof due to water damage	Replace the sheets which are severely rusted.	Serious
F	Falling apart of the metal sheets on the roof	Replace/reattach the portions that are coming apart. Use identical sheeting for replacement	Critical

G	Staining of wood due to water damage.	Correction of the source of water; pay attention to roof leaks & holes in wall panels.	Serious
I	Tilting of the structural wooden posts leading to de-stability & bending of the shed sideways.	Stabilise the structure by realigning the main structural posts. If necessary reassess the condition of the tie-beam and strengthen it to bind the structure	Critical
J	Falling apart of the wooden planks near the base of the structure.	These pieces should be nailed back to the structure.	Critical
K	Sagging of the floor.	The cause of the problem should be addressed , for e.g. the whole floor should be repaired.	Critical
N	Missing pieces from the Gypsum board paneling & false ceiling in the interior	The paneling should be replaced if too severely damaged	Serious

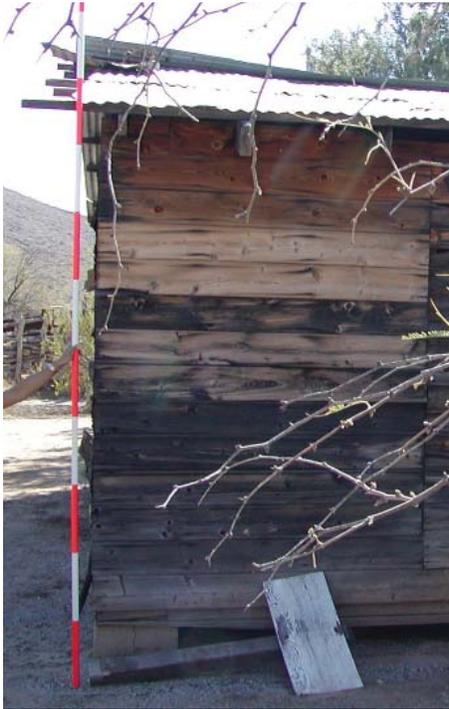
*J. Detail view of north facade. Note the plank that is falling apart off near the base of the structure*

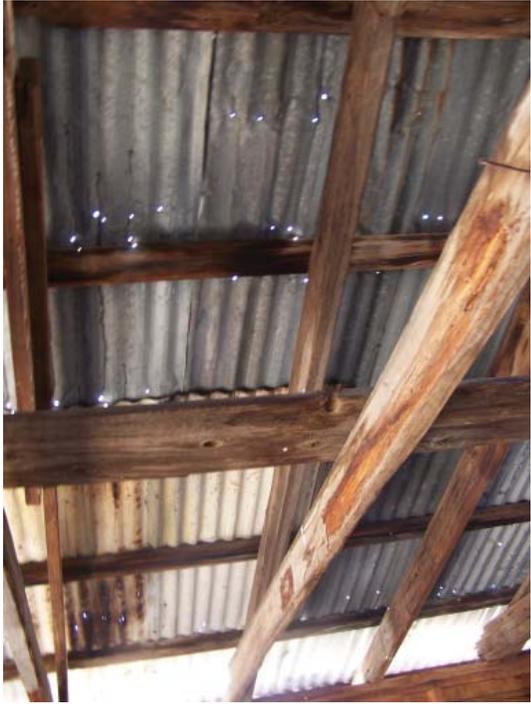
*E. Detail view of metal roofing from the interior. Notice the rusting of sheets.*

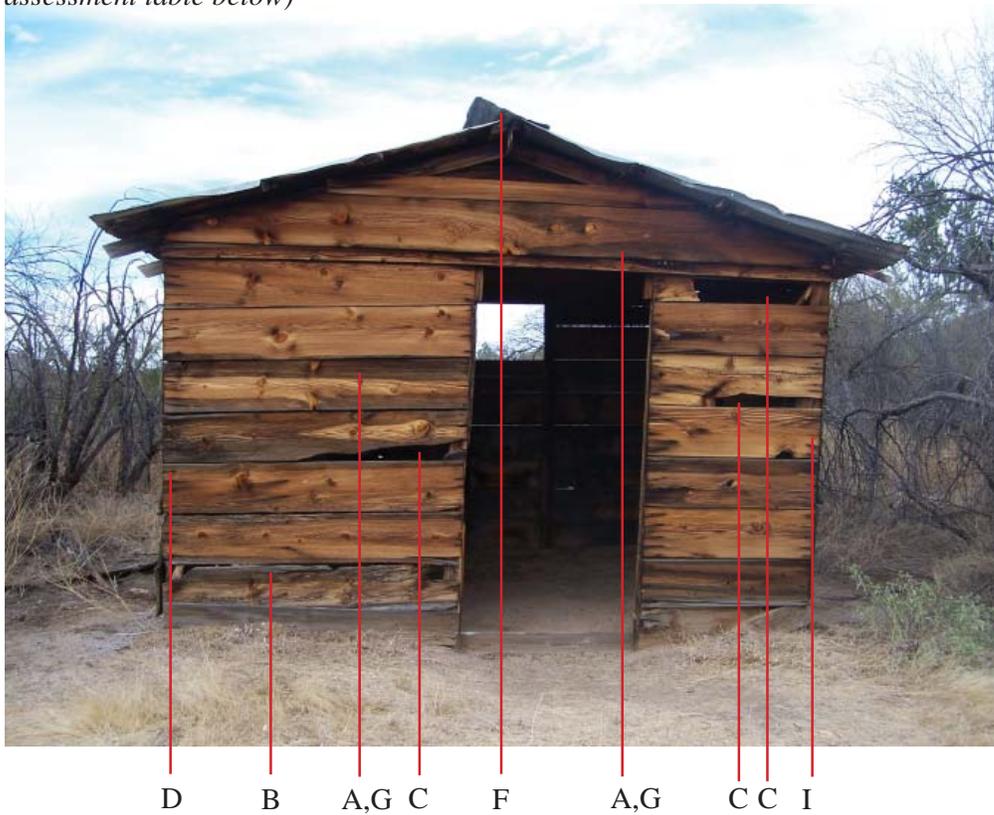
Fig. 3 - South elevation of the Tack House (letters refer to notes in condition assessment table below)

At present, the condition of the structure has been assessed as fair relative to the condition of the other ranch structures on site. However, there are many pressing problems which need to be addressed. Firstly, the shed has tilted sideways and suffers from bulging of the wooden posts leading to structural de-stability. The wooden planks suffer from extensive rotting and staining. The major causes are animals / pests and termite infestation. The other major cause is moisture damage. As a result there is rusting at the juncture of wood & iron nails, leading to eventual corrosion of the surrounding wood. Thus either entire planks get disjointed or else rotten pieces fall off leading to gaping holes in the exterior facade. The metal roof displays rusting too. Also, the surrounding mesquite trees are pretty close to the building surface barring the south elevation, and may pose a fire hazard.

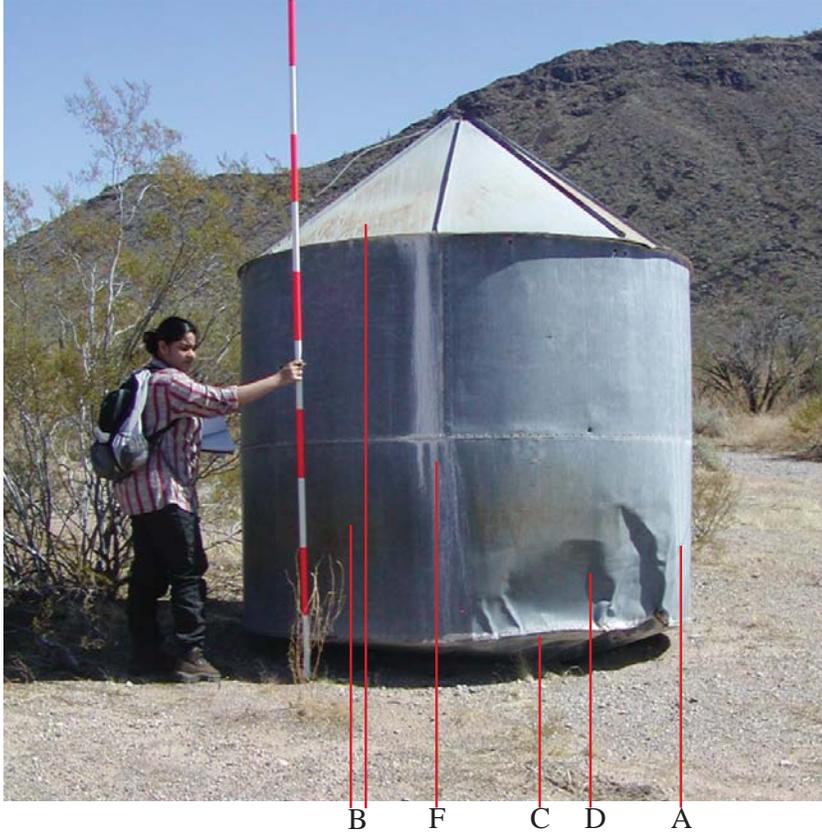
Fig. 3 - East elevation of the water tank  
(letters refer to notes in condition assessment table)

<b>Deficiencies</b>	<b>Recommended Treatments</b>	<b>Priority</b>
A	Material displacement	Reorganize elements into a more cohesive cluster: rebuild water tank platform, orient with concrete slab	Critical
B	Corrosion of iron due to water	Chemically treat or replace elements whose integrity is damaged by corrosion	Critical
C	Convexity caused by structural damage	Reform the tank bottom	Serious
D	Concavity in metallic sheeting	Reform the tank sides	Serious
E	Vegetable overgrowth	Trim or remove vegetation that obscures visibility and orientation of elements into a cohesive grouping	Serious
F	Staining of material due to water	Allow to occur naturally	Low

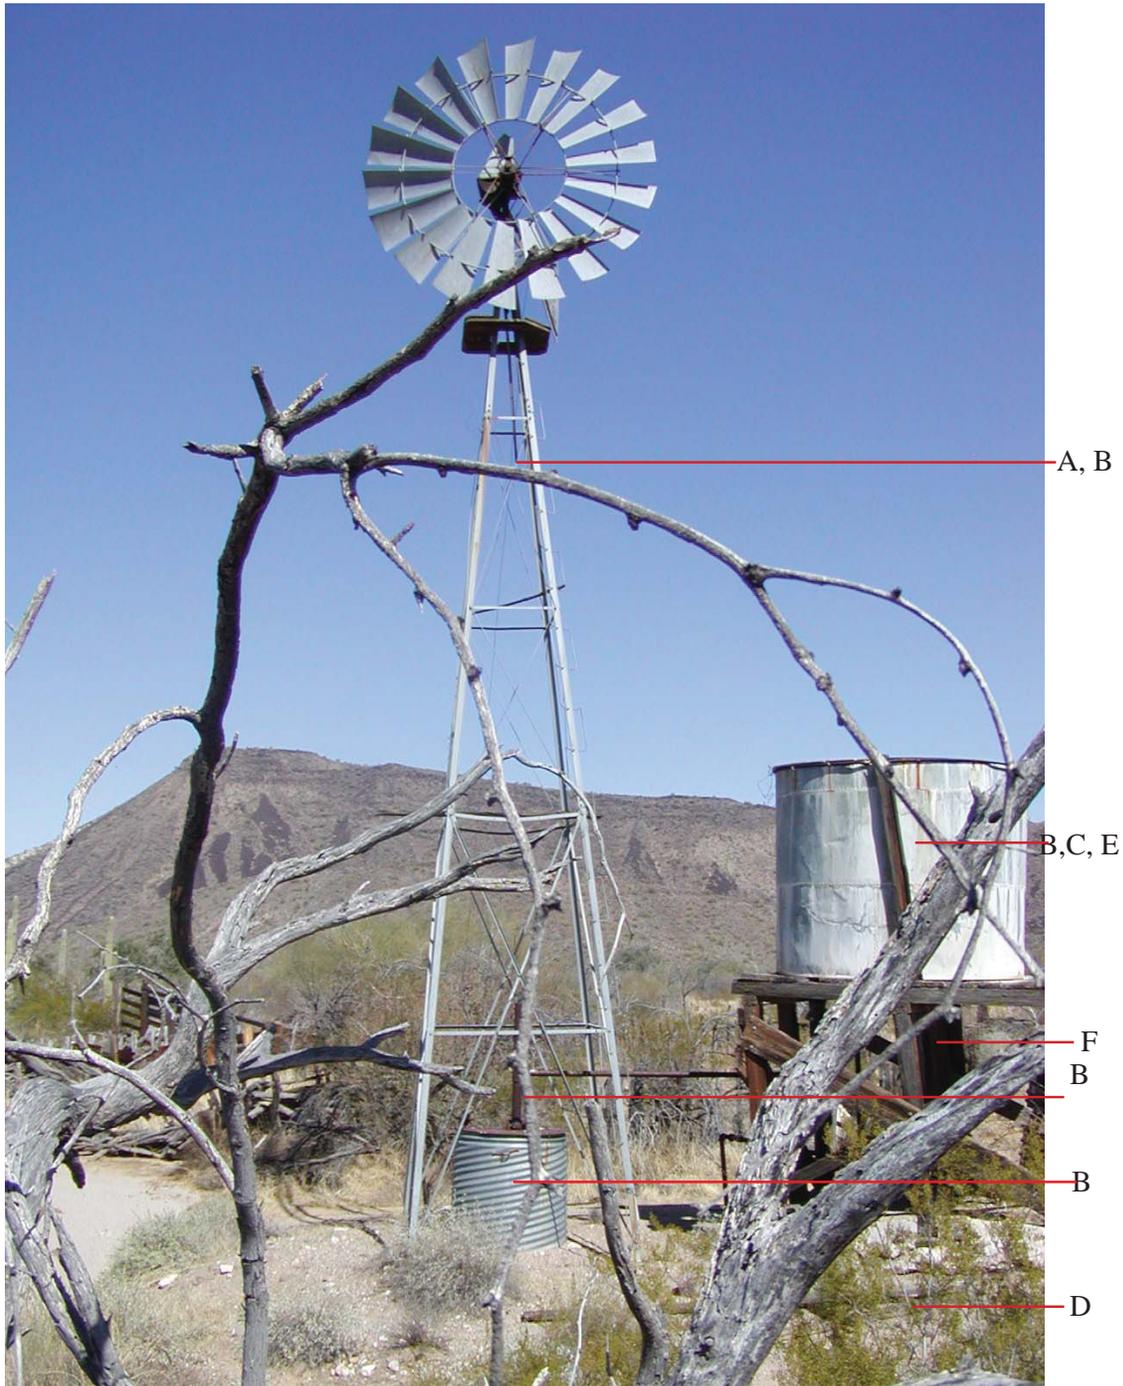
*Fig 3. View of Windmill #2 from the west side showing existing damages and deficiencies. (letters refer to notes in condition assessment table below)*

<b>Deficiencies</b>	<b>Recommended Treatments</b>	<b>Priority</b>
A	Detached, Deformed and/or missing components. Connector between rotor and well pump detached. Horizontal members on windmill A frame bent.	Repair and Reattachment of existing members if possible. Replacement of damaged/missing members.	Critical
B	Rusting of metal parts Well cap, pipe	Chemically treat or replace elements whose integrity has been damaged by corrosion	Critical
C	Warping of Water Tank metal sheet	Reform appropriately and affix in place.	Serious
D	Vegetation Overgrowth around Structure	Trim or remove vegetation that obscures visibility and orientation of elements into a cohesive grouping	Serious
E	Staining of material due to water	Allow to occur naturally	Low
F	Rotting and Warping of wooden members in water tank platform	Chemically treat or replace members whose integrity has been compromised.	Serious

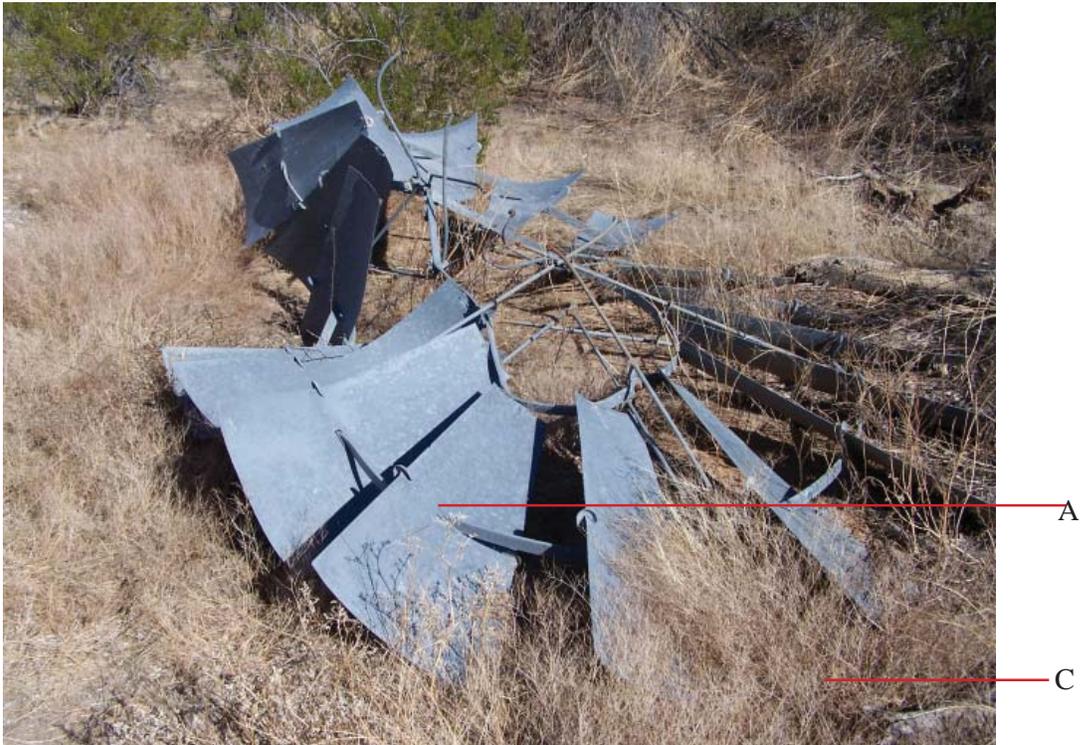
*Fig. 4 - Blades from Windmill#3 lie on the ground near its base. (letters indicate damages and deficiencies based on table that follows*
