HISTORIC STRUCTURE REPORT

FIRST ADMINISTRATION BUILDING

GRAND CANYON NATIONAL PARK

June 2008

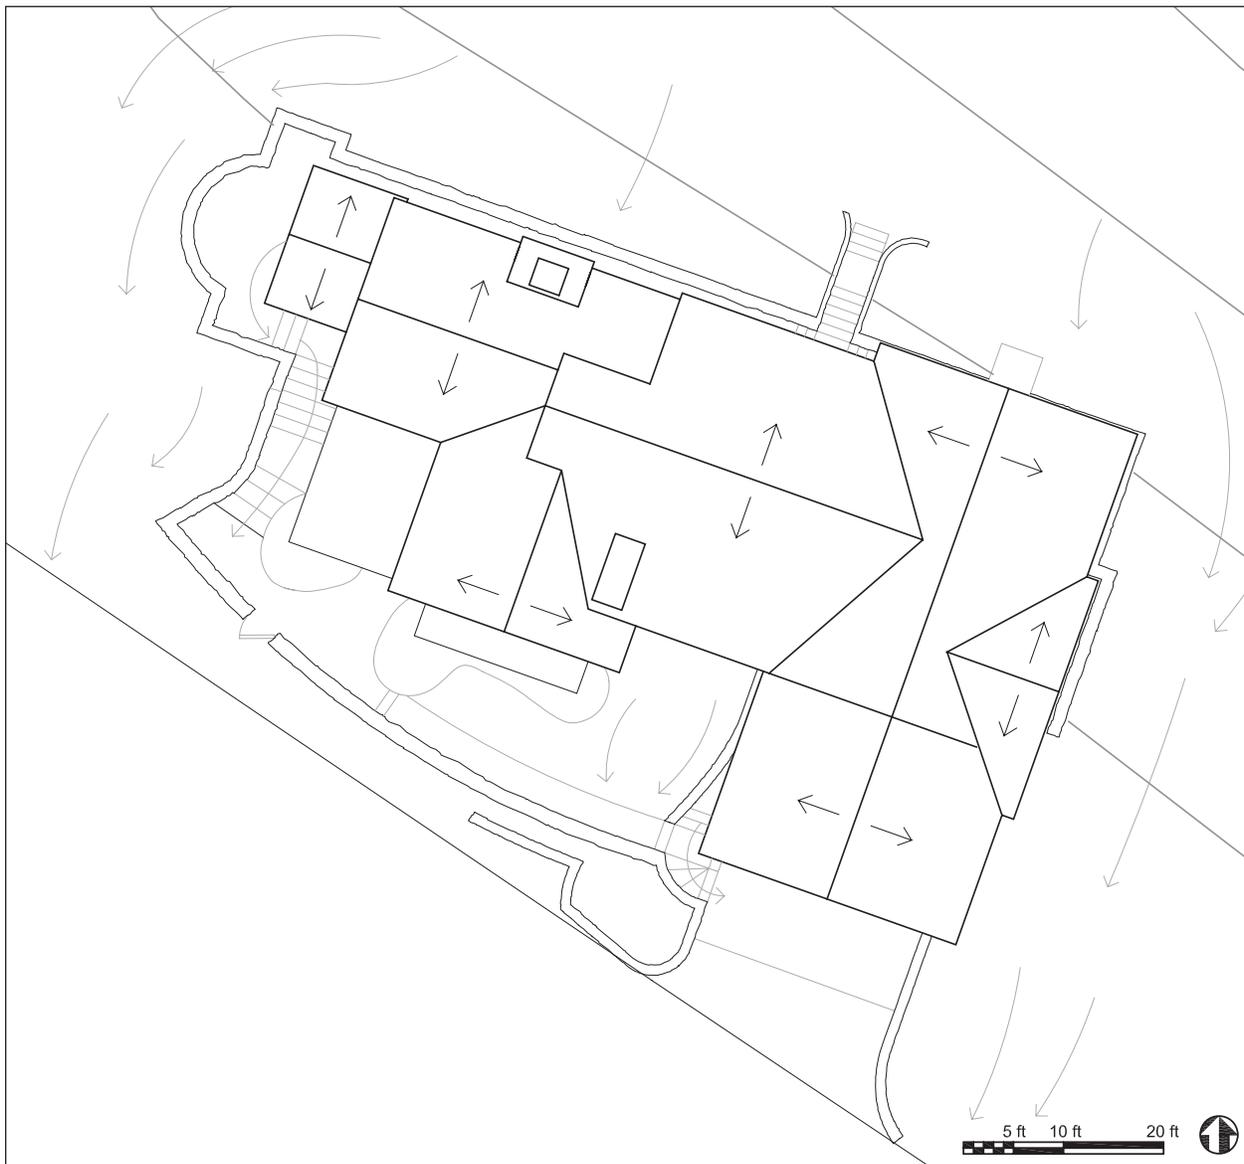
FIG. S2: Site plan showing drainage/runoff, 2008.

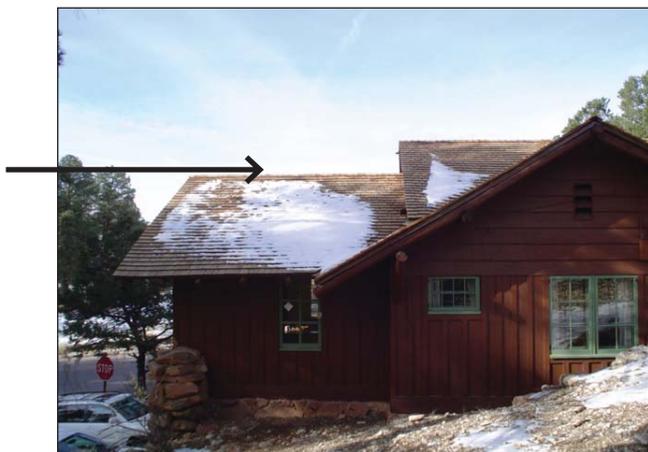
FIG. E5: East wall showing the deflected roof over Room Eight at arrow, 2008.

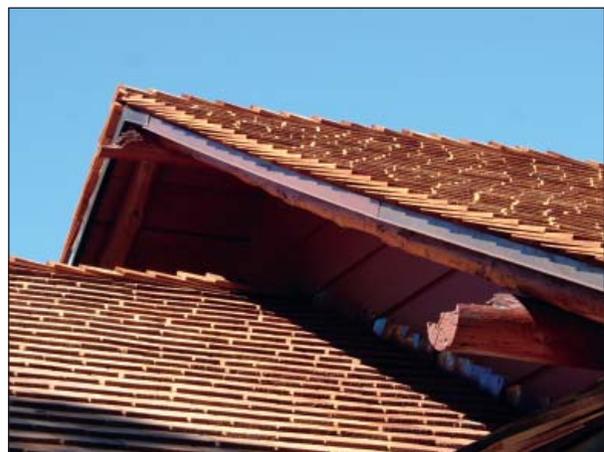
FIG. E6: Decayed outriggers on the south wall, 2007.

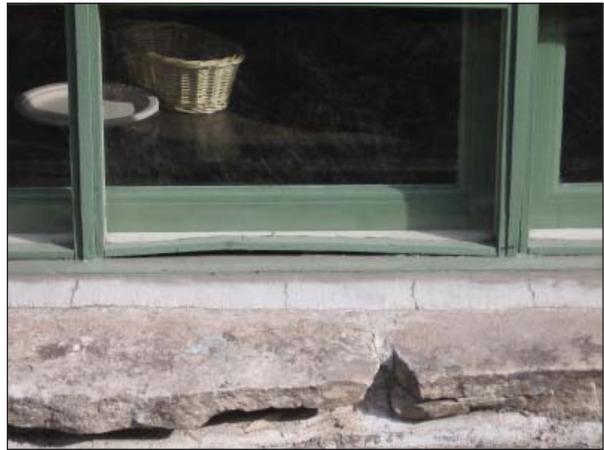
FIG. E28: Damaged wood sill on south window to Room Eighteen, 2007.

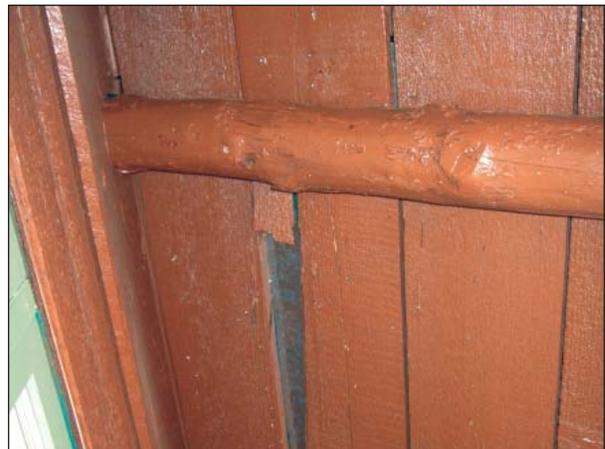
FIG. E34: Damaged wood roof sheathing on the north wall, 2007.

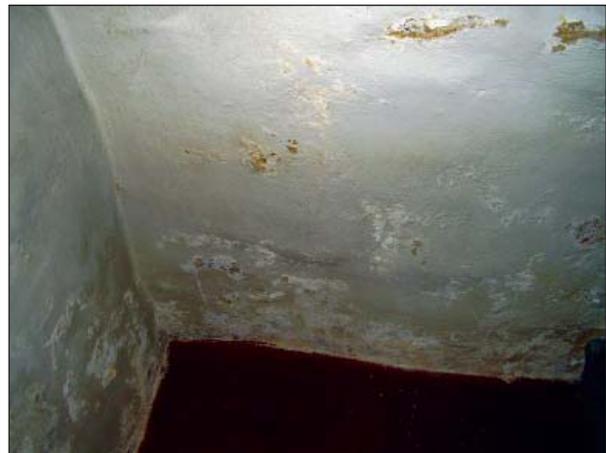
FIG. LH5: Water damage on the exposed stone walls at the northwest corner of the stairwell, 2007.

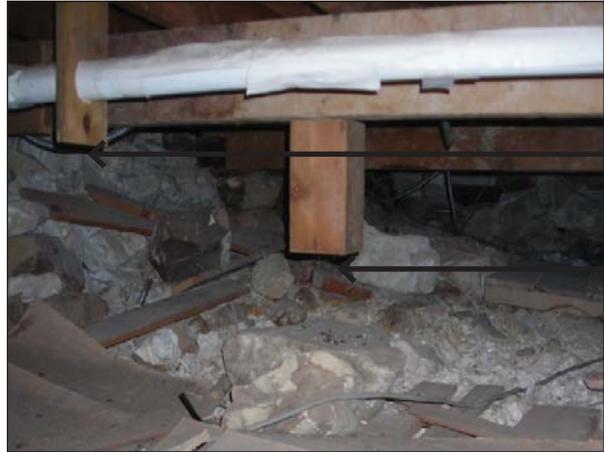
FIG. LH11: Displaced stones and missing supports under posts in crawlspace at arrows, 2007.

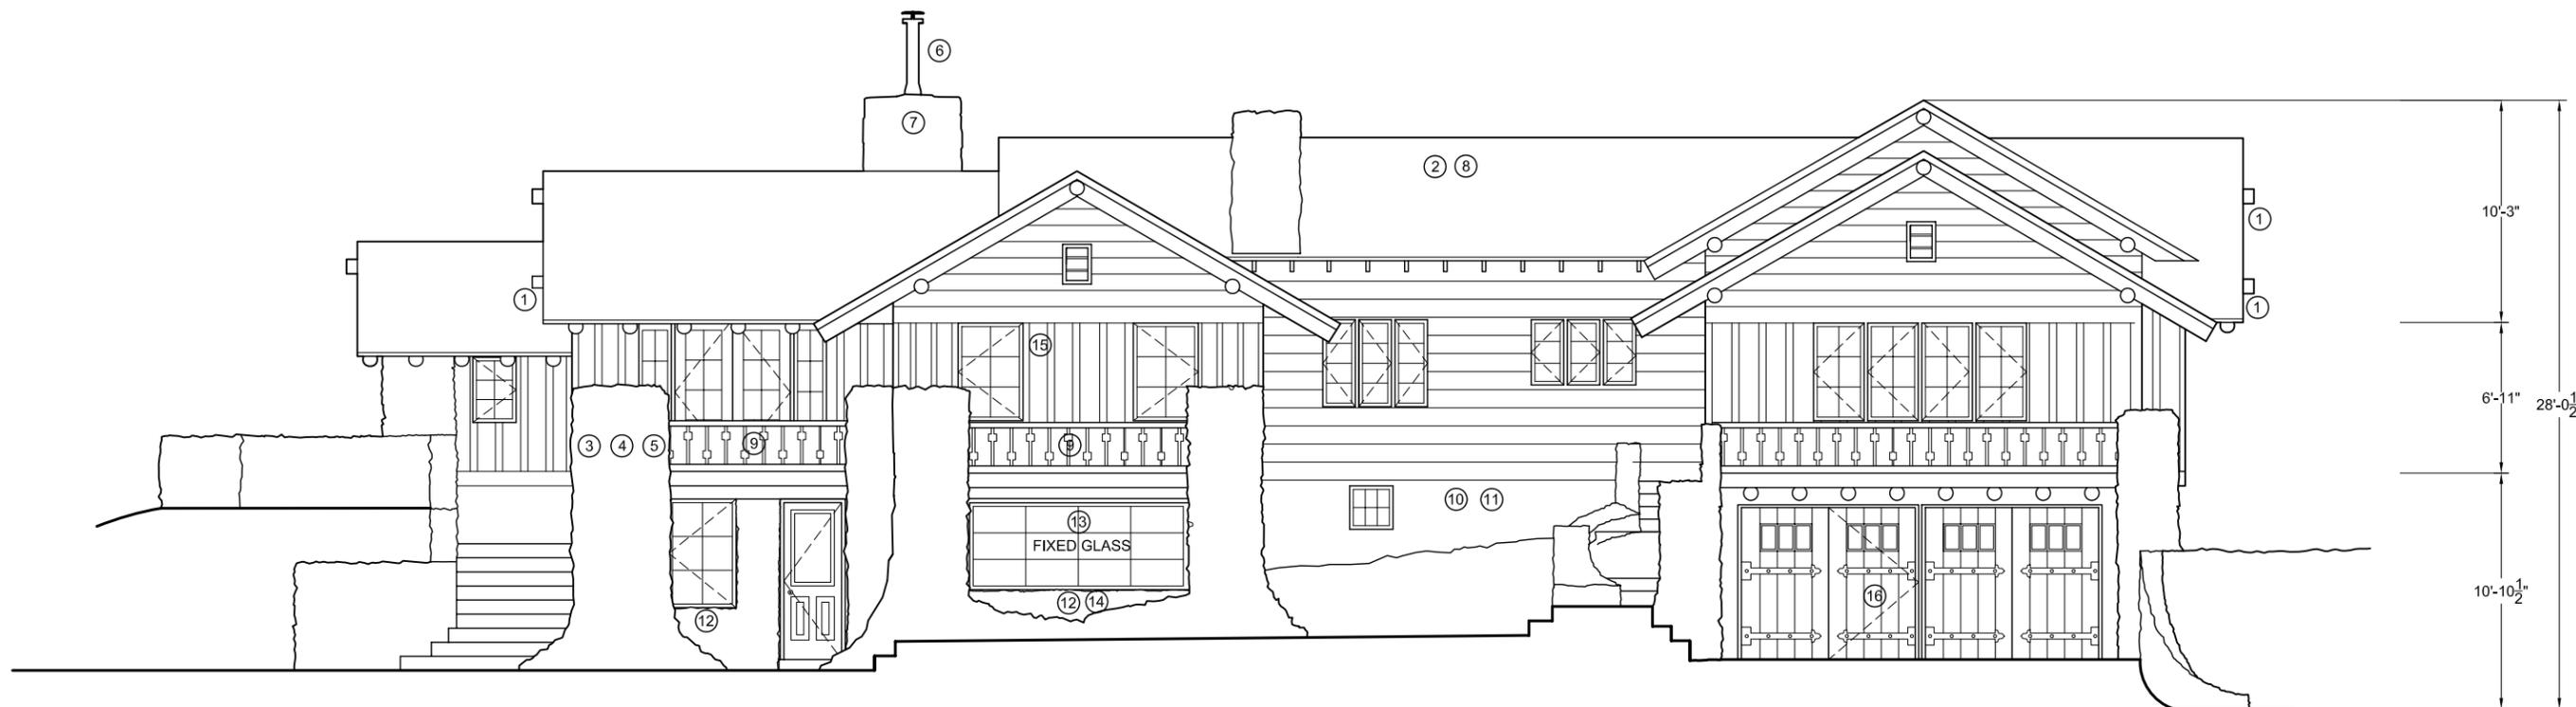
⑬	Cracked wood beam. See FIG. E27.

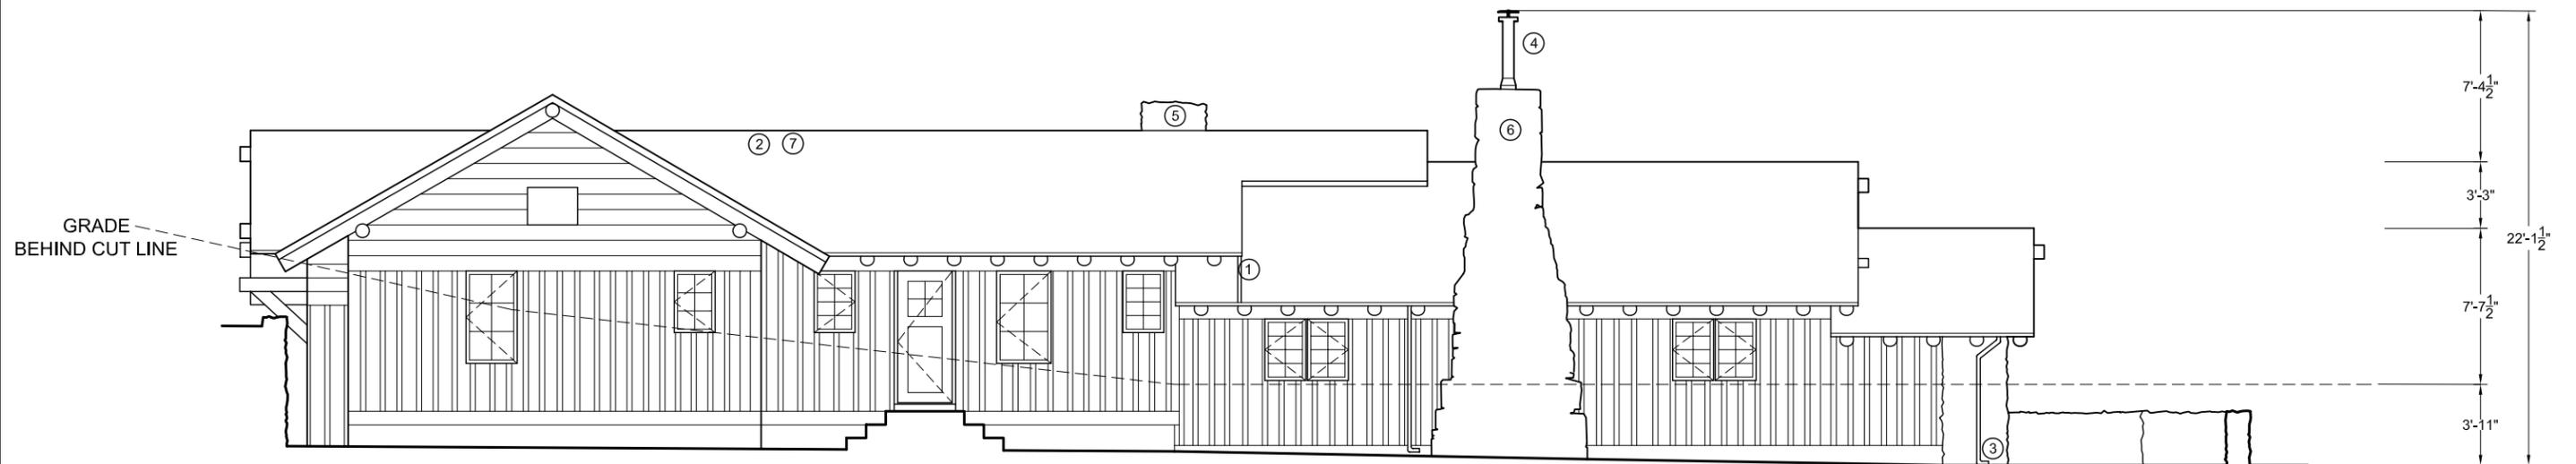
①	Water directed onto rafter from roof valley. See FIG. E7.
②	Insufficient and/or damaged collar ties in attic. See FIG. E10.
③	Water directed toward foundation due to improperly placed leader on the west corner of the north elevation. See FIG. E13.
④	Displaced metal flue on chimney to Room Two. See FIG. E21.
⑤	Lack of spark arrester on Room Two chimney. See FIG. E21.
⑥	Mortar cracks on chimney to Room Two. See FIG. E22.
⑦	Presence of asphalt shingles on the earlier roof under a superimposed roof. See FIG. E9.
⑧	Damaged wood siding and/or roof sheathing. See FIGS. E29, E34 and E35.

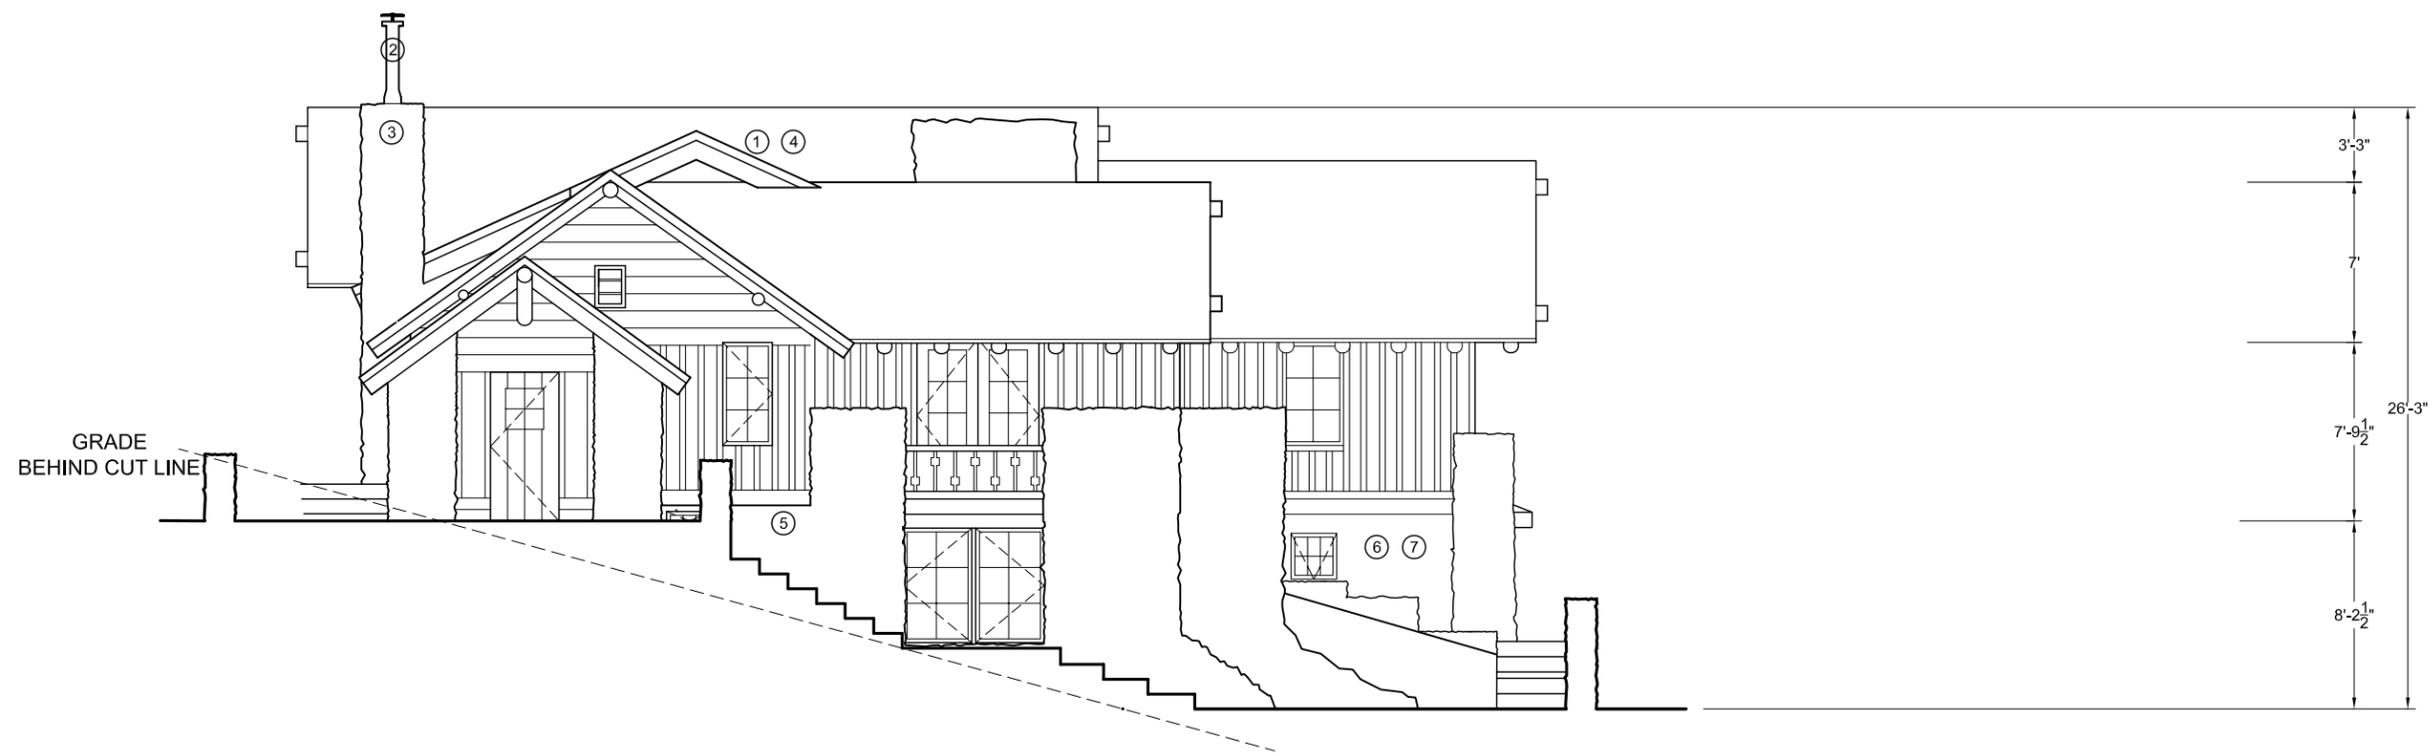
①	Insufficient and/or damaged collar ties in attic. See FIG. E10.
②	Displaced metal flue on chimney to Room Two. See FIG. E21.
③	Lack of spark arrester on Room Two chimney. See FIG. E21.
④	Presence of asphalt shingles on the earlier roof under a superimposed roof. See FIG. E9.
⑤	Inappropriate repair including excessive and/or incompatible mortar. See FIGS. E23, E25.
⑥	Damaged modern light fixture. See FIG. E40.
⑦	Lack of light fixture at entrance to upper level hallway.

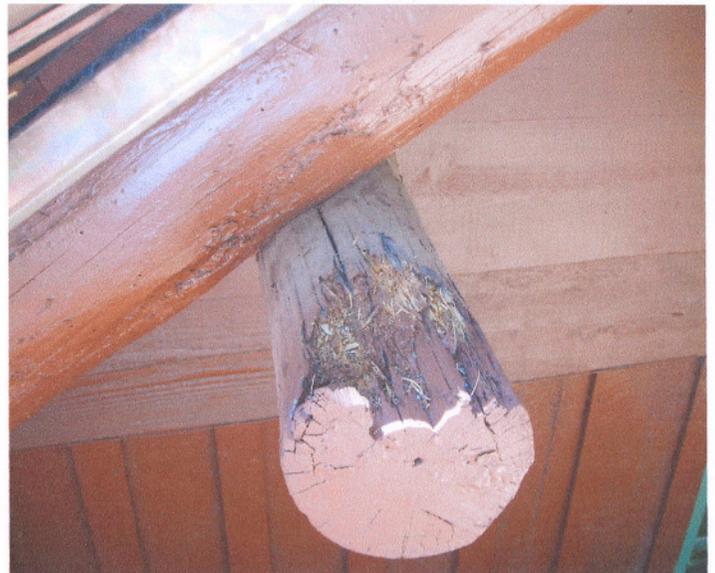
8. Weather deteriorated exposed ends of outlookers

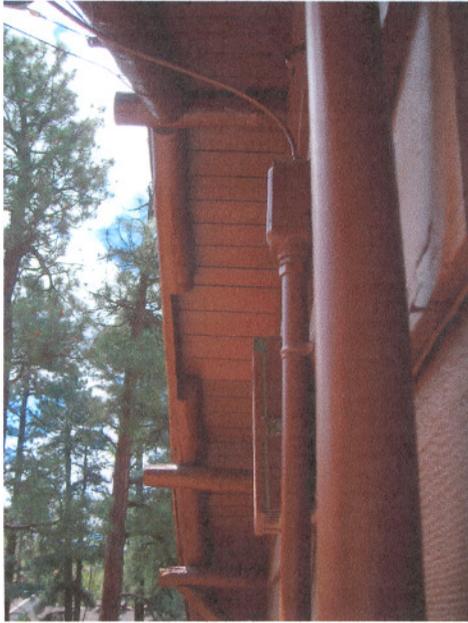
9. Missing portion of fascia beam

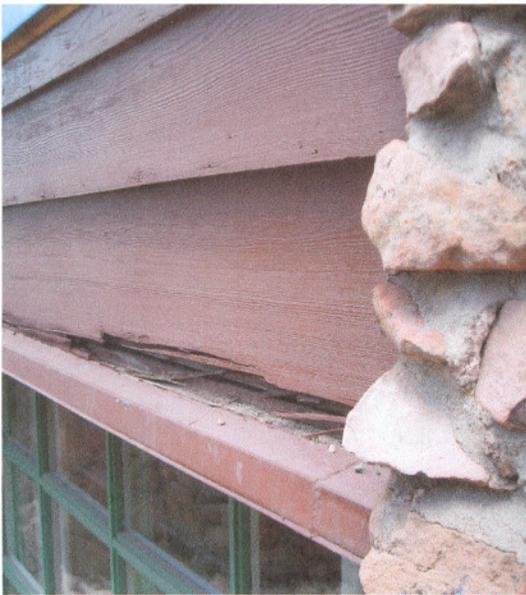
11. Deteriorated wood fascia members

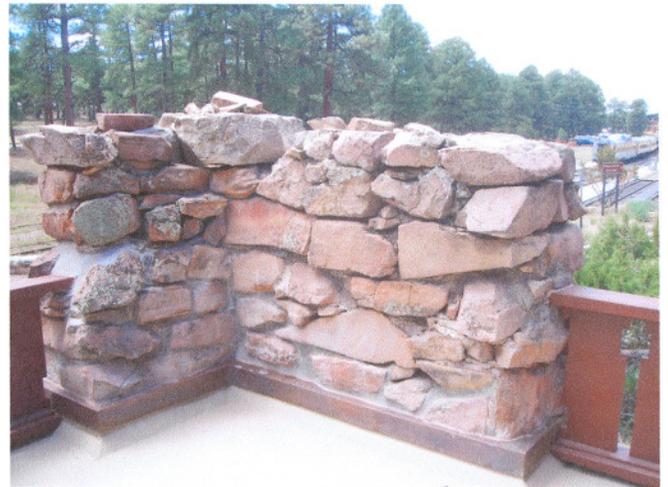
12. Cracks in stone masonry guardrail wall

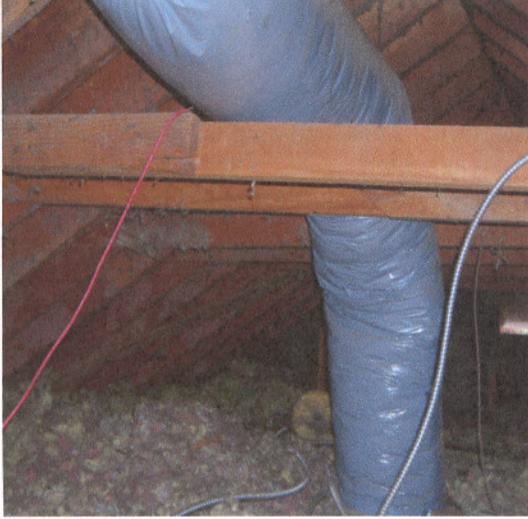
13. Split and partially repaired collar tie

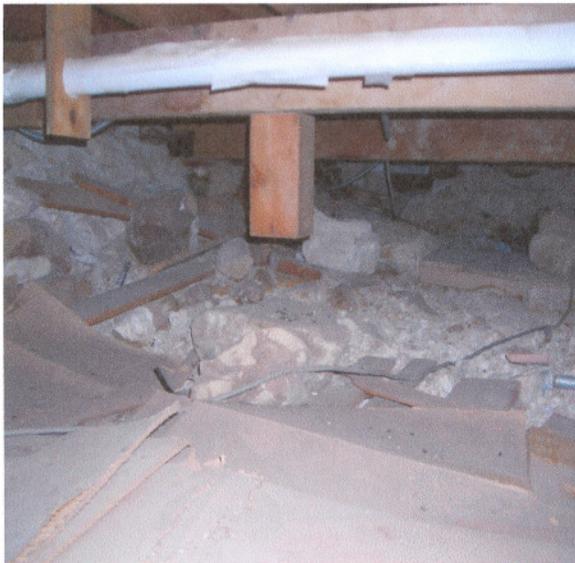
15. Missing pilaster floor beam support

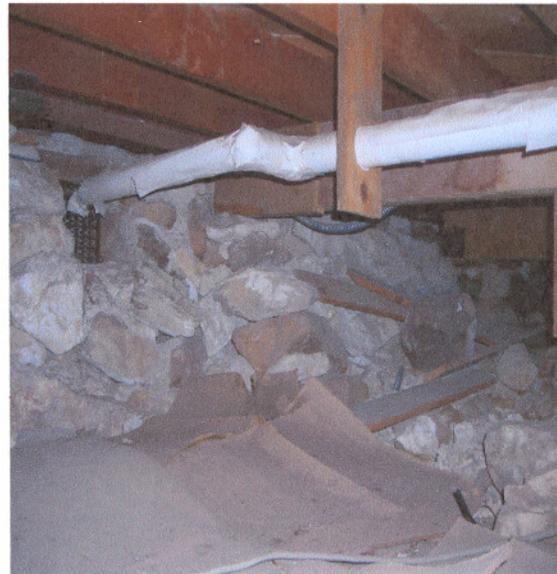
16. Floor beam bearing on stone rubble
