Volume IV  
Commercial Corridors  
Profile of Existing Conditions:

Commercial Corridor Profile of Existing Conditions, Volume IV

Prepared for:  
Department of Community Development  
and Neighborhood Conservation  
Pima County, Arizona

April 2013

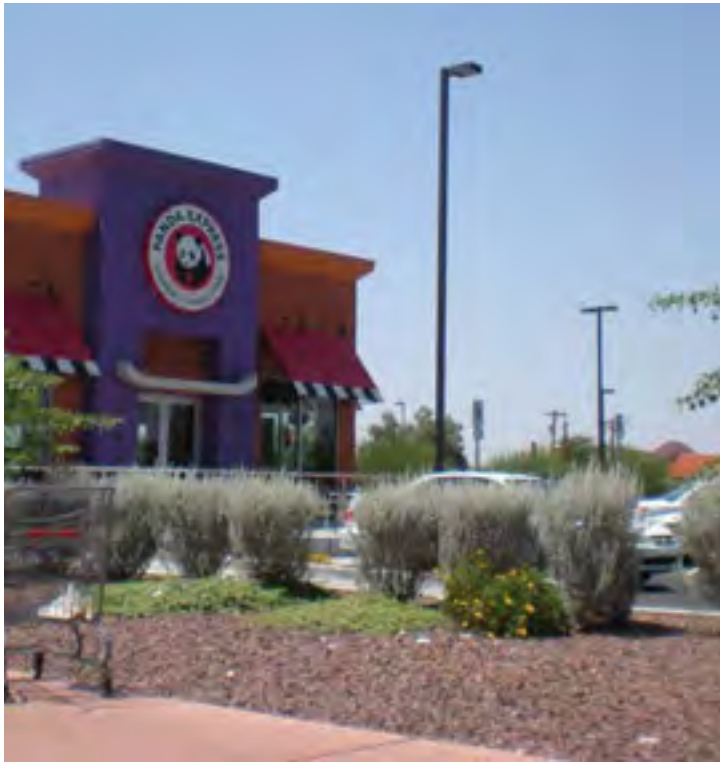
*Windshield survey teams assessed the condition of structures and grounds for each business property.*

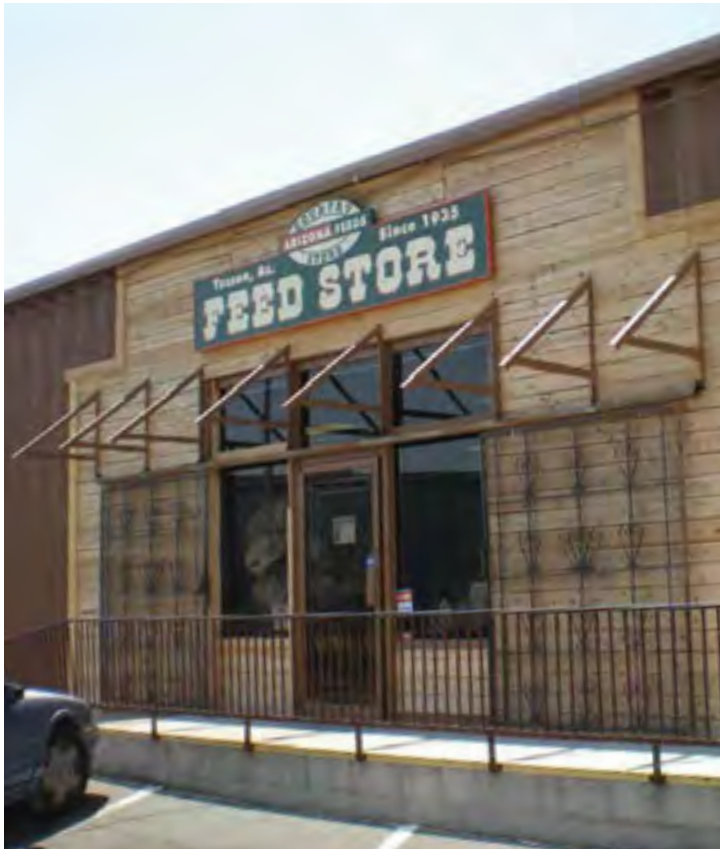
*Example of a business with no landscape to assess.*

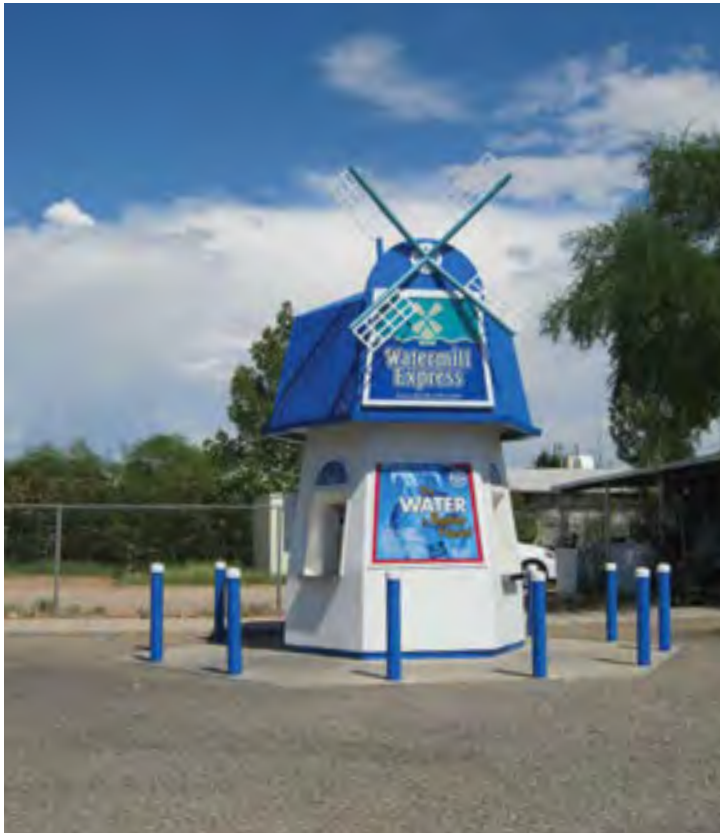
*The majority of structures are in “good” or “excellent” condition.*

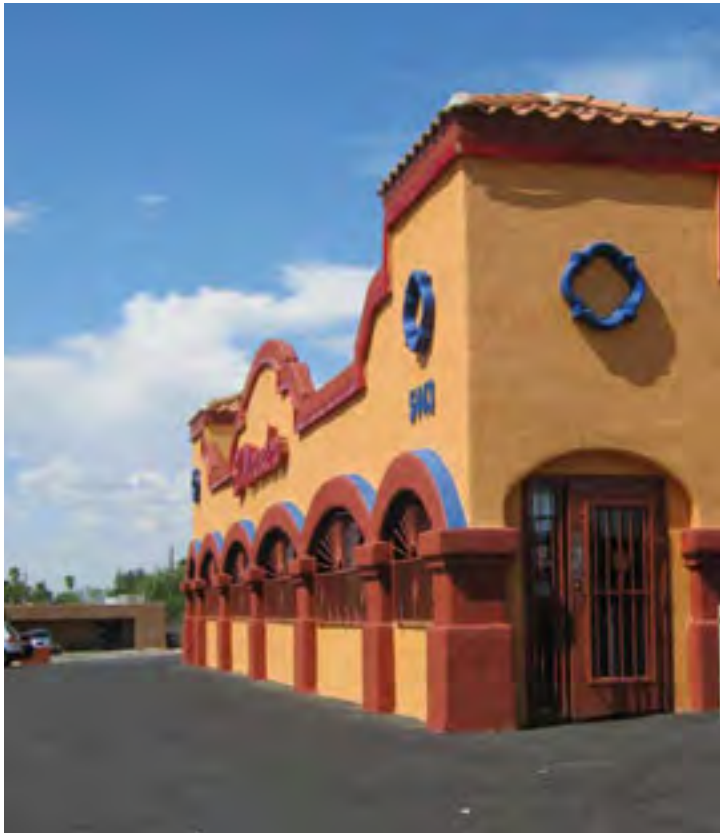
*Example of a business with no landscape to assess.*

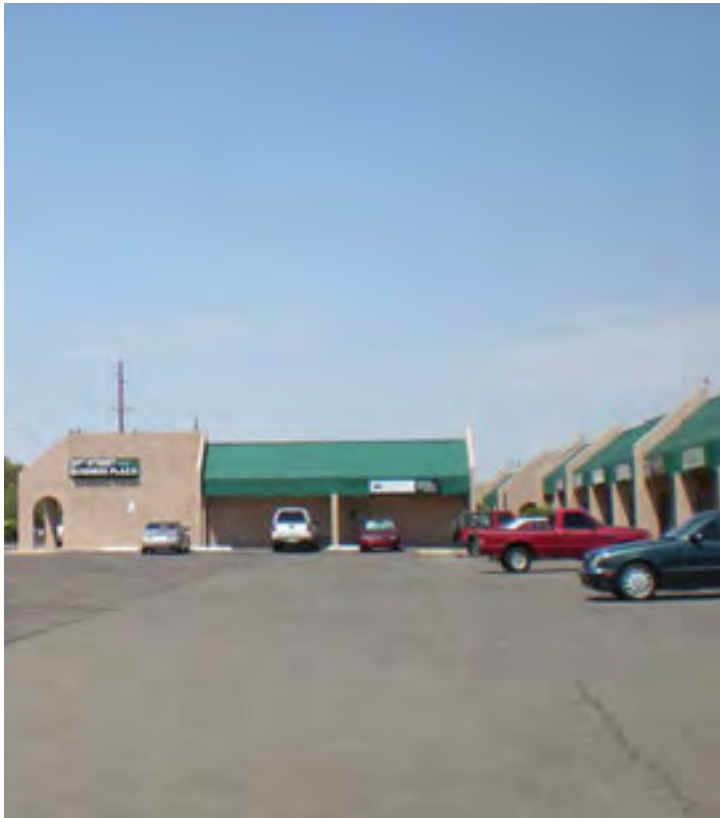
*Businesses with no landscape present.*

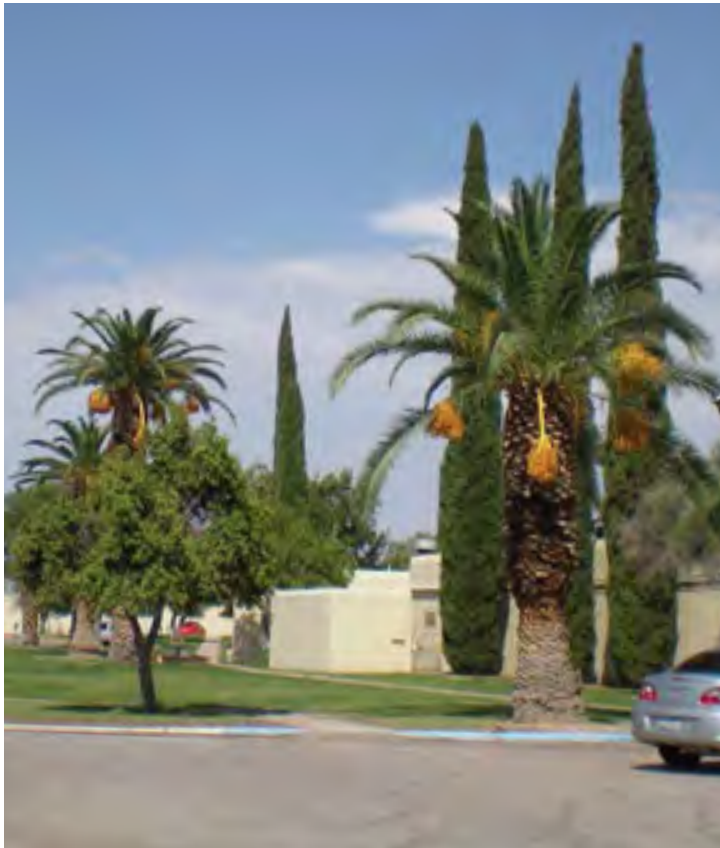
*Intentional and maintained grounds at the Community Resource Center, 29th Street and Swan Road.*

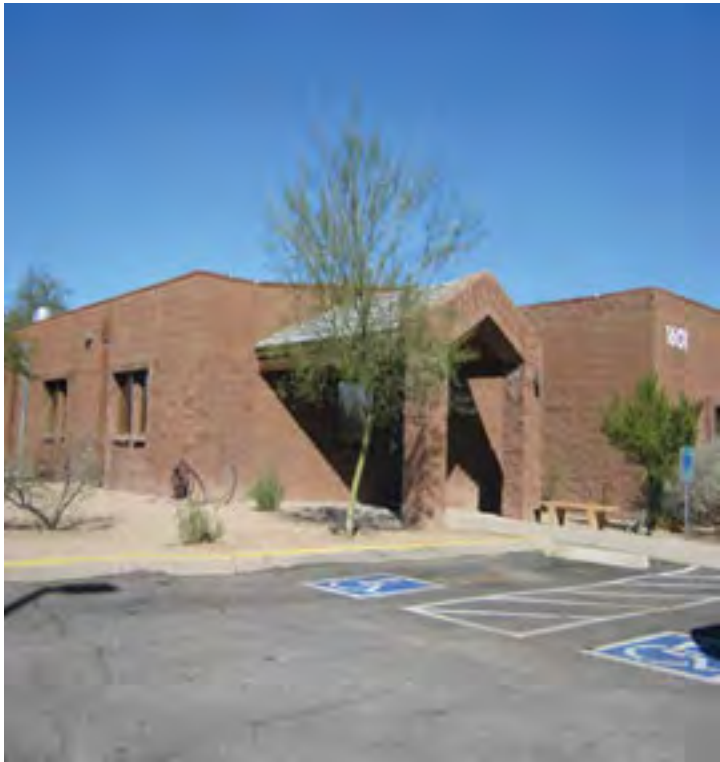
*Windshield survey teams assessed grounds as “excellent” if intentional and maintained.*

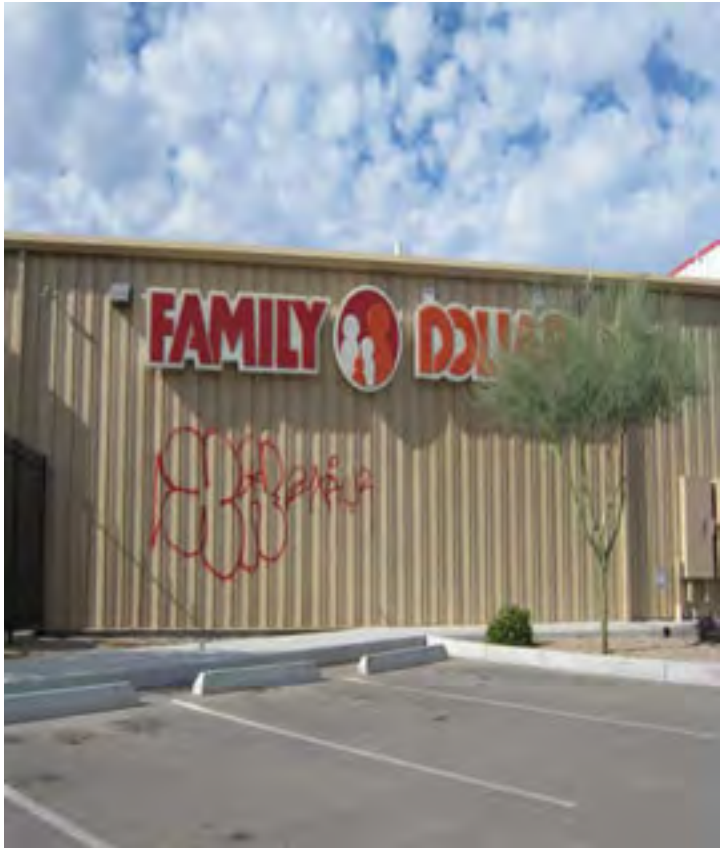
*Graffiti was present on thirty percent of business properties at the time of the windshield survey.*

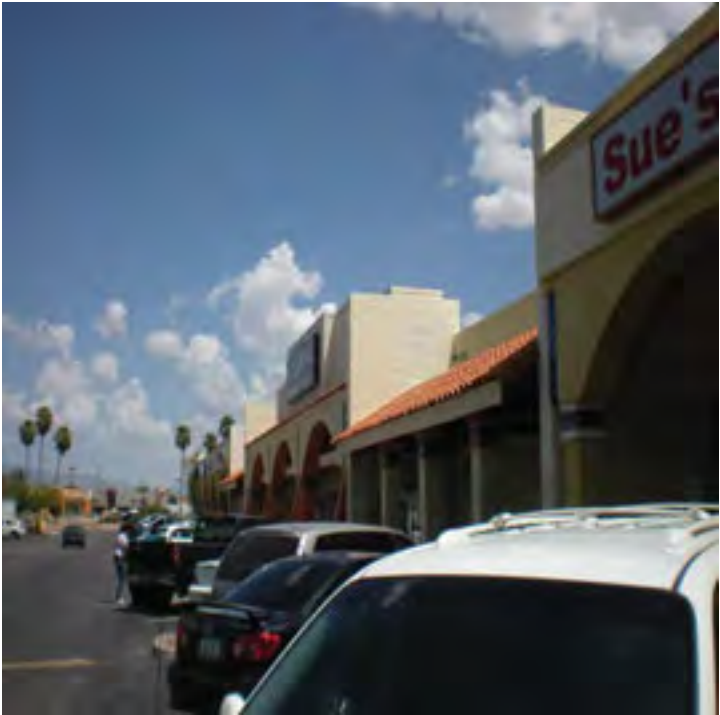
*The majority of business properties on the corridor are in good structural condition.*

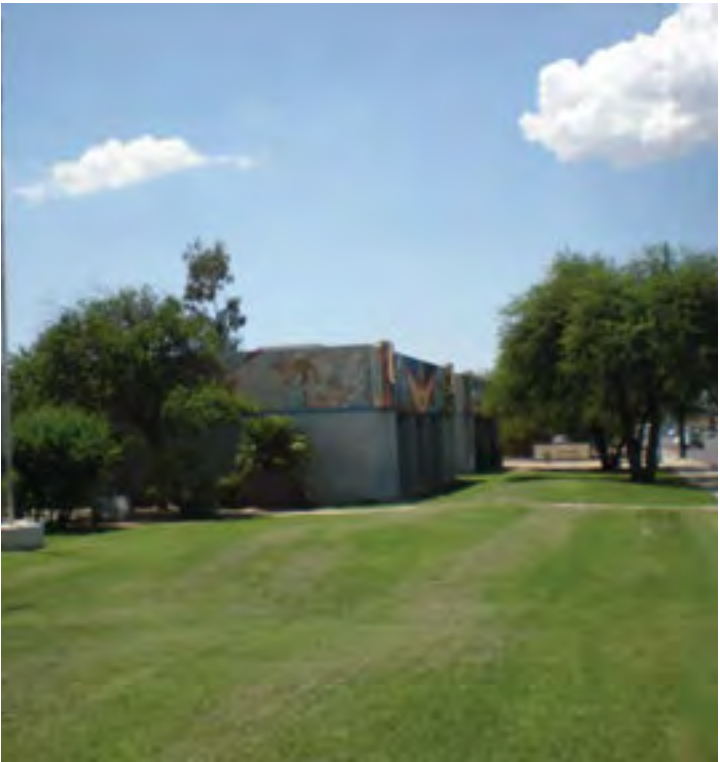
*‘Excellent’ grounds are intentional and maintained.*

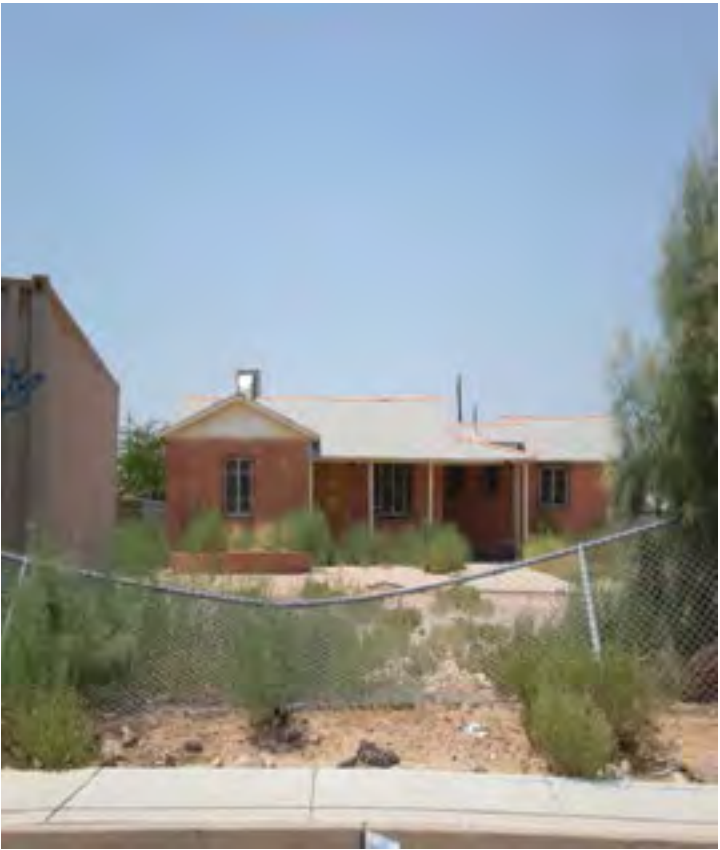
*A vacant home on Irvington Road*
