# **HISTORIC STRUCTURE REPORT**

## **PRATT CABIN**

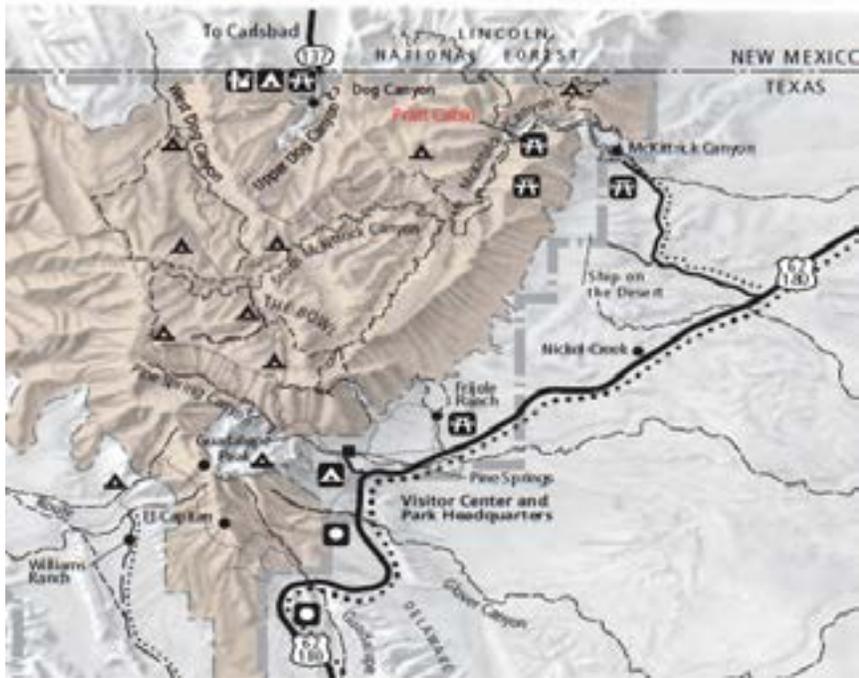
FIG. ES 1: Location map (Source: Guadalupe Mountains National Park Draft General Management Plan/ Environmental Impact Statement, 2008).

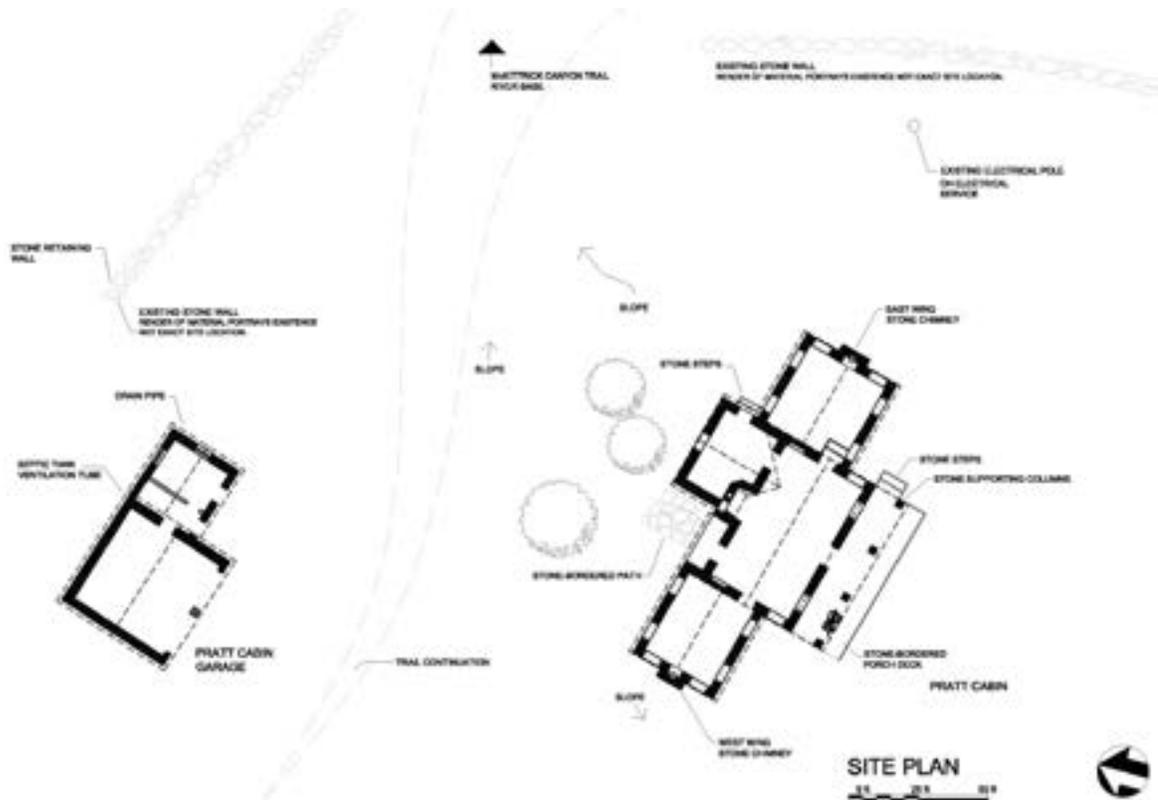
The Cabin and associated structures are located in McKittrick Canyon at the confluence of North and South McKittrick Creek. The site is approximately 2.5 miles from the McKittrick Canyon Visitor's Center along the McKittrick Canyon Trail. In addition to the two main buildings-the Cabin and the Garage-the site includes a pump house, a dirt driveway and a stone picnic table. The buildings are situated on the south facing slope of the canyon and are bordered by a stone wall to the west, south and east. The bordering stone wall and pump house have not been included in this report.

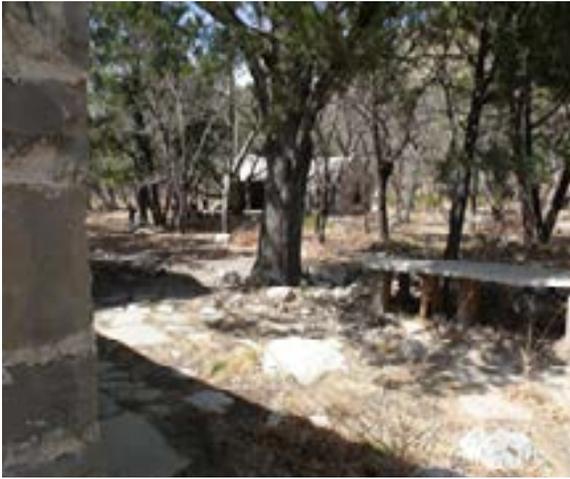
Figure ST 1- Site view from northeast corner of Cabin, looking northwest toward Garage, 2011.

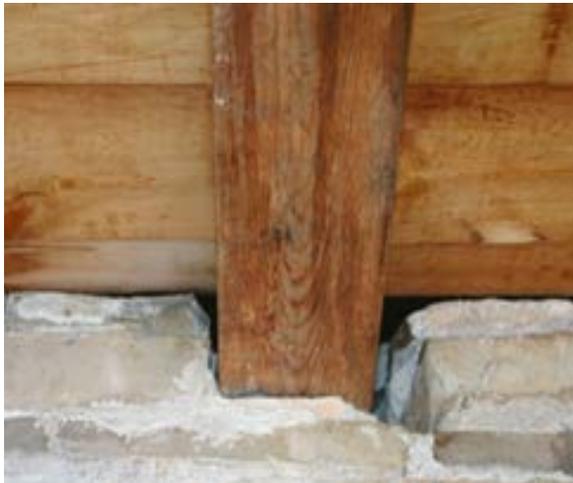
Figure SE 1- Gaps in mortar and missing stones at connection of south bearing wall and wooden porch cover, 2011.

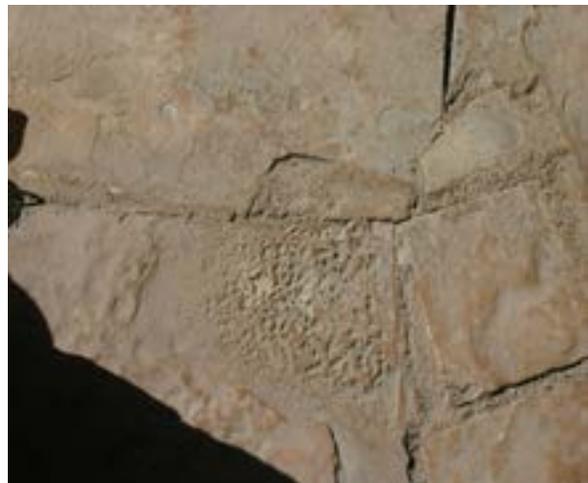
Figure SE 2- Erosion of stone slabs on porch floor at drip-line, 2011.

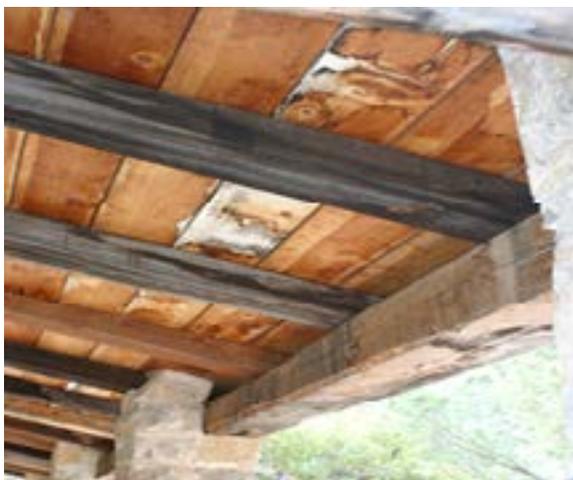
Figure SE 3- Water staining on wood planks of porch cover, 2011.

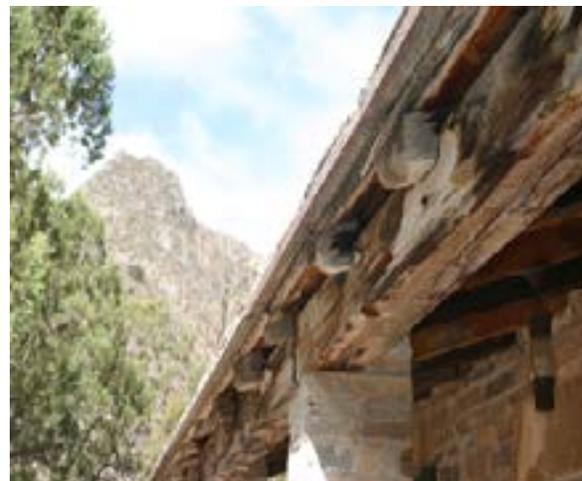
Figure SE 4- Bull-nosed ends of rafters on porch cover are a character defining feature. Note extensive water damage to ends of rafters and support beam, 2011.

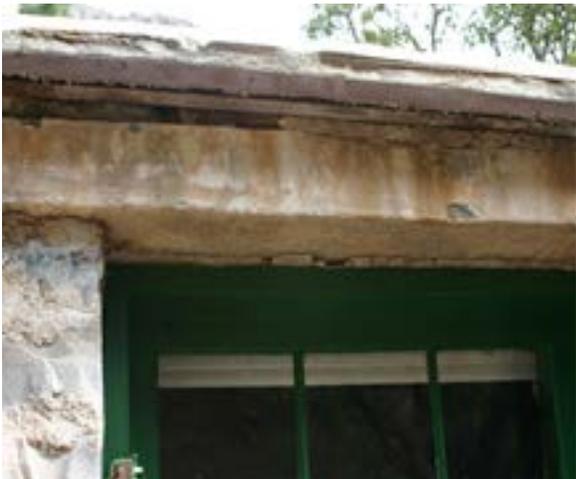
Figure SE 5- Mortar deteriorating on southwest façade above stone bond beam and above west window frame, 2011.

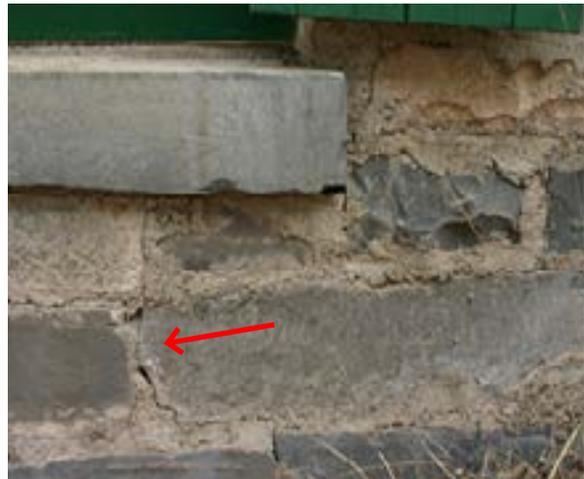
Figure SE 6- Crack under window lintel on west side of south façade, 2011.

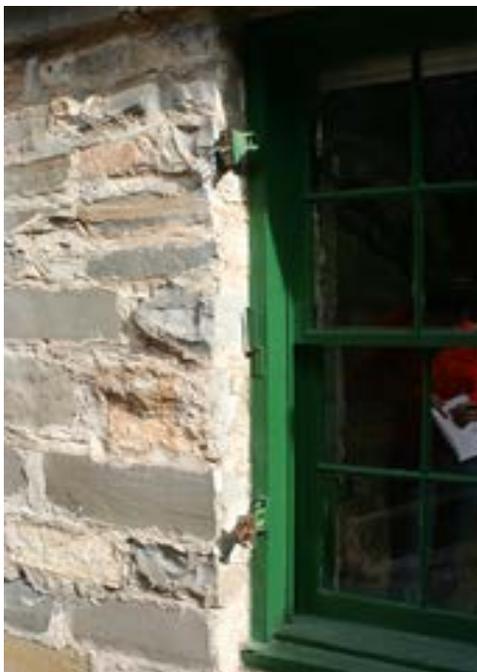
Figure SE 7- Shutter missing from western window on south façade, 2011.

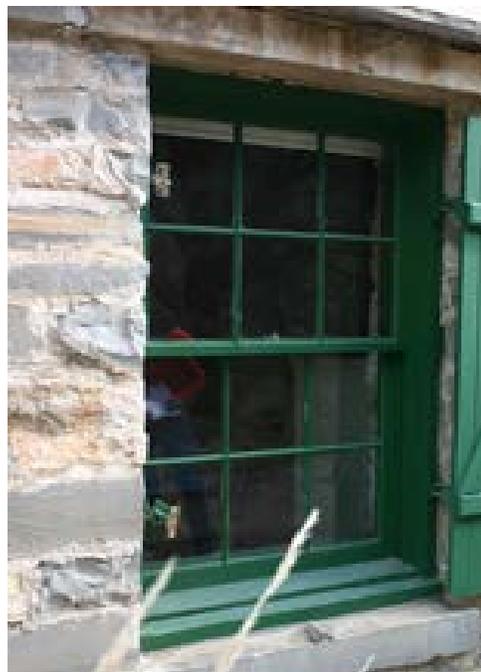
Figure SE 8- Shutter missing from window on west wing, south façade, 2011.

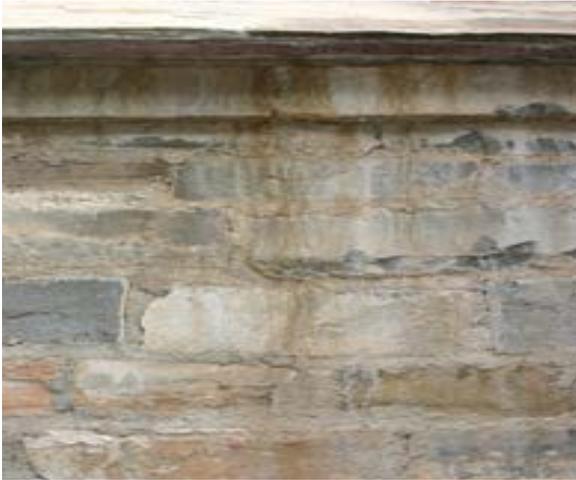
Figure SE 9- Rust staining on stone wall and bond beam on west end of south façade indicate exposure to water draining off roof angle iron, 2011.

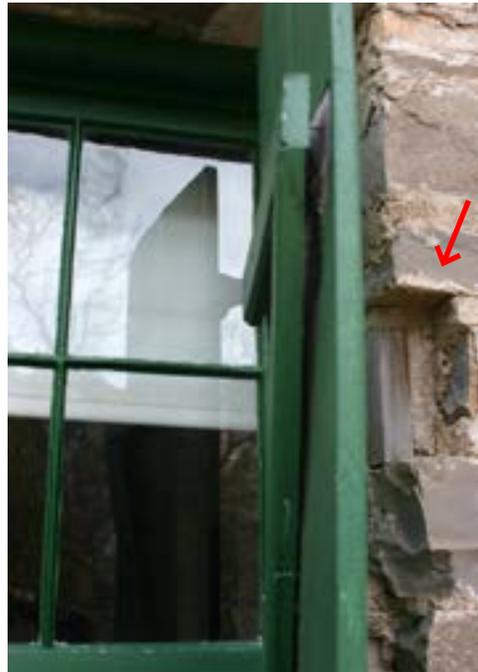
Figure SE 10- Stone missing from edge of west living room window, 2011.

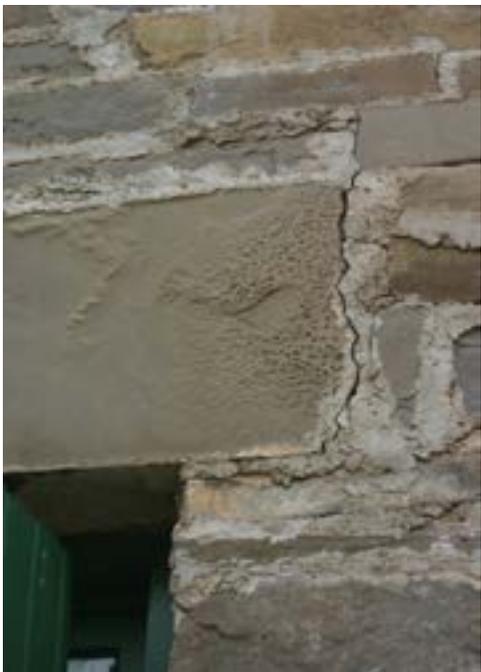
Figure SE 11- Crack around west living room window lintel, 2011.

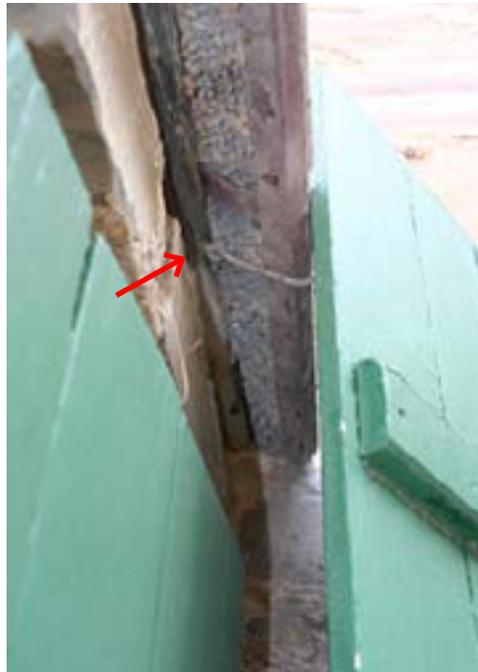
Figure SE 12- West living room window shutter fastened to roof plank, 2011.

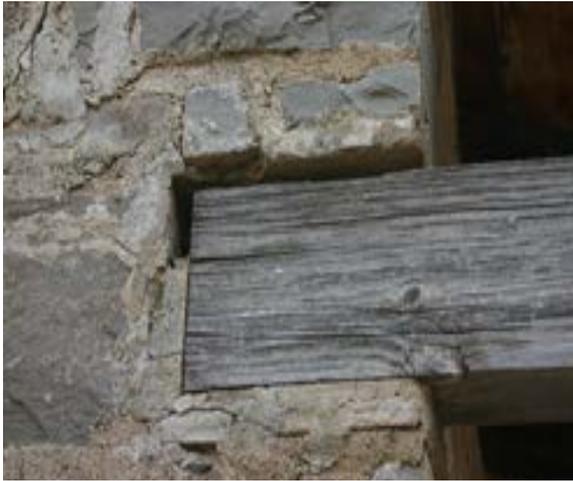
Figure SE 13- Mortar missing around south porch tie beam at joint west living room wall, 2011.

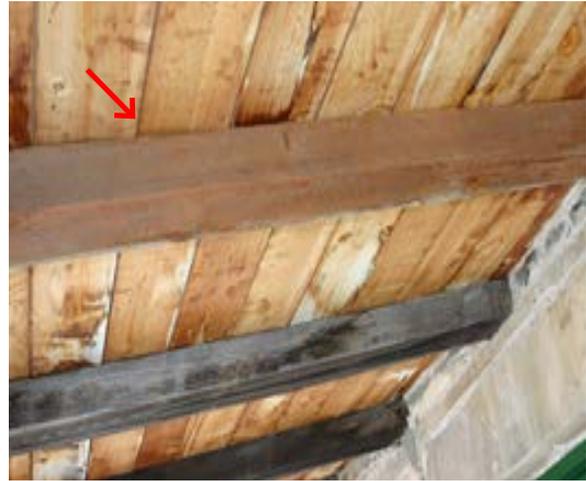
Figure SE 14- Replaced wood rafter on south porch roof, 2011.

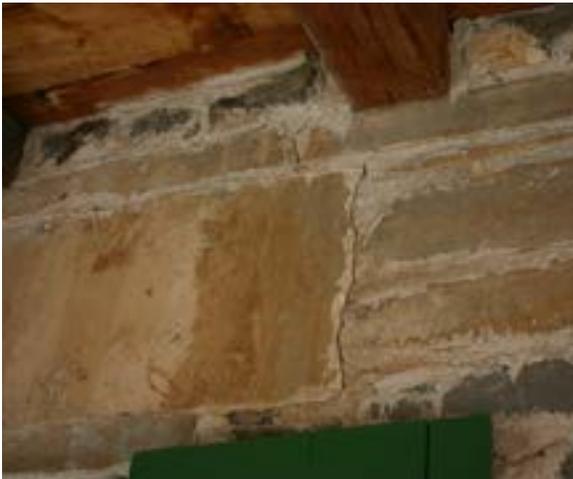
Figure SE 15- Crack from roof along lintel on south living room wall, 2011.

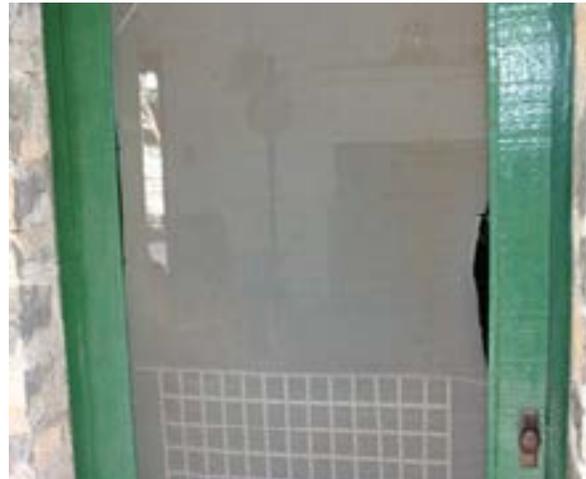
Figure SE 16- Separation of screen from wood frame; south entrance, 2011.

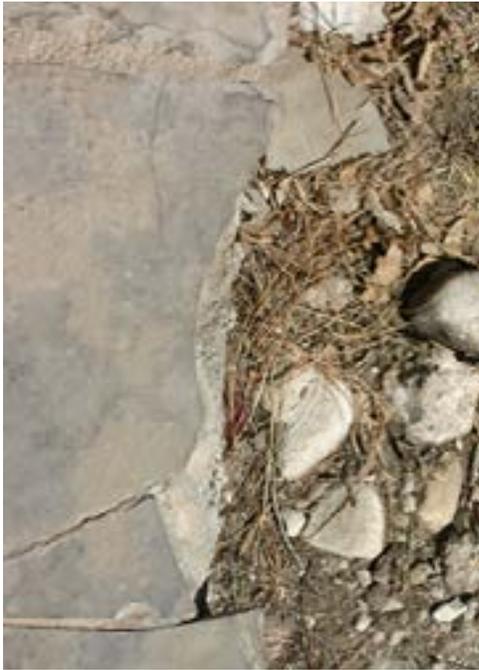
Figure SE 17- Cracked edge of stone floor at east edge of porch, 2011.

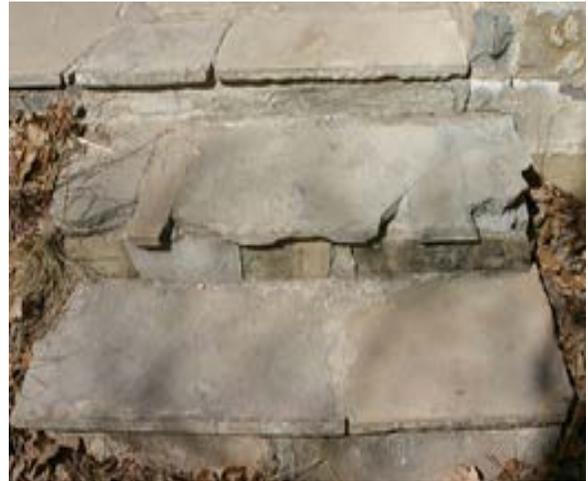
Figure SE 18- Cracked edges of stone steps on east side of south porch, 2011.

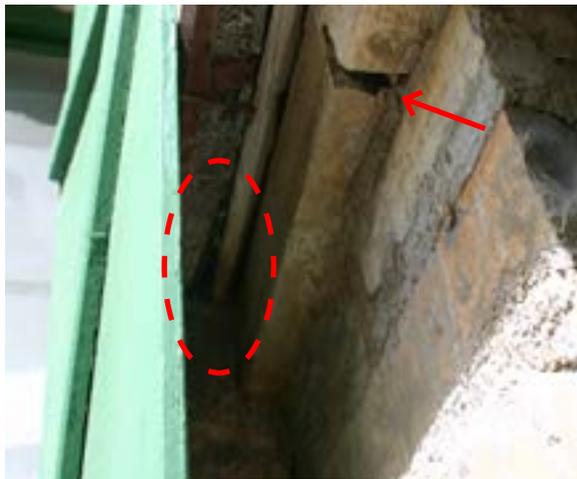
Figure SE 19- Gap in mortar at bond beam at joint of living room and west wing walls (indicated with arrow); note exposed impermeable membrane (outlined in red), 2011.

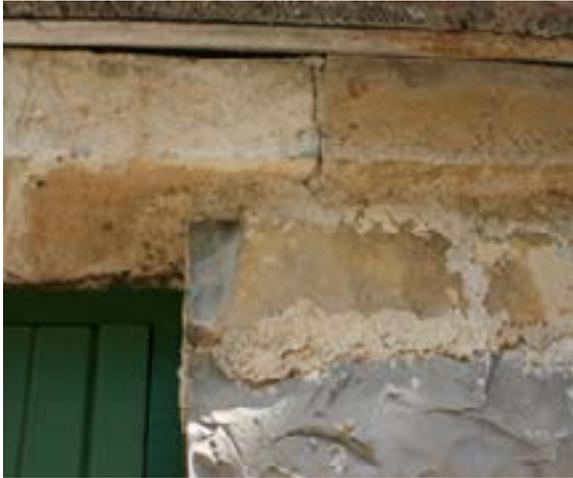
Figure SE 21-Crack at bond beam on south wall of east wing; note gaps between bond beam and wood roof sheathing, 2011.

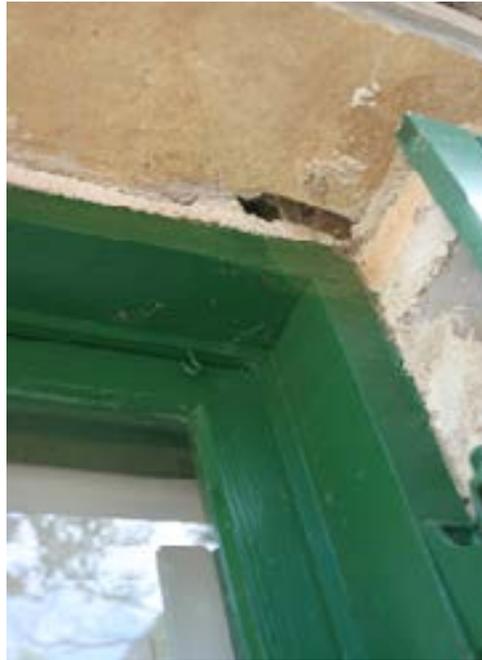
Figure SE 22- Hole between lintel and frame on southeast bedroom window, 2011.

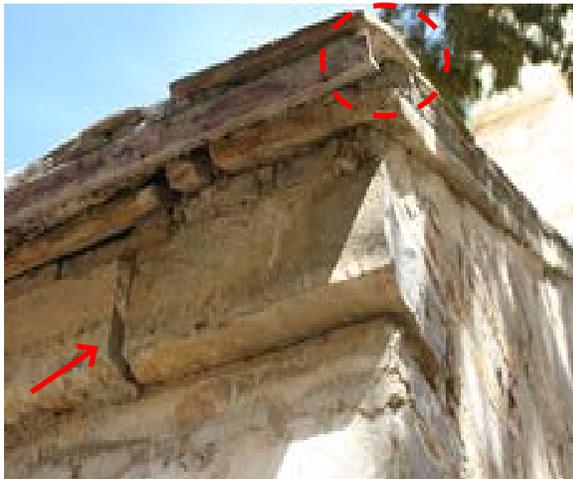
Figure SE 23- Deteriorating mortar at southeast corner of east bedroom at angle iron (outlined in red); crack at bond beam (indicated with arrow), 2011.

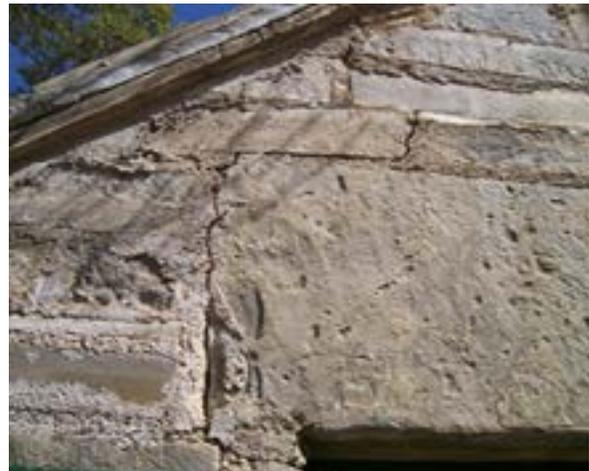
Figure WE 24- Crack around lintel above north window on west façade, 2011.

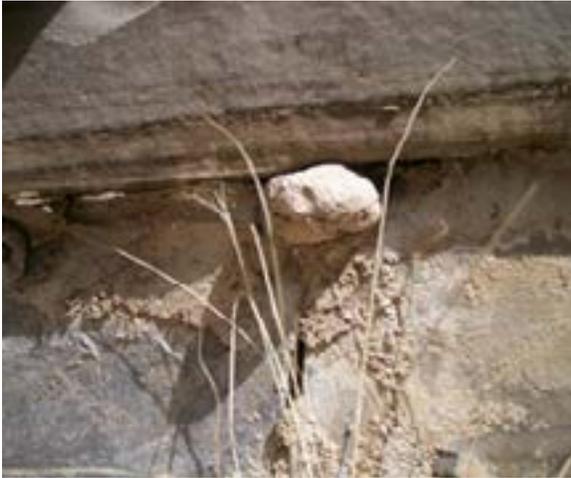
Figure WE 25- Cobble in gap between window base and west façade wall, 2011.

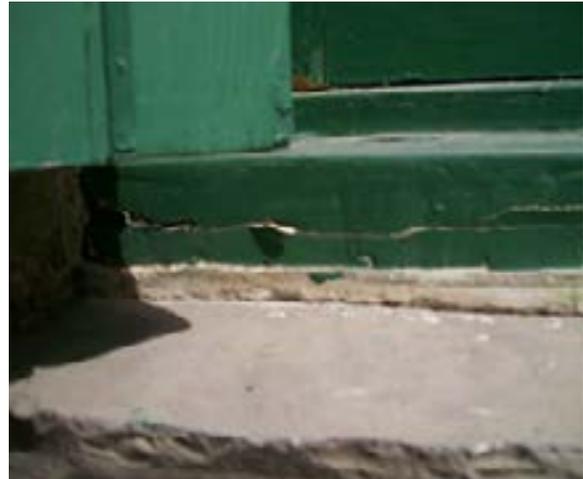
Figure WE 26- Frame of south window on west façade cracked, 2011.

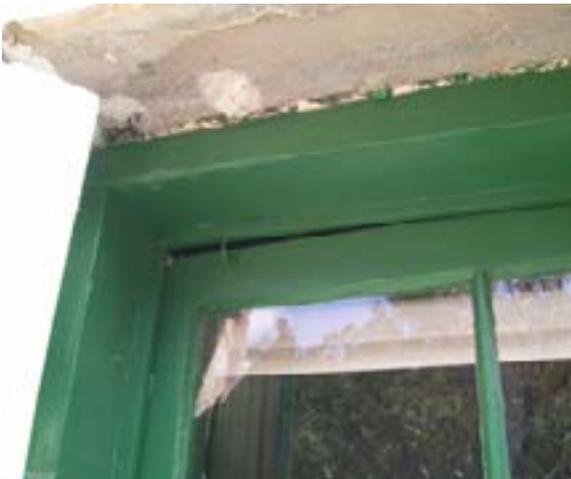
Figure WE 27- Sash sagging on south window of west façade, 2011.

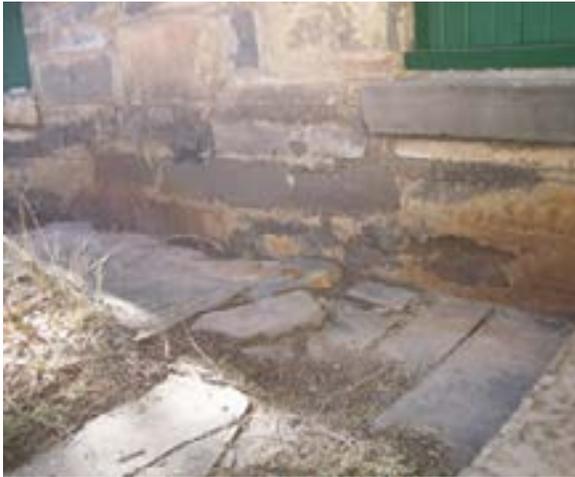
Figure NE 29- Rust stains on north stone wall of east bedroom, 2011.

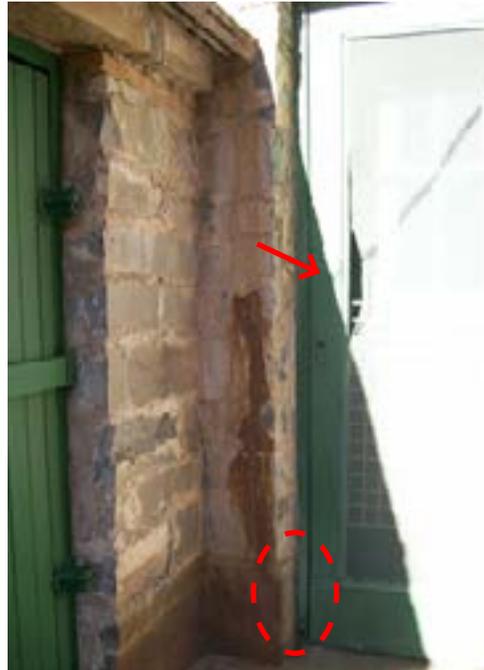
Figure NE 30- Rust stains on northeast exterior and east kitchen wall; water damage on lower door frame (outlined in red); screen separating from frame (indicated with arrow), 2011.

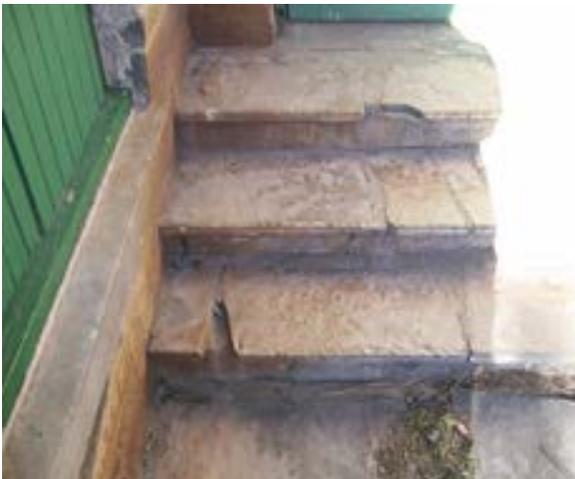
Figure NE 31- Stairs at kitchen entry are eroding and chipped due to water exposure, 2011.

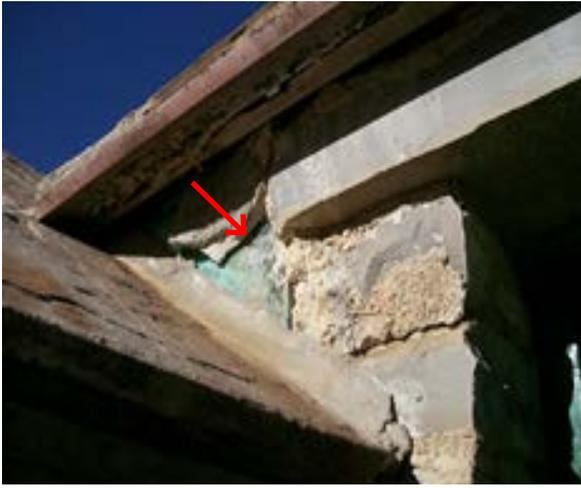
Figure NE 33- Missing stone and mortar at joint of east bedroom with kitchen extension resulting in exposed metal flashing (indicated by arrow). Site of heavy drainage off stone roof; note rust stains on stone roof slabs, 2011.

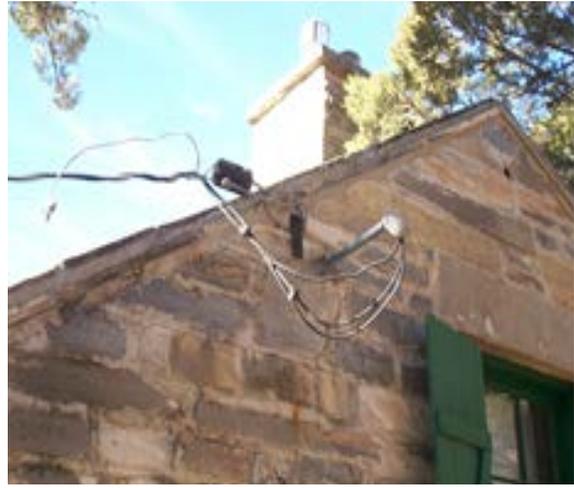
Figure NE 34- Modern electrical conduit connection (not original), note shallow overhang of roof, 2011.

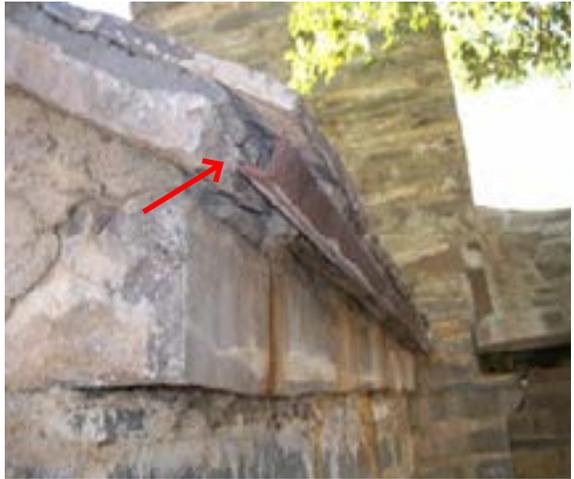
Figure NE 36- Extensive rust staining on west wall of kitchen; mortar missing at angle iron at roof edge (indicated by arrow), 2011.

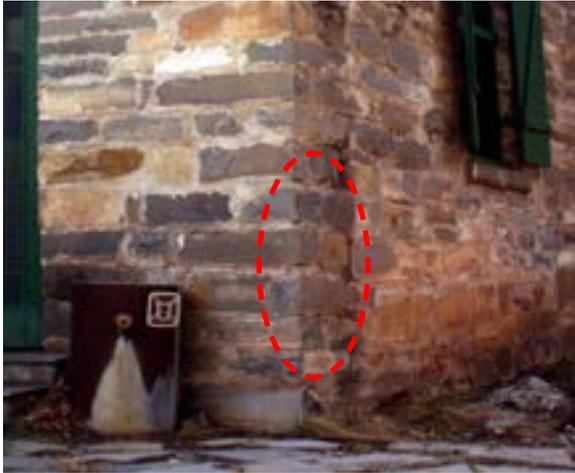
Figure NE 37- Crumbling mortar at northeast corner of kitchen extension, 2011.

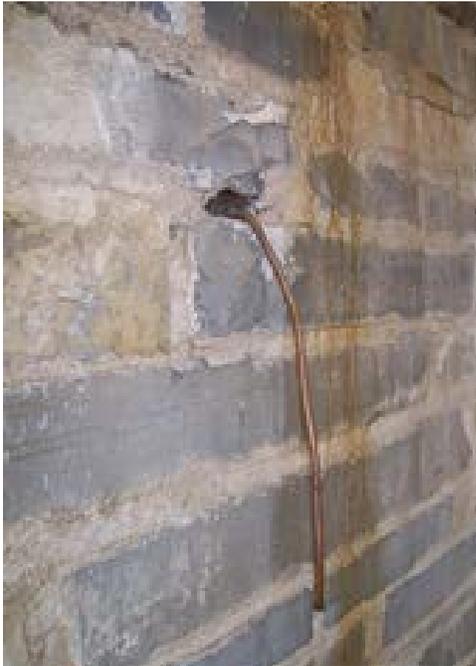
Figure NE 39- West kitchen wall punctured by copper pipe; cut pipe has jagged edges. Note rust stains on wall, 2011.

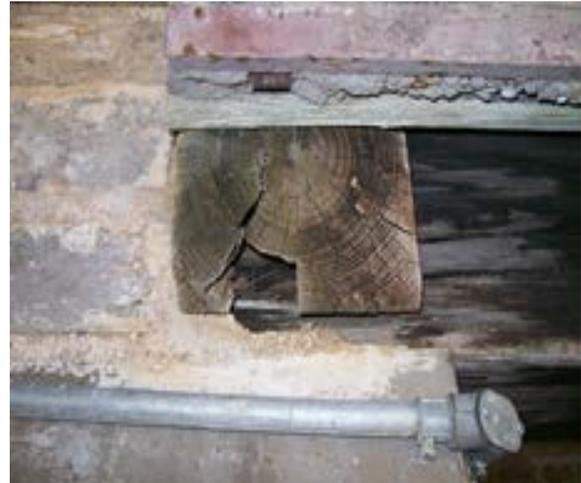
Figure NE 40- Water damage on north entry overhang, wood deteriorating, 2011.

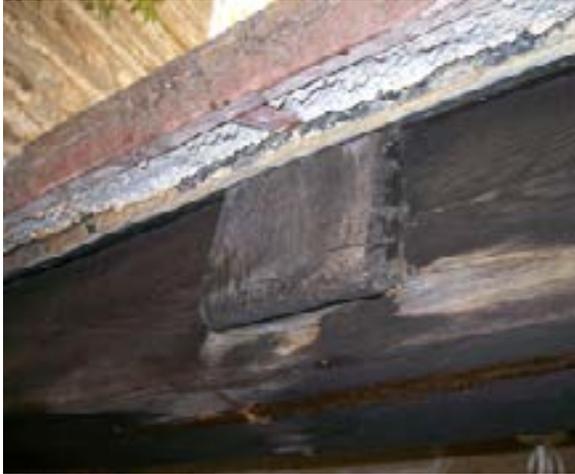
Figure NE 41- Water staining on north entry overhang support beam; note detail of bull-nosed end on rafter, 2011.

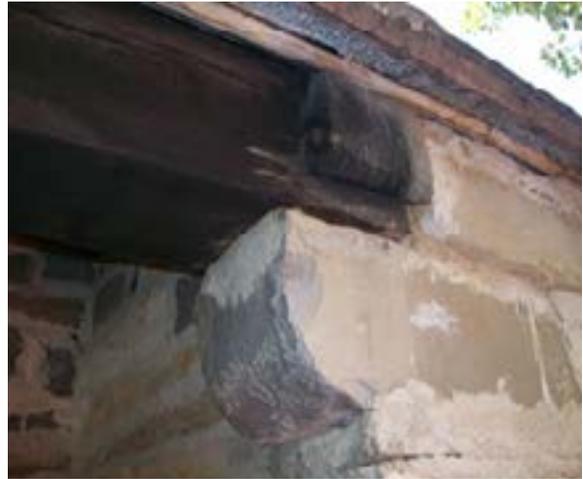
Figure NE 42- North entry overhang details: bull-nose ends of rafters and rounded stone support block, 2011.

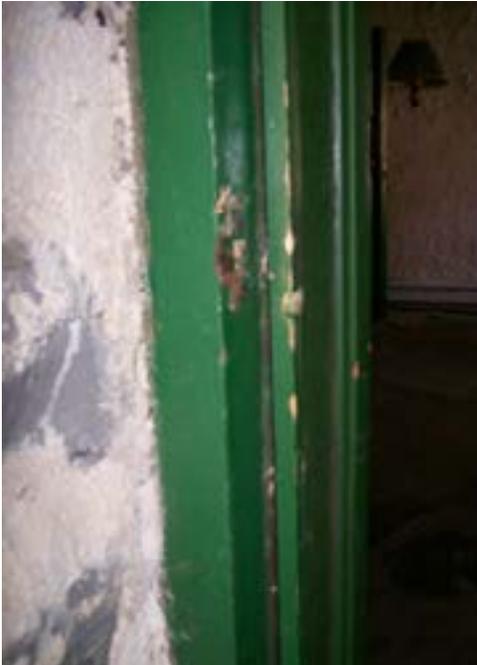
Figure NE 43- Wooden door frame damaged at north entry, 2011.

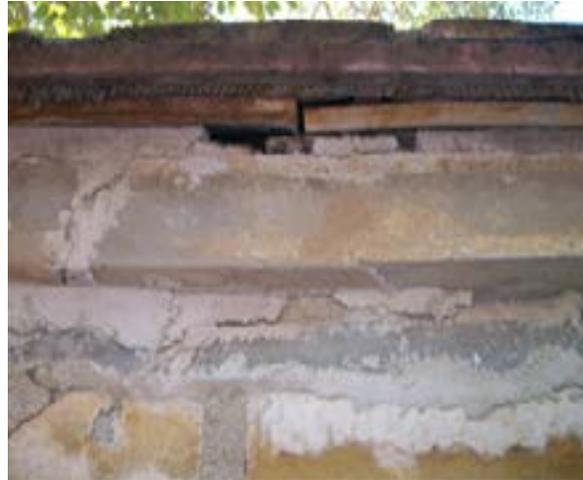
Figure NE 44- Missing mortar at interface of roof with north wall of west bedroom; interior roof timbers may be exposed, 2011.

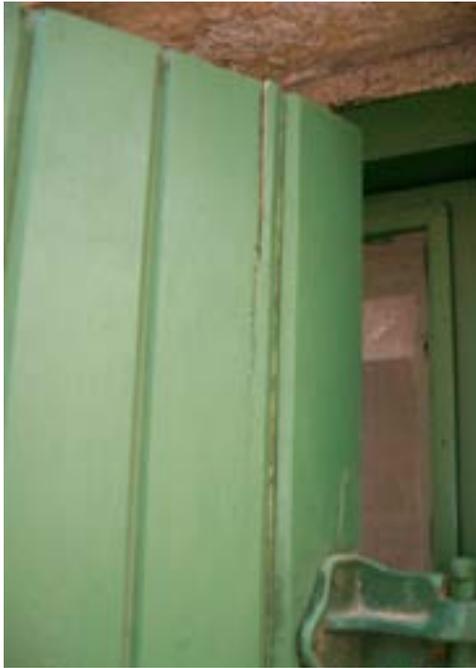
Figure NE 45- Crack in shutter on west wing of north façade (left window), 2011.

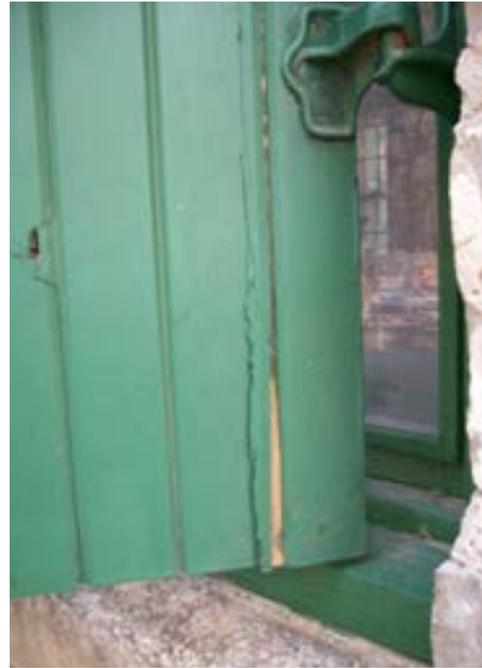
Figure NE 46- Crack in shutter on west wing of north façade (right window), 2011.

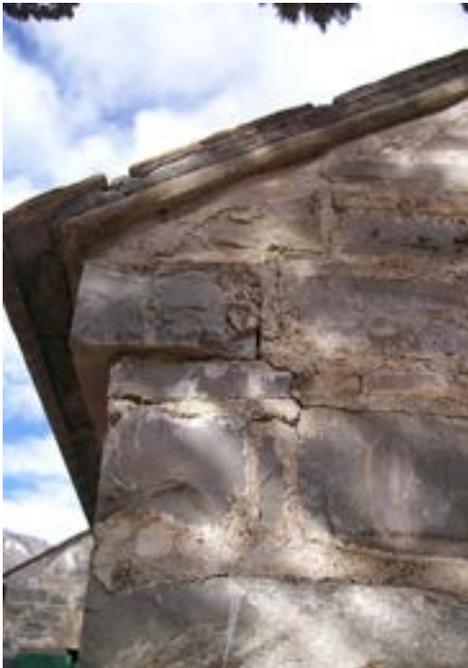
Figure EE 47- Crack at upper southern corner of east façade, 2011.

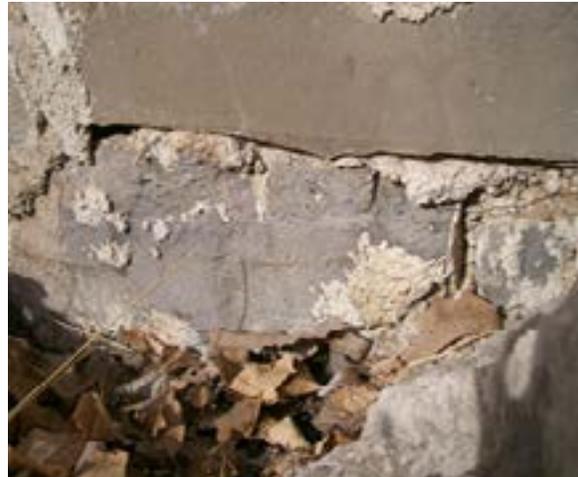
Figure EE 48- Deep hole in mortar at base of chimney on east façade (view partially obscured by debris on ground), 2011.

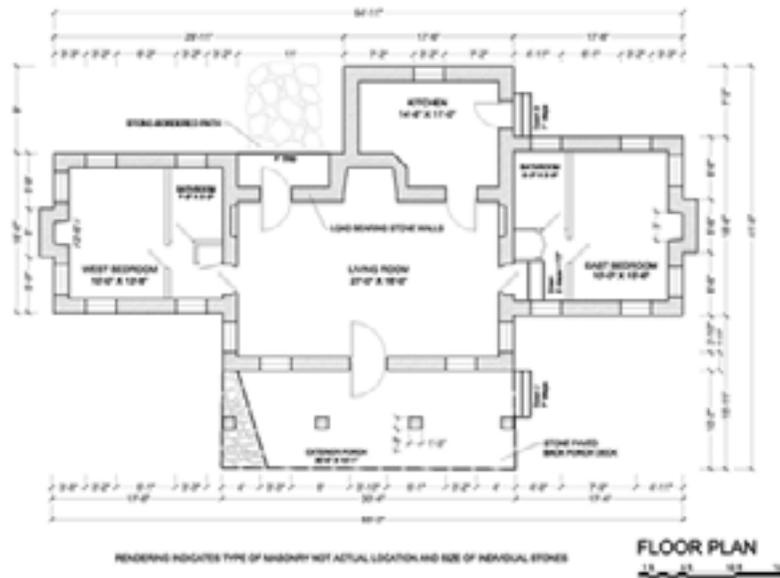
Primary Character Defining Features: Stone lintels over windows and doorways; stone wall masonry and floor finishes; built-in cabinets and shelves; stone slab mantles; exposed roof timbers; rafters and collar beams joined with wood pegs.

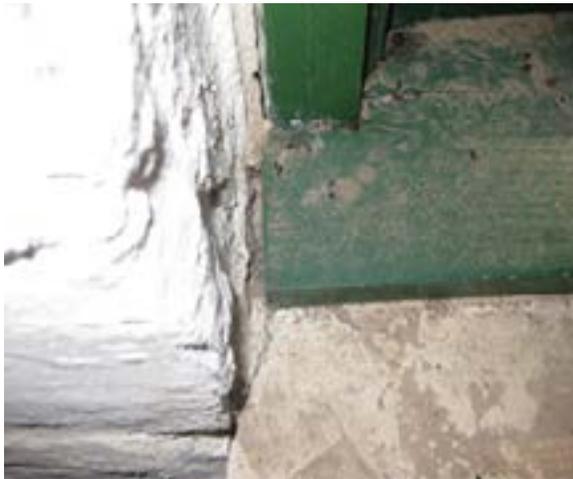
Figure LR 1- Gap in sill of window on east wall, 2011.

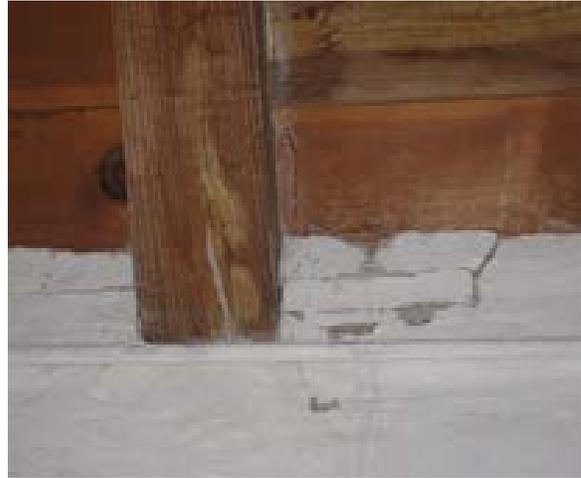
Figure LR 4- Crack in south stone wall at joint with ceiling, 2011.

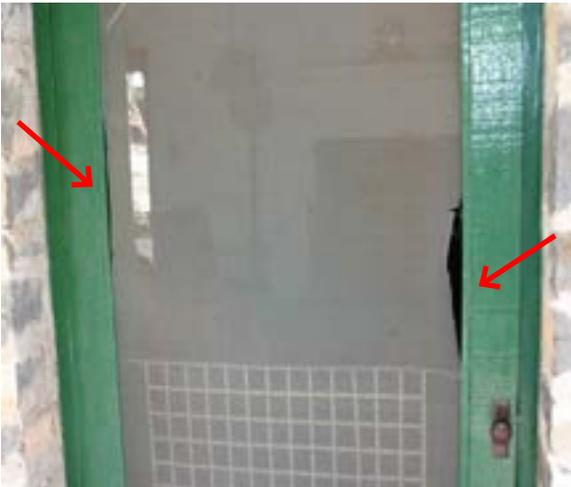
Figure LR 5- Screen separating from wood frame, south entrance, 2011.

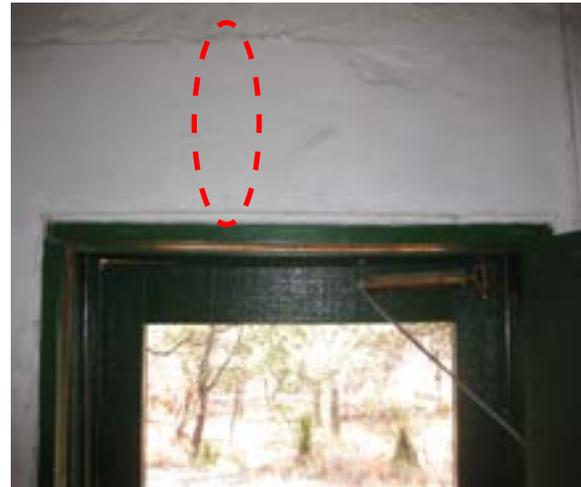
Figure LR 6- Crack in lintel above doorway on south wall, 2011.

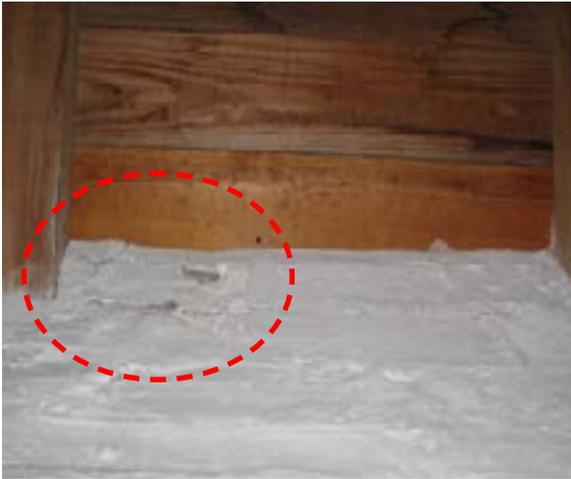
Figure LR 7- Cracked mortar on south wall near ceiling, 2011.

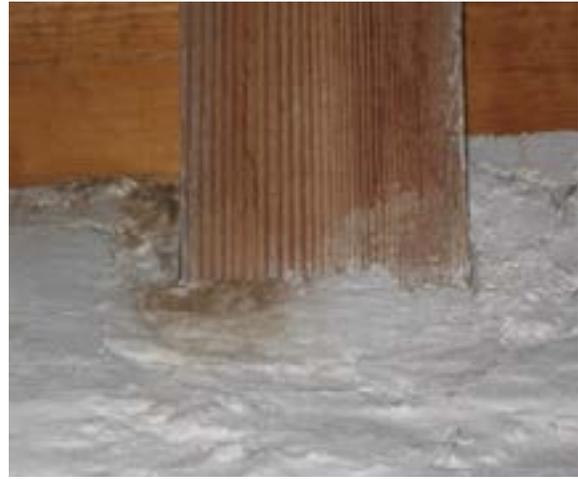
Figure LR 8- Water damage to roof beam at south living room wall, 2011.

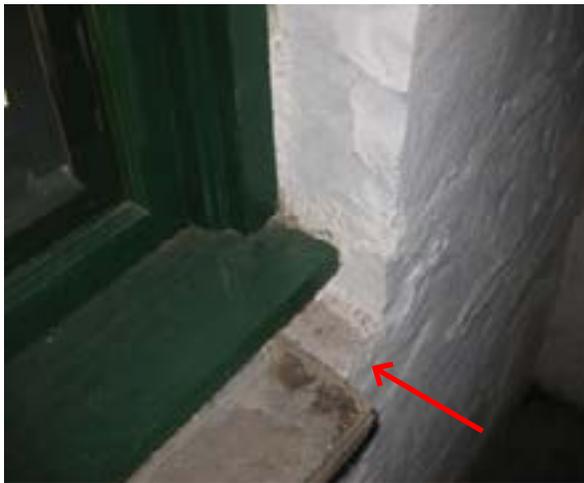
Figure LR 9- Gap in stone under window sill on south wall of living room, 2011.

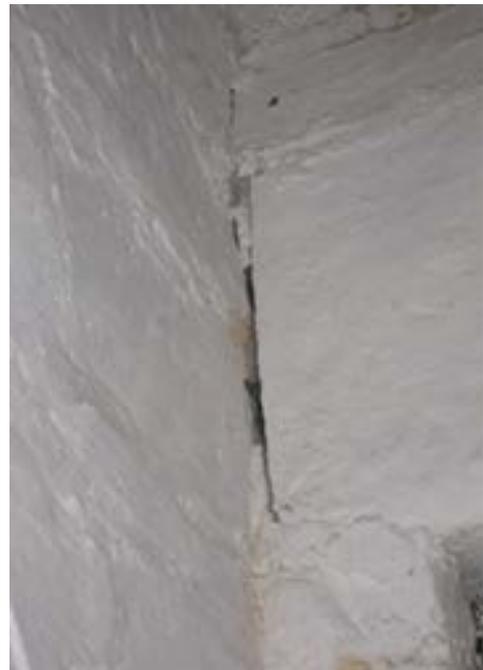
Figure LR 10- Crack at lintel over window on south living room wall, 2011.

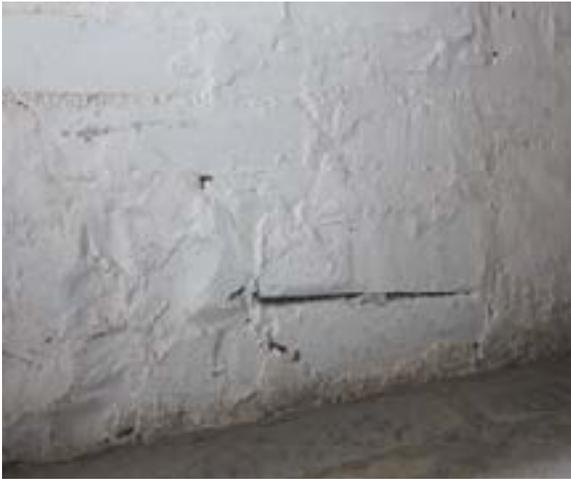
Figure LR 11- Substantial gaps in southwest corner of west wall, 2011.

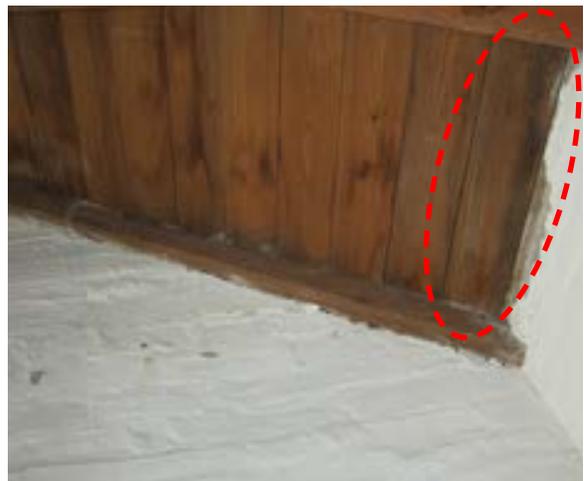
Figure LR 16- Deterioration of wall infill material between rafters and ceiling joint on west wall, 2011.

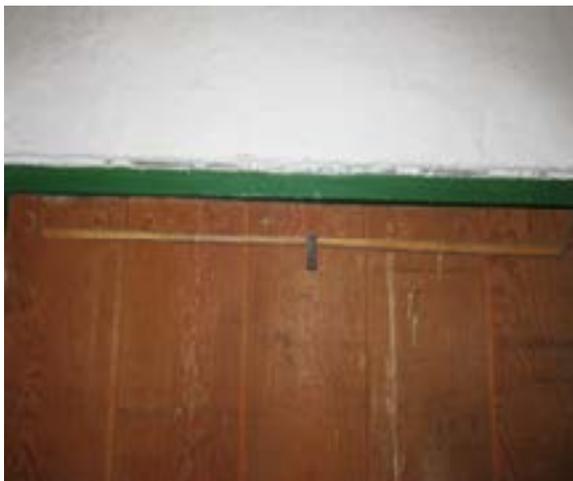
Figure LR 17- Gaps above door frame on north wall of living room, 2011.

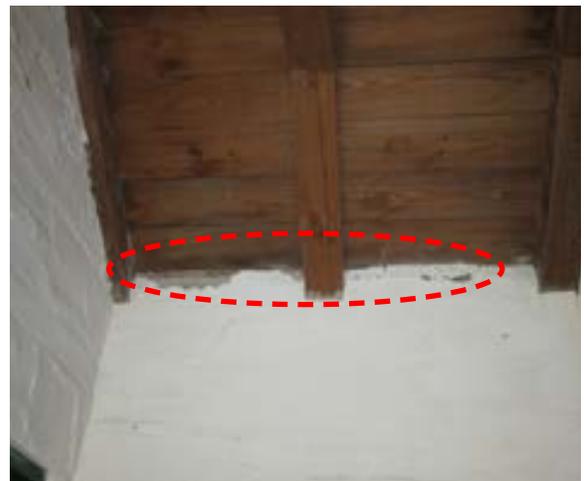
Figure LR 18- Water damage and peeling whitewash on north wall of living room, 2011.

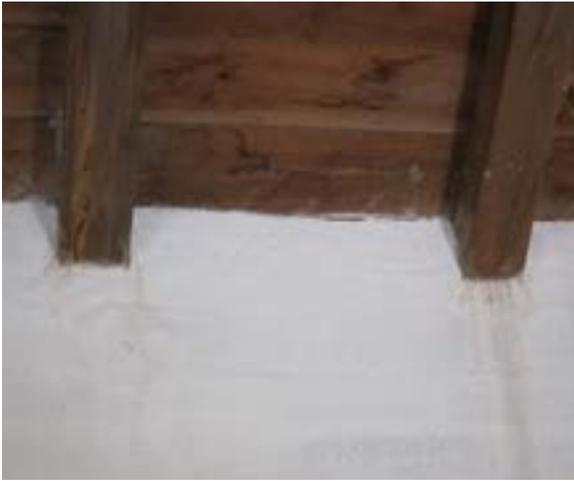
Figure LR 19- Water stains at rafter on north wall, 2011.

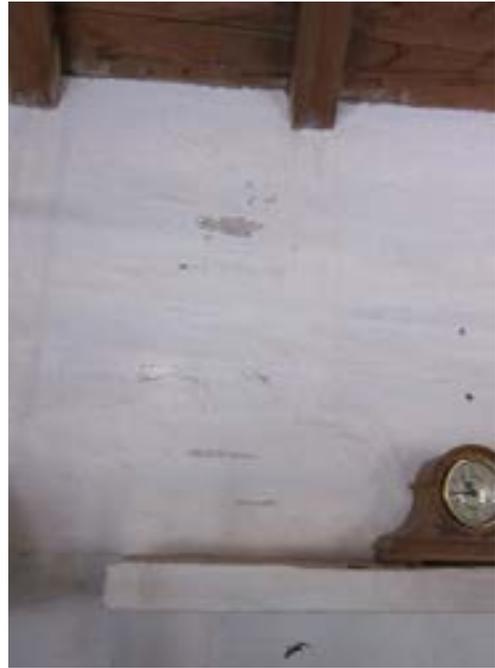
Figure LR 20- Staining and chipping of white wash on north wall indicate water damage, 2011.

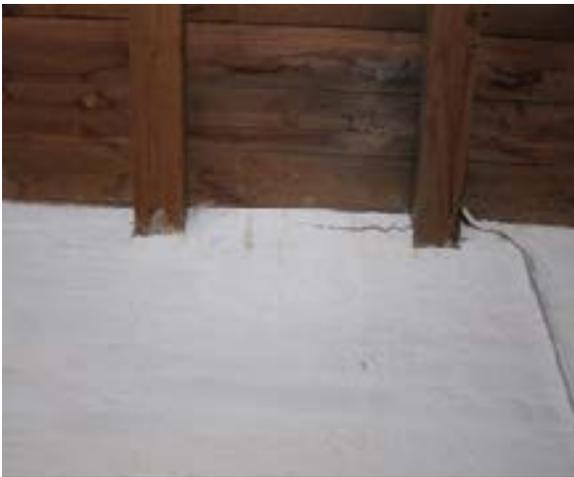
Figure LR 21- Water staining on exposed roof planks; note staining on the whitewash and the crack extending from rafter near joint of ceiling and north wall, 2011.

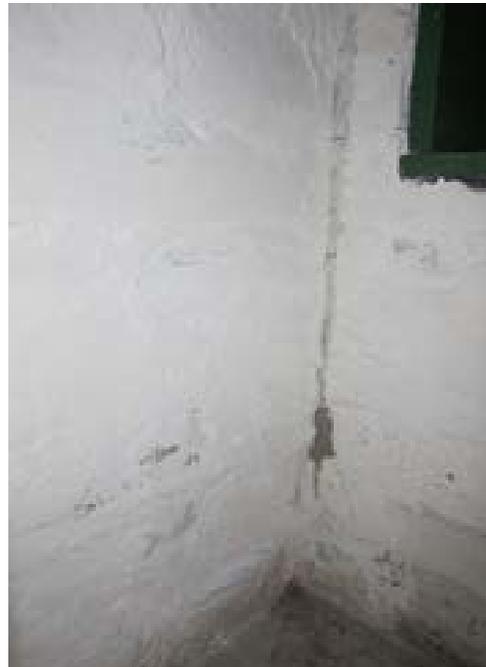
Figure LR 22- Peeling whitewash and deteriorating mortar in north corner of living room, 2011.

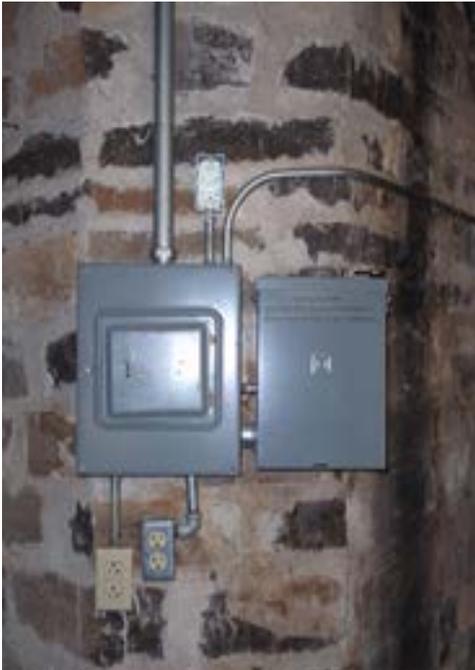
Figure KI 1- Non-historic electrical box on south kitchen wall; addition, 2011.

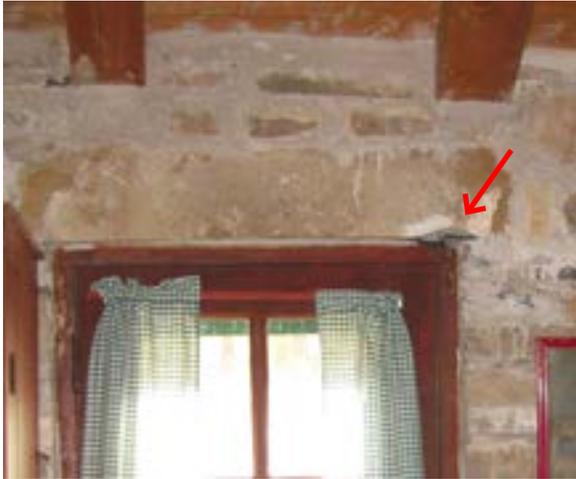
Figure KI 5- Mortar deteriorating about corner of door on east wall, 2011.

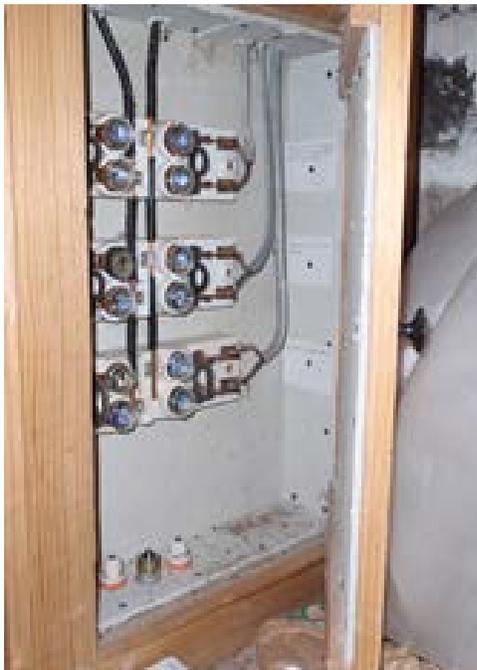
Figure EH 1- Original electrical box located in closet in the east hallway, 2011.

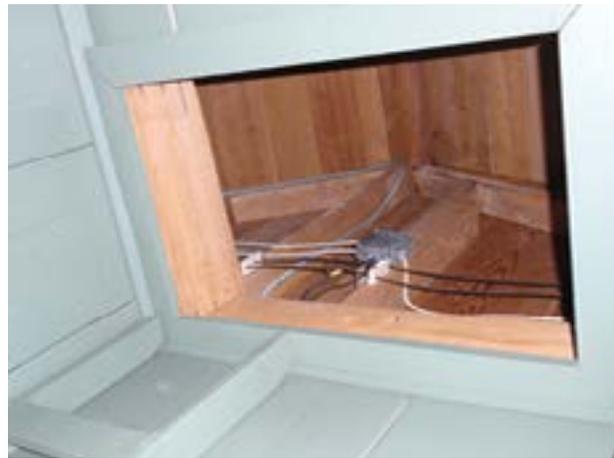
Figure EH 2- Missing cover for attic scuttle opening in east hallway ceiling, 2011.

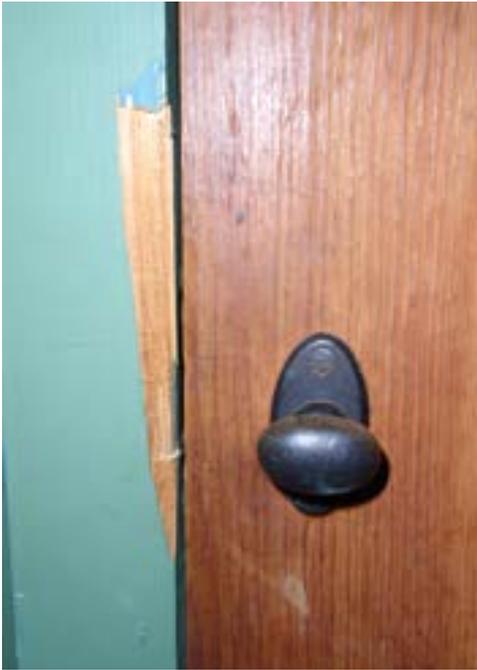
Figure EB 1- Chipped wood at door frame on south bathroom wall, 2011.

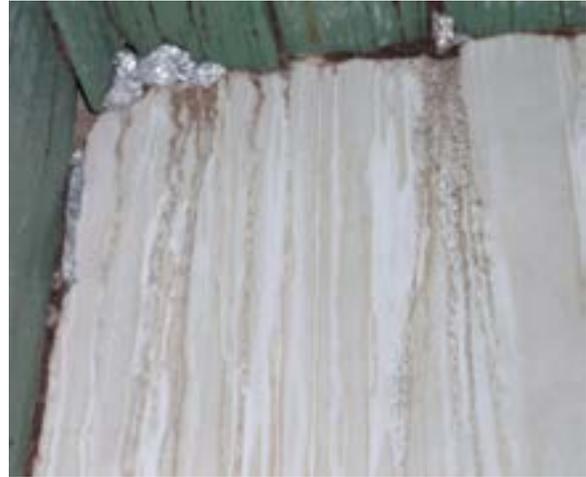
Figure EB 2- Extensive water damage in upper southwest corner of bathroom (ceiling, and walls) ; note tin foil in gaps at corner, 2011.
