# **HISTORIC STRUCTURE REPORT**

## **PRATT CABIN**

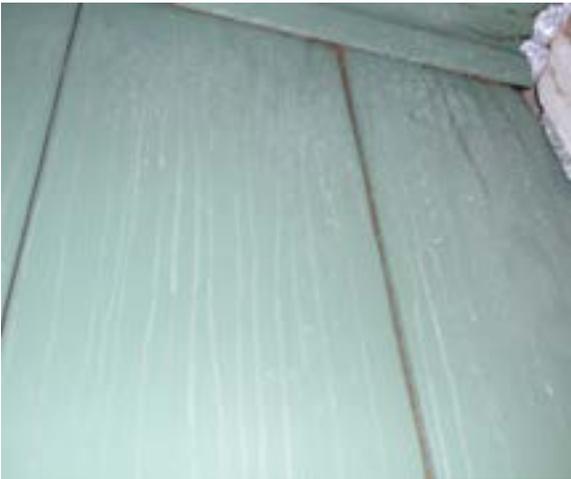
Figure EB 3- Water damage in upper southwest corner of bathroom (ceiling and walls), 2011.

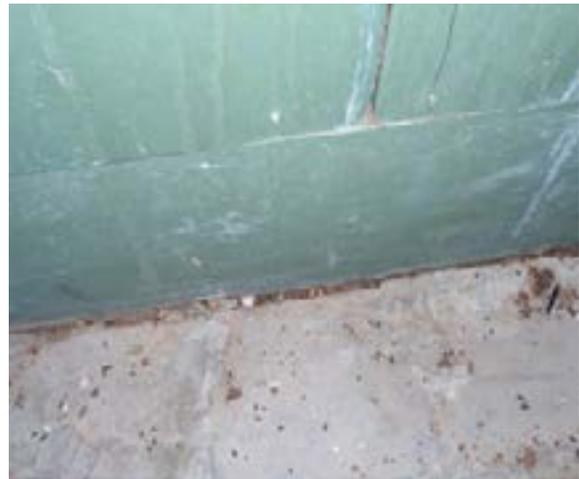
Figure EB3- Crack between south wall and stone floor; note water staining on wood wall, 2011.

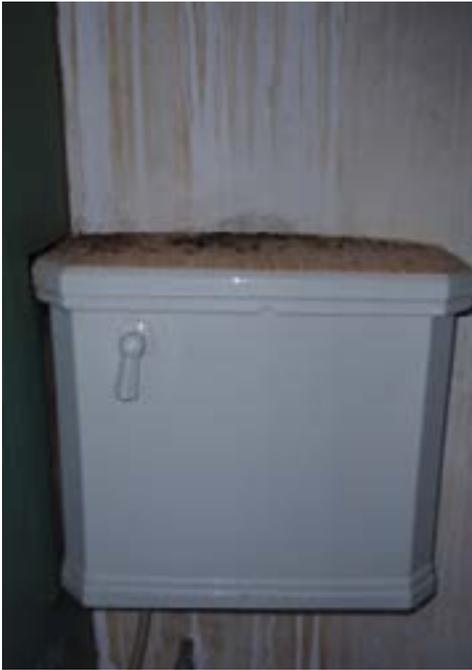
Figure EB 5- Remaining tank of toilet fixture (bowl removed); note debris on tank and water damage to wall behind tank, 2011.

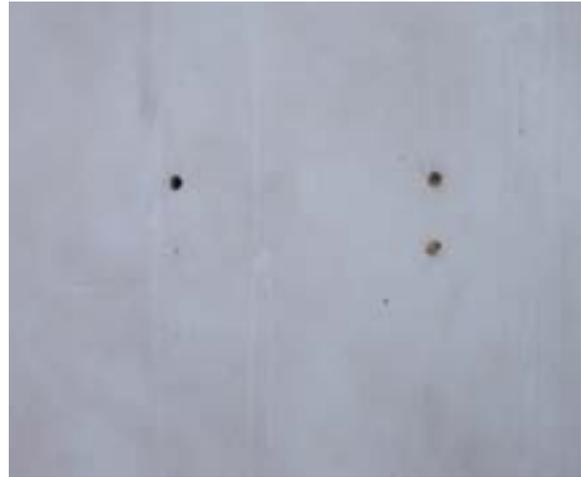
Figure EB 6- Holes in west bathroom wall; note water staining, 2011.

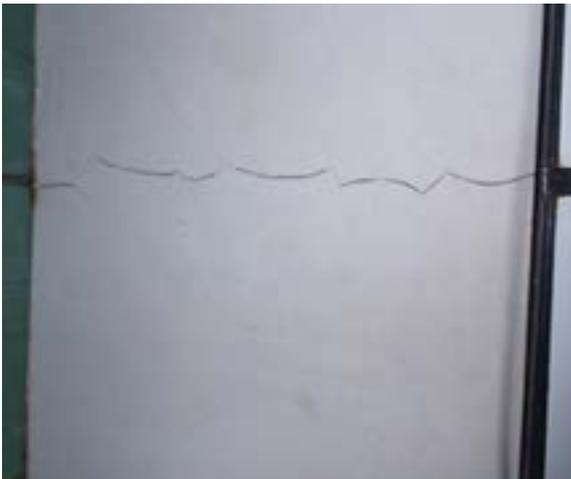
Figure EB 7- Cracks in plaster on west wall, 2011.

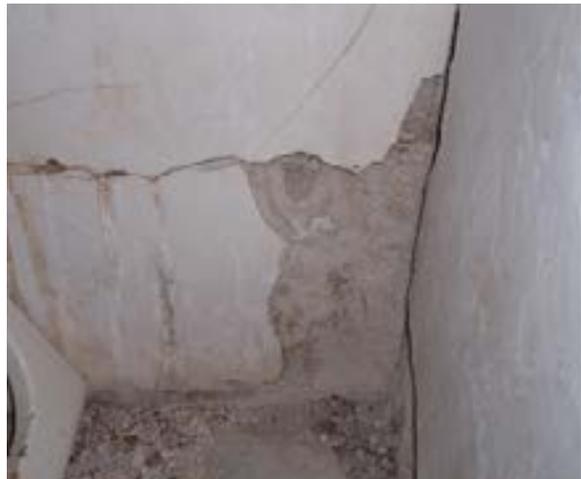
Figure EB 8- Extensive cracking and detachment of plaster in northwest corner, 2011.

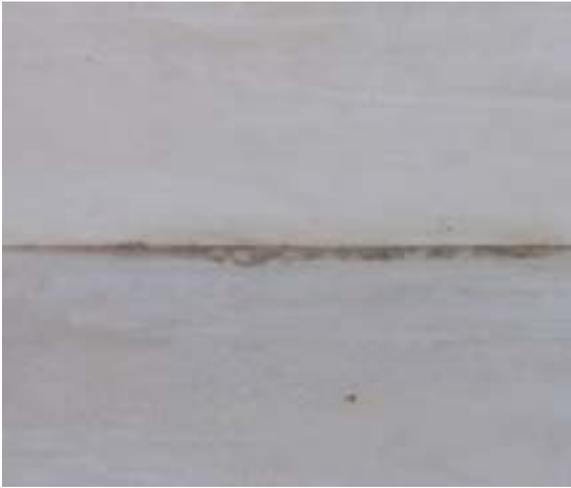
Figure EB 9- Cracks and staining in plaster on north wall, 2011.

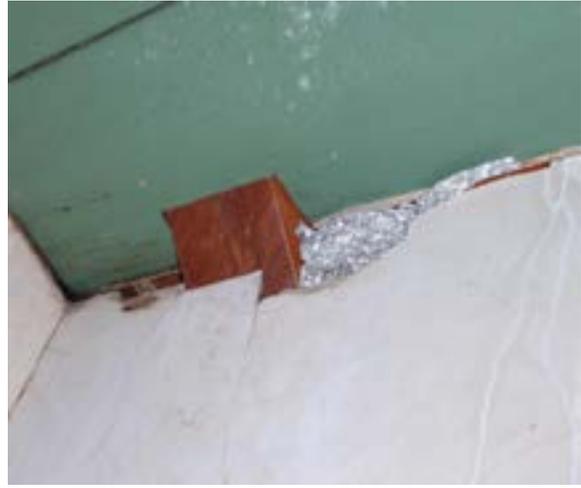
Figure EB 10- Water damage to north plaster wall and suspended ceiling.; gaps filled with tin foil. Note exposed rafter, 2011.

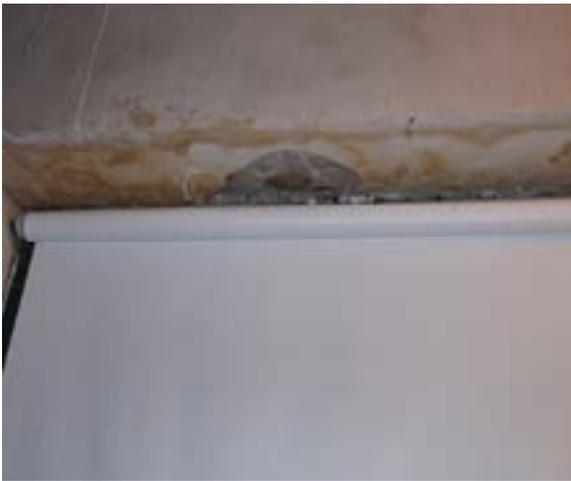
Figure EB 11- Extensive water staining and damage to plaster above window on the north wall, 2011.

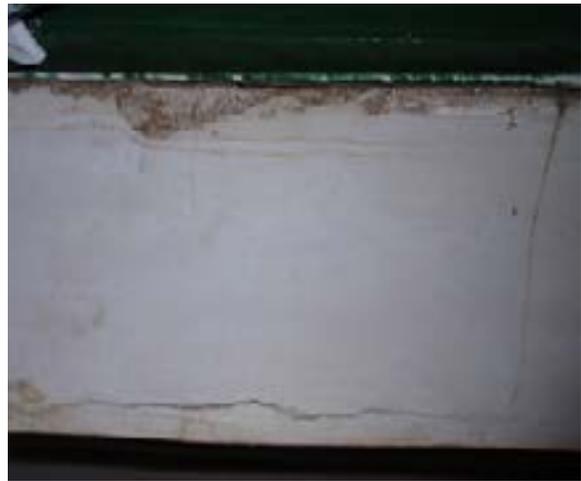
Figure EB 12- Deteriorated mortar under window sill and cracked/detached plaster under window on the north wall, 2011.

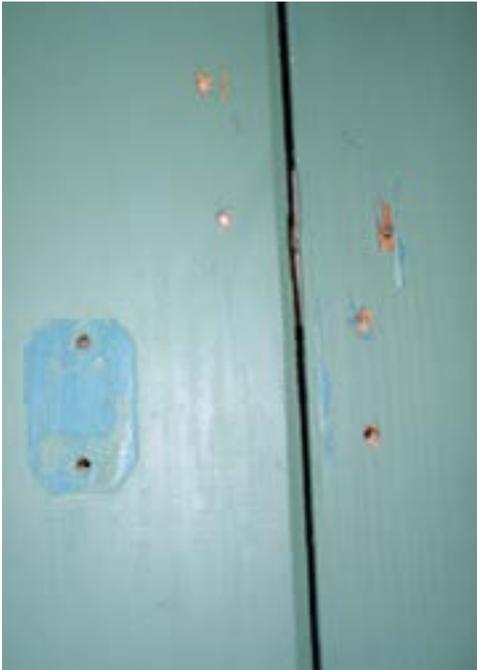
Figure EB 13- Holes in wood panels on east wall, 2011.

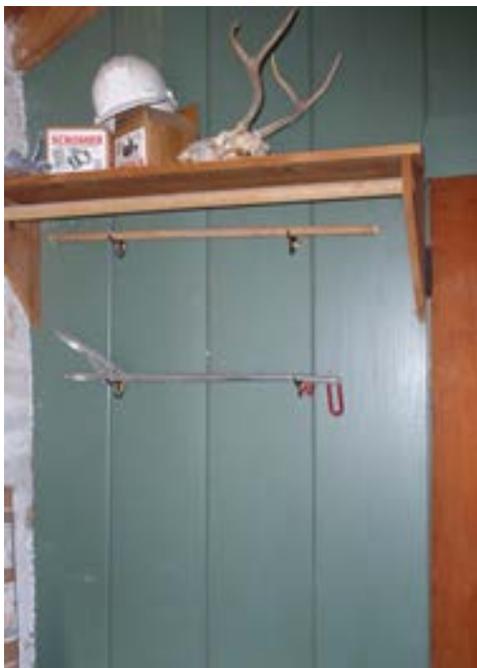
Figure EBR 1- Built-in shelf and rod fixture and hook fixtures on west wall, 2011.

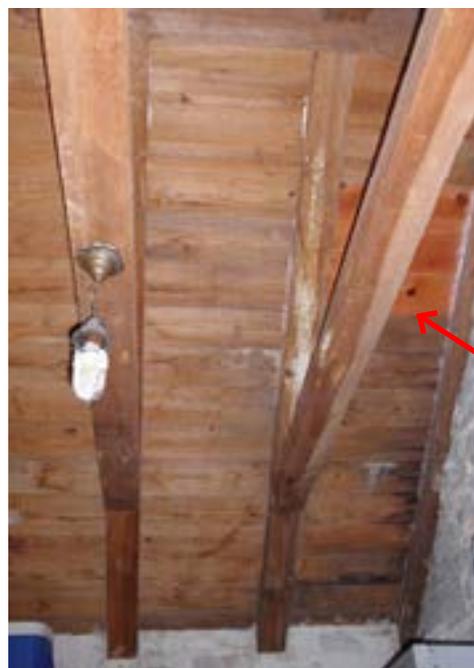
Figure EBR 2- Metal light fixture on central collar beam; note replaced sheathing (indicated with arrow), 2011.

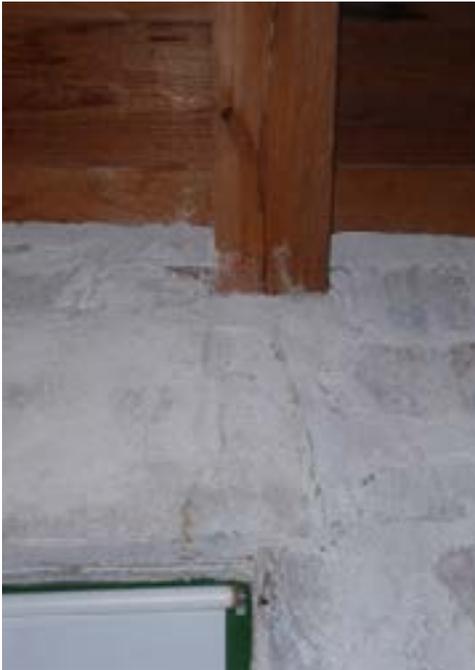
Figure EBR 3- Water staining on south wall under rafter, 2011.

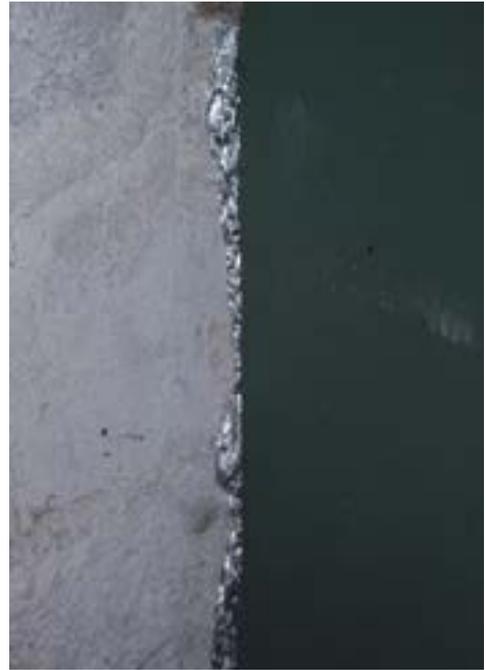
Figure EBR 4- Foil in gaps between south stone wall and west partition wall, 2011.

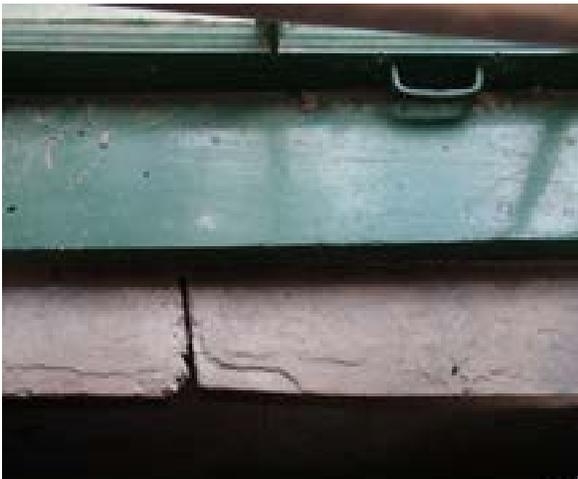
Figure EBR 5- Crack between stone blocks under window sill on south wall, 2011.

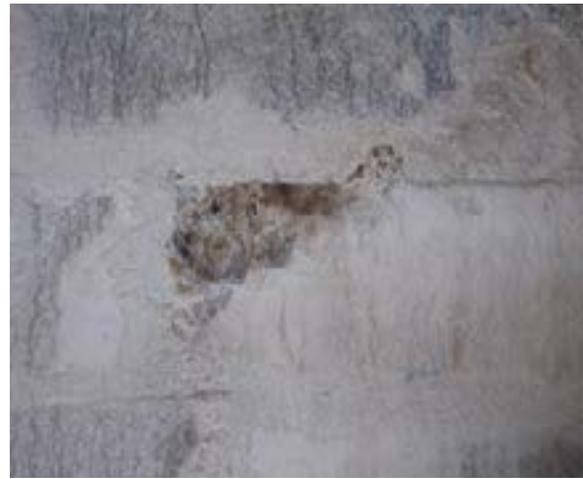
Figure EBR 6- Discoloration of south stone wall; possible water damage, 2011.

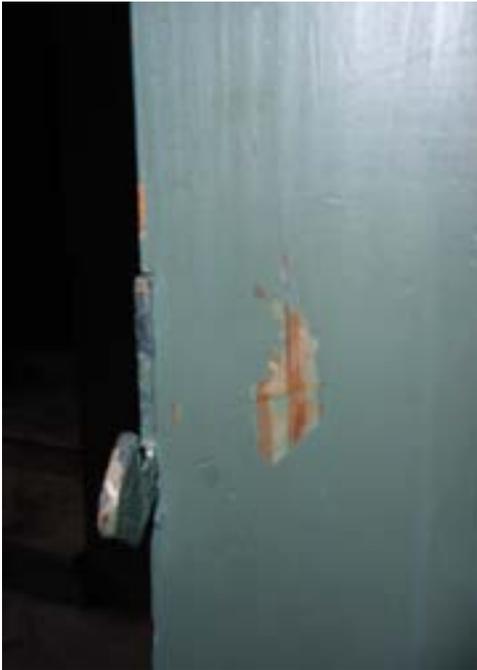
Figure EBR 7- Chip in wood of door frame; note hinge is damaged and protruding, 2011.

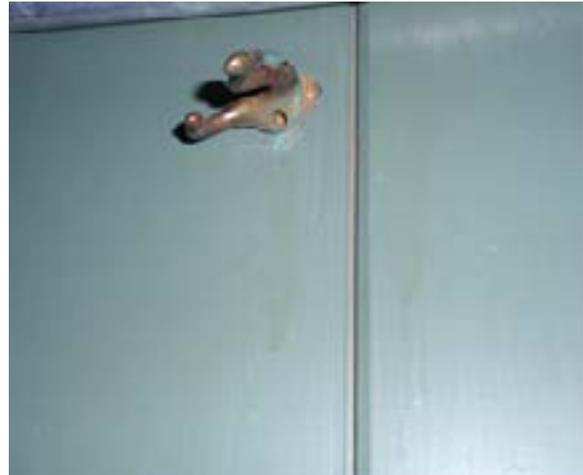
Figure EBR 8- Hook fixture missing a screw and falling off west wall, 2011.

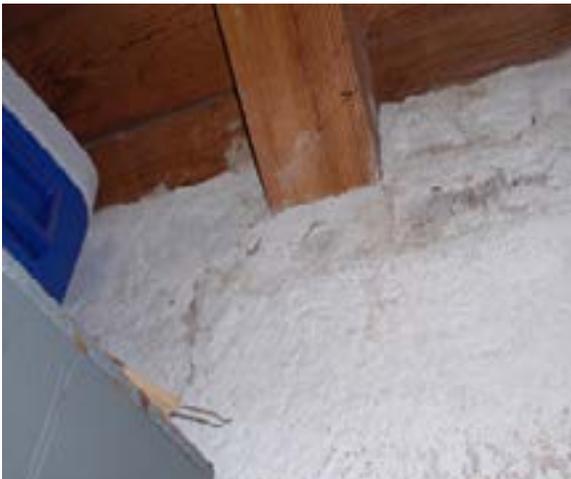
Figure EBR 9- Crack in north stone wall under rafter, 2011.

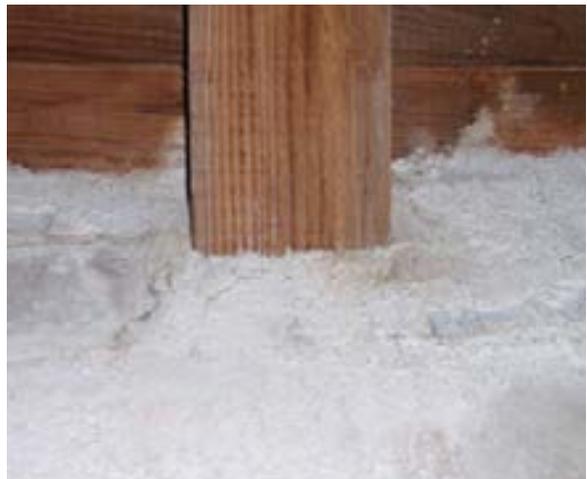
Figure EBR 10- Water staining on north stone wall at joint with roof; note white stains on exposed planks, 2011.

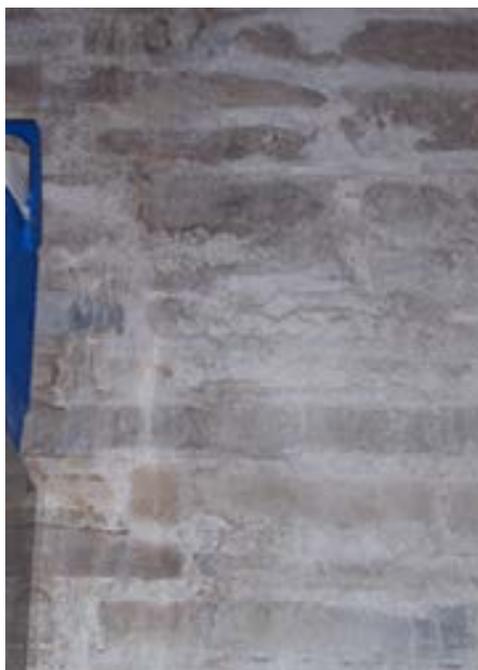
Figure EBR 11- Discoloration of east stone wall; possible water damage, 2011.

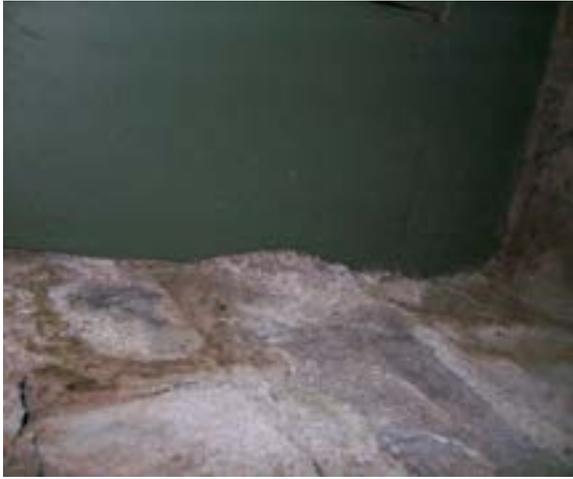
Figure WH 1- Wood planks of drop-down ceiling carved to fit curves of stone wall, 2011.

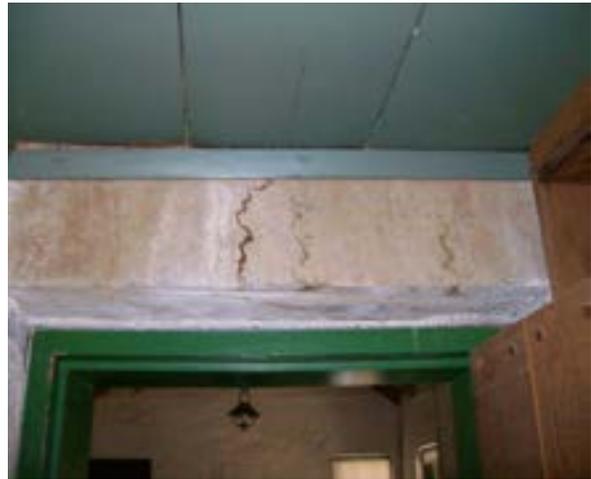
Figure WH 4- Water stains on the lintel above door on east wall; wood trim detaching, 2011.

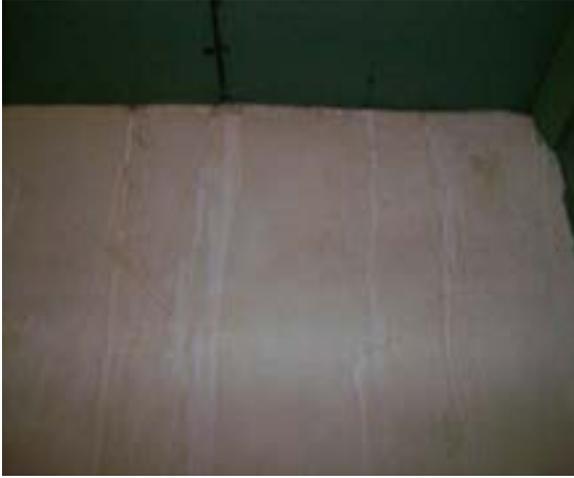
Figure WB 1- Water damage on east plastered wall (plaster eroded), 2011.

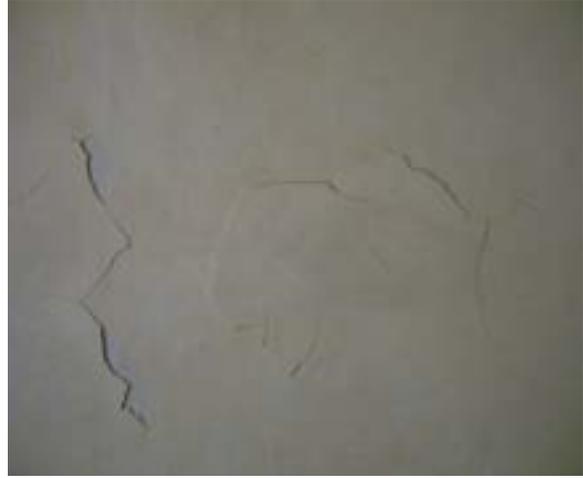
Figure WB 2- Cracked and peeling plaster on east wall, 2011.

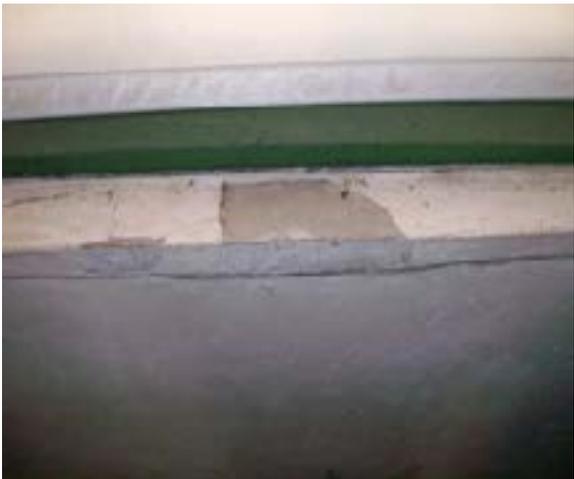
Figure WB 3- Cracked and detached plaster at window sill on north wall, 2011.

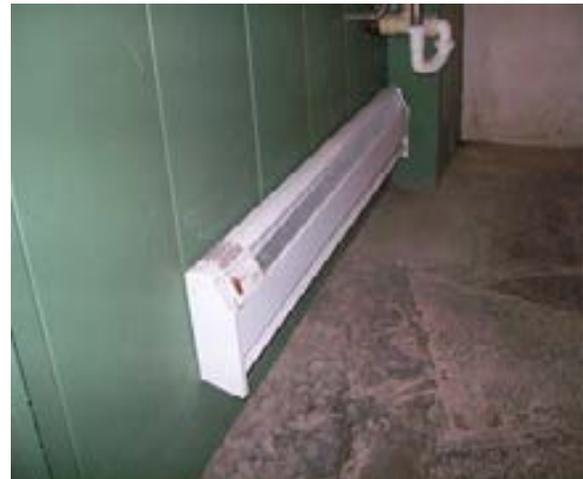
Figure WB 4- Non-historic heater at base of west partition wall, 2011.

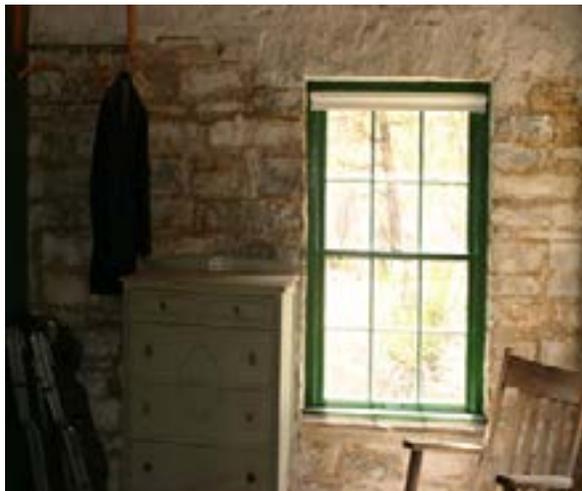
Figure WBR 1- Extensive discoloration on south wall due to water filtration, 2011.

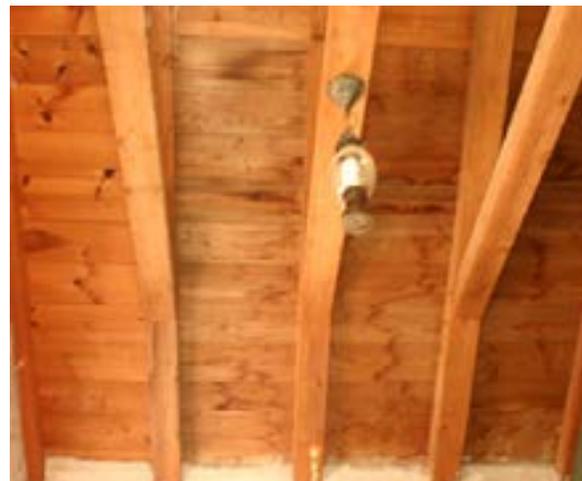
Figure WBR 2- Water staining on sheathing; note light fixture on central collar beam and replaced section of sheathing (far left), 2011.

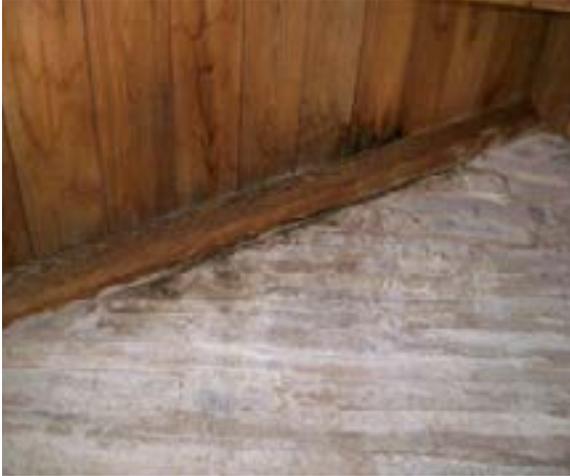
Figure WBR 3- Extensive water damage at gable rafter at joint with west wall; note water discoloration of north stone wall, 2011.

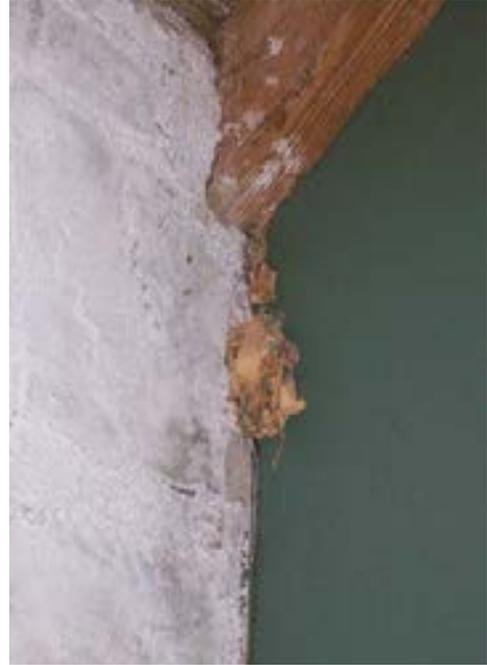
Figure WBR 4- Exposed newspaper insulation at joint of east partition wall, north stone wall and rafter, 2011.

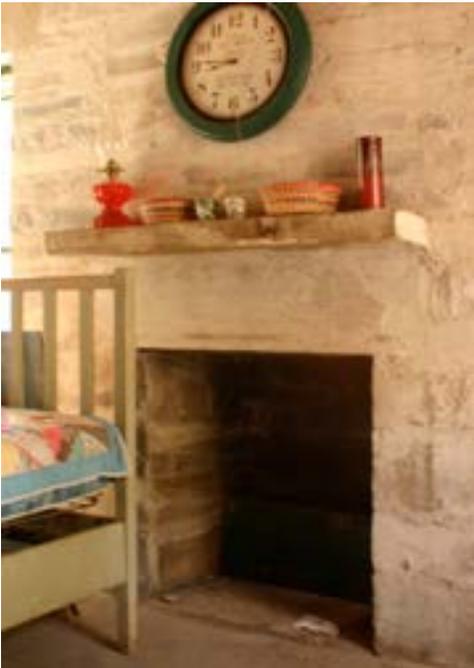
Figure WBR 5- Fireplace in West Bedroom; queen-size bed and plywood board that block fireplace moved at time of assessment for photograph and subsequently replaced.

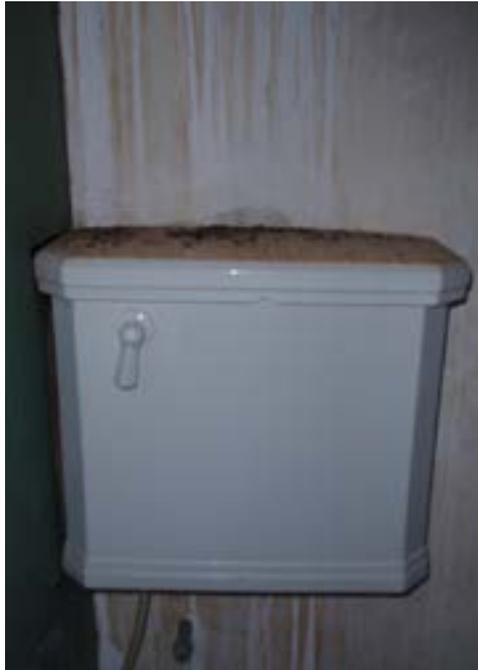
Figure CS 1- Toilet bowls have been removed in both bathrooms; tanks remain in place, 2011.

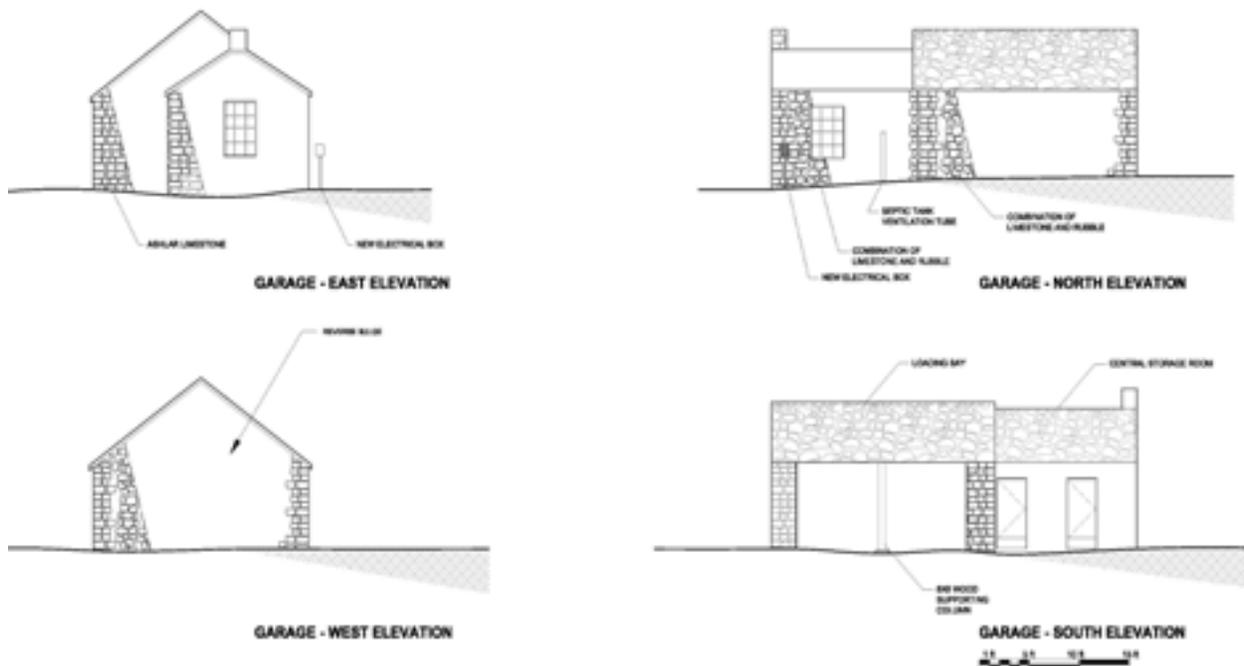
Exterior Deficiency/ Alteration	Recommended Treatment*	Impact
Mortar deteriorating on east wall. No photo available.	Repoint mortar, monitor for further deterioration.	Low
Non-historic vent hole on east façade. See FIG. EG 2.	Determine function of ventilation hole; if not in use, cover ventilation hole with limestone blocking to prevent exposure to water and pests.	Low
Holes in joints at center of the west façade. See FIG. EG 3, EG 4.	Repoint mortar.	Low
Bulge in west wall. See FIG. EG 5.	Ensure proper drainage of water away from the structure. Develop a monitoring system to track further structural deformation of the load bearing walls. Consult with a licensed architect or engineer for further information on underlying causes and treatments.	Severe

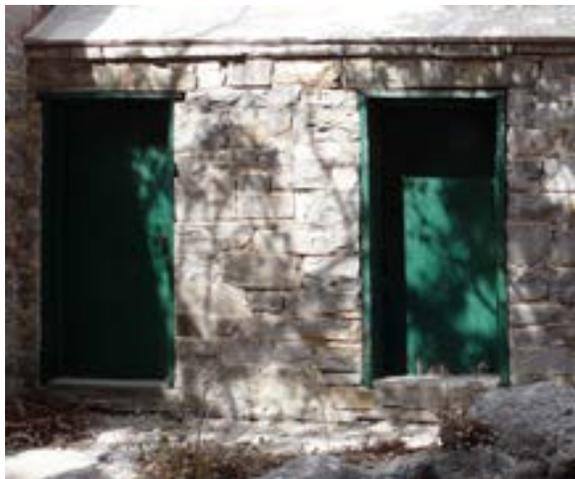
Figure EG 1-Doors on south facade of east wing of garage; note elevations of sills and frame construction, 2011.

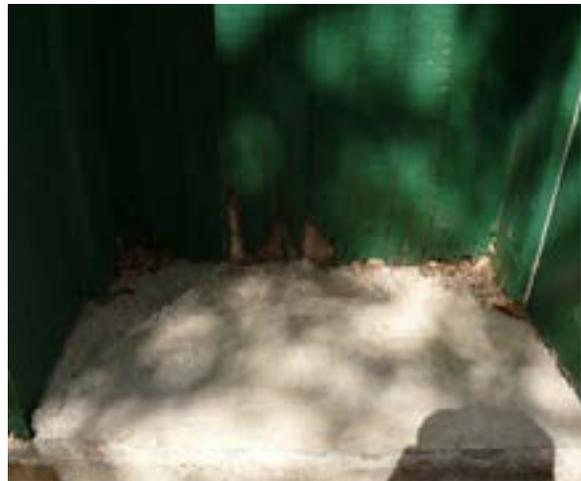
Figure EG 6 – Water damage at bottom wooden door frame and door, 2011.

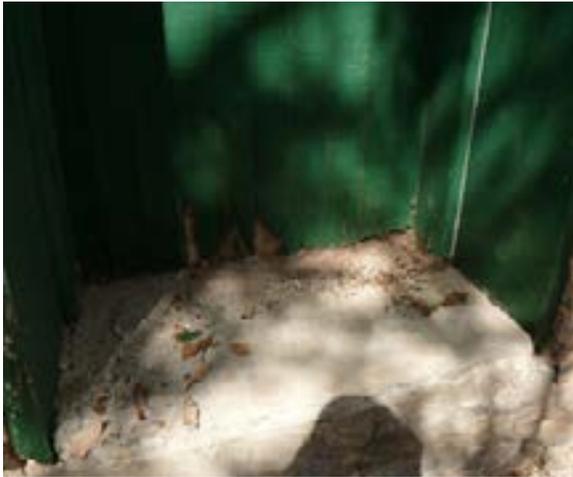
Figure EG 7- Wood planks weathering at bottom of wood door, 2011

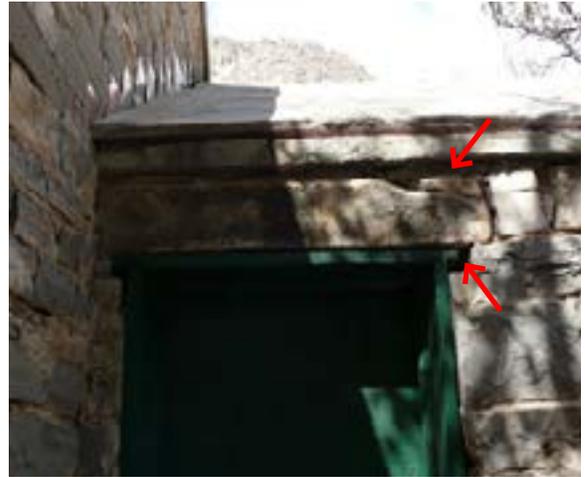
Figure EG 8- Crack in lintel over west exterior door; note gap between door frame and stone masonry, 2011.

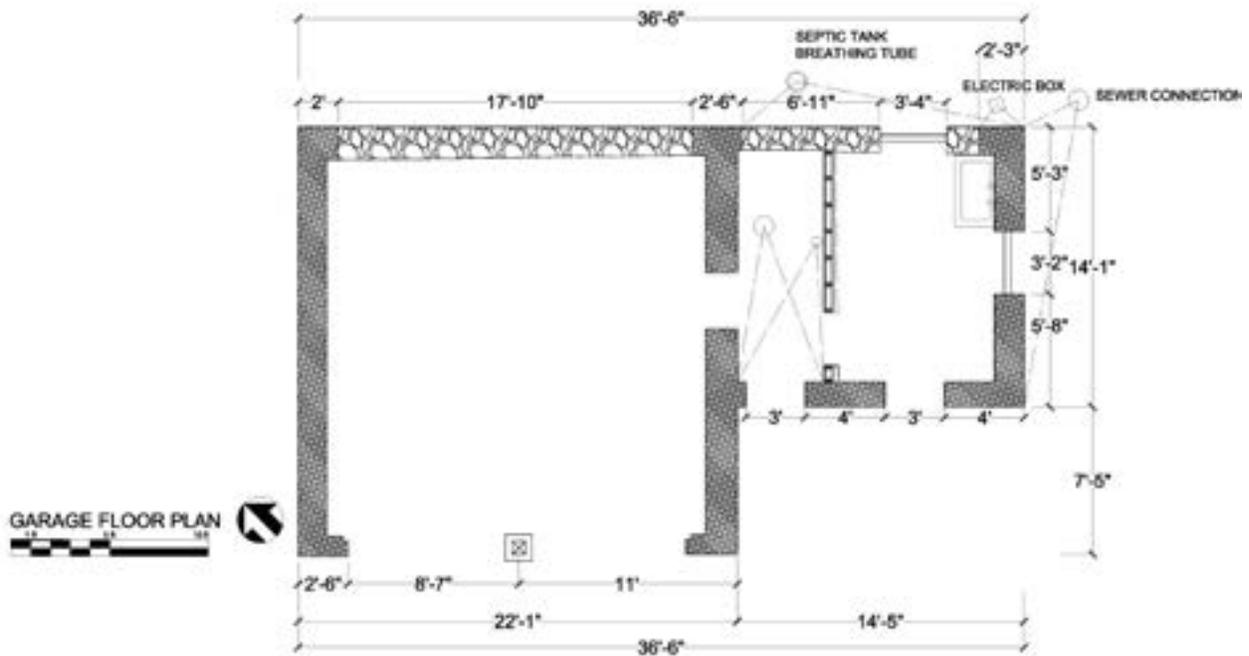
Garage Interior Bay Deficiency/ Alteration	Recommended Treatment*	Impact
Garage doors have been removed; exposed bolts are a possible hazard. See FIG. IG 1.	As fastenings are evidence of the historic garage doors, they should be capped rather than removed.	Low
Non-historic tension rods deforming. See FIG. IG 2.	Discontinue use of tension rods for shelving purposes. Consult with a licensed structural engineer to determine continued need for tension rods for structural purposes and perform treatment accordingly.	Severe
Significant water stains on west and south walls. See FIG. IG 3.	Seal joint of roof and wall with mortar or clear silicone caulk to prevent water exposure to interior structural elements.	Moderate
Plaster crumbling in east corner of north wall. See FIG IG 4.	Repair cause of exterior water penetration, then remove and replace damaged plaster in-kind.	Low

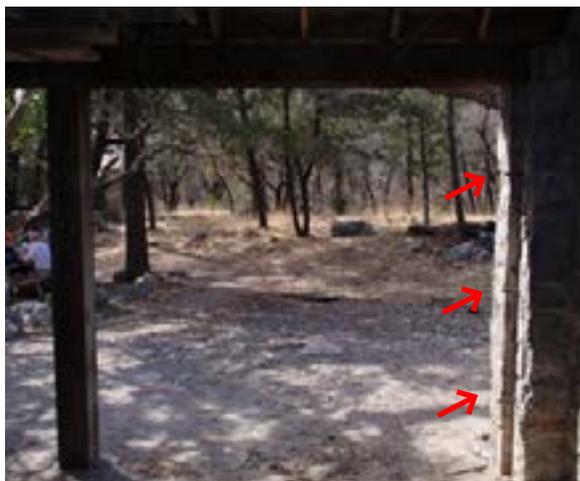
Figure IG 1- Garage doors have been removed; metal bolts are exposed, 2011.

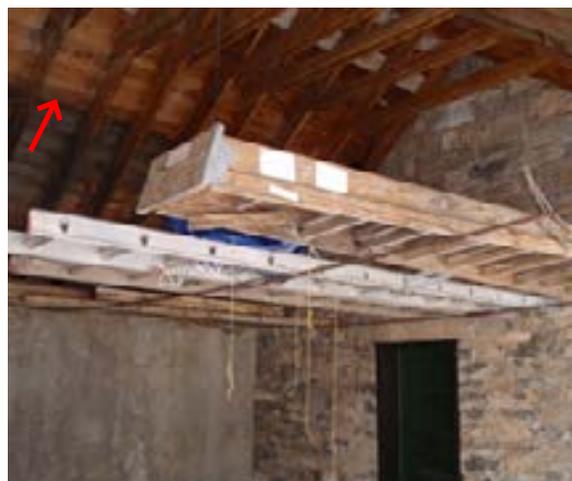
Figure IG 2 – Non-historic steel tension rods, which currently are used as shelving; note replaced sheathing (indicated with arrow), 2011.

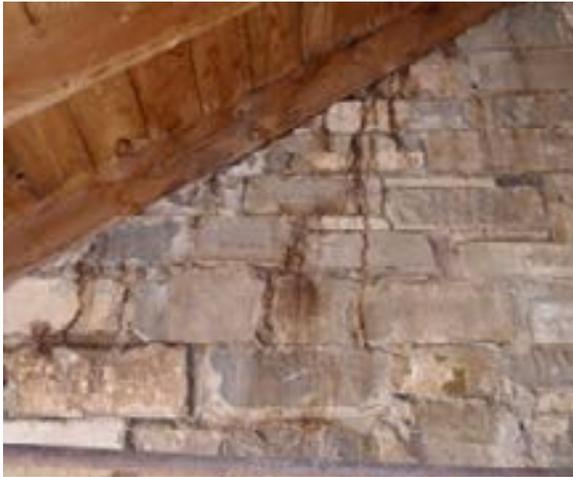
Figure IG 3 - Extensive staining on west wall at connection with wood gable rafter, 2011.

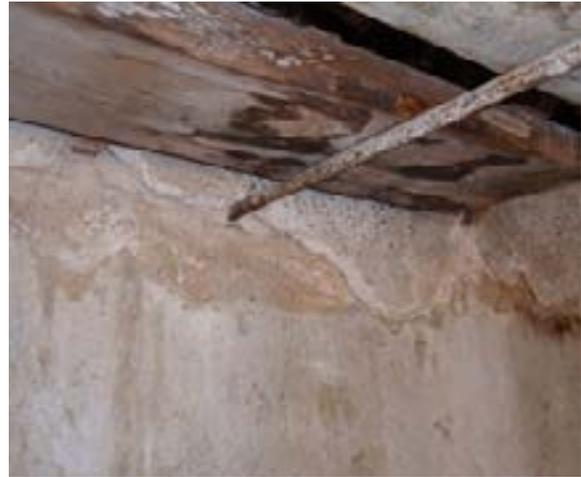
Figure IG 4 - Coarse mortar coat cracking at southern-east corner, 2011.

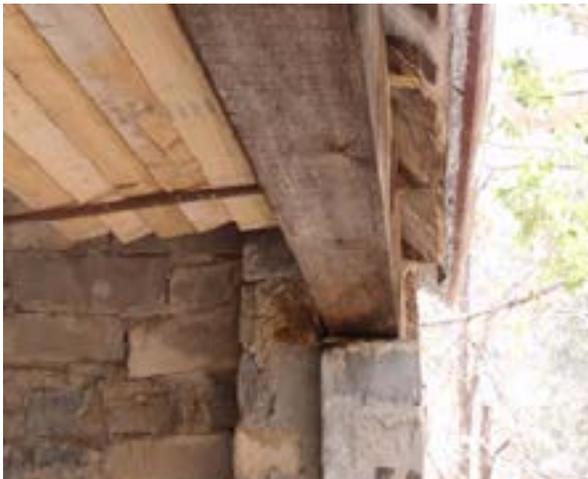
Figure IG 5 - Rust stains at 8" x 8" wood beam connection points with stone wall; note water damage on sheathing at edge of roof overhang, 2011.

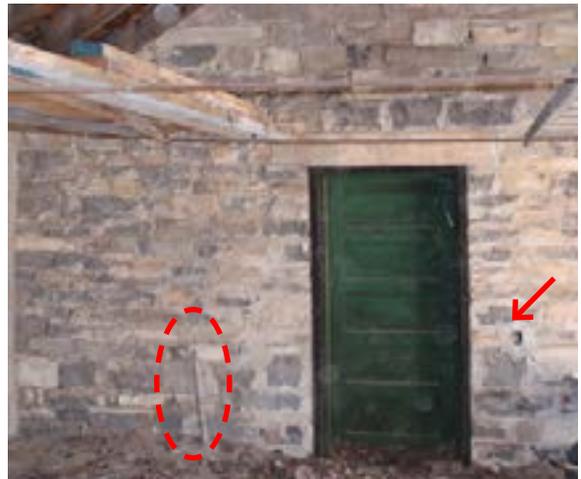
Figure IG 6 - Protruding pipe line (outlined in red) can be enclosed with a protective cage; note lightswitch south of doorway (indicated with arrow), 2011.

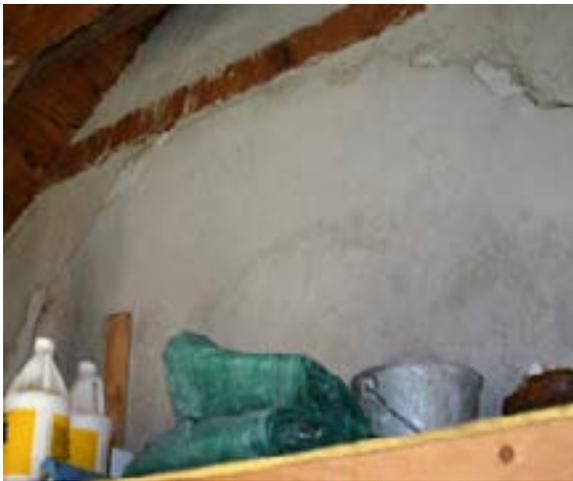
Figure IG 7 – Stud and plaster partition wall intersecting with wood collar beam presents multiple cracks and peeling of cement plaster sheathing, 2011.

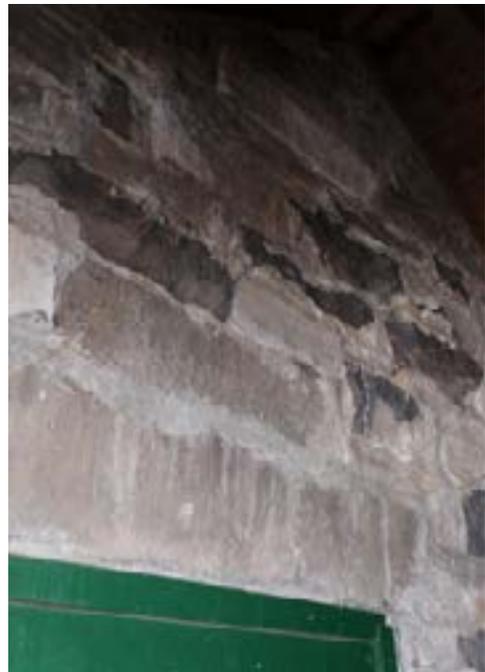
Figure IG 8- West wall of the garage central storage room is bulging eastward above door to Garage bay, 2011.

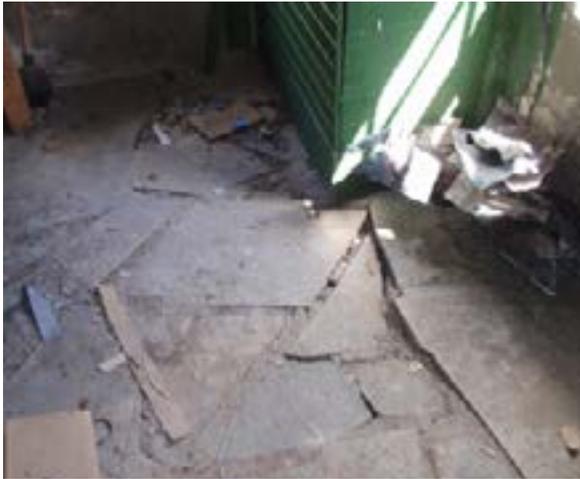
Figure IG 13- Uneven floor surface, possibly due to deficiencies in foundation, and detachment of the stone flooring, 2011.

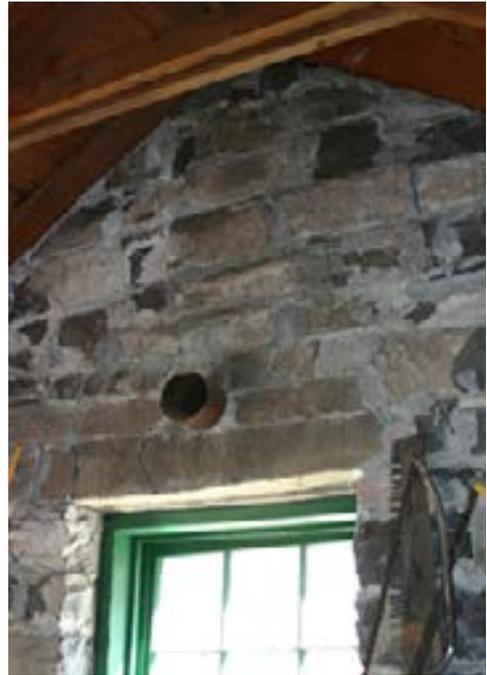
Figure IG 14- Ventilation hole on east wall of east storage room may be allowing pests into the interior of the Garage, 2011.

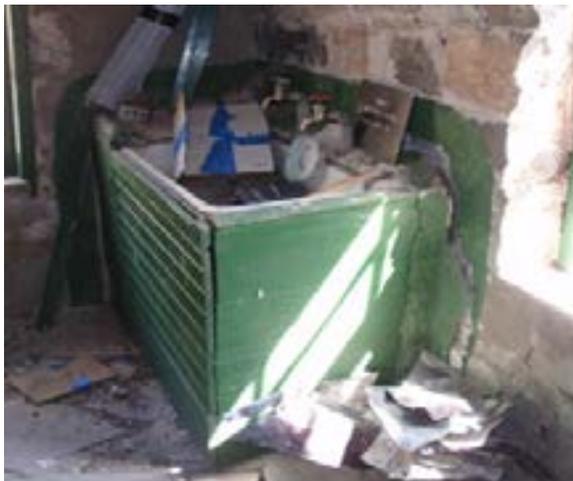
Figure IG 15 - The sink exhibits extensive damage and detachment from the stone wall, 2011.

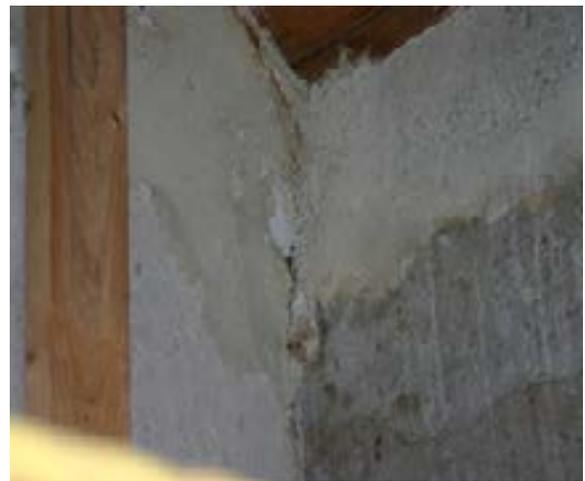
Figure IG 16- Separation of partition wall and stone wall in southwest corner of east storage room, 2011.

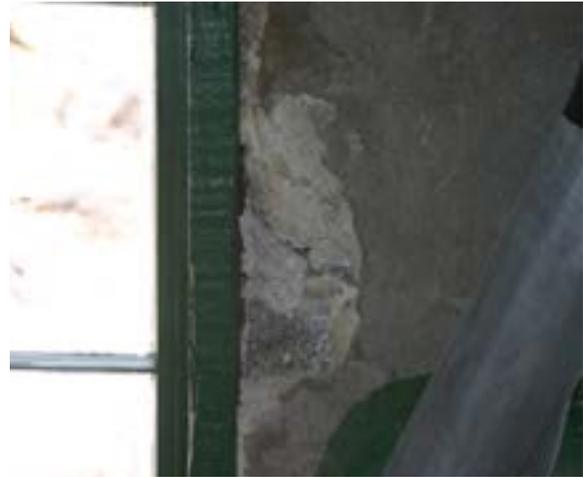
Figure IG 18- Example of spalling cement plaster on north wall of east Garage storage room, 2011.

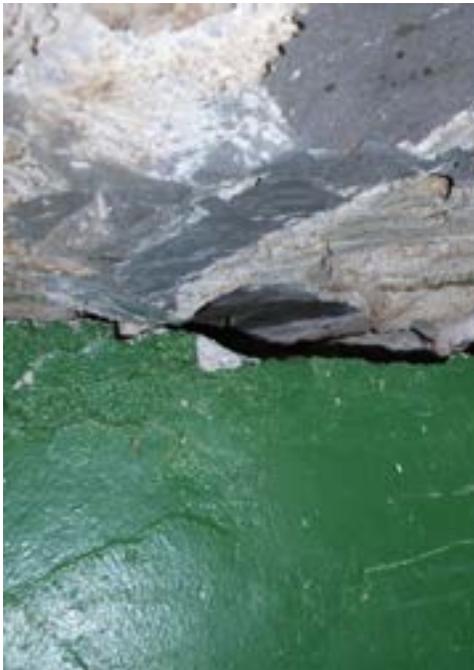
Figure IG 19- Gap between east partition wall and south stone wall in central storage room, 2011.

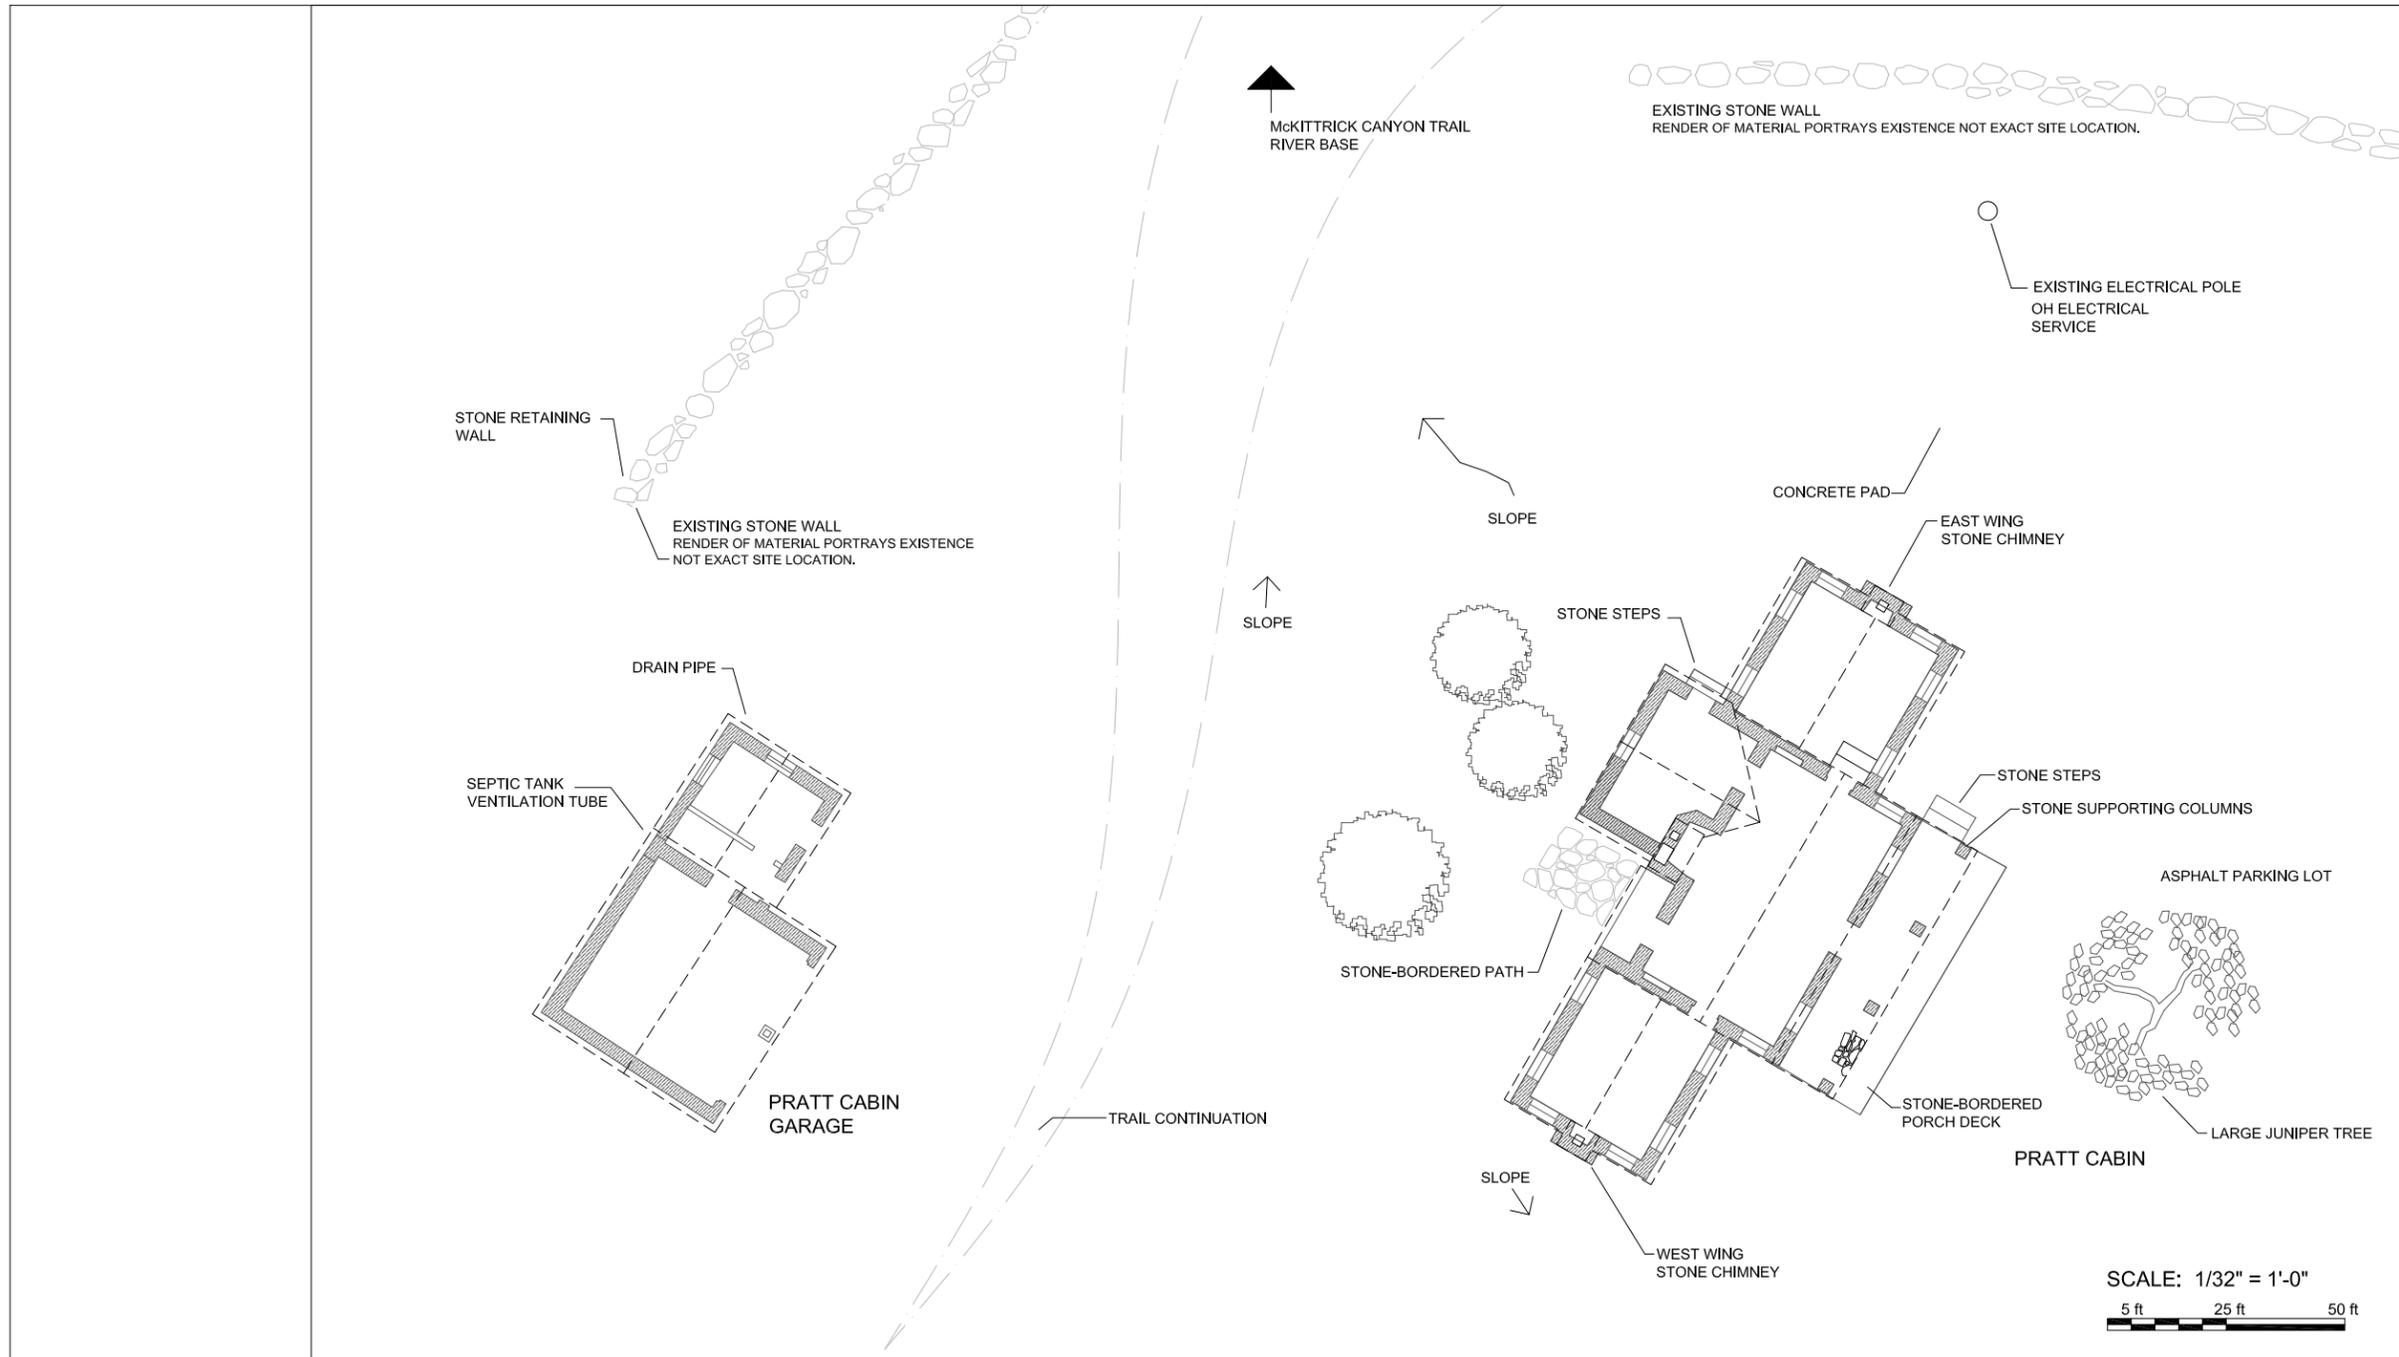
PRESERVATION STUDIES PROGRAM  
COLLEGE OF ARCHITECTURE  
AND LANDSCAPE ARCHITECTURE  
THE UNIVERSITY OF ARIZONA
