BRYCE CANYON NATIONAL PARK: OLD NPS HOUSING AND BRYCE CANYON LODGE CULTURAL LANDSCAPE REPORT

**BRYCE CANYON NATIONAL PARK: BRYCE CANYON LODGE DISTRICT
AND HISTORIC NATIONAL PARK SERVICE HOUSING DISTRICT
CULTURAL LANDSCAPE REPORT**

**UNIVERSITY OF ARIZONA COLLEGE OF ARCHITECTURE, LANDSCAPE ARCHITECTURE AND PLANNING
SCHOOL OF LANDSCAPE ARCHITECTURE AND PRESERVATION STUDIES PROGRAM**

December 2008

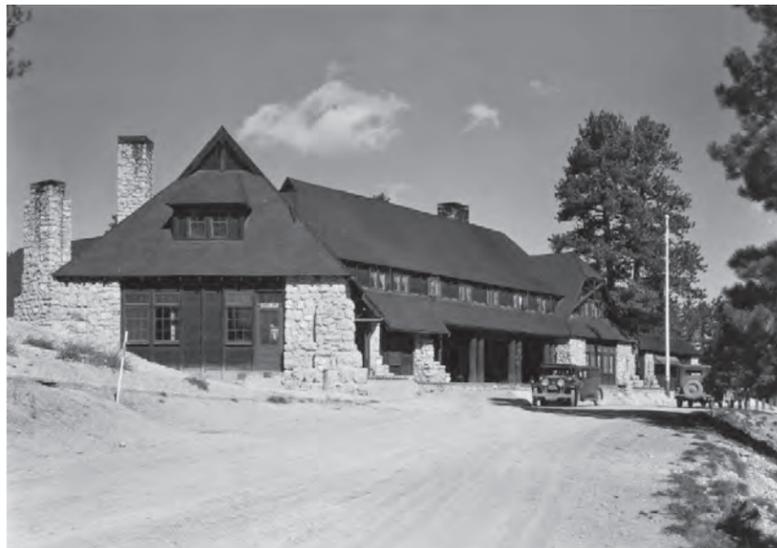
Photograph 10. View of Lodge front after the 1927 additions, 1929
(BRCA Archives: Photographer George A. Grant #3919 00381)

up by sleeping accommodations for overnight guests. Additional wings were added in 1926, probably to accommodate a quick increase in the number of available sleeping accommodations. A curio store occupied the lower level of the south wing. The addition of a Recreation Hall in 1927 rounded out the Lodge's final configuration. By September 1927 no fewer than sixty-seven standard and economy cabins were grouped about the Lodge. Construction on these had begun during 1925. Concrete walks connected all cabins to the Lodge. The smaller scale of the cabins in comparison to the Lodge and the use of natural building materials resulted in a gentle blending with the surrounding natural and architectural environments.⁴⁵ For the sake of aesthetics, electrical wiring was placed in underground conduits. In September 1927 only five deluxe cabins were in existence, but by 1929 ten more augmented the Lodge complex. The building materials for most of this construction came from local sources—stone was quarried a short distance from the site, and logs were cut from the National Forest.⁴⁶ Rather than designing the entire complex at one time, Underwood designed and re-designed it over a period of several years as visitation increased and the Utah Parks Company saw the need for expanded development. Even though the development was done in phases, the buildings and surrounding landscape possess unifying qualities that create an outstanding sense of place. The irregular massing and chunkiness of the buildings imitates the irregularities found in nature giving them a rustic honesty and informality characteristic of park architecture from this era.

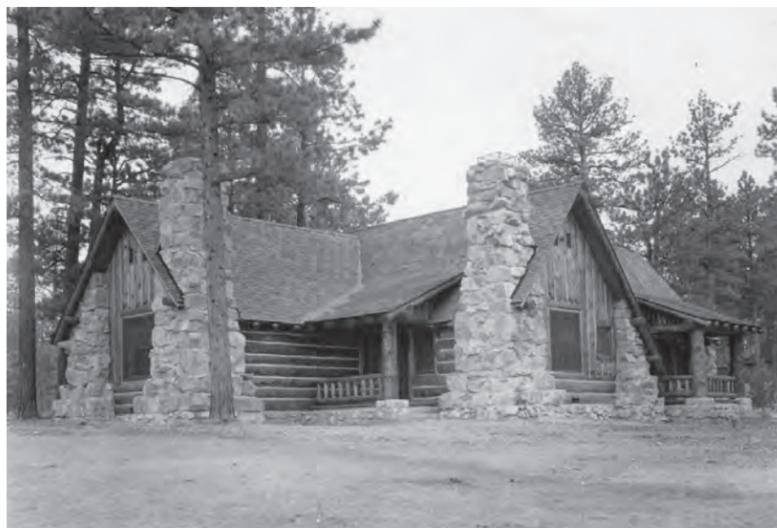
Photograph 11. Deluxe Quaruplex Cabin in Lodge Area, 1929
(BRCA Archives: 00350 B1.1 F2)

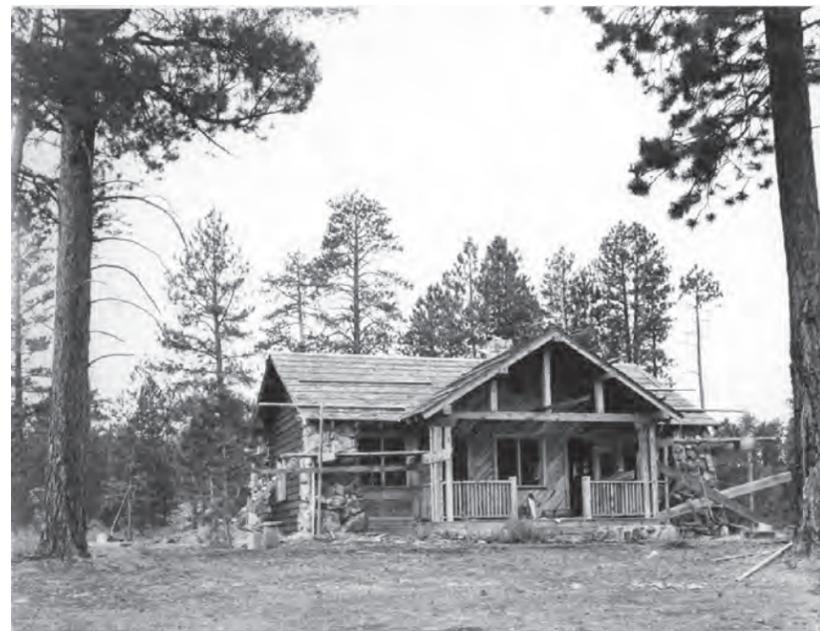
Photograph 13. View of east facade of the Ranger Station/ Residence HS-01, the first structure to be built in the Old NPS Housing Area, 1929
(BRCA Archives: 00350 B1.1 F2)

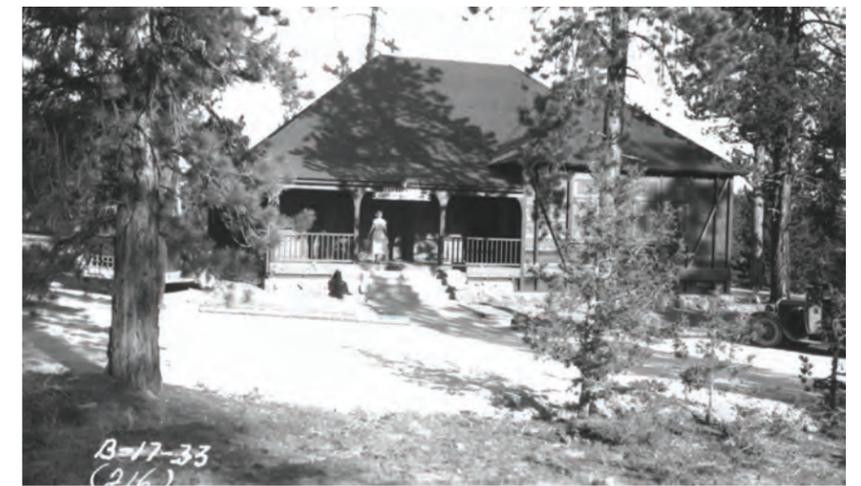
Photograph 14. View of southeast facade of the Bryce Cafeteria/ General Store HS-118, 1933 (BRCA Archives: Duplicates 1201-1700 ACC #370 Photo#1247)

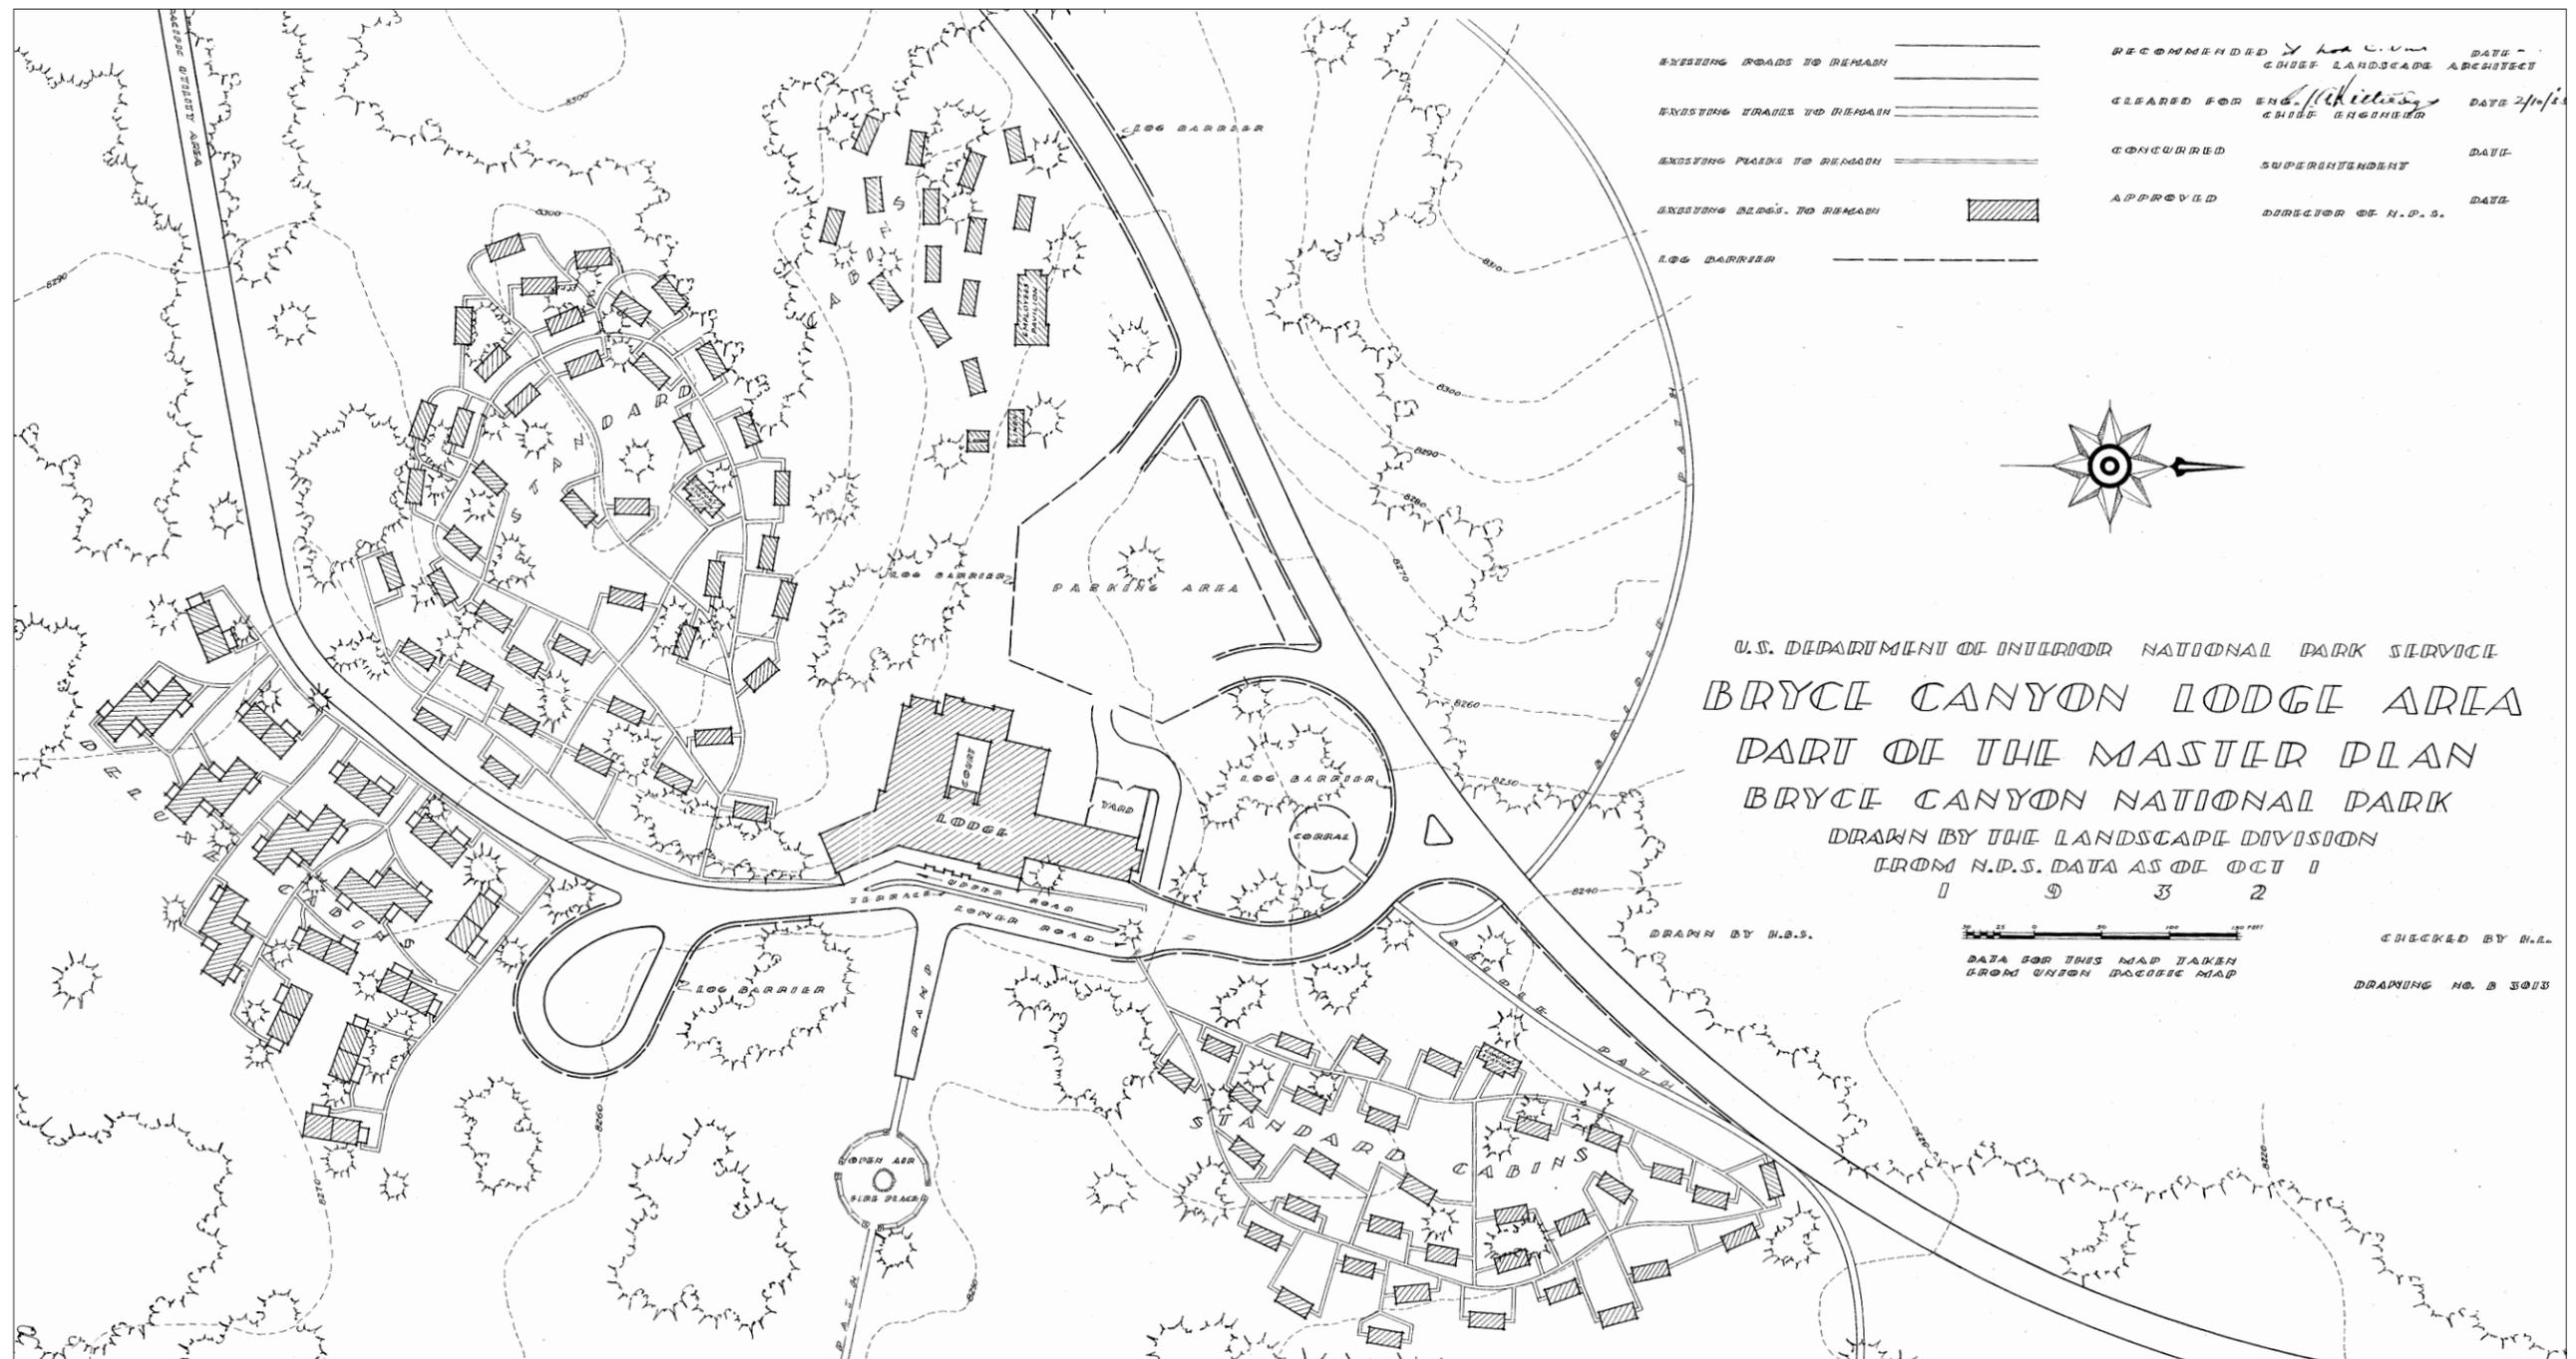
Figure 1. Bryce Canyon Lodge Area: Part of the 1932 Master Plan for Bryce Canyon National Park (BRCA Archives)

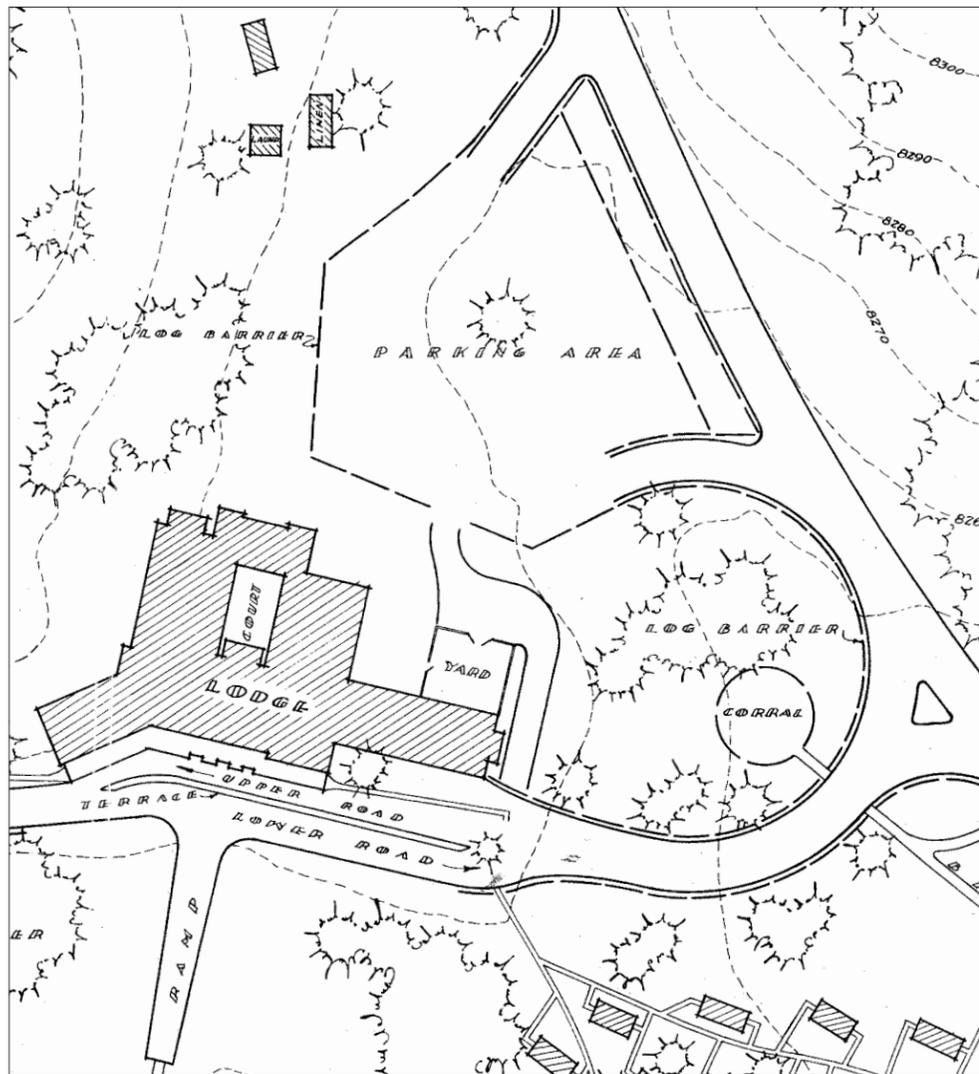
Figure 2. Zoom of Bryce Canyon Lodge and proximity. Bryce Canyon Lodge Area: Part of the 1932 Master Plan for Bryce Canyon National Park (BRCA Archives) Not To Scale

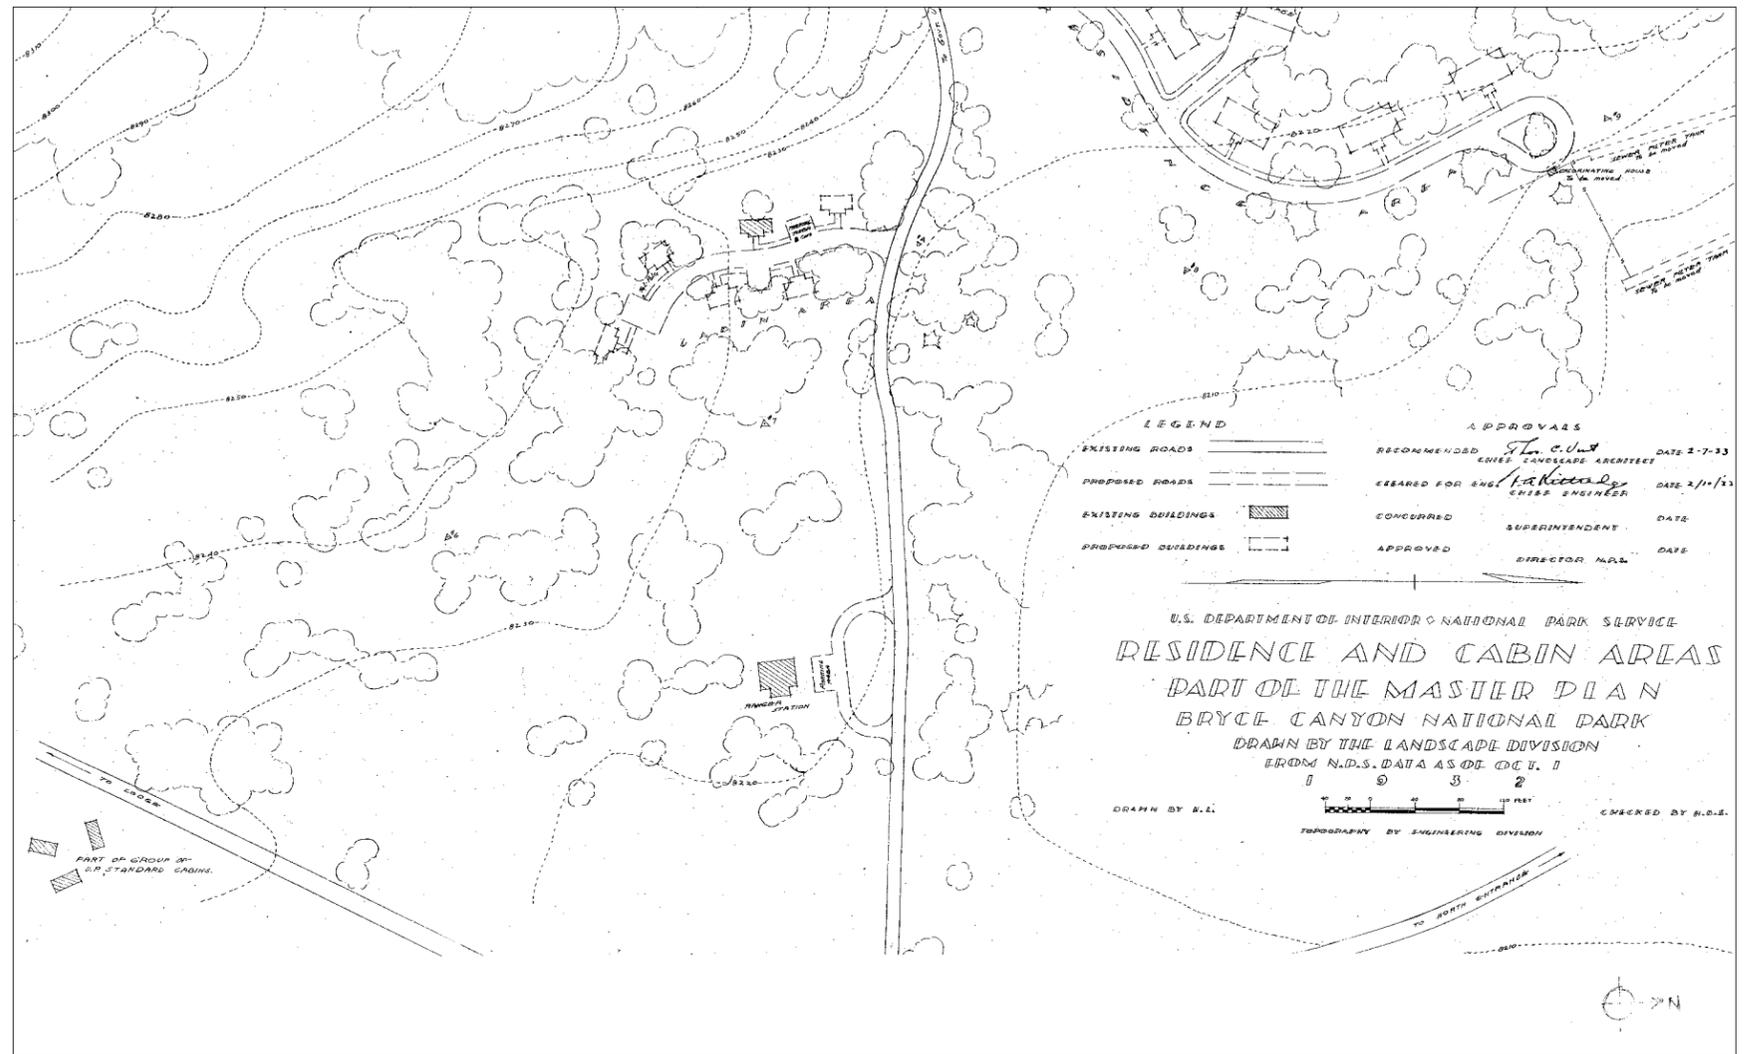
Figure 3. Residence and Cabin Areas: Part of the 1932 Master Plan for Bryce Canyon National Park (BRCA Archives)

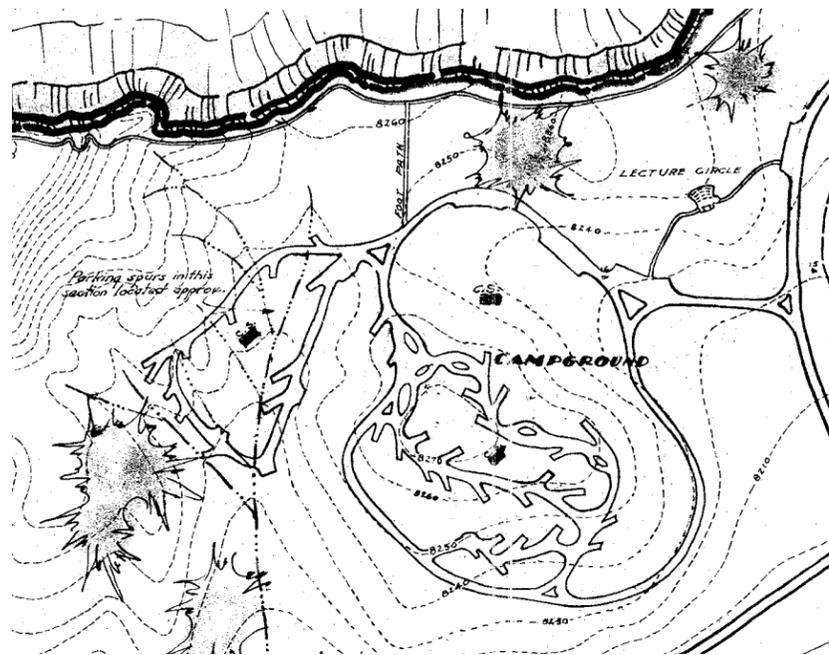
Figure 4. North Campground Development: Part of the 1938 Master Plan for Bryce Canyon National Park (BRCA Archives)

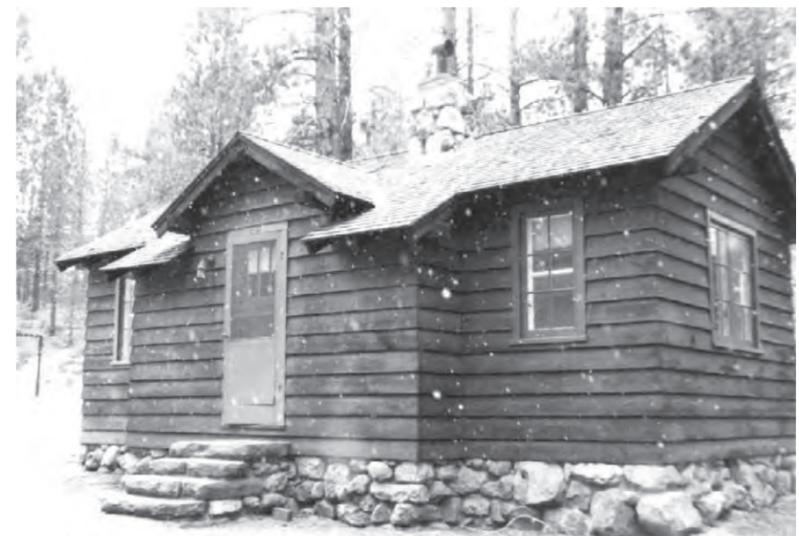
Photograph 20. Employee Residence in Old NPS Housing Area HS-05. Note the ‘simplified rustic’ design (BRCA Archives: BRCA 3943 BRCA-00408)

access), where they did not need to be exceptionally crafted, in fact were supposed to suffice a rather austere and “primitive” lifestyle.⁸⁵ Thus all the residences constructed at Bryce during this time were rather modest wood frame cabins, incorporating rustic weatherboard siding and stone foundations.

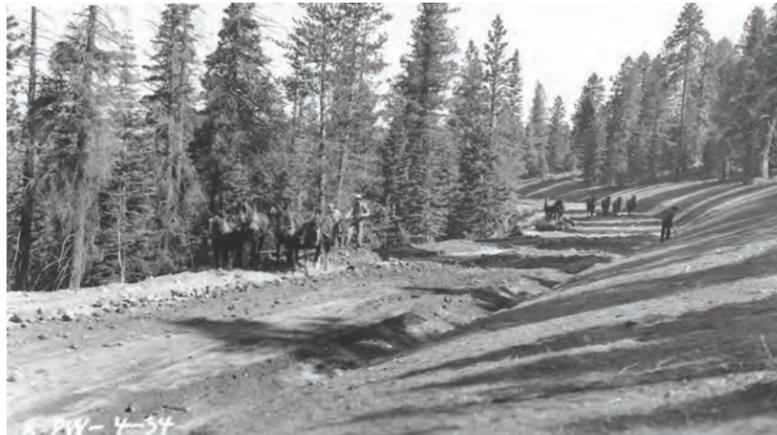
Photograph 21. Rough grading, Bryce Rim Road ; PWA project under B.P.R. supervision (BRCA Archives: ACC#350 Photo#1)

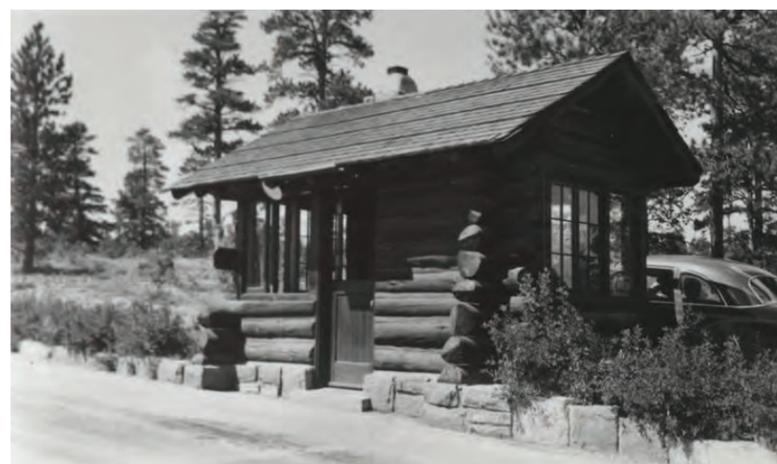
Photograph 28. Checking Station built by CCC in 1935, undated photo (BRCA Archives: ACC #370 Photo#879)

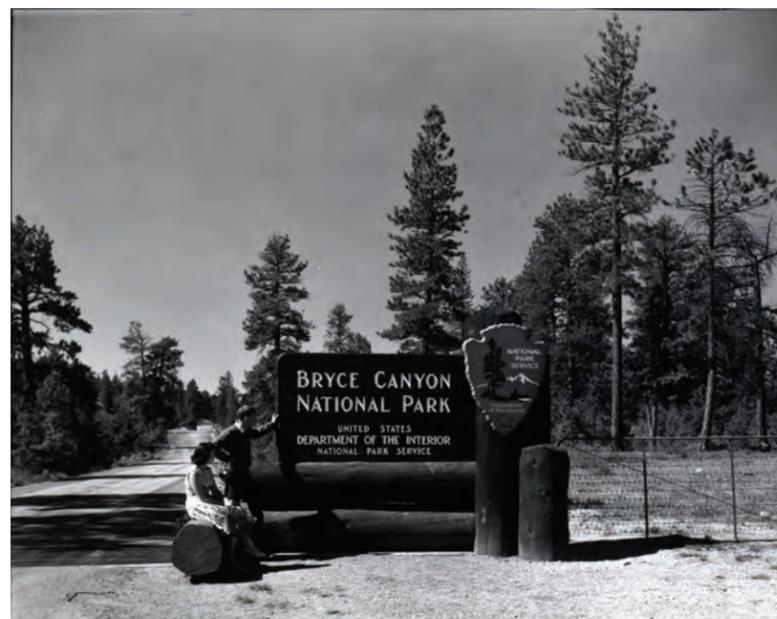
Photograph 32. Park entrance sign/ motif constructed by CCC in 1940, undated photo (BRCA Archives: ACC #370 Photo#1005)

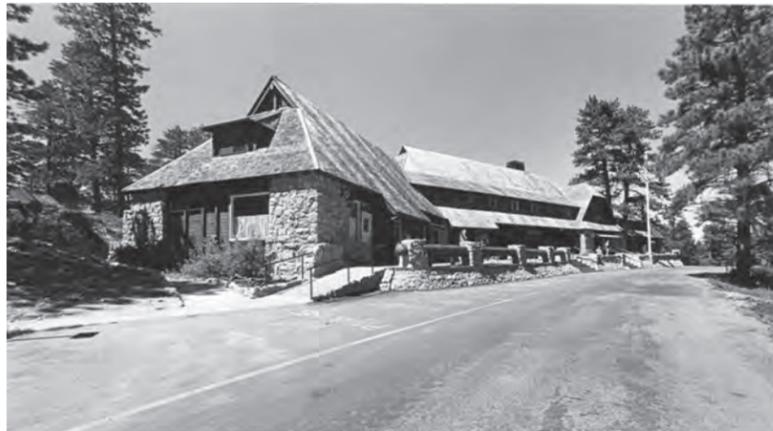
Photograph 42. Bryce Canyon Lodge, c. 1980's after extension of front portico and log-rail fence (BRCA Archives: BRCA 3885 BRCA-00359)

Prior to its protective NRHP listing, the Lodge District had undergone several significant alterations, including the 1983 Lodge Road realignment that changed the traffic pattern around the lodge so that visitors now approach from the rear.¹²⁵ A new employee dining room was added to the rear elevation during the winter of 1987.¹²⁶ Additionally, the bus-lane in front of the Lodge was removed to create room for a larger portico, fenced in by a log-rail parapet.¹²⁷ Extensive roof repairs, interior restoration and rehabilitation projects were initiated for the Lodge as well as for the Deluxe Cabins, the Men's Dormitory and the Recreation Hall.

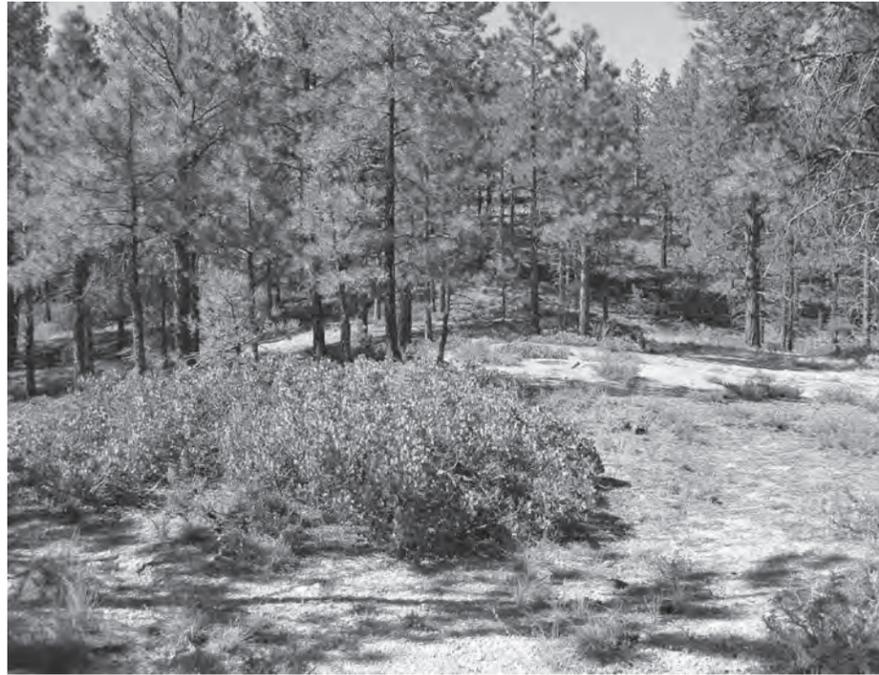
Photograph HD/1. View at the top of the Knoll with understory growth (N-1).

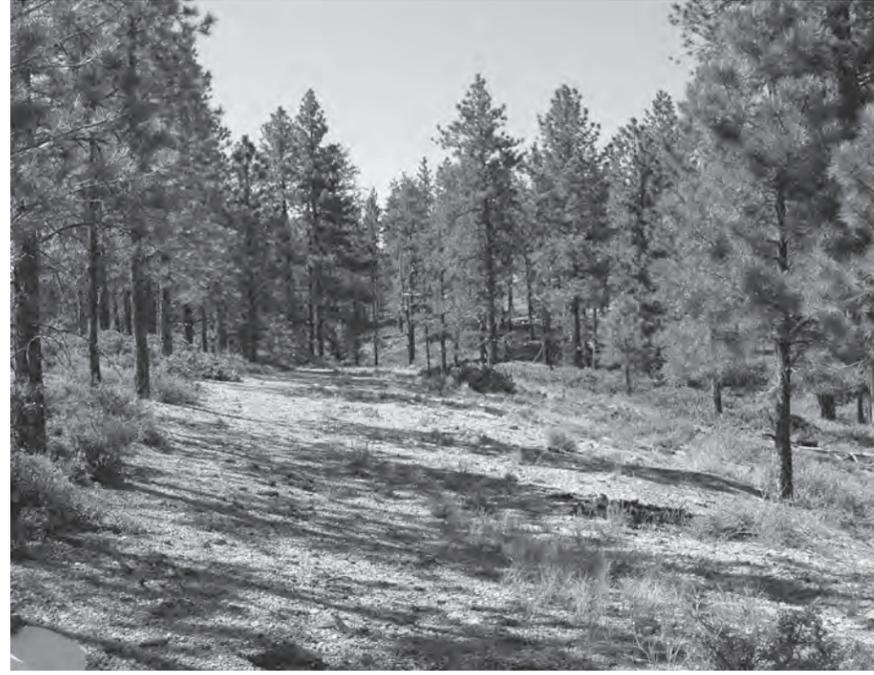
Photograph HD/2. View of historic asphalt trace road (C-4).

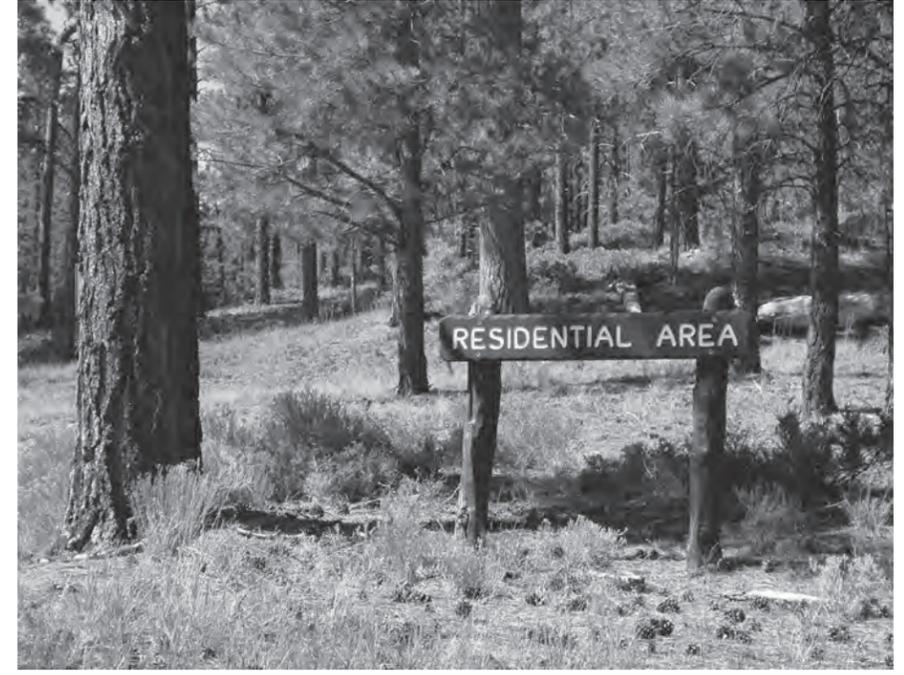
Photograph HD/3. Entrance to Residential Area at the intersection of the North Access Road (C-2) and the Lodge Loop Road (C-1).

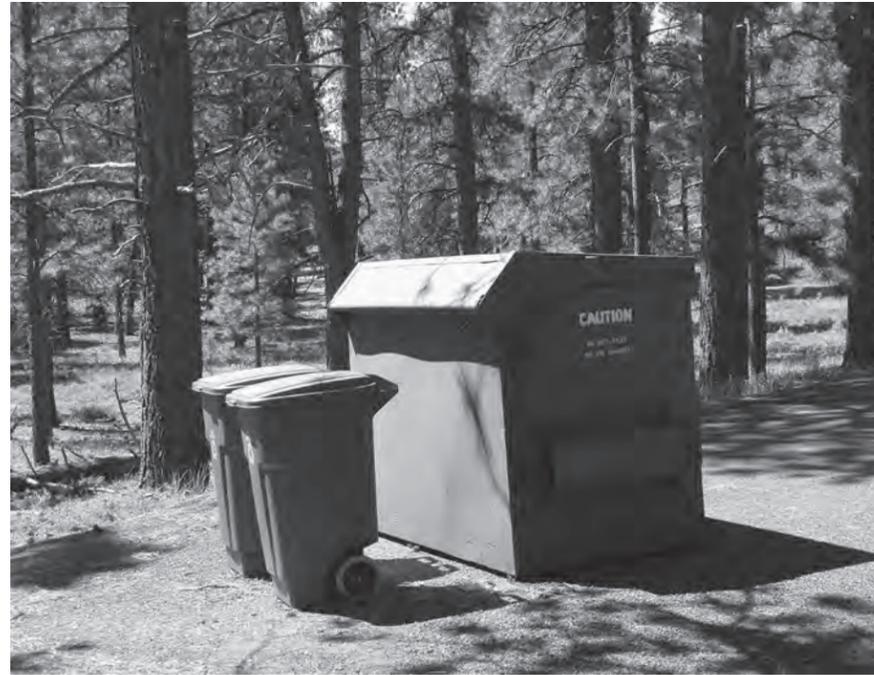
Photograph HD/5. Trash receptacles in front of B-2 (HS-2).

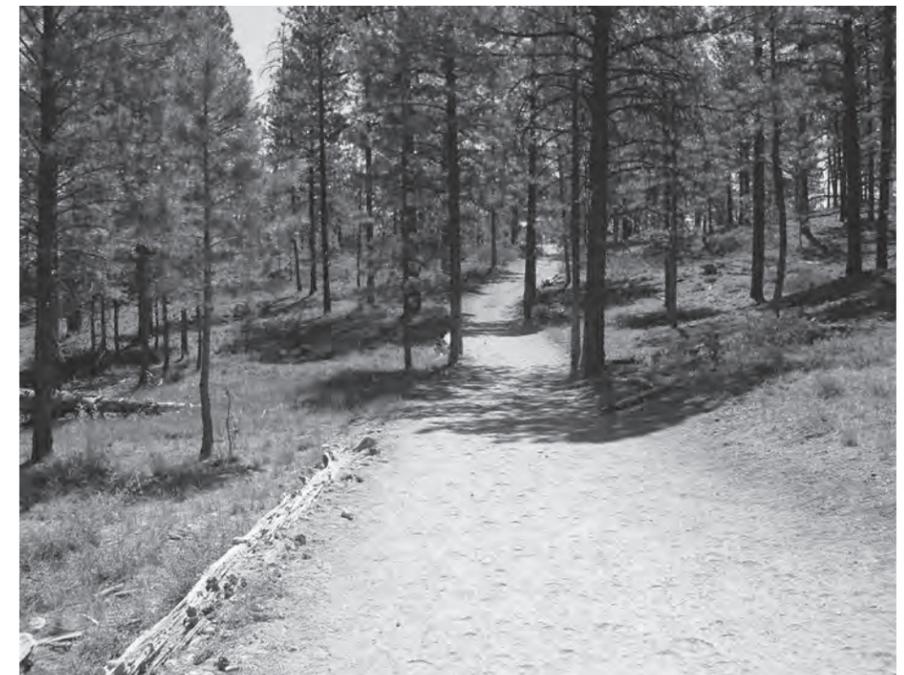
Photograph HD/6. Horse Trail (C-5) passing through Old NPS Housing Sub-Area.

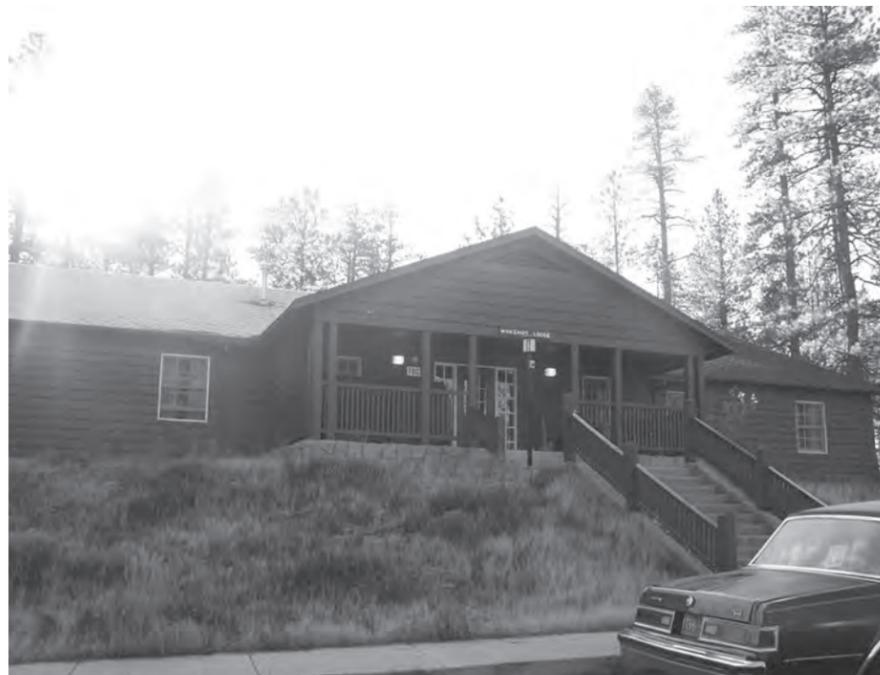
Photograph HD/10. Manzanita Lodge, NPS dormitory for married staff. B-4 with revegetated landscape in the foreground.

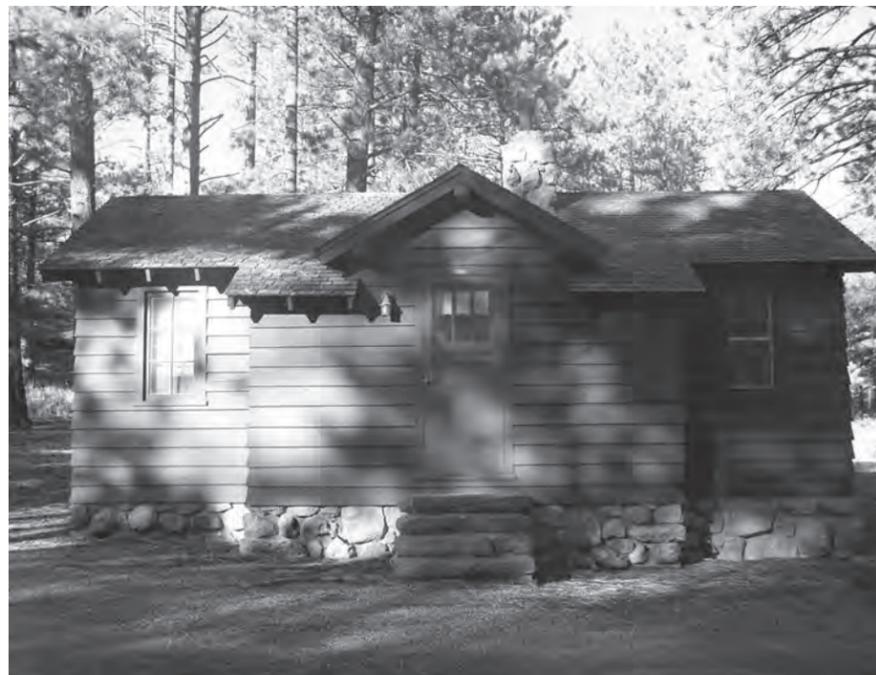
Photograph HD/11. NPS Seasonal Residence B-5 (HS-5).

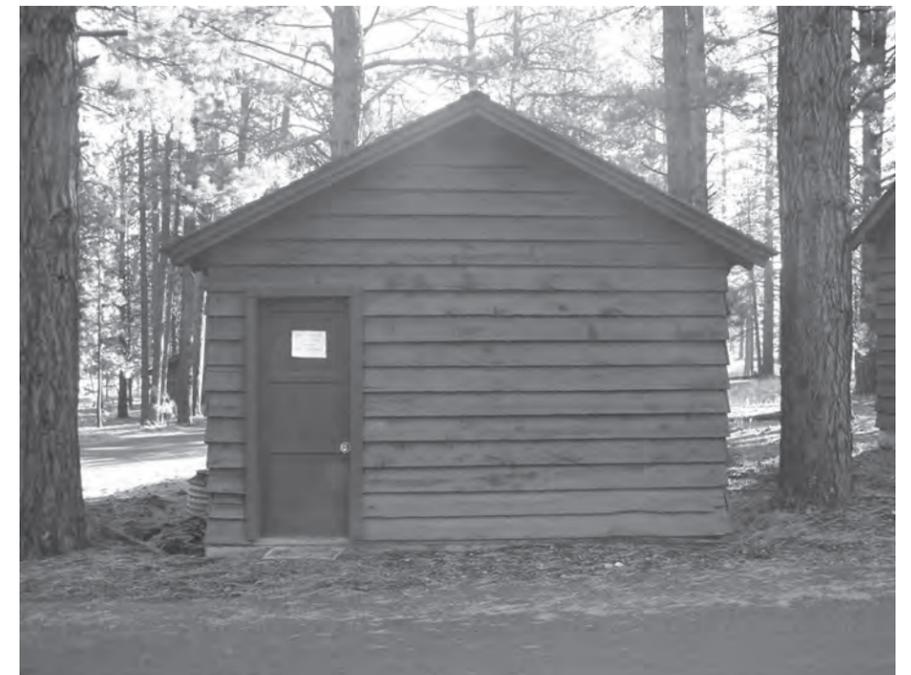
Photograph HD/12. Wood Vendor Building B-6 (HS-6). Note the proximity of mature trees to the structure.

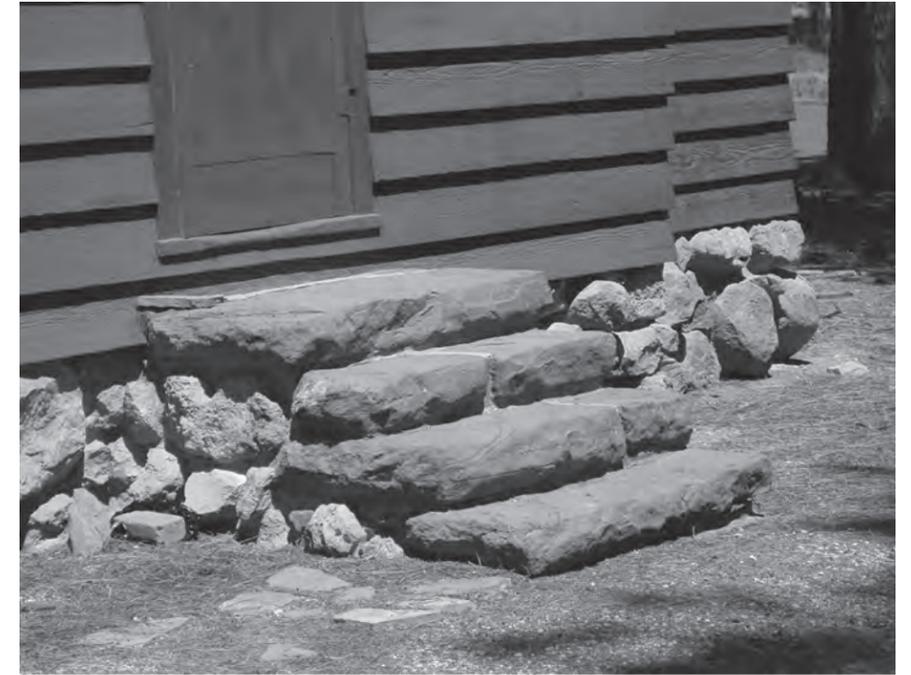
Photograph HD/21. Historic stone steps in front of cabins.

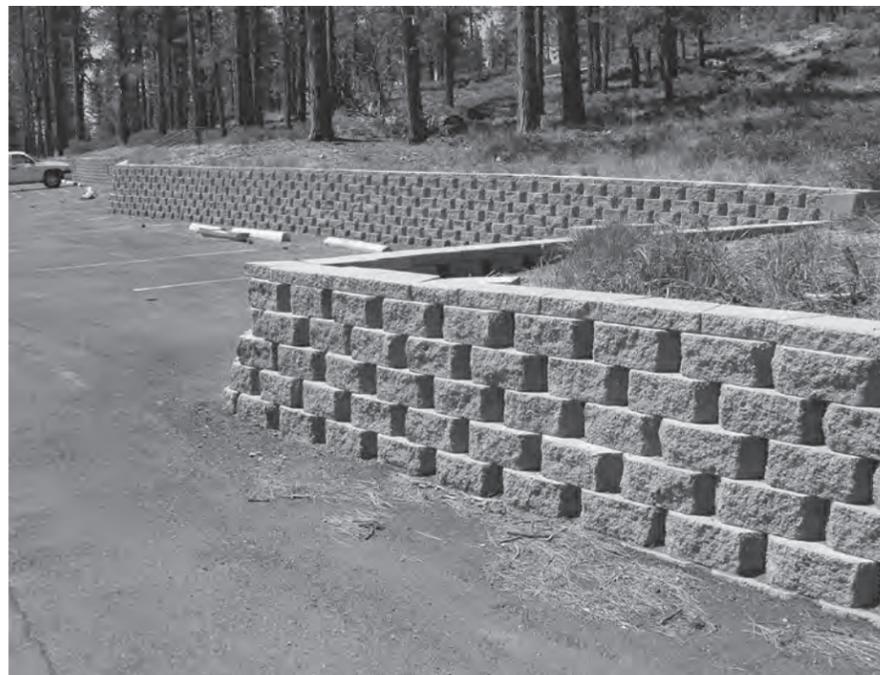
Photograph HD/22. New stone parapet wall along parking lot in front of concessionaire dorms.

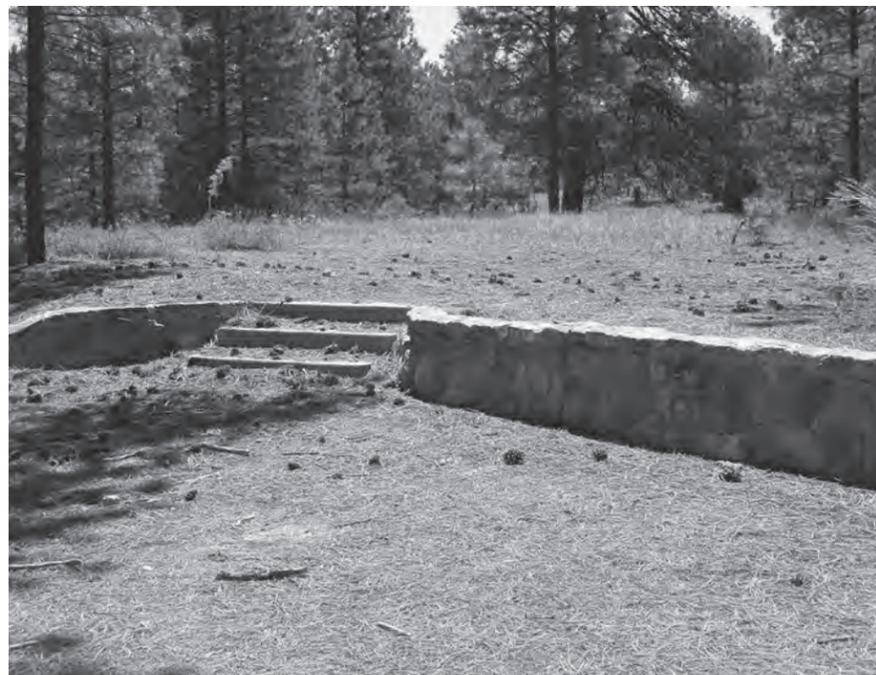
Photograph HD/23. Remnant Stone Wall S-1 near the site of the burnt down Ranger's Cabin.

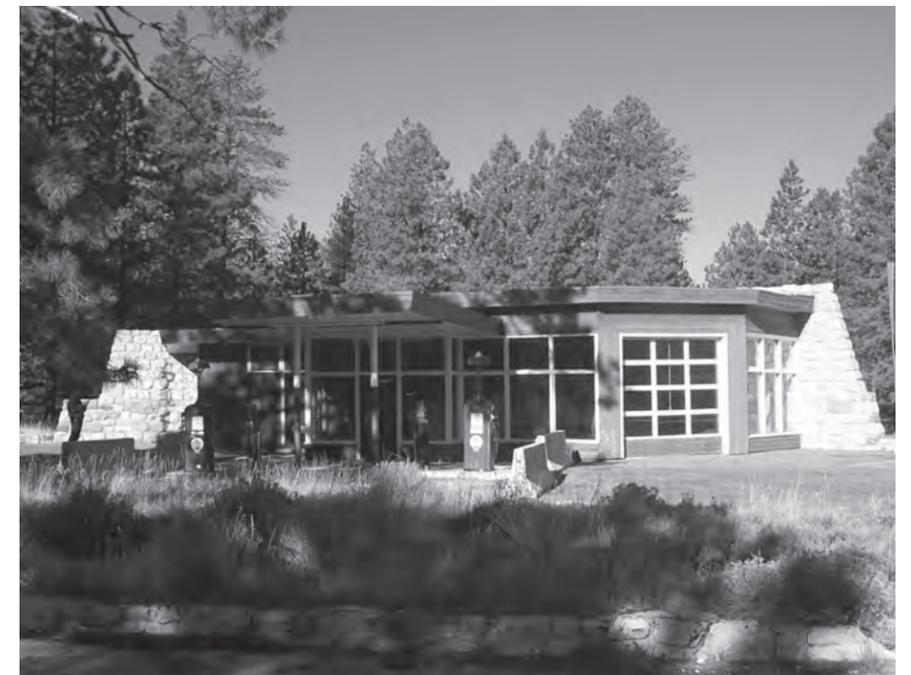
Photograph HD/24. Service Station B-13 (HS-117).

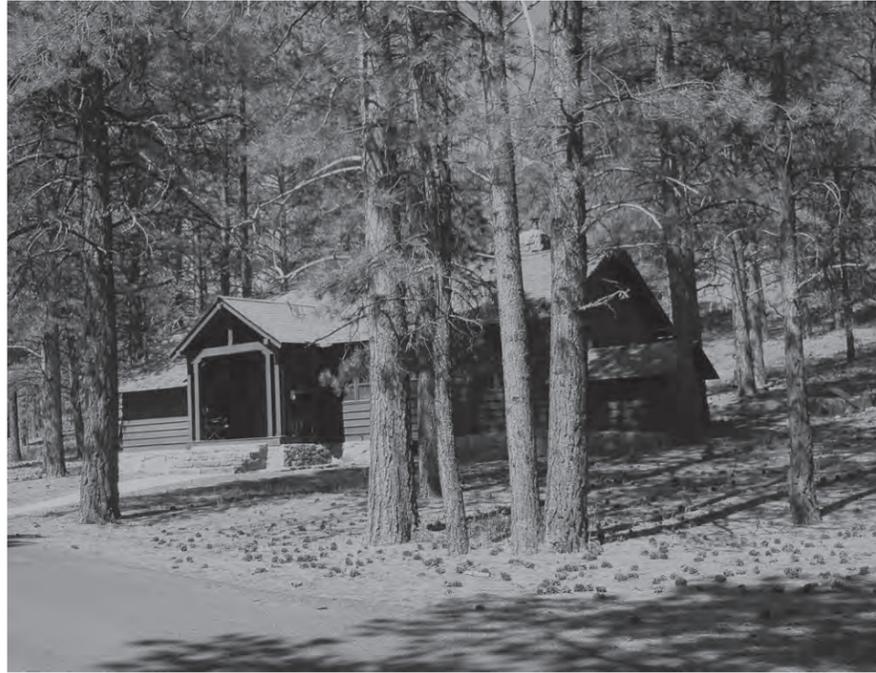
Photograph HD/25. Mature forest around historic cabins.

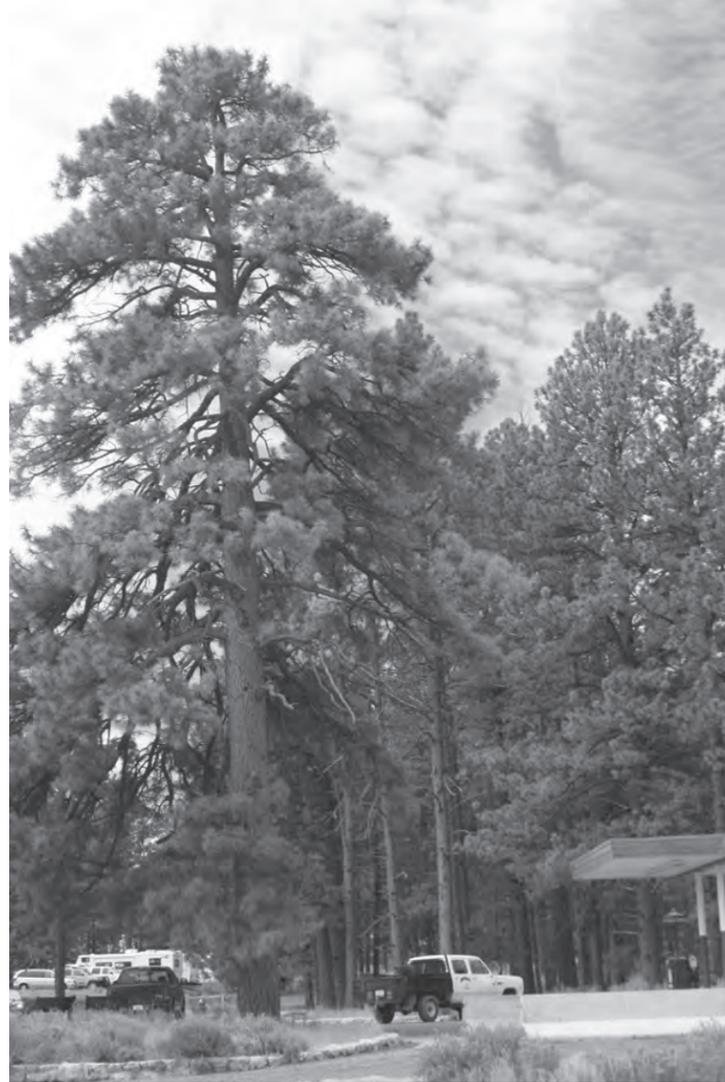
Photograph HD/26. The large Ponderosa pine in front of the Service Station.

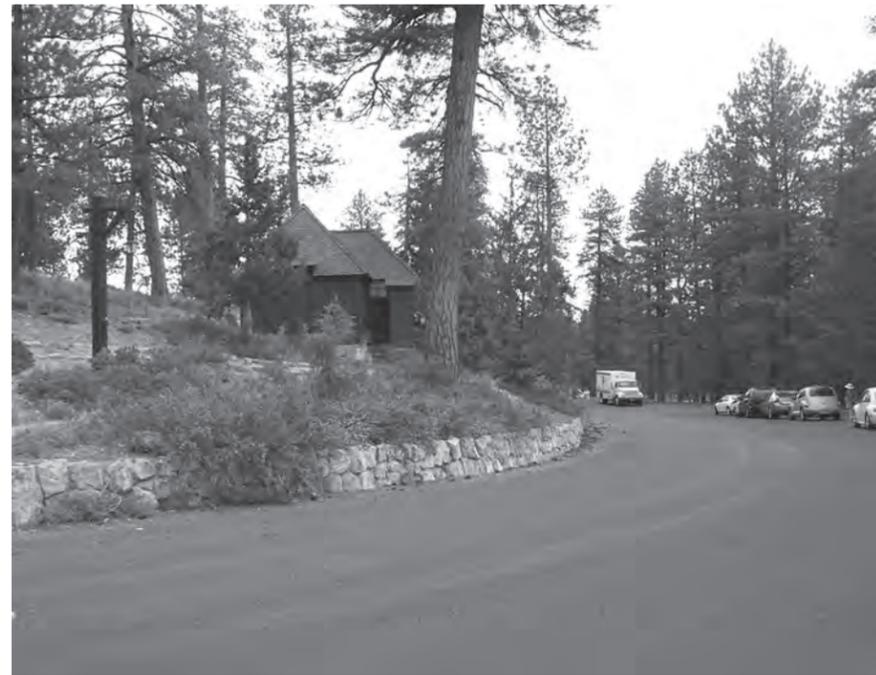
Photograph LD/2. View of the Lodge Access Road C-10.

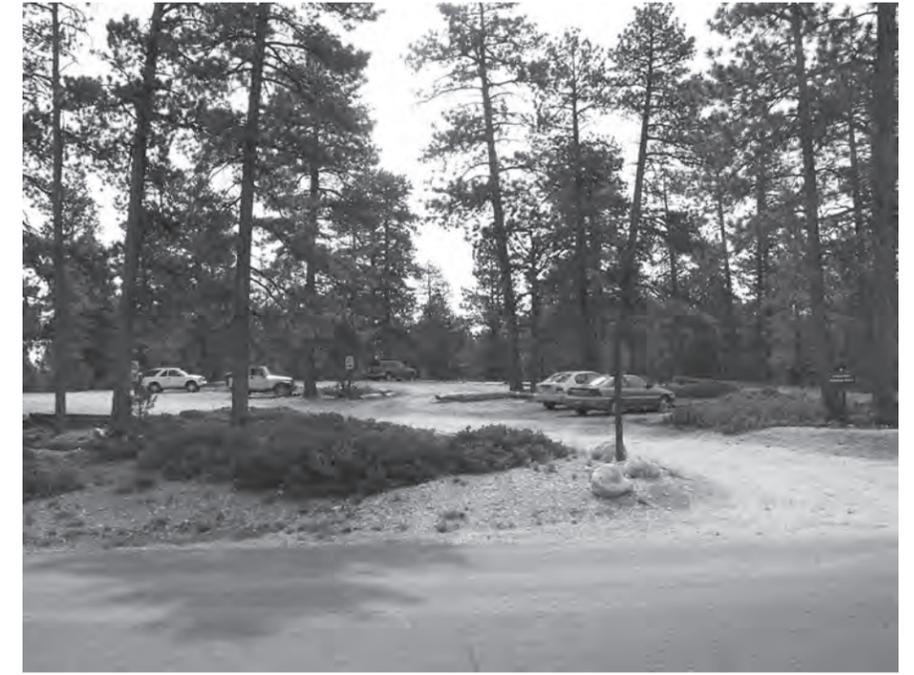
Photograph LD/3. Entrance to Administrative parking area from Lodge Access Road C-10.

At the top of this hill is the Administrative parking lot. This lot is unusual in that it is not paved, and is not used by visitors. The parking area has a somewhat informal appearance, which serves to discourage visitors from using it inappropriately, but also gives the impression of lack of maintenance or planning. The vegetation at the edges of the lot, however, is healthy and denser than the hillside approaching it. Although this was also the site of the missing Standard Cabins, perhaps the edges created by the parking barriers and the lighter pedestrian use of the area have improved the conditions for the forest recovery (*Photograph LD/3*).

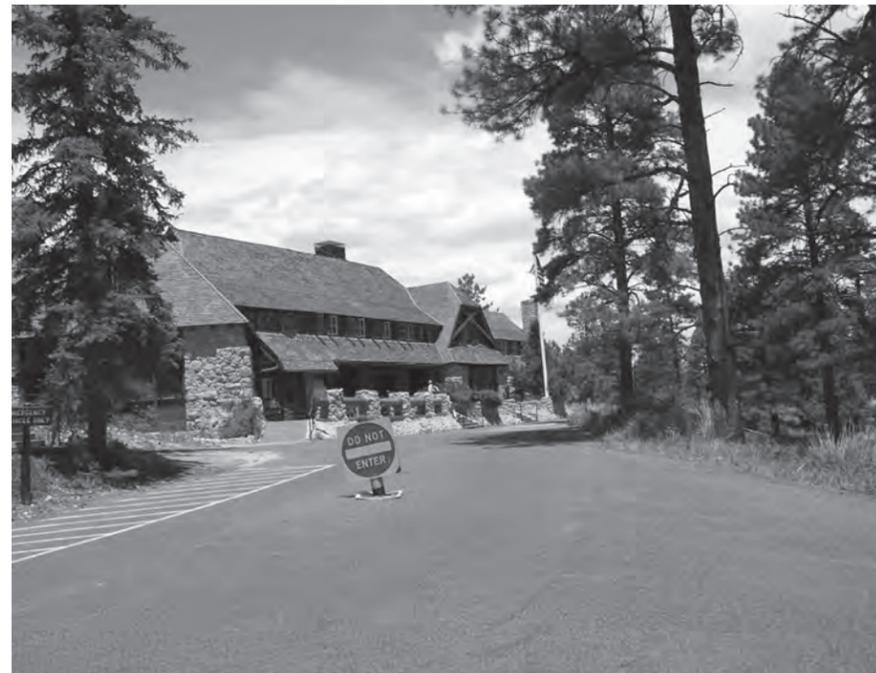
Photograph LD/5. Traffic sign prohibiting vehicular access in front of the Lodge.
