BRYCE CANYON NATIONAL PARK: OLD NPS HOUSING AND BRYCE CANYON LODGE CULTURAL LANDSCAPE REPORT

**BRYCE CANYON NATIONAL PARK: BRYCE CANYON LODGE DISTRICT
AND HISTORIC NATIONAL PARK SERVICE HOUSING DISTRICT
CULTURAL LANDSCAPE REPORT**

**UNIVERSITY OF ARIZONA COLLEGE OF ARCHITECTURE, LANDSCAPE ARCHITECTURE AND PLANNING
SCHOOL OF LANDSCAPE ARCHITECTURE AND PRESERVATION STUDIES PROGRAM**

December 2008

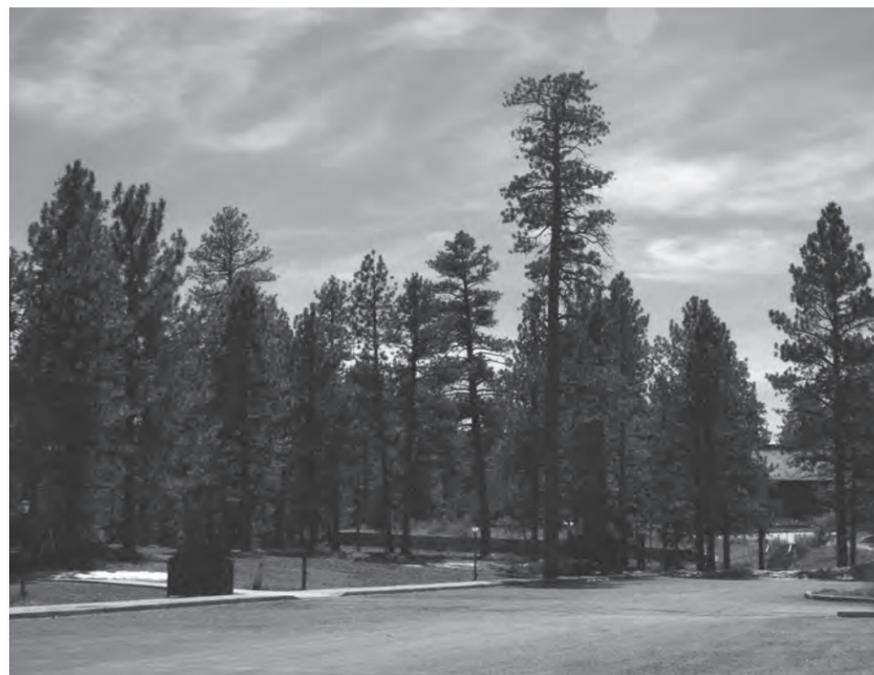
Photograph LD/11. Sunrise Motel parking lot.

The Sunrise Motel's parking lot (*Photograph LD/11*) is accessed directly via the Lodge Loop Road through two entries **C-43** and **C-44**. Traces of an **abandoned vehicular road C-15** can be found in the western part of the Study Area reflecting the historic alignment of the Rim Road. Presently this corridor remains poorly revegetated (*Photograph LD/12*).

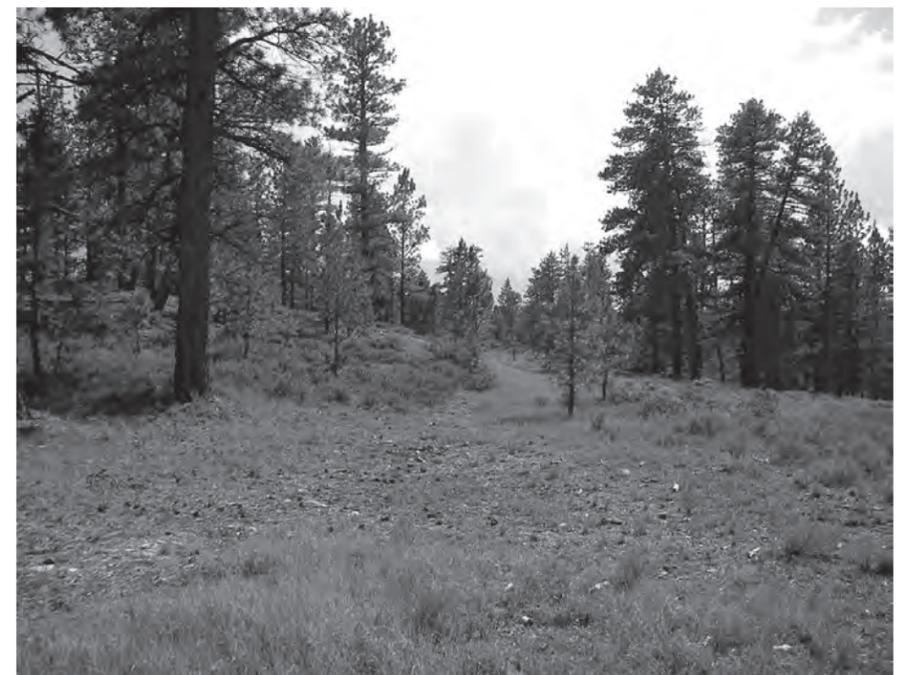
Photograph LD/12. Abandoned vehicular road C-15.

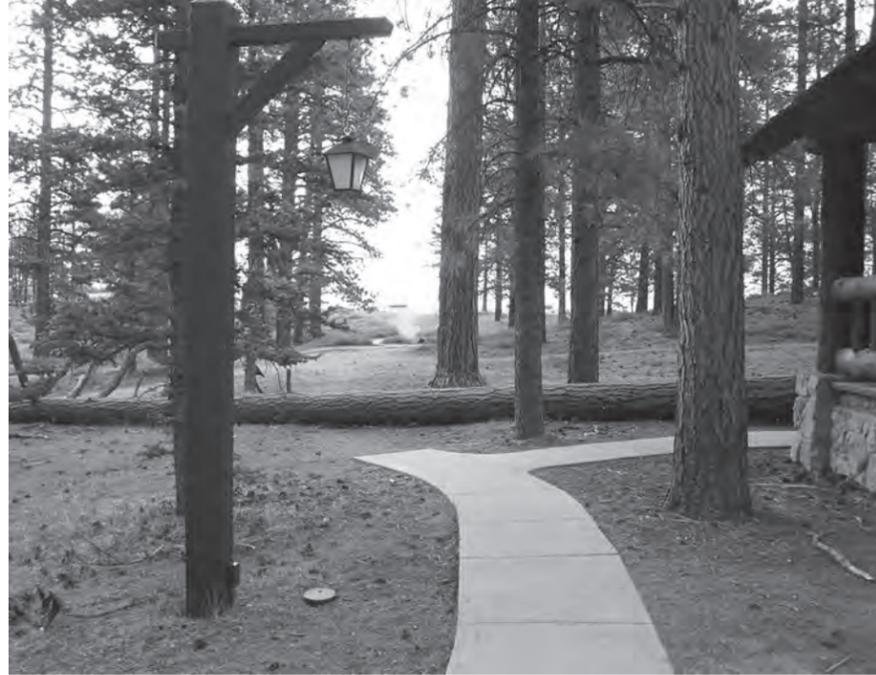
Photograph LD/14. Trail from Deluxe cabins cluster to the rim with lack of understory vegetation C-38.

The understory in the whole study area has been dramatically impacted, with few shrubs or grasses present in the heavily traveled areas - such as between the Deluxe Cabins, along the trails or near the parking areas (*Photograph LD/14*). In areas where the understory has maintained a foothold, the typical Ponderosa forest friends are found, including greenleaf manzanita, mountain snowberry, Oregon grape and the native *Elymus* species bunch grasses.

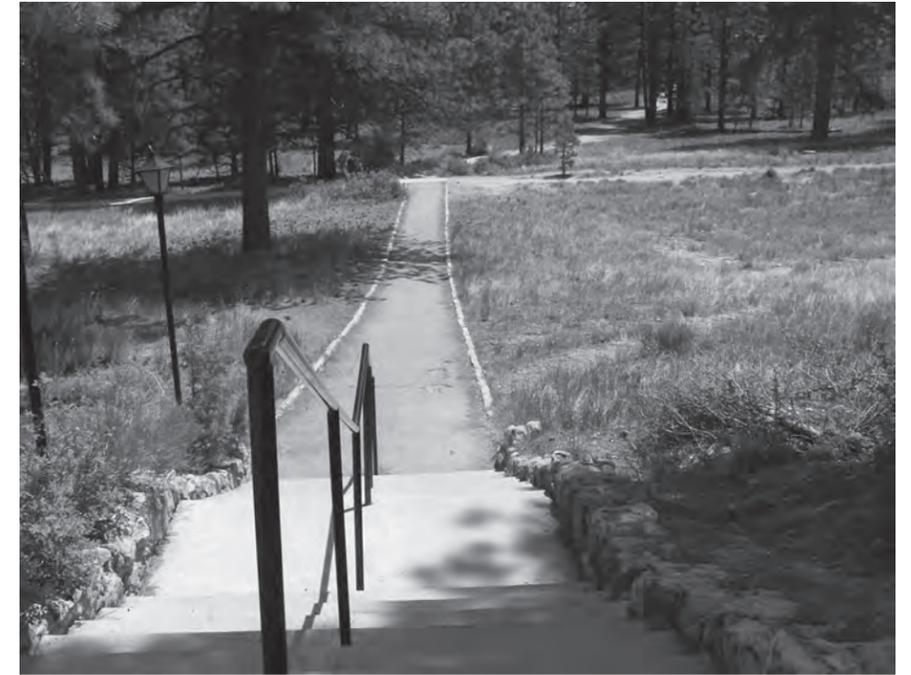
Photograph LD/15. Central trail leading from Lodge steps to the rim. C-22.

Another important pedestrian trail is **C-22** which begins at the steps leading down from the front entrance of the Lodge and continues up to the rim. The trail has been surfaced with asphalt and lined with stone curbing for around 30 meters from the steps because of heavy traffic, although it is dirt from the end of the pavement to the rim (*Photograph LD/15*). Due to a combination of factors such as skewed alignment, topography and vegetation the features beyond the rim are not visible from the trail. Other significant trails can be found in the vicinity of Sunrise Motel (**C-24 to C-33**), connecting the Motel to

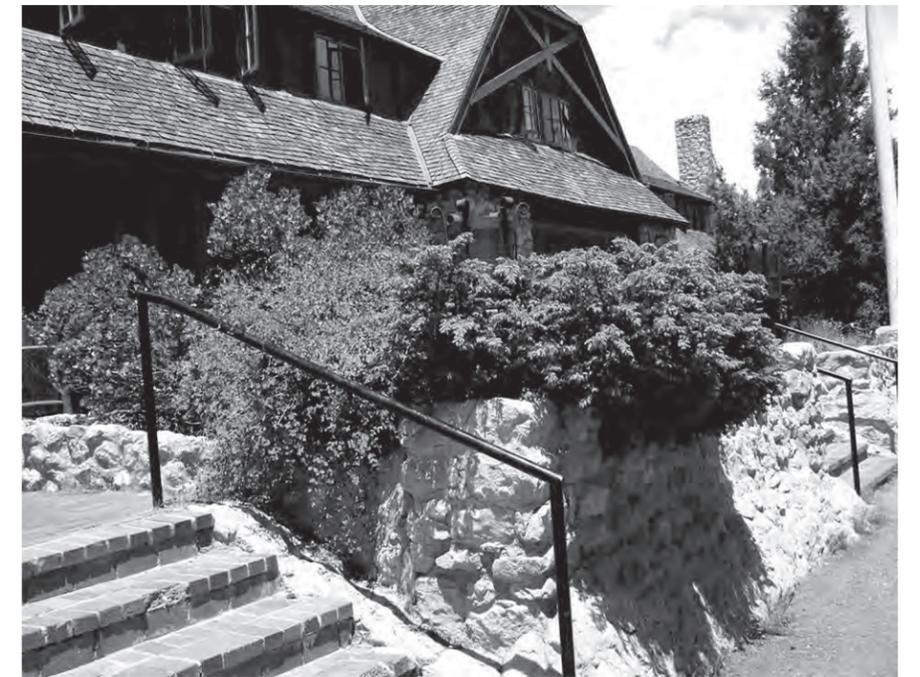
Photograph LD/18. Stone planters (with non-native vegetation) at the front of the Lodge are a response to the drop in topography.

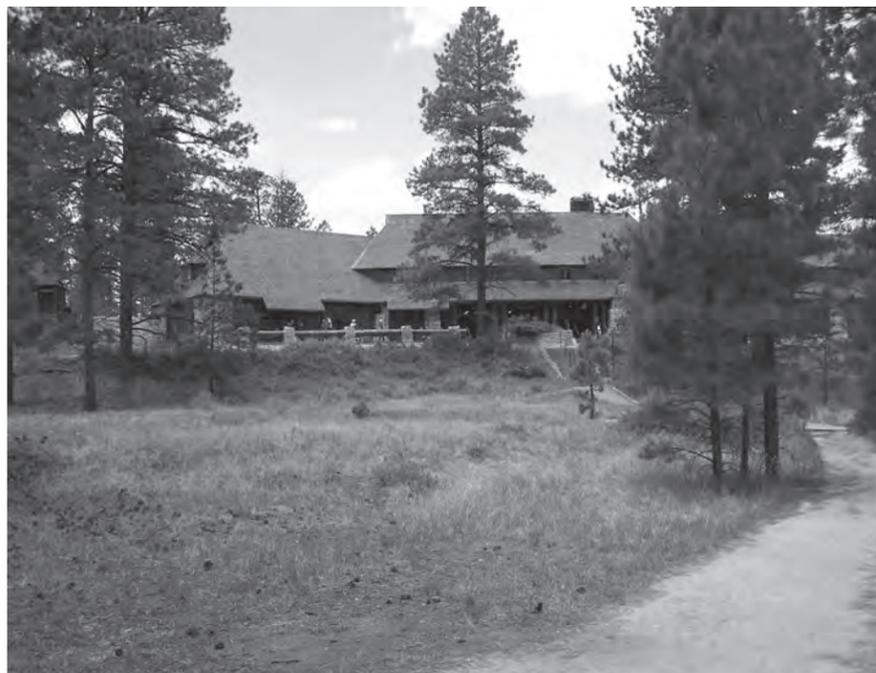
Photograph LD/19. View from central trail looking back at lodge; note how the land drops in front of the Lodge. The clearing in the foreground used to hold a corral and parking.

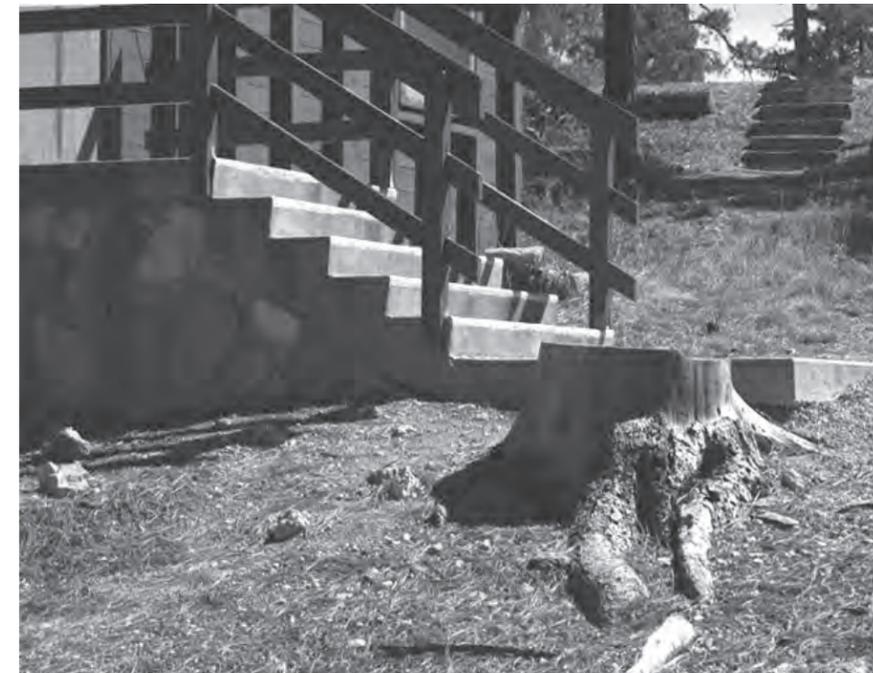
Photograph LD/21. Evidence of hazard tree removal near the Recreation Hall.

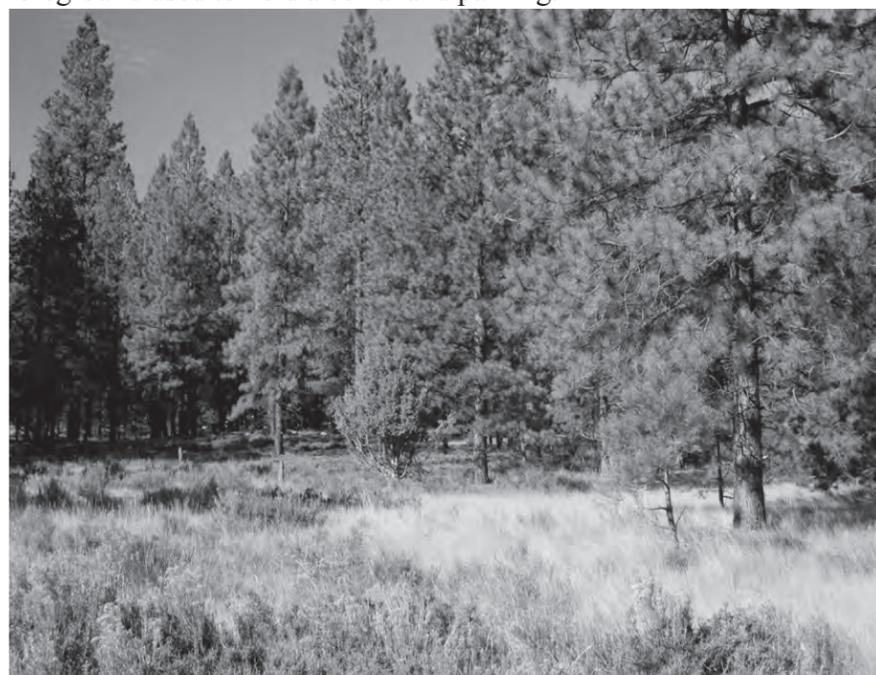
Photograph LD/22. Trees shielding Sunset Motel from Sunset Vista parking area.

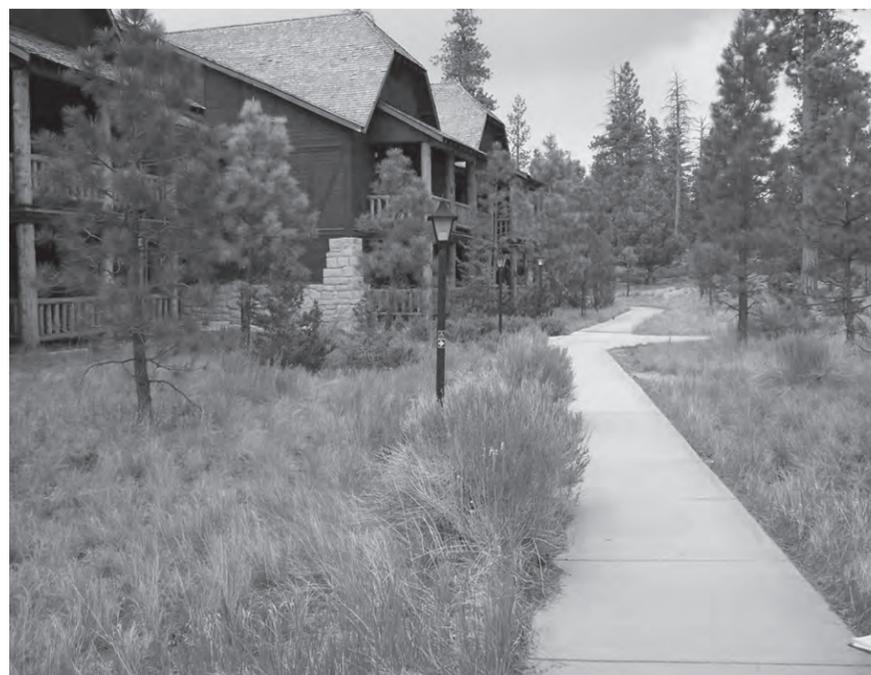
Photograph LD/23. Uniform plantings in front of the Sunset Motel.

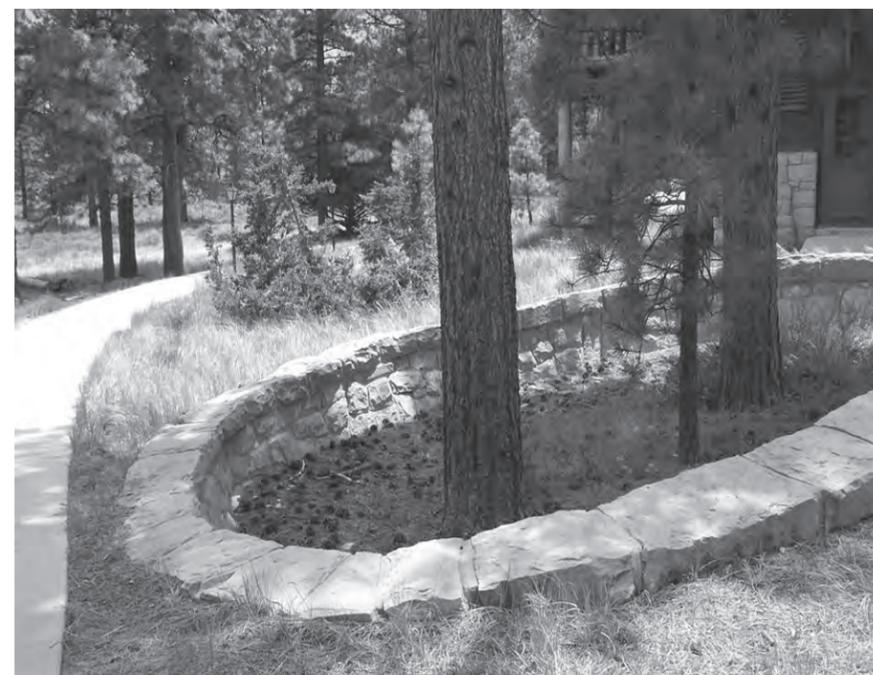
Photograph LD/24. Sunken planter near the Sunrise Motel.

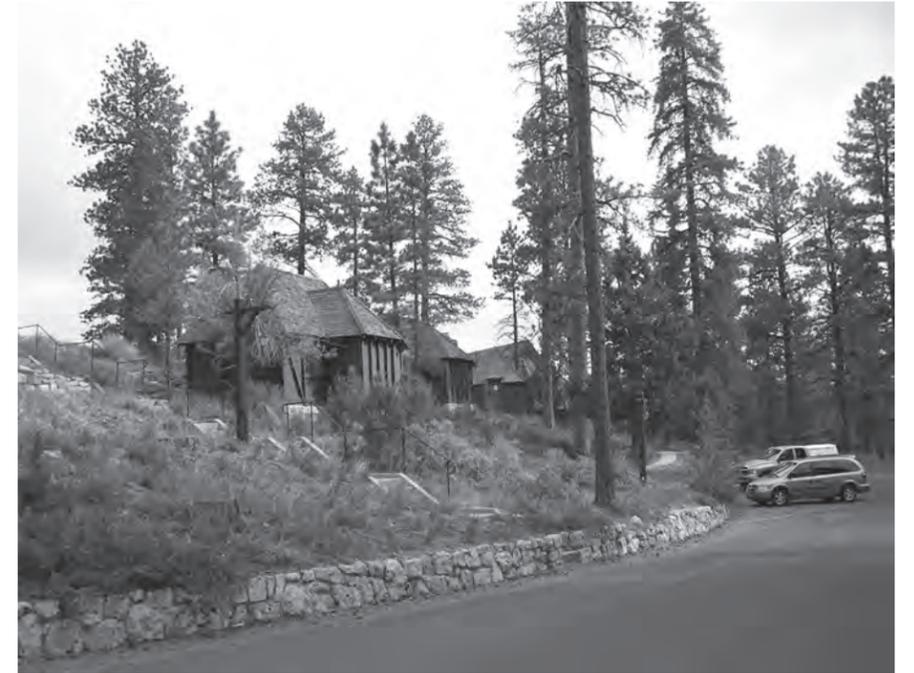
Photograph LD/27. View of Standard Cabins B-21 located on the slope of a low timbered knoll.

Lying directly to the south of the Lodge is an area with six **Standard Cabins B-16 to B-21** (HS-112 & HS-150 to 154). These represent the only six survivors from an original grouping of 91 cabins. Also designed by Underwood and constructed between 1925 and 1927, these cabins are sited on a terrace excavated into a moderately steep hill (*Photograph LD/27*). The six cabins are all one-story, rectangular, studs-out buildings constructed on a stone foundation (*Photograph LD/28*). The hip roofs are covered with wood shingles applied in a wavy pattern. Metal stove pipes with conical hoods protrude from the northwest and southwest corners of the roof. The exterior walls are made up of tongue-and-groove boards nailed to studs; all the exterior wall surfaces are painted brown. The north and south elevations each contain a central entry through two-panel wooden doors painted green. The east elevation features a bathroom addition with a cross-hipped roof. These bathrooms were added in 1940-41. Each cabin, originally a duplex, was thus symmetrically divided into two halves, each with a bedroom and subsequently a very small bathroom. At present, three of the standard cabins have been modified as residences with a small kitchenette installed in place of one bathroom and are used seasonally

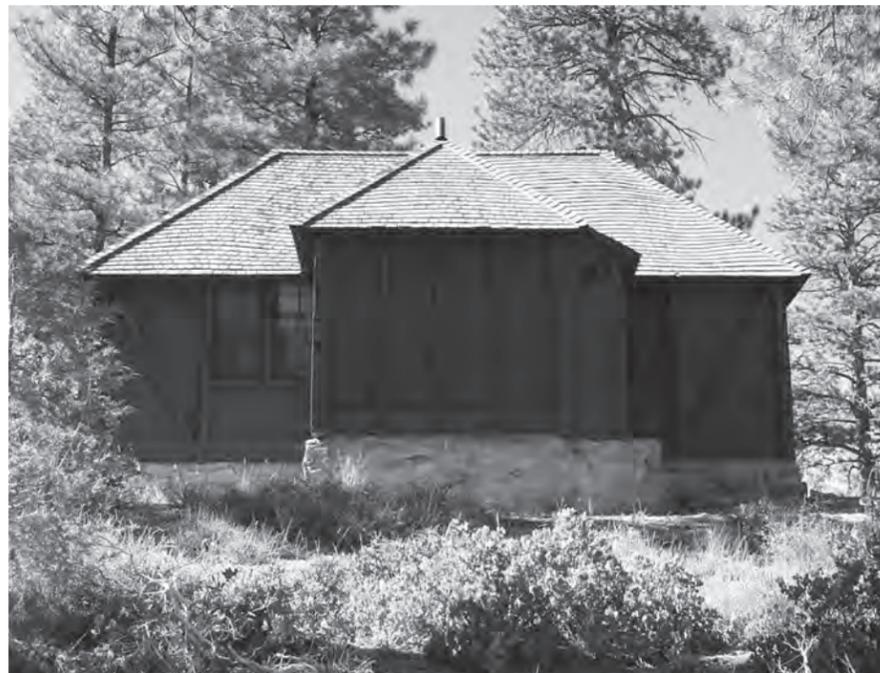
Photograph LD/28. View of a typical Standard Cabin. Particular structure photographed here is B-21 (HS-150).

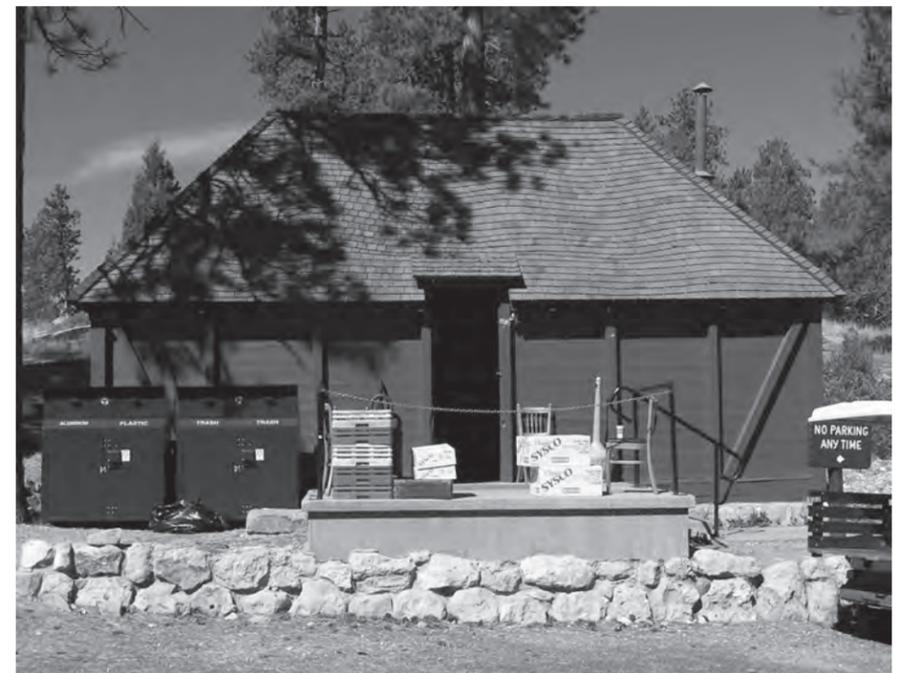
Photograph LD/30. Front view of Linen House B-15 (HS-111).

The **Linen House B-15** (HS-111) is located directly north of the Pump House and is believed to have been constructed at approximately the same time as the Standard Cabins (1925-27). It appears to have always been used for dispensing linen and supplies for the concessionaire’s housekeeping operations. This is a rectangular, one-story, studs out building with a hip roof and a stone foundation. The walls are formed by horizontal tongue and groove planks painted brown. The roof is finished with wood shingles applied in a wavy pattern. The only entry to the building is on the southwest elevation. A new concrete loading porch is located just outside this entry (*Photograph LD/30*).

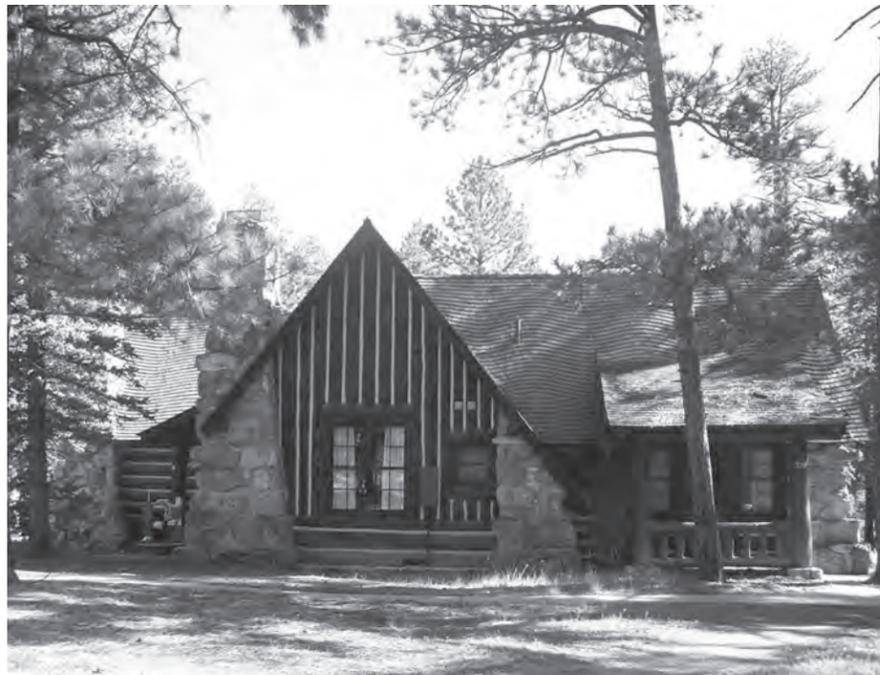
Photograph LD/31. Side view of a typical Deluxe Quadruplex Cabin B-32 particular structure photographed here is HS-214.

stone foundations (*Photograph HD/31*). As the name indicates, each structure contains four guestrooms (with their independent bath and fireplace). Each unit is accessed by a porch, one on each elevation, through stone steps. All of these buildings consist of a central rectangular block with two wings constructed on alternate corners. Roofs are formed by the gable of the central block intersected by the gables of the two wings. The sheathing is done by green-painted wood shingles applied in a wavy pattern. The wall logs are peeled, painted brown and daubed with cement. They are placed horizontally, except at the four gable ends, where they are placed vertically under the eaves. Massive stone piers with stepped bases anchor each of the eight corners of the buildings. Four of these are chimneys that rise about ten feet above the eaves and form a distinctive feature of the cabins.

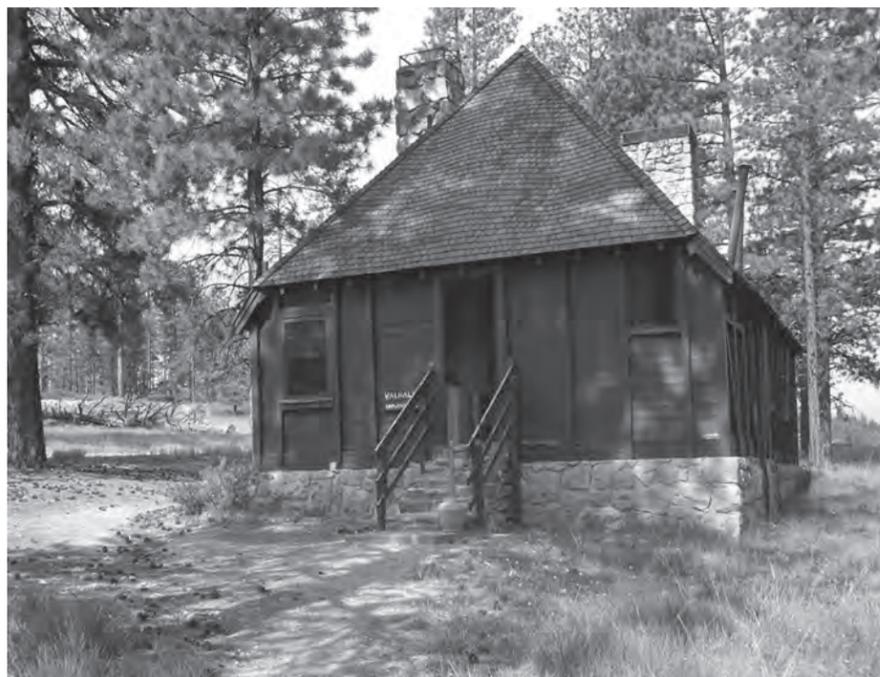
Photograph LD/34. View of Recreation Hall/Valhalla B-37 (HS-105).

The **Recreation Hall B-37** (HS-105), also known as “Valhalla” or “Girls’ Dormitory”, is a building located to the west of the Lodge at the base of a low knoll. It is believed to have been constructed circa 1927. The Recreation Hall is a rectangular, one-story, studs-out building resting on a stone and concrete foundation (*Photograph HD/34*). The exterior wall surfaces are made up of tongue-and-groove boards painted brown. Like the other buildings in this district, it has a hipped roof covered with wood shingles applied in a wave pattern. A large random course stone chimney is located on the west elevation and is flanked by narrow wood-frame windows on either side. The interior is divided into three main rooms – a recreation room, laundry and lavatory. The building is currently operated by the concessionaire.

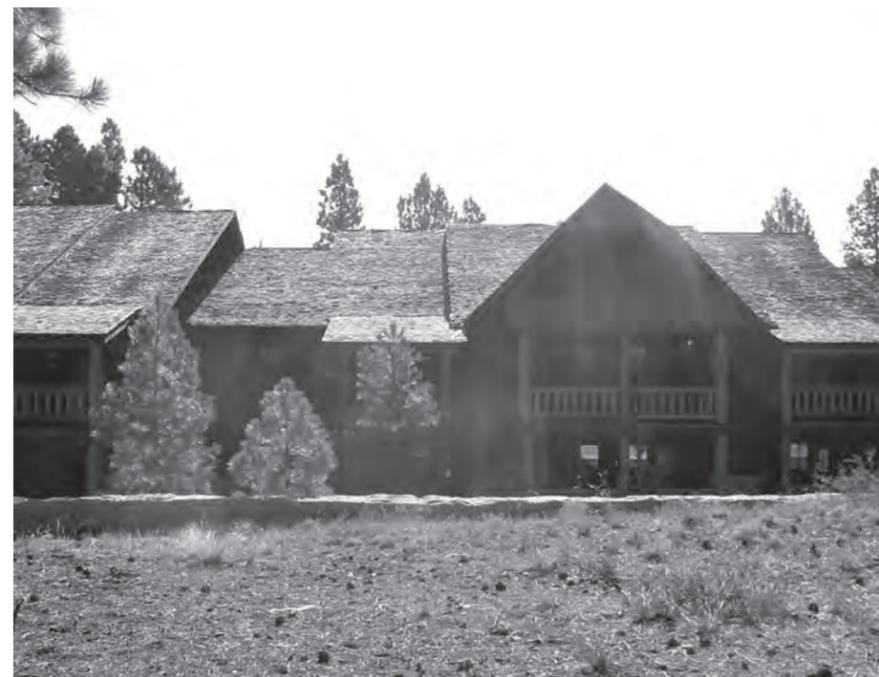
Photograph LD/36. View of Sunrise Motel B-40.

The **Sunrise Motel B-40** (*Photograph HD/36*) and **Sunset Motel B-39** (*Photograph HD/37*) are both motel units that were constructed in 1985 as a replacement for the standard cabins that were removed from the Bryce Canyon Lodge Study Area in the 1970’s and 80’s. While the Sunrise Motel is located to the northeast of the lodge on the site of the former Standard Cabins, the Sunset Motel is located to the southwest of the Lodge on a previously undeveloped site. Barring slight deviations due to site constraints, both the units are similar

in design and appearance. An attempt was made to adapt the rustic architectural theme (prevalent in the design of the historic Lodge and cabins) to a multi-story motel typology. Stone construction has been used till half the height of the first floor, above which all the construction is exclusively in wood. The motel units are rectangular in plan with both of them oriented roughly north-south along their longer axes. Entrance porches are centrally located on the longer facades. The roofs are formed by a gable running along the long axis and punctuated intermittently by shorter cross-gables that give rise to shaded balconies on the second floor. Balconies are also formed in the space between two cross-gables by a slight extension of the roof to provide shade. In contrast to the alternating “solid and void” architectural vocabulary of the longer facades, the shorter sides present a relatively flat façade. Secondary entrances are located on each of the shorter facades, although none of these are defined by entrance porches.

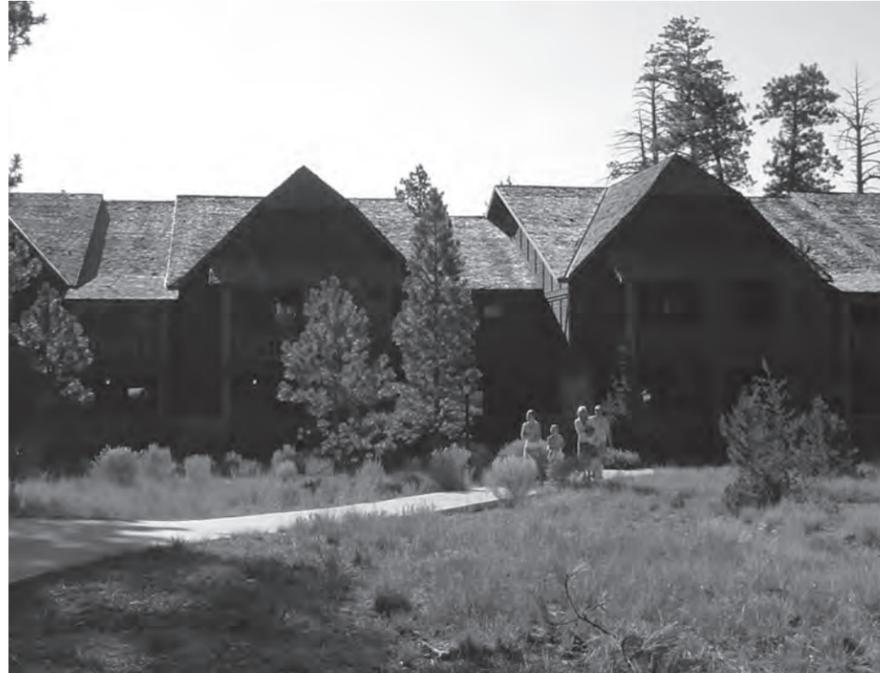
Photograph LD/37. View of Sunset Motel B-39.

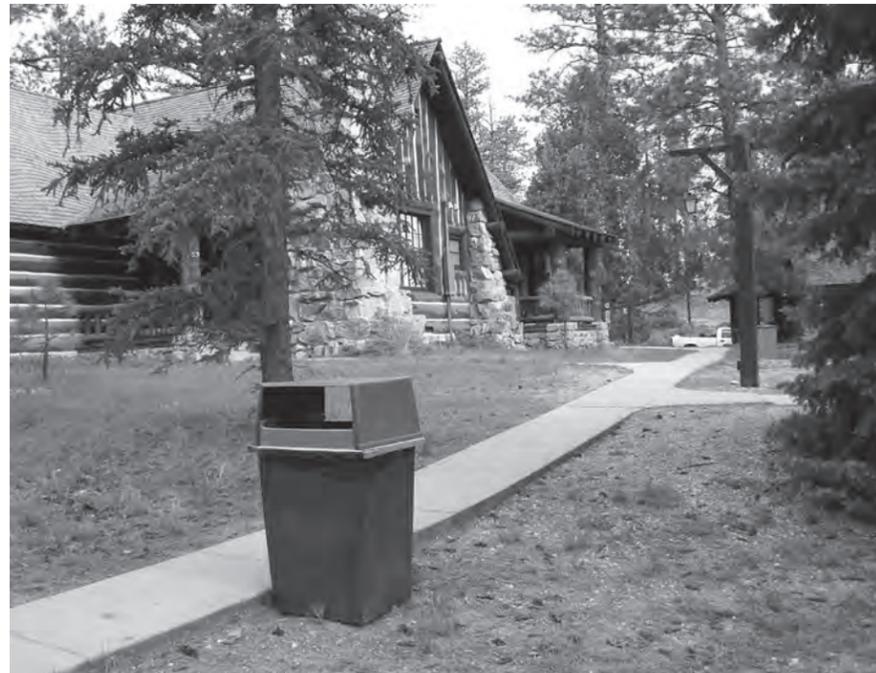
Photograph LD/41. A trash receptacle within the Deluxe Cabins. This zone features at least four different types of trash cans.

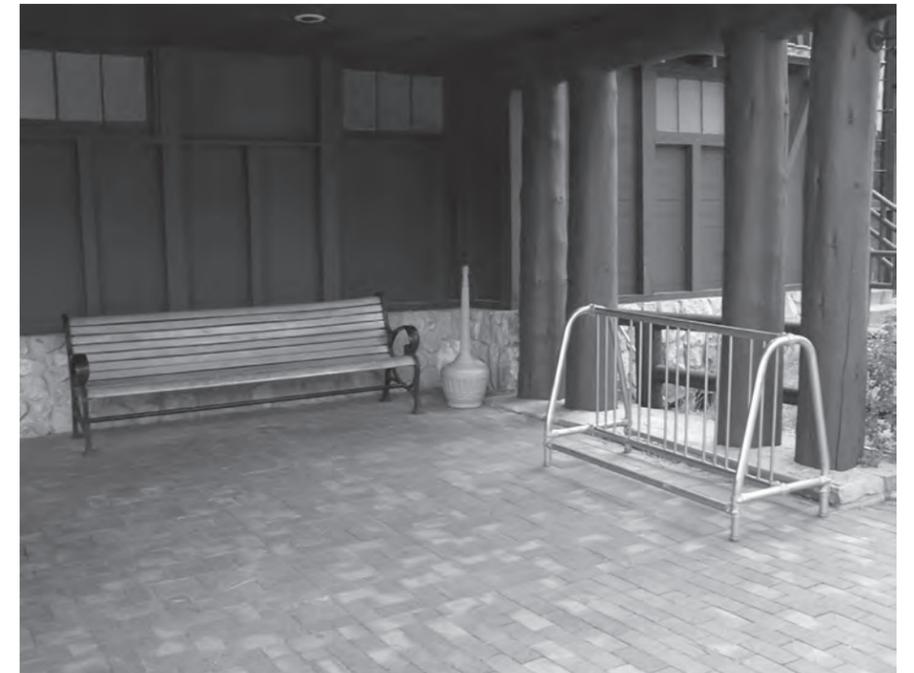
Photograph LD/42. A wooden bench, bike rack and outdoor ashtray placed at the rear entry into the Lodge on brick paved patio.

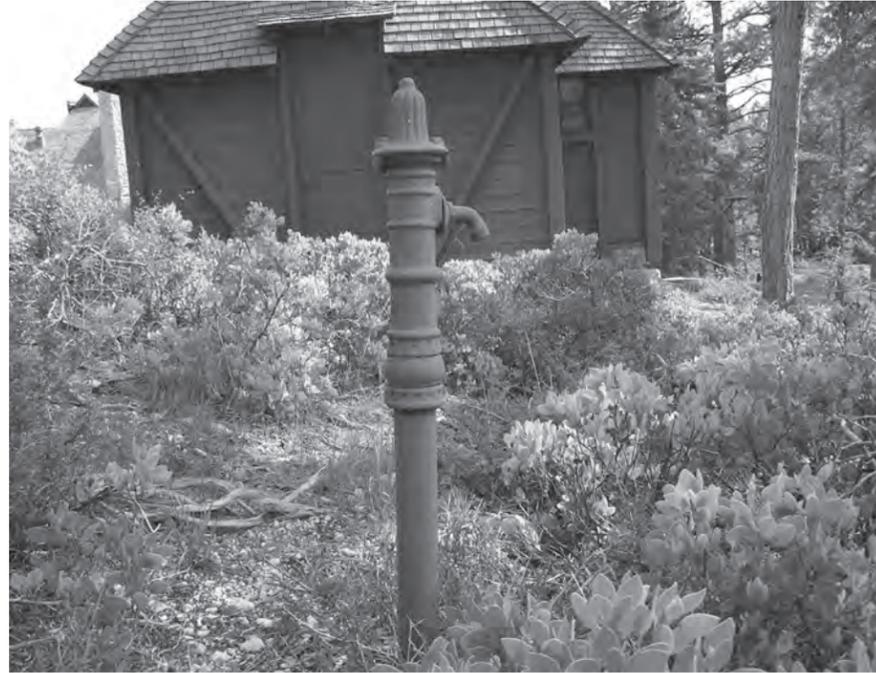
Photograph LD/44. View of a hand pump near the Standard Cabins.

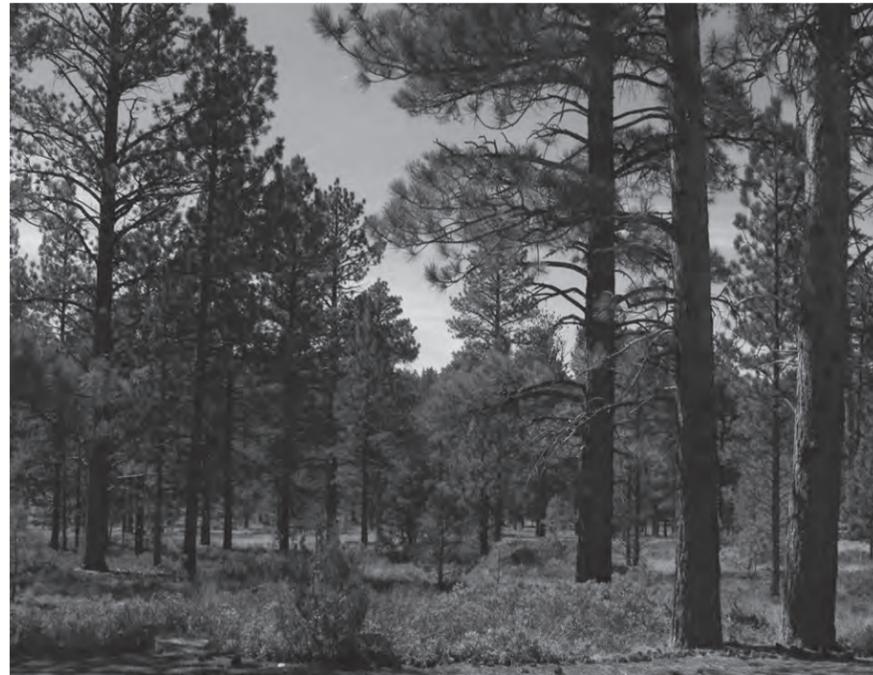
Photograph GS/2. Ponderosa pine forest east of the rim, near the Sunrise Point Trail Head.

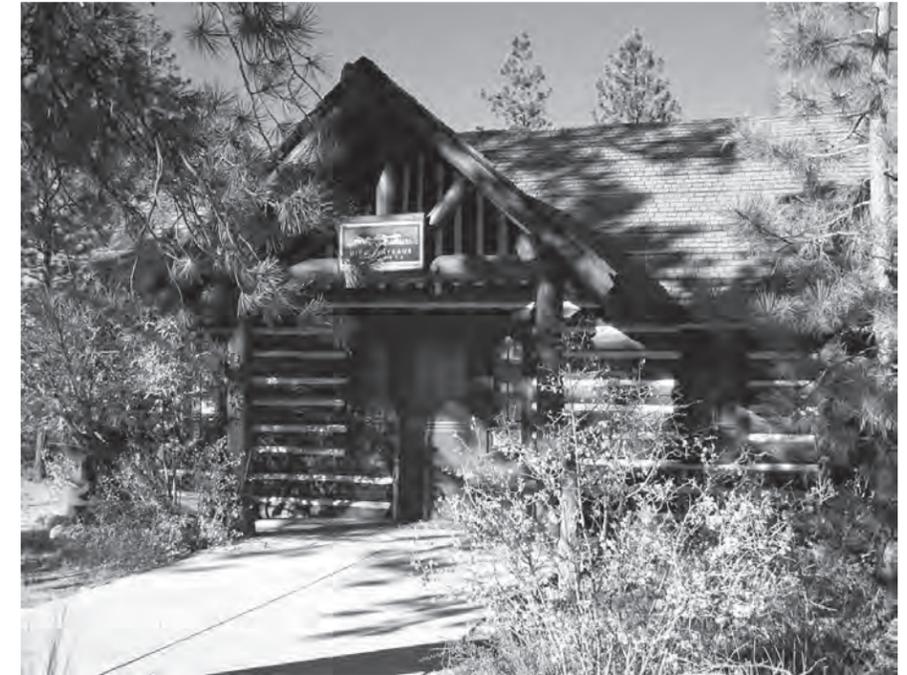
Photograph GS/3. Old Administration Building B-2 - front view with plantings.

in this area are found around the base of the buildings including, elderberry (*Sambucus velutina*), wax currant (*Ribes cereum*) and Utah serviceberry (*Amelanchier utahensis*) (*Photograph GS/3*). The slopes to the northwest of the General Store were once the site of the complex of housekeeping cabins. Although the area was not deliberately revegetated after the cabins’ removal, it has begun to recover naturally, if slowly (*Photograph GS/4*). Revegetation efforts have been limited to more recent disturbances and unwanted social trails.

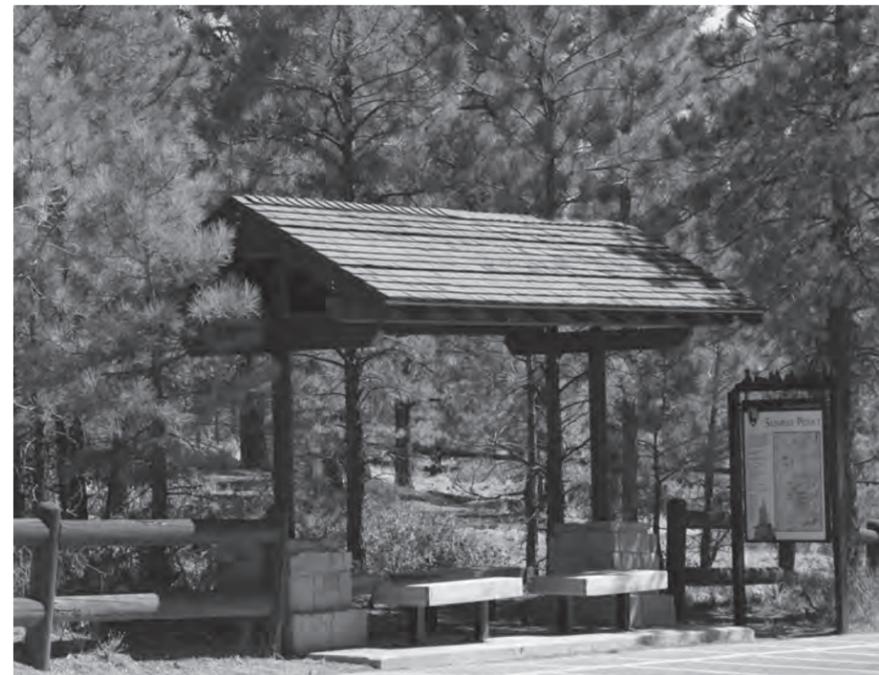
Photograph GS/9. Shuttle bus stop S-1.

The **shuttle bus stop S-1**, located across the parking area from the Old Administration Building, consists of a small shade structure of wood framing and green shingles supported on a foundation of natural stone pillars. The structure was designed to fit in with the architecture of the area, as well as to give shuttle riders a shady place to wait outside of the flow of pedestrian and vehicular traffic (*Photograph GS/9*).

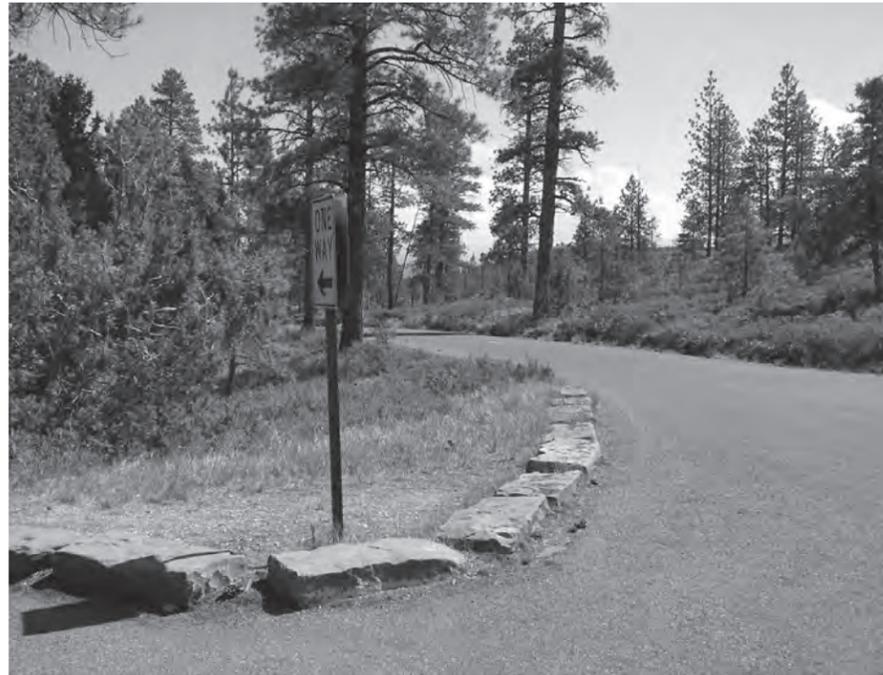
Photograph GS/13. Rugged stone curbing along road edge.

Small-scale features in this Sub Area are largely consistent with those found elsewhere in the Park and relate directly to visitor facilities. These include **stone curbs** along concrete pavements and parking areas (*Photograph GS/13*). A rather unique circulation path can be observed around the old Administration Building comprising of irregularly-shaped stone treads set in gravel (*Photograph GS/14*). Consistent with the rest of the sub areas are **traffic and wood directional signs**, **fire hydrants** and **utility boxes**. **Wood screen fencing** keeps utility and service areas out of view, including the propane tank. A pair of **telephone booths**, fitted with open glass enclosures and wood-shingled roofs, are located on the northwest façade of the General Store (*Photograph GS/15*).

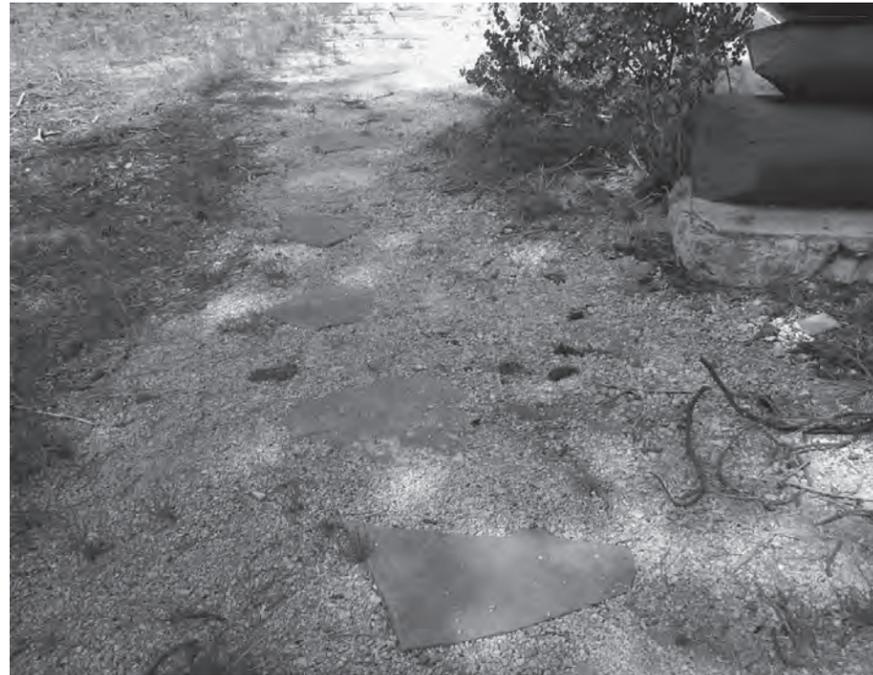
Photograph GS/14. Path around Old Administration Building with irregularly-shaped stone treads set in gravel.

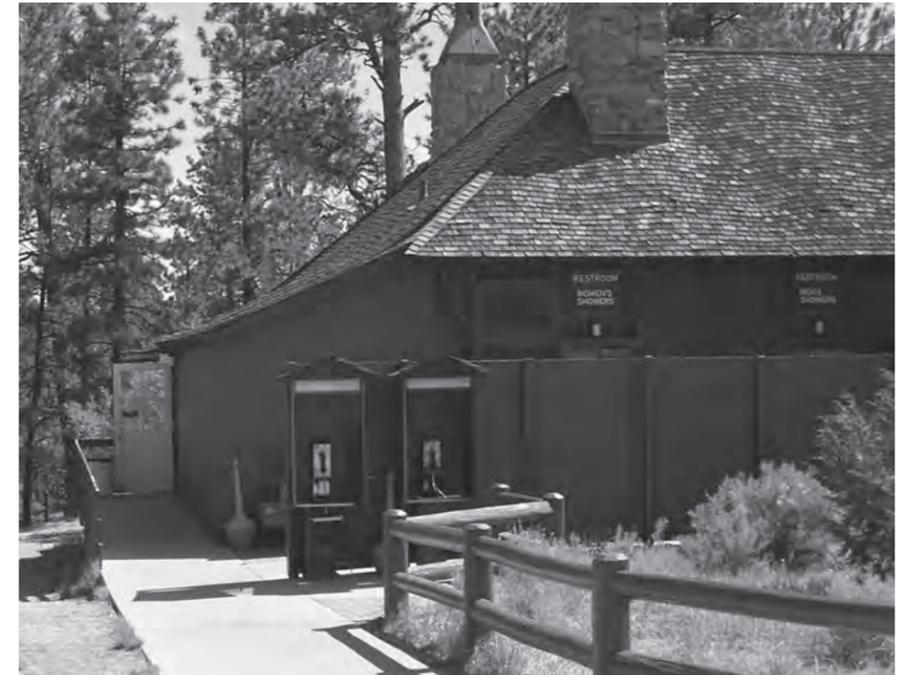
Photograph GS/15. Telephone booths along the northwest facade of the General Store.

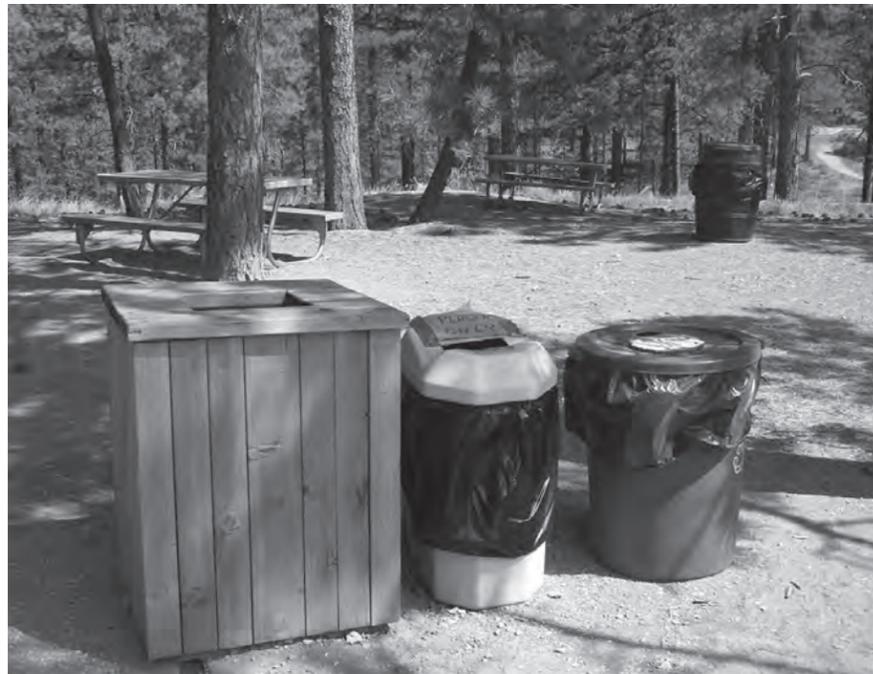
Photograph GS/17. View of smaller trash receptacles in the picnic areas - note variety of types.

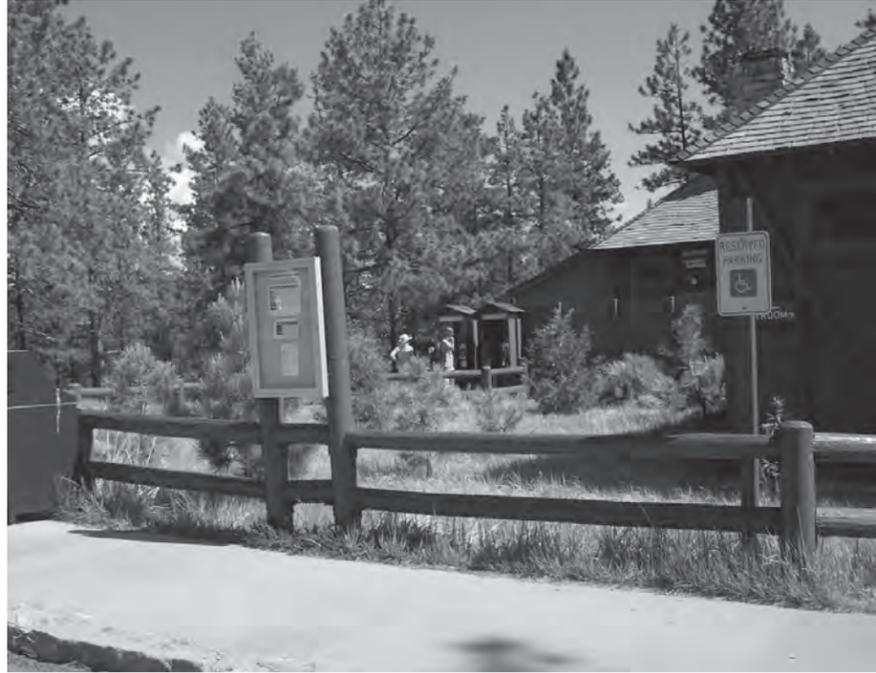
Photograph GS/19. Wooden post fence with interpretation signs.

A **wooden post fence**, or secondary barrier fence, consistent with those found in the Bryce Canyon Lodge Study Area and elsewhere in the Park defines circulation pavements around the General Store, and out to Sunrise Point. **Interpretive signage** is also incorporated in this fence in the form of metal and glass boxes mounted on wooden posts (*Photograph GS/19*). A flagpole is also present outside the Old Administration Building (*Photograph GS/20*).

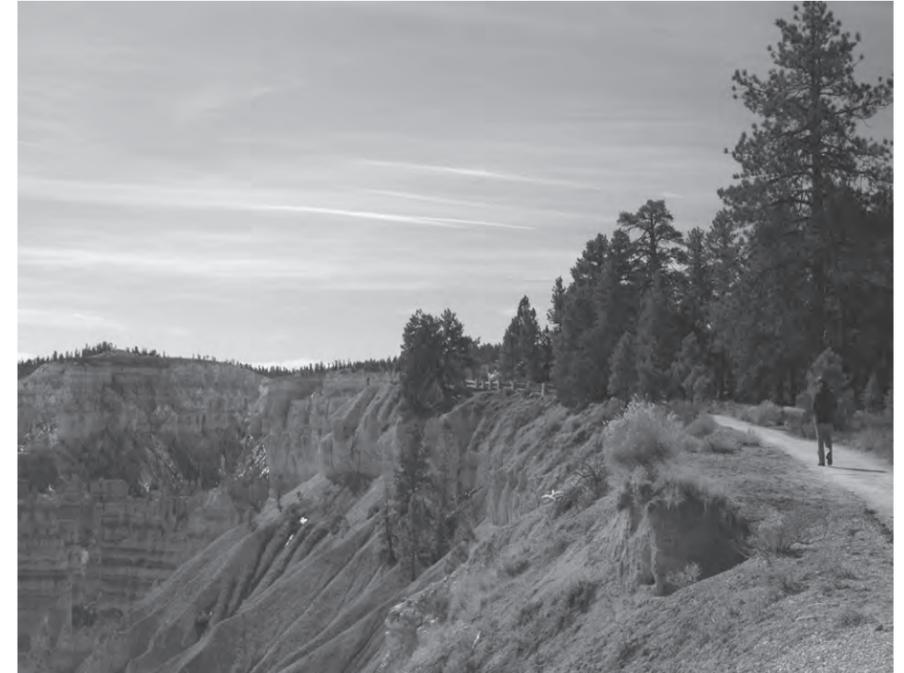
Photograph RT/3. Evidence of the erosion of the rim near the Rim Trail in the vicinity of Sunset Point.

Where the trail encounters the breaks, large bare patches of ground can be found as a result of natural and human-caused erosion. Although these patches of open ground make views more accessible, they also create even greater erosion problems. In some more heavily traveled areas, such as near the Bryce Canyon Lodge Study Area, the Rim Trail is being re-located further to the west to avoid areas where rim erosion has come nearly to the trail edge (*Photograph RT/3*). Natural erosion is not always a problem, however. It creates the more spectacular formations below the rim, along with smaller features that can be observed right at the rim. This includes **pedestaed plants**, plants whose roots have been exposed due to the removal of soil from their base. The most common plants affected by this phenomenon are pine and juniper trees. Many such trees are located on the rim and they are favorites of photographers (*Photograph*

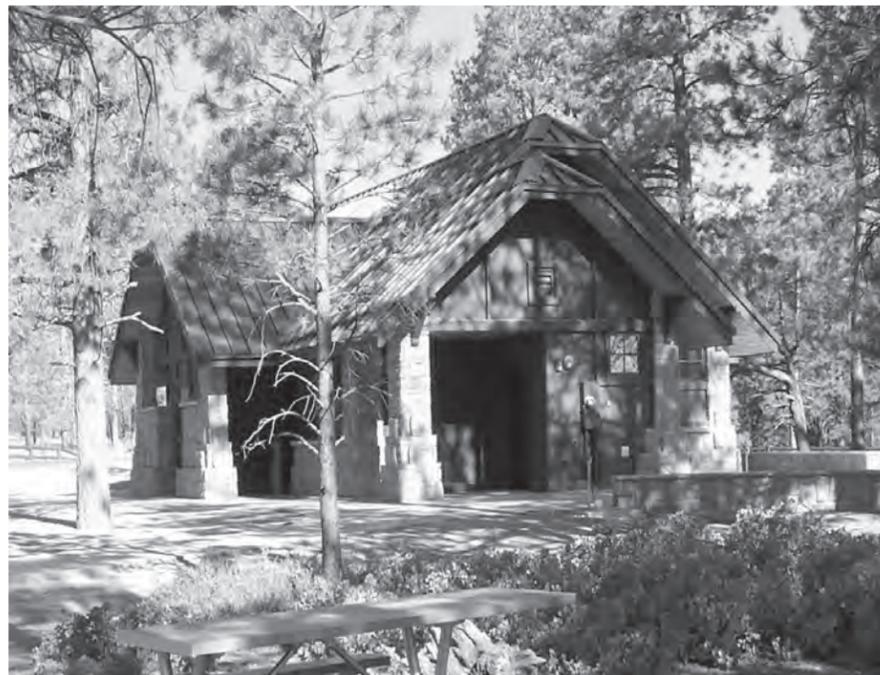
Photograph RT/10. Sunset Point Comfort Station B-1.

spur from the Rim Road. It contains parking for private vehicles and tourist buses, a **shuttle bus stop S-1** (*Photograph RT/9*) and a large centrally located **Comfort Station B-1**. Constructed in 2005, the Comfort Station is a one-story symmetrical building utilizing a combination of both timber and stone construction (*Photograph RT/10*). Although it is constructed with modern materials and construction techniques, the structure attempts to conform to the rustic architectural typology of historic structures found elsewhere in the Park.

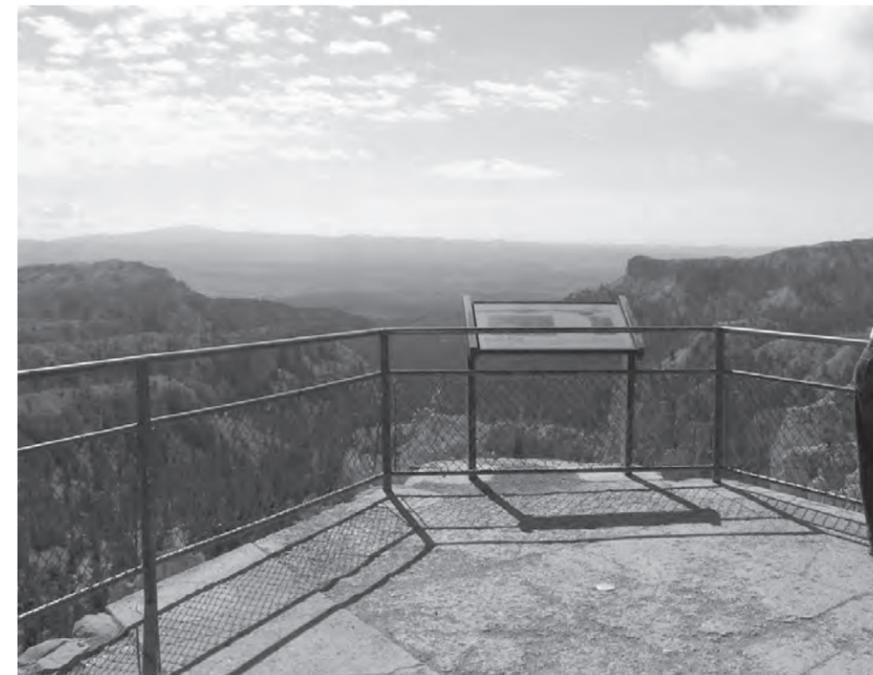
Photograph RT/15. Metal fence at Sunset Point.

Varieties of fences help to direct visitors and protect against vegetation damage throughout the Sub Area. **Metal fences** define and enhance visitor safety at the edge of Sunrise, Sunset and Inspiration Points (*Photograph RT/15*). In the case of Sunset and Inspiration Points, the approach along the Rim Trail is bordered by a “**primary barrier**” - a wooden log fence with stone piers usually located along the rim side of the trail (*Photograph RT/16*)- and a “**secondary barrier**” - a wooden log fence with log piers located on the forest side of the trail. **Interpretive signage** and **split log benches** are located at regular intervals along the trail corridor (*Photograph RT/17*). The Sunset Point parking lot area has **picnic tables**, **trash and recycling receptacles** and **water fountains** amongst other features (*Photograph RT/18*).
