BRYCE CANYON NATIONAL PARK: OLD NPS HOUSING AND BRYCE CANYON LODGE CULTURAL LANDSCAPE REPORT

**BRYCE CANYON NATIONAL PARK: BRYCE CANYON LODGE DISTRICT
AND HISTORIC NATIONAL PARK SERVICE HOUSING DISTRICT
CULTURAL LANDSCAPE REPORT**

**UNIVERSITY OF ARIZONA COLLEGE OF ARCHITECTURE, LANDSCAPE ARCHITECTURE AND PLANNING
SCHOOL OF LANDSCAPE ARCHITECTURE AND PRESERVATION STUDIES PROGRAM**

December 2008

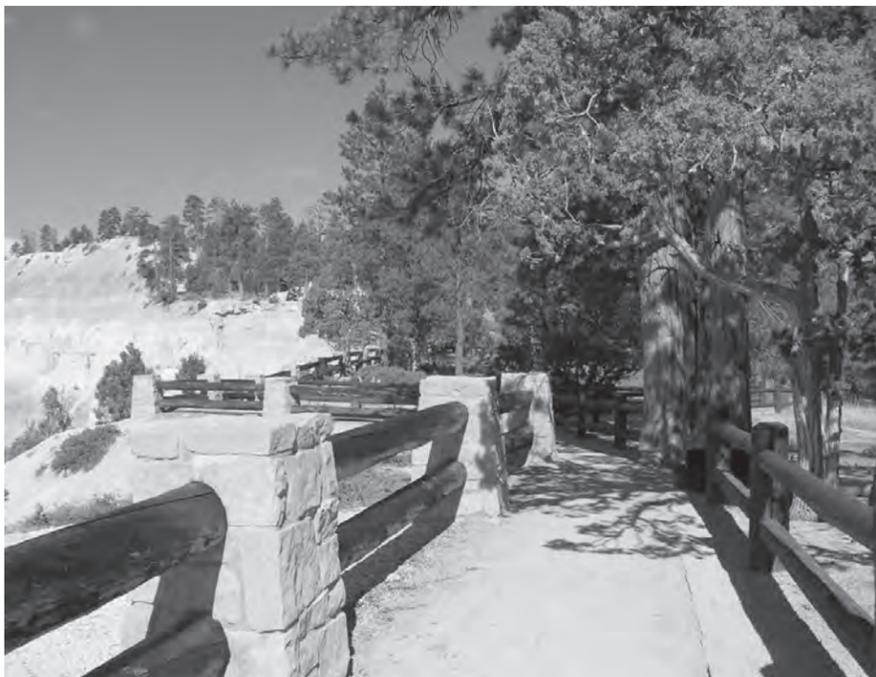
Photograph RT/16. "Primary Barrier" - wooden log fence with stone piers and "Secondary Barrier" wood log fence along Rim Trail.

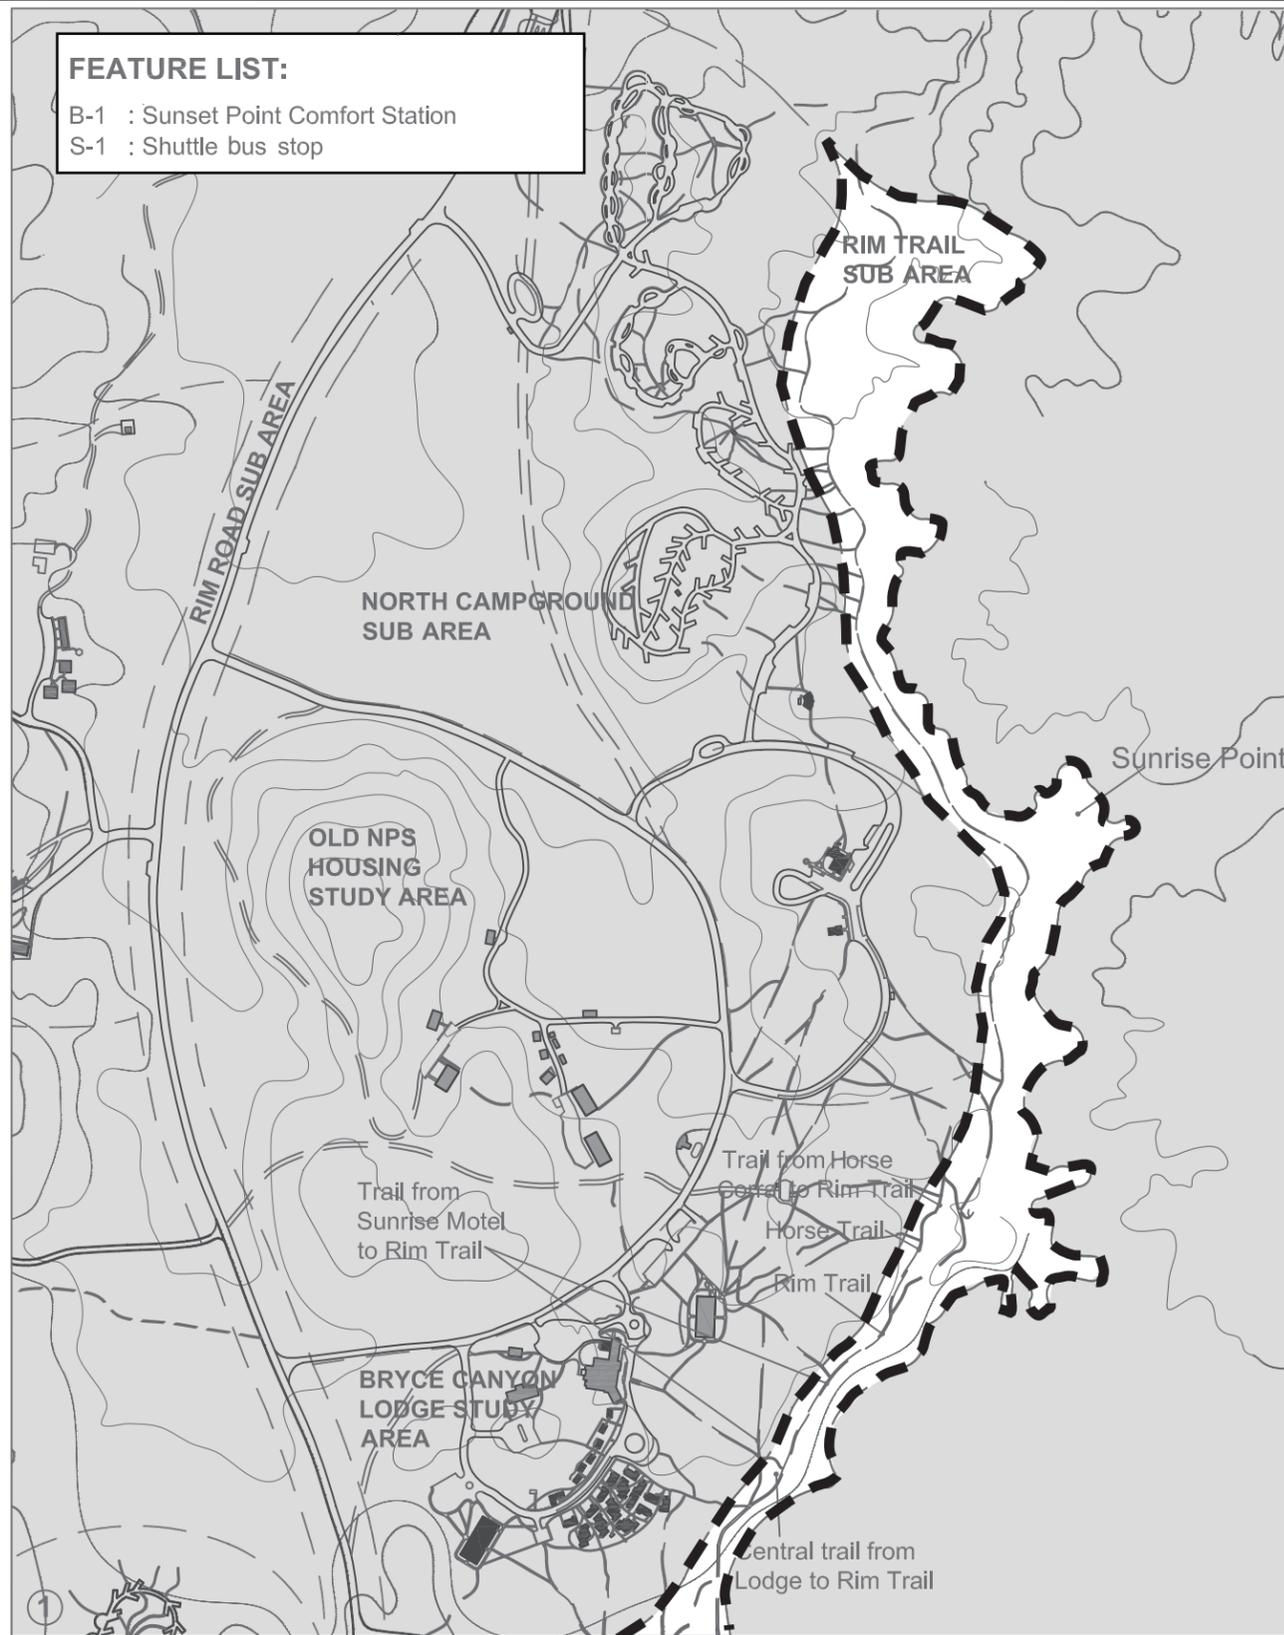
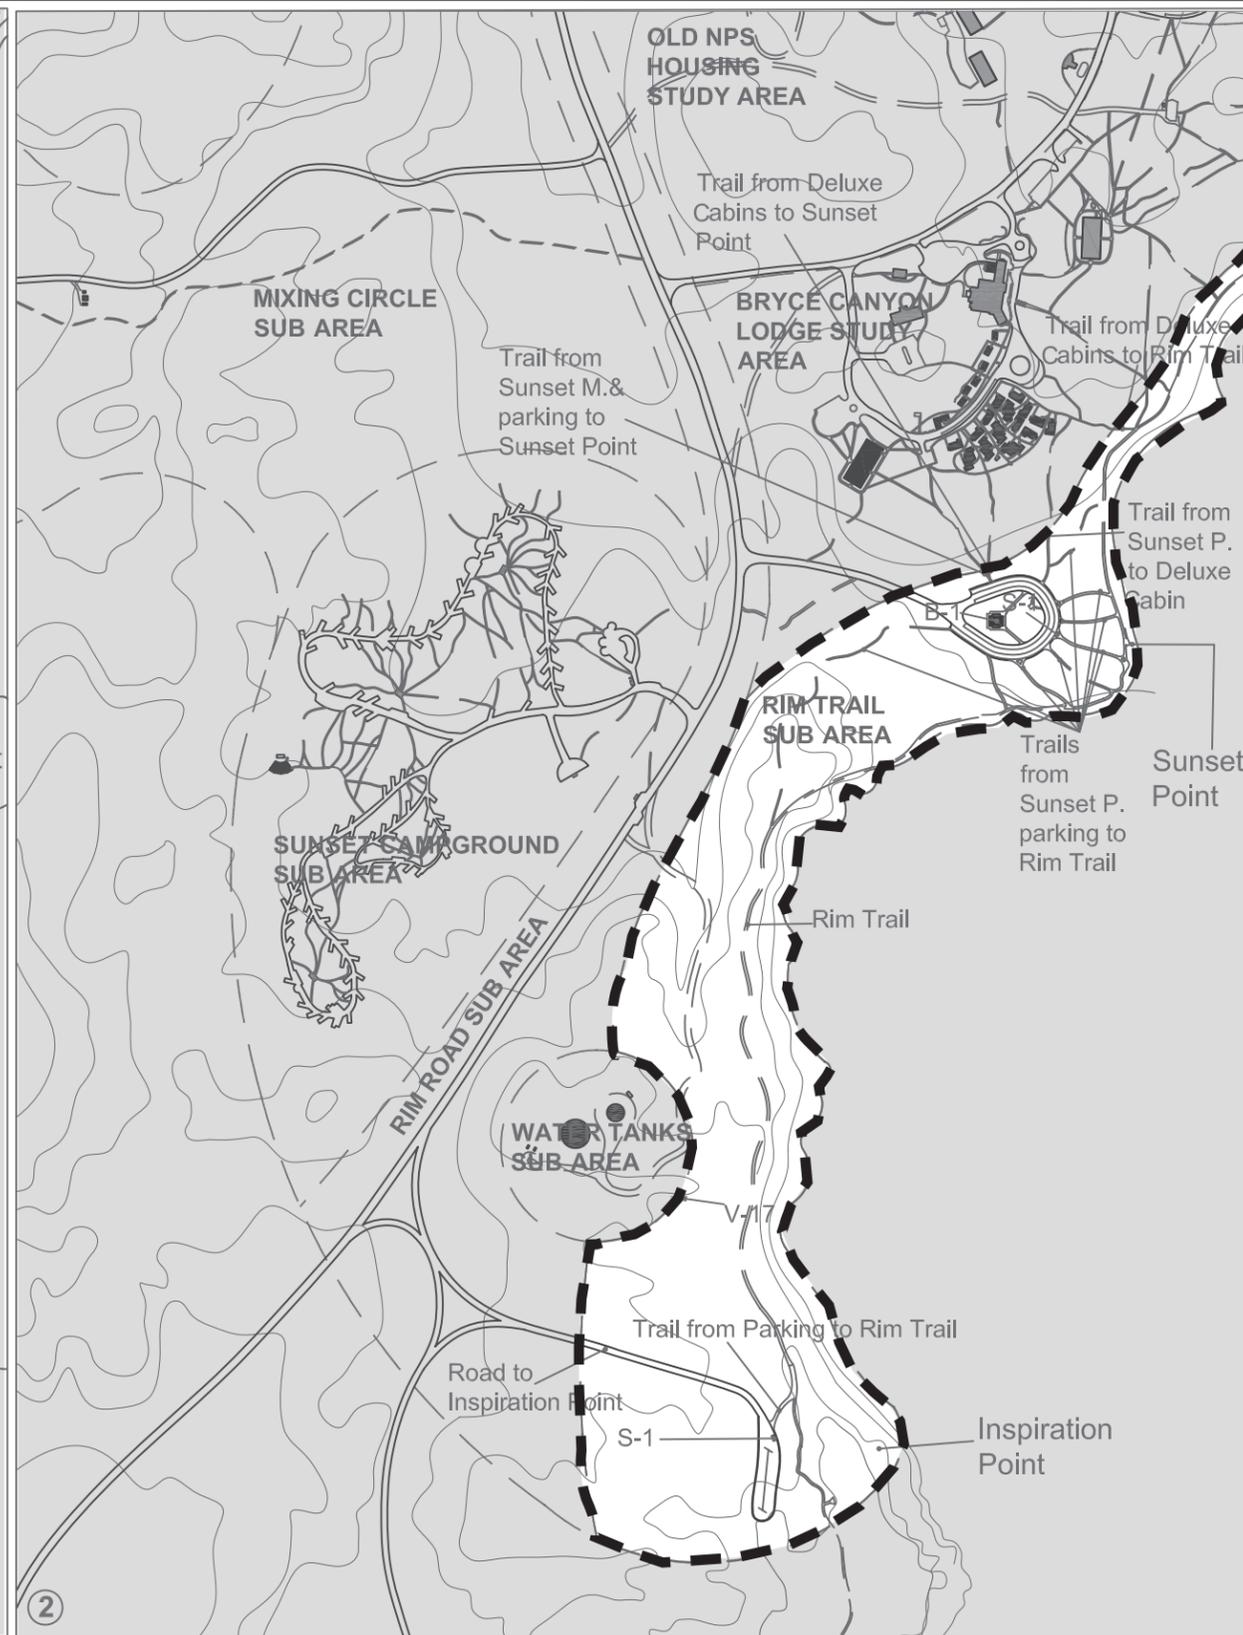
SUB AREA: RIM TRAIL CORRIDOR

- B-1 : Sunset Point Comfort Station
- S-1 : Shuttle bus stop

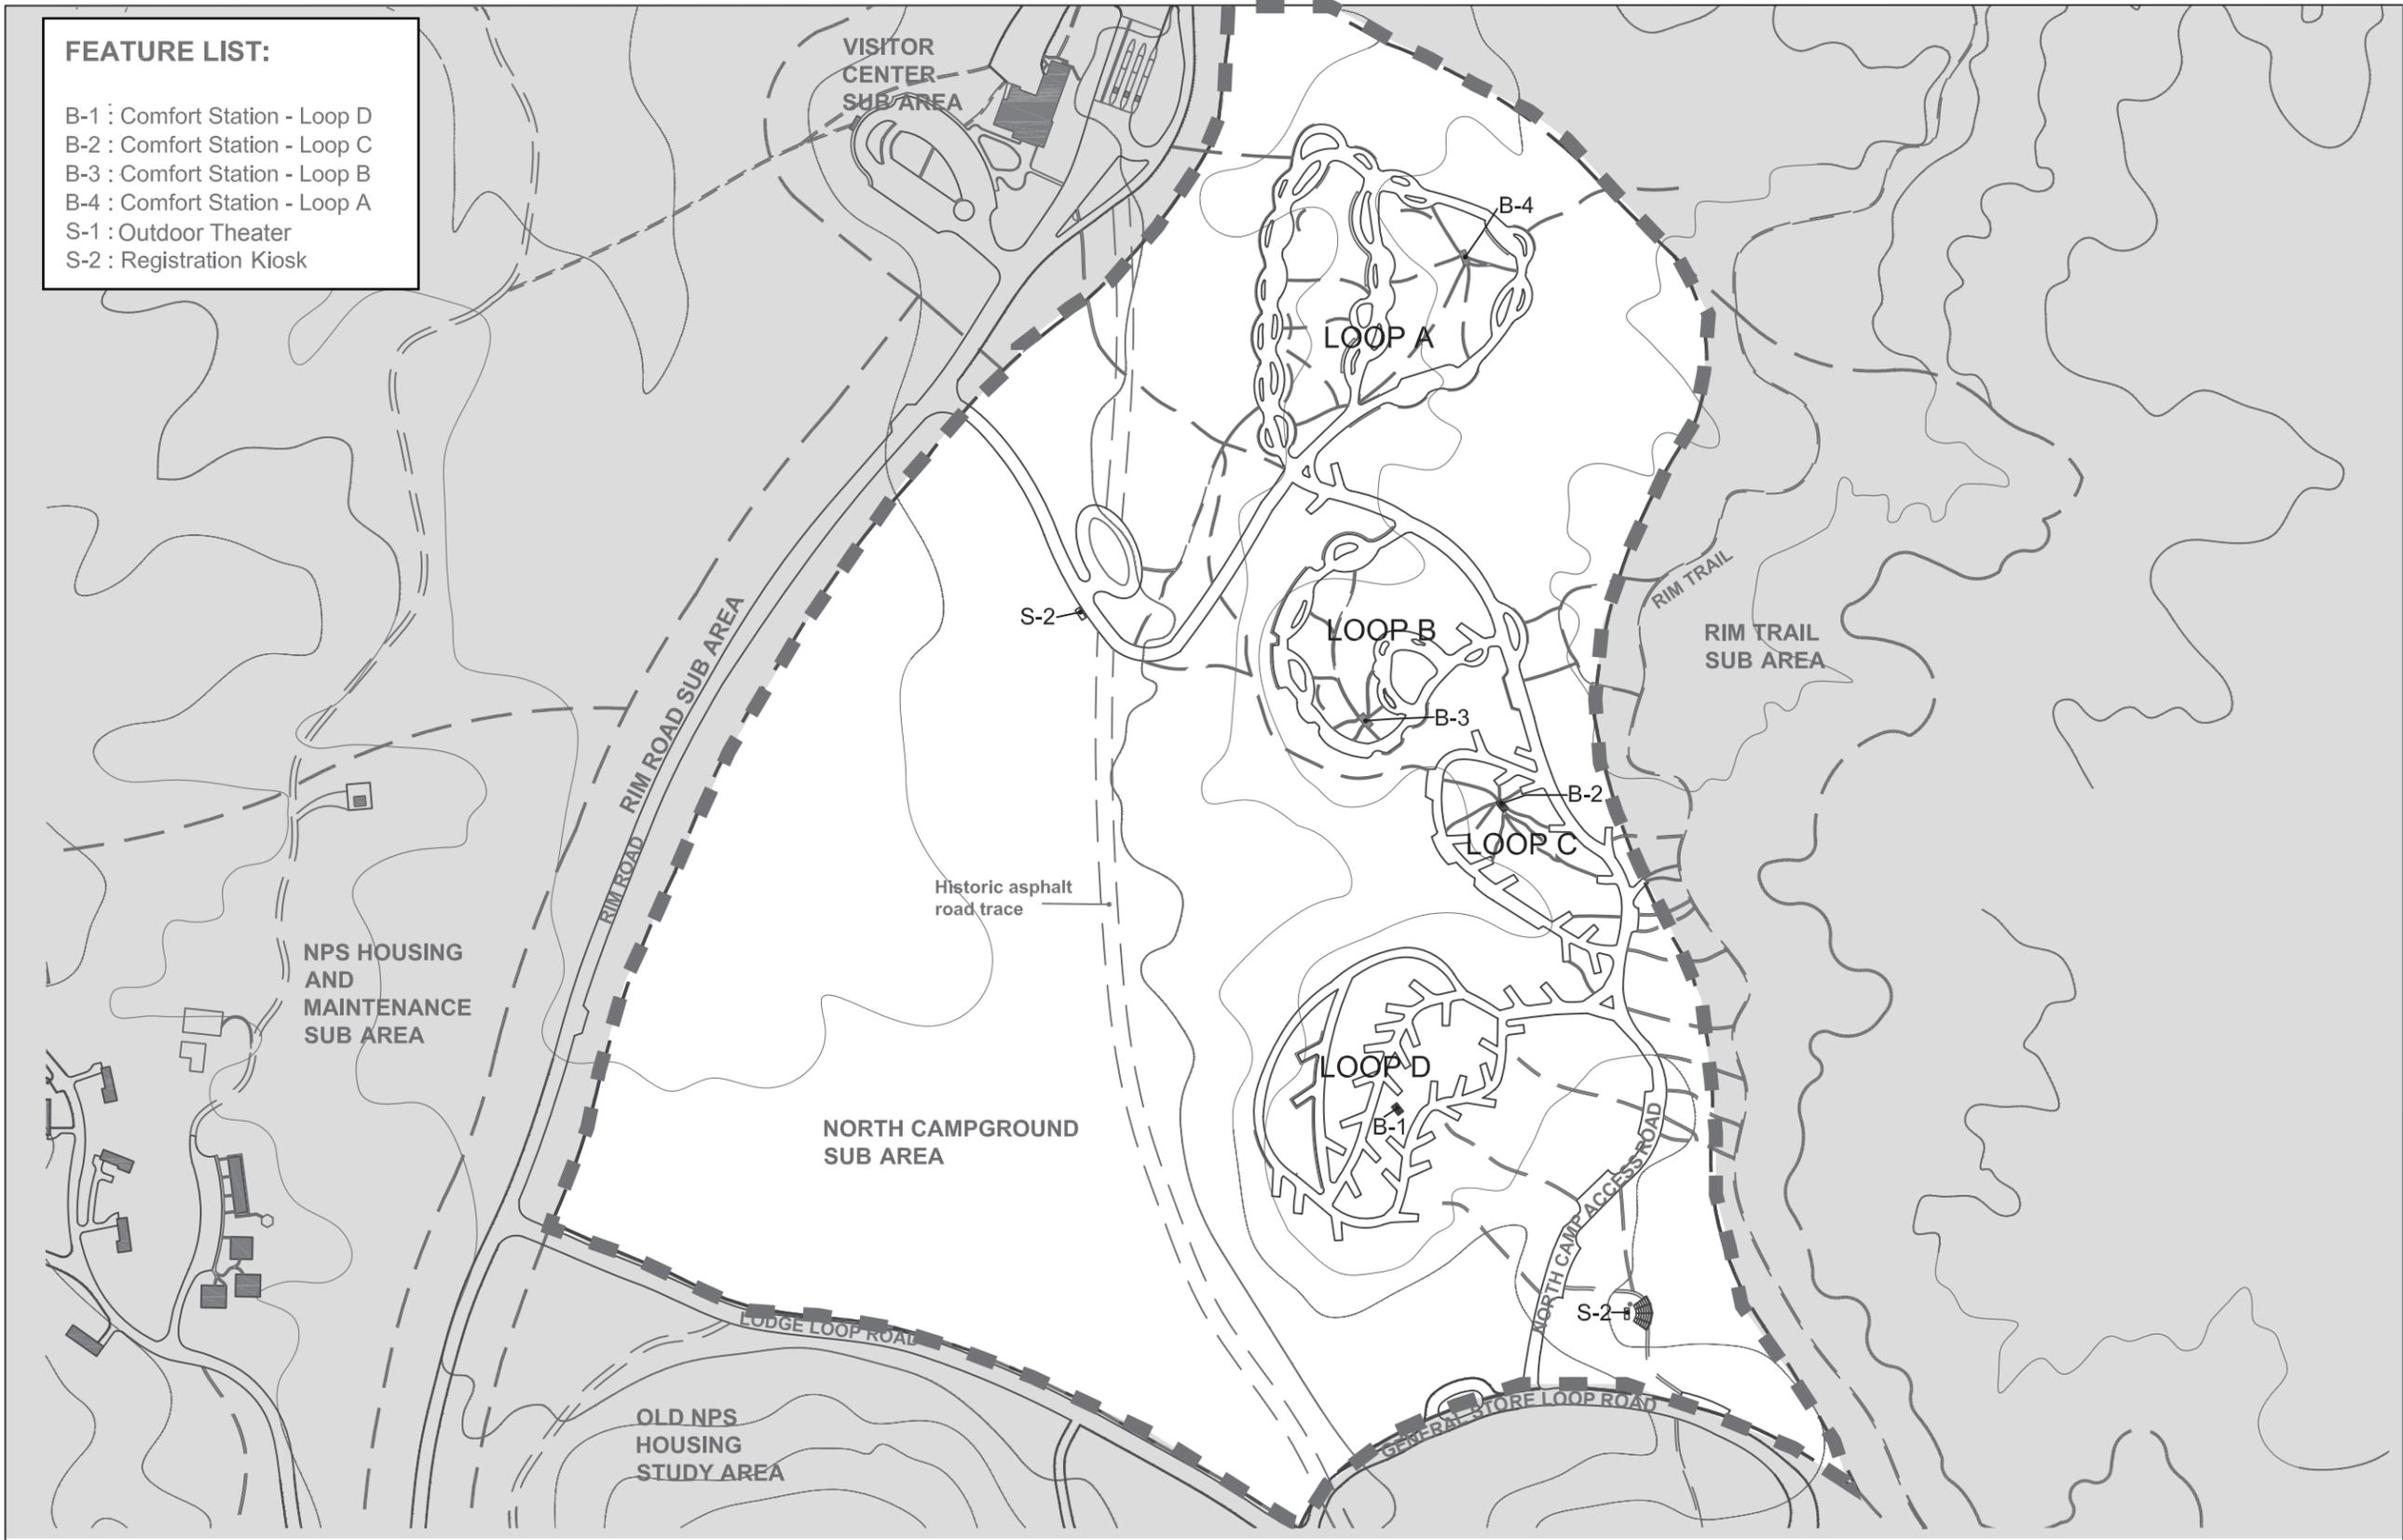
SUB AREA: NORTH CAMPGROUND

- B-1 : Comfort Station - Loop D
- B-2 : Comfort Station - Loop C
- B-3 : Comfort Station - Loop B
- B-4 : Comfort Station - Loop A
- S-1 : Outdoor Theater
- S-2 : Registration Kiosk

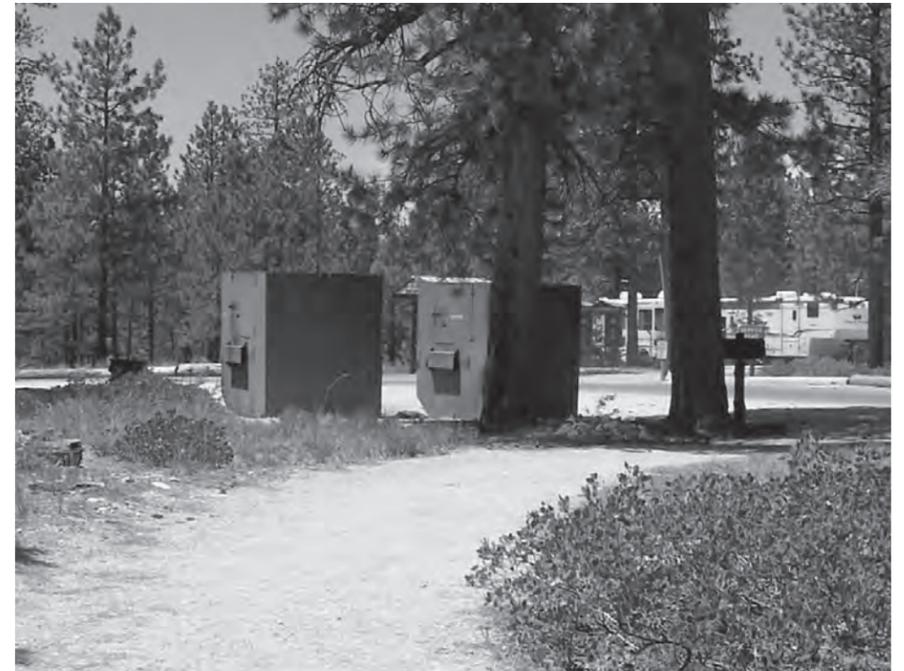
Photograph SC/18. Metal trash receptacles at the entrance to the Campground.

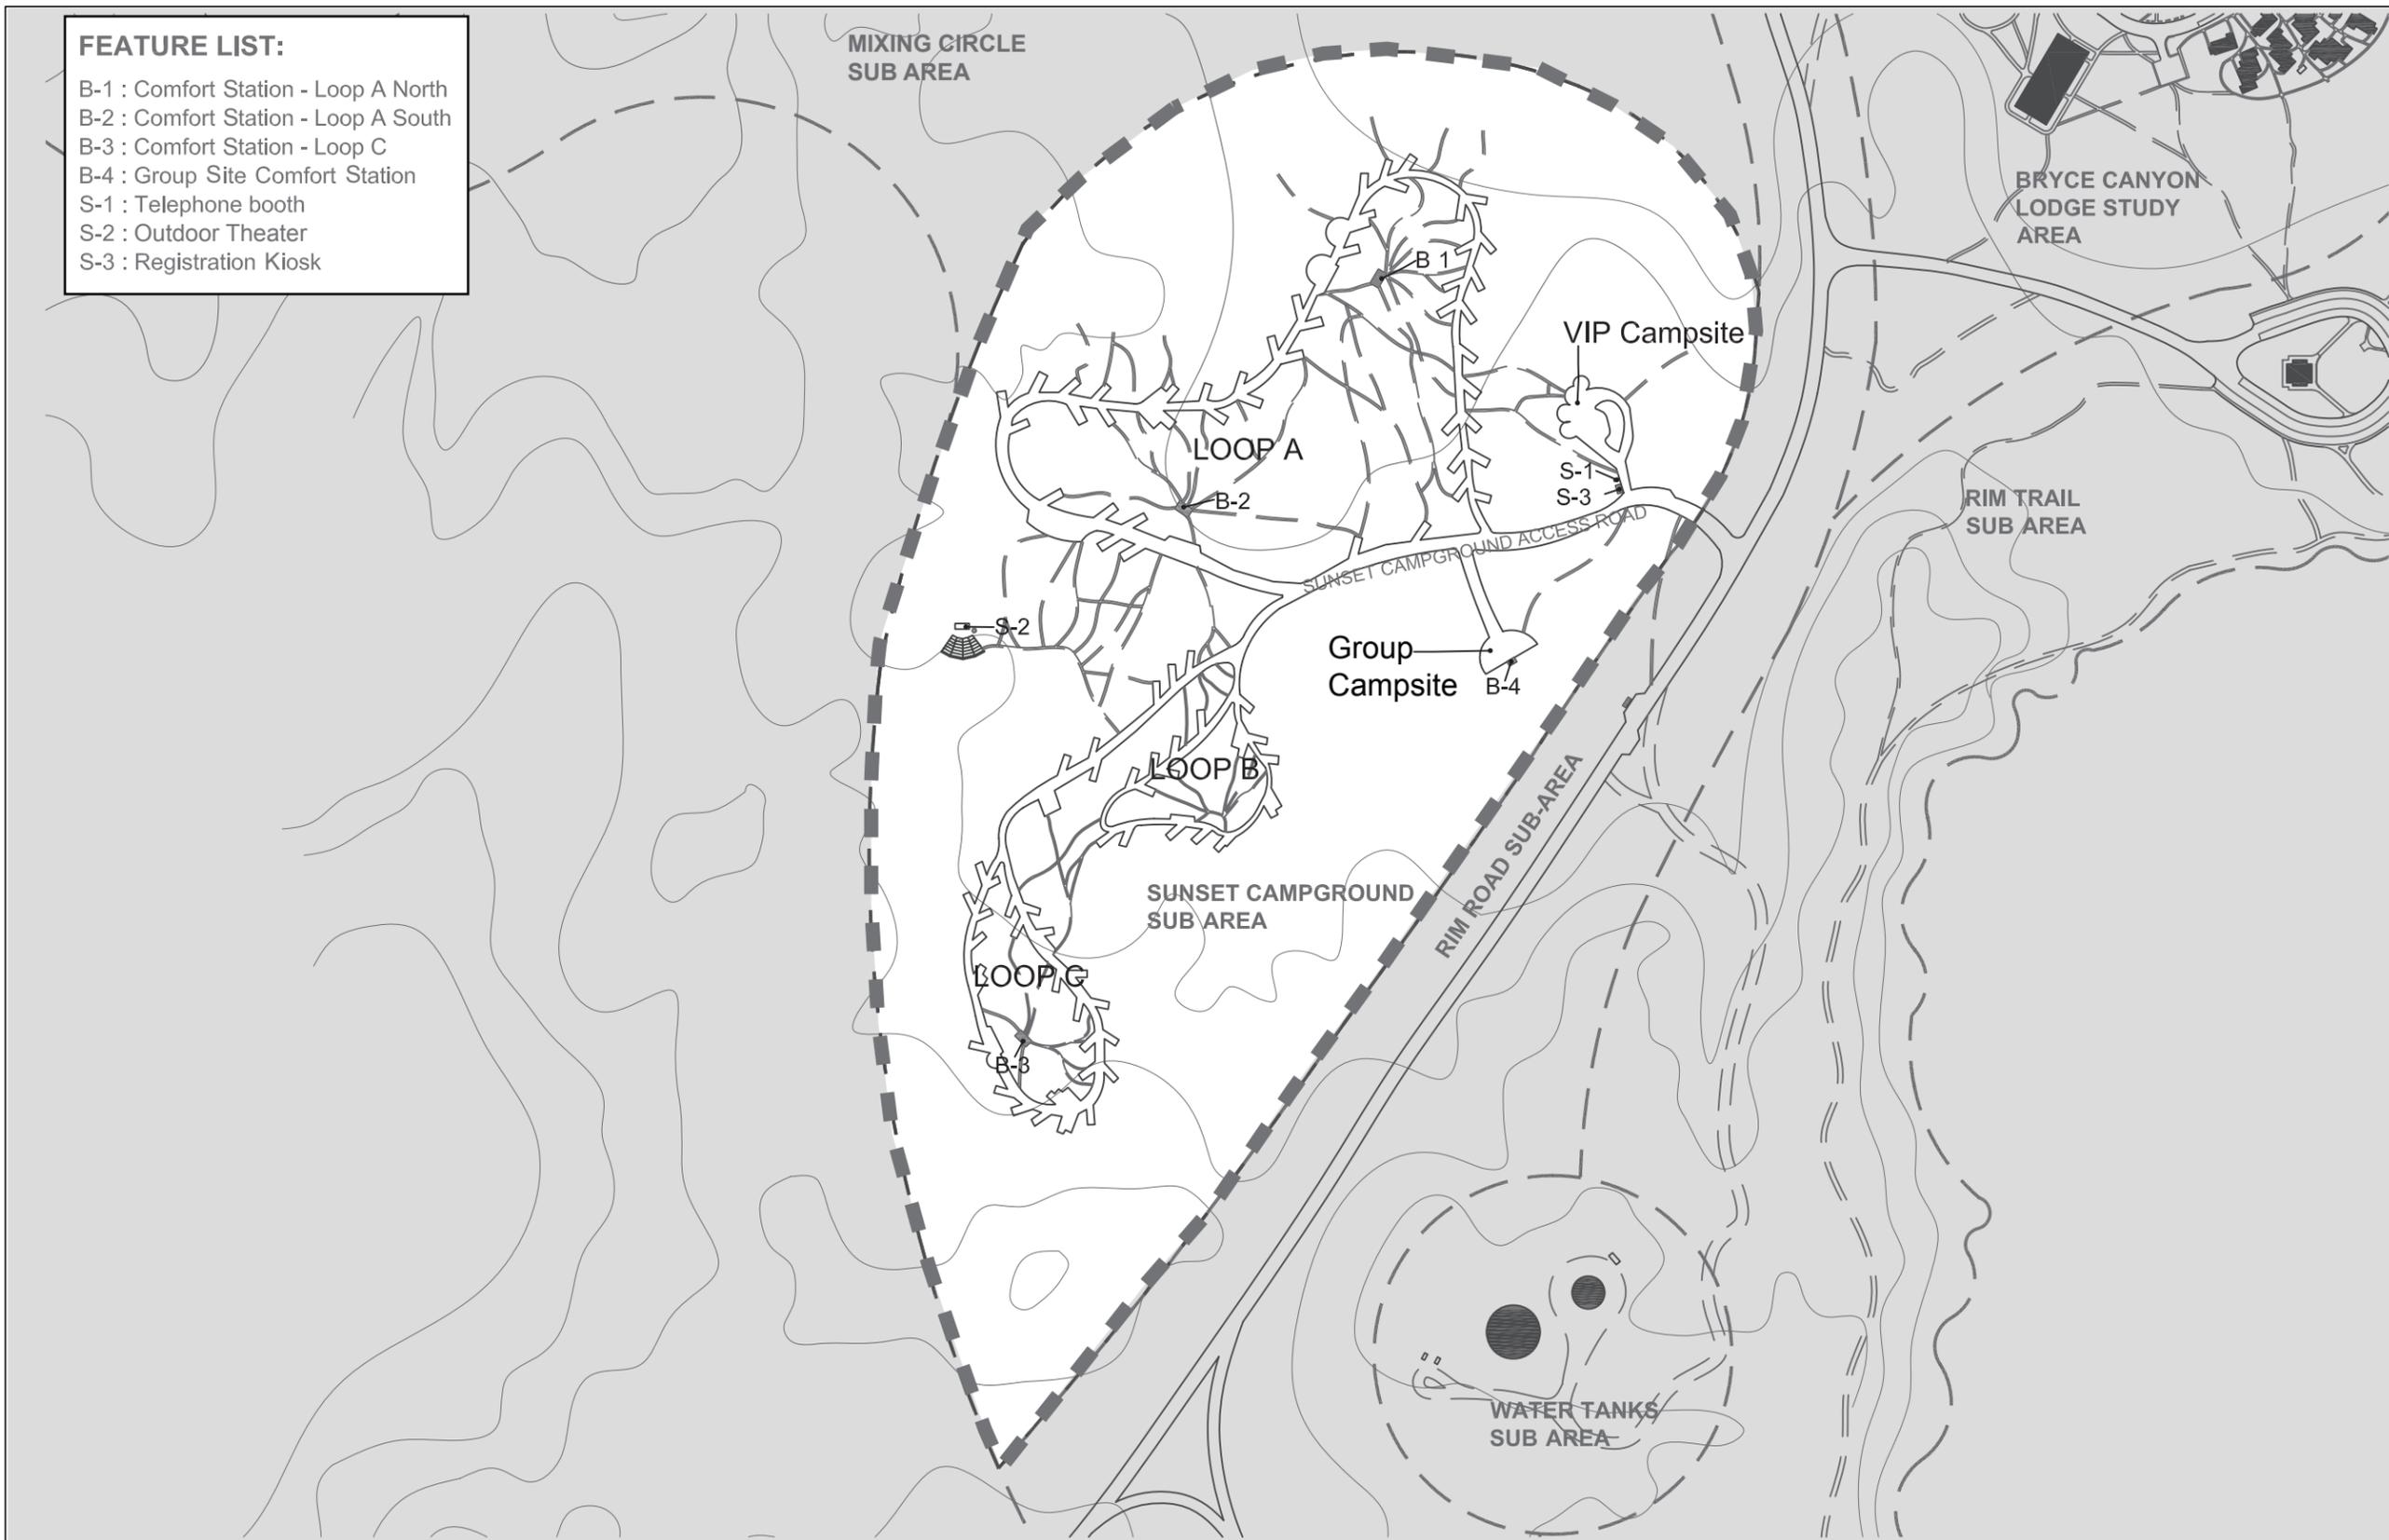
SUB AREA: SUNSET CAMPGROUND

- B-1 : Comfort Station - Loop A North
- B-2 : Comfort Station - Loop A South
- B-3 : Comfort Station - Loop C
- B-4 : Group Site Comfort Station
- S-1 : Telephone booth
- S-2 : Outdoor Theater
- S-3 : Registration Kiosk

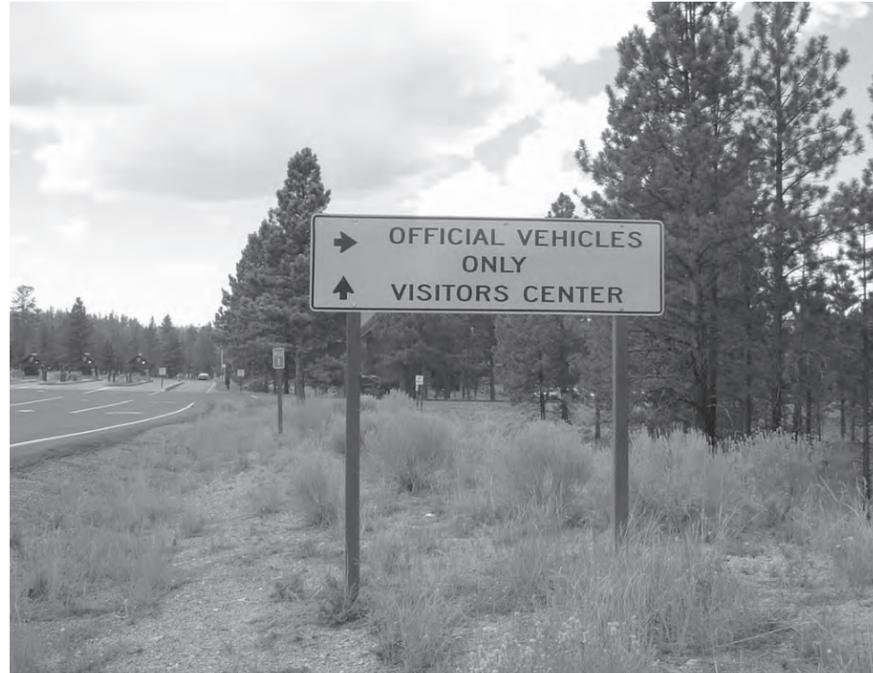
Photograph VC/8. Metal directional signage east of the Visitor Center directing official vehicles to rear parking lot.

The Visitor Center Sub Area has a number of **traffic signs** and **wood directional signs** that are visible to the arriving traffic and help to orient the visitors. **Metal directional signs** (examples of which are not seen in the other Sub Areas) are also found here (*Photograph VC/8*). **Interpretive signs** (*Photograph VC/15 & VC/16*), a **flagpole** (*Photograph VC/17*), **water fountain** (*Photograph VC/18*), and **low stone walls** can be seen in front of the south façade of the Visitor Center at the main entry onto the building. A **satellite dish** is located on the west façade; smaller **trash receptacles** are placed all along the front parking lot while larger metal ones are placed in the rear parking lot. Boulder edging, concrete and asphalt curbing, similar to that found elsewhere in the Park, have been used here to define the road edge and planting areas.

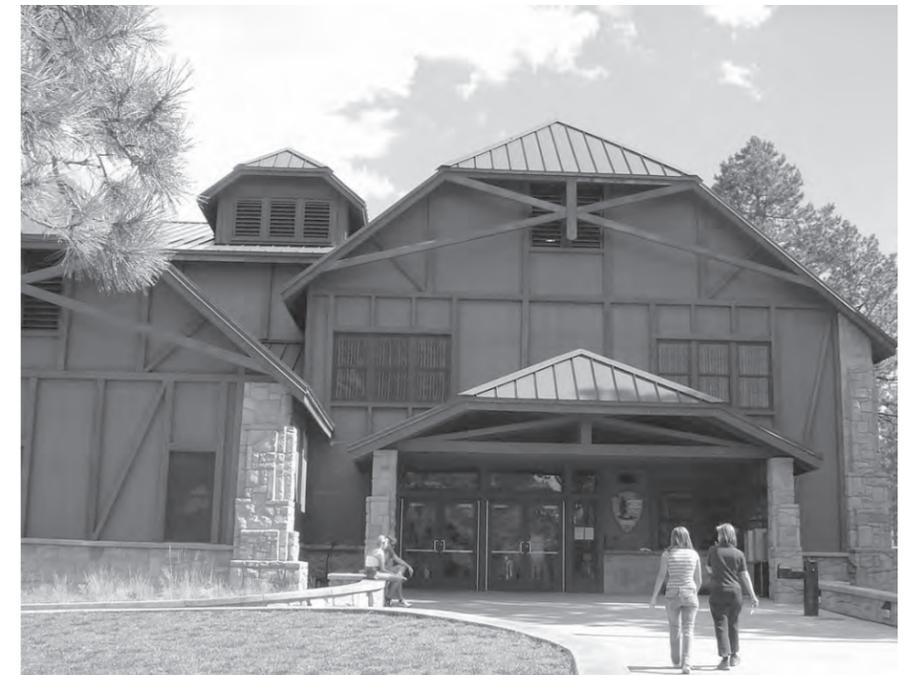
Photograph VC/12. Visitor Center B-1 - south entrance.

The **Visitor Center B-1** is a three-story, L-shaped building resting on a concrete foundation (*Photographs VC/12 & VC/13*). The construction comprises of a combination of studs-out wood framing with plywood panels nailed on the inside and concrete piers faced with stone. The sharply pitched gable roof is covered with green corrugated metal sheeting. The exterior walls are painted dark brown and contrast with the lighter colored stone facing. A concrete plinth runs around base of the building and is faced with stone on the south façade. The present form of the building is a result of a large-scale addition and remodeling that was carried out in 2002. The original Visitor Center that existed at this location was constructed in 1960 as a Mission 66 project and was a one-story structure built in the modern style, as opposed to the rustic architectural style. However the 2002 remodeling not only added two stories to the original building but also transformed its appearance to conform to the rustic architectural style used elsewhere in the Park. The building has modern interiors and houses a museum, a small auditorium, and a gift shop on the ground floor along with other visitor facilities. Administrative functions are shared between the different floors of the structure.

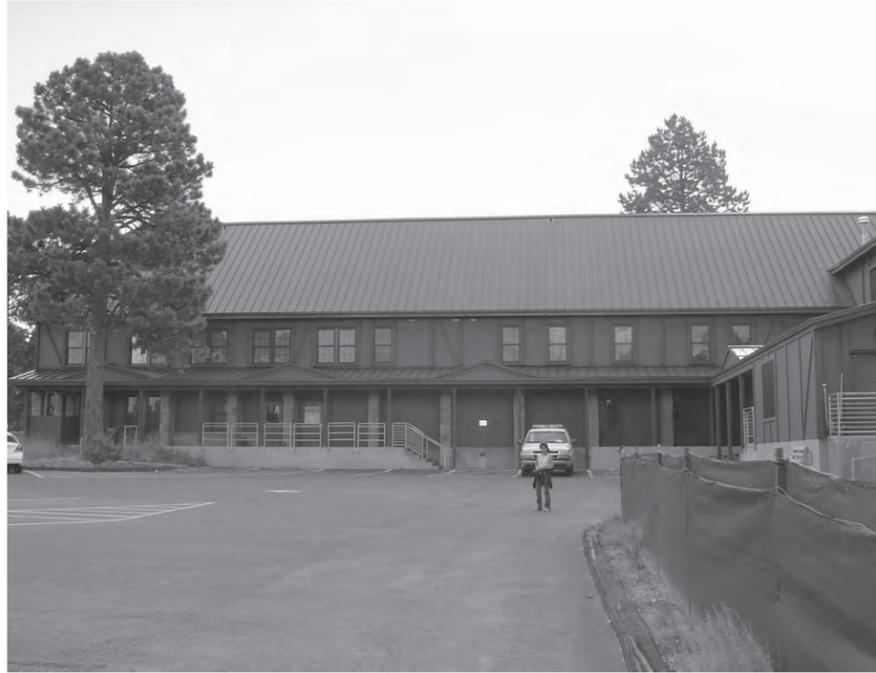
Photograph VC/13. Visitor Center B-1 - west facade.

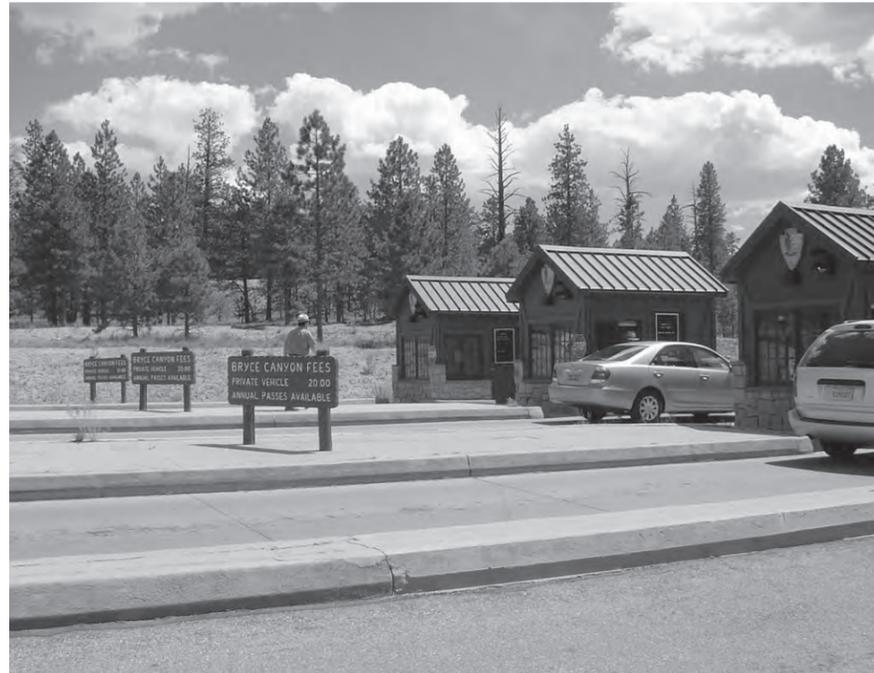
Photograph VC/14. Entrance Station Kiosks B-2, B-3 and B-4.

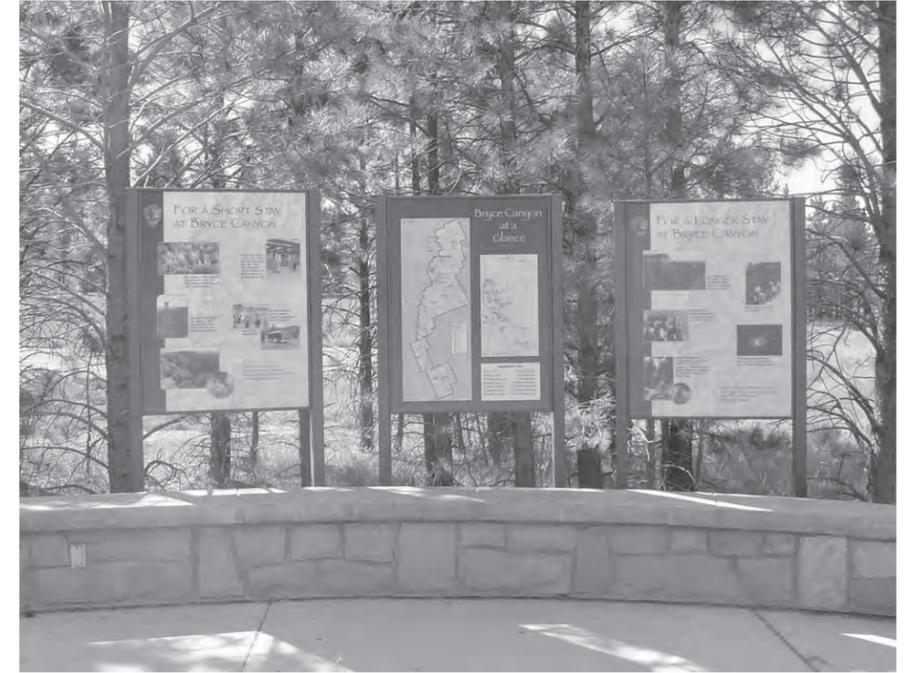
Photograph VC/15. Interpretative signs south of the Visitor Center.

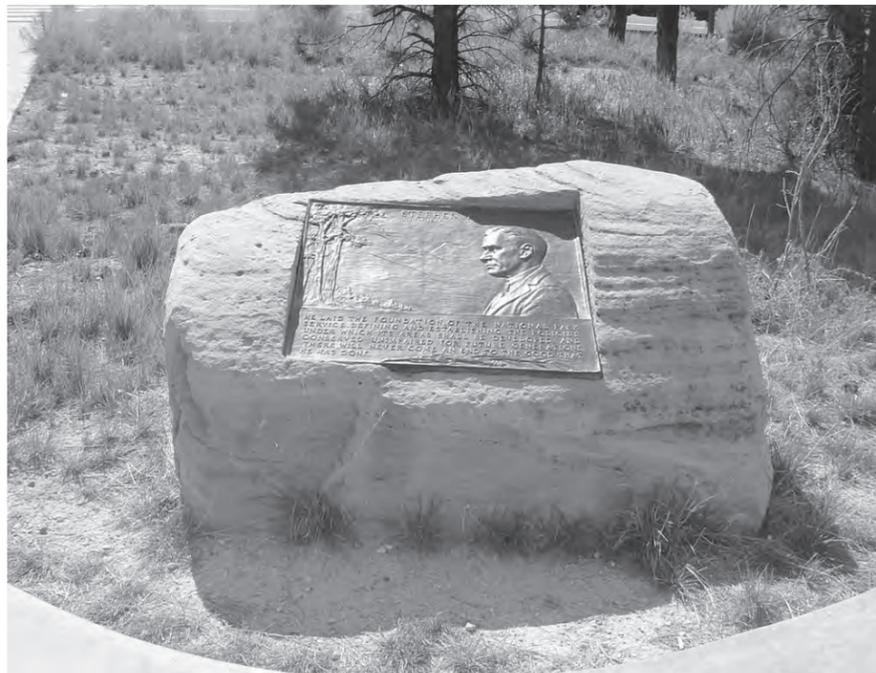
Photograph VC/16. Interpretative sign south of the Visitor Center.

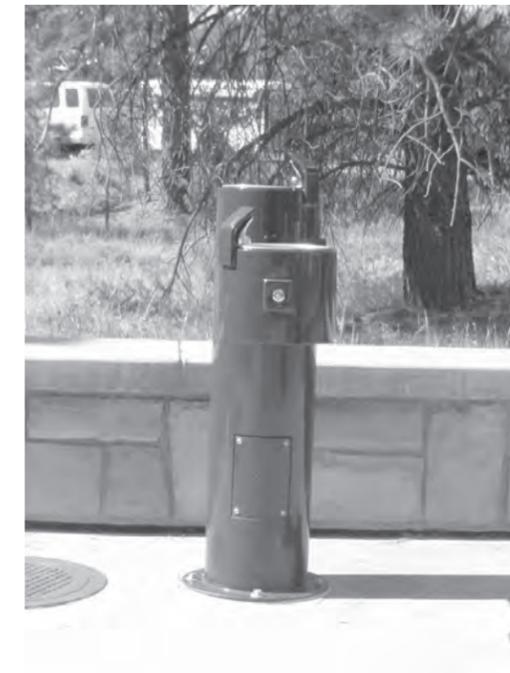
Photograph VC/18. Water fountain placed at south entrance of Visitor Center.

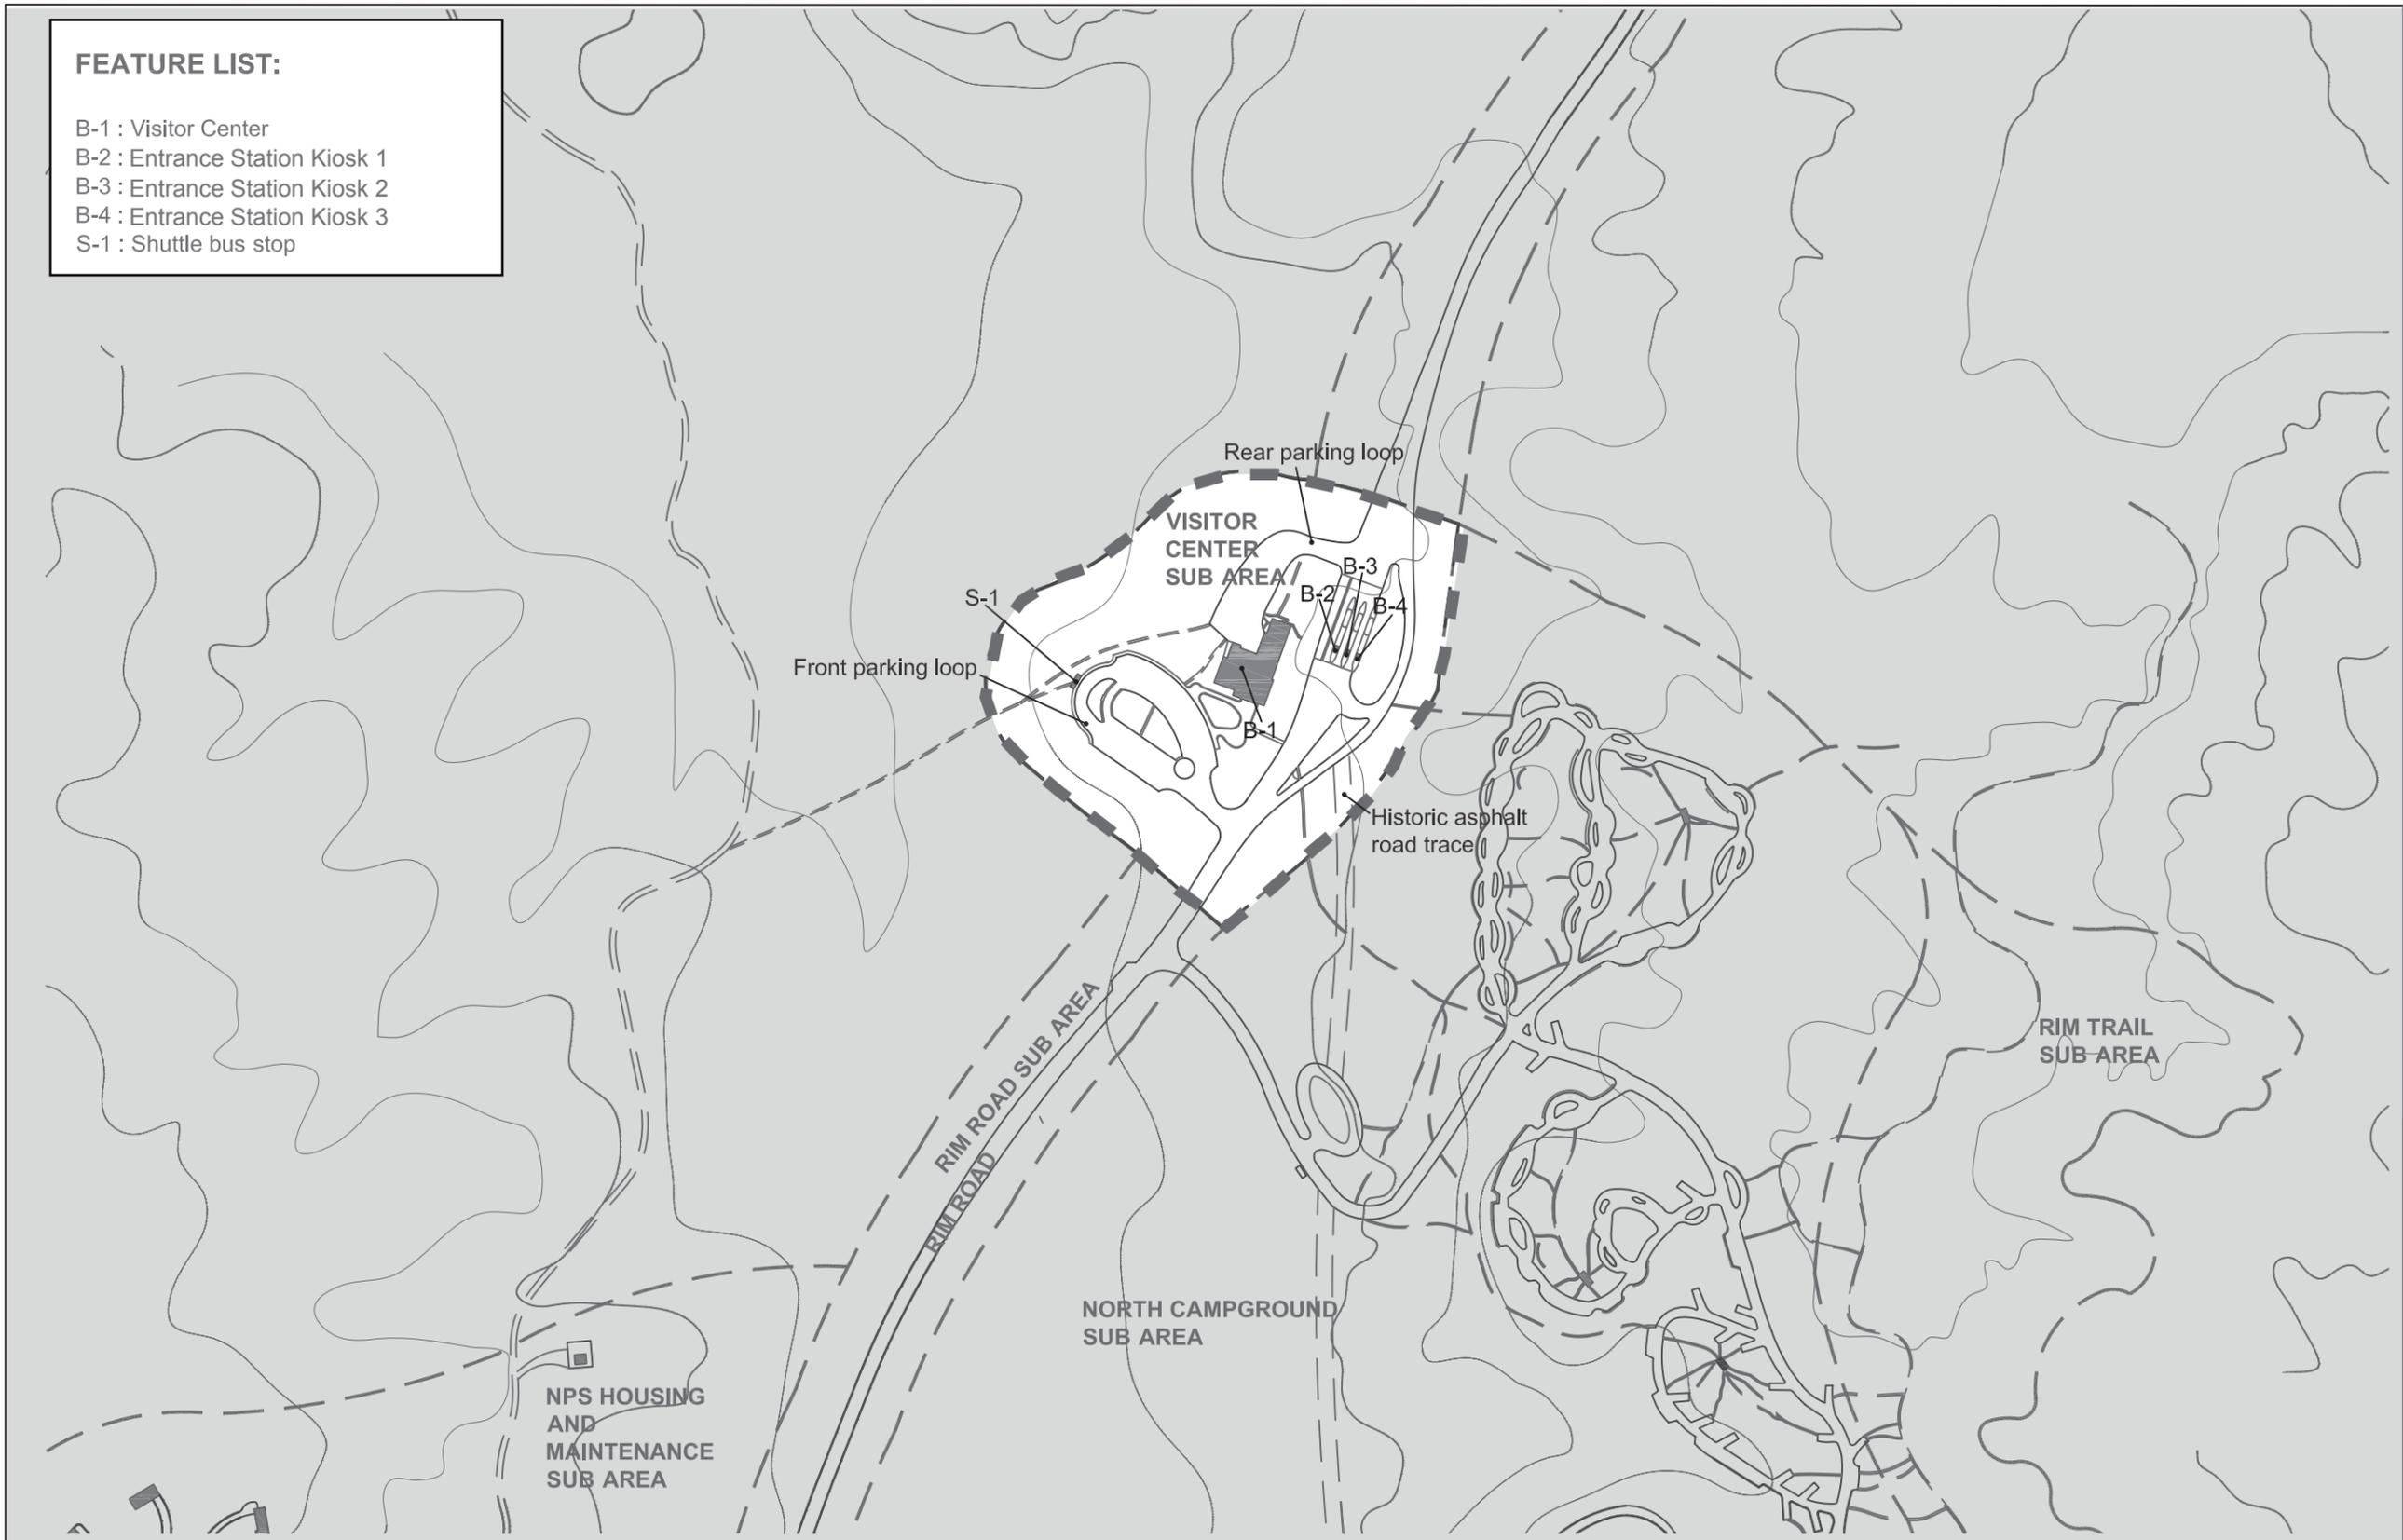
KEY PLAN :
SUB AREA: VISITOR CENTER

- B-1 : Visitor Center
- B-2 : Entrance Station Kiosk 1
- B-3 : Entrance Station Kiosk 2
- B-4 : Entrance Station Kiosk 3
- S-1 : Shuttle bus stop

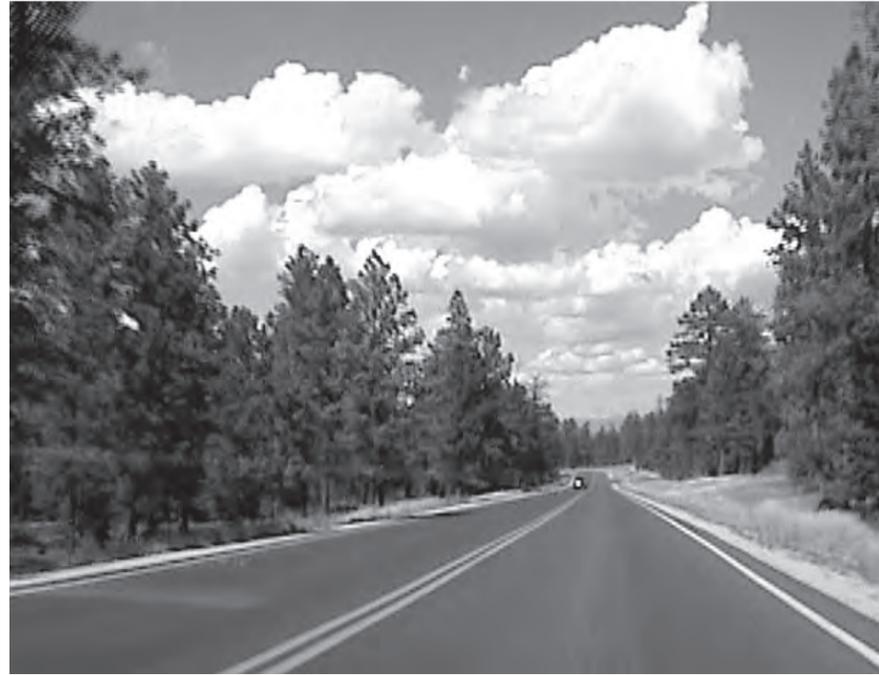
Photograph RR/1. Rim Road with forested edge on either side.

The vegetation here is similar to that found in other Sub Areas west of the plateau rim, predominantly Ponderosa Pine Forest with openings into Sagebrush Meadows (*Photograph RR/1*). The Road encounters a number of meadows of different size as it moves through the Developed Area, each providing important viewing of wildlife such as the Utah Prairie Dog and deer (*Photograph RR/2*). Pullouts have been placed along side the roadway in some of the more popular viewing areas, some accompanied with interpretive signage.

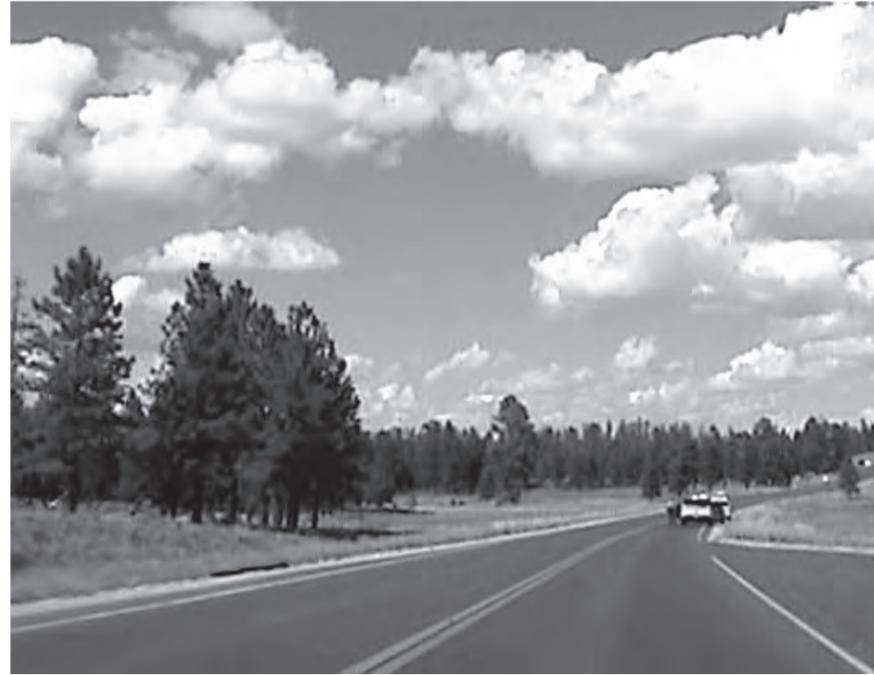
Photograph RR/2. Rim Road with open meadows on either side and pull-off in foreground.

The Rim Road is a 23-24' wide graded two-lane parkway with 3' shoulders that vary from grass to gravel. It serves as a spine for the greater circulation system of the Park, with spurs branching off to the east and west providing access to each of the Study Areas and Contextual Sub Areas. In this way, the Rim Road ties together the separated elements of the Developed Area. The only feature found along the Rim Road that does not relate directly to another Sub Area or activity zone is the Entrance Sign and its associated parking area (*Photograph RR/3*). This feature, located just inside the north entrance to the Park, provides a unique photo opportunity with a specially placed "photo-stand" that allows visitors to take group pictures in front of the Entrance Sign.
