BRYCE CANYON NATIONAL PARK: OLD NPS HOUSING AND BRYCE CANYON LODGE CULTURAL LANDSCAPE REPORT

**BRYCE CANYON NATIONAL PARK: BRYCE CANYON LODGE DISTRICT
AND HISTORIC NATIONAL PARK SERVICE HOUSING DISTRICT
CULTURAL LANDSCAPE REPORT**

**UNIVERSITY OF ARIZONA COLLEGE OF ARCHITECTURE, LANDSCAPE ARCHITECTURE AND PLANNING
SCHOOL OF LANDSCAPE ARCHITECTURE AND PRESERVATION STUDIES PROGRAM**

December 2008

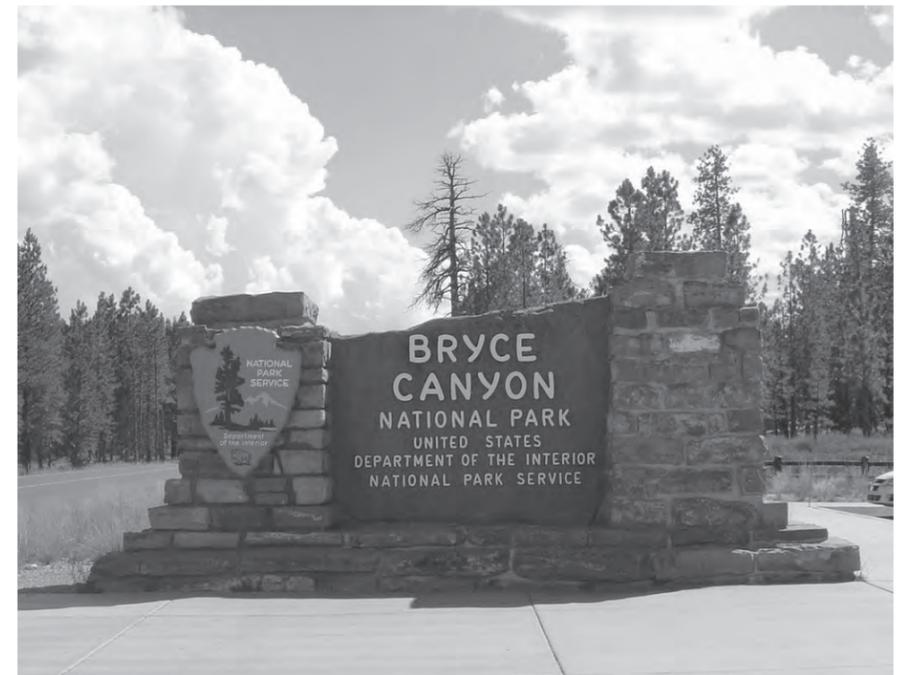
Photograph RR/6. Park Entrance Sign at the north boundary.

Several types of signage exist within the Rim Road Sub Area: Park identification, directional, traffic and interpretive. While majority of the signs follow rustic typology and are made of wood, evidences of contemporary metal signage can also be seen. The **Park Entrance Sign** (*Photograph RR/6*) is located right at the northern Park boundary. Constructed in the rustic style in 1963, the sign is a roughly-finished, darker-color stone slab encased within stout piers of lighter-color, coursed-rubble stone masonry. The "photo-stand" in front of the sign is constructed of similar course-rubble stone masonry, and is located to support cameras for those wishing personal pictures with the sign. **Secondary barriers** or wood-log fences (*Photograph RR/7*) and **concrete curbing** (*Photograph RR/8*) are found at various places to define the Road edge. **Metal and rock culverts** and drainage gullies also exist along the Road length (*Photograph RR/10*).

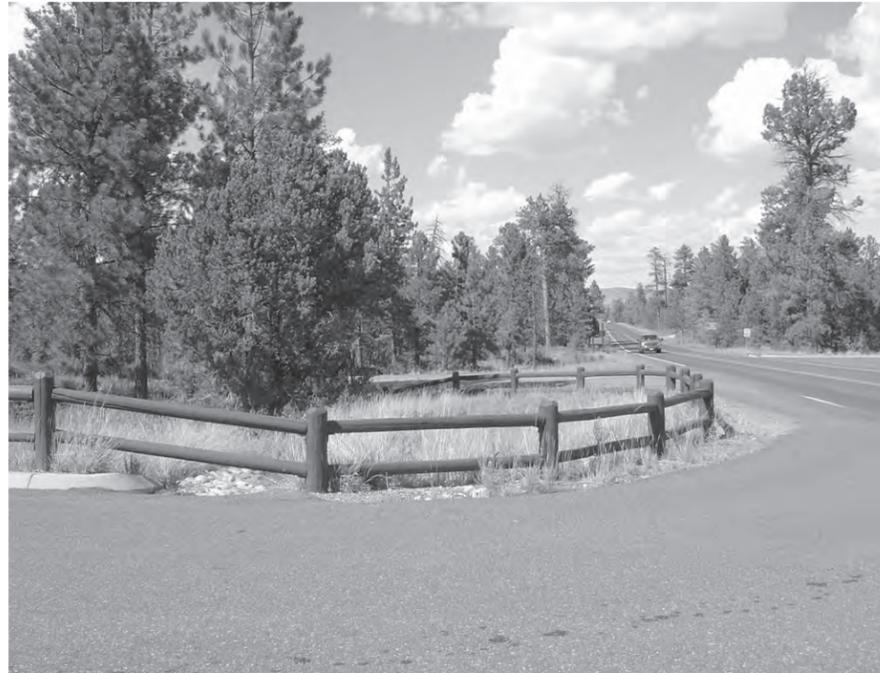
Photograph RR/7. Wood-log fence defining Rim Road edge.

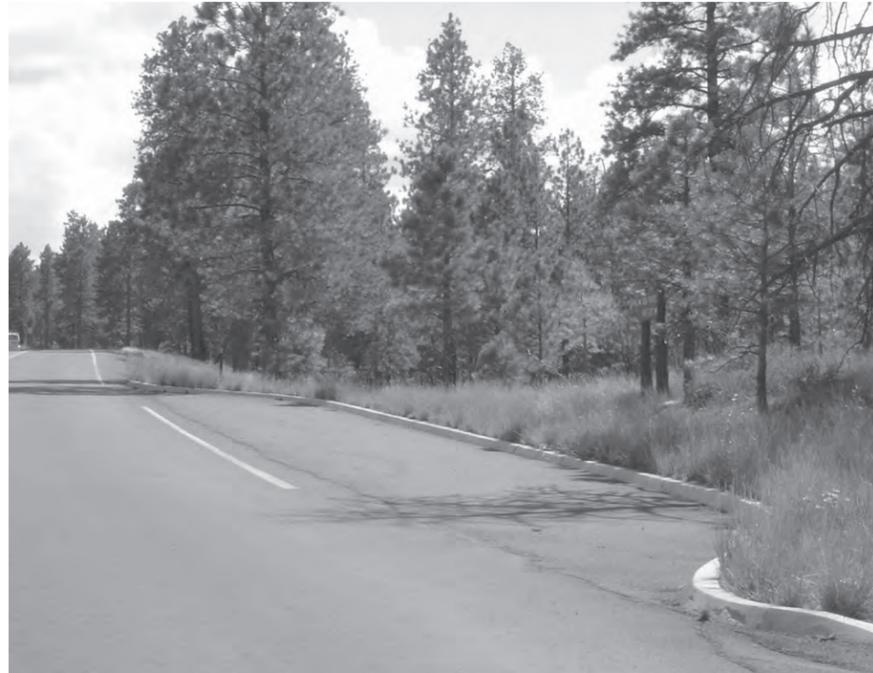
Photograph RR/8. Concrete curbing along pull off on Rim Road.

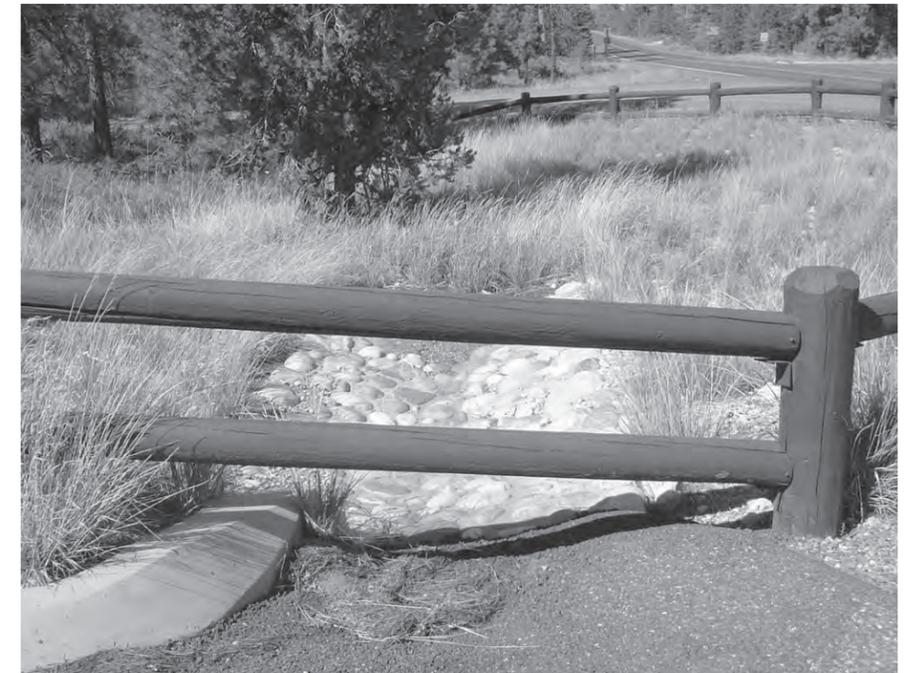
Photograph RR/9. Drainage gully along Rim Road.

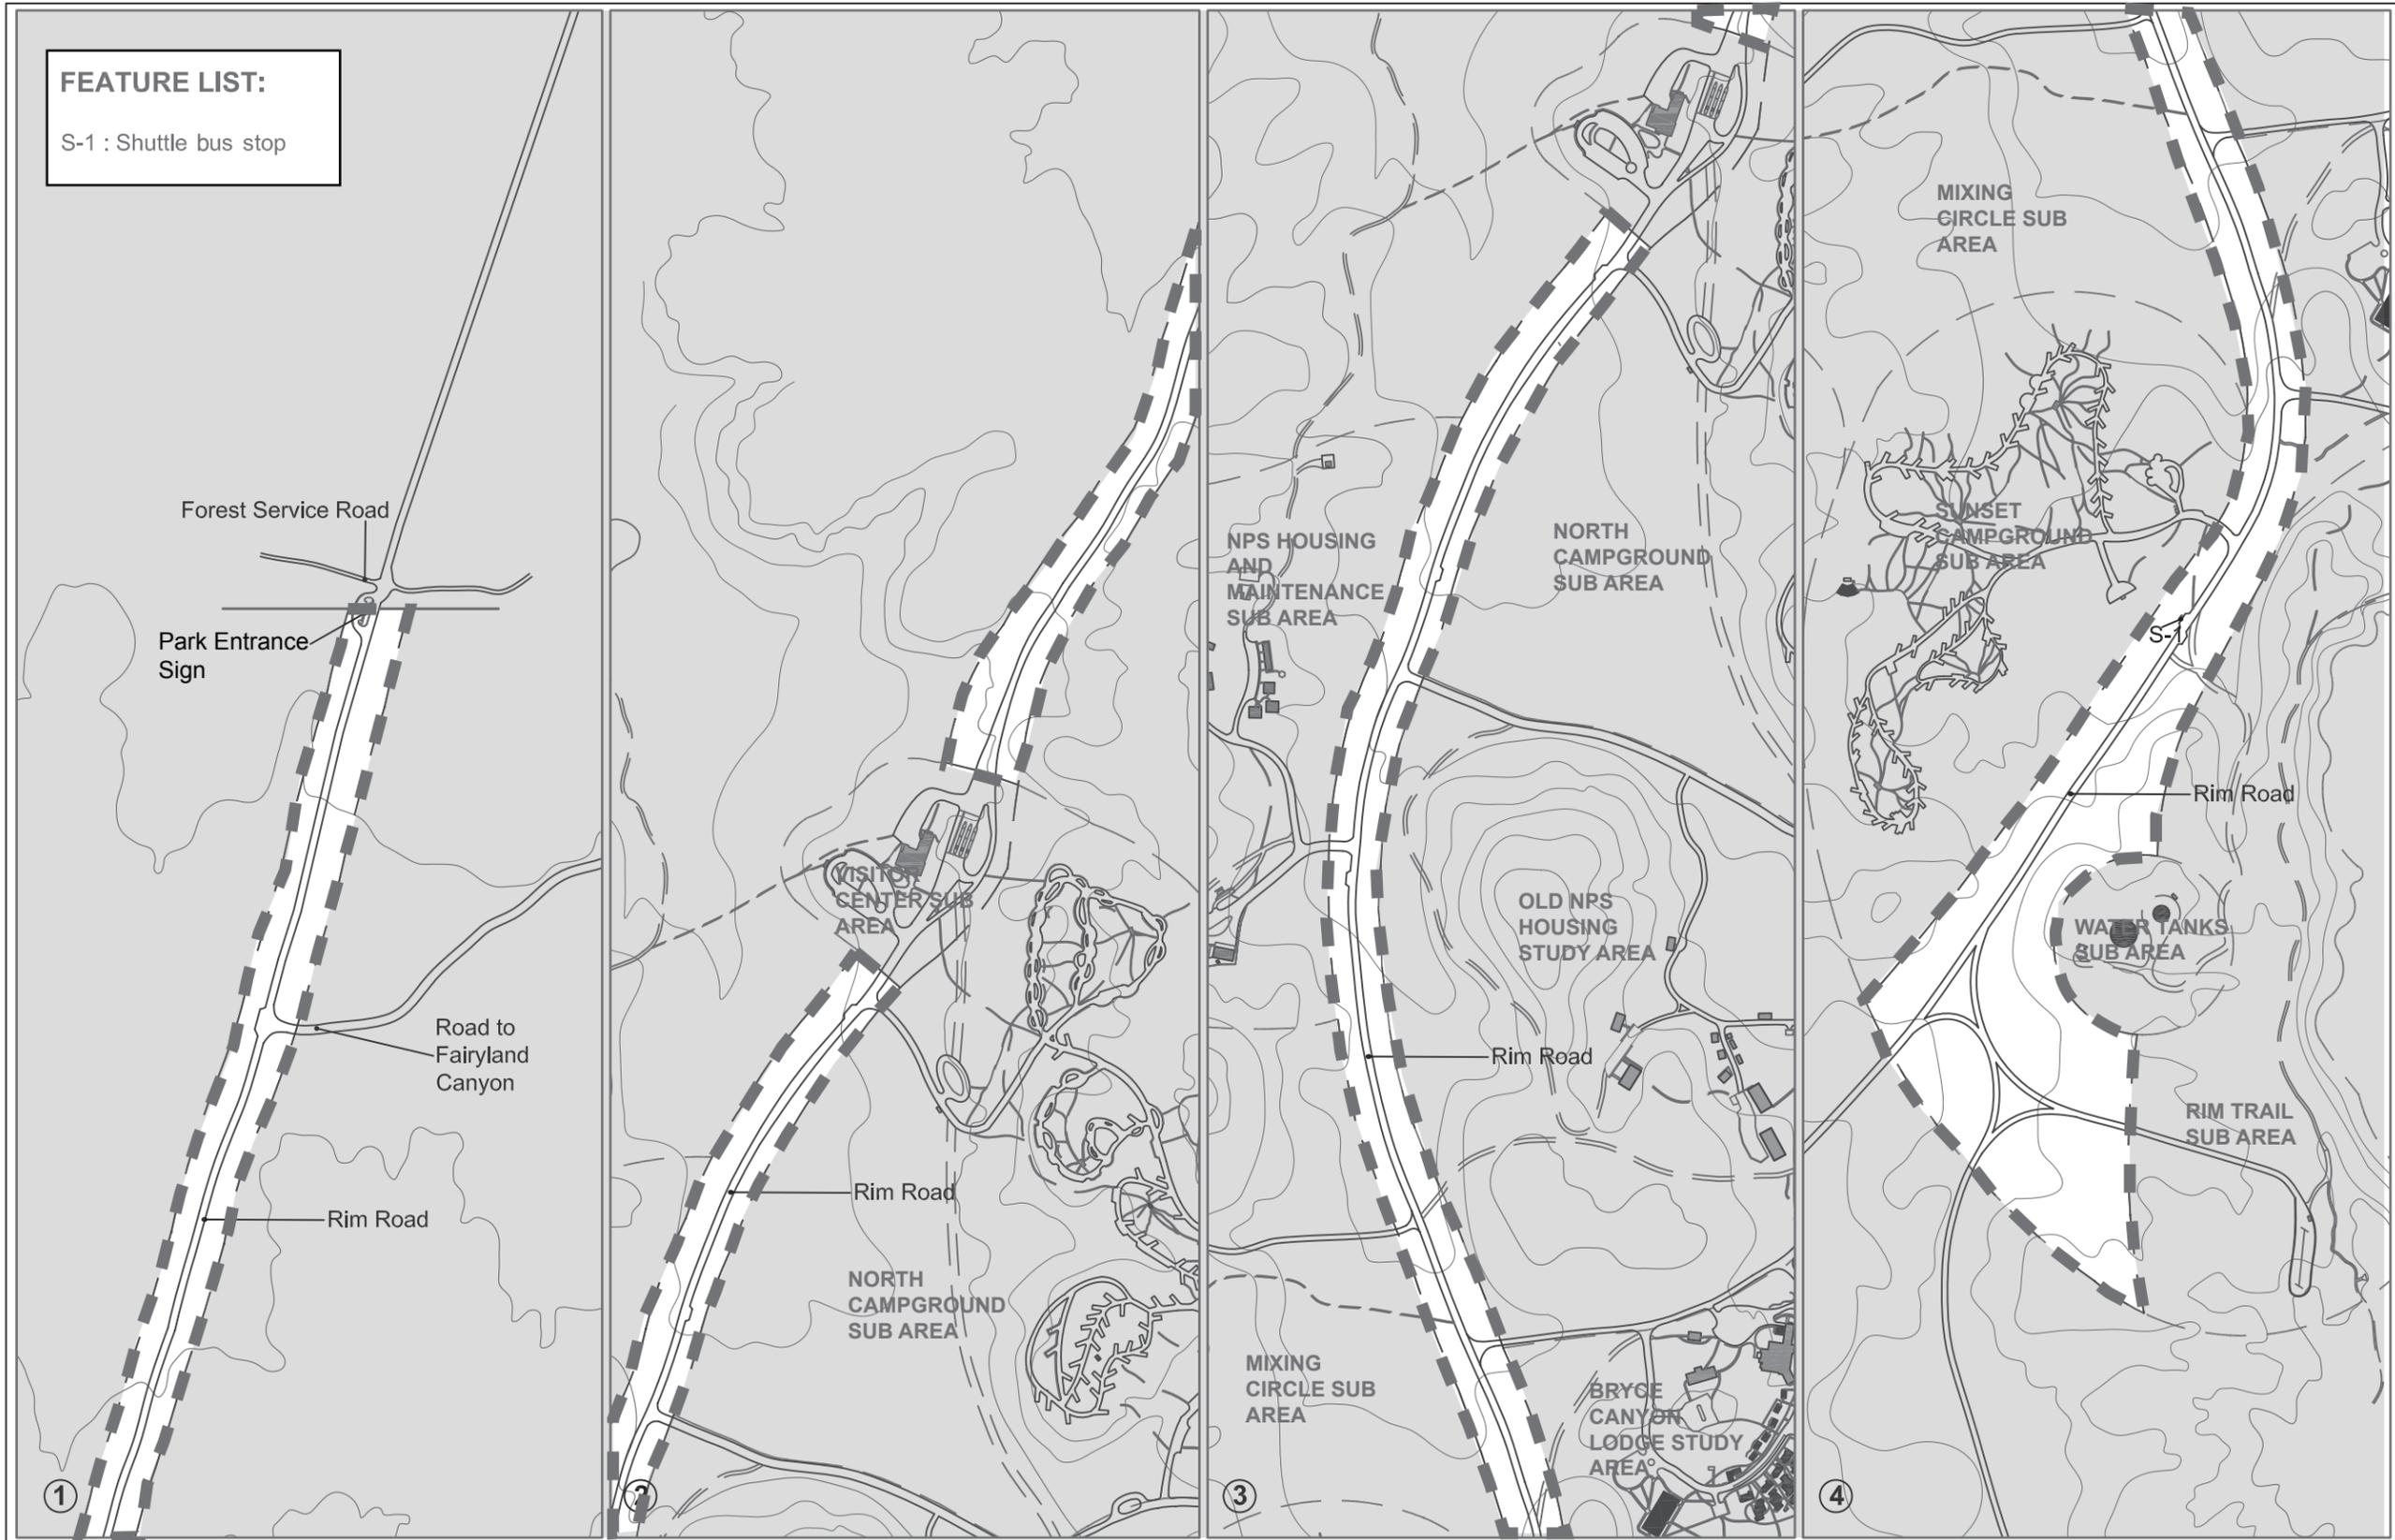
KEY PLAN :
SUB AREA: RIM ROAD

S-1 : Shuttle bus stop

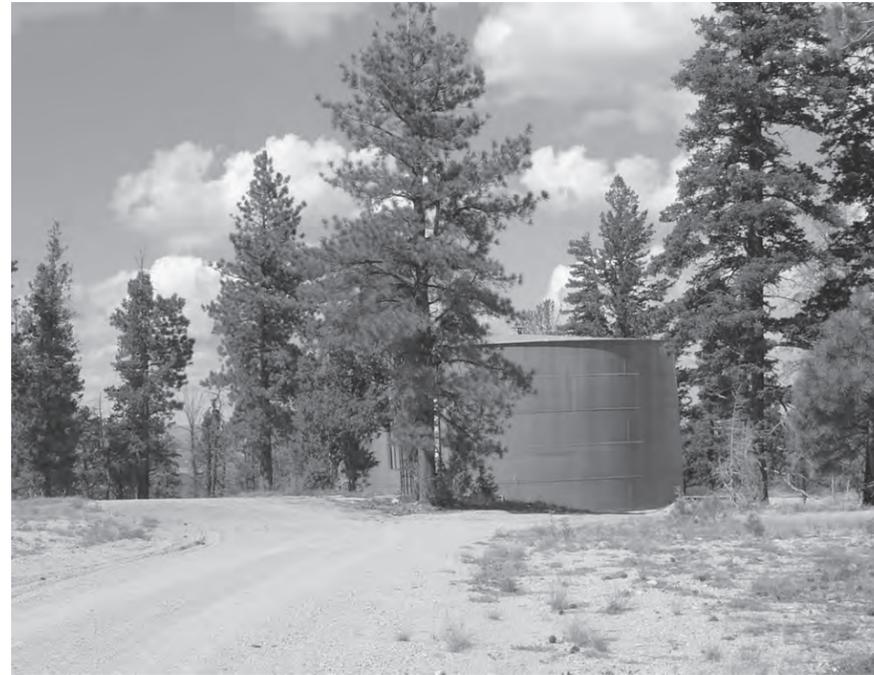
Photograph WT/5. Small water tank S-1.

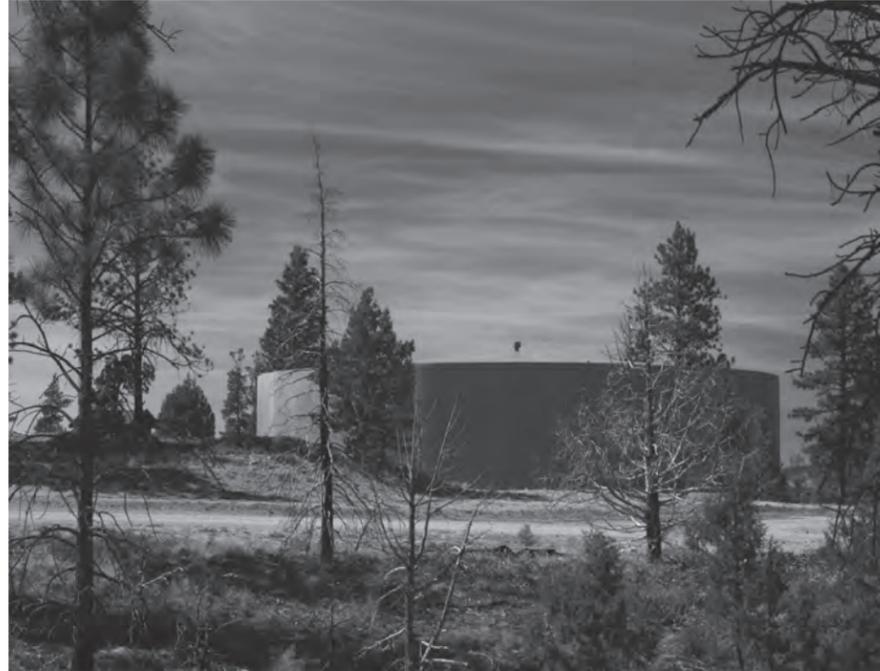
Photograph WT/6. Water tank S-2.

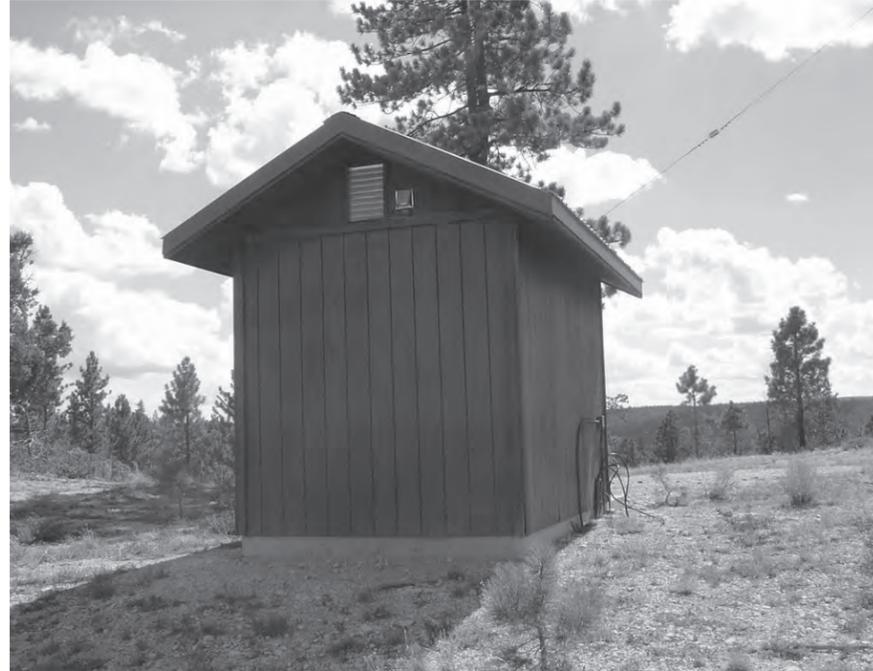
Photograph WT/7. An example of the other structures surrounding the water tanks.

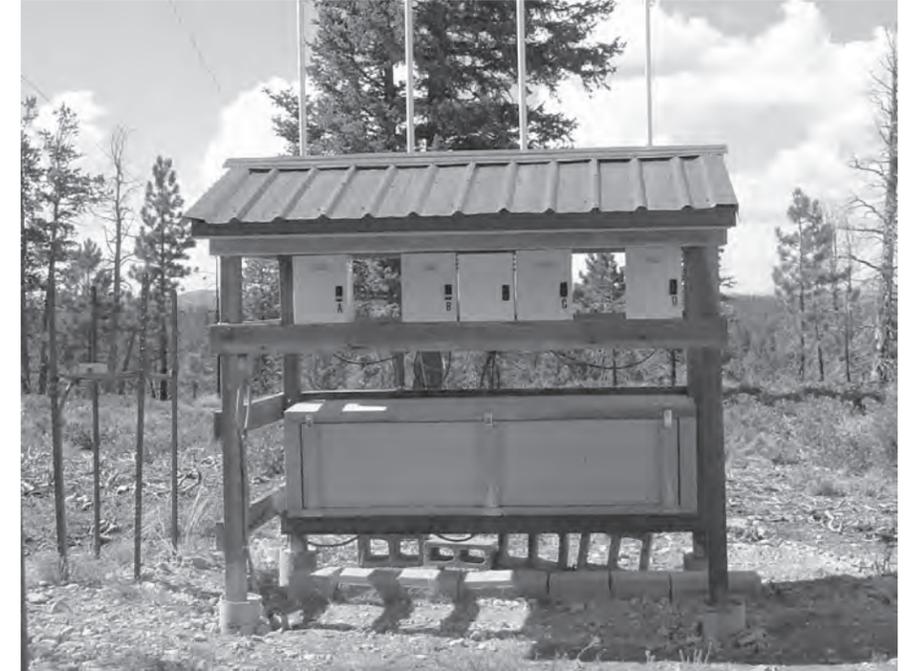
Photograph WT/8. Air quality monitoring equipment B-1 and B-2.

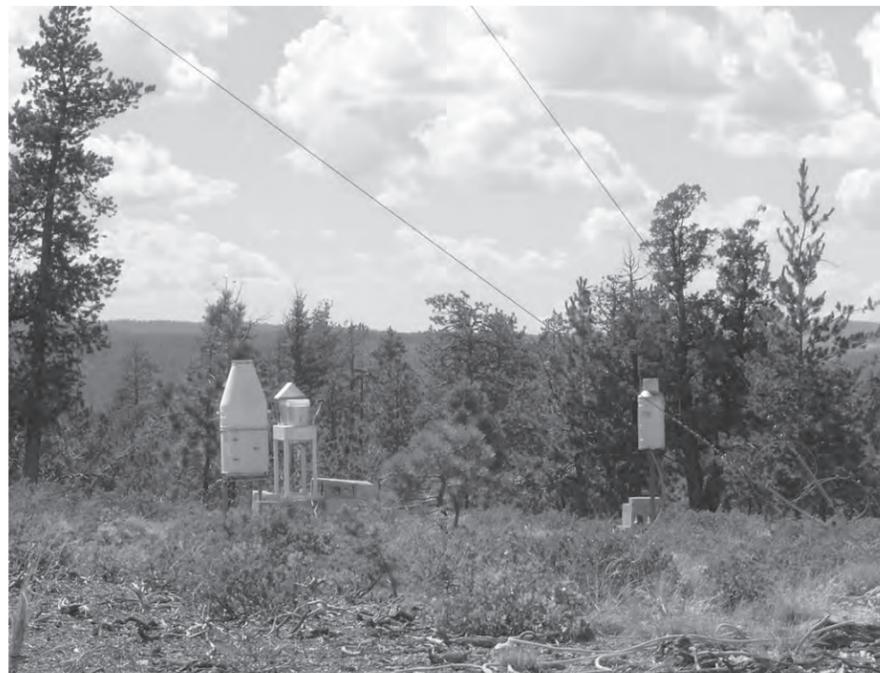
Photograph WT/9. Small-scale features (air quality monitoring equipment) S-3.

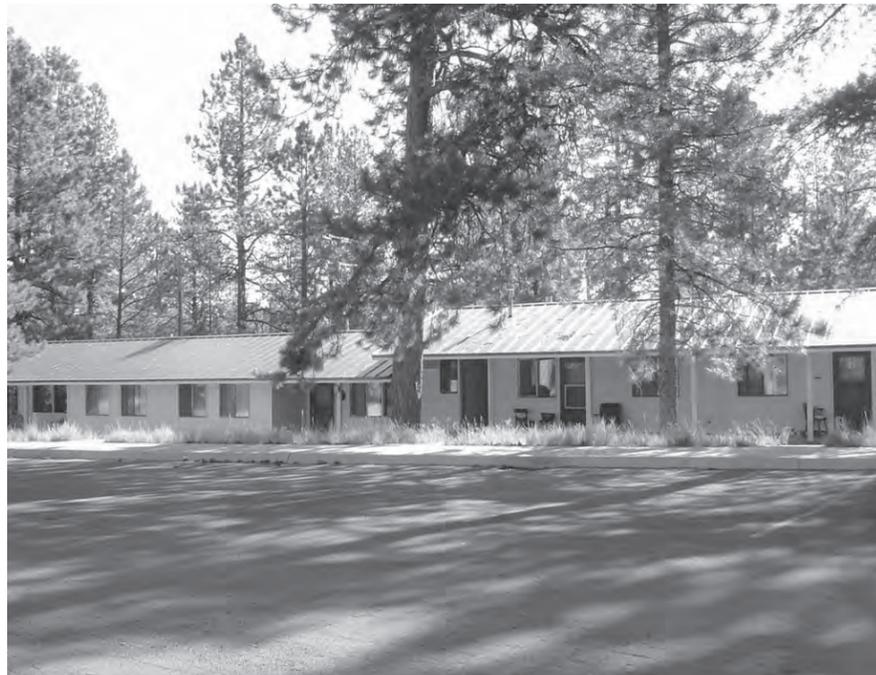
Photograph MH/8. Multi-Unit Apartment B-2 west facade.

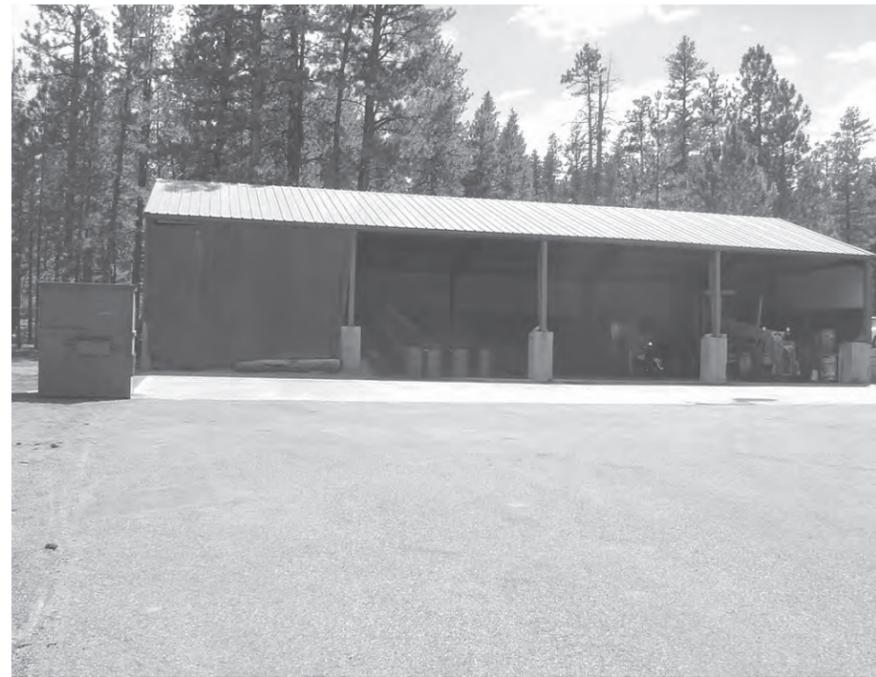
Photograph MH/12. Maintenance Garage B-5 north facade.

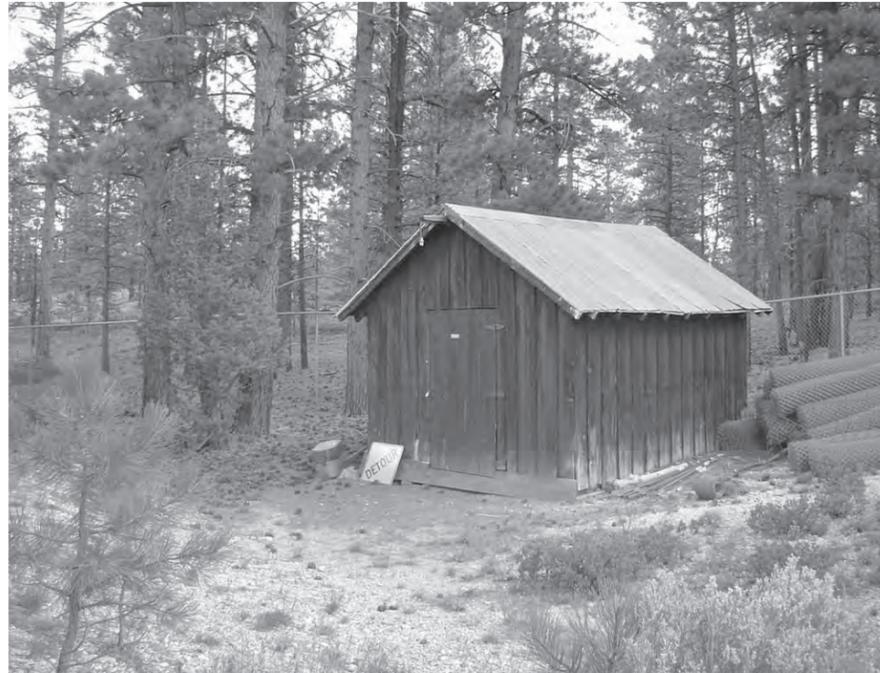
Photograph MH/13. Oil House B-6 (HS-39) -- view from northwest.

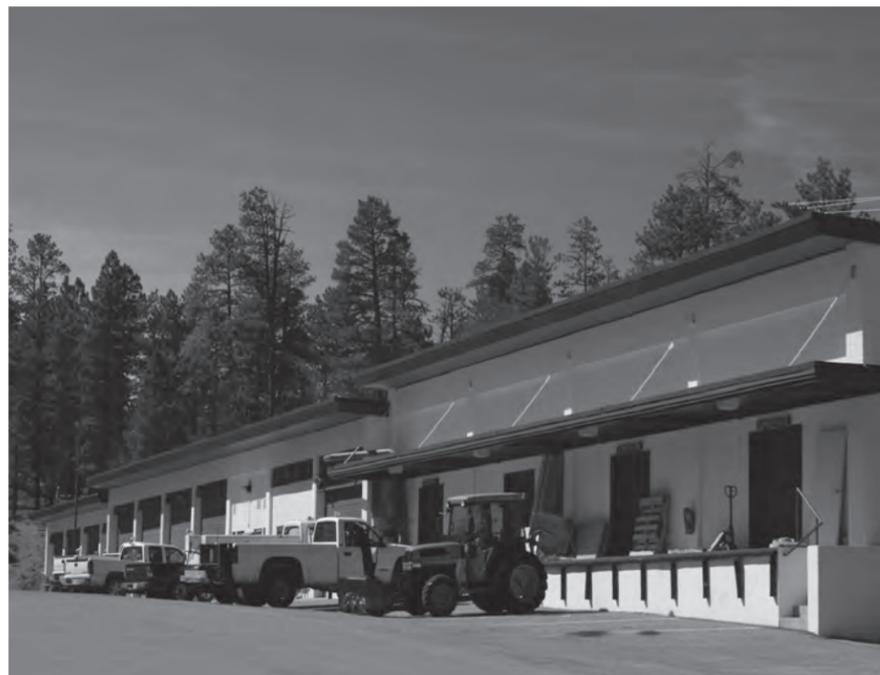
Photograph MH/16. Utility Building/ Warehouse B-9 south facade.

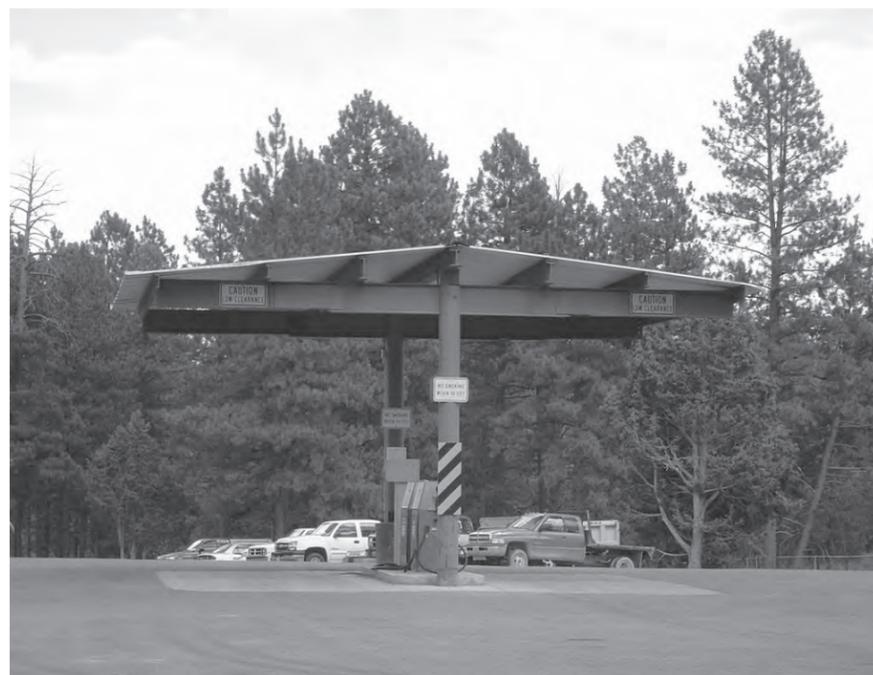
Photograph MH/17. Gas Fueling Station S-12.

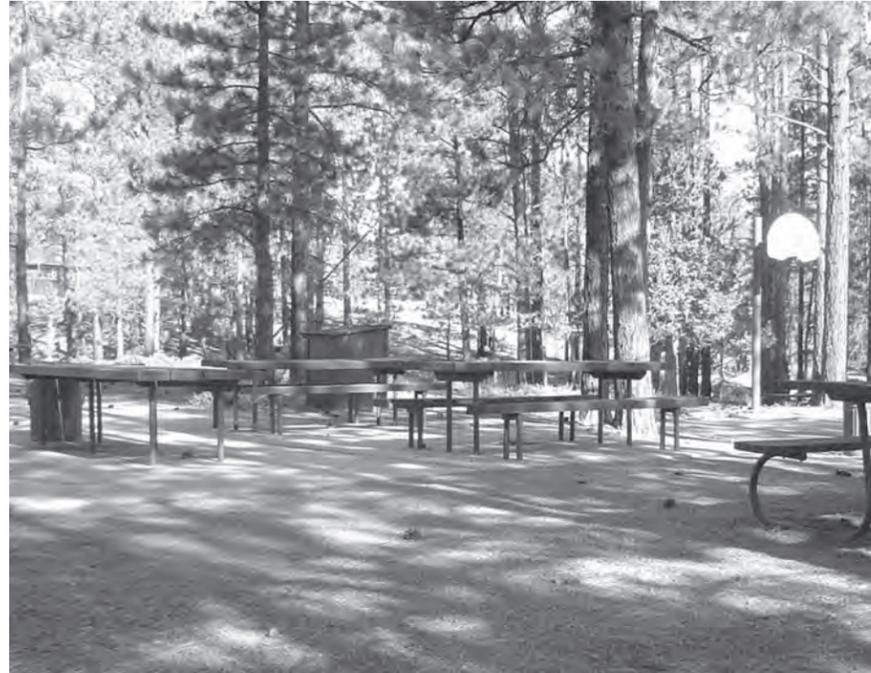
Photograph MH/20. Picnic/Playground area to the north of the apartment node.

The Picnic/Playground area houses a number of picnic tables, barbecue grills and two basketball hoops (*Photograph MH/20*). A smaller **play area** in the center of the main housing loop has a metal play set (*Photograph MH/21*).

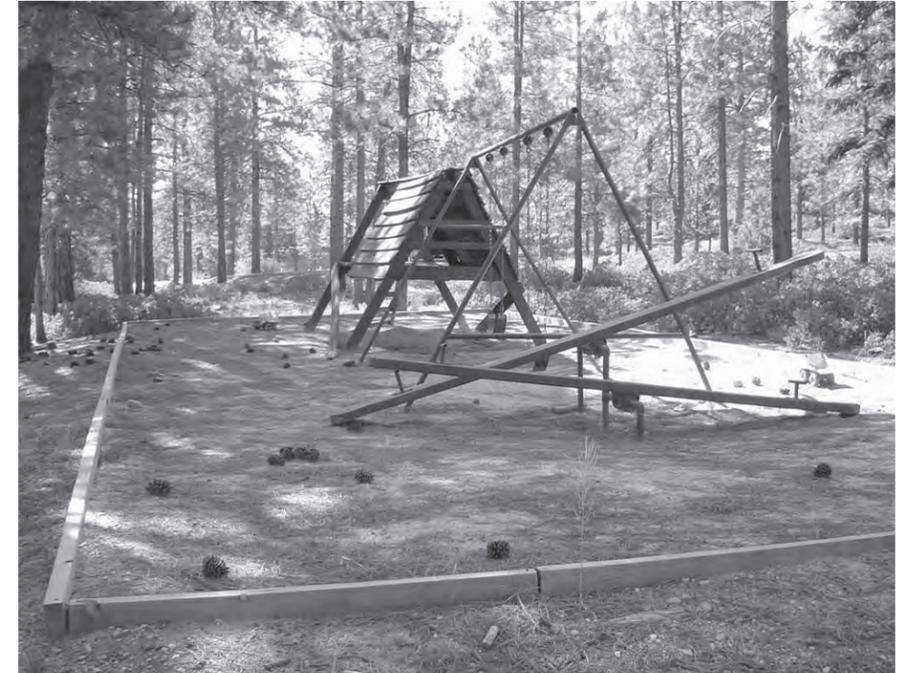
Photograph MH/21. Children's play area located within the main housing loop.

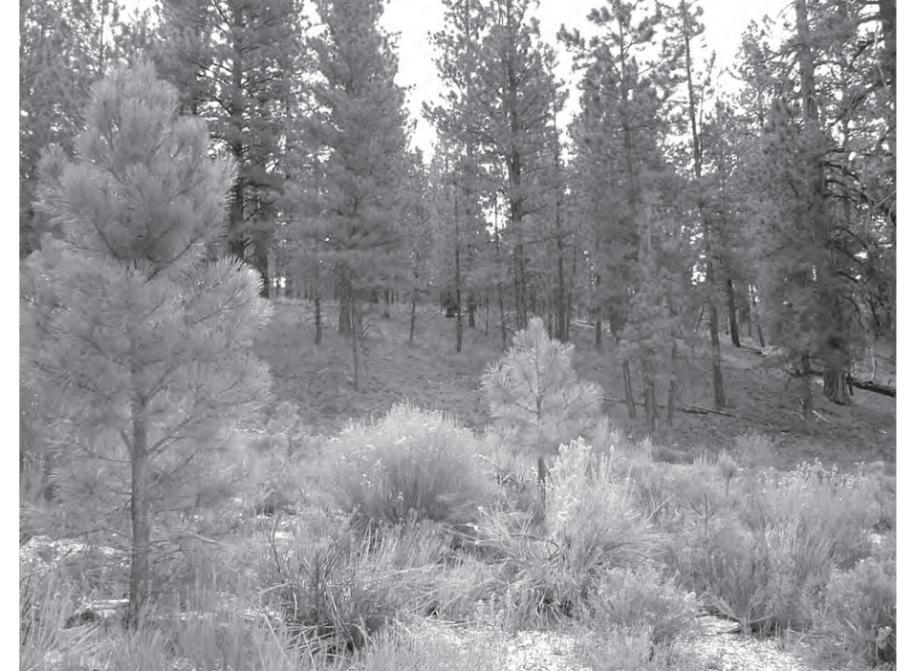
Photograph MC/3. The transition point from meadow to forested slopes.

The forest on the hills surrounding the meadows is typical of that found elsewhere in the Developed Area, dominated by Ponderosa pine, with an understory of manzanita, bitterbrush and other mixed shrubs and grasses (*Photograph MC/3*).

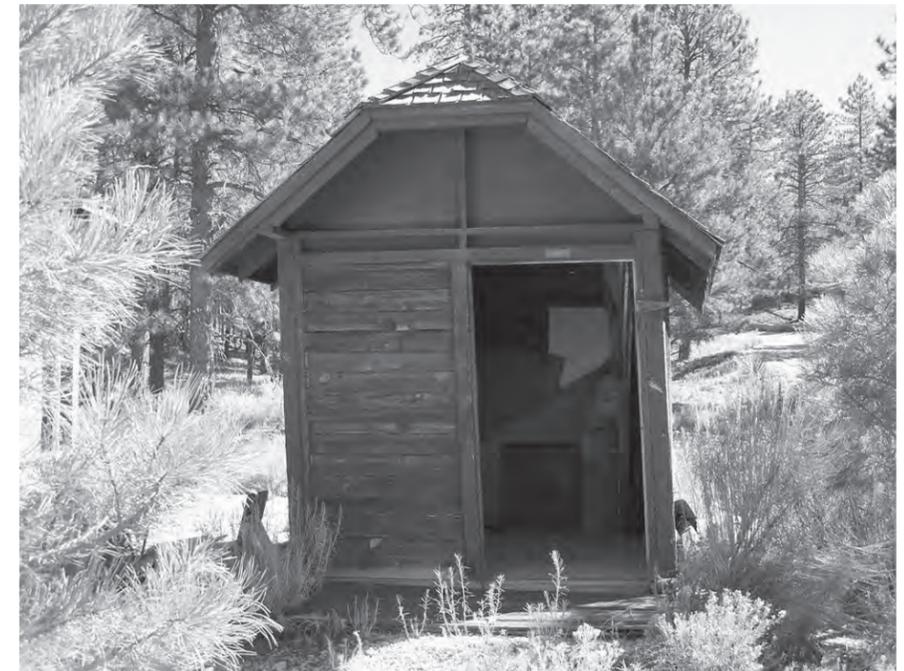
Photograph MC/6. Ice House B-3 (HS-71) looking east.

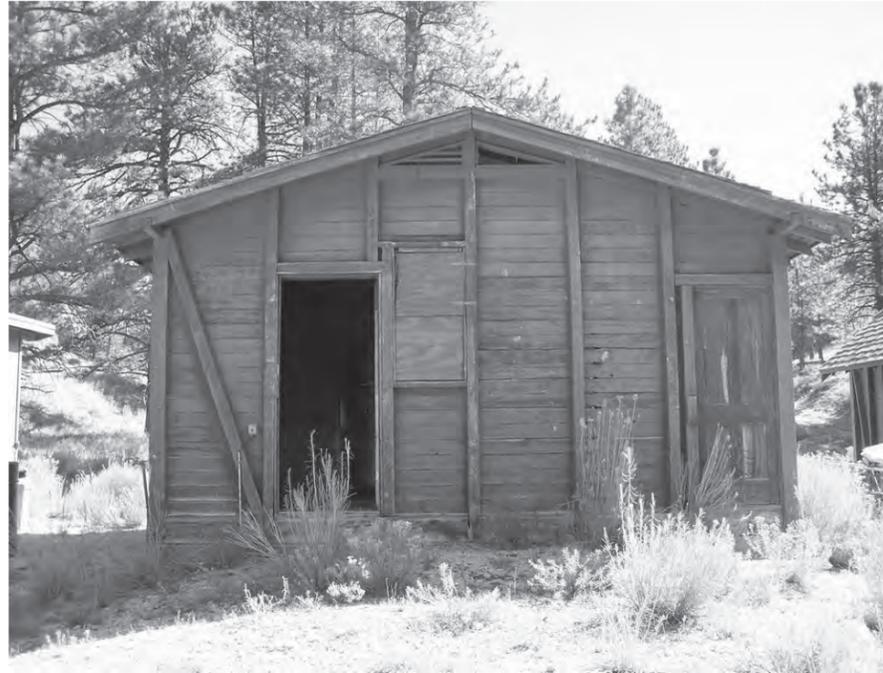
Photograph MC/7. Linen House B-2 (HS-72) looking east.

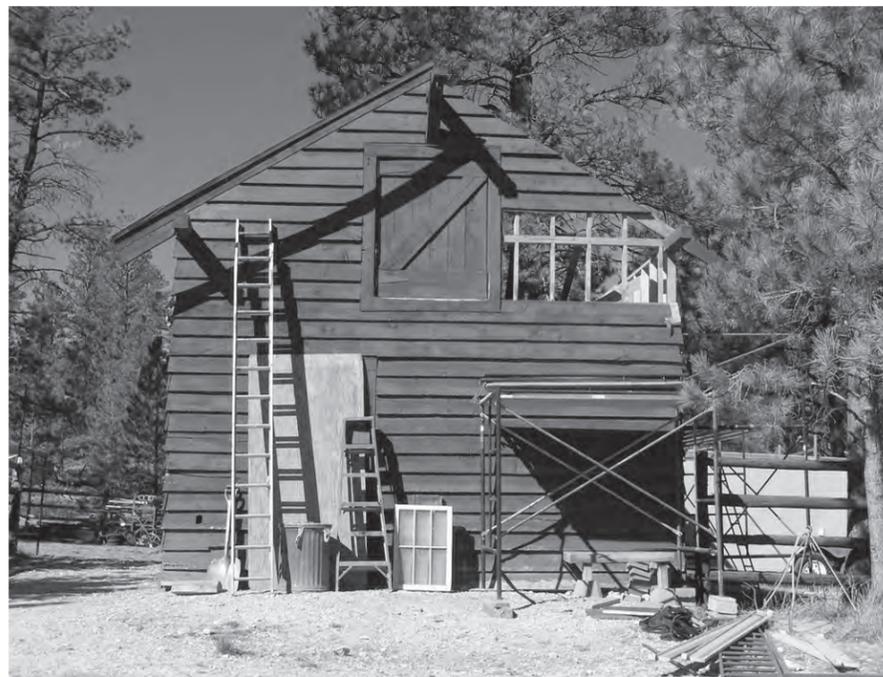
Photograph MC/10. NPS Horse Barn B-6 (HS-48) looking west.

The **NPS Horse Barn B-6** (HS-48) was constructed between 1929 and 1935 and is located along the outer dirt loop of the mixing circle to the west of the Metal & Utility Buildings described earlier. It was moved to this location circa 1965 from its original location in the old NPS Utility Area west of the Old NPS Housing Complex. The building is on the National Register of Historic Places. This one-and-a-half story rectangular wood frame building is constructed on a concrete foundation. Exterior walls are covered with 12" weatherboard siding, painted brown (*Photograph MC/10*). The interior of the structure was remodeled circa 1990-1992 into a maintenance shop. The gable roof of the building has been undergoing repair and replacement since 2005.

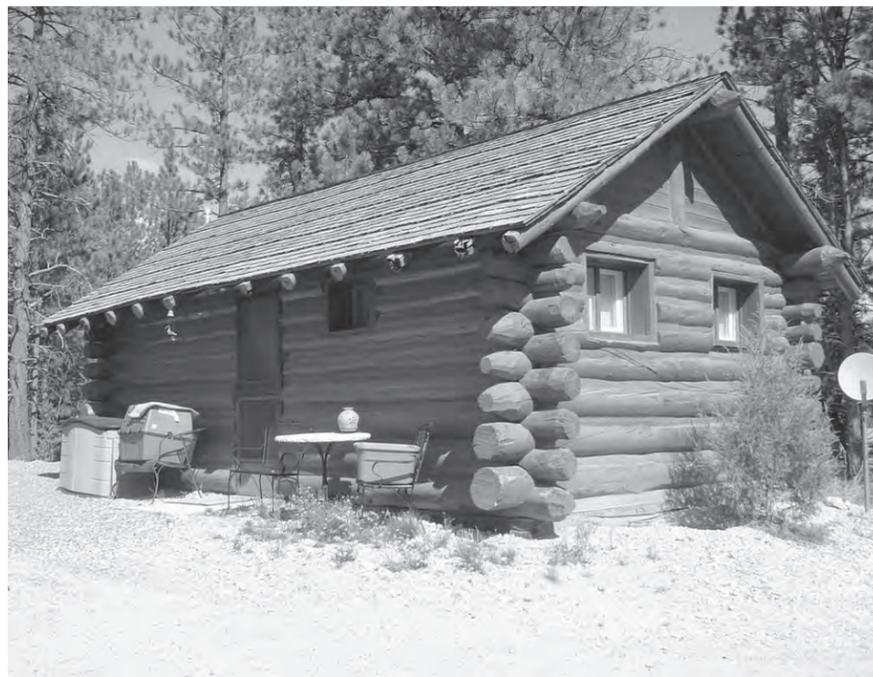
Photograph MC/11. Old Sunset Point Comfort Station B-7 looking northwest.

The **Old Sunset Point Comfort Station B-7** is a one-story, rectangular log building joined at the corners with ventral saddle notches (*Photograph MC/11*). It is located slightly northeast of the NPS Horse Barn and was moved to this location in the 1980's from Sunset Point where it was replaced by a new, larger Comfort Station. It was originally constructed in 1934 by the CCC. Presently the structure exists as a remodeled residence used for concessionaire staff housing. West of the Mixing Circle Loop, a short driveway branches off the Main Road to the north to access the **Concessionaire's Horse Barn B-9** (HS-75). The main structure was constructed in 1928 by the UPC in a location directly west of the Bryce Canyon Lodge, and was subsequently moved to the Mixing Circle Sub Area in the late 1960's. The Barn has two major structural components—the eastern component has a front facing gable roof that is covered with corrugated metal; the northern component contains 24 horse

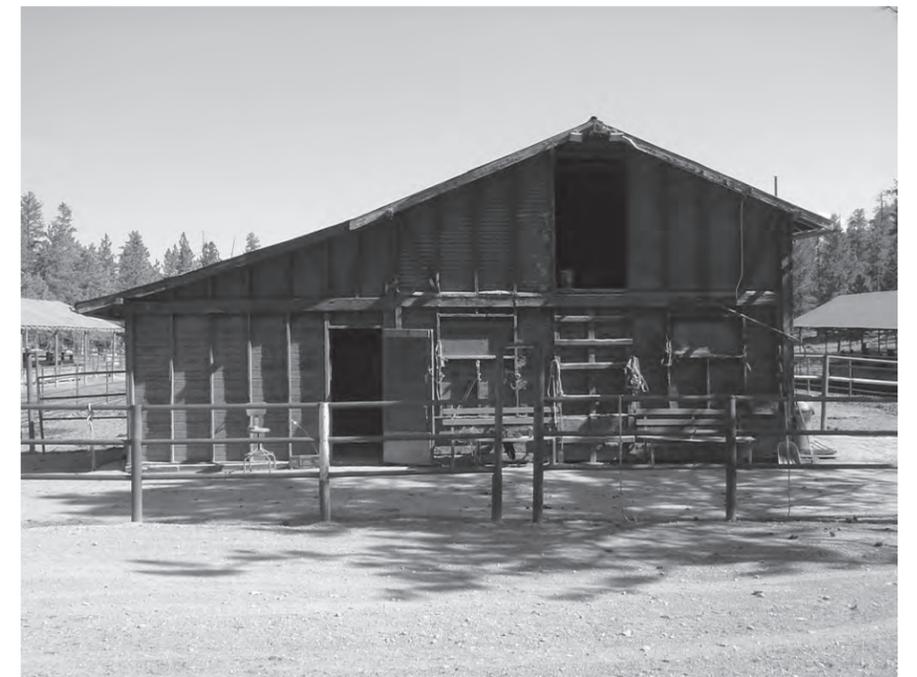
Photograph MC/12. Concessionaire's Horse Barn B-9 (HS-75) looking north.

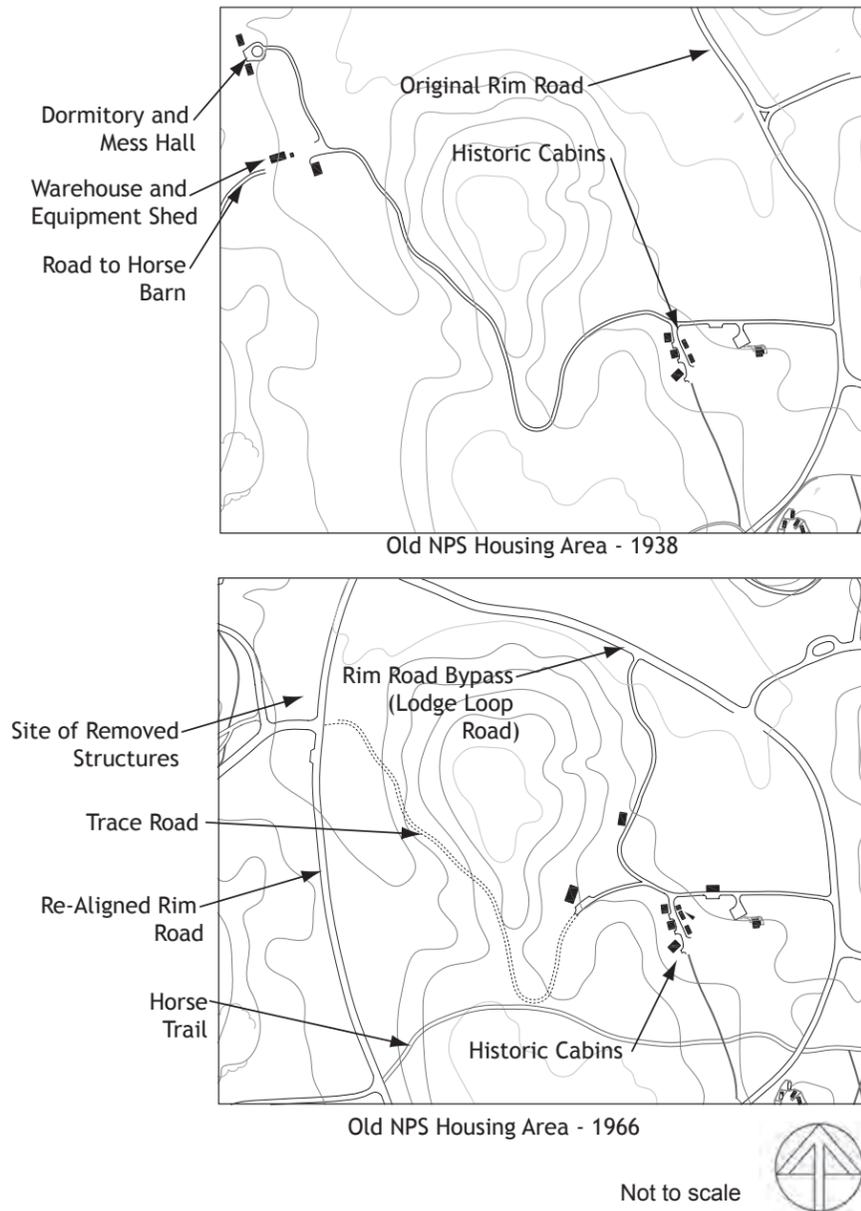
Figure 4-1.
Changes to Old NPS Housing Study Area with Realignment of Rim Road

During the period of significance, access to the Study Area was available from only one point directly off of the Rim Road north of the Lodge. This road continued past the residential area, over a low saddle between the knolls and continued on to the NPS maintenance area. At some point after 1955, a second access point was created when a road was installed around the northern edge of the knoll behind the housing area. With this alignment, it was no longer necessary to go through the main housing area to reach the maintenance and dormitory buildings to the west. When the Rim Road was realigned in 1958, creating the current route that bypasses the Lodge area, the direct vehicular connection between the housing and the maintenance area was eliminated and the maintenance area was moved (*Figure 4-1*). The portion of the road between the Ranger's Dormitory and the maintenance area was removed as well, though traces of it remain.

Two large parking areas, built after the 1980's, were added to accommodate the newer lodges. The parking adjacent to the Manzanita Lodge is essentially a widening of the old roadbed with parking along either side. This new dormitory unit is actually located on a low knoll, connected to the parking area by a wide staircase with 3 landings. The slope has been seeded with grasses in an attempt to return it to a natural appearance, but it is steeper than the surrounding, natural topography. The parking area adjacent to the new Concessionaire Dormitories is larger, and is bounded on one side by

a large retaining wall made of decorative concrete masonry units which holds back the hill slope that would have been present here. The material of the retaining wall is inconsistent with the native stone retaining walls seen in other parts of the Park. In addition to a difference of materials, both of these parking areas have proportions that are too large for the original small scale village atmosphere of the housing area (*Photograph A/1 and A/2*). These out of scale parking areas have increased traffic flow through the historic parts of the Study Area, particularly in front of the smaller cabins (B-5 and B-7-10). Within the period of significance, and before the construction of the Concessionaire's Dormitories, the small spur road that is aligned with the front of these cabins would have received only occasional vehicular traffic. The addition of the combined 40 space parking areas have significantly changed this traffic pattern resulting in degradation of the quiet village atmosphere – reducing the overall historic integrity of the area.

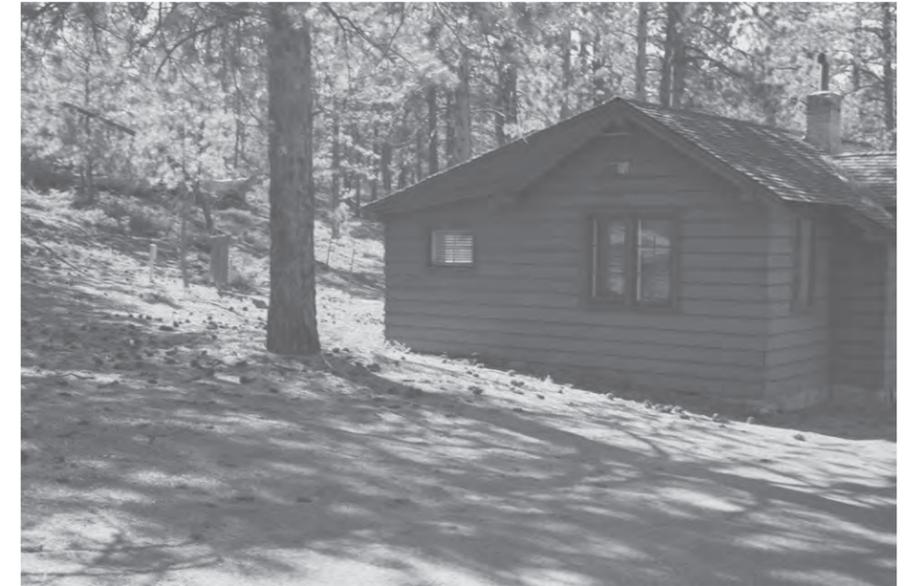
Photograph A/1. Small scale parking area near one of the historic cabins in the Old NPS Housing Study Area.

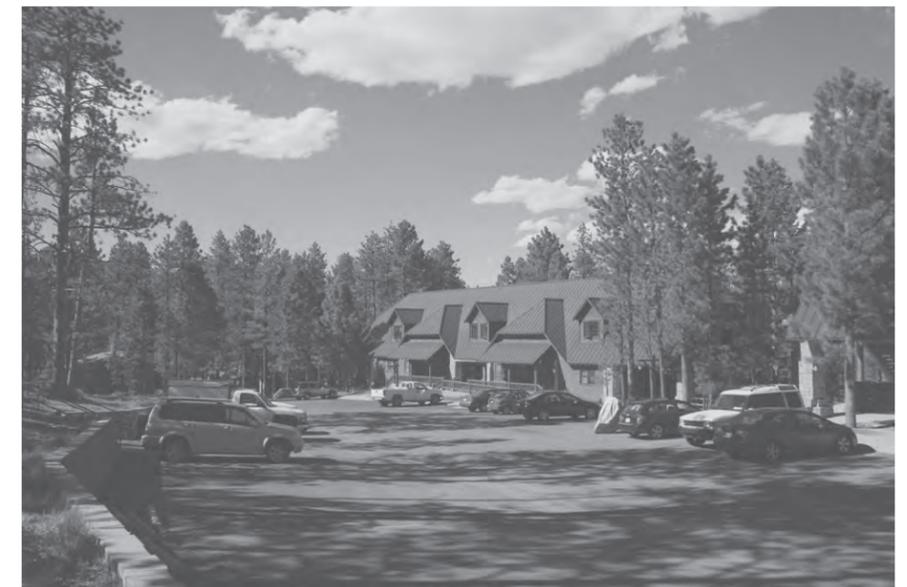
Photograph A/2. The large scale parking area in front of the new Concessionaire Dormitories in the Old NPS Housing Study Area.

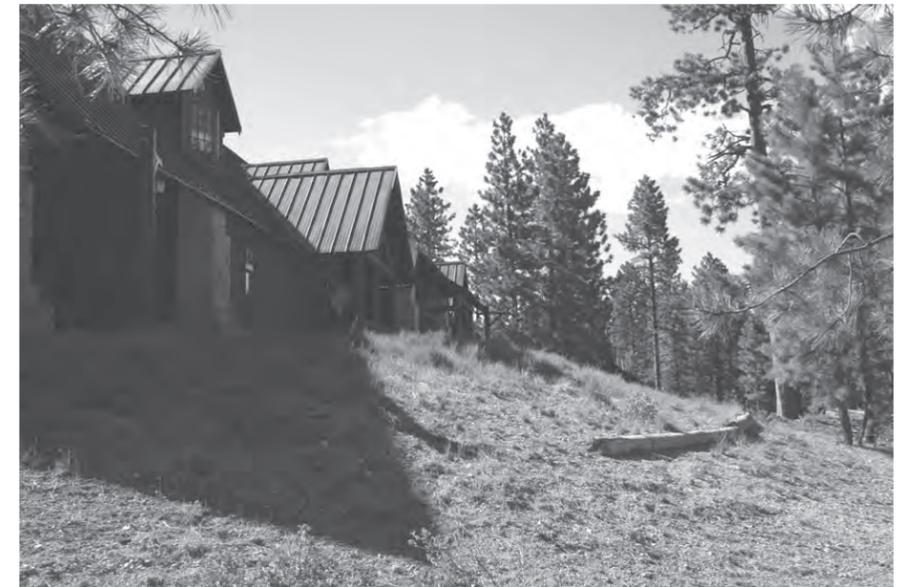
Photograph A/3. The fill area behind the Concessionaire Dormitories. Notice the lack of mature trees near the structure. No new trees have established themselves in this area.

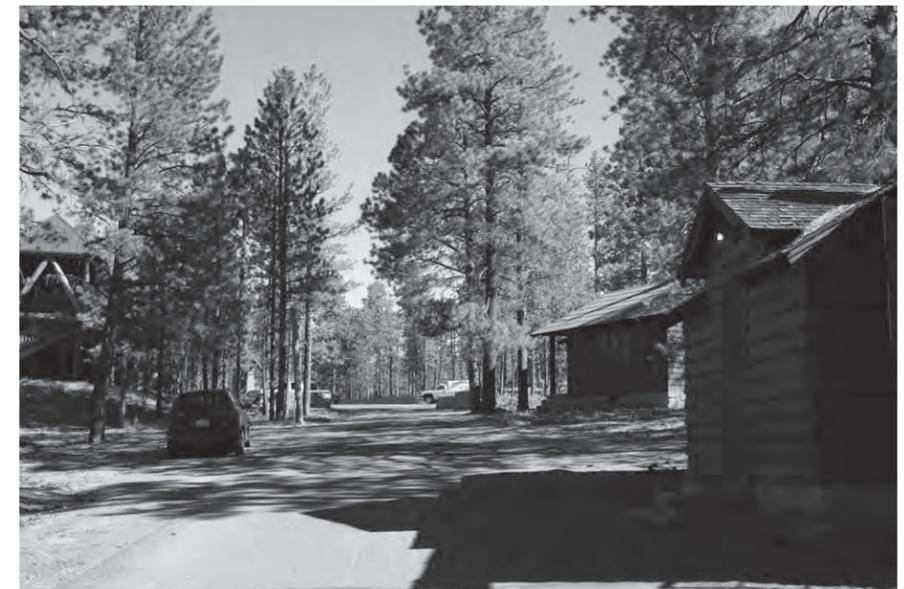
Photograph A/4. The view from the cabins toward the Concessionaire Dormitories today. During the period of significance, this would have overlooked a forested knoll.
