BRYCE CANYON NATIONAL PARK: OLD NPS HOUSING AND BRYCE CANYON LODGE CULTURAL LANDSCAPE REPORT

**BRYCE CANYON NATIONAL PARK: BRYCE CANYON LODGE DISTRICT
AND HISTORIC NATIONAL PARK SERVICE HOUSING DISTRICT
CULTURAL LANDSCAPE REPORT**

**UNIVERSITY OF ARIZONA COLLEGE OF ARCHITECTURE, LANDSCAPE ARCHITECTURE AND PLANNING
SCHOOL OF LANDSCAPE ARCHITECTURE AND PRESERVATION STUDIES PROGRAM**

December 2008

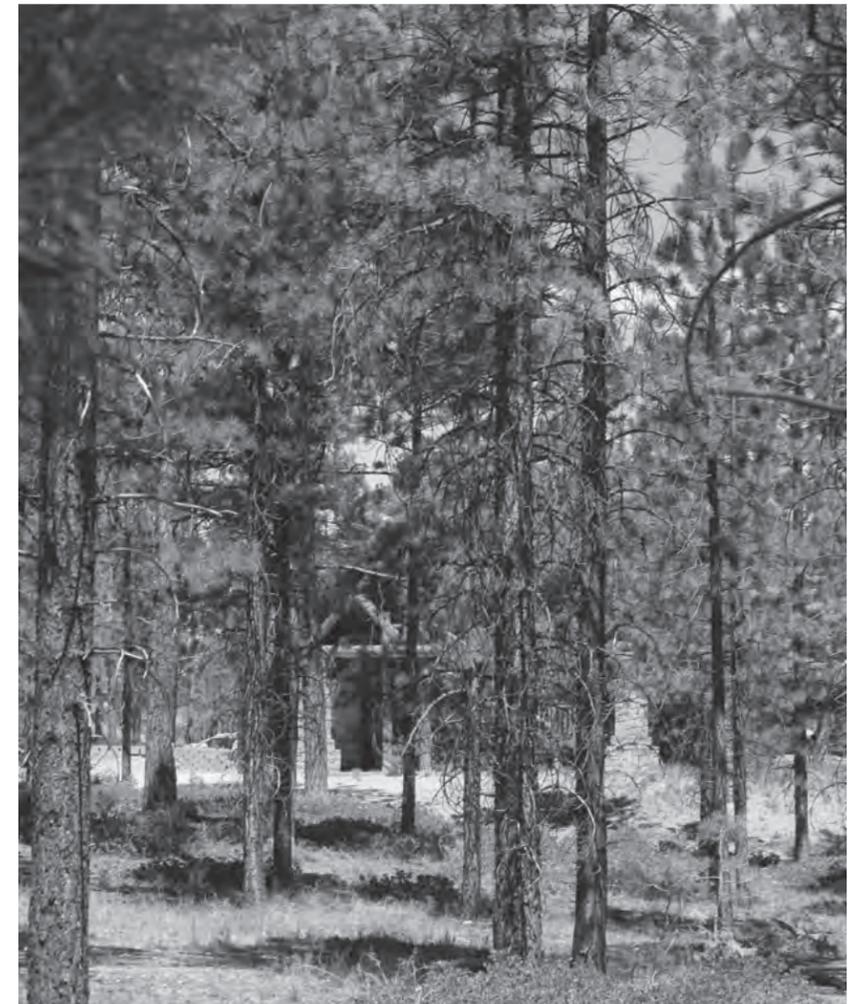
Photograph A/5. The view of the Whispering Pines Dormitory from the Lodge Loop Road.

As discussed in *Topography* and *Vegetation*, the knolls and forests bordering this Study Area served, during the period of significance, to create privacy and shield the NPS Historic Housing to and from the visitor areas. Not only was this seen as a way to enhance the visitor experience (by visually obstructing incongruous land uses), but the privacy it helped to create offered Park staff a means to escape the public realm and visitor bustle of the Park. These features are largely intact today, reinforcing this important aspect of isolation. However, the combination of the siting of the new Concessionaire Dormitories and their larger out-of-context scale disturbs the original intent of the views. As a result those larger non-historic structures are visible from visitor areas and people within these structures have views into the Bryce Canyon Lodge Study Area (*Photograph A/5*).

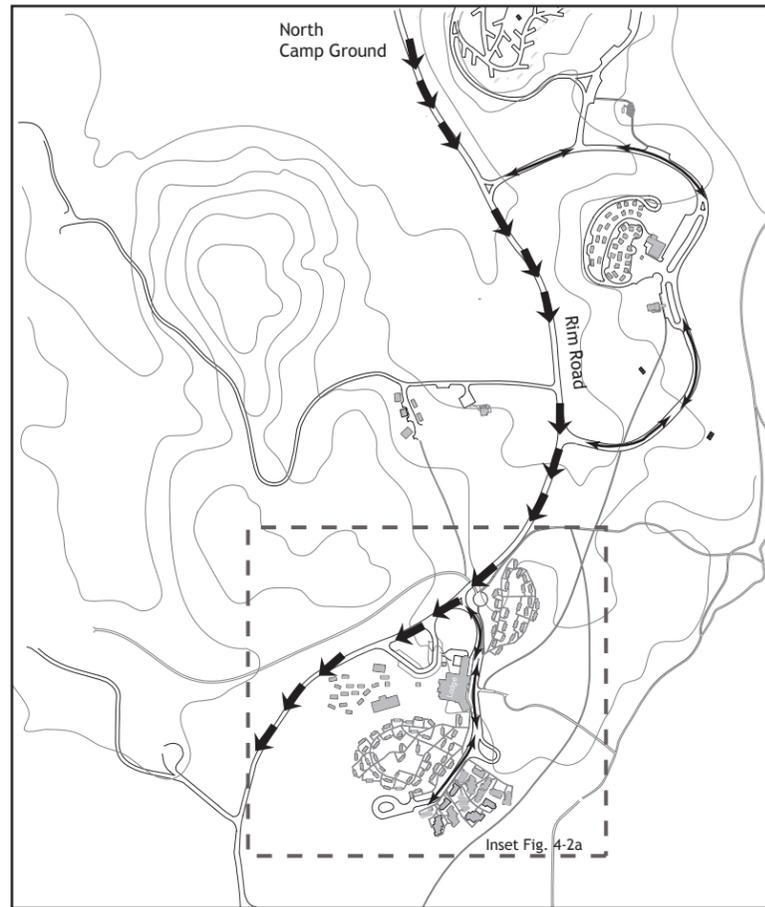
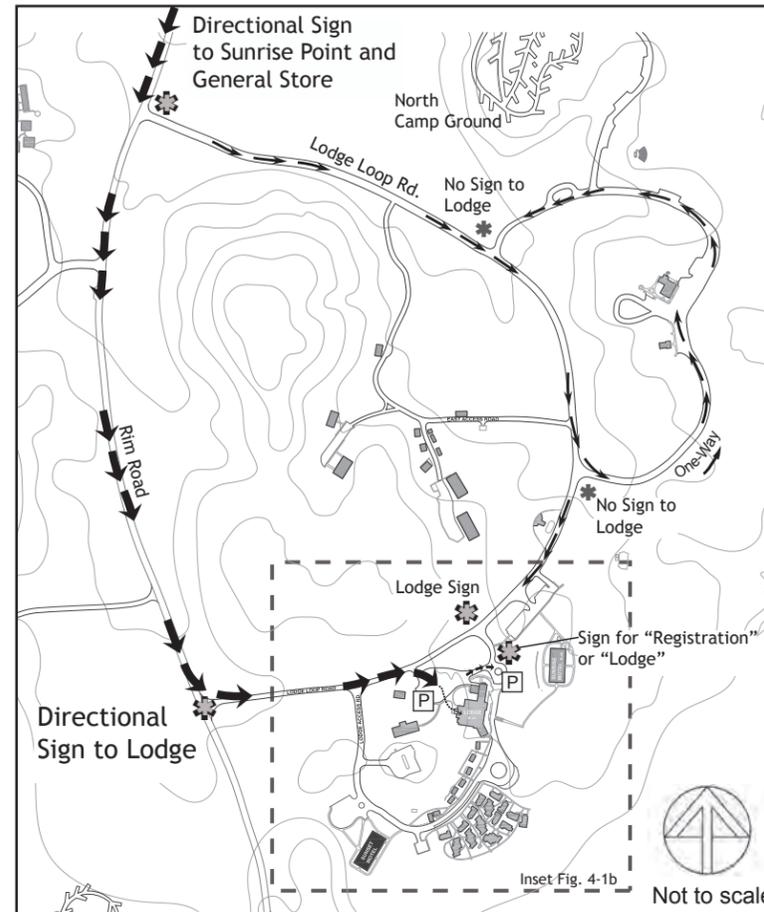
Figure 4-2.

Approach to Lodge circa 1938.

Approach to Lodge 2006.

Changes to the Approach to the Bryce Canyon Lodge with Realignment of Rim Road

Changes to the Lodge building itself and to the Lodge Access Road have altered the overall vehicular and pedestrian circulation pattern in the Study Area, with a particular effect on the visitor's arrival sequence (*Figure 4-2*). Originally, visitors arriving by car or bus were able to use the road to the east of the Lodge and entered primarily via the building's front façade. The Utah Parks Company buses actually pulled into a parking lane adjacent to the steps to the Lodge, unloading passengers directly to the front of the building. The Lodge Access Road did not link back to the Lodge Loop Road to the south as it does today, so visitors wishing to park in the parking areas south of the Lodge would have been forced to enter and exit by passing again in front of the Lodge. Today there is no vehicular access to the front of the Lodge, and a small turn-around with short-term "registration" parking has been installed just to the north of the building close to the intersection with the Lodge Loop Road. Access to the Lodge Access Road parking near the Deluxe Cabins and for the Sunset Motel is gained from the Lodge Loop Road to the south. The primary access for visitors to the main Lodge building is through the rear of the building near the parking area. Though parking has always been available at this location, it is unclear whether guests regularly accessed the building through the rear patio. The rear entry to the building moves visitors past several unsightly elements of the Lodge, including the employee dining area, the smoking patio and the restaurant dumpster (see Photographs LD/9 and LD/10 in Chapter 3).

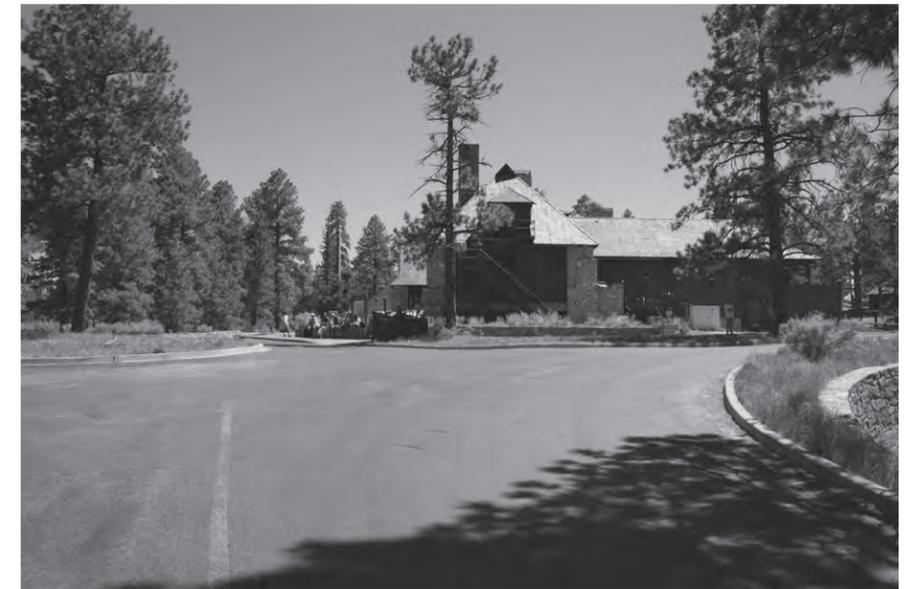
Photograph A/6. The Lodge Access Road as it approaches the Registration and Rear Parking Areas. Registration parking is ahead and to the left behind the trees and vegetation, the larger driveway circles to the right to the Rear Parking area.

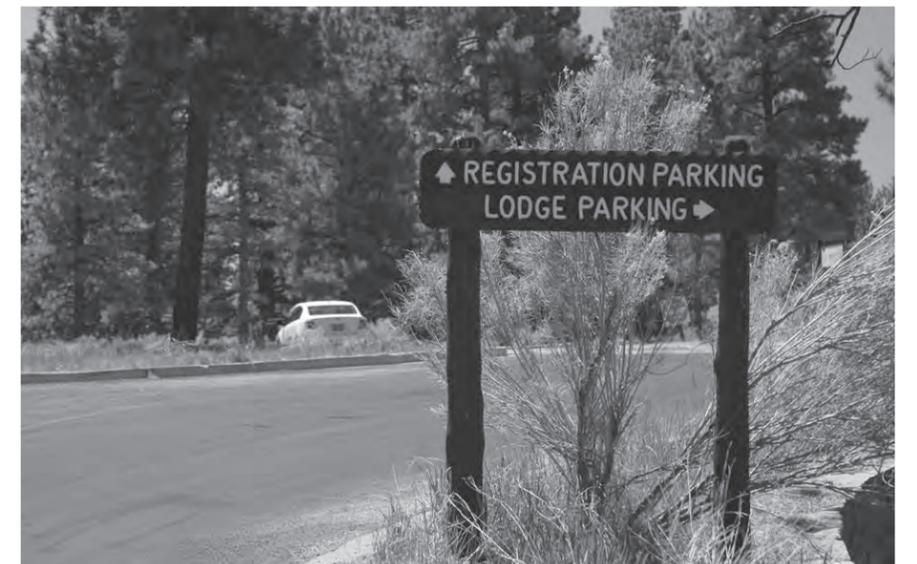
Photograph A/7. Signage indicating registration parking area as separate from Lodge parking, which could create confusion for Lodge visitors.

The intent of the small registration parking area to the north of the Lodge is to encourage Lodge guests to utilize the front of the building for at least their initial interaction with the Lodge. However, a number of factors work to reduce the effectiveness of this registration parking area for capturing first-time visitors, including the overall vehicular traffic pattern (as dictated by directional signage outside the Study Area), the size and visual accessibility of the rear parking area and confusing signage (*Photographs A/6 and A/7*). When this parking area was installed, the approach of the Lodge Access Road was shifted further to the east of the original alignment, which brings traffic more to the side of the building than the front. This further reduces the visual importance of the front façade of the Lodge.

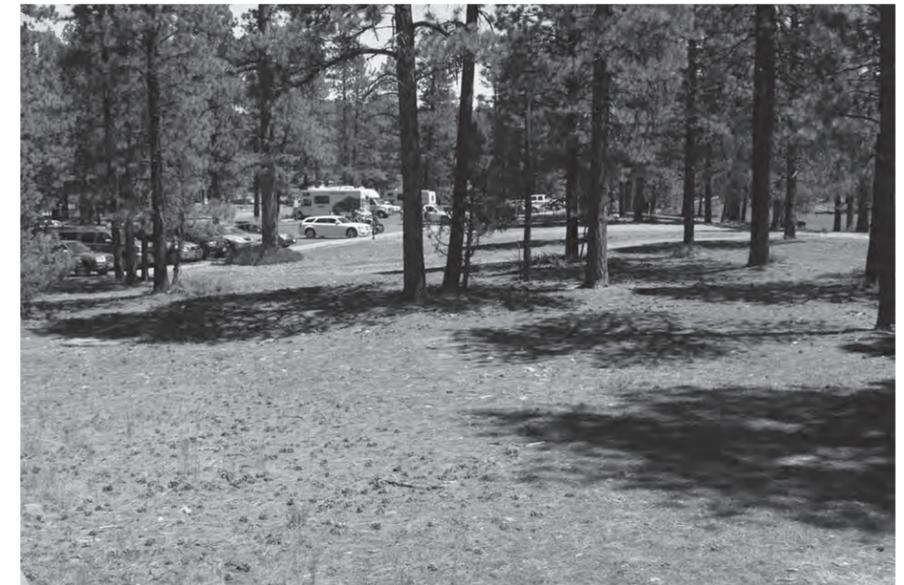
Photograph A/8. The former location of a cluster of Standard Cabin units, now reverted to open space between the Lodge and the Sunrise Motel Unit.

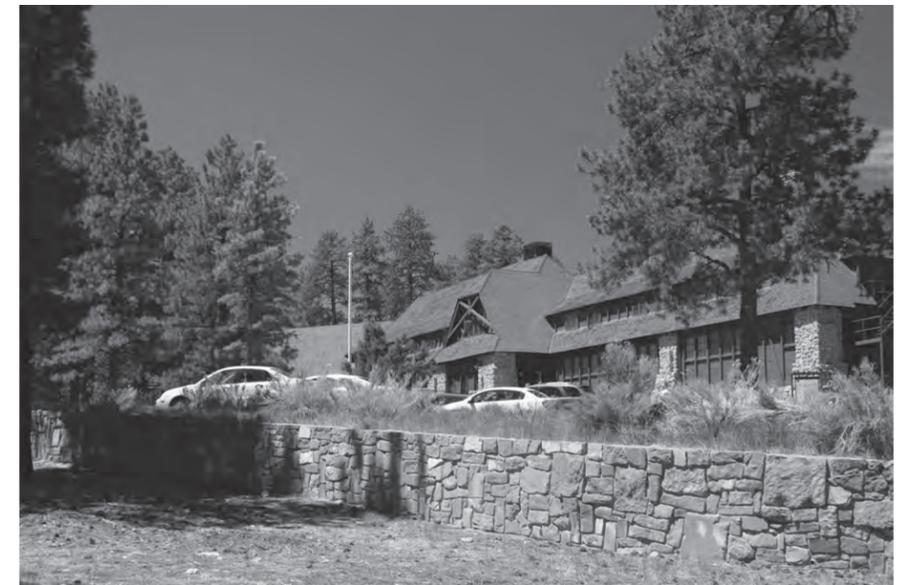
Photograph A/9. The retaining wall between the Lodge and the Sunrise Motel Unit which creates the space for the Registration Parking Area.

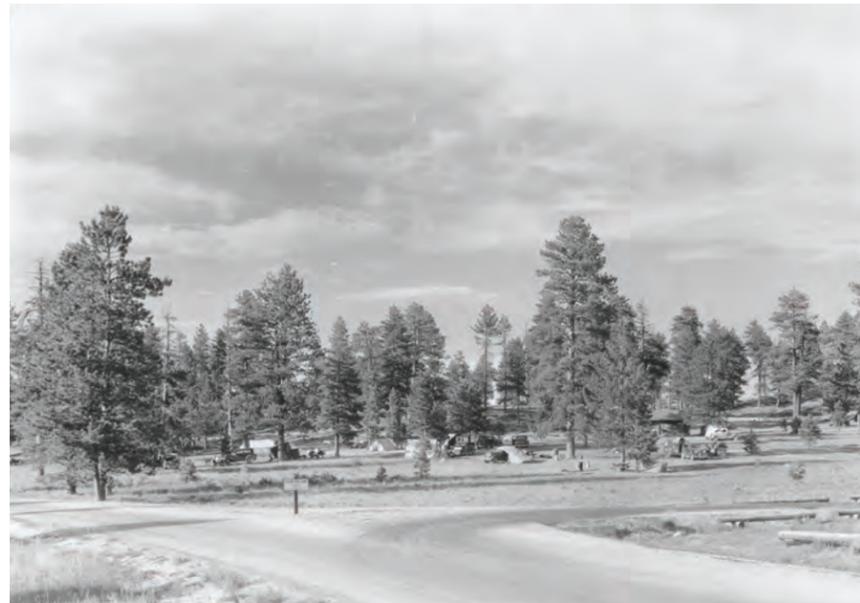
Photograph A/10. The North Campground at the time of its construction in 1935, looking toward the Rim (BCRA Archives ACC381_CAT3919 #8).

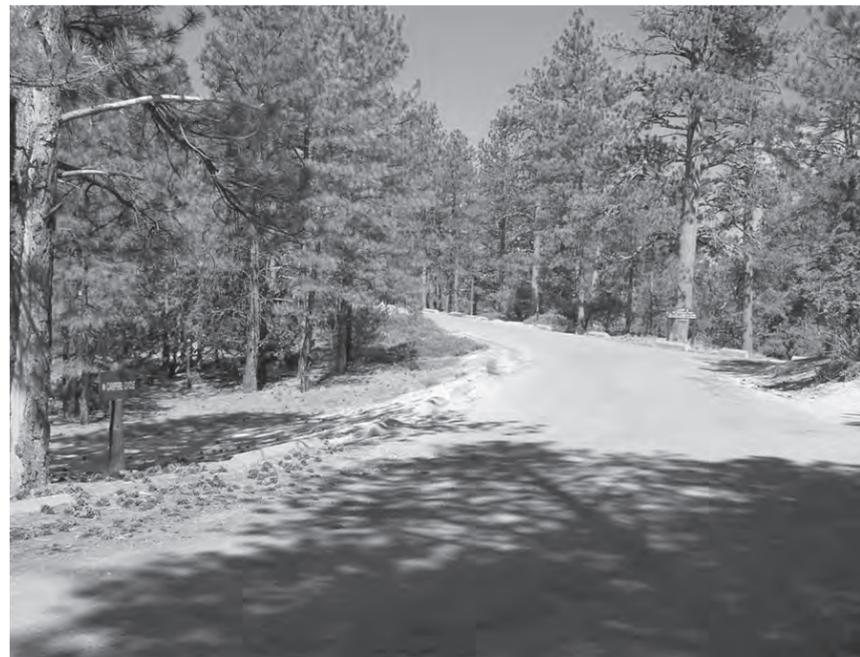
Photograph A/11. The North Campground today. Although this photo is taken from a different vantage point, the change in forest density is obvious.

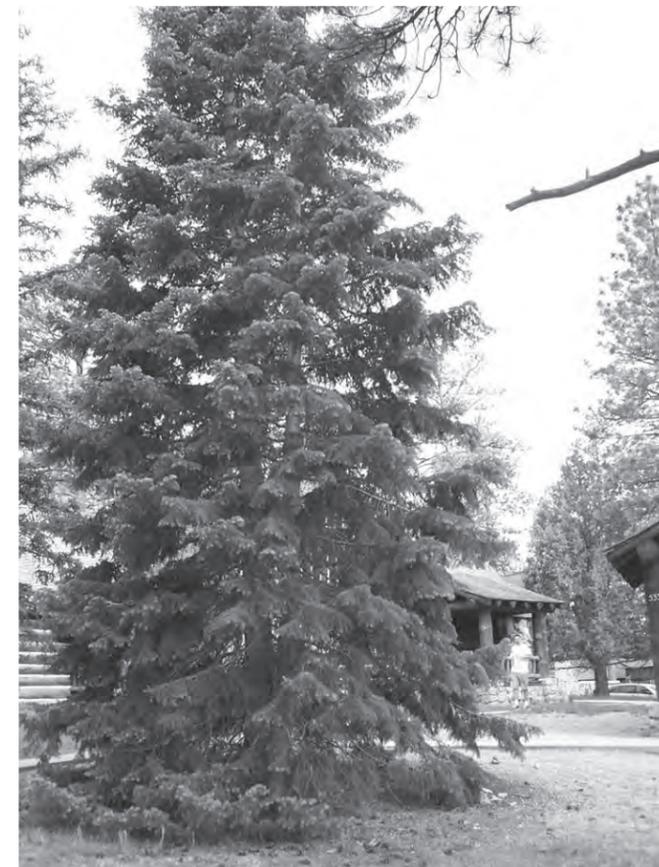
Photograph A/12. A large Douglas Fir in the Deluxe Cabin cluster. This specimen was like planted when the cabins were built, however a number of younger trees in the area indicate that it has naturalized here.

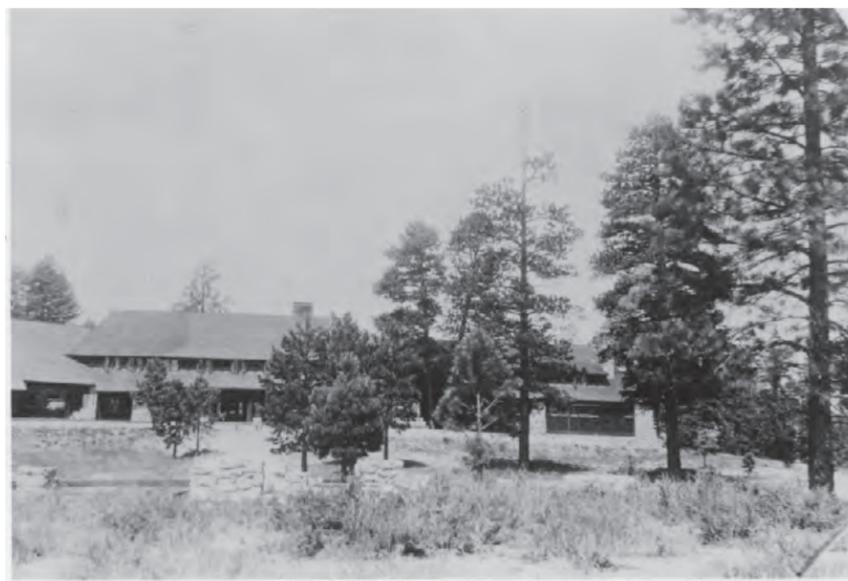
Photograph A/13. The front of the Lodge circa 1930, before the campfire ring was removed (BCRA Archives Cope BRCA 2).

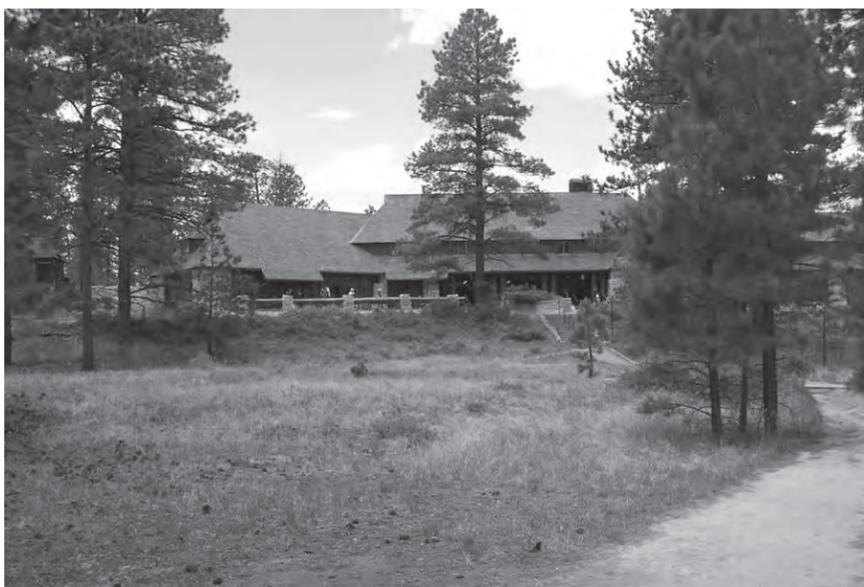
Photograph A/14. The front of the Lodge today. Several trees from the 1930's image have matured, lending a more established feeling to the Lodge.

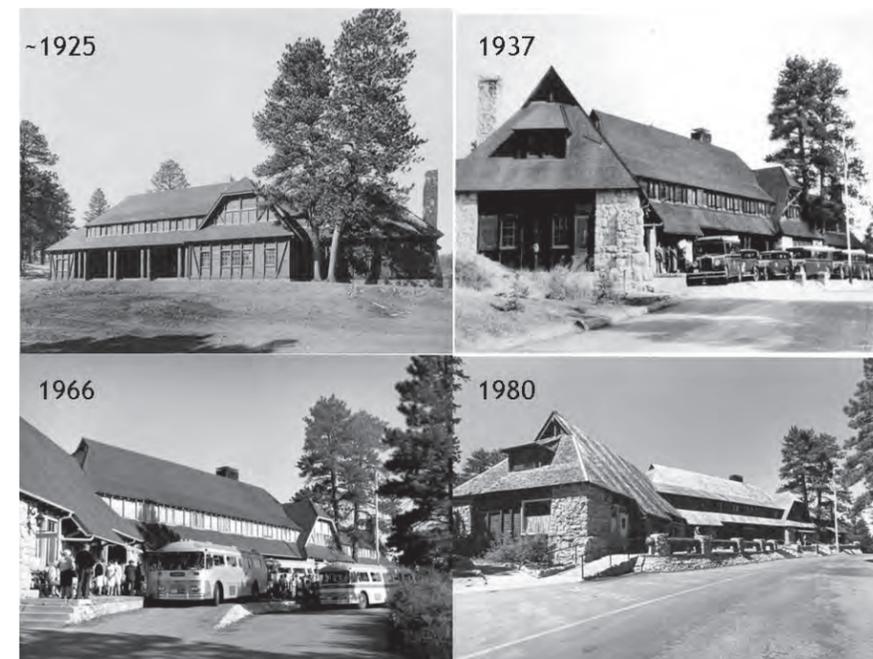
Photograph A/15. A montage of the Lodge with the two prominent Ponderosa pines in place (collected from BCRA Archives).

Photographs of the front of the Lodge during the period of significance and later show two specimen Ponderosa pine trees near the building entry (*Photograph A/15 and A/16*). The visibility and distinctiveness of these trees made them an important part of the Lodge's façade, as well as giving the building a sense of having been a part of the forest for some time. These trees were removed in the 1990s as a result of their threat to the foundation of the building, and were not replaced. Although other mature vegetation surrounds the Lodge building to help ensure its forest retreat character, the absence of the landmark trees does have a significant impact on the structure's appearance.

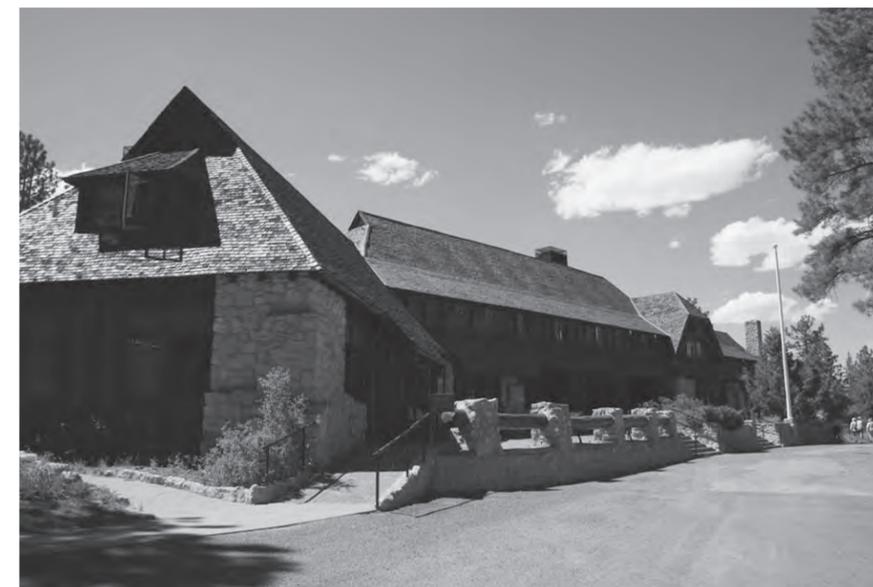
Photograph A/16. The front of the Lodge today from a similar angle with the prominent trees missing.

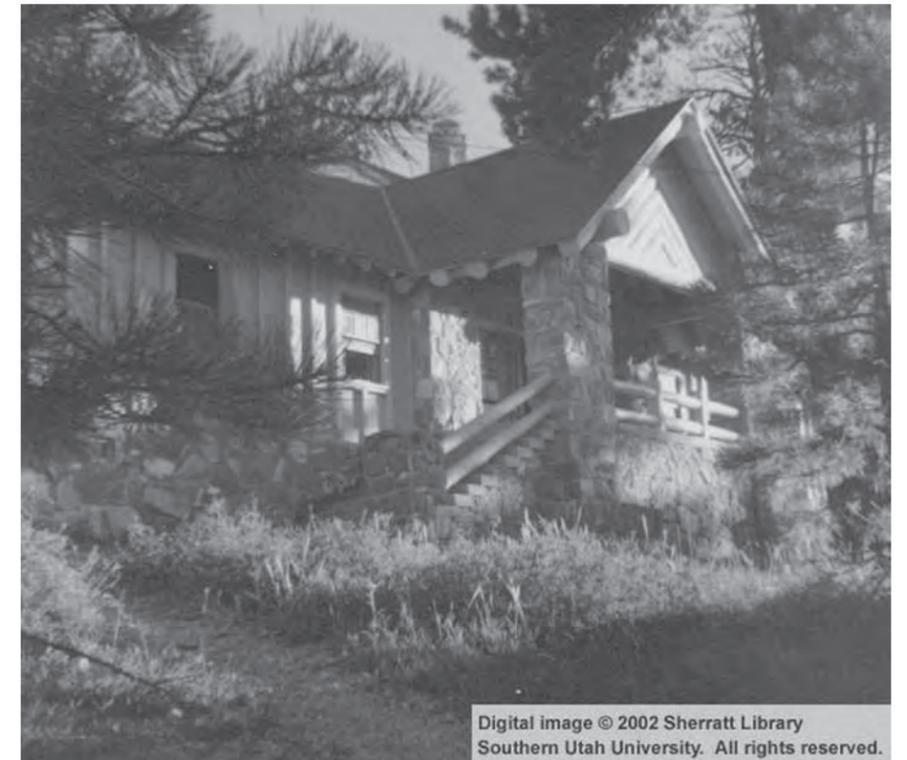
Photograph A/17. The front of the Male Dormitory circa 1940. Note the natural surface path leading toward the entry running bottom, center to left on picture. (Sherratt Library).

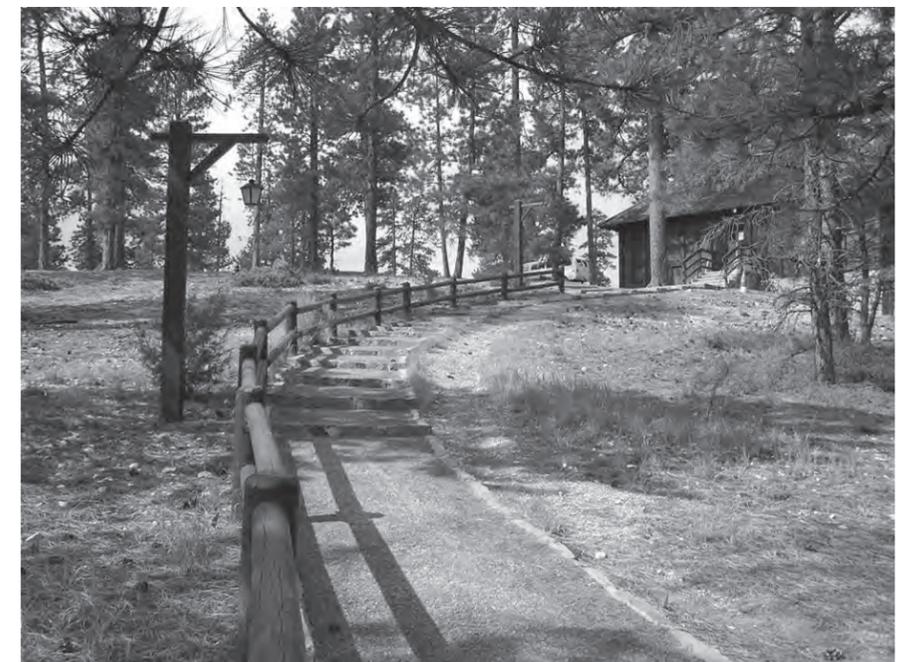
Photograph A/18. The existing path to the side entry to the Male Dormitory.

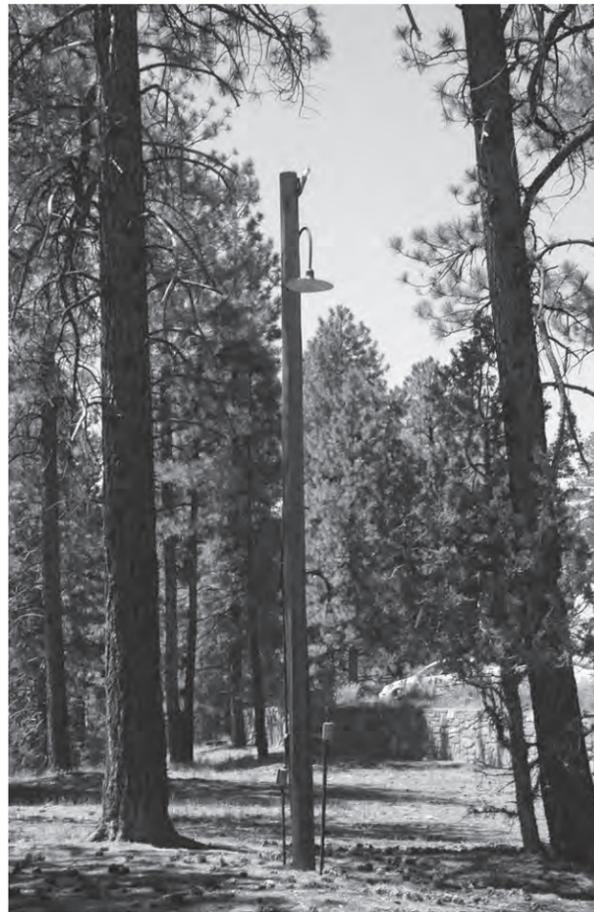
Photograph A/19. A utility pole with a light remaining in the area where the Standard Cabins were removed between the Lodge and the Sunrise Motel unit.

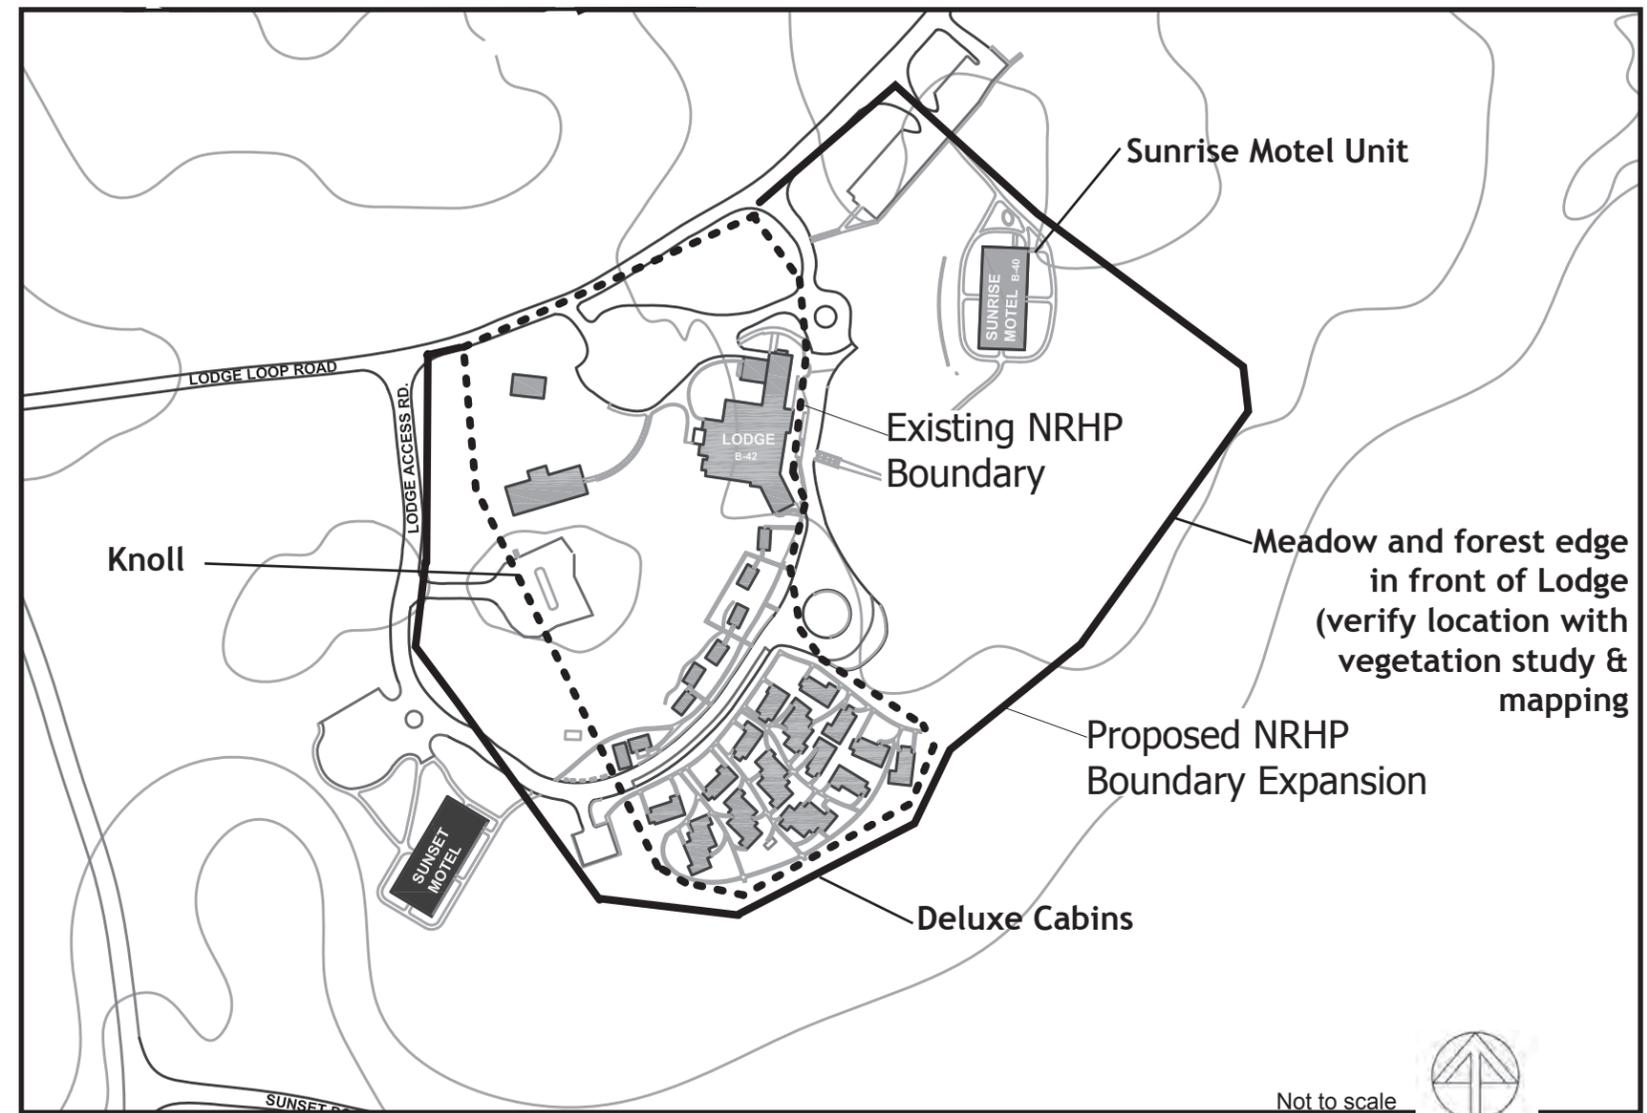
Figure 5-1.
Proposed Revisions to NRHP Boundaries - Bryce Canyon Lodge Historic District

Revision of the Bryce Canyon Lodge Historic District boundaries is proposed for the following expansion (*Figure 5-1*): to include the meadow in front of the Lodge and the tree lined edge along the Rim Trail to the south and southeast, the forests around the District to the Lodge Loop Road to the north and the Lodge Access Road to the west. This includes the knoll where the Standard Cabins were once located – although the structures are gone, the natural feature of the knoll and the forest still contribute to the overall character of the District as a forest village (the Lodge was sited at the base of the knoll rather than the top, for example, and the forest was retained even though development later occurred on the hill). The meadow in front of the lodge gives the lodge itself a sense of place by providing a natural setting with scenic value, albeit not the powerful vista of the rim itself. The forest surrounding the meadow is vital to defining the meadow as well as for shielding the Lodge from the rim and below (which was an important and deliberate consideration at the time of design, as discussed in Chapter 4). The forested edge should include sufficient depth of the tree canopy to protect the viewshed, but should not include the Rim Trail. The recommended vegetation study should assist in determining the precise location of the edge of the meadow and the forest boundary.

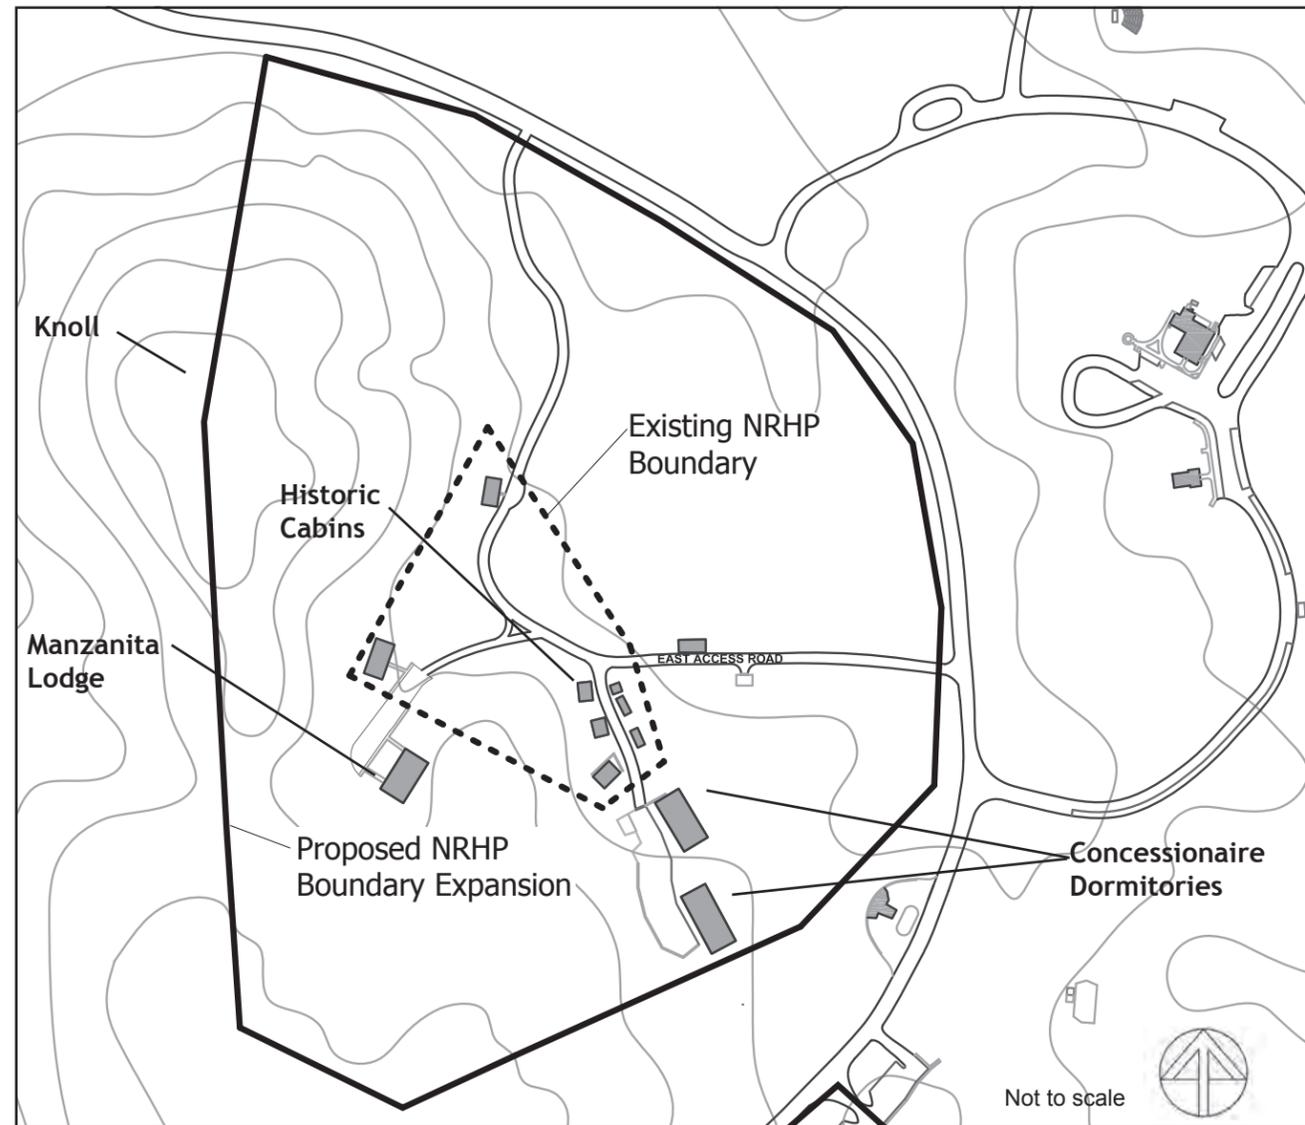
Figure 5-2.
Proposed Revisions to NRHP Boundaries - Old NPS Housing Historic District

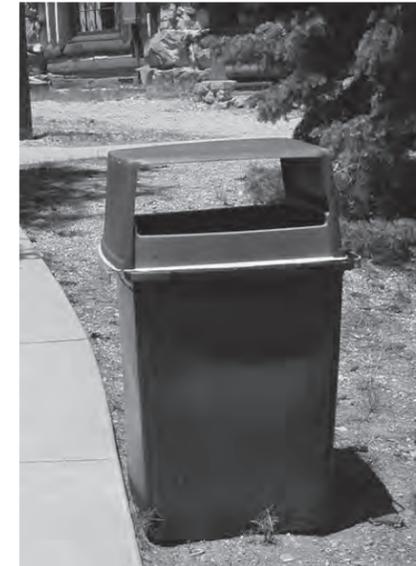
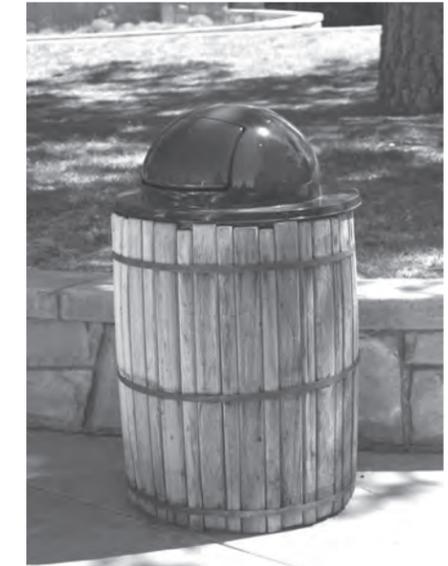
Photographs R/1 and R/2. Two trash receptacles at use within the park. The plastic one on the left does not convey the sense of Rustic style or careful design desired within the Study Areas. The one on the right mimics some of the materials and design characteristics that would have been followed during the period of significance.

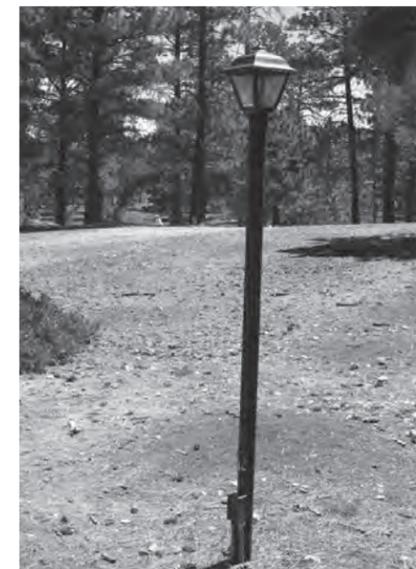
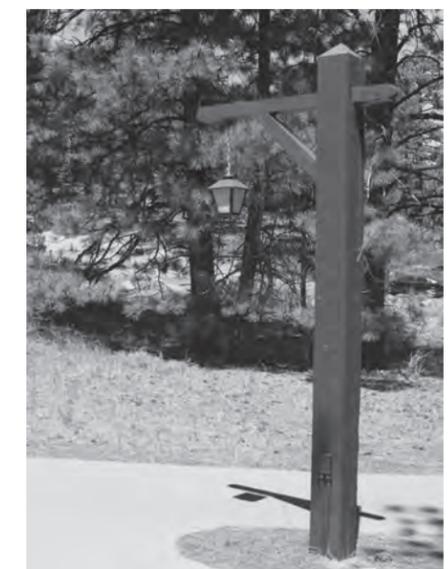
Photographs R/3 and R/4. Light fixtures should be consistent throughout the park, including the Study Areas. These photos illustrate that though some similarities exist between fixtures, that there is also a great deal of inconsistency throughout the developed area. Photo R/3 is found near the Lodge and R/4 is near the Sunset Motel unit. Fixtures should be carefully chosen to fit in with the Rustic style character and to convey a unified design aesthetic.

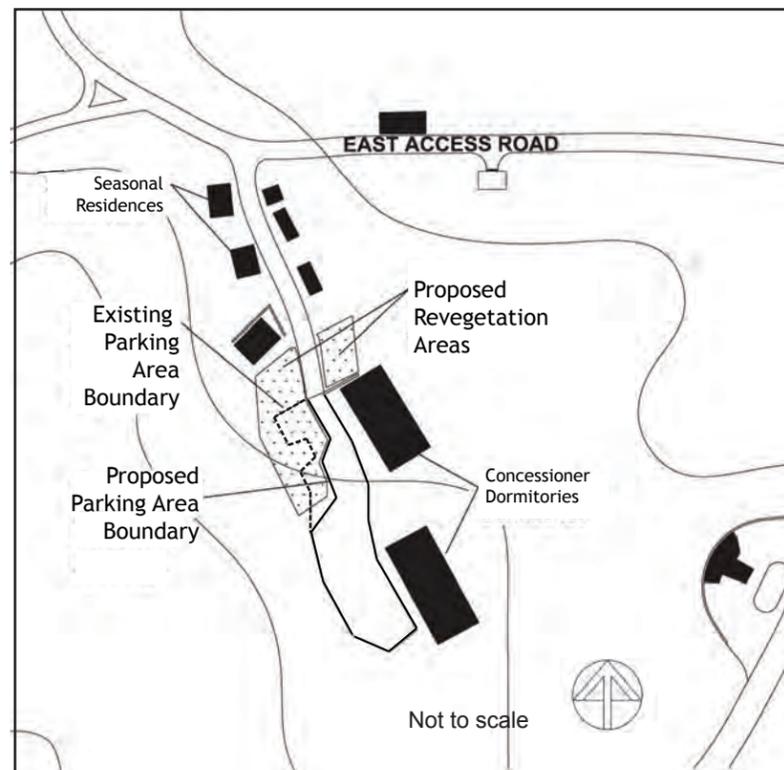
Figure 5-3.
Reducing Parking Area to Screen Seasonal Cabins in Old NPS Housing Study Area

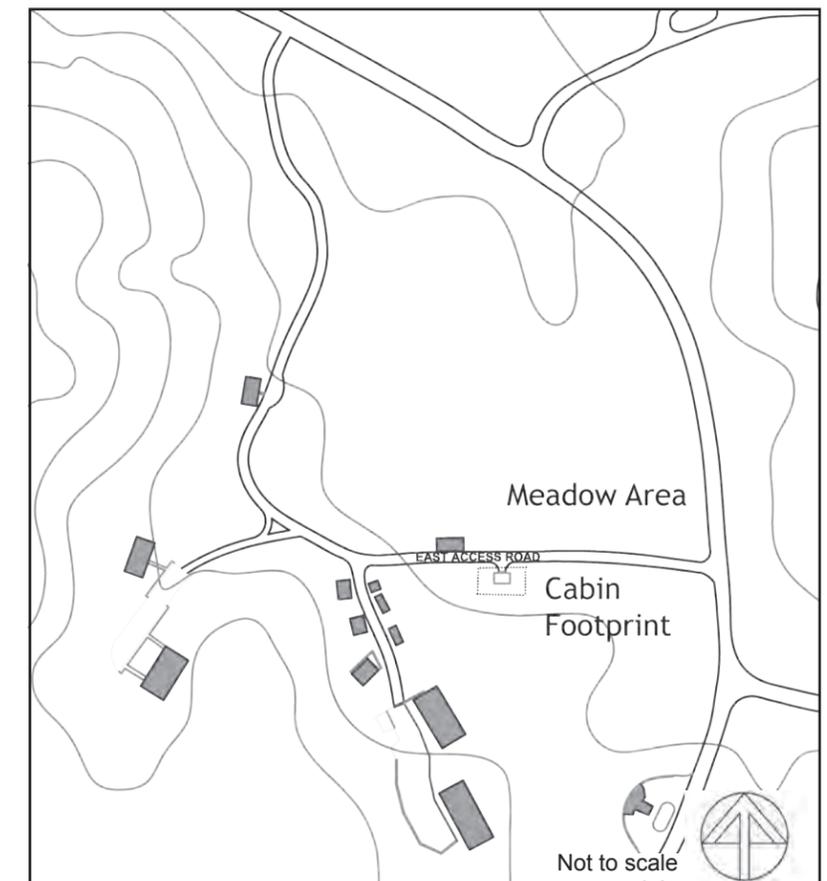
Figure 5-4.
Site of Historic Ranger Cabin

- An architect specializing in historic structures should be hired to design the structure to be compatible with the Simplified Rustic style of the Study Area. If adequate documentation and architectural drawings of the historic structure exists, reconstruction of the historic cabin could be warranted as determined by Park administration. In this case, the interior features of the cabin could accommodate current housing needs and even reflect a more contemporary design approach while the exterior would follow prescribed NPS guidelines so as to recreate the historic log cabin. If adequate documentation does not exist to reconstruct the cabin, a new design should be created which will strive to combine contemporary interpretation with the flavor and feeling of the Rustic style architecture of the existing historical structures. Consideration for small scale massing, simple utilitarian lines, and attention to proportions and materials that use the historic architecture as inspiration will serve as a critical guide for this endeavor.

- New construction must not interfere with the existing historic structures’ ability to convey a feeling of integration with nature and Simplified Rustic ambiance. The design of this new building should strive add to this overall feeling.
- The footprint of any new structure would have some latitude to extend beyond the dimensions of the original layout provided the scale of the building is appropriate. While the new building need not match the original historic structure layout, care should be taken to minimize the new building’s impact upon the land. Design considerations include the footprint of the building itself and the area affected by construction, storage or parking. As land might be disturbed in the construction process, revegetation is warranted as described previously.

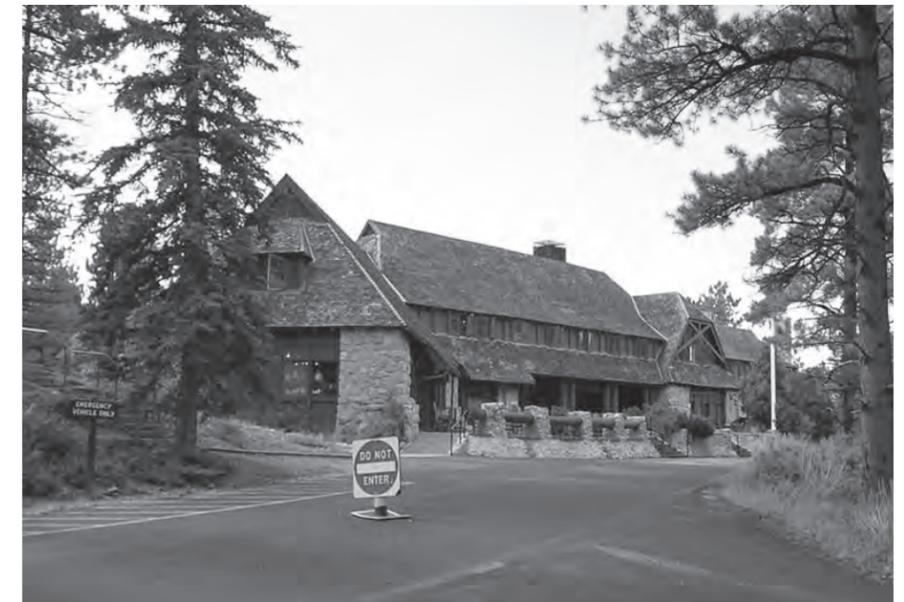
Photograph R/5. Proposed location for the new Bryce Canyon Shuttle stop - near the large tree on the left side of the photo. This would give visitors an excellent view of the Lodge as they rode the shuttle and as they waited at the stop.

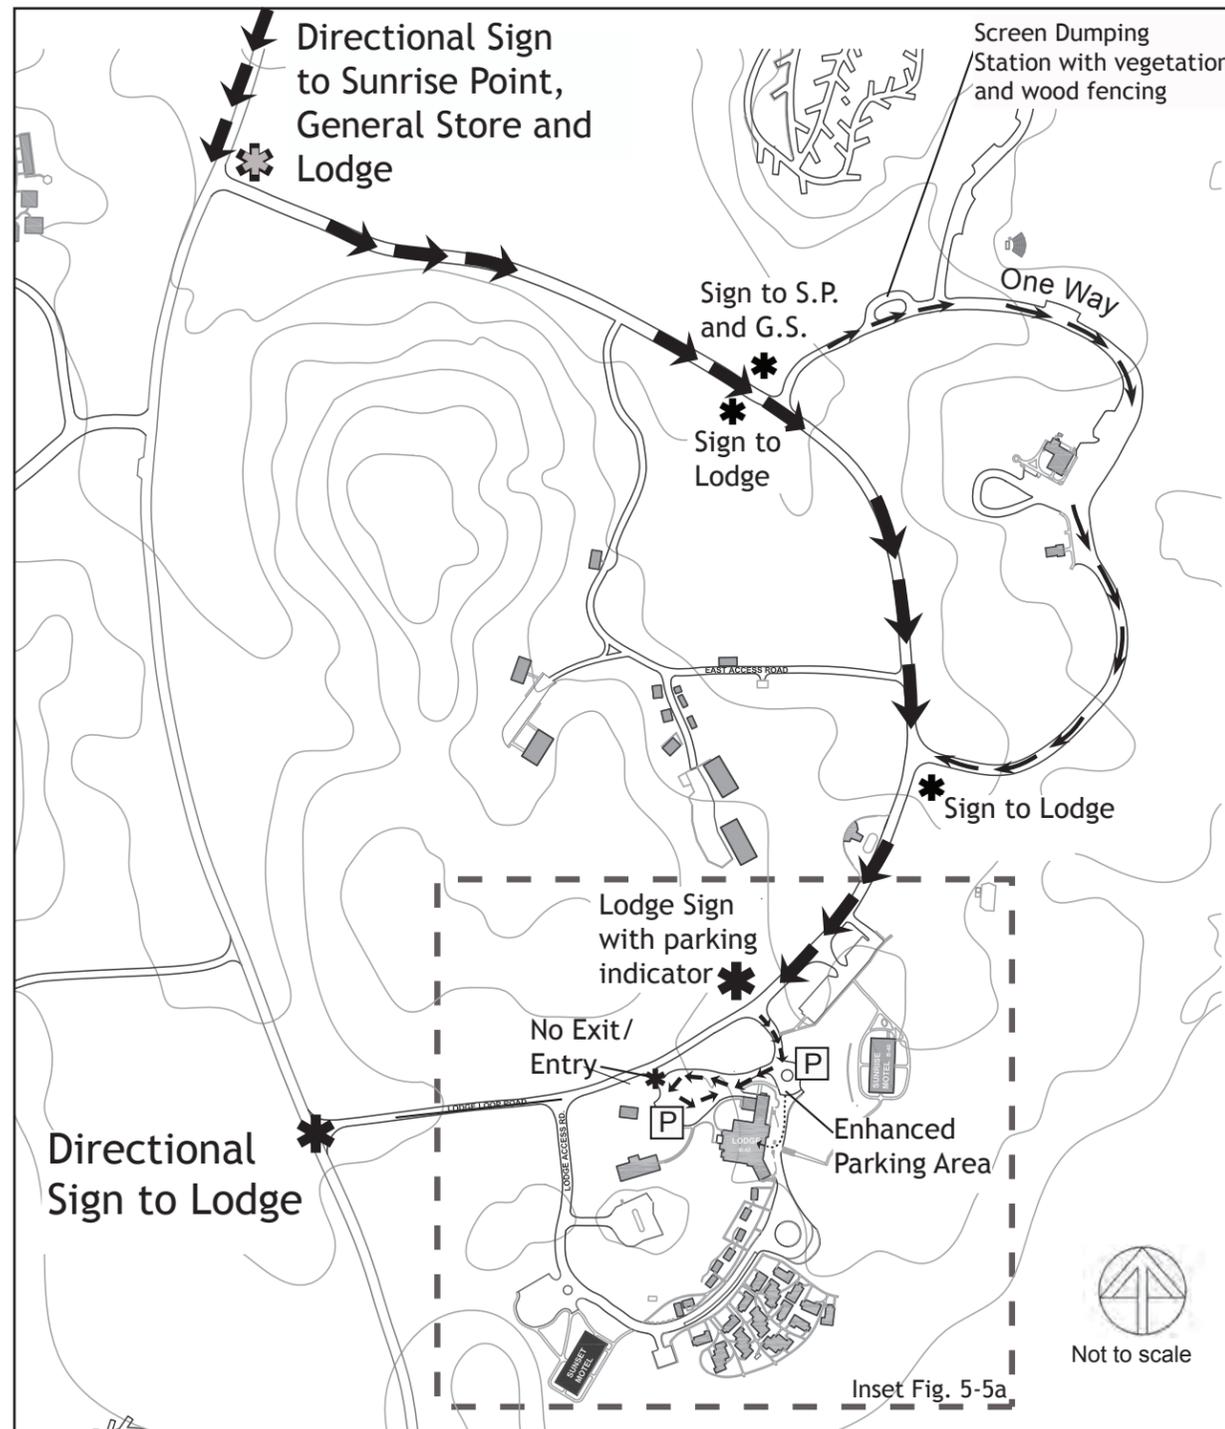
Figure 5-5.
 Proposed Circulation Pattern to Bryce Canyon Lodge

- Wayfinding to the Bryce Canyon Lodge itself as well as throughout the Park in general would be improved by reversing the direction of the Sunrise Point Access Road to travel one-way counter-clockwise

(rather than clockwise as is currently in place). This direction would further reinforce the historic north-to-south circulation pattern and would prevent back-tracking as visitors travel between the logical destinations along the rim. The reversal would also reduce some traffic on the Lodge Access Road in front of the residential area

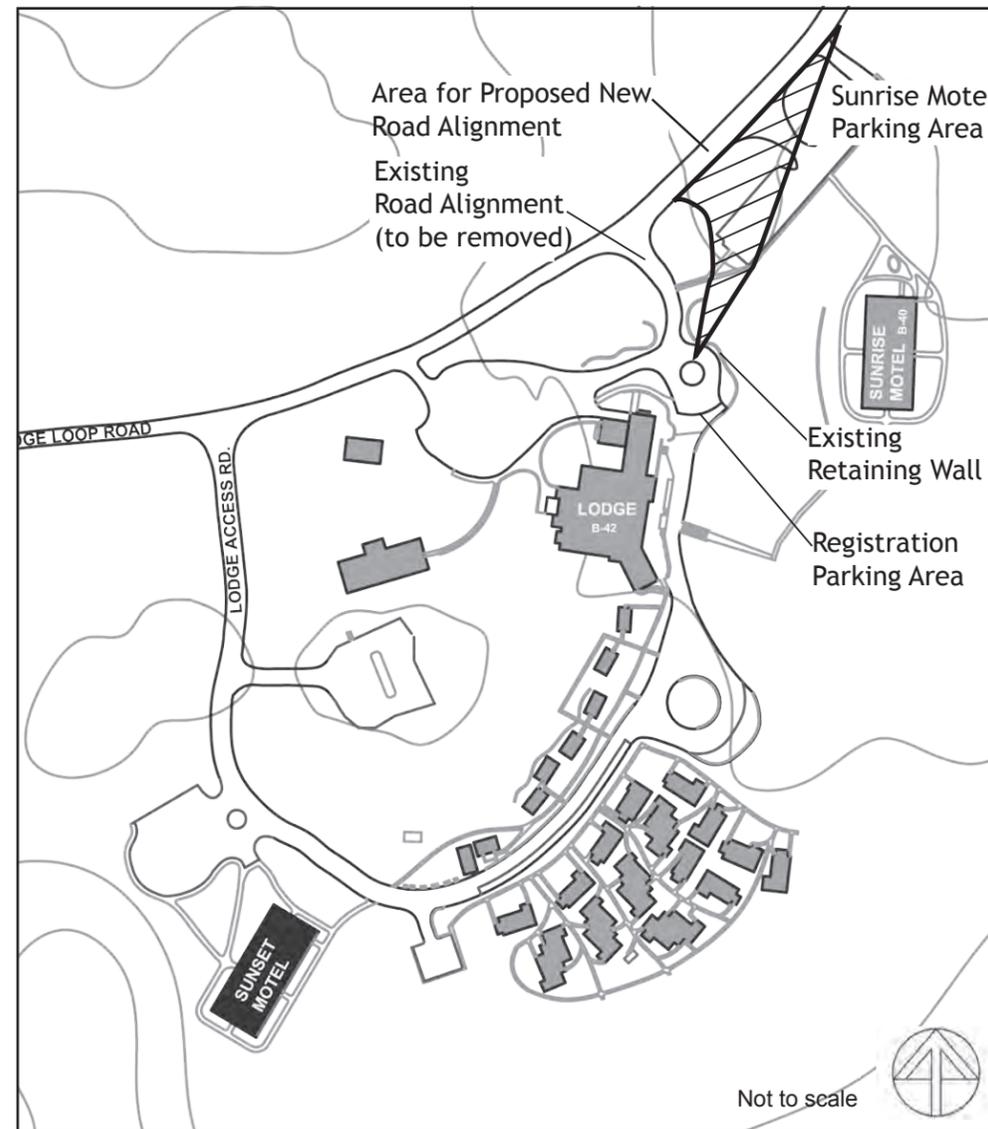
Figure 5-6.
Proposed Realignment of the Lodge Access Road North of the Lodge

- The new alignment of the Lodge Access Road should be properly integrated into the pedestrian circulation system and include accessible paths from the Lodge to the Sunrise Motel unit, the Old NPS housing area and the Utah Parks Company Service Station.

- A reconfiguration of the existing Sunrise Motel Unit parking area will most likely be necessary with the changes to the Lodge Access Road realignment. Some expansion of the parking into the forest to the southeast may be acceptable, as this area has been heavily impacted by historic uses and may even have served as lower-density parking in the past. Efforts should be made to reduce new impact, however, and to keep the footprint of the parking area to a minimum.
