BRYCE CANYON NATIONAL PARK: OLD NPS HOUSING AND BRYCE CANYON LODGE CULTURAL LANDSCAPE REPORT

**BRYCE CANYON NATIONAL PARK: BRYCE CANYON LODGE DISTRICT
AND HISTORIC NATIONAL PARK SERVICE HOUSING DISTRICT
CULTURAL LANDSCAPE REPORT**

**UNIVERSITY OF ARIZONA COLLEGE OF ARCHITECTURE, LANDSCAPE ARCHITECTURE AND PLANNING
SCHOOL OF LANDSCAPE ARCHITECTURE AND PRESERVATION STUDIES PROGRAM**

December 2008

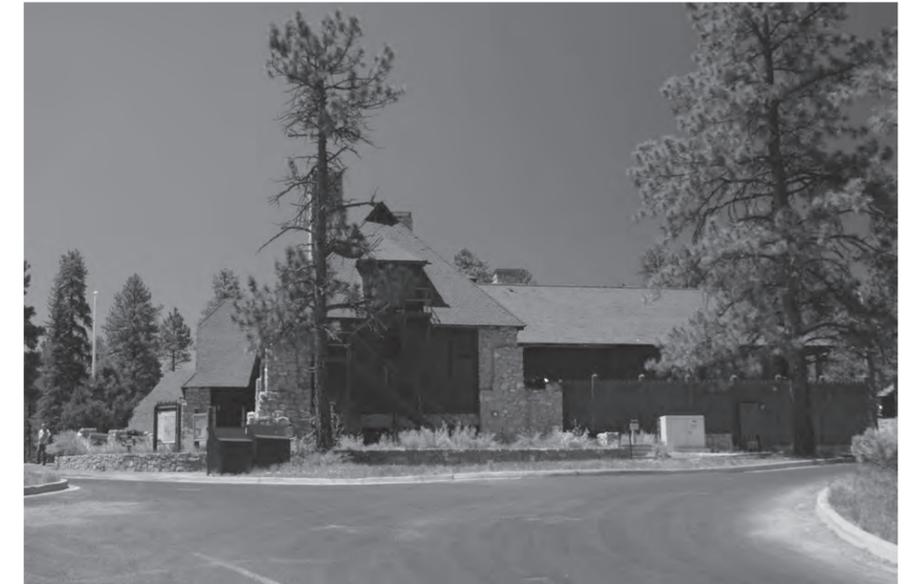
Photograph R/6. View of the Lodge from the existing alignment of the Lodge Access Road. The temporary visitor parking begins immediately to the left of this photo.

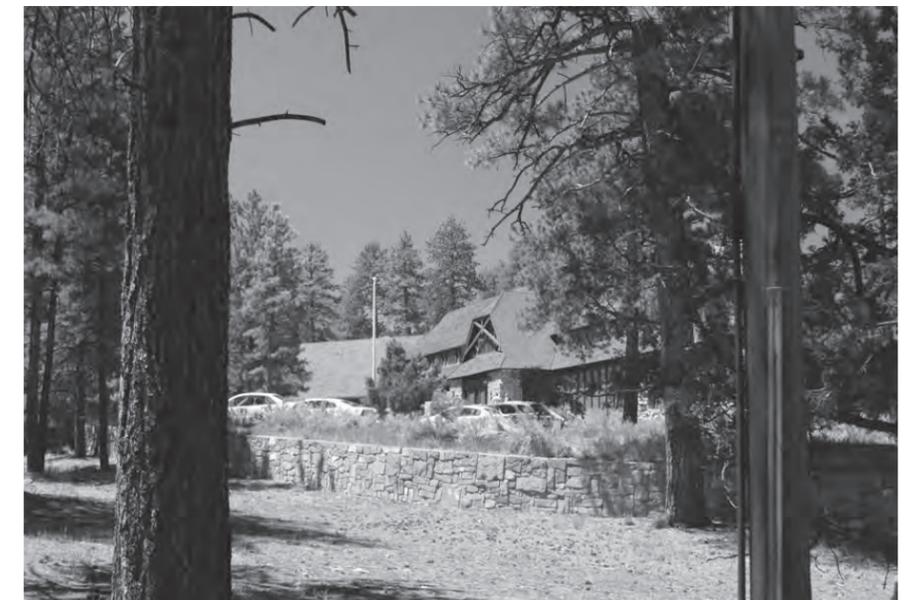
Photograph R/7. View of the front of the Lodge from the approximate location of the realigned Lodge Access Road. Existing vegetation and retaining walls would be cleared, creating a clear view of the front façade of the structure.

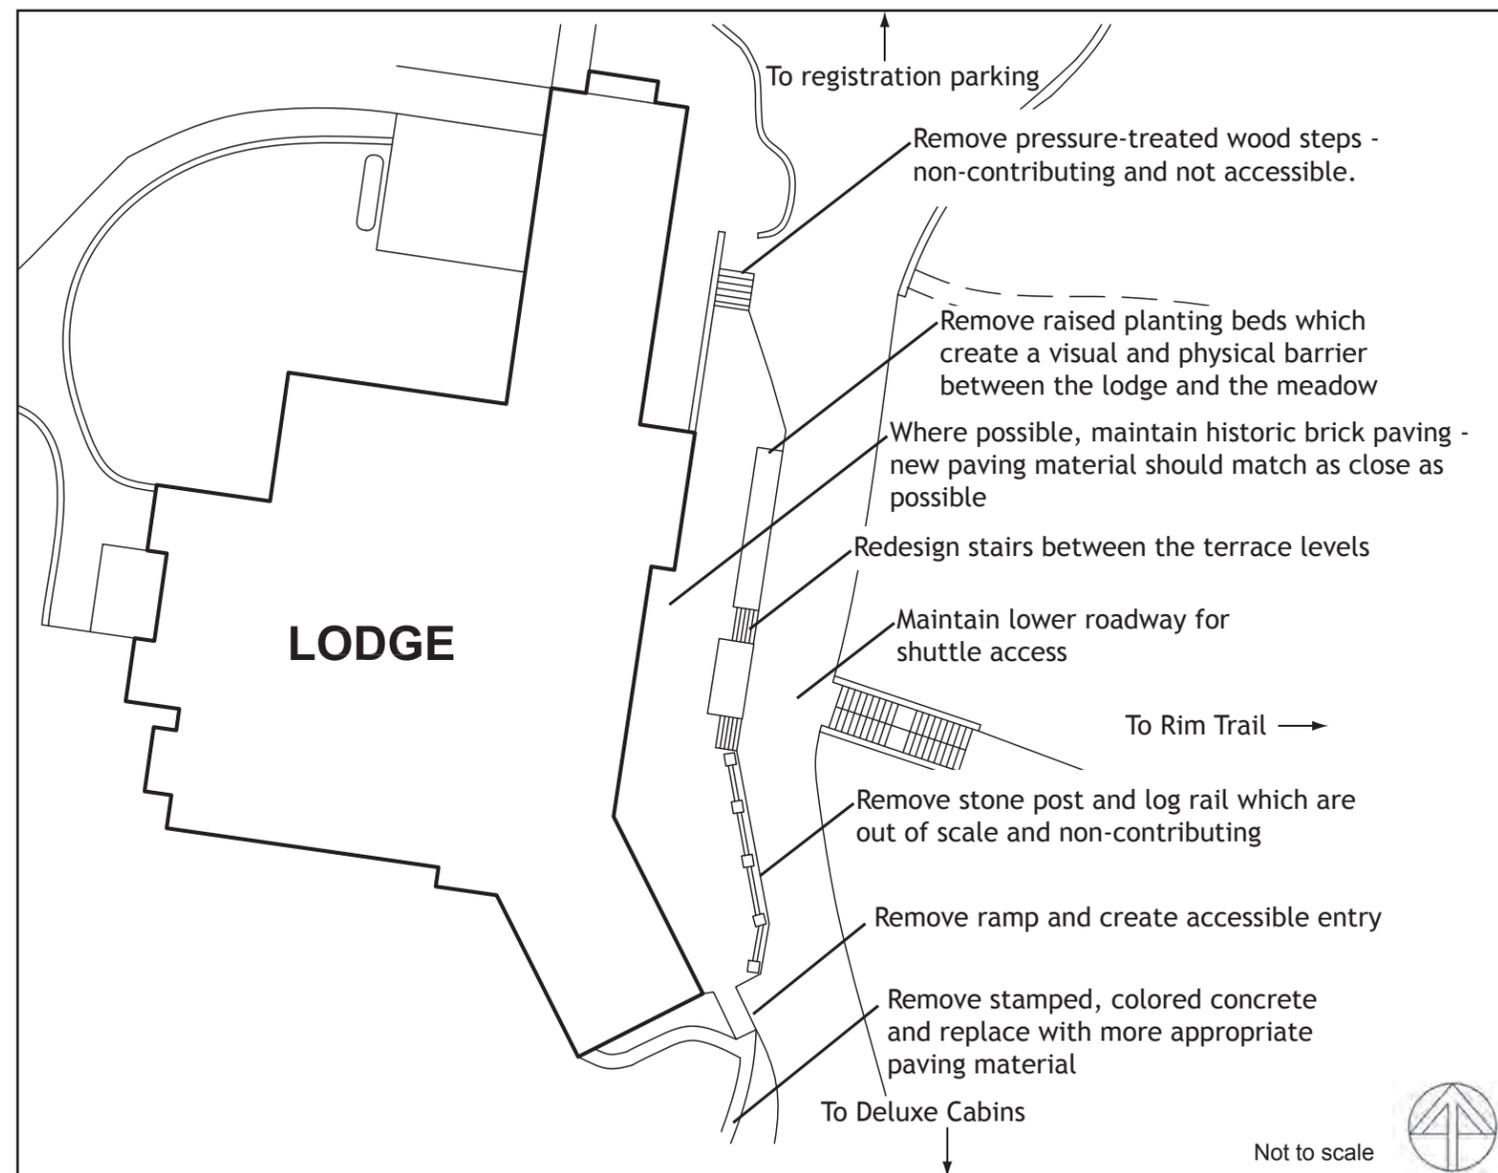
Figure 5-7.
Notes on Redesign of Bryce Canyon Lodge Façade

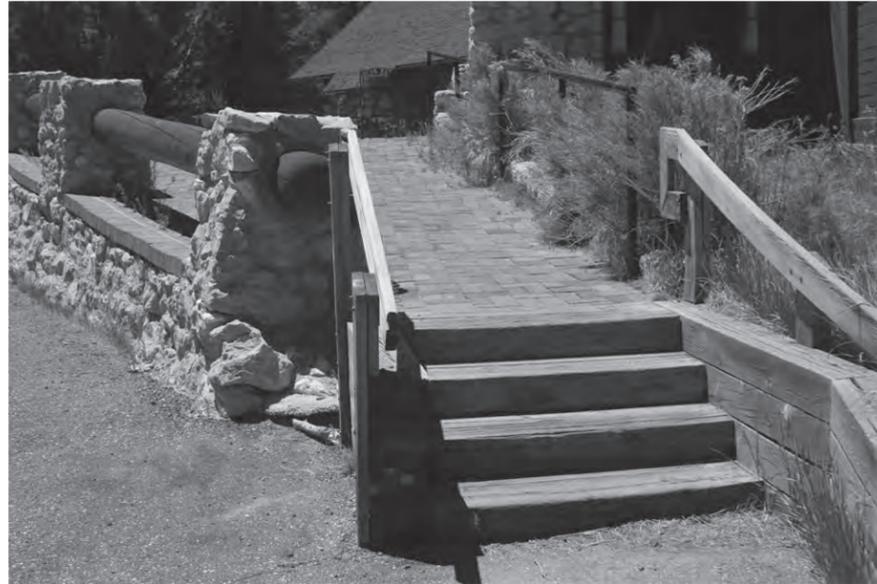
Photograph R/8. Steps up to Lodge patio area are not consistent either with historic aesthetics and materials or with the treatment installed in the 1980's.

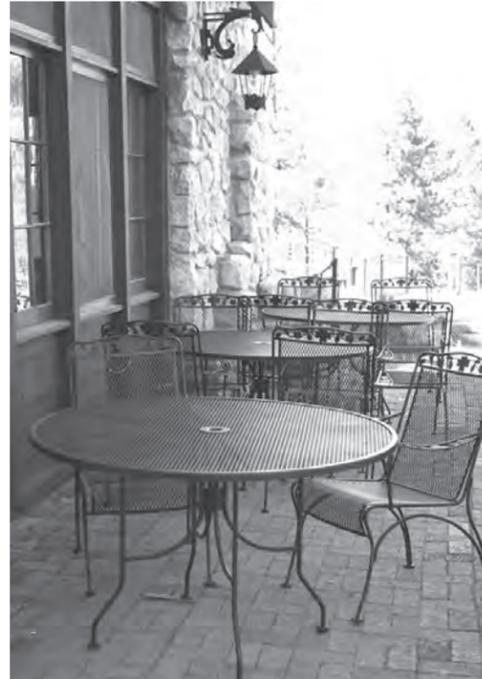
Photograph R/10. Site furniture on the terrace in front of the Lodge which does not meet the materials or aesthetic character of the Rustic style.

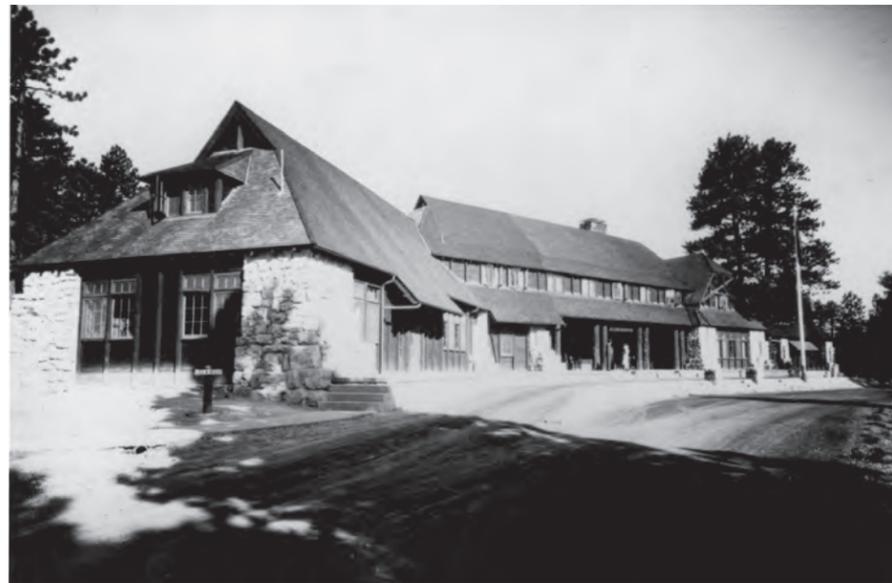
Photograph R/9. Photos such as this one, taken of the lodge in the 1930s, should be utilized in the process of redesigning the front entry to the lodge (BCRA Archives: BCRA 3897)

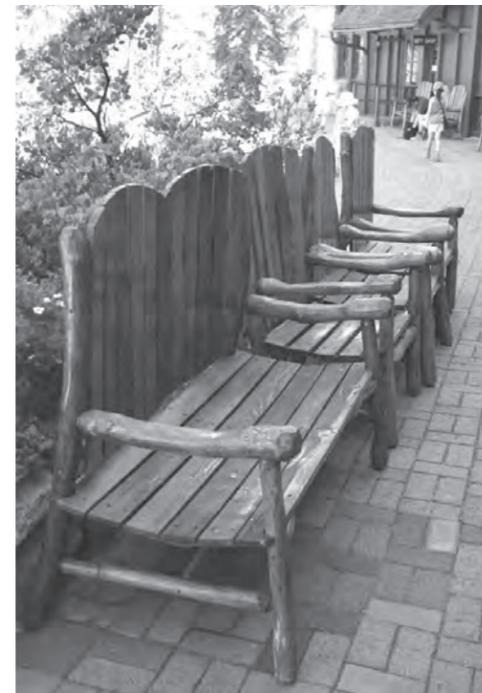
Photograph R/11. Furniture such as these benches on the terrace, made of natural materials with a "hand hewn" look more closely match the Rustic style. All site furniture in this area should be coordinated and should match in terms of style, scale and materials.

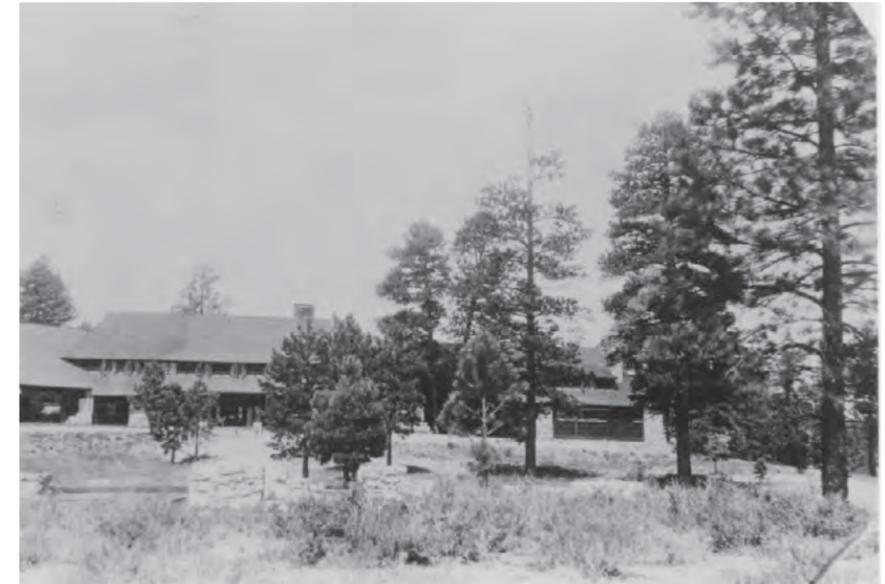
Photograph R/12. A view of the Lodge from the meadow circa 1930. The increase in vegetation from this vantage point compromises the original intent of a feeling of openness in front of the building (BCRA Archives Cope BCRA 3).

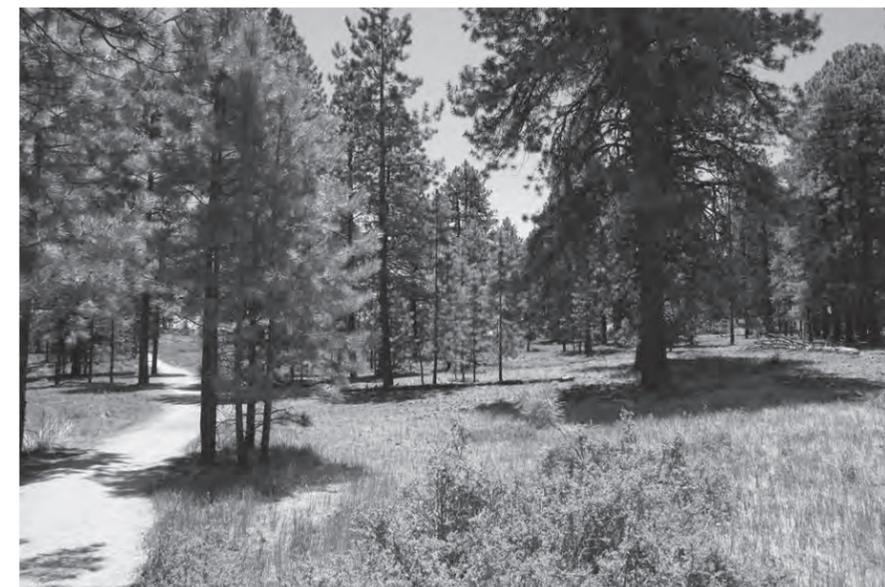
Photograph R/13. Young trees encroaching upon the edges of the meadow in front of the lodge. The shrub in the foreground is a Woods Rose, which has naturalized in the meadow from plantings along the Lodge Access Road.

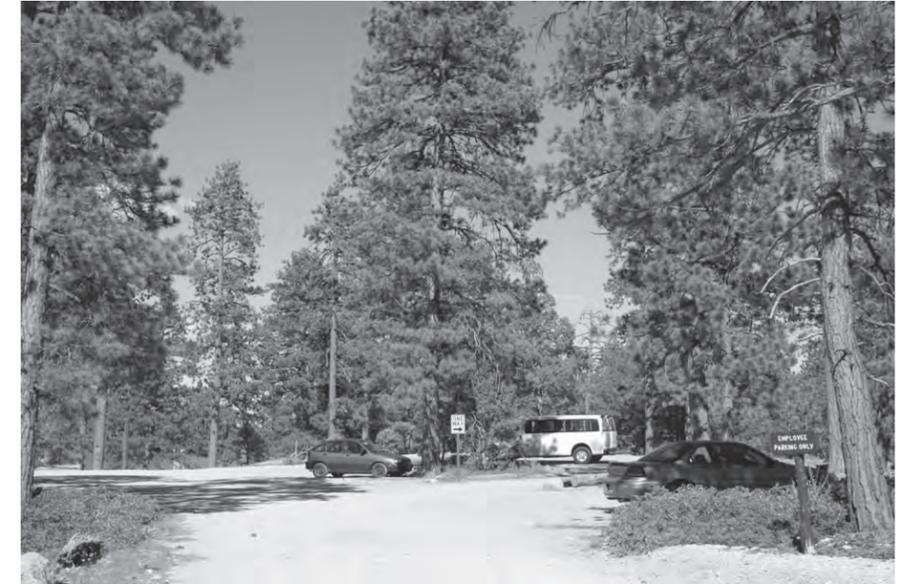
Photograph R/14. The view of the Administrative Parking Area from the Lodge Access road near the Sunset Parking Area. This area should be revegetated or used to site additional employee lodging facilities.

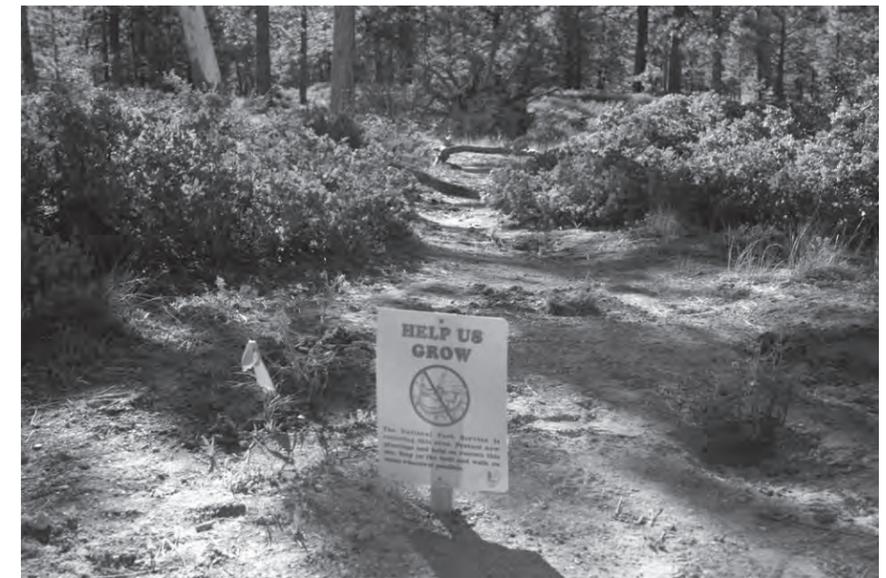
Photograph R/15. An example of signage being used to deter pedestrian traffic on a recovering social trail near the Rim Trail.

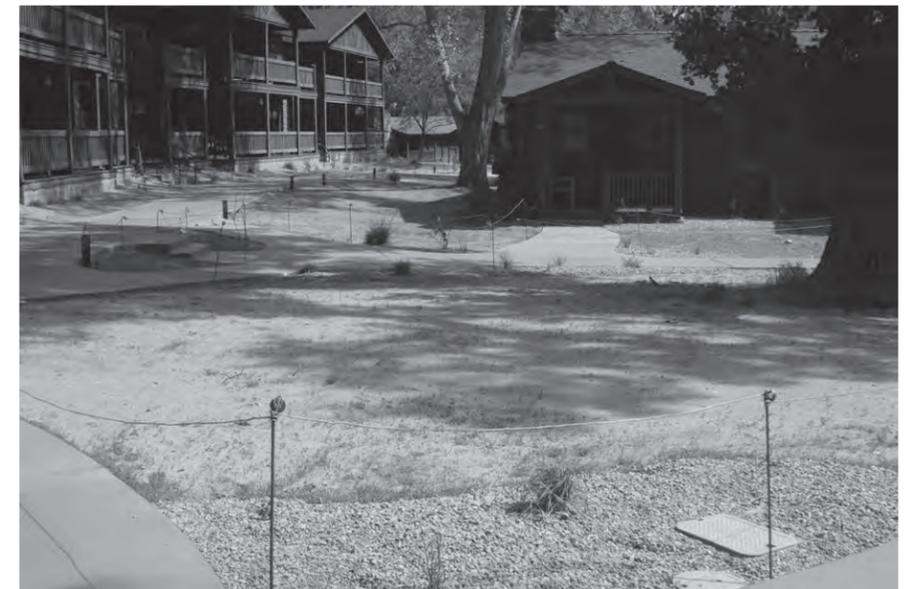
Photograph R/16. A temporary barrier in use near the lodge in Zion National Park which provides an even more obvious barrier to pedestrians while vegetation is recovering.

- Wherever trails are to be eliminated, revegetation should be completed as described in the General Recommendations. These efforts can be augmented with physical barriers to keep visitors and other pedestrian traffic from disturbing the vegetation as it is being re-established. Natural elements such as rocks and tree limbs or trunks used as barriers provide a more natural feeling to barrier design that is in keeping with the Rustic style of the Park and these treatments may satisfy immediate

aesthetic goals. However, often these materials are not interpreted by users as intentional circulation limits and they are frequently bypassed. Elsewhere in the Park, small scale man-made barriers (stakes and string) in conjunction with signage have been used explain that revegetation efforts are underway (*Photograph R/15*). This strategy can be taken a step further, with more substantial and obviously manufactured temporary barriers installed for as many seasons as necessary for solid reestablishment of the natural condition (*Photograph R/16*). Materials should be simple and visually unobtrusive in order to prevent them from being interpreted as historic but they should not distract from the historic character of the Study Area as a whole. Barriers should be planned in conjunction with informative signage described above.

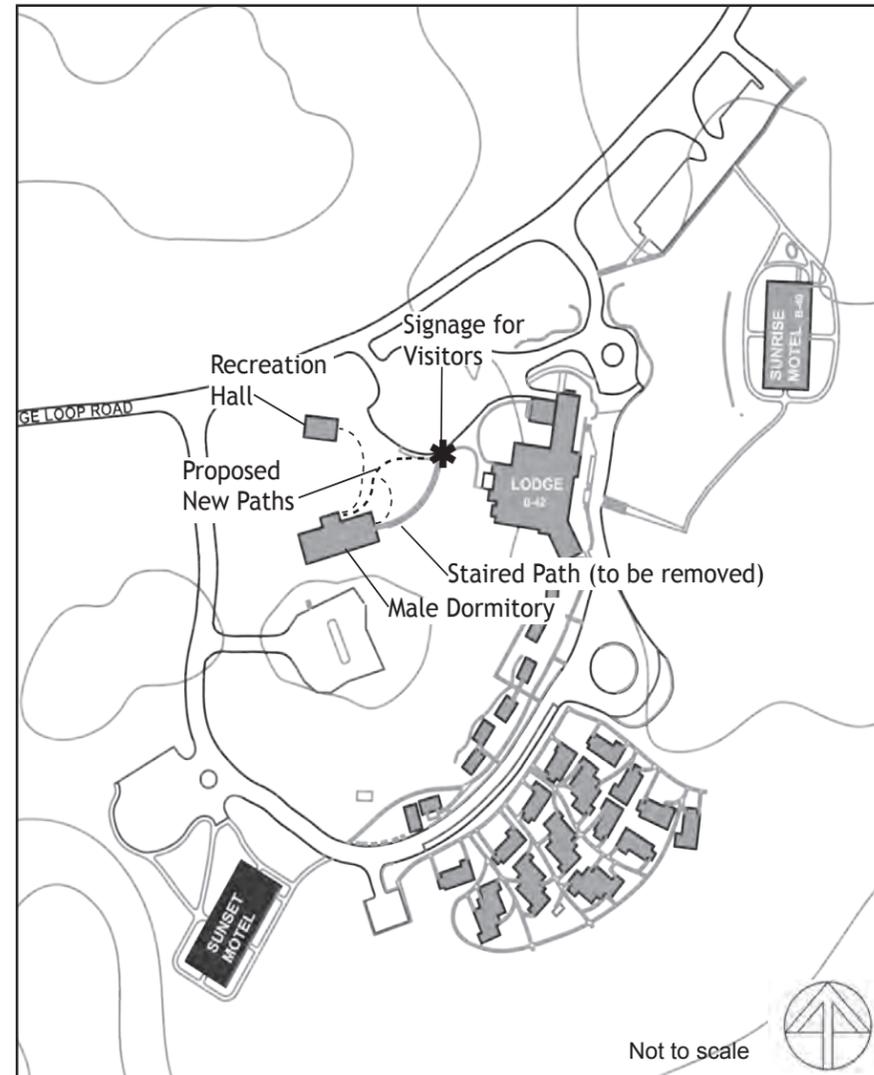
Entry to the Dormitory (Figure 5-8)

- Areas impacted by the former trail alignment or construction of the new trail should receive a revegetation treatment consistent with the General Recommendations, with the inclusion of the signage and barrier recommendations for social trails above.

- Currently, neither the Male Dormitory nor the Recreation Hall meets universal accessibility standards. The redesign effort should explore options which would improve accessibility within a historically correct design aesthetic.

- The new path system should be accompanied with appropriate signage indicating that this is a residential area, discouraging visitors from approaching the residential buildings.

Figure 5-8. Proposed Realignment of the Path to the Male Dormitory.

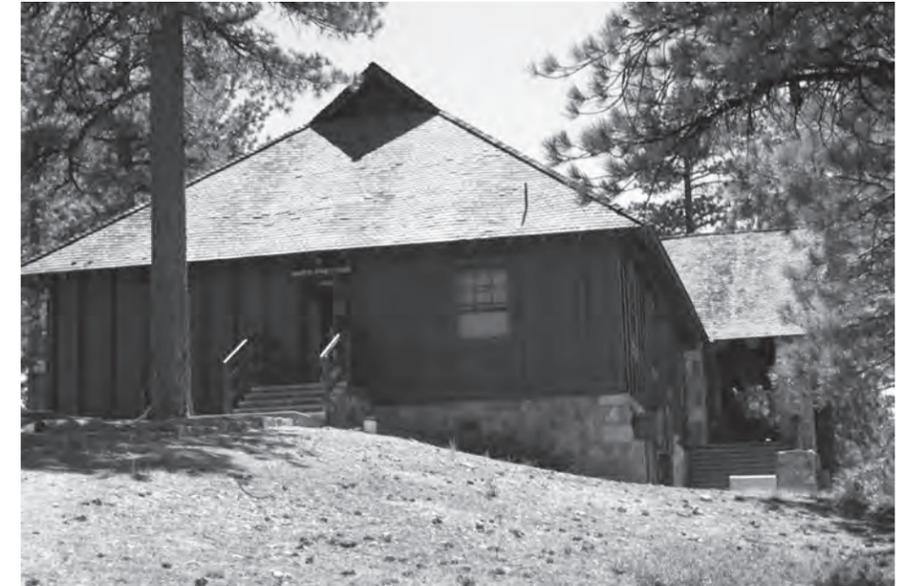
Photograph R/16. The current entry bypasses the main building entrance (to the right in the photo) and uses the side entrance as primary building access. The original entrance should be reclaimed through the installation of a new pathway.
