Casa Grande Ruins National Monument Landscape Assessment

CASA GRANDE
NATIONAL MONUMENT
PREHISTORIC RUINS
NATIONAL PARK SERVICE
U.S. DEPARTMENT OF INTERIOR

Gina Chorover, MS, MLA, AICP
University of Arizona

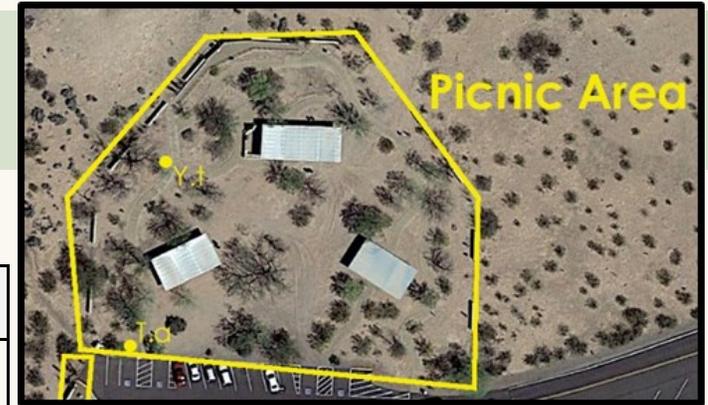
Picnic Area

Plant	Common Name	#	Notes (native/near/non)
<i>Vachellia constricta</i> , <i>Acacia constricta</i>	Whitethorn acacia	1	Pinal Native
<i>Atriplex polycarpa</i>	Cattle saltbush	1	Pinal Native
<i>Carnegiea gigantea</i>	Saguaro	5	Pinal Native
<i>Ferocactus cylindraceus</i>	Fire barrel cactus	1	Pinal Native
<i>Fouquieria splendens</i>	Ocotillo	7	Pinal Native
<i>Lycium exsertum</i>	Gray wolfberry	2	Pinal Native
<i>Olneya tesota</i>	Ironwood	8	Pinal Native
<i>Parkinsonia florida</i> and <i>Parkinsonia microphylla</i>	Blue palo verde and Foothill palo verde	7	Pinal Natives
<i>Opuntia engelmannii</i>	Engelmann prickly pear	1	Pinal Native
<i>Prosopis glandulosa</i>	Honey mesquite	1	Pinal Native
<i>Prosopis velutina</i> (and hybrids)	Velvet mesquite (and hybrids)	~10	Pinal Native
<i>Tephrocactus articulatus</i> var. <i>papyracanthus</i>	Paper spine cactus	1	Non-Native (Argentina)
<i>Yucca torreyi</i>	Torrey's yucca	1	Near Native (New Mexico, West Texas) Y.t on map

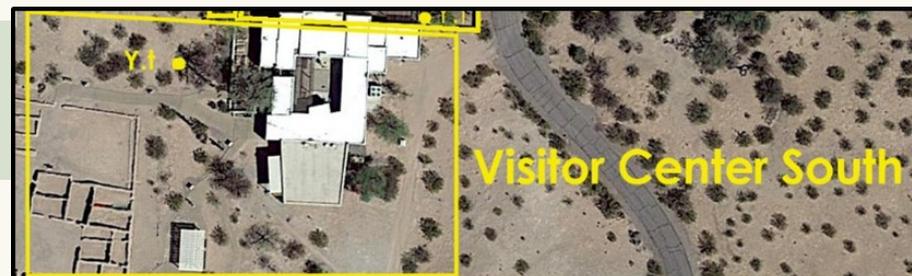
Visitor Center South Area

Plant	Common Name	#	Notes (native/near/non)
<i>Agave murpheyi</i>	Murphey's agave	1	Arizona Native - rare in nature
<i>Agave palmeri</i>	Palmer's agave	1 planter	Pinal Native
<i>Atriplex polycarpa</i>	cattle saltbush	Secondary matrix plant	Pinal Native
<i>Carnegiea gigantea</i>	Saguaro	6	Pinal Native
<i>Cylindropuntia leptocaulis</i>	Christmas cactus	1 planter	Pinal Native
<i>Echinocereus sp</i>	Hedgehog cactus	1 planter, 1 west side	Pinal Native
<i>Ferocactus cylindraceus</i>	Fire barrel cactus	1	Pinal Native
<i>Ferocactus wislizeni</i>	Fishhook barrel cactus	2	Pinal Native
<i>Fouquieria splendens</i>	Ocotillo	3	Pinal Native
<i>Larrea tridentata</i>	Creosotebush	Primary matrix plant	Pinal Native
<i>Lycium berlandieri</i>	Berlandier wolfberry	1 courtyard	Pinal Native
<i>Mammillaria grahamii</i>	Arizona fishhook cactus	1 planter	Pinal Native
<i>Opuntia santa-rita</i>	Santa Rita pricklypear	1 planter	Pinal Native

<i>Pachycereus schottii</i>	Senita cactus	2	Pinal Native
<i>Parkinsonia florida and/or Parkinsonia microphylla</i>	Blue palo verde and/or Foothill palo verde	3	Pinal Native
<i>Peniocereus greggii</i>	Night Blooming Cereus, Queen of the Night	1 courtyard	Pinal Native
<i>Prosopis velutina (and hybrids)</i>	Velvet mesquite and hybrids	3	Pinal Native
<i>Yucca torreyi</i>	Torrey's yucca	1	Near Native (New Mexico, West Texas) Y.t on map

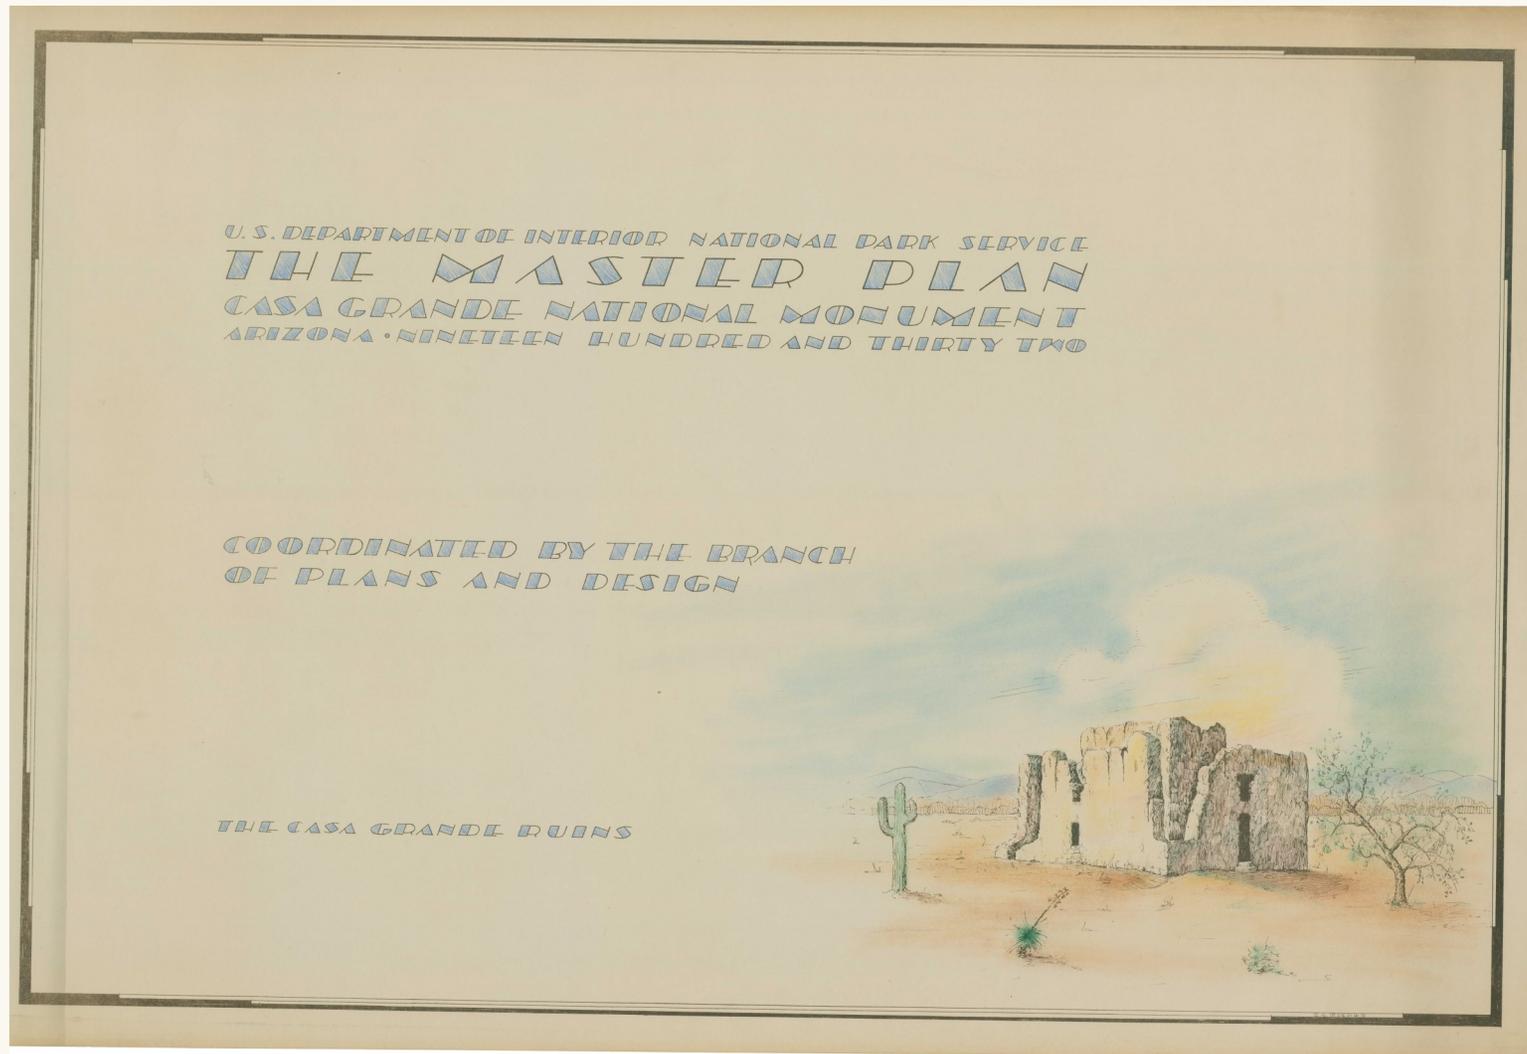
Between 1928 and 1933, NPS landscape architect Thomas C Vint and Southwestern National Monument (SWNM) Superintendent Frank Pinkley drafted a series of master plans for buildings, roads, and signs within the Monument to create the Visitor and Operations Complex. The following slides include the original plans.

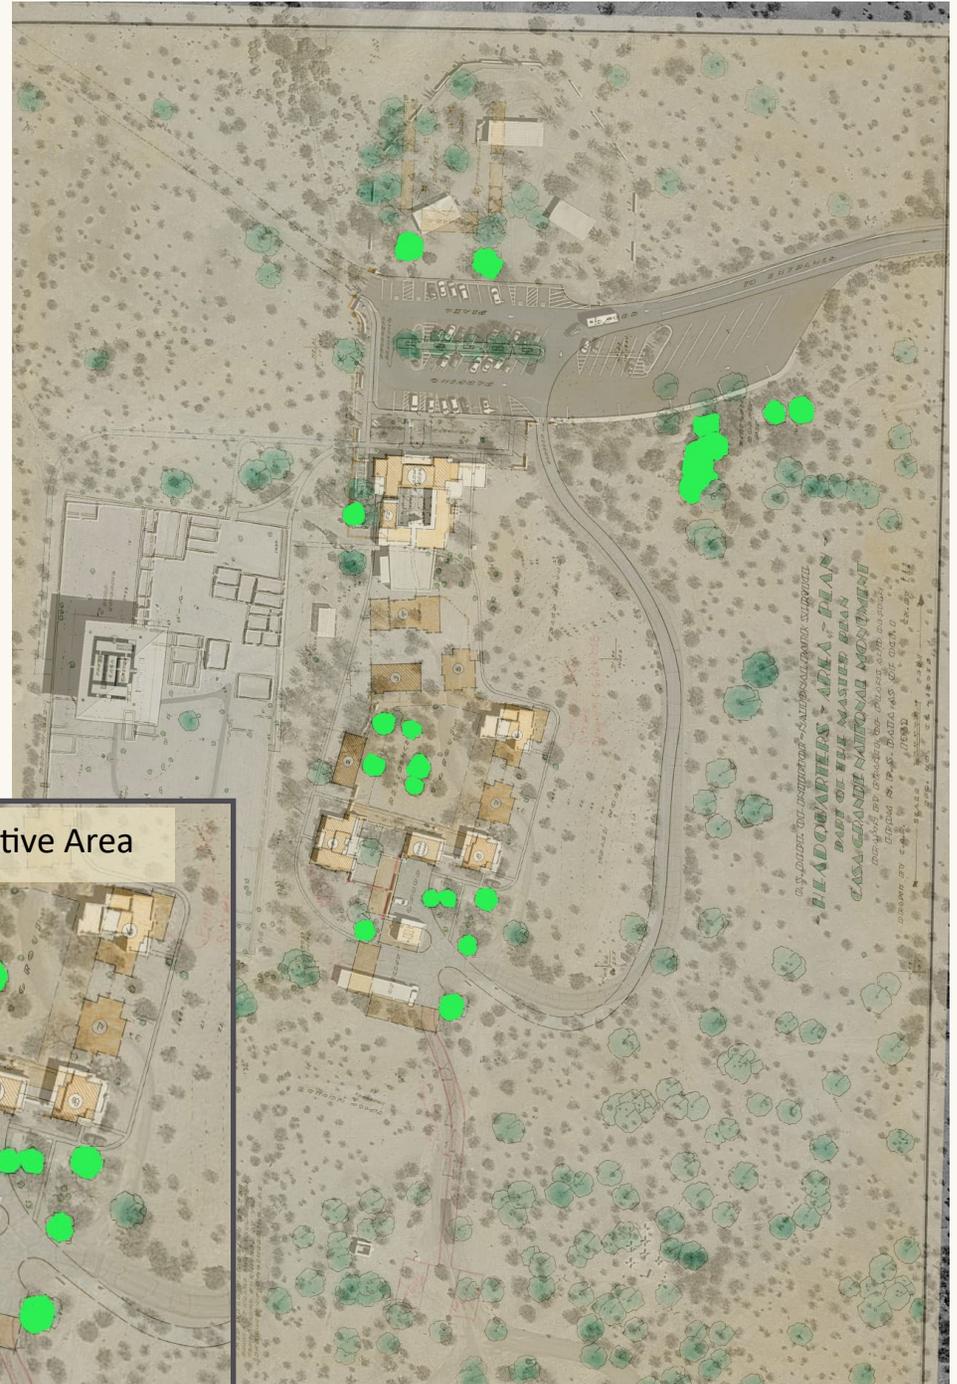
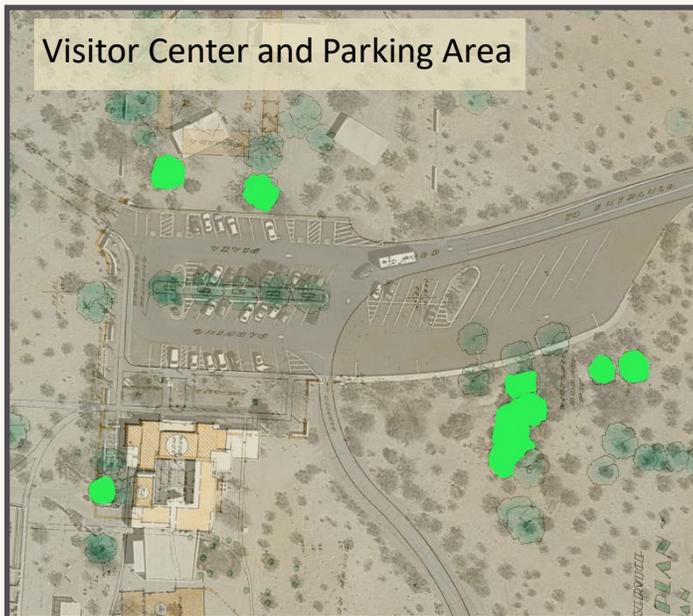
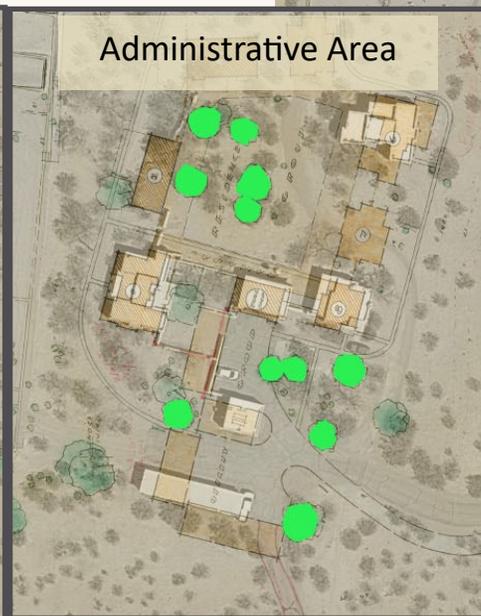
1932 Master Plan Overlay

A comparison of the 1932 master plan with a contemporary aerial photograph (2019) illustrates overlap between the two and can provide a “best guess” as to which plants may have been planted at the time of the original plan. Due to inconsistencies in the scale of the drawings vis-à-vis the aerial photos, the images do not line up perfectly so the identifying the location of historic trees from the map are estimates. The bright green trees indicate a location where the plan dictated the planting of a tree and where there currently is a tree.

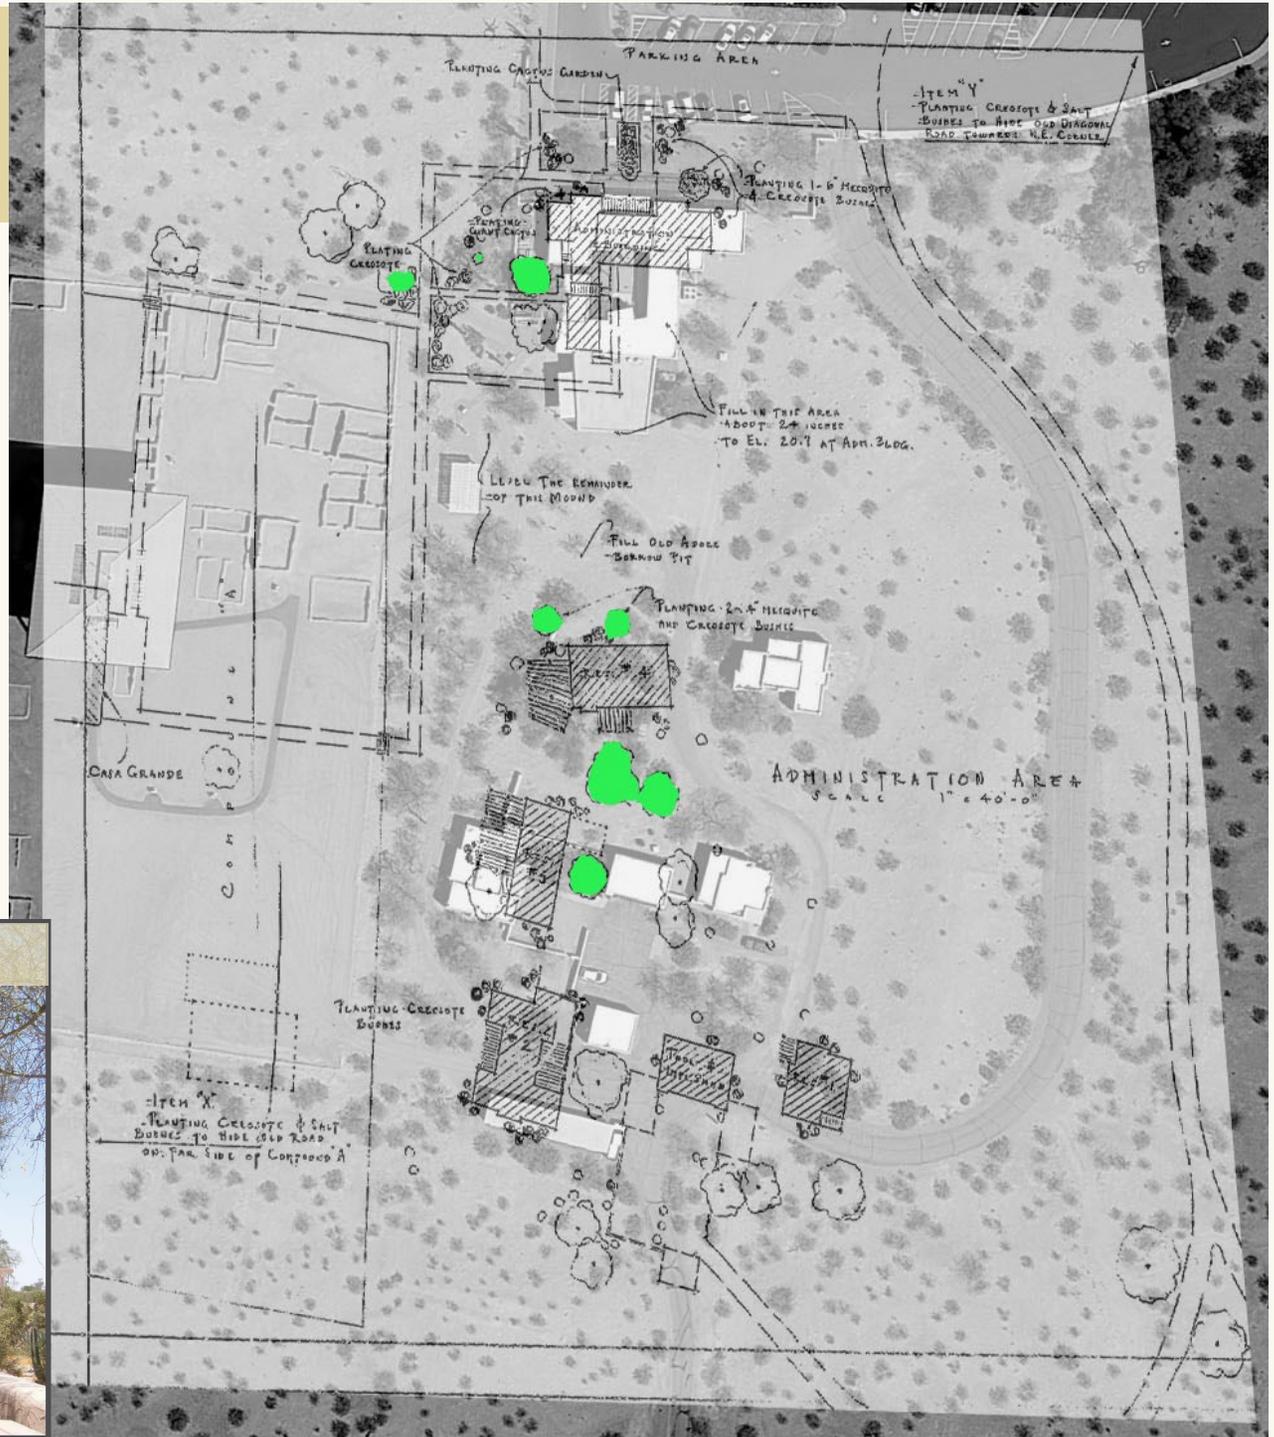
1932 Landscape and Planting: Plan Overlay

The 1932 Landscape Plan indicates the planned location of mesquite trees, creosote, saguaro cactus, and salt bush. The green shapes indicate the current location of trees, shrubs and a saguaro which matches the locations shown on the plan. Major construction and landscape work was completing during the Mission 66 improvements and likely many of the plants that were installed in the 1930s were removed or relocated during the 1960s.

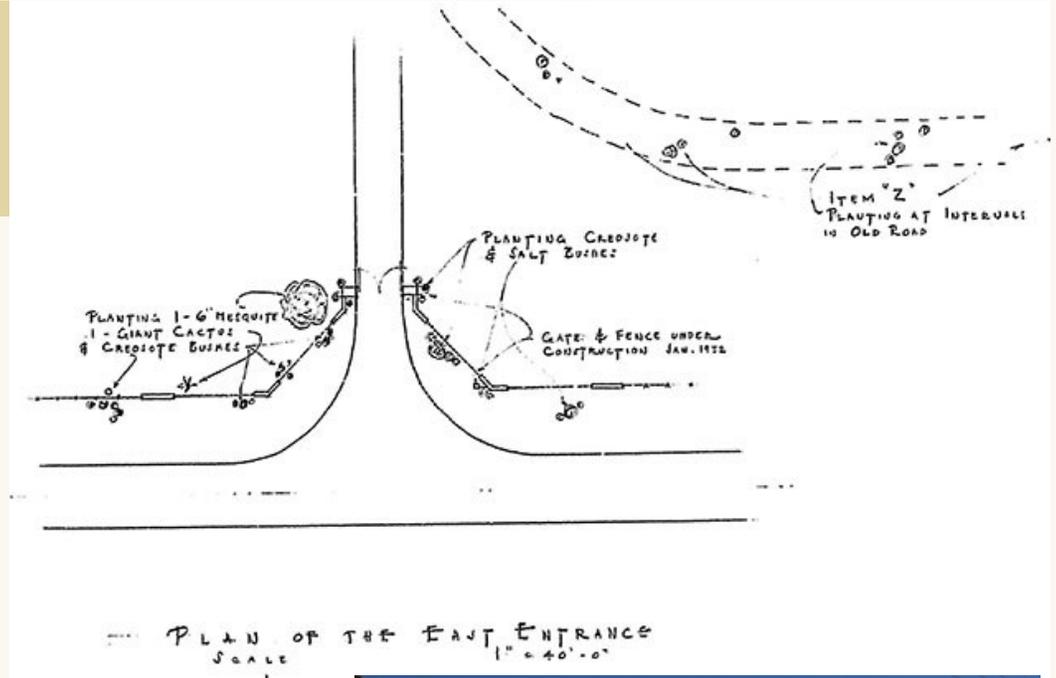
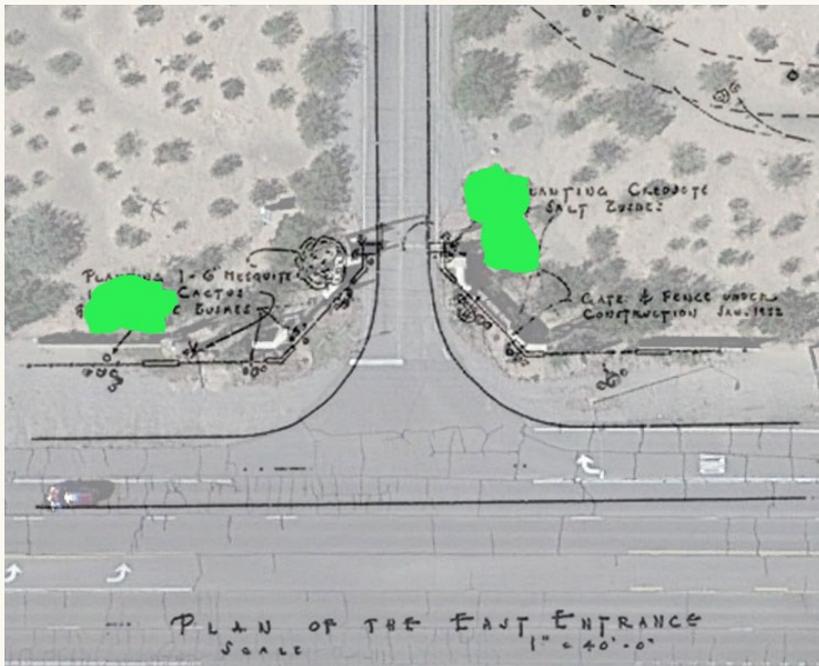
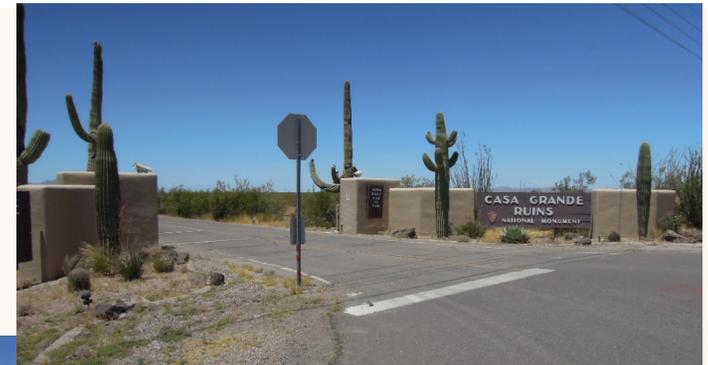
1932 Landscape and Planting Plan: Monument Entrance

The 1932 Landscape & Planting Plan for the monument entrance called for the installation of a mesquite tree, several creosote bushes and one saguaro cactus. Mature creosote can be found behind the entrance monument wall and may well be from the 1930s period. The saguaro cactus, while mature and likely quite old, do not line up with the location indicated on the plan. It's possible that the planting of the saguaro did not follow the plan or that the existing ones were planted at another time. The mesquite tree is not evident.

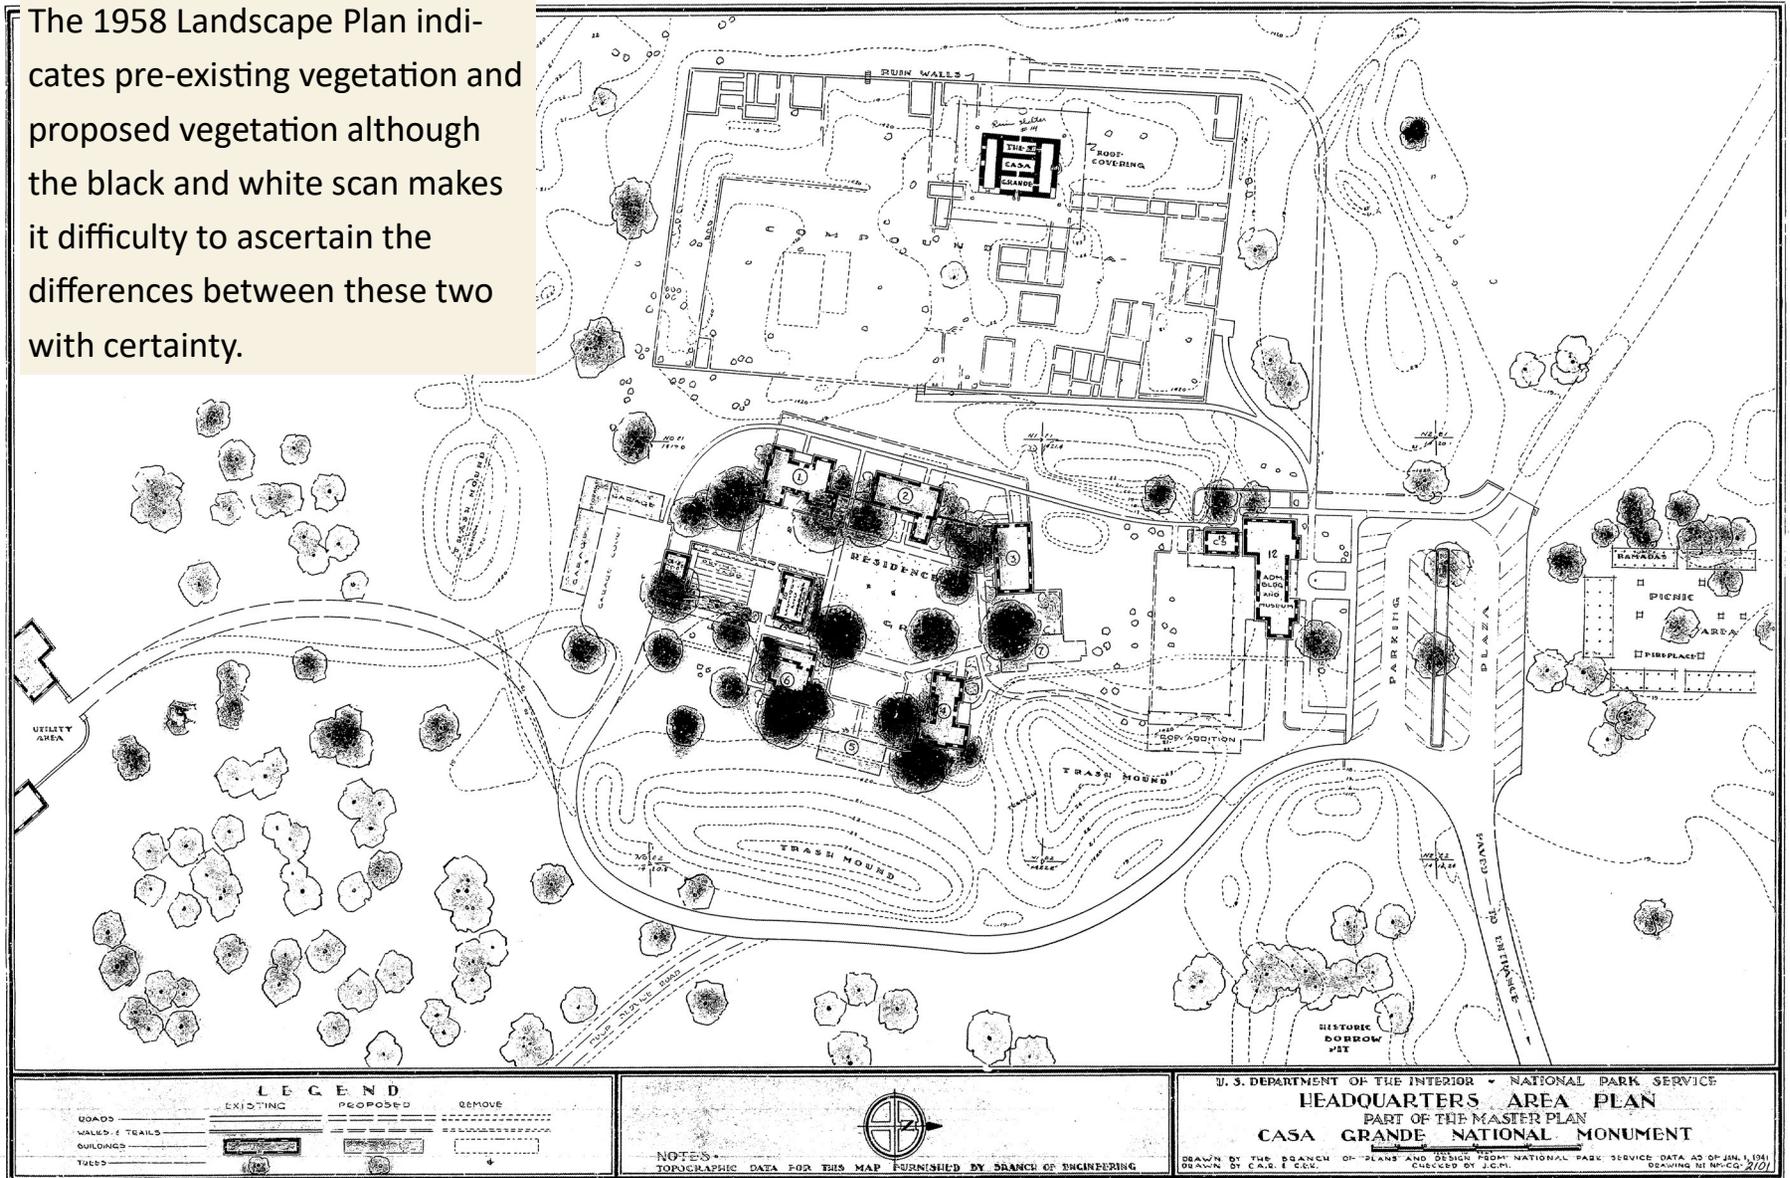
1958 Plan: Landscape

The 1958 Landscape Plan indicates pre-existing vegetation and proposed vegetation although the black and white scan makes it difficult to ascertain the differences between these two with certainty.

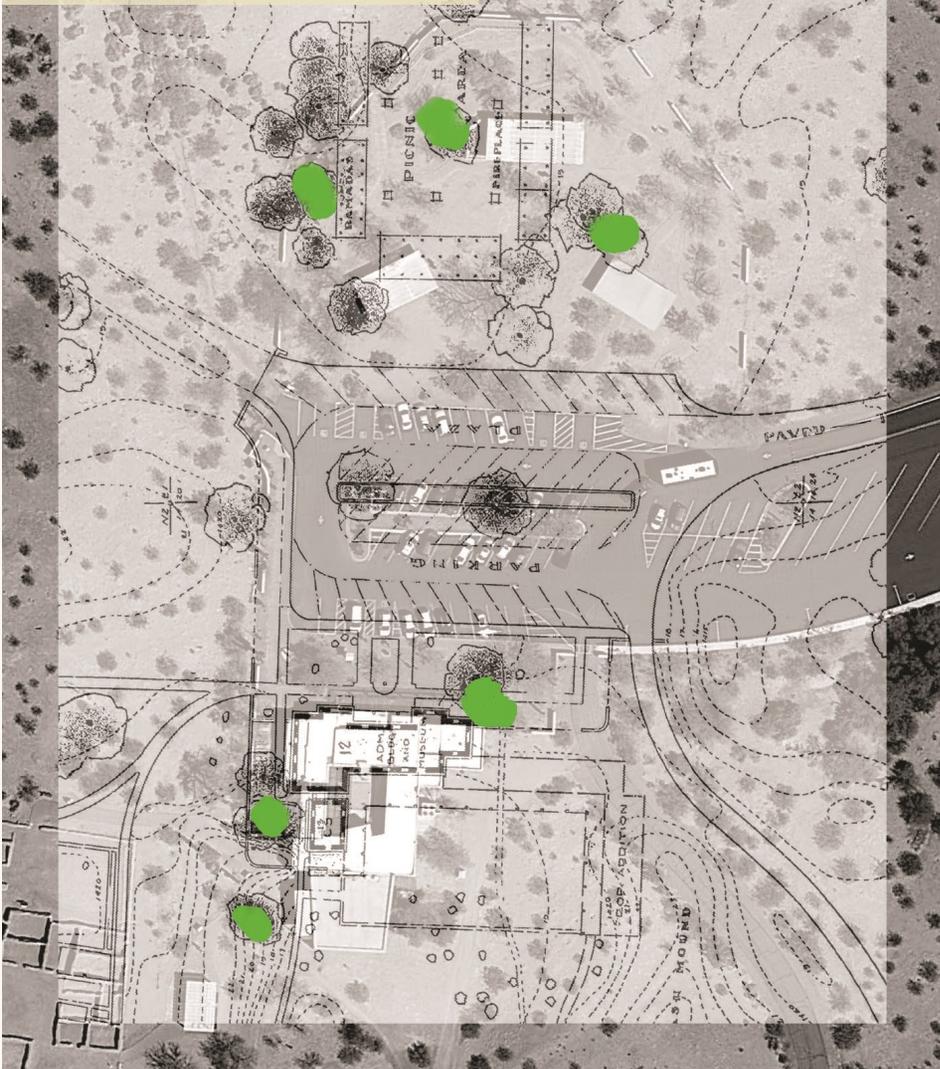
Visitor Center and Picnic Area

As it was difficult to distinguished pre-existing trees from proposed trees on the 1958 plan due to the black-and-white scans, the location of any trees shown on the plan which roughly correspond with the location of trees on the current aerial photograph are highlighted in green.

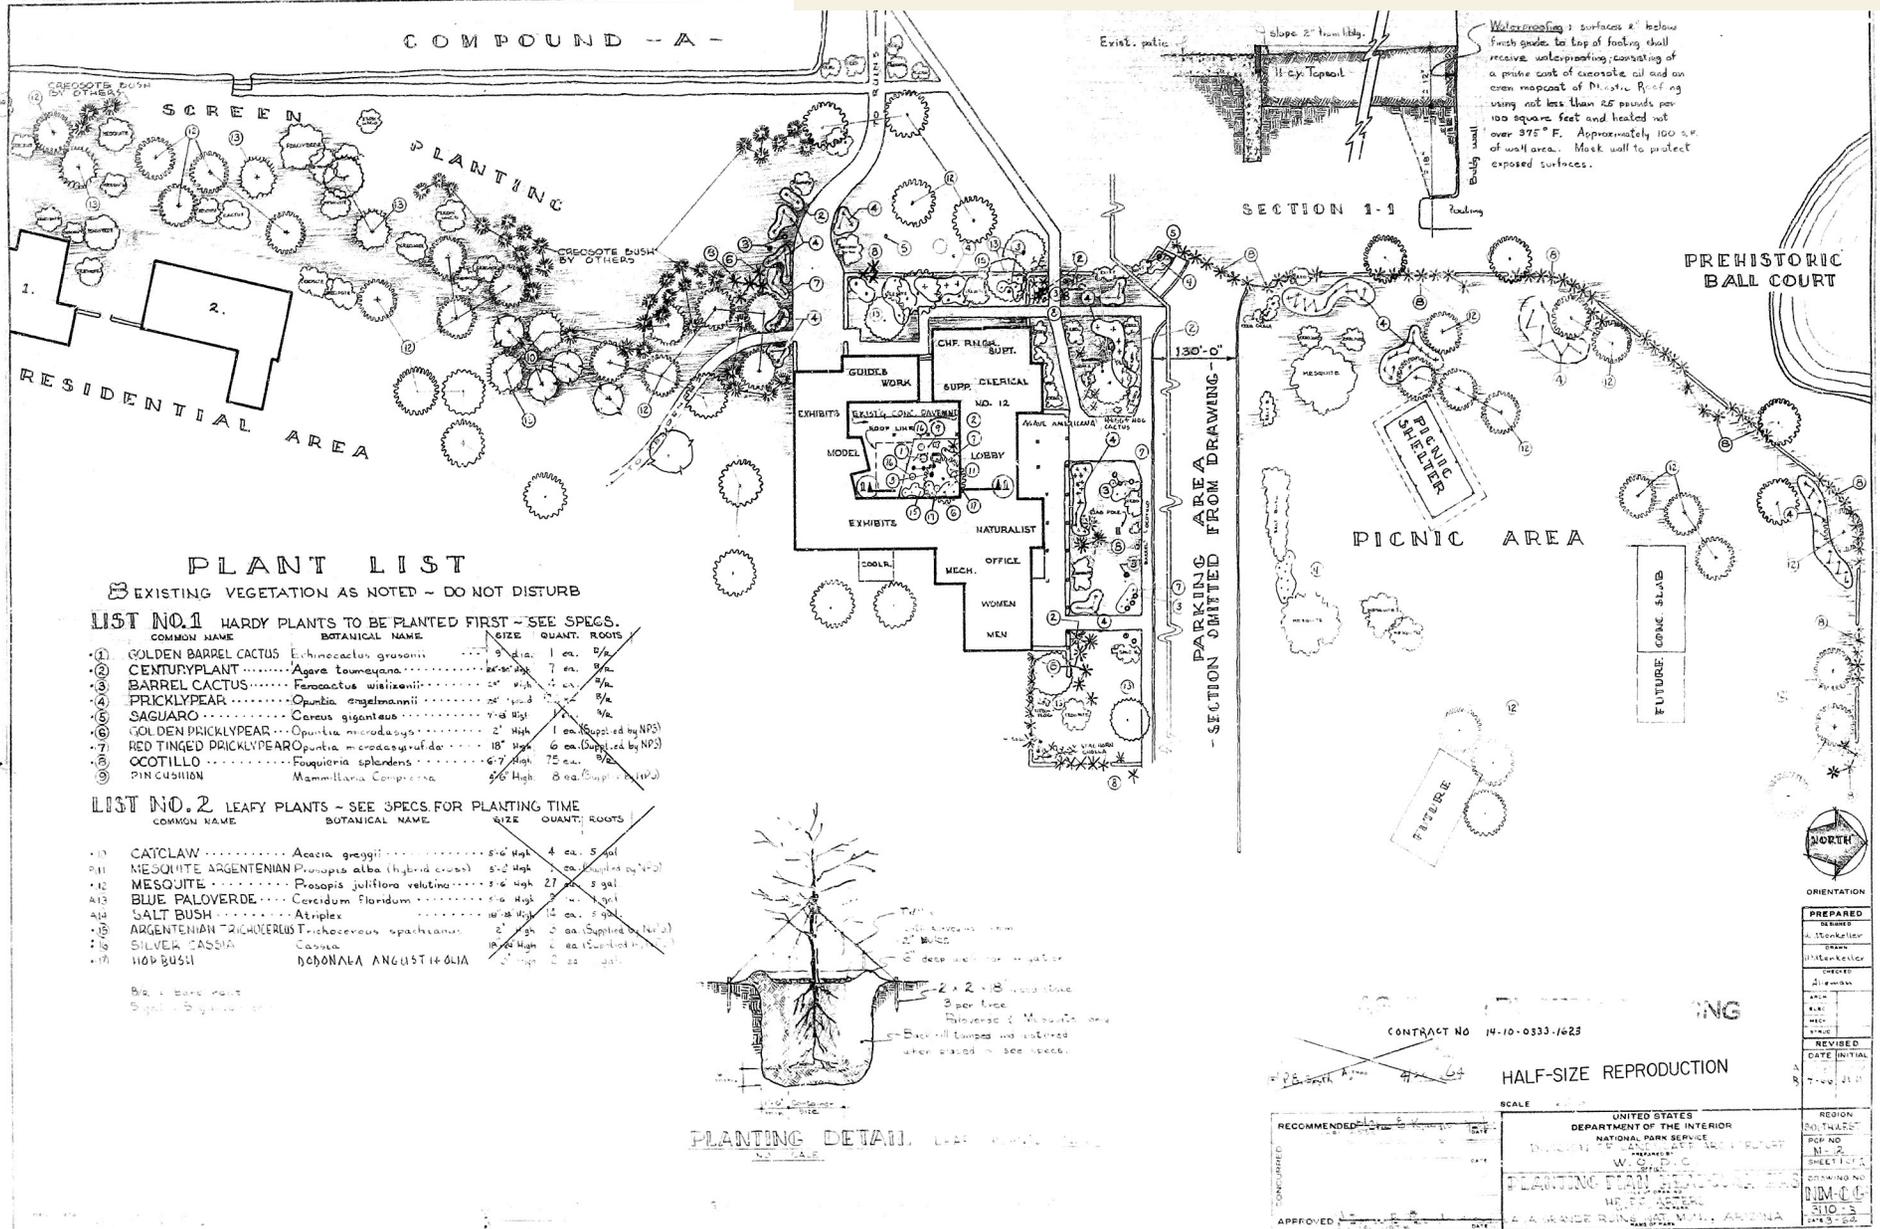
1964 Landscape Plan

The 1964 landscape plan was prepared as part of the NPS Mission 66 program. Improvements included expanding and remodeling the visitor's center, improvements to the picnic area, the installation of new plant materials and enhancement of the picnic area.
