**National Register of Historic Places
Registration Form**

1. Name of Property Chiricahua National Monument Historic Designed Landscape

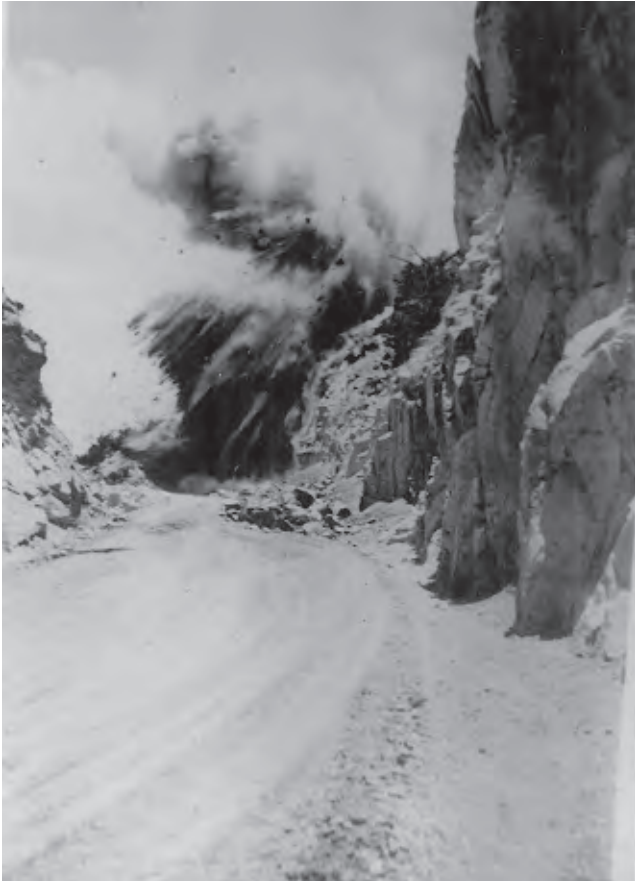
Figure 3. Blasting overhanging rock on Bonita Canyon Highway.

- Figure 3. Blasting overhanging rock on Bonita Canyon Highway. Chiricahua National Monument Archives.
- Figure 4. Air compressor used for drilling rock on Bonita Canyon Highway. Chiricahua National Monument Archives.

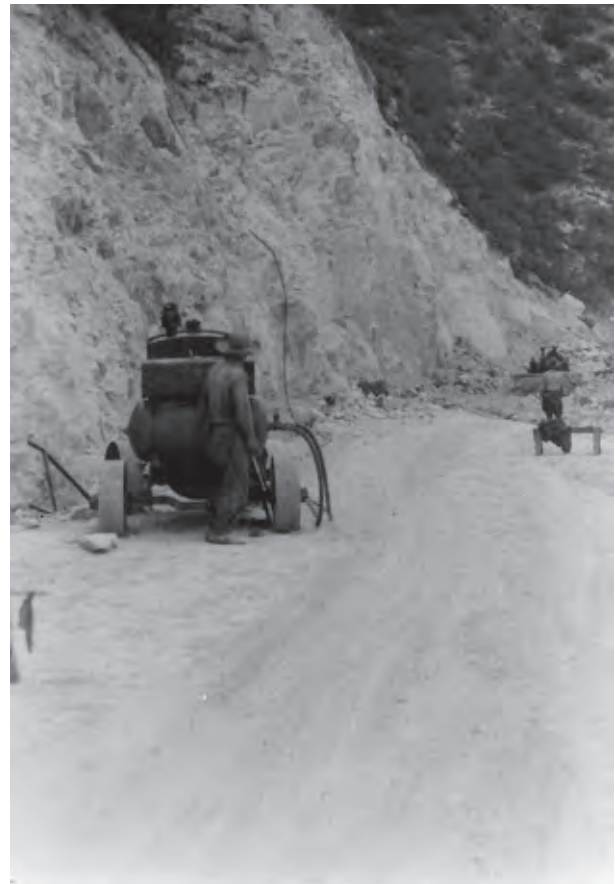
Figure 4. Air compressor used for drilling rock on Bonita Canyon Highway.

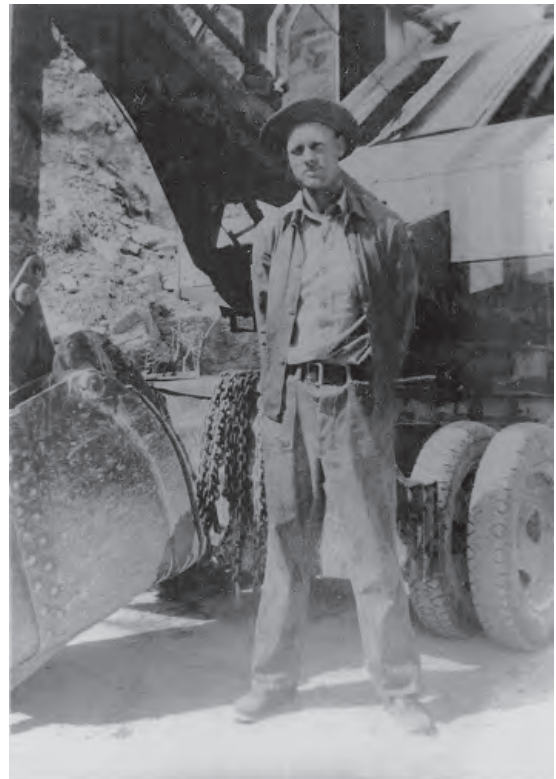
Figure 6. Shovel truck used on Bonita Canyon Highway.

- Figure 5. Clearing Bonita Canyon Highway after blasting. Chiricahua National Monument Archives.
- Figure 6. Shovel truck used on Bonita Canyon Highway. Chiricahua National Monument Archives.

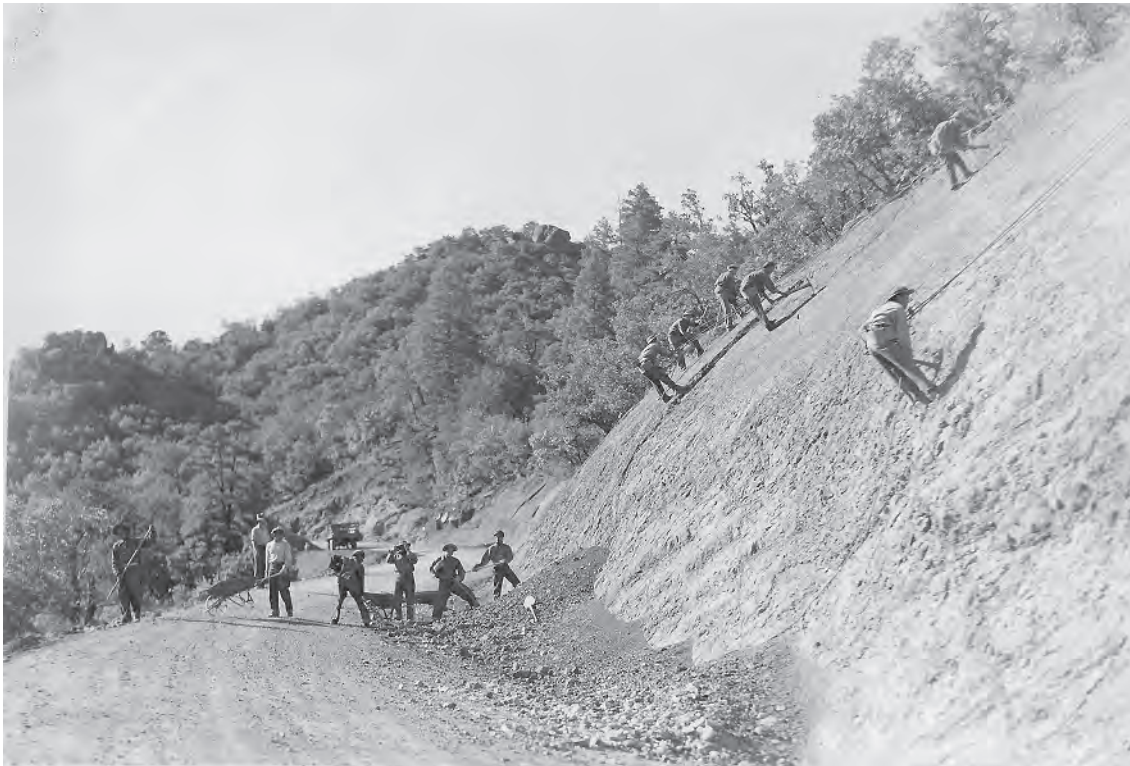
Figure 7. Road crew uses picks and shovels in backsloping effort on Bonita Canyon Highway.

- Figure 7. Backsloping on Bonita Canyon Highway. Chiricahua National Monument Archives.
- Figure 8. Clearing slide debris on Bonita Canyon Highway. Chiricahua National Monument Archives.

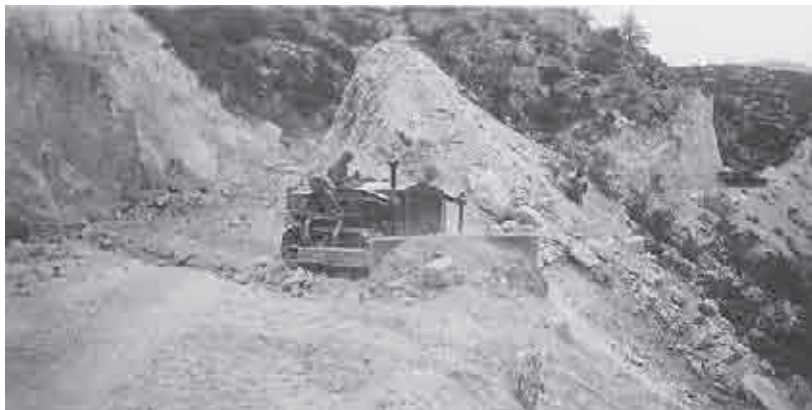
Figure 8. Clearing blasting debris on Bonita Canyon Highway

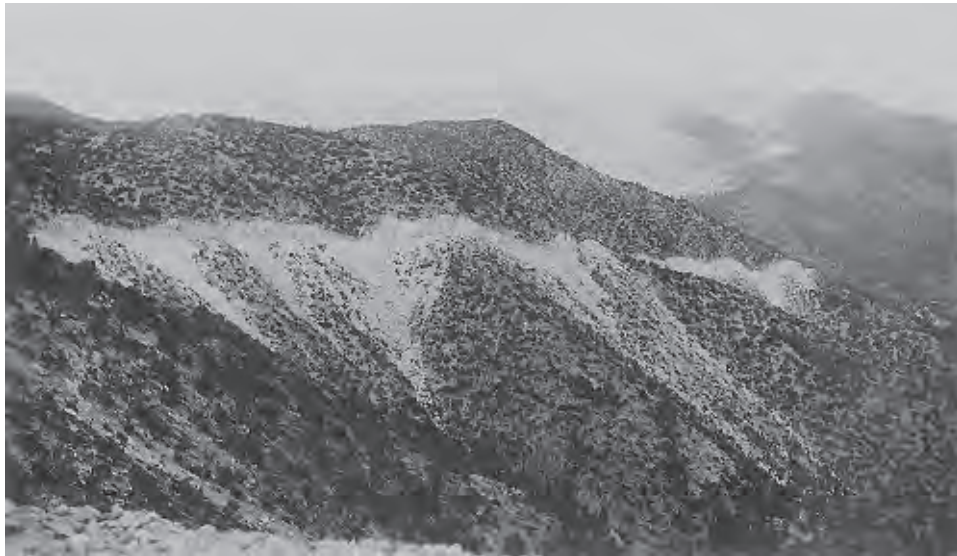
Figure 9. Road scars on Bonita Canyon Highway, 1935.

- Figure 9. Road scars on Bonita Canyon Highway, 1935. Chiricahua National Monument Archives.
- Figure 10. Road scars on Bonita Canyon Highway, 2003. R.L. Pinto.

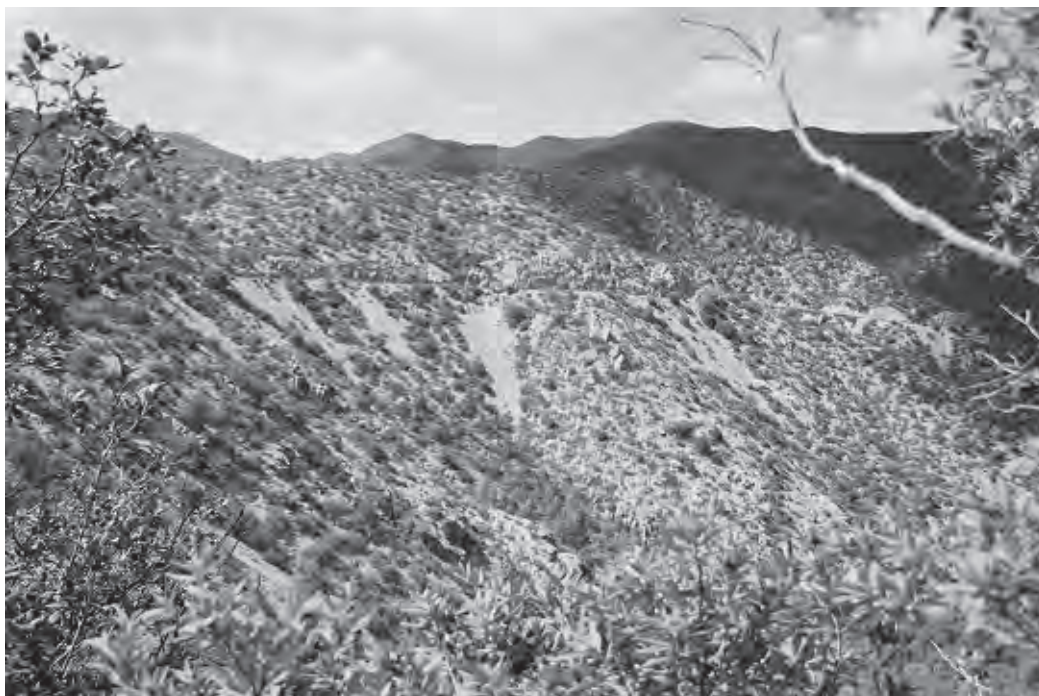
Figure 10. Road scars on Bonita Canyon Highway, 2003.

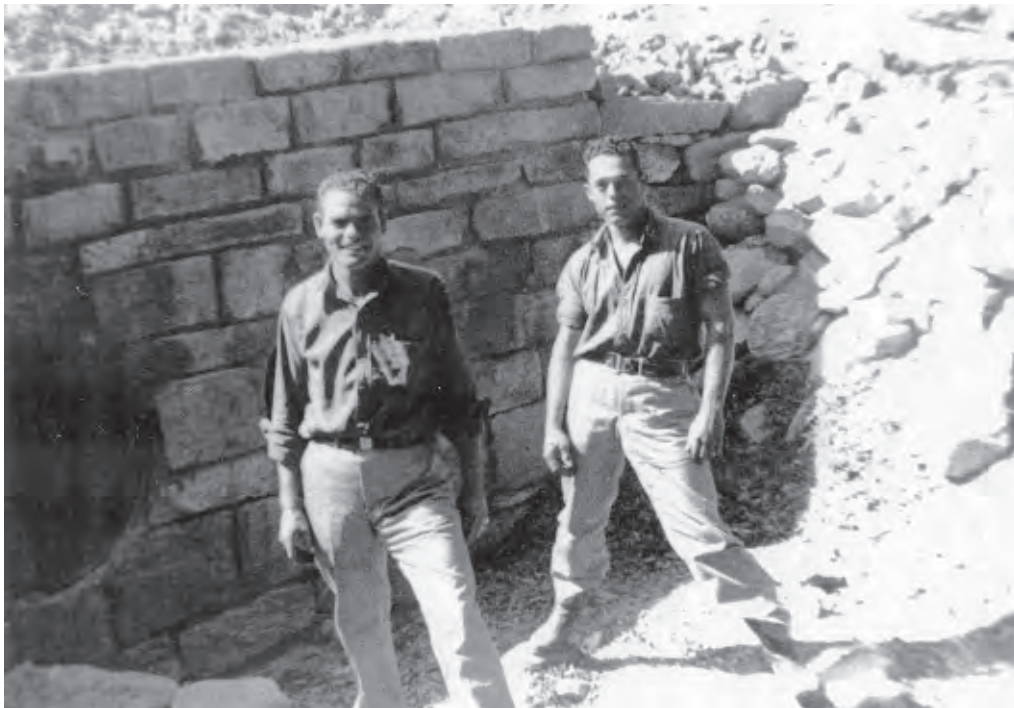
Figure 11. CCC enrollees reconstructed many Bureau of Public Roads culverts.

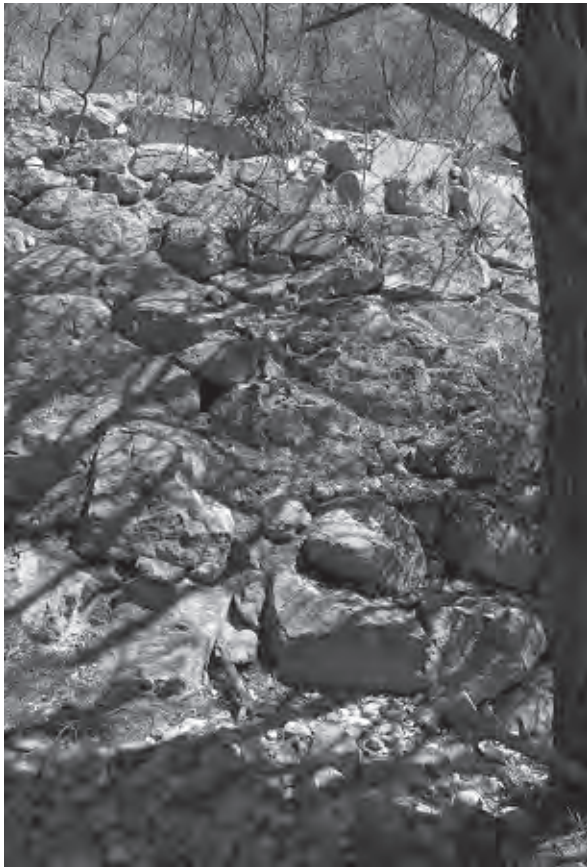
Figure 12. Riprap along Bonita Canyon Creek, 2004.

- Figure 11. CCC enrollees reconstructed many Bureau of Public Roads culverts. Chiricahua National Monument Archives.
- Figure 12. Riprap along Bonita Canyon Creek, 2004. R.L. Pinto.

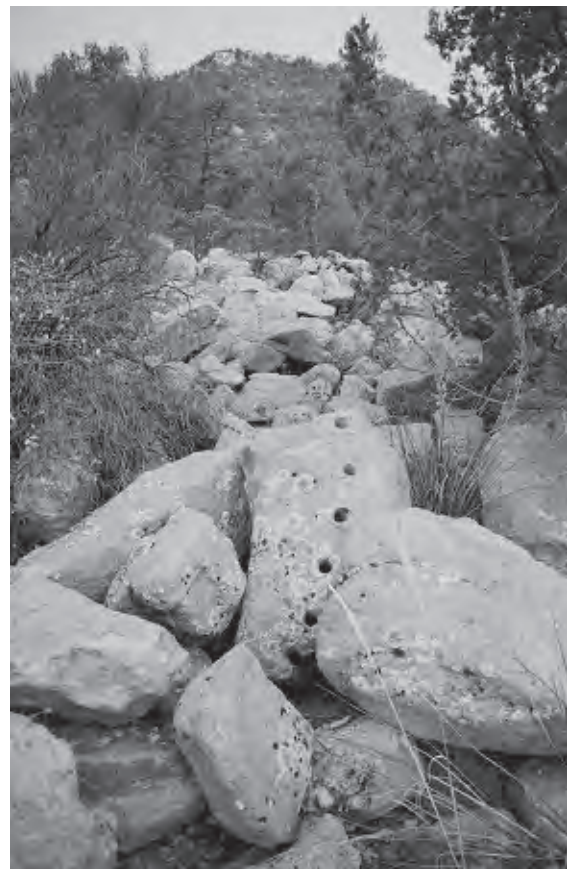
Figure 13. Old BPR borrow pit located near Campground and later used by CCC for dumping road construction debris, 2003.

- Figure 13. Old BPR borrow pit located near Campground and later used by CCC for dumping road construction debris, 2003. R.L. Pinto.
- Figure 14. Old BPR borrow pit located near north slope of Sugarloaf Mountain and partially covered with topsoil by CCC road crew to encourage revegetation, 2003. R.L. Pinto.

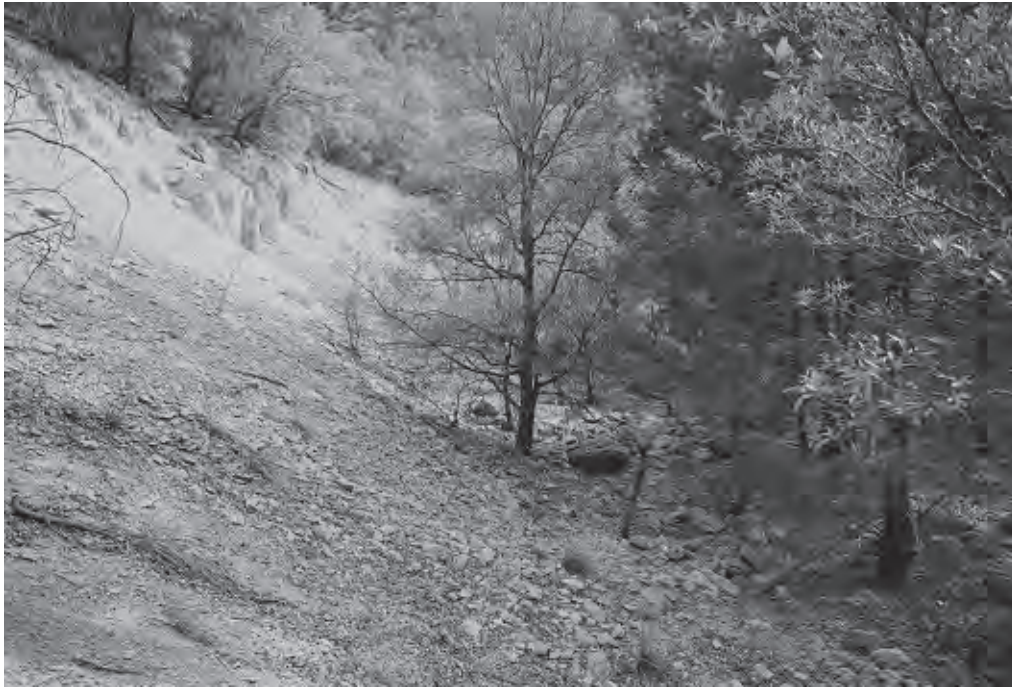
Figure 14. Old BPR borrow pit located near north slope of Sugarloaf Mountain and partially covered with topsoil by CCC road crew to encourage revegetation, 2003.

Revegetation of damaged areas became a major project in the later years of the CCC Camp. Revegetation efforts occurred at the Visitor Center, Residential Area, Massai Point, Public Campground and the CCC Campsite. Revegetation efforts made use of locally available, native species of trees and shrubs that were specific to the slope, orientation and elevations of the site. CCC enrollees also covered in topsoil and replanted sections of old, abandoned Forest Service roads and the borrow pits created by the Bureau of Public Roads.

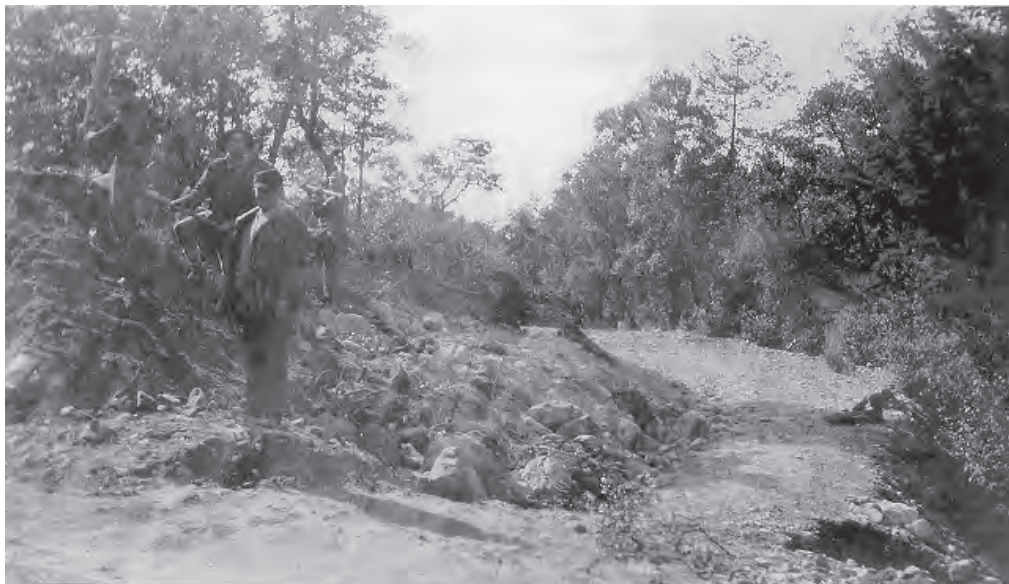
Figure 15. CCC road crew obliterating old Forest Service road.

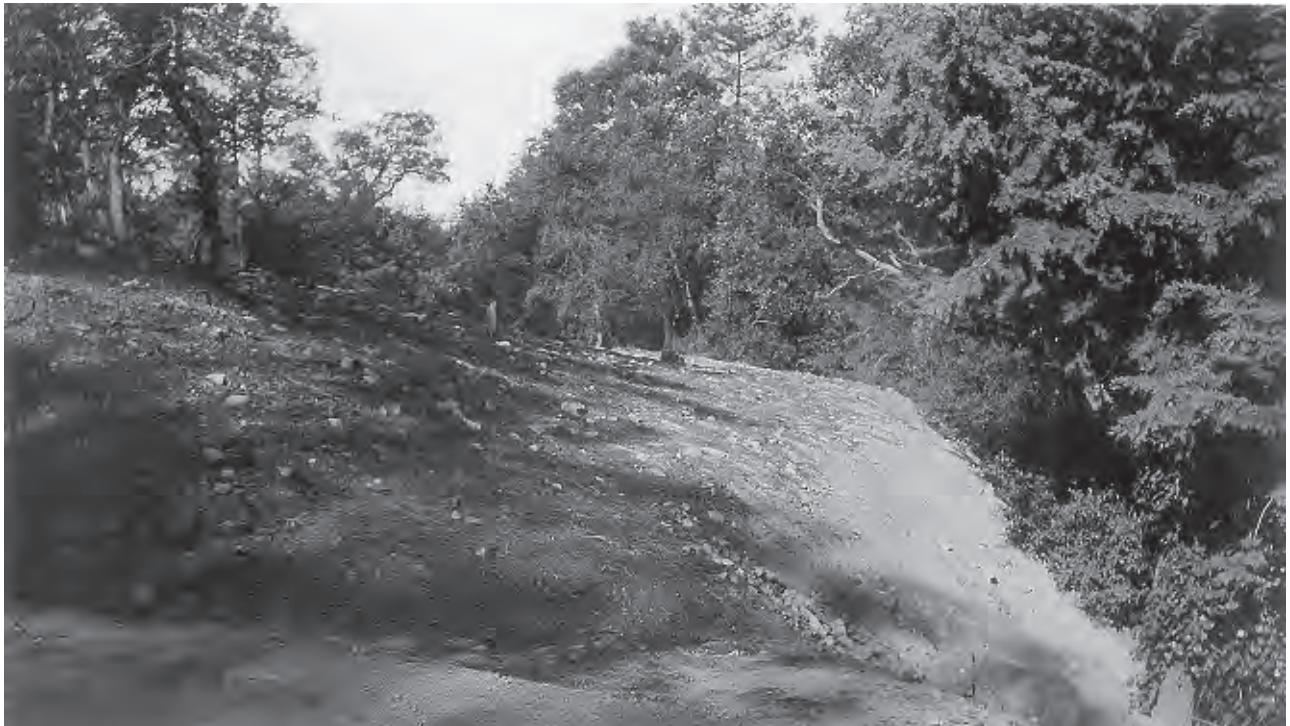
Figure 16. Obliteration of old road completed.

- Figure 15. CCC road crew obliterating old Forest Service road, 1935. Chiricahua National Monument Archives.
- Figure 16. Obliteration of old road completed, 1935. Chiricahua National Monument Archives.

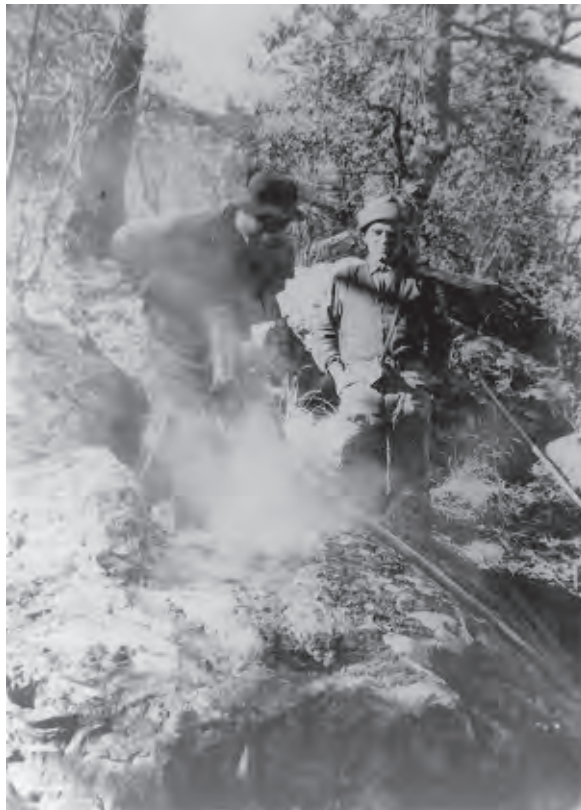
Figure 21. CCC trail crew using air-powered jackhammer to cut through rock.

Figure 21. CCC trail crew using air-powered jackhammer to cut through rock. Chiricahua National Monument Archives.

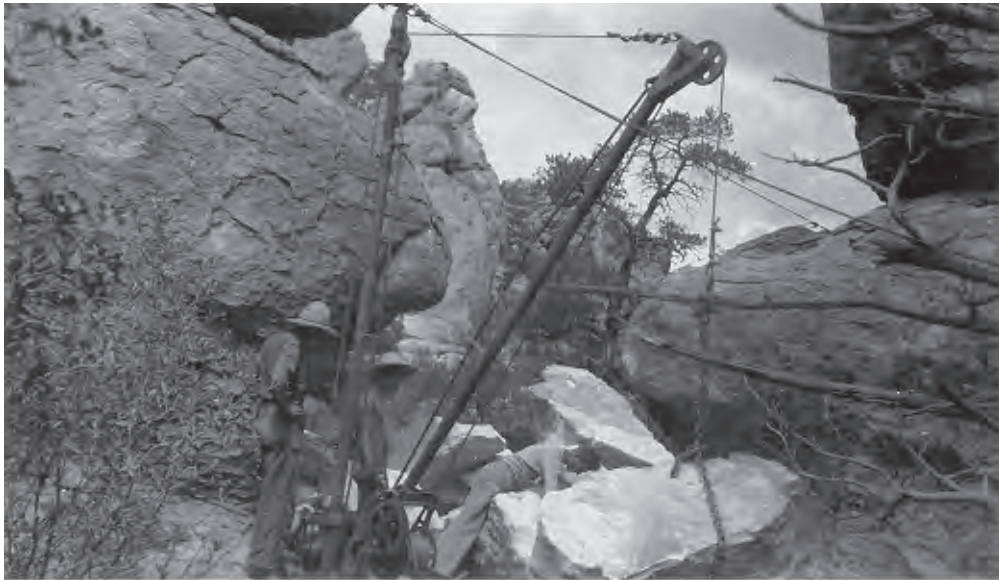
Figure 22. Trail crews used a portable hoist system with boom and winch to move large rocks.

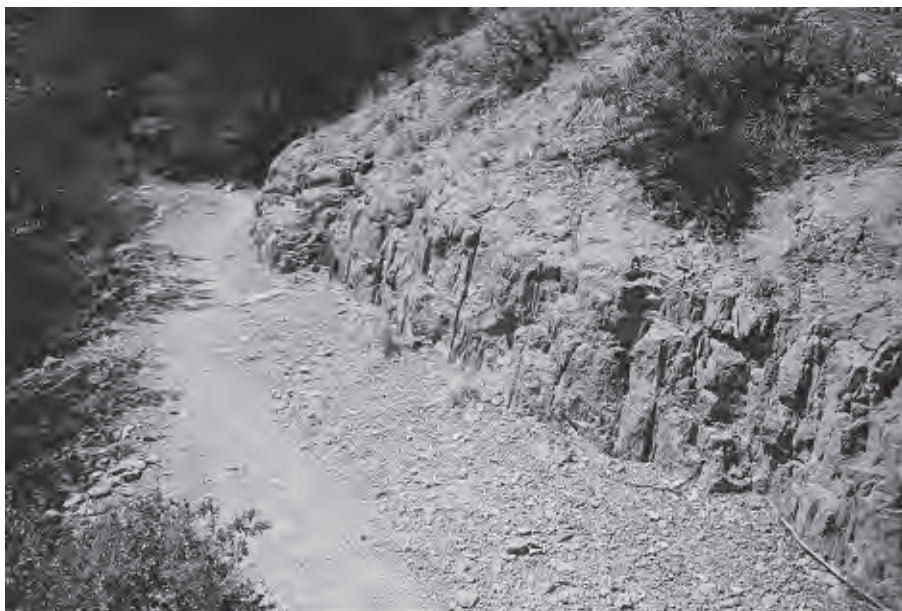
Figure 23. Evidence of drill work in upper slope cuts on Lower Rhyolite Trail.

Figure 23. Evidence of drill work in upper slope cuts on Lower Rhyolite Trail, 2002. R.L. Pinto.

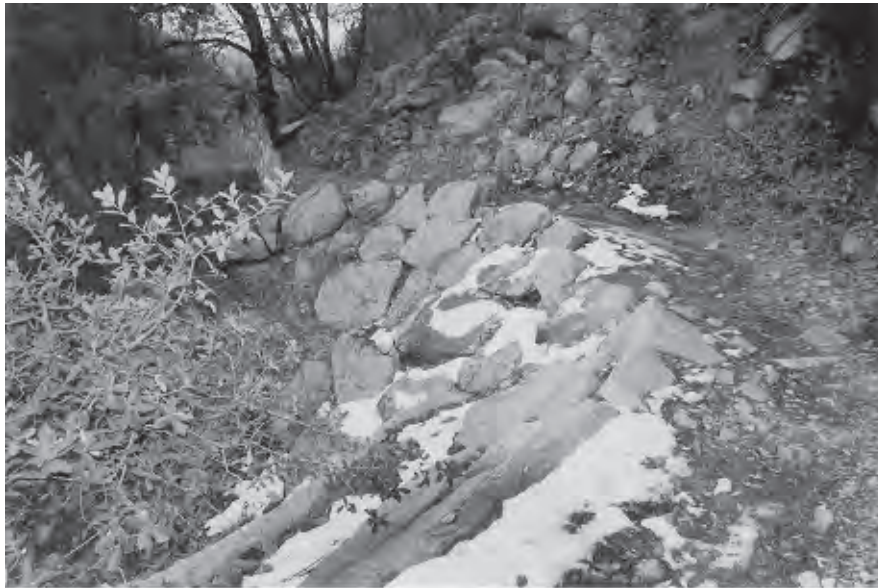
Figure 24. Retaining walls on Lower Rhyolite Trail show damage from rainstorms, 2002.

In the recent past, flood damage and wear have caused problems for many CCC-constructed features including retaining walls, curbs, water bars, and drainage ditches (Travis 2001). Comparisons between historic and modern photographs indicate that much of the tread on the trail has been lost (Figures 26, 27). The integrity of Echo Canyon, despite its need for maintenance, is very good. The integrity of the Echo Canyon Dam is very good.

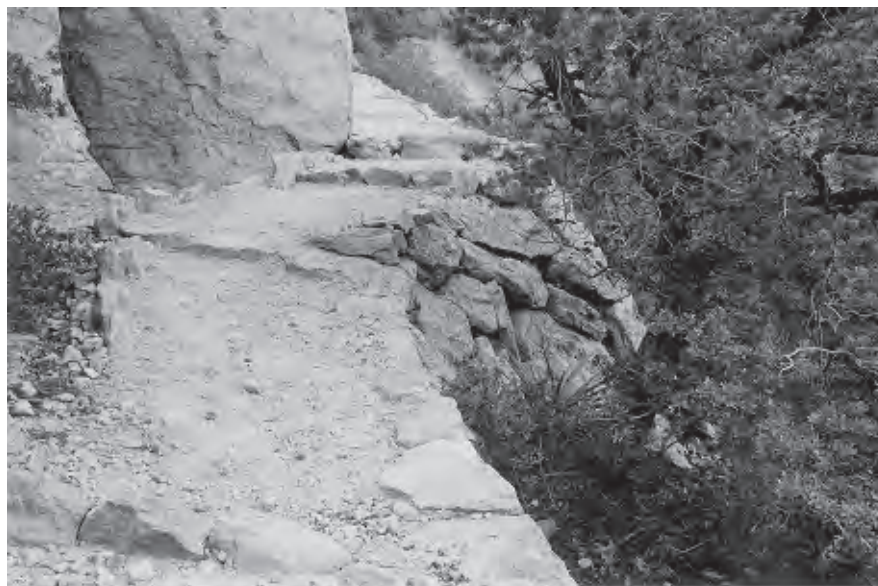
Figure 25. Echo Canyon trail contains numerous constructed features: water bars, retaining walls, and drainage channels, 2002.

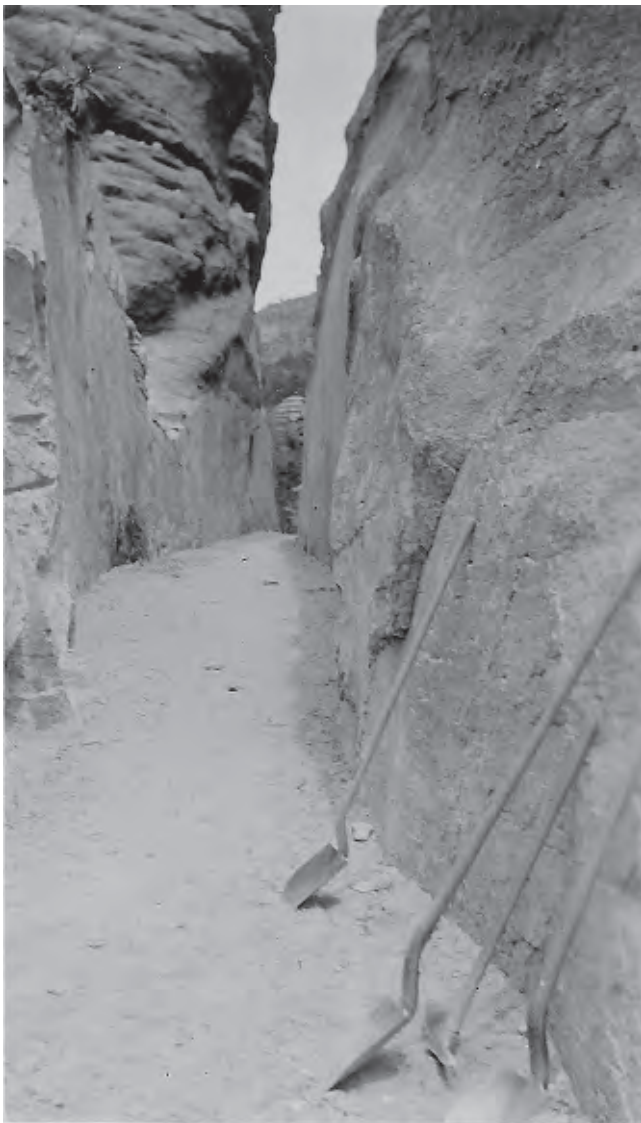
Figure 26. Trail feature known as 'Wall Street' on Echo Canyon trail shortly after completion.

Figure 26. Trail feature known as 'Wall Street' on Echo Canyon trail shortly after completion. Chiricahua National Monument Archives.

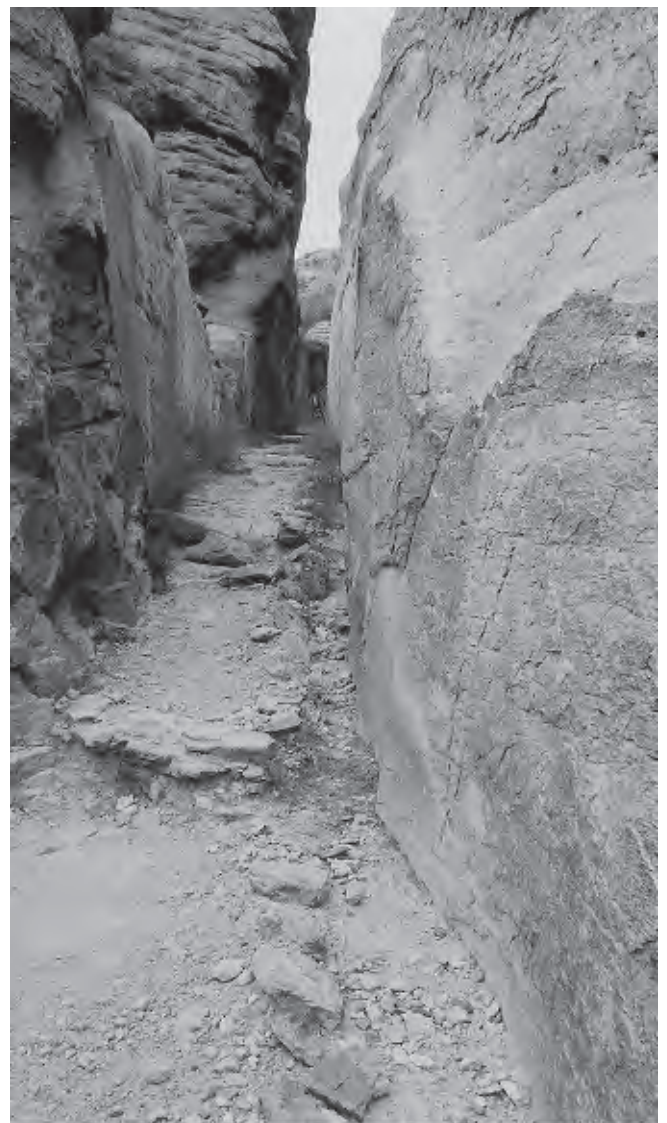
Figure 27. Modern photograph of 'Wall Street' shows extent of trail base erosion, 2003.

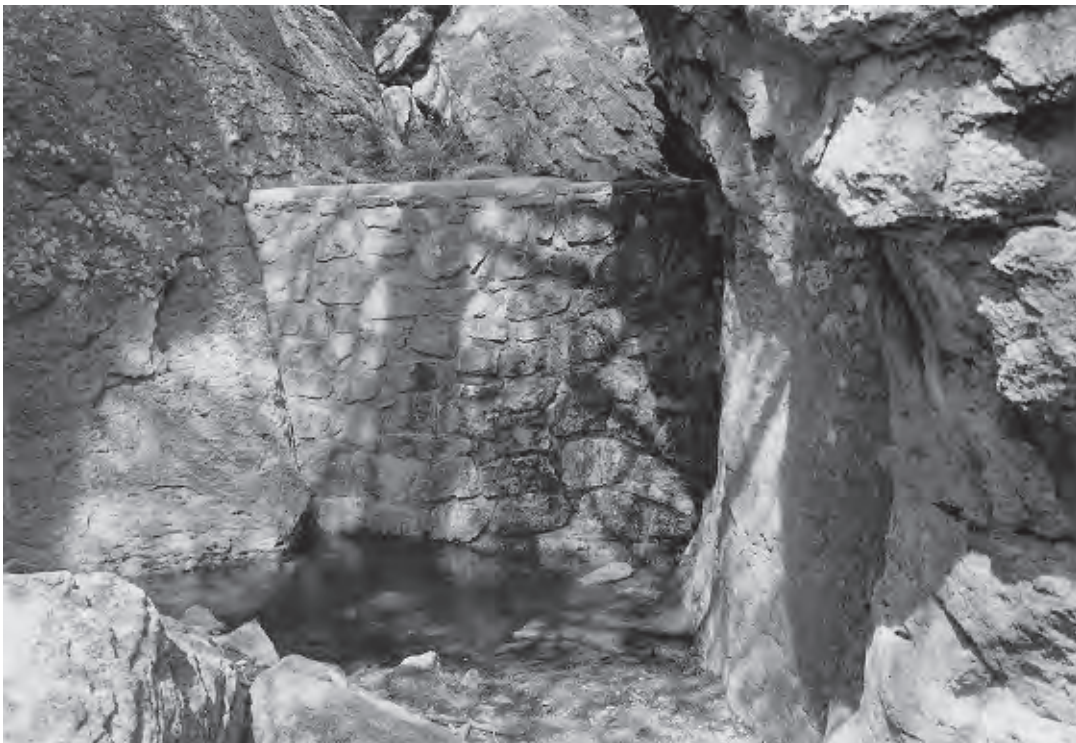
Figure 28. Echo Canyon dam was constructed of concrete and faced with stone, 1993.

Another feature, a small dam, was constructed across Echo Creek above Echo Park. The dam was situated between two large rhyolite columns, built of concrete and faced with local stone (Figure 28). The dam was designed to provide a reliable water supply for the fly camp during the construction of the trail. After completion of the trail, the crews had planned to pipe the reservoir water down to Echo Park for the convenience of tourists (Stevenson 1935) but apparently this idea was never carried through to completion. The dam is still in very good condition even though the retention basin has been filled with rocks and sediment (Figure 29).

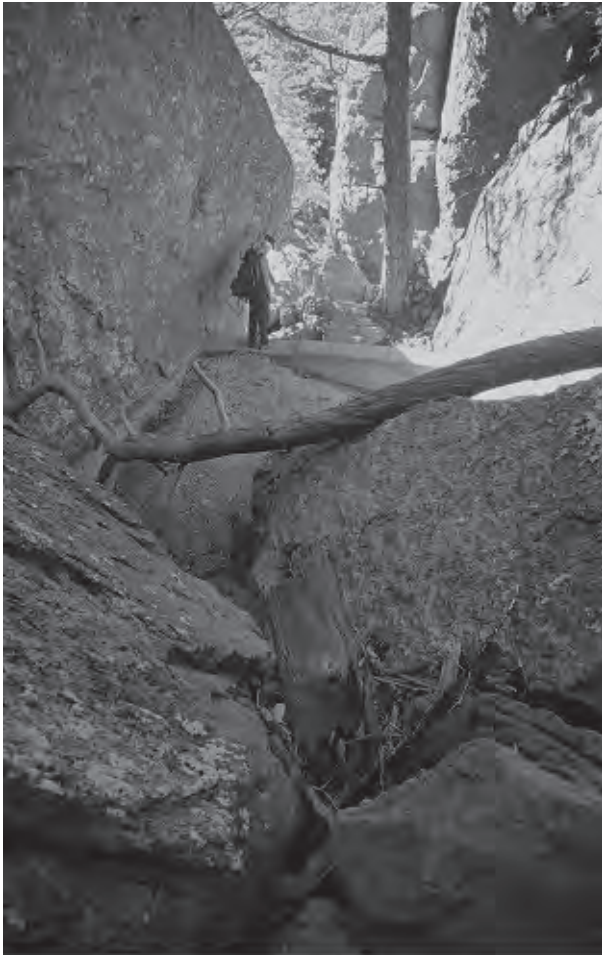
Figure 29. Echo Canyon dam is now filled with sediment, 2004.

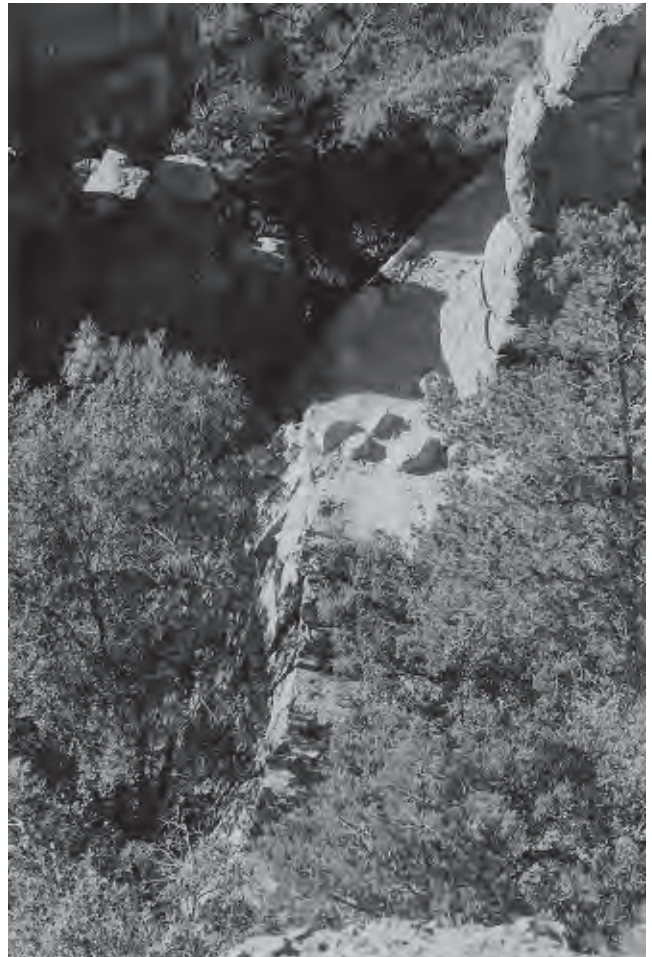
Figure 31. Large retaining walls on upper Sarah Deming trail, 2003.

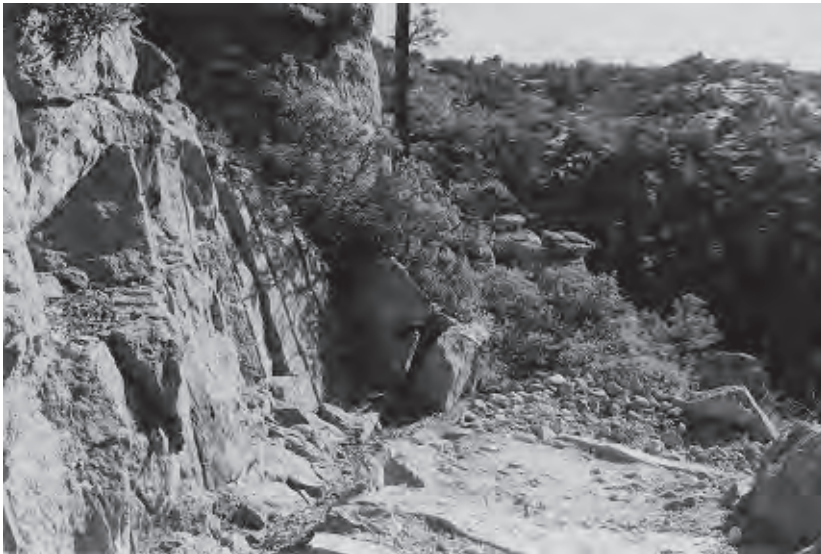
Figure 32. Water bars, drainage channels, and drill marks on upper Sarah Deming trail, 2003.

Figure 32. Water bars, drainage channels, and drill marks on upper Sarah Deming trail, 2003. R.L. Pinto.

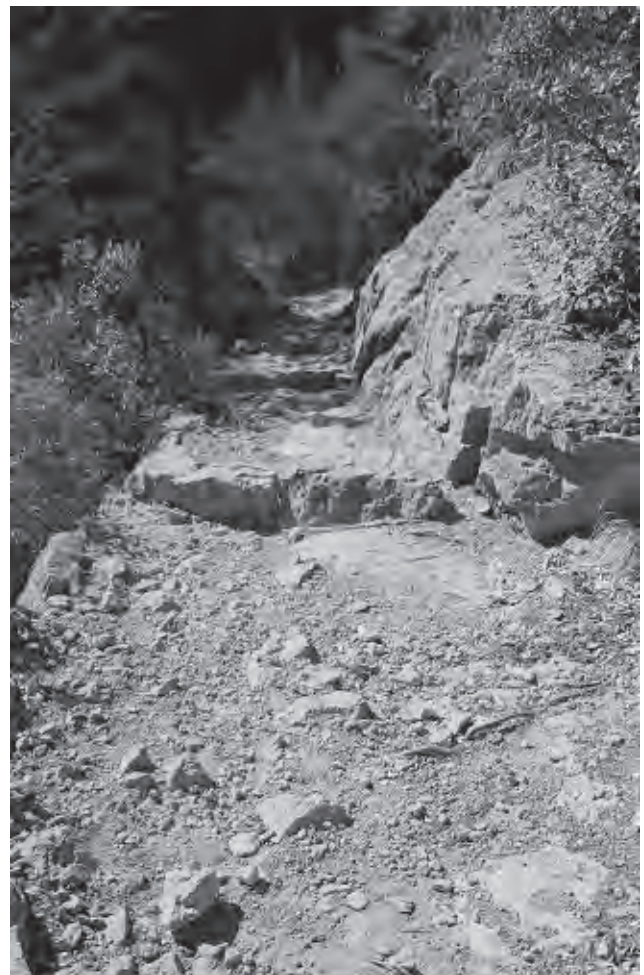
Figure 35. Portions of Ed Riggs trail are cut from rock slope; others are built up with retaining walls. Jackhammer drill marks are visible on the right slope, 2003.

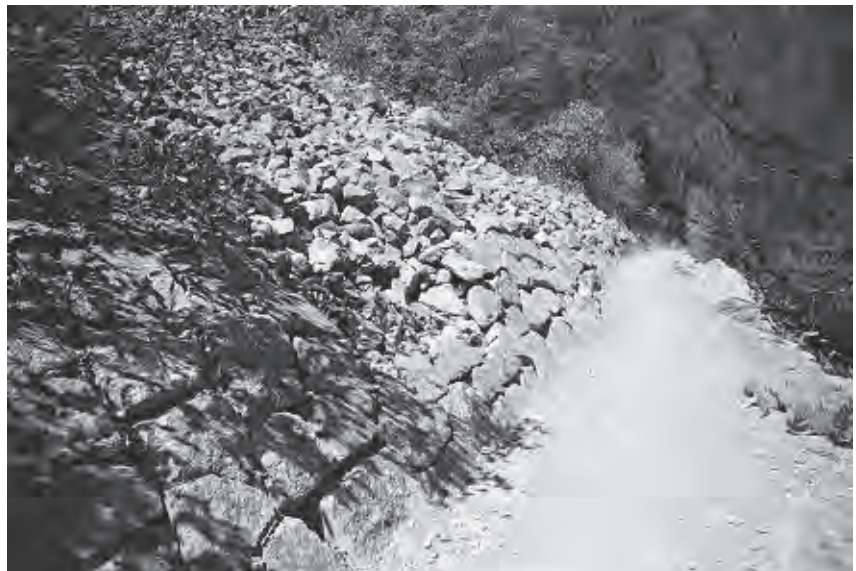
Figure 39. Most of the CCC-constructed Upper Rhyolite trail on north-facing slope of Rhyolite Canyon remains unchanged.

Figure 39. Portions of CCC-constructed Upper Rhyolite trail on north-facing slope of Rhyolite Canyon are still extant, 2003. R.L. Pinto.

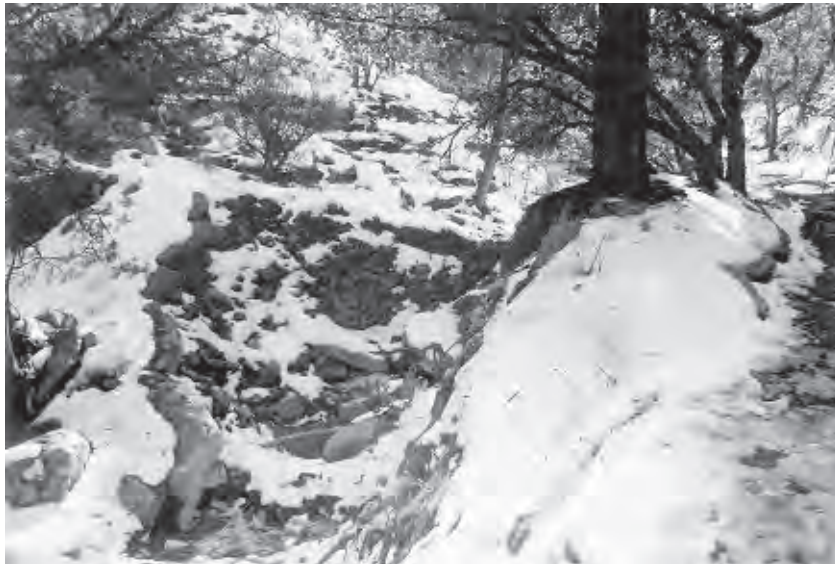
Figure 40. Wildlife pool (at left) on Mushroom Rock trail (far right) has been partially destroyed by floods in Hunt Creek, 2003.

Figure 40. Wildlife pool on Mushroom Rock trail has been partially destroyed by floods in Hunt Creek, 2003. R.L. Pinto.

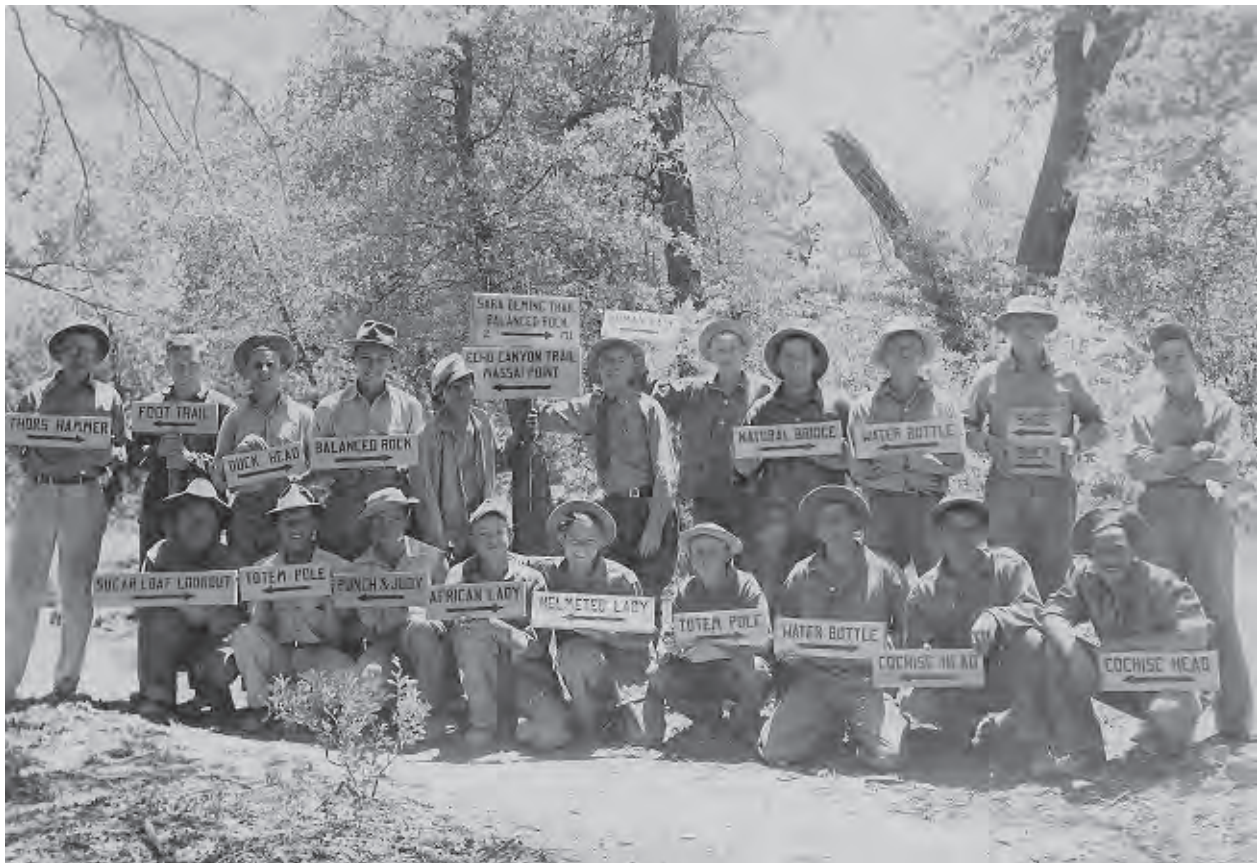
Figure 46. Trail signs constructed by the carpentry crew to identify many named rhyolite features and other points of interest.

Figure 46. Trail signs constructed by the carpentry crew to identify many named rhyolite features and other points of interest. Chiricahua National Monument Archives.

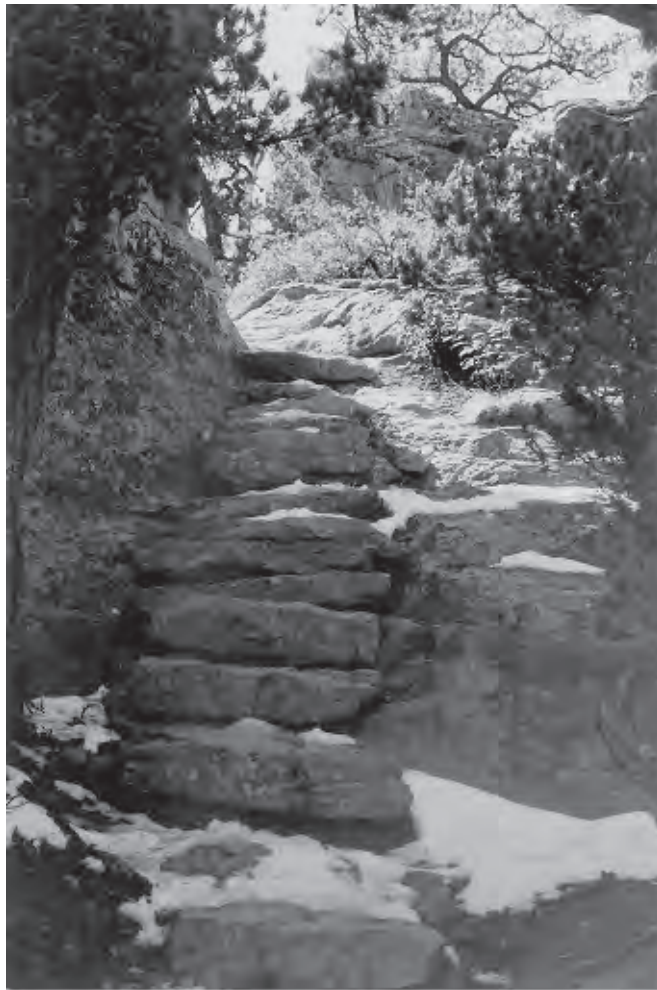
Figure 47. Stairs on the Heart of Rocks trail, 2003.

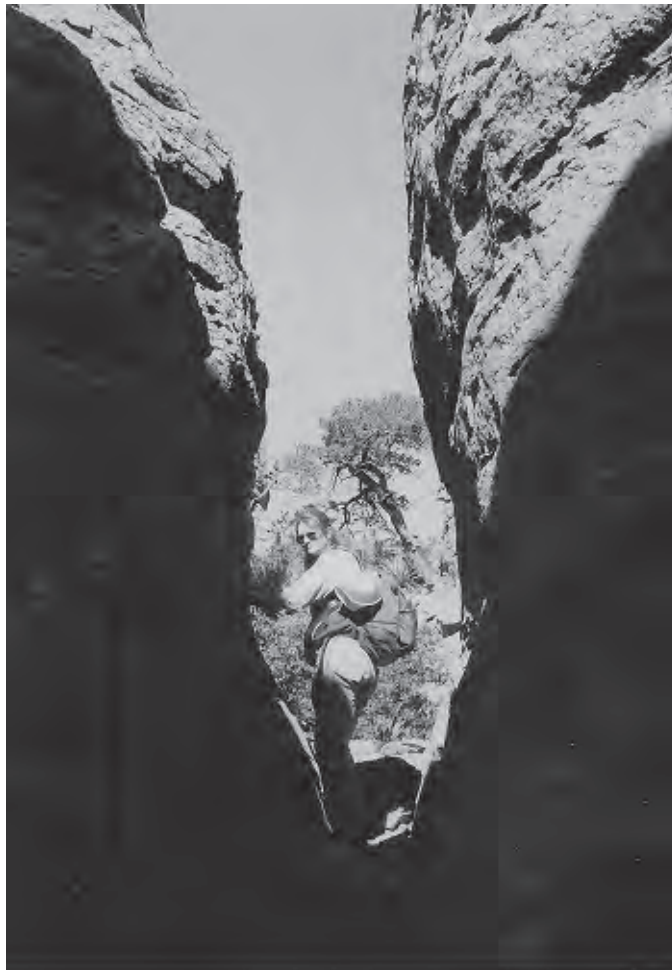
Figure 50. Narrow trails and stairs make the Heart of Rocks trail suitable only for foot traffic, 2003.

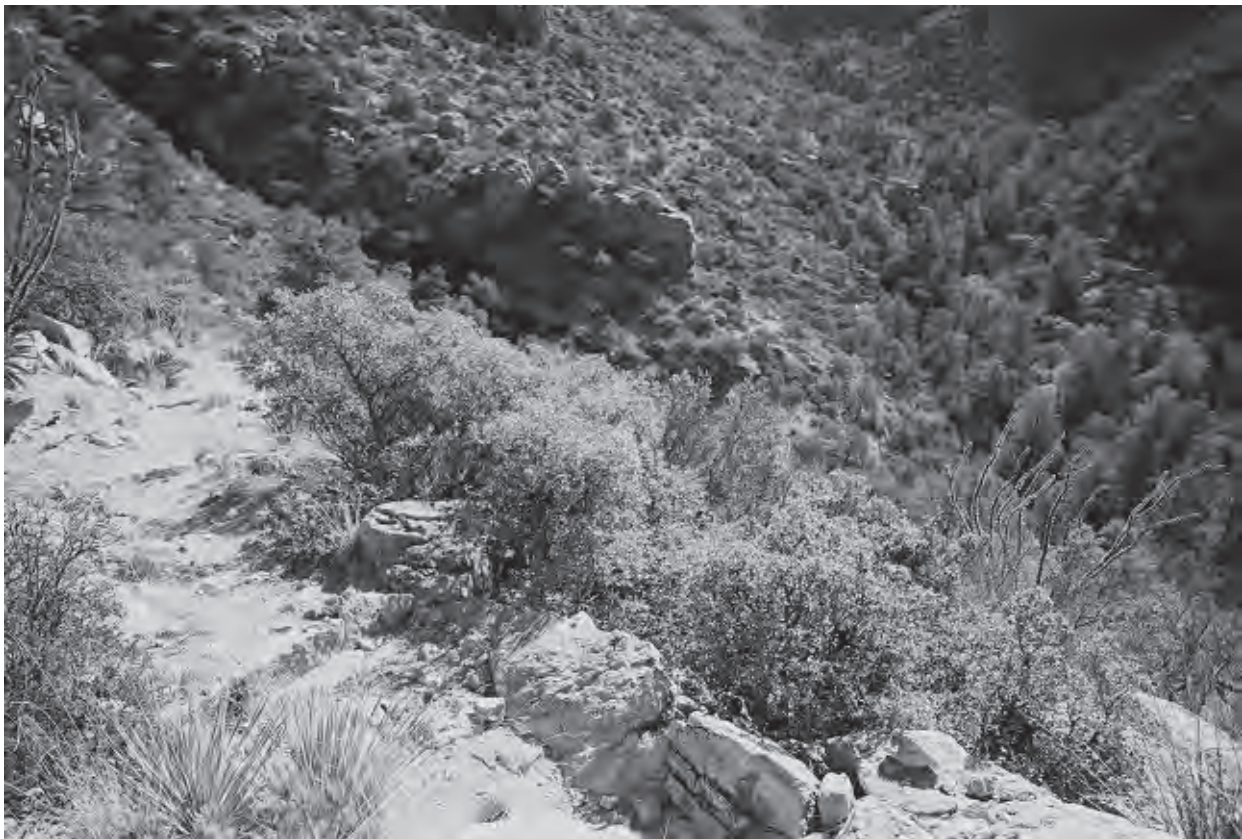
Figure 52. Natural Bridge trail ascends out of North Bonita Canyon through a series of steep switchbacks, 2003.

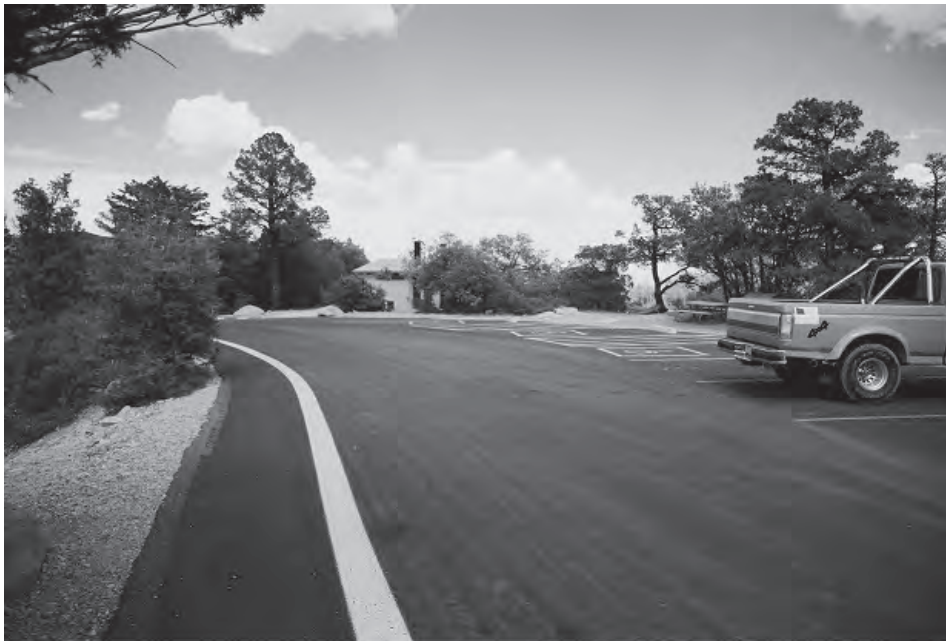
Figure 57. Massai Point Turnaround, the terminus of Bonita Canyon Highway, 2003.

Figure 57. Massai Point Turnaround, the terminus of Bonita Canyon Highway, 2003. View looking north R.L. Pinto.

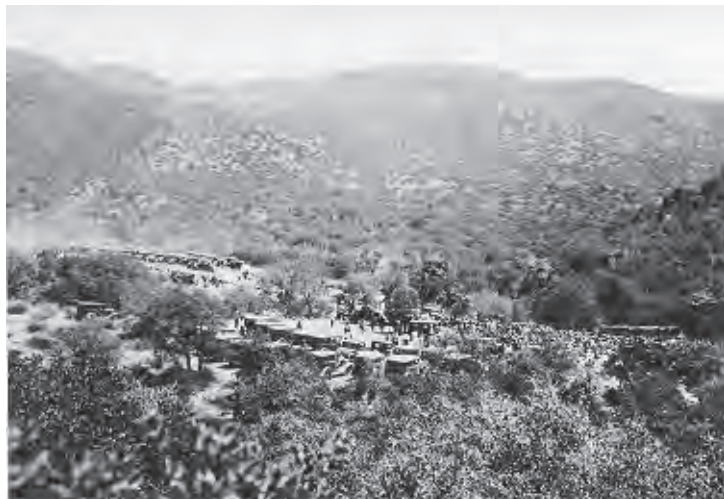
Figure 59. Parking lot at the Dedication Ceremony. September 1934.

Figure 59. Parking lot at the Dedication Ceremony, 1934. Chiricahua National Monument Archives.

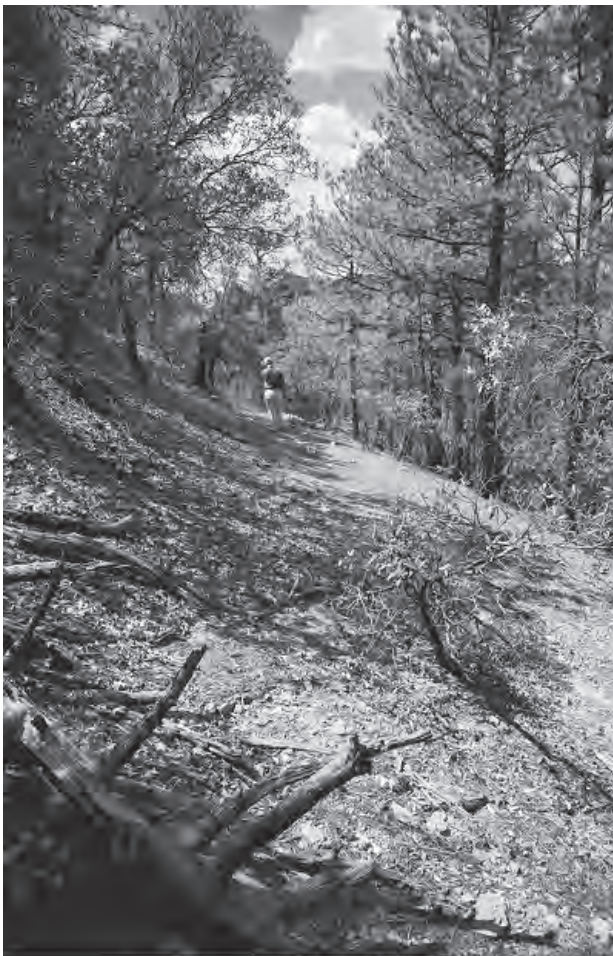
Figure 62. Remains of temporary access road into Barbeque Hill. View looking Northwest. July 2003.

Figure 62. Remains of temporary access road into Barbeque Hill, 2003. View looking northwest. R.L. Pinto.
