**National Register of Historic Places
Registration Form**

1. Name of Property Chiricahua National Monument Historic Designed Landscape

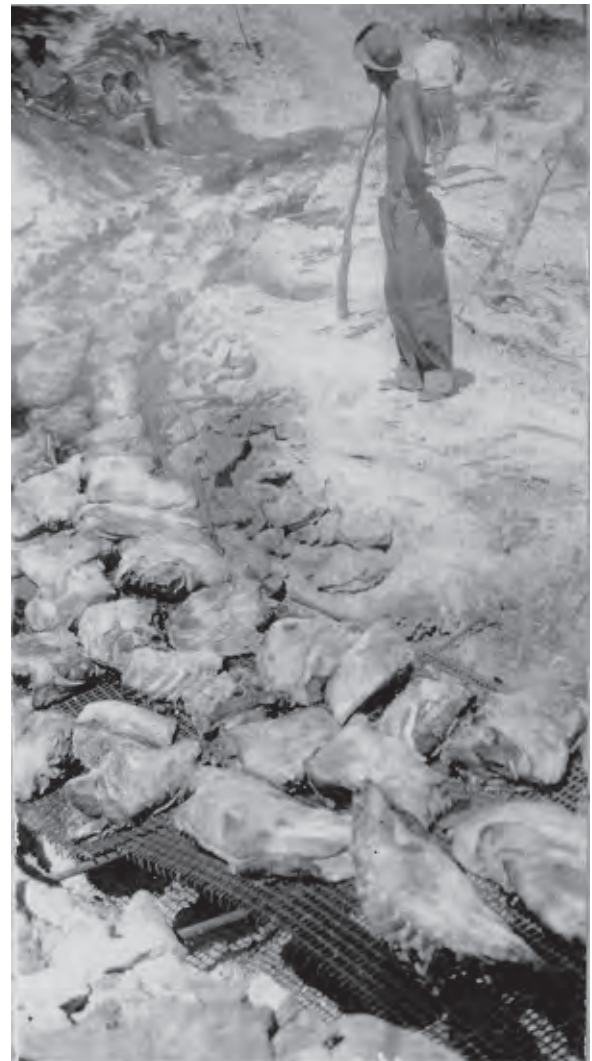
Figure 63. Camp NM2A enrollee tends the 85-foot long barbeque pit of beeves at Dedication Ceremony. View looking West. September 1934.

Figure 63. Camp NM2A enrollee tends the 85-foot long barbeque pit of beeves at Dedication Ceremony, 1934. View looking west. Chiricahua National Monument Archives.

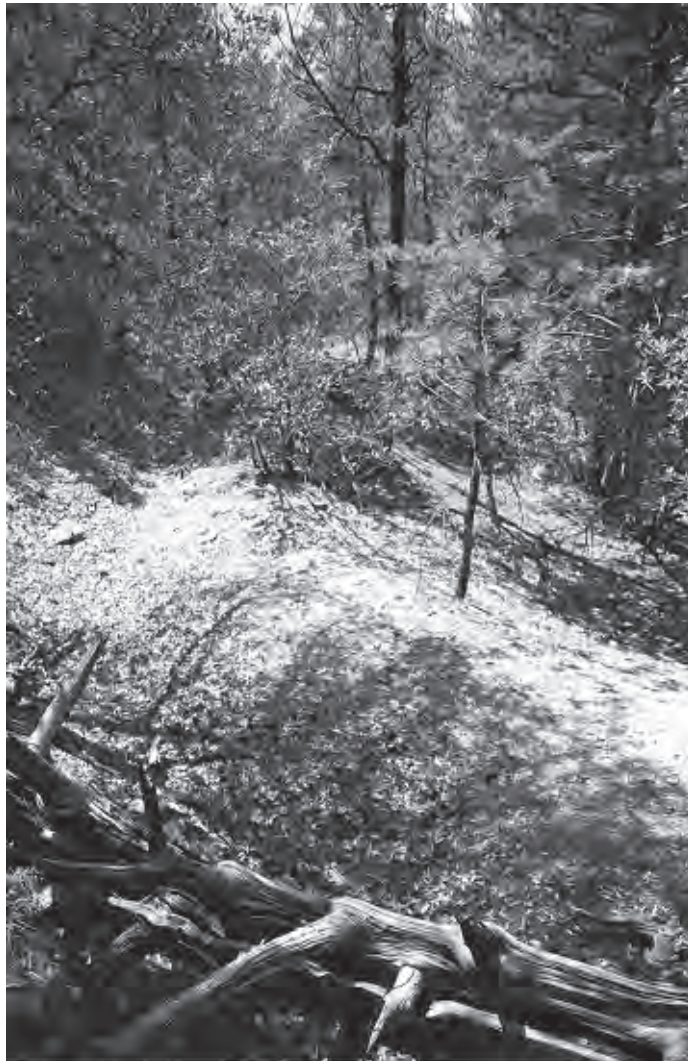
Figure 64. Remains of barbeque pit from Dedication Ceremony. View looking West. July 2003.

Figure 64. Remains of barbeque pit from Dedication Ceremony, 2003. View looking west. R.L. Pinto.

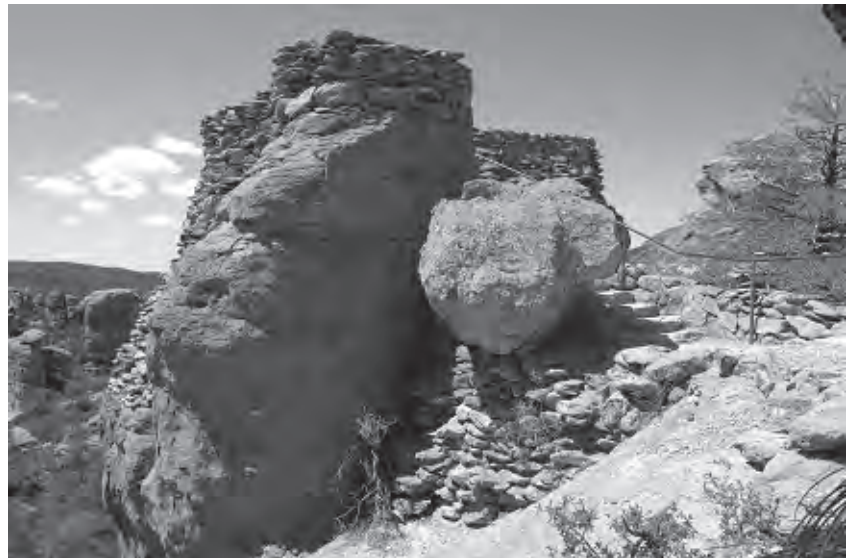
Figure 66. Speakers Rock at Massai Point incorporates large boulders into base of rostrum and boundary of stairs. View looking Northwest. March 2004.

Today Speakers Rock remains the only permanent remnant of the dedication ceremony. The integrity of the Speakers Rock and its surrounding Amphitheater is good. Repairs to the stairway leading up to the Speakers Rock platform, however, will be required soon as erosion events have undercut the stone and mortar at its base (Travis 2000; 2001). The integrity of the foot trail is fair.

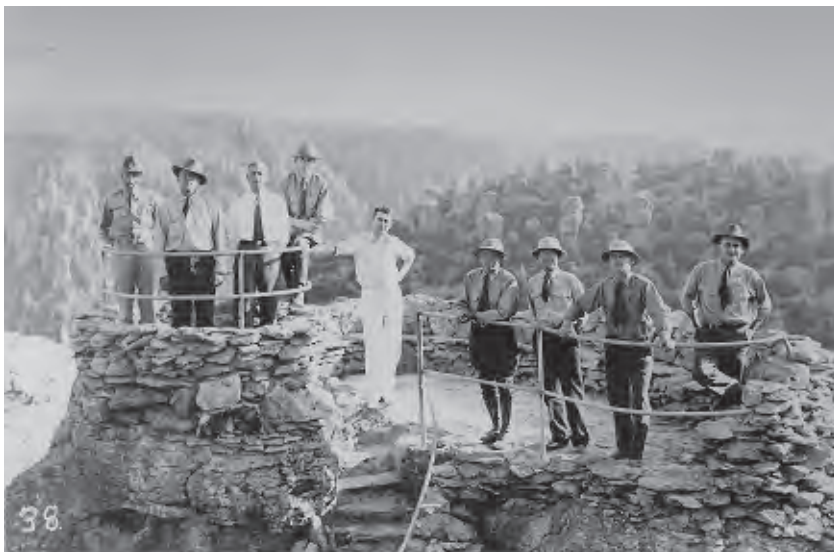
Figure 67. Speakers Rock prior to removal of iron handrails and construction of seating wall on North side. View looking South.

Figure 67. Speakers Rock prior to removal of iron handrails and construction of seating wall on north side. View looking south. Chiricahua National Monument Archives.

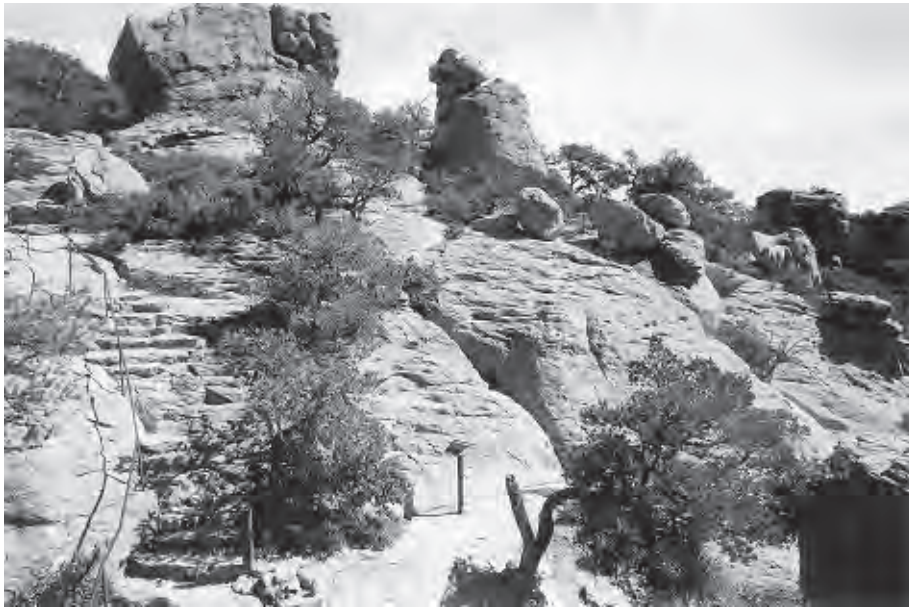
Figure 68. View of the amphitheatre from Speakers Rock showing trail, steps and handrailing on left. View looking Northeast. October 2002.

Figure 68. View of the amphitheatre from Speakers Rock showing trail, steps and handrailing on left, 2002. View looking northeast. R.L. Pinto.

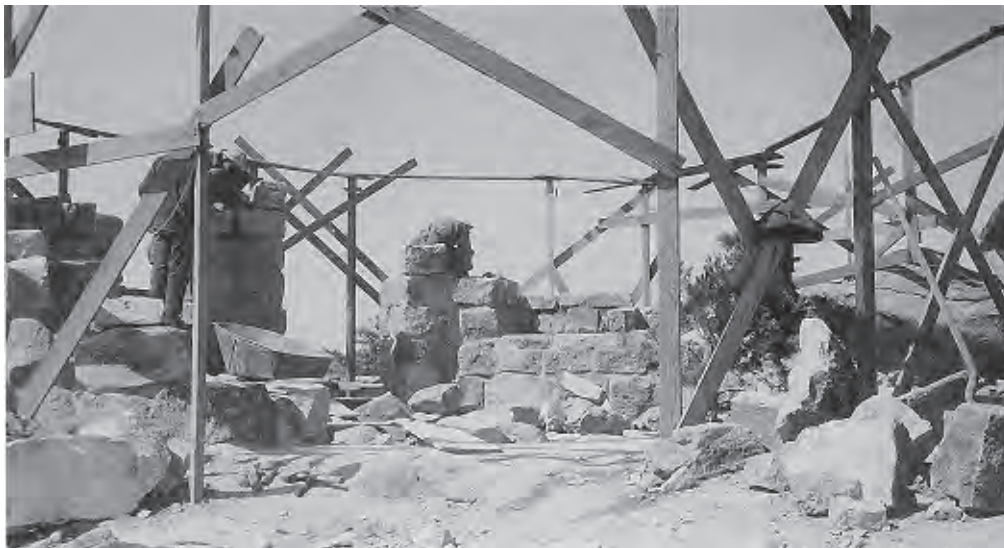
Figure 69. Construction of Orientation Station walls. Note large boulder at right incorporated into Northwest wall. View looking West. 1939.

Figure 69. Construction of Orientation Station walls 1939. Note large boulder at right incorporated into Northwest wall. View looking west. Chiricahua National Monument Archives.

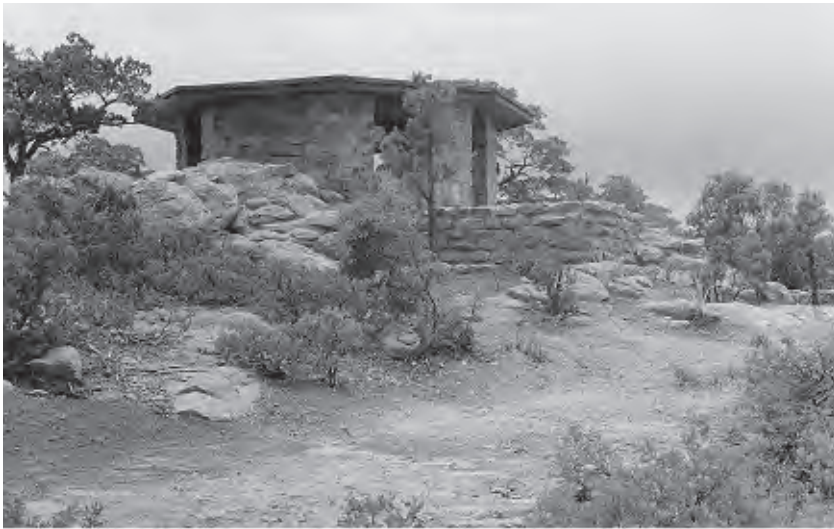
Figure 70. Orientation Station following completion of construction and landscaping in 1940. View looking East.

Figure 70. Orientation Station following completion of construction and landscaping in 1940. View looking east. Chiricahua National Monument Archives.

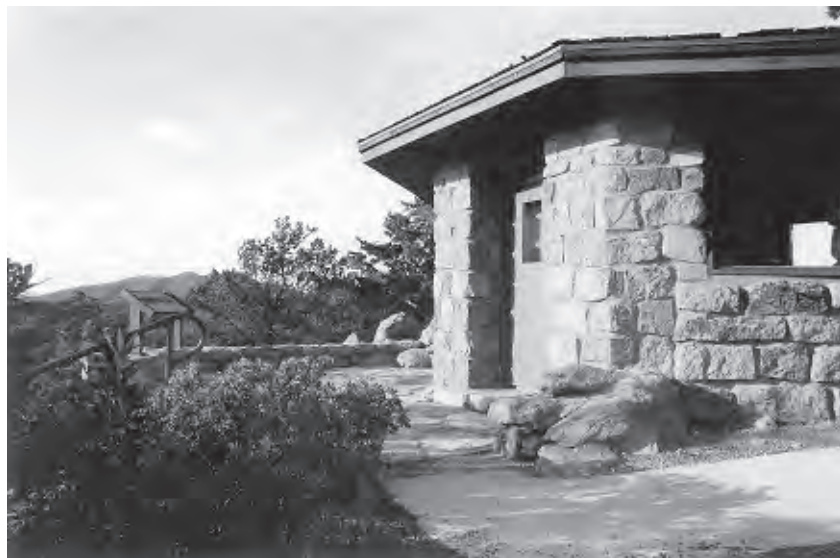
Figure 71. Terrace and seating wall at entrance to Orientation Station. View looking Northwest. October 2002.

Figure 71. Terrace and seating wall at entrance to Orientation Station, 2002. View looking northwest. R.L. Pinto

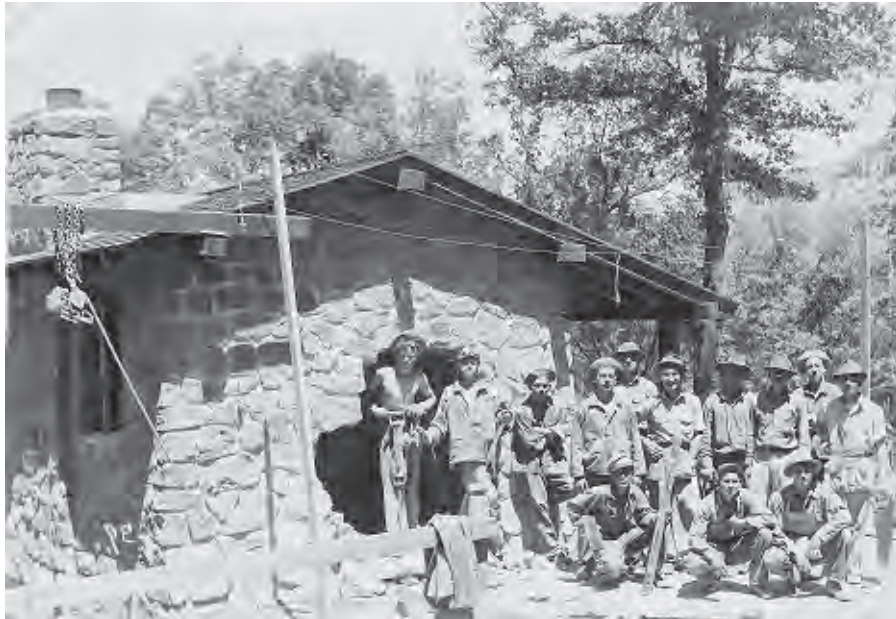
Figure 74. CCC enrollees create opening in Ranger Station to accommodate east wing of Administration Building, 1937. Note excavation for basement on left. View looking northwest.

- Figure 74. CCC enrollees create opening in Ranger Station to accommodate east wing of Administration Building, 1937. Note excavation for basement on left. View looking northwest. Chiricahua National Monument Archives.

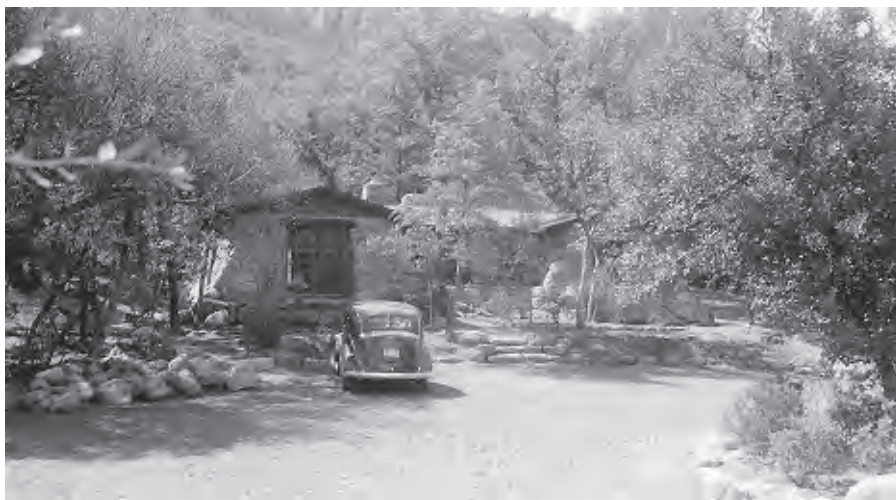
Figure 75. Administration Building, paths, and parking area, 1939. View looking south.

- Figure 75. Administration Building, paths, and parking area, 1939. View looking south. Chiricahua National Monument Archives.
- Figure 76. Rear porch and entry to Administration Building, 1960. View looking northeast. Chiricahua National Monument Archives.

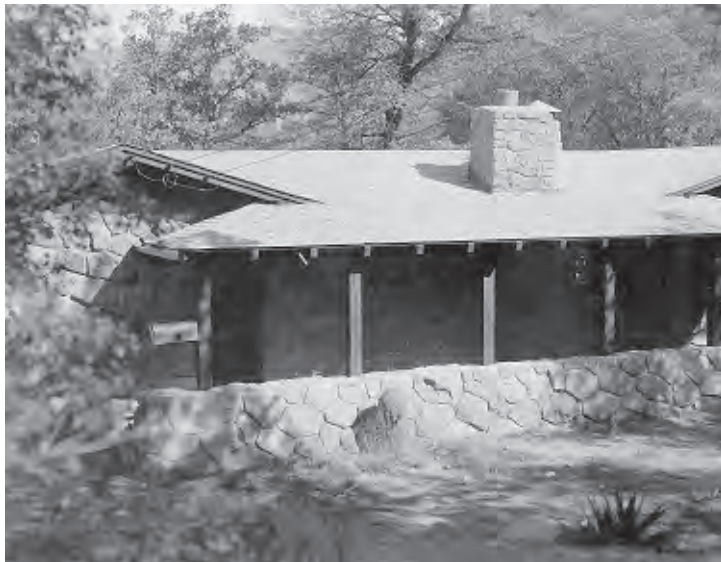
Figure 76. Rear porch and entry to Administration Building, 1960. View looking northeast.

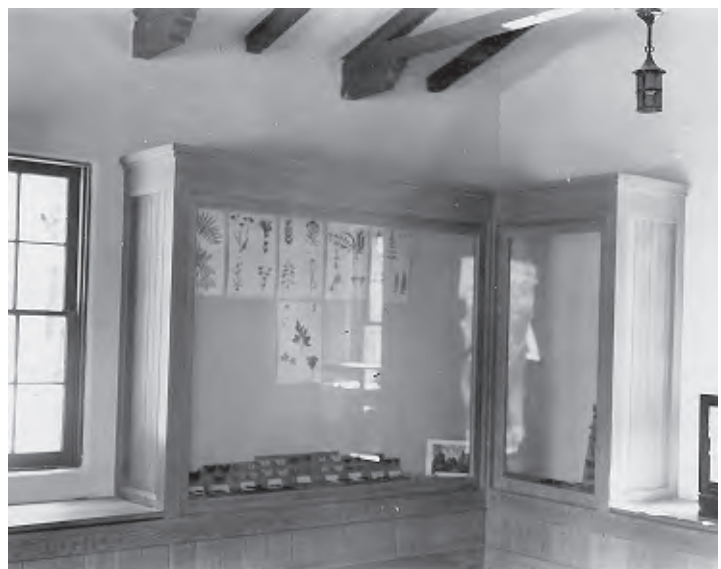
Figure 77. Display cases in Museum wing of Administration Building, 1941. Wrought iron lighting fixture is similar, though not identical, to those designed by Cecil Doty.

- Figure 77. Display cases in Museum wing of Administration Building, 1941. Wrought iron lighting fixture is similar, though not identical, to those designed by Cecil Doty. Chiricahua National Monument Archives.

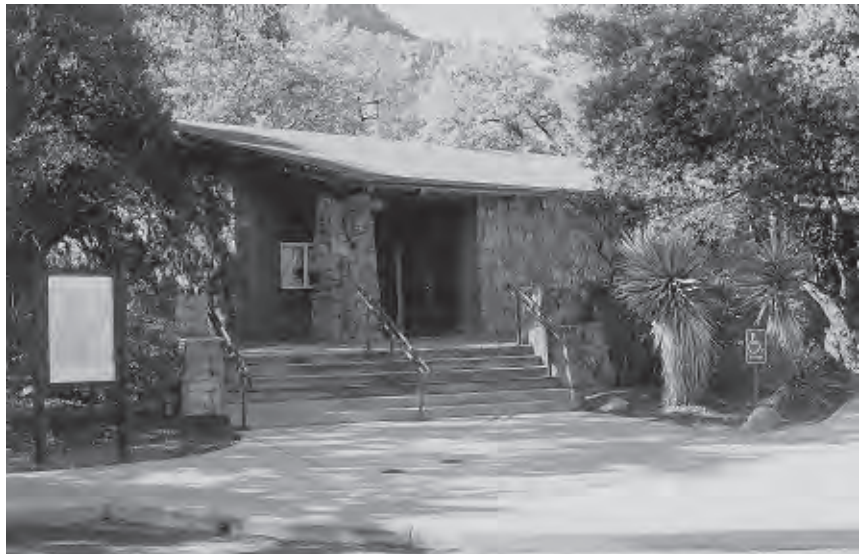
Figure 78. Front entrance to Visitor Center with steps, porch, and stone-veneered walls, 2002. View looking southwest.

- Figure 78. Front entrance to Visitor Center with steps, porch, and stone-veneered walls, 2002. View looking southwest. R.L. Pinto.
- Figure 79. Additional door on right was added in 1965 to rear of Administration Building, 2002. R.L. Pinto.

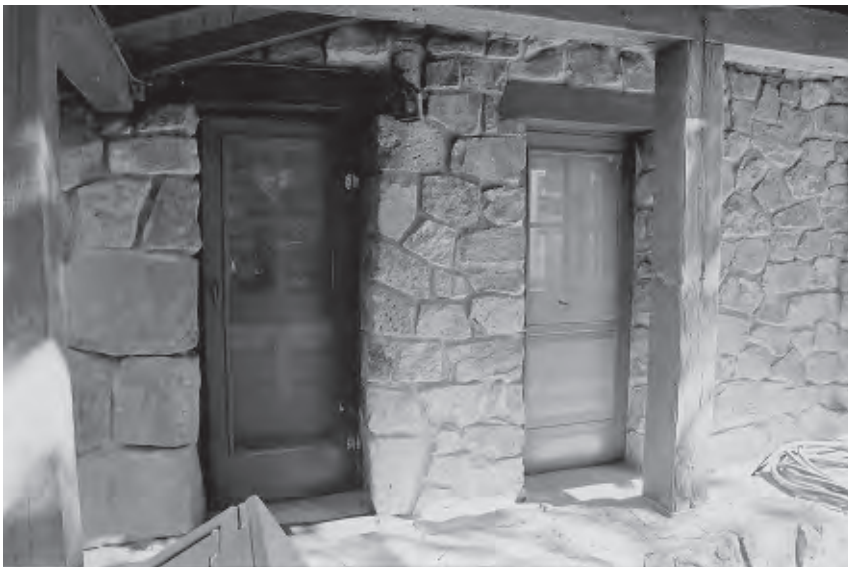
Figure 79. Additional door on right was added in 1965 to rear of Administration Building, 2002.

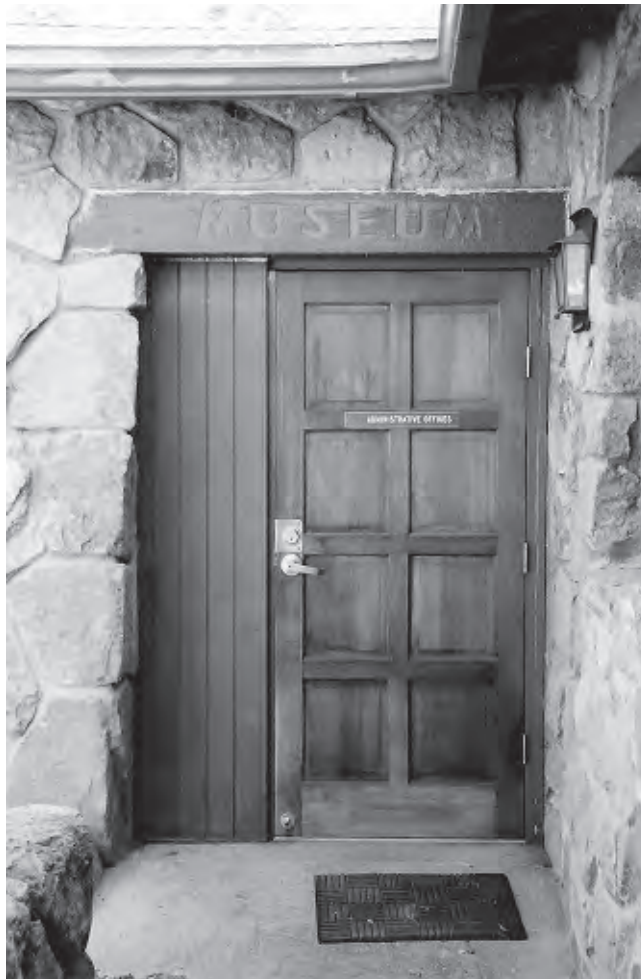
Figure 80. Museum wing double French doors were replaced by a single door after 1965. Note entrance sign carved by CCC carpentry shop in lintel above door, 2002.

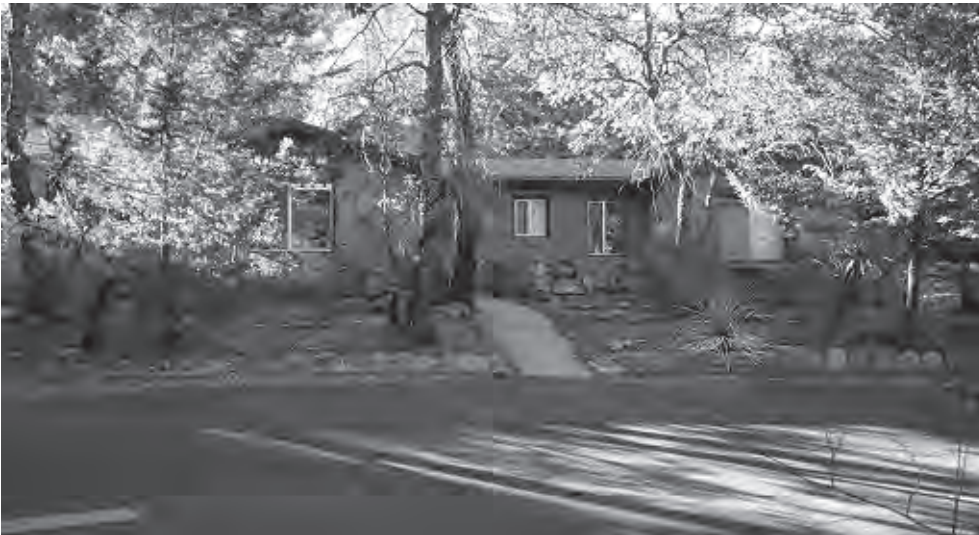
Figure 81. Recent changes to Administration Building include windows, doors, and walkway, 2003. View looking south.

- Figure 81. Recent changes to Administration Building include windows, doors, and walkway, 2003. View looking south. R.L. Pinto.
- Figure 82. Parking area and entrance were both enlarged in 1965 following construction of Visitor Center, 2003. View looking east. R.L. Pinto.

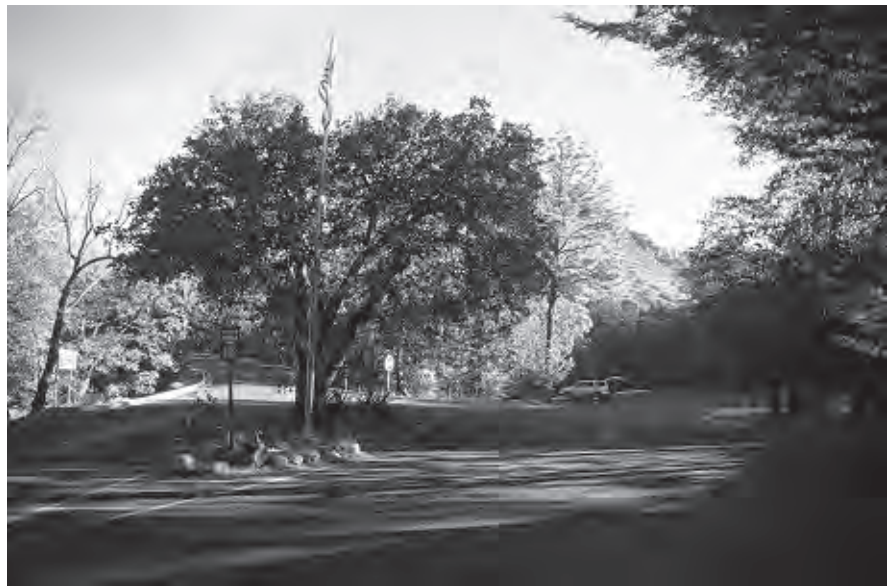
Figure 82. Parking area and entrance were both enlarged in 1965 following construction of Visitor Center, 2003. View looking east.

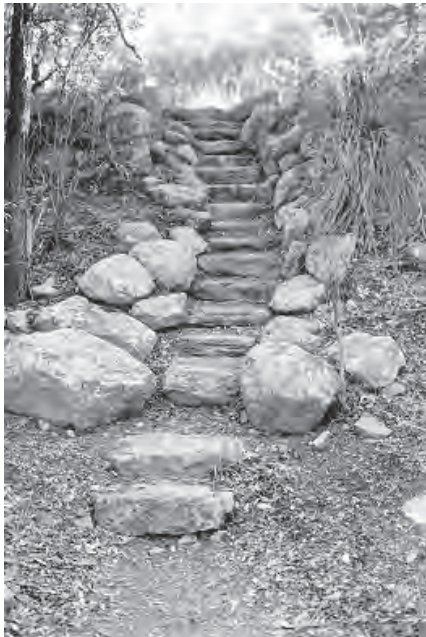
Figure 83. Stairs to Residential Area from rear of Visitor Center, 1993.

- Figure 83. Stairs to Residential Area from rear of Visitor Center, 1993. Dewey Livingston. Chiricahua National Monument Archives.
- Figure 84. Entrance to Powder Magazine cave. Note vent in upper right. View looking north. Chiricahua National Monument Archives.

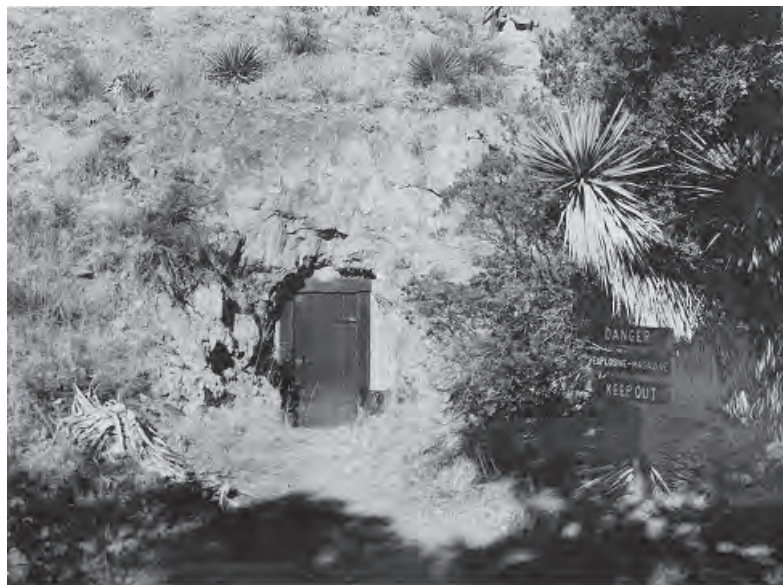
Figure 84. Entrance to Powder Magazine cave. Note vent in upper right. View looking north.

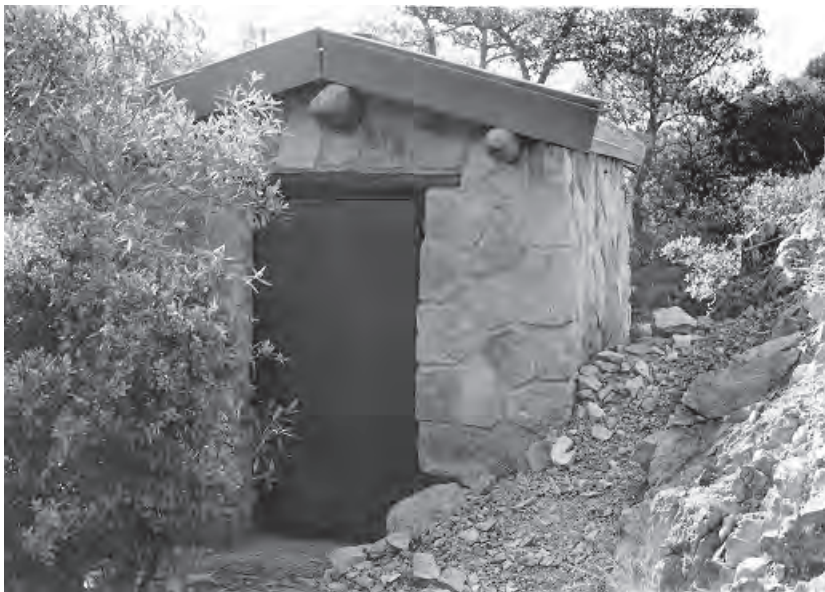
Figure 86. Second Cap Magazine with steel door, vigas, and replaced roof, 2003. View looking west.

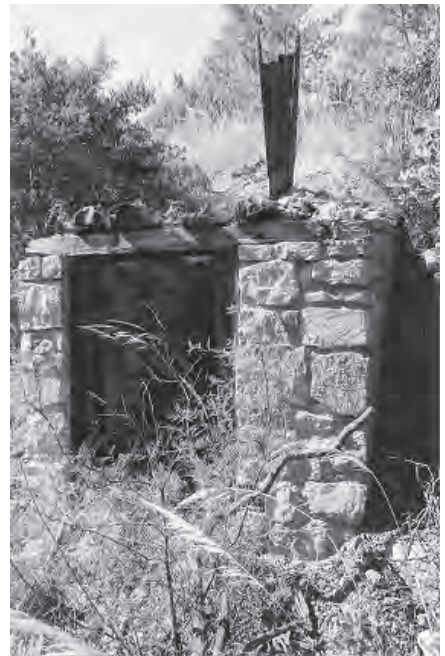
Figure 85. Ruins of first Cap Magazine, 2002. Roof has partially collapsed. Note remains of wooden vent. View looking northwest.

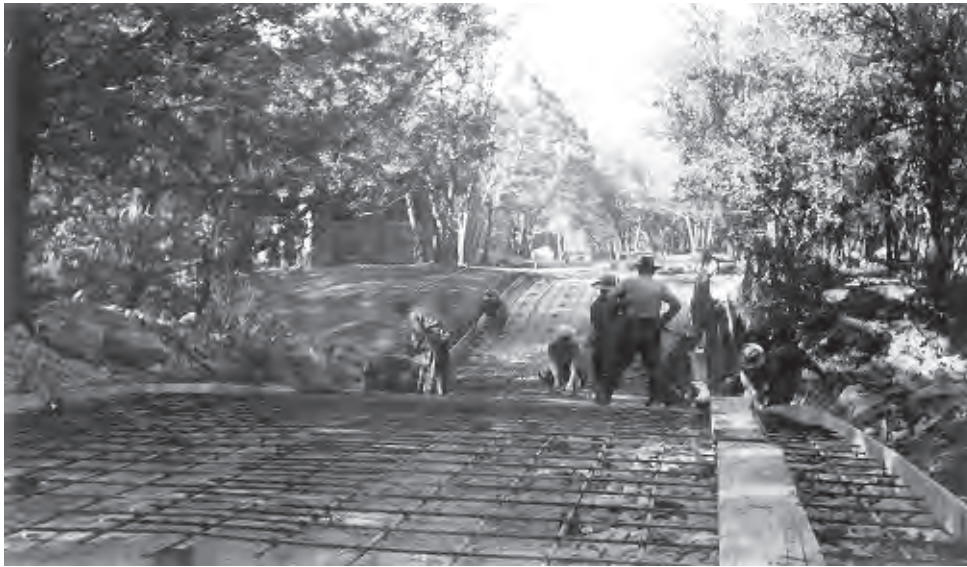
Figure 87. CCC enrollees lay wire mesh prior to pouring concrete in first campground "dip," 1935. View looking southwest.

- Figure 87. CCC enrollees lay wire mesh prior to pouring concrete in first campground "dip," 1935. View looking southwest. Chiricahua National Monument Archives.

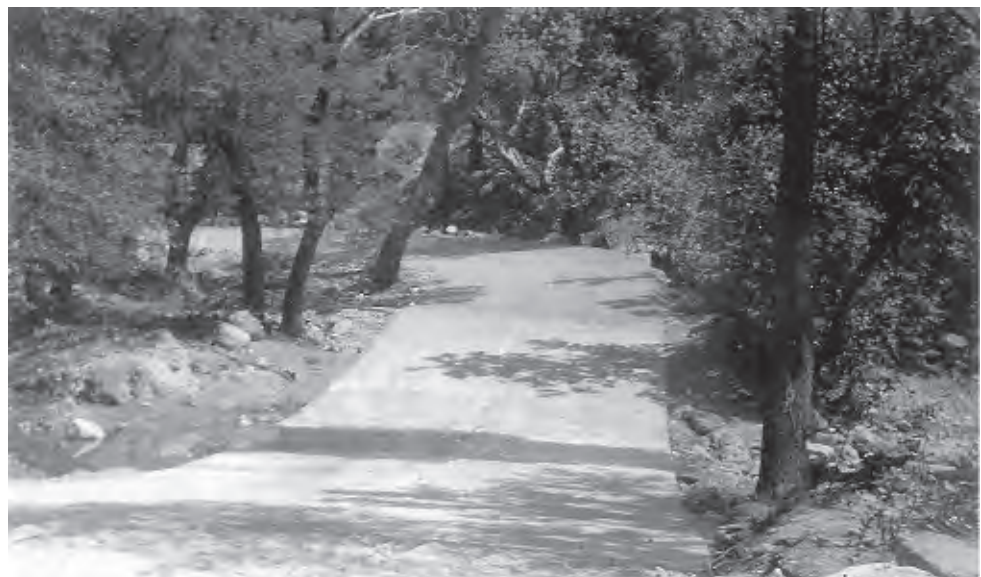
Figure 88. Second concrete dip, 1935. View looking southeast.

- Figure 88. Second concrete dip, 1935. View looking southeast. Chiricahua National Monument Archives.
- Figure 89. Stones mark boundary of parking spur associated with each campsite, 1935. Chiricahua National Monument Archives.

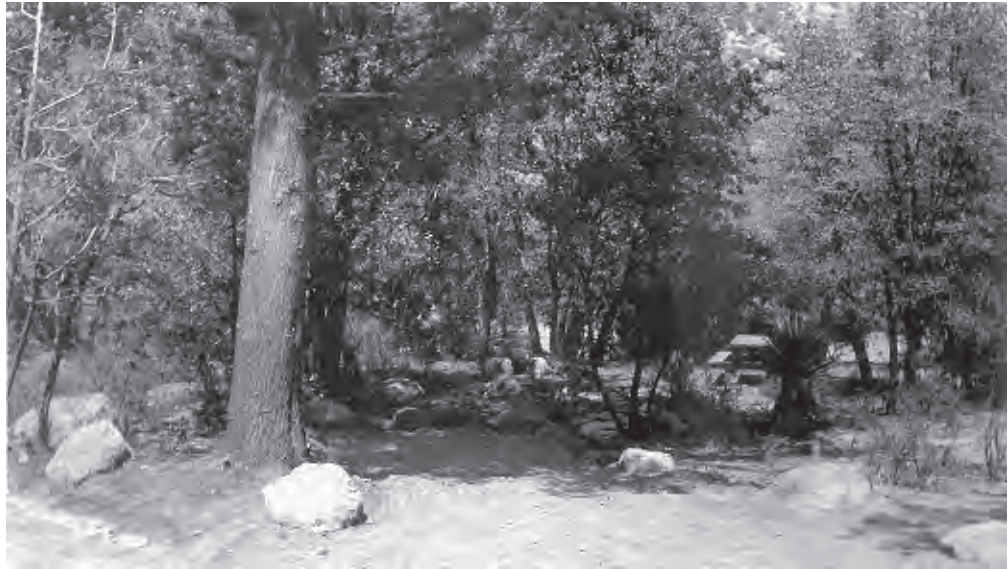
Figure 89. Stones mark boundary of parking spur associated with each campsite, 1935.

At a smaller scale, the circulation within the Public Campground was laid out according to the "Meineke plan." Emilio Meineke, a US Forest Service plant pathologist, developed this plan in 1932 which was immediately adopted by the National Park Service for use in its own campgrounds (McClelland 1998: 277-278). The plan emphasizes a one-way automobile circulation and creates restrictions on locations available for automobile and camper parking. This circulation arrangement limits damage caused by automobile tires to soils and surrounding vegetation.

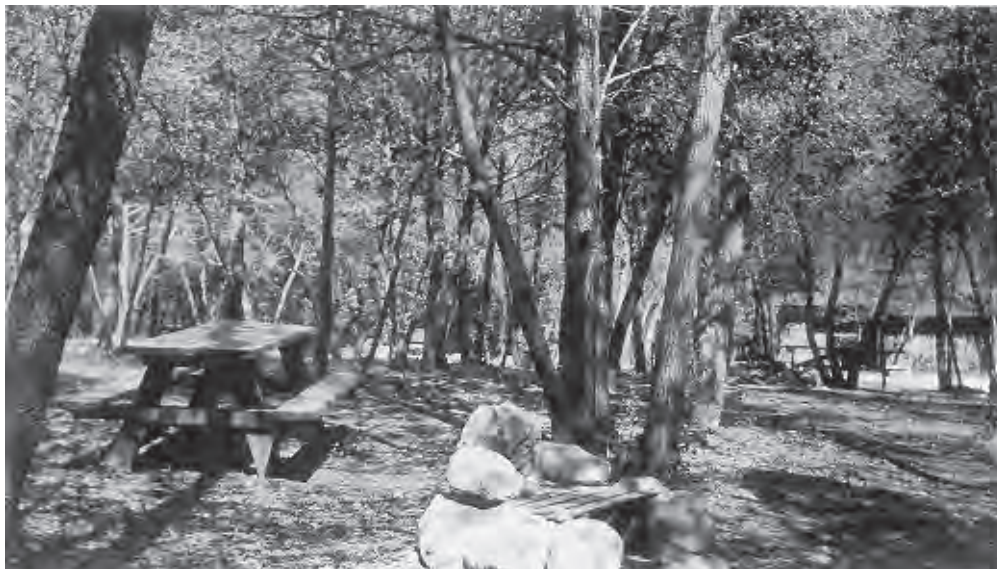
Figure 90. CCC crews built wooden picnic tables and stone-and-mortar camp grills for each campsite unit, 1935.

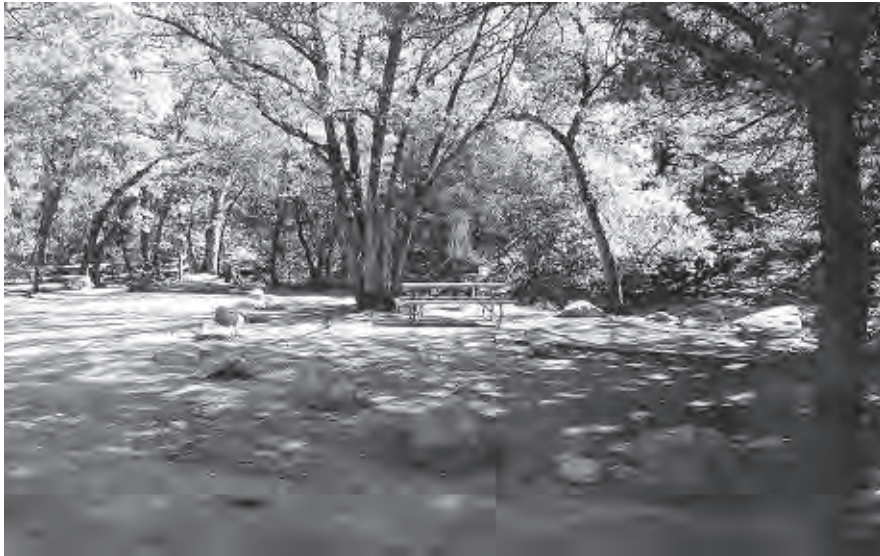
Figure 91. Campsite with tent platform, picnic table, and grill, 2003.

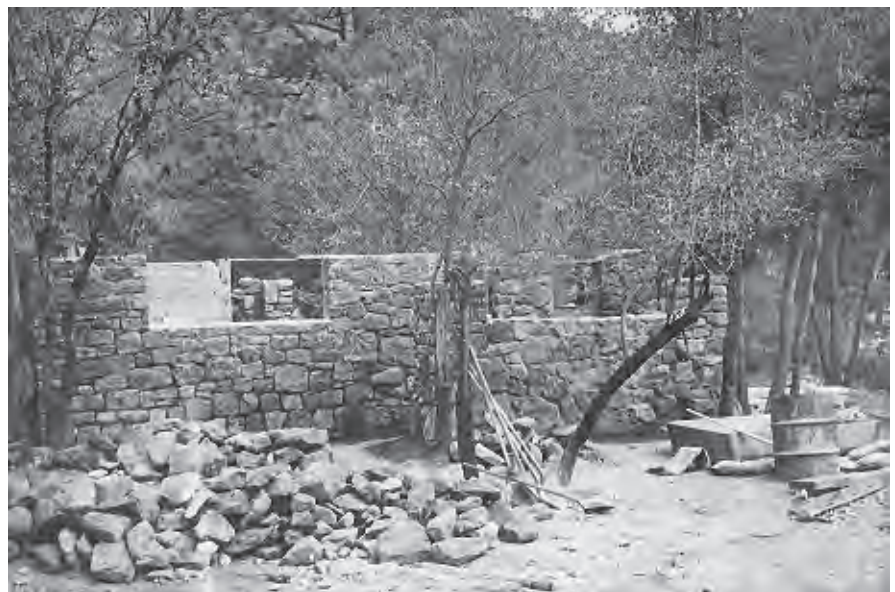
Figure 92. Construction of Campground Comfort Station, 1935. View looking northeast.

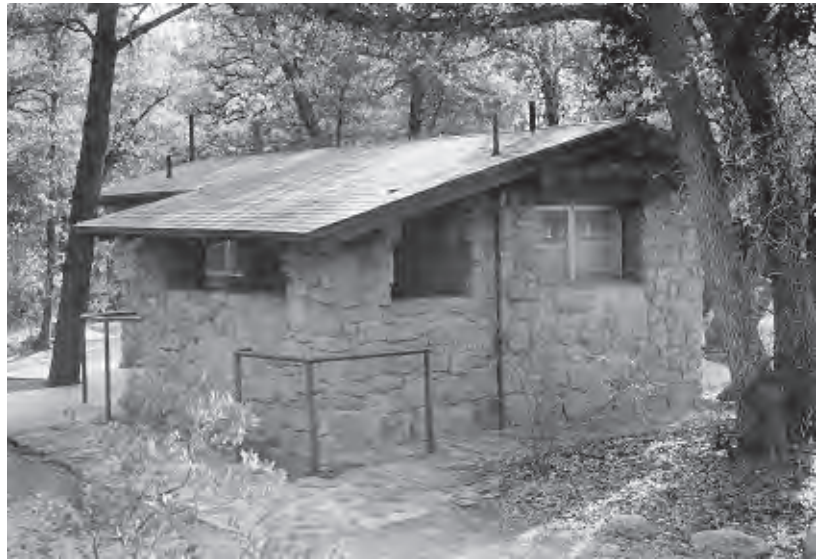
Figure 93. Modern campground comfort station with pathways and handicap access, 1993. View looking southwest.

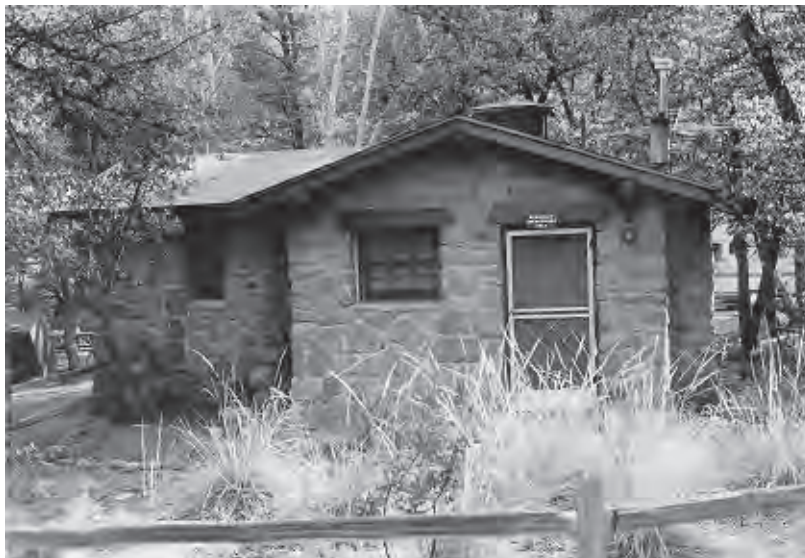
Figure 94. Campground Bath and Laundry House in 1970 was converted to employee residence, 1993. View looking west.

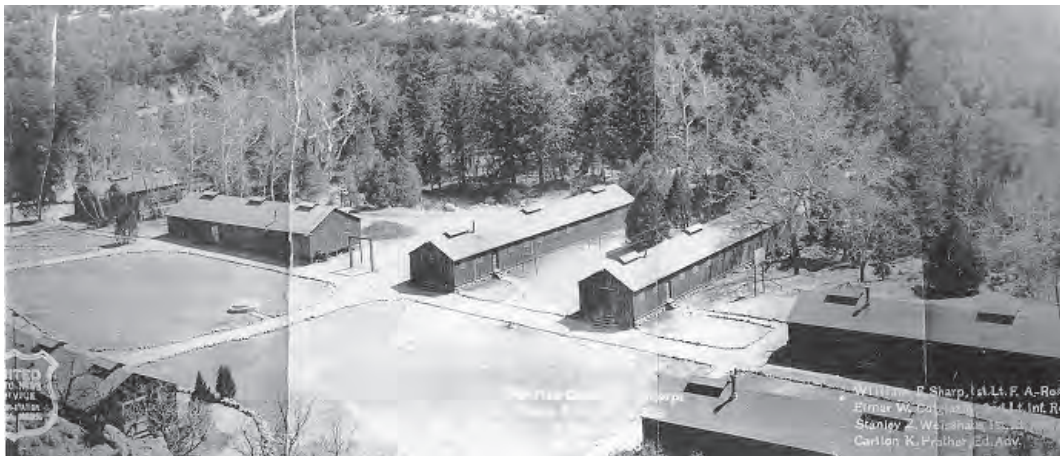
Figure 95. Rectangular layout of CCC Campsite as seen from water tower location, 1936. From left to right on far side of marching grounds: dispensary (in sycamore trees), recreation hall, and 4 barracks. Below left is mess hall. View looking southeast.

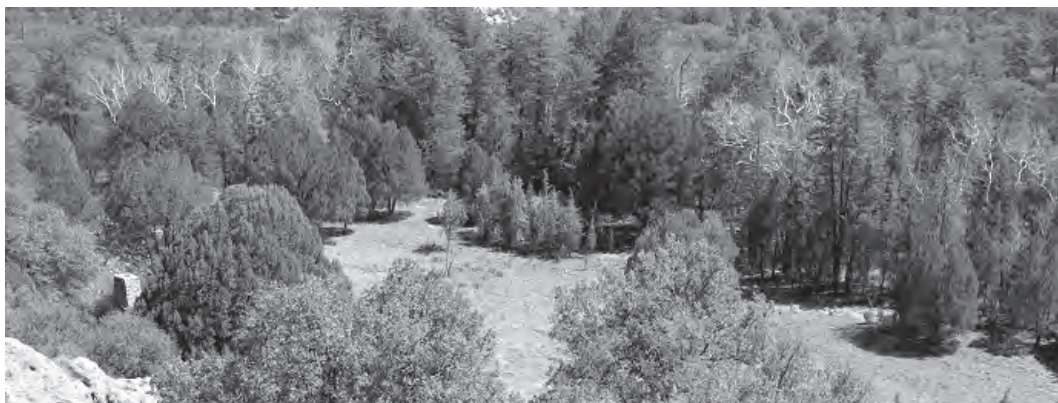
Figure 96. Photographic match to Figure 95, 2004. Vegetation has begun to encroach on open meadow. Note chimney ruin from CCC mess hall/Silver Spur Lodge in lower left. View looking southeast.

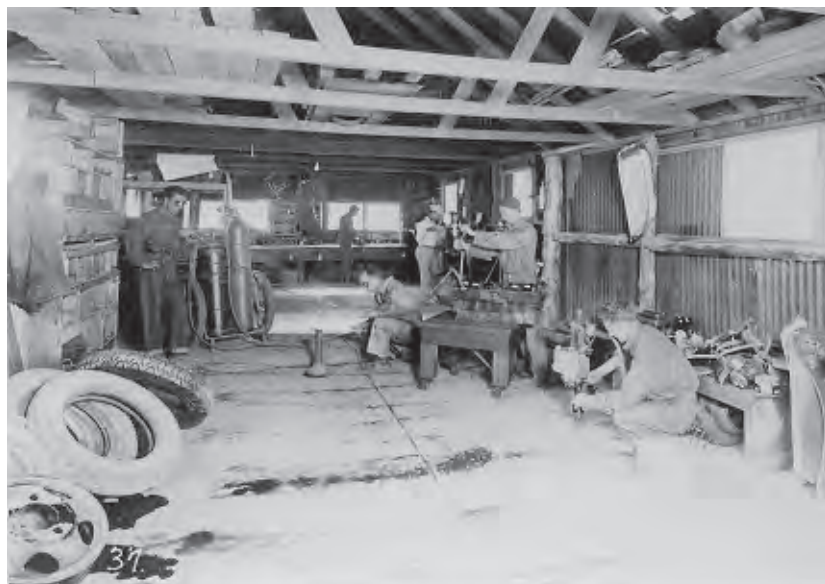
Figure 98. Interior of truck garage in National Park Service area at CCC Campsite.

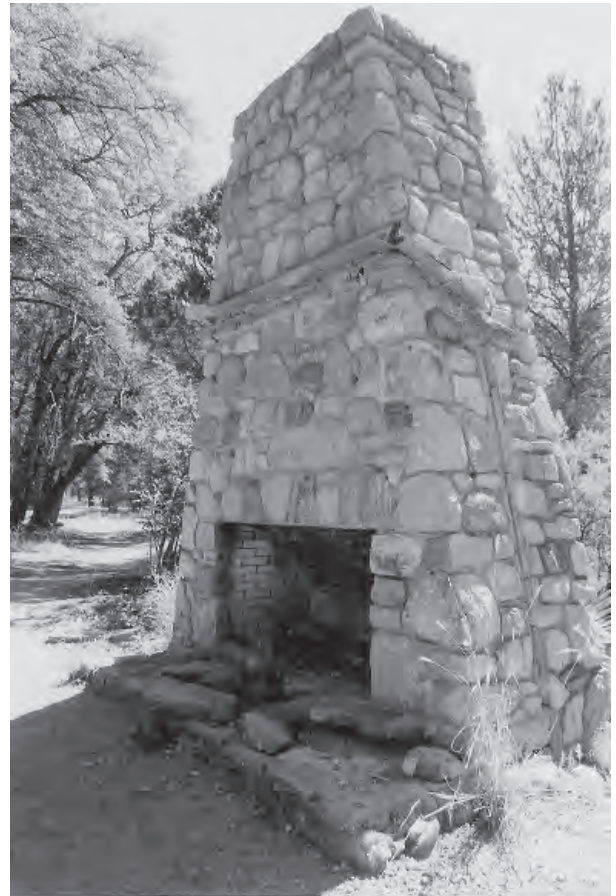
Figure 100. Chimney ruins, 2002. One of two fireplaces added to CCC mess hall following sale to Silver Spur Guest Ranch. View looking southeast.

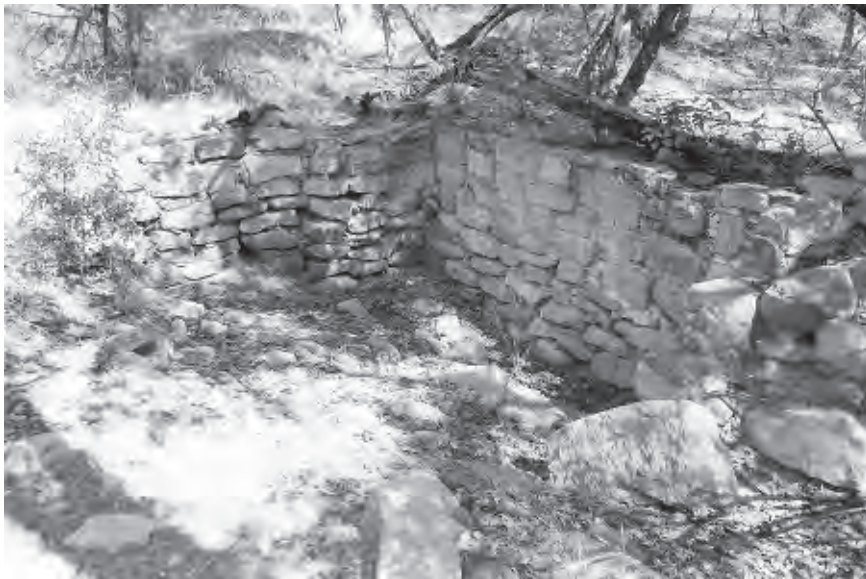
Figure 101. Foundation remains of Army buildings at CCC Campsite, 2002.

Figure 101. Foundation remains of Army buildings at CCC Campsite, 2002. R.L. Pinto.

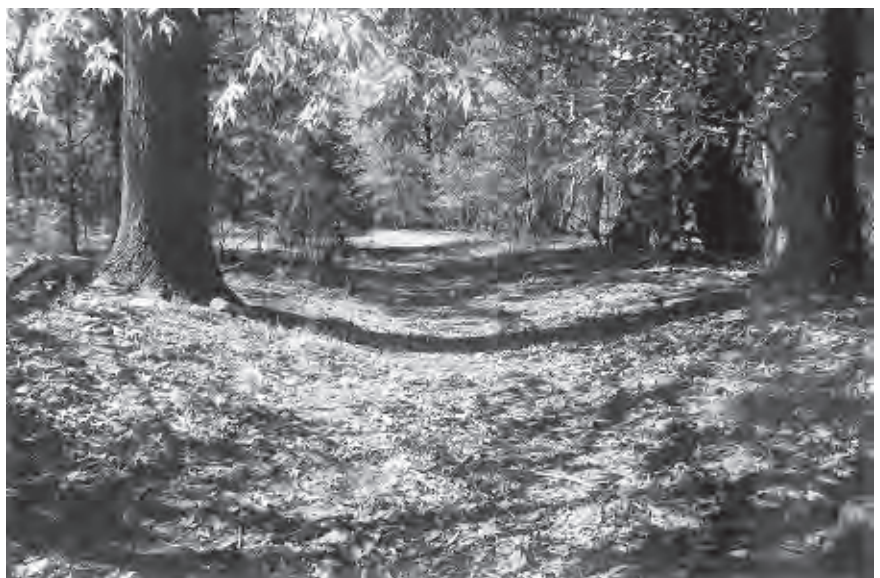
Figure 102. Remains of CCC access road to Campsite, 2002.

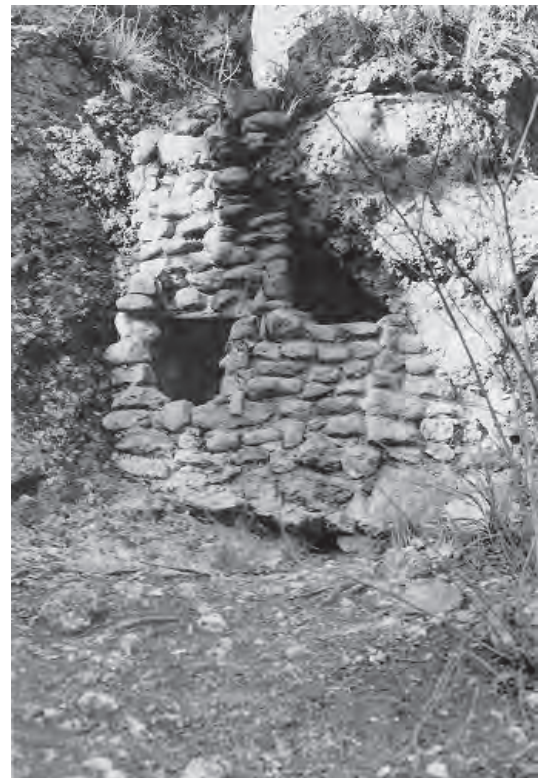
Figure 104. Remains of Cima Bear Cage built by CCC enrollees to house pet bear cub, 1993.

Figure 104. Remains of Cima Bear Cage built by CCC enrollees to house pet bear cub, 1993. Dewey Livingston. Chiricahua National Monument Archives.

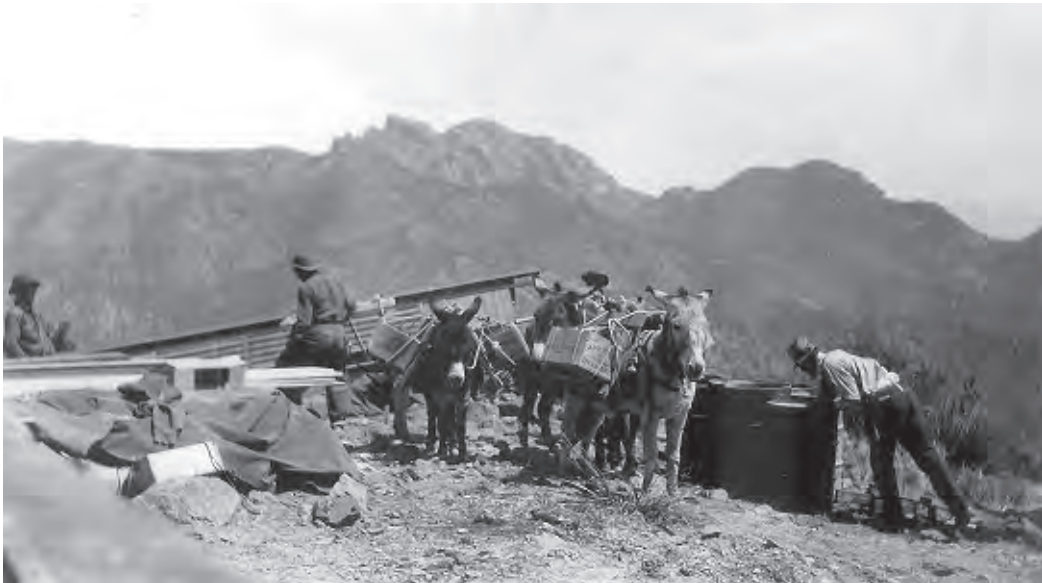
Figure 105. CCC enrollees used mules to haul materials to Sugarloaf Mountain during construction of the Lookout, 1935. Note boxes of dynamite for excavating the Lookout foundation. View looking north

Figure 105. CCC enrollees used mules to haul materials to Sugarloaf Mountain during construction of the Lookout, 1935. Note boxes of dynamite for excavating the Lookout foundation. View looking north. Chiricahua National Monument Archives.

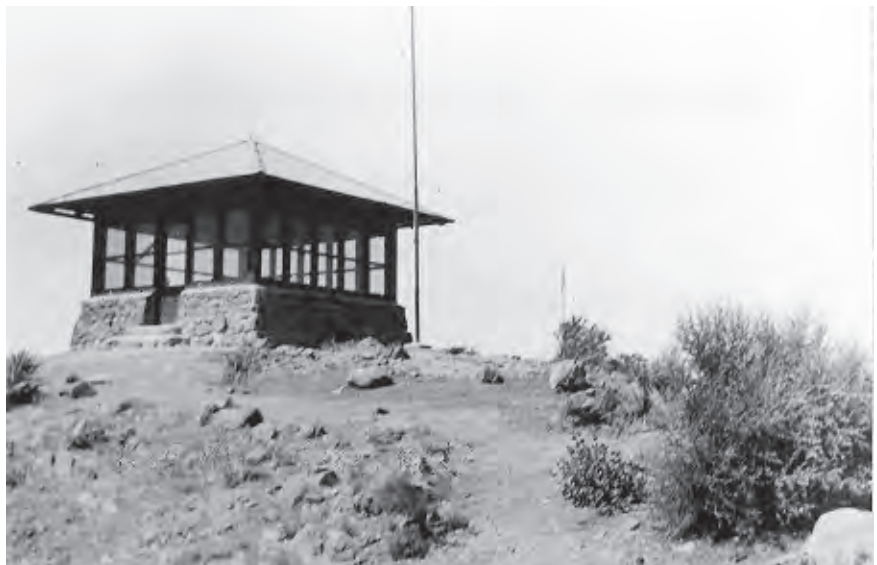
Figure 106. Sugarloaf Lookout illustrates the National Forest Service L-4 design, 1935. View looking southwest.

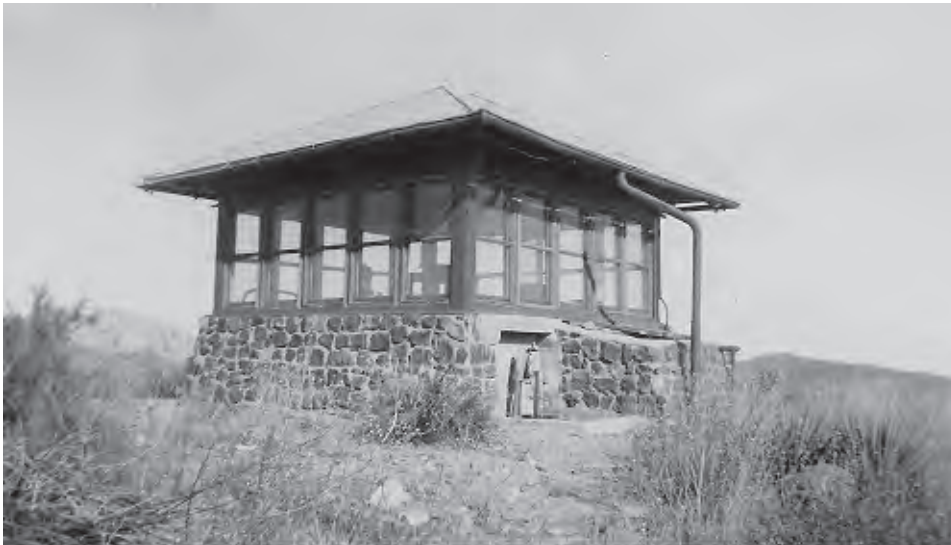
Figure 107. Sugarloaf Lookout, 1949. Note cistern on south face. View looking northeast.

Figure 107. Sugarloaf Lookout, 1949. Note cistern on south face. View looking northeast. Chiricahua National Monument Archives.

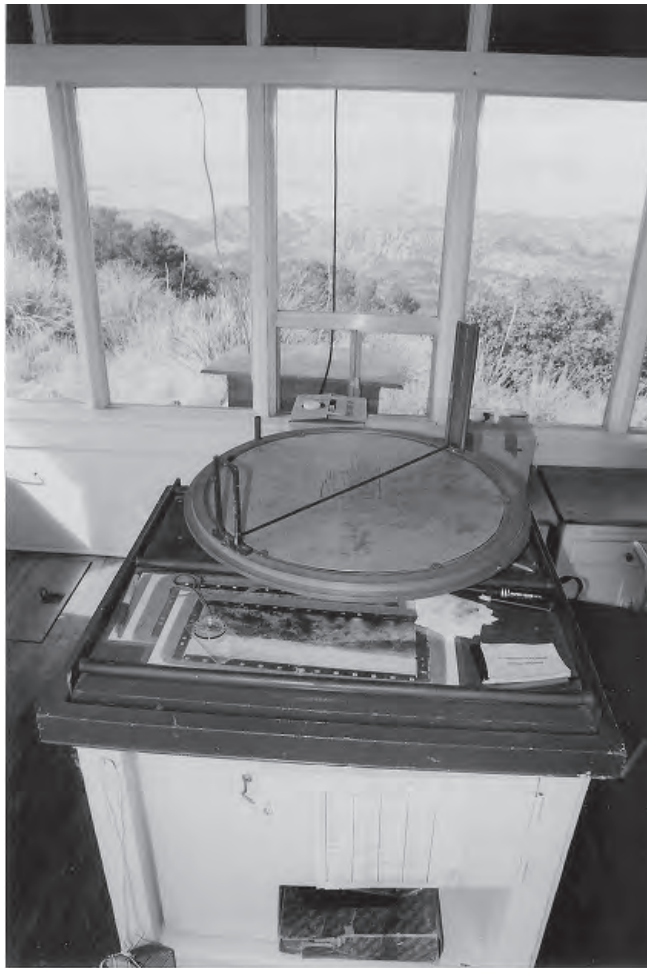
Figure 109. The Osborne Firefinder was installed in the Lookout shortly after construction.
