**National Register of Historic Places
Registration Form**

1. Name of Property Chiricahua National Monument Historic Designed Landscape

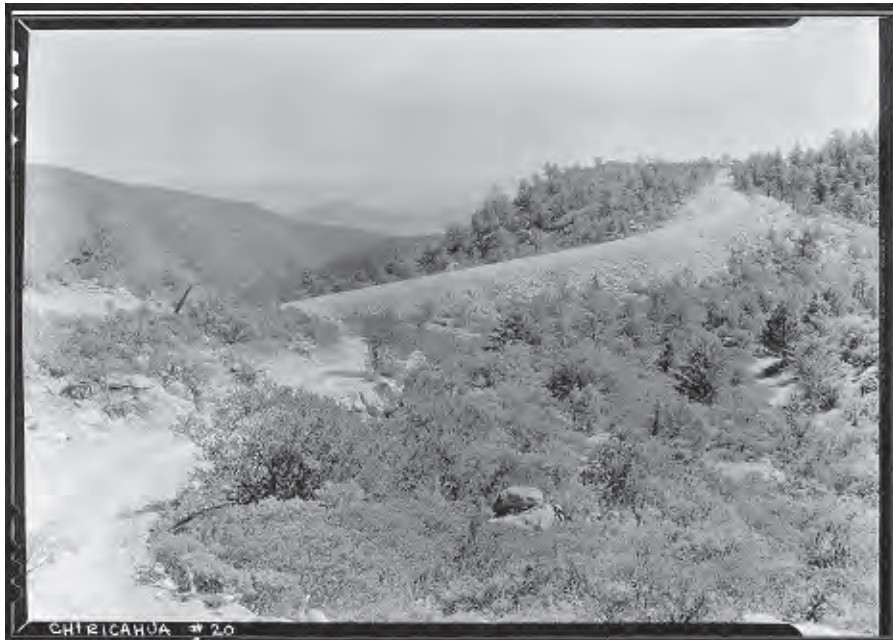
Figure 110. Early access road to Sugarloaf Mountain diverges from Bonita Canyon Highway, 1935. View looking east.

Figure 110. Early access road to Sugarloaf Mountain diverges from Bonita Canyon Highway, 1935. View looking east. George Grant. Chiricahua National Monument Archives.

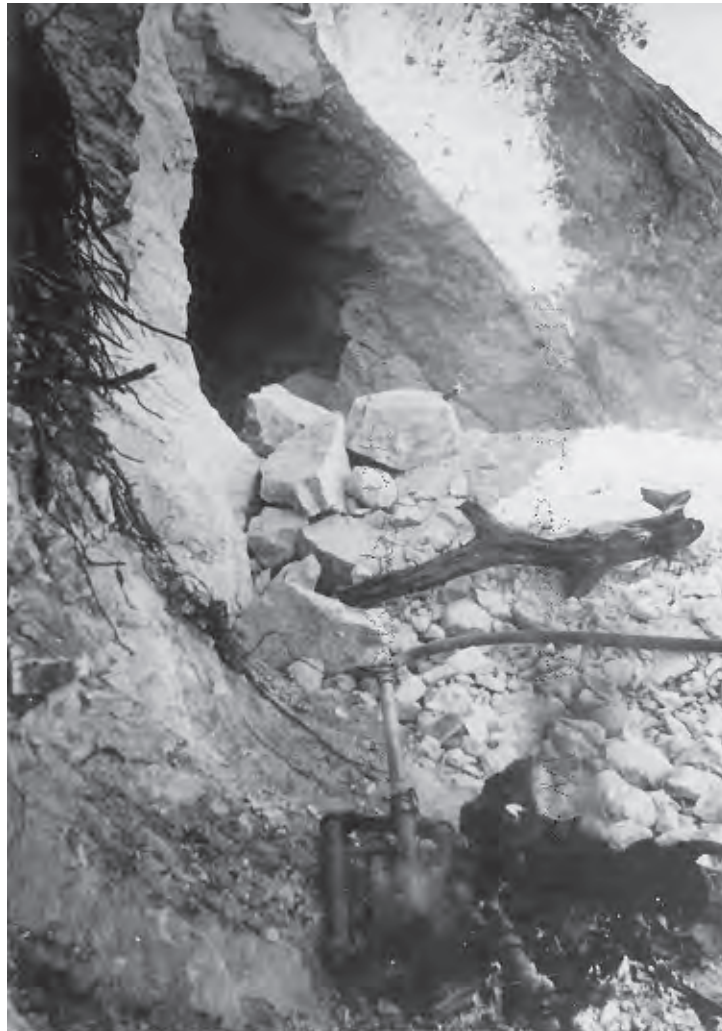
Figure 112. Portable air compressor used for cutting through tunnel on Sugarloaf Trail, 1935.

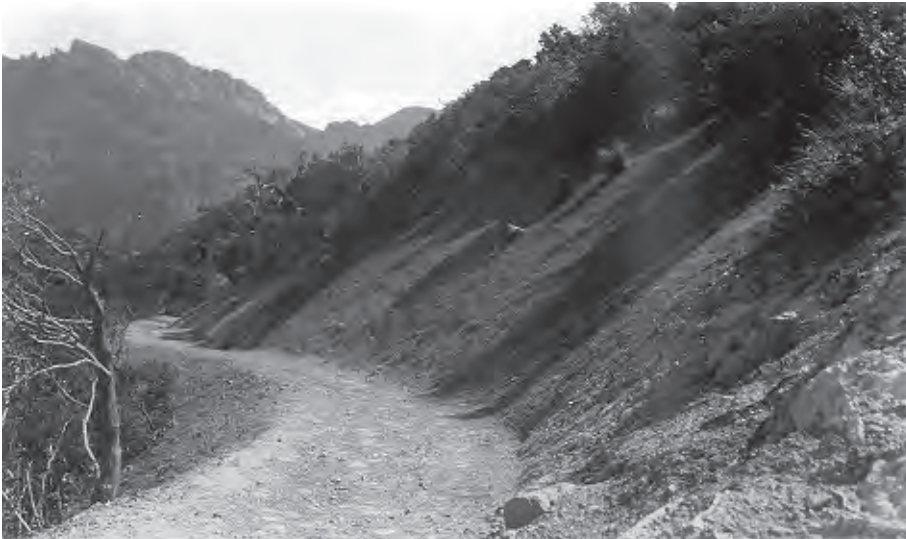
Figure 113. Section of Sugarloaf Trail shortly after completion, 1935. View looking northeast.

Figure 113. Section of Sugarloaf Trail shortly after completion, 1935. View looking northeast. Chiricahua National Monument Archives.

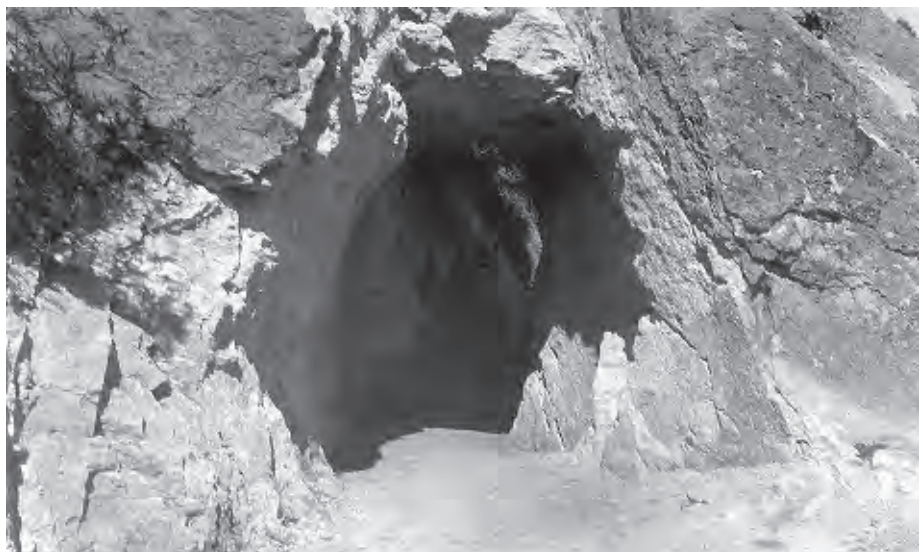
Figure 114. Sugarloaf Trail tunnel shortly after completion, 1935.

Figure 114. Sugarloaf Trail tunnel shortly after completion, 1935. Chiricahua National Monument Archives.

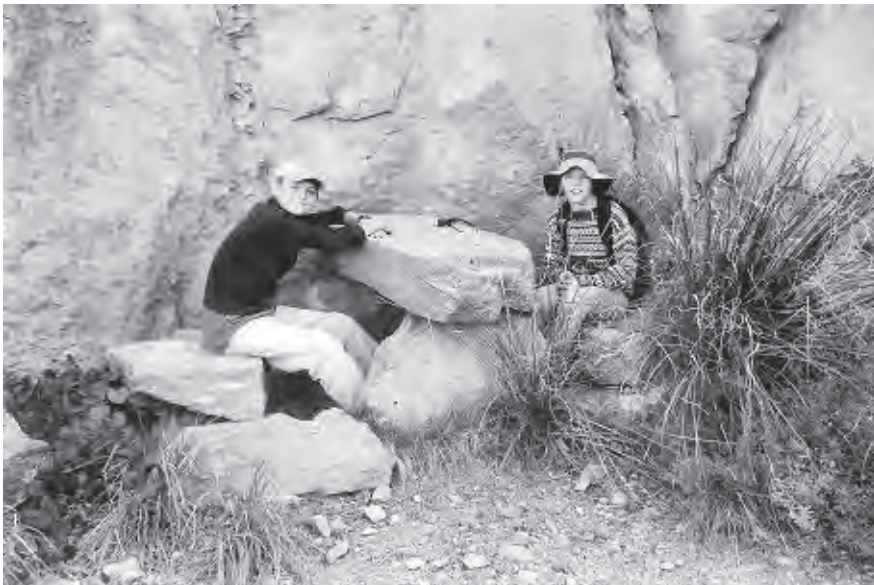
Figure 115. Bench and table created from tunnel debris on Sugarloaf Trail, 2002.

Figure 115. Bench and table created from tunnel debris on Sugarloaf Trail, 2002. R.L. Pinto.

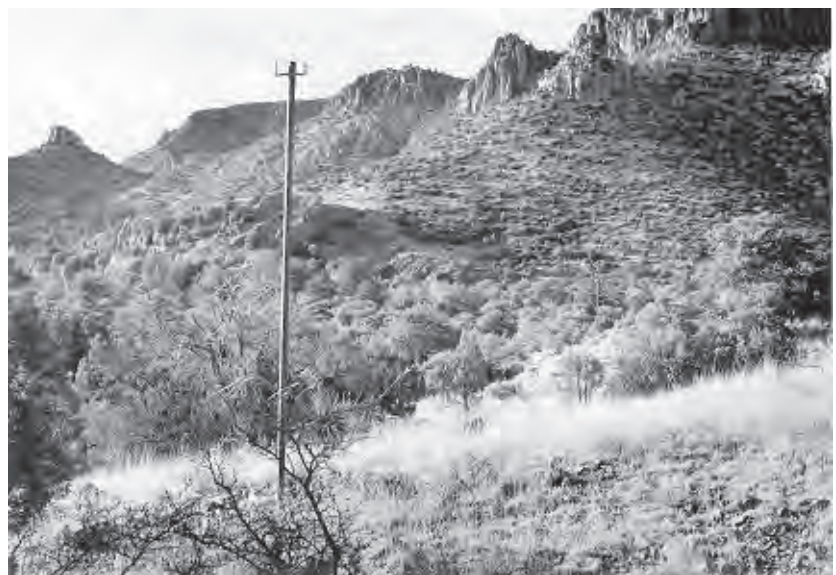
Figure 116. Remains of telephone communication system between Headquarters, Sugarloaf Lookout, and NFS Portal Ranger Station, 1993. View looking northwest.

Figure 116. Remains of telephone communication system between Headquarters, Sugarloaf Lookout, and NFS Portal Ranger Station, 1993. View looking northwest. Dewey Livingston. Chiricahua National Monument Archives.

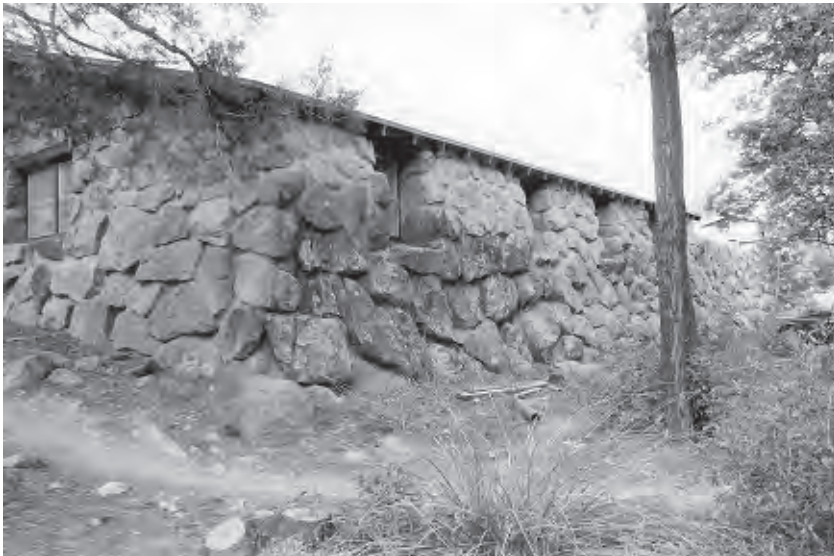
Figure 117. Northeast corner of the utility wall is constructed with largely uncut, uncoursed boulders, 2002. The wall is strongly battered. Note Warehouse incorporates wall in east and north faces. View looking southwest.

Figure 117. Northeast corner of the utility wall is constructed with largely uncut, uncoursed boulders, 2002. The wall is strongly battered. Note Warehouse incorporates wall in east and north faces. View looking southwest. R.L. Pinto.

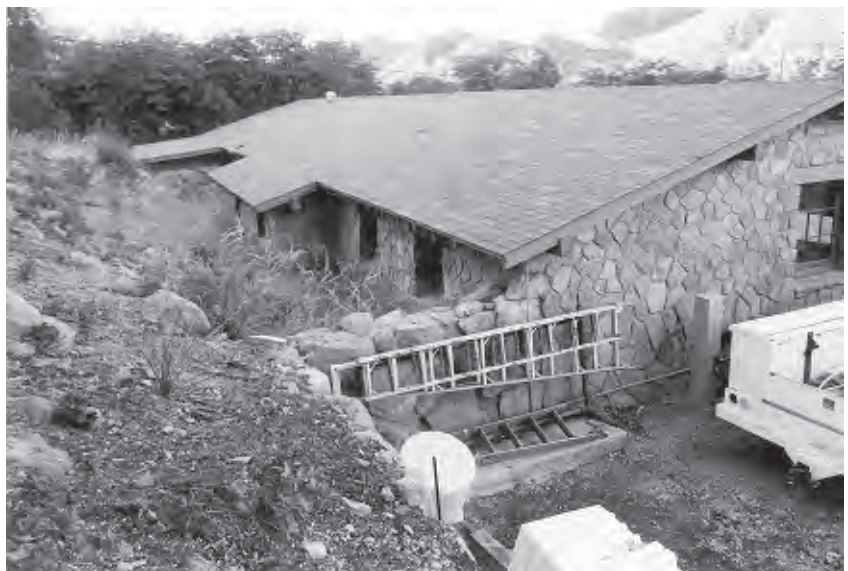
Figure 118. The Southeast retaining wall was added on to existing Equipment Shed, 2003. Note difference in stonemasonry of the Equipment Shed and adjoining utility wall. View looking northwest.

Figure 118. The Southeast retaining wall was added on to existing Equipment Shed, 2003. Note difference in stonemasonry of the Equipment Shed and adjoining utility wall. View looking northwest. R.L. Pinto.

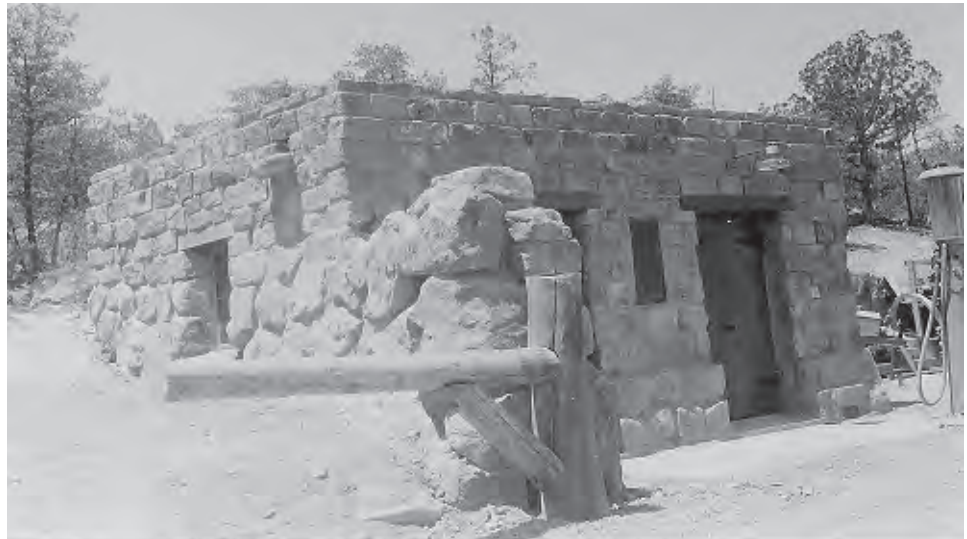
Figure 119. Oil and Gas House, rock pier, and wooden gates at east entrance of the Utility Area, 1939. Note light fixture above door and gas pump on the far right. View looking southwest.

Figure 119. Oil and Gas House, rock pier, and wooden gates at east entrance of the Utility Area, 1939. Note light fixture above door and gas pump on the far right. View looking southwest. Chiricahua National Monument Archives.

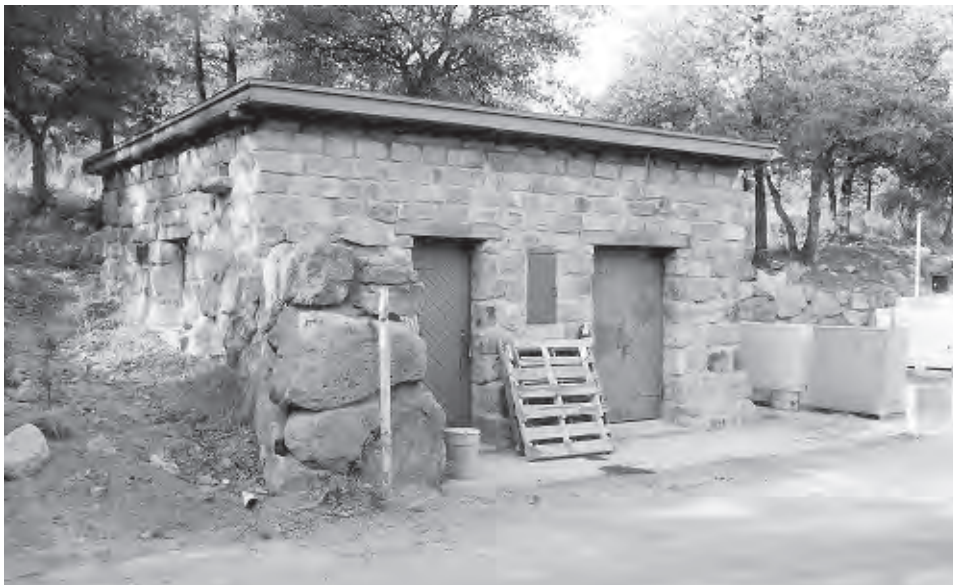
Figure 120. The wooden gate was replaced by a chain link gate, 2002. The vertical post is all that remains today. View looking southwest.

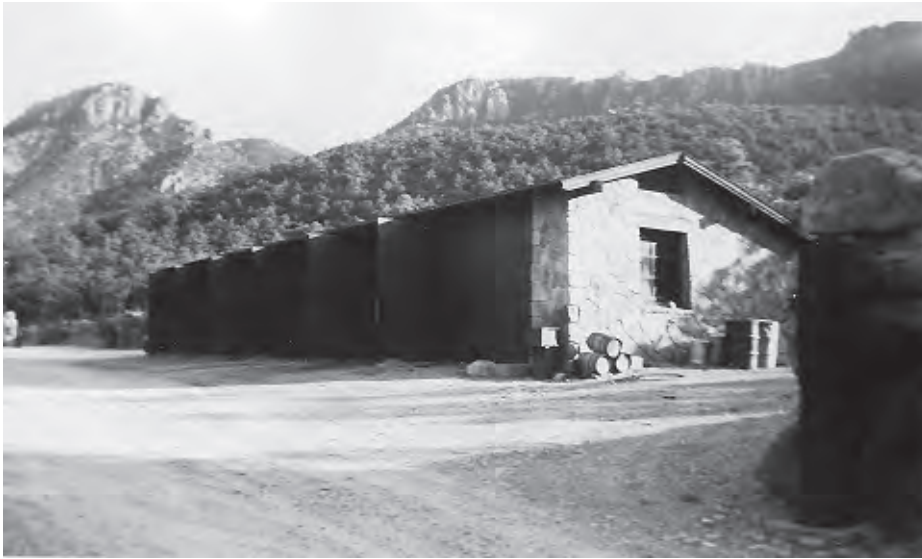
Figure 121. An early image of the Equipment Shed prior to the western addition shows the original bay doors, 1949. View looking southeast.

Figure 121. An early image of the Equipment Shed prior to the western addition shows the original bay doors, 1949. View looking southeast. Chiricahua National Monument Archives.

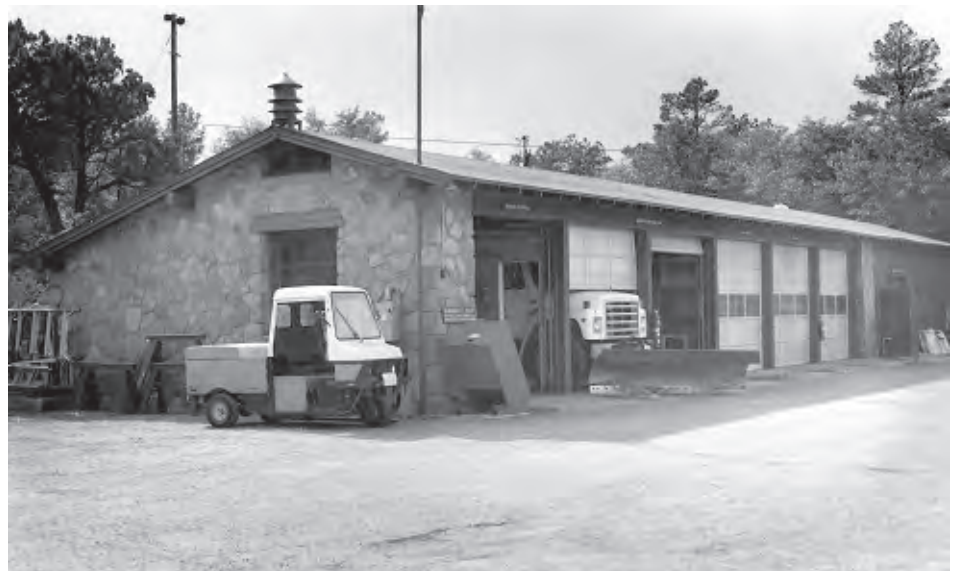
Figure 122. The Equipment Shed with modern pulldown doors and its addition at right, 1993. View looking southwest.

Figure 122. The Equipment Shed with modern pulldown doors and its addition at right, 1993. View looking southwest. Dewey Livingston. Chiricahua National Monument Archives.

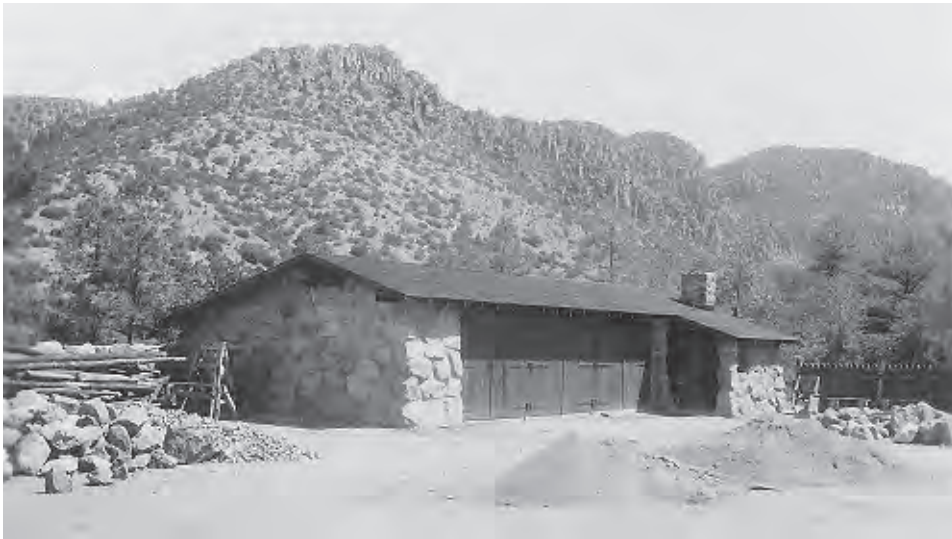
Figure 123. Warehouse shortly after construction with three bays and 'ell' at south-east corner, 1939. Note wooden stockade at far right. View looking northeast.

Figure 123. Warehouse shortly after construction with three bays and 'ell' at southeast corner, 1939. Note wooden stockade at far right. View looking northeast. Chiricahua National Monument Archives.

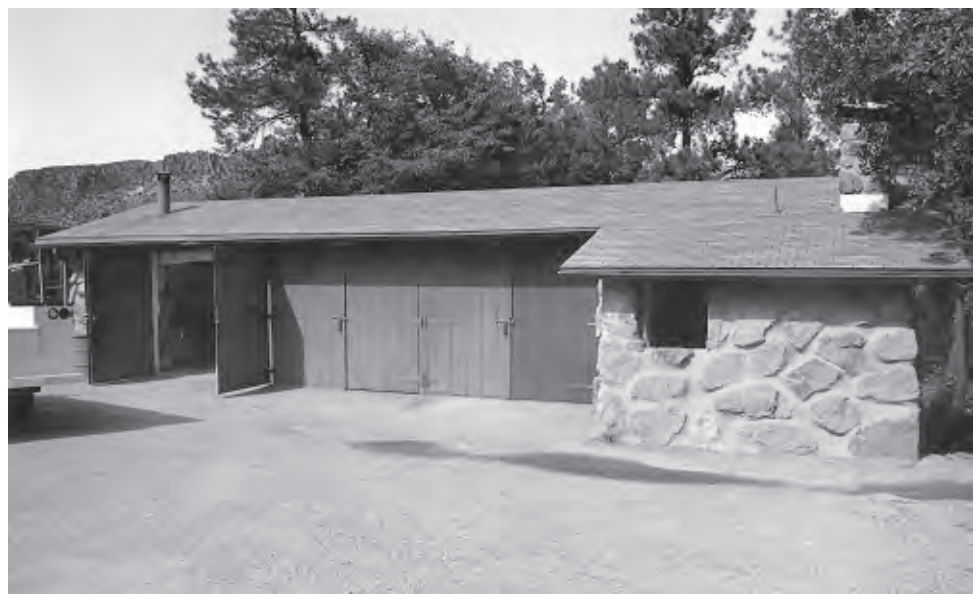
Figure 124. Warehouse with modern bay doors, 1993. Walls are composed of un-coursed stone and are slightly battered. Note the decreasing size of stone from the foundation up. View looking northwest.

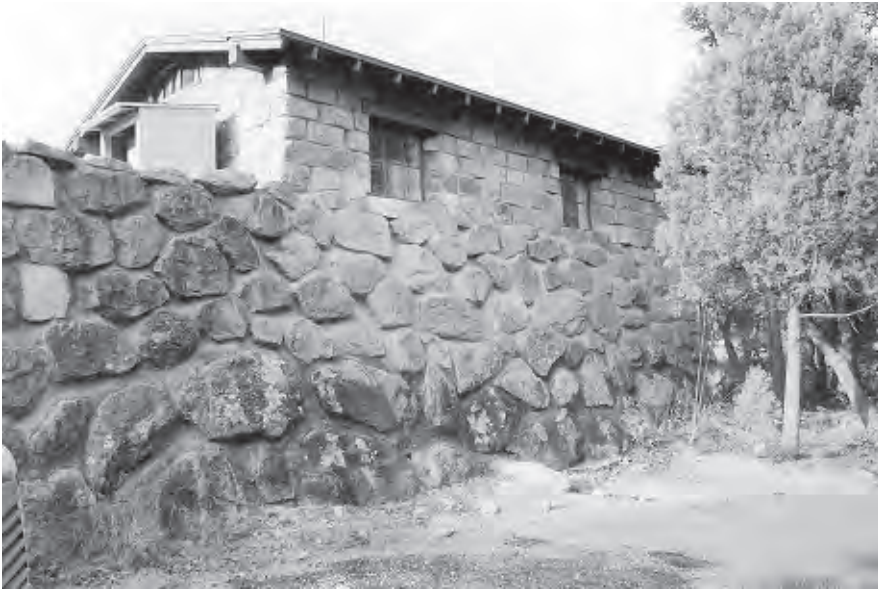
Figure 125. The Power House and Laundry incorporates the utility wall as part of its north and west faces, 2002. View looking southwest.

Figure 125. The Power House and Laundry incorporates the utility wall as part of its north and west faces, 2002. View looking southwest. R.L. Pinto.

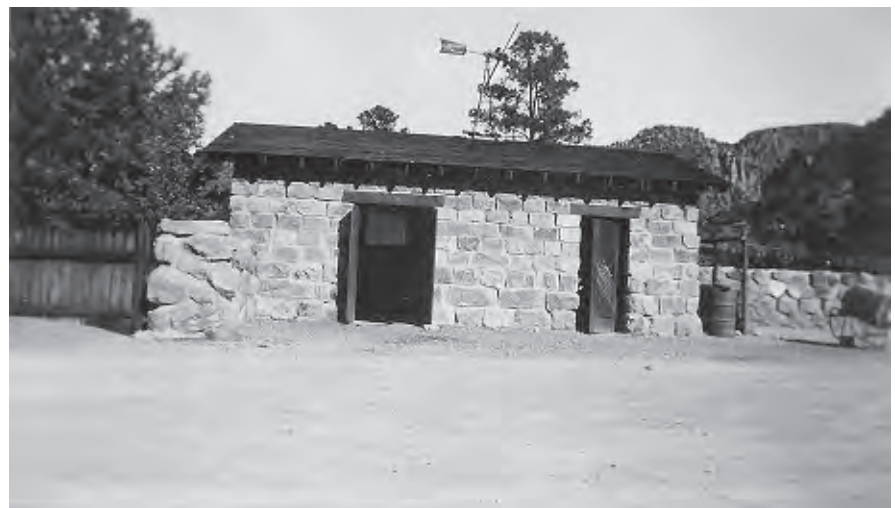
Figure 126. The south face of the Power House and Laundry walls are composed of rectangular cut block and show little batter, 1949. Note the wooden stockade on the left hand side. View looking north.

Figure 126. The south face of the Power House and Laundry walls are composed of rectangular cut block and show little batter, 1949. Note the wooden stockade on the left hand side. View looking north. Chiricahua National Monument Archives.

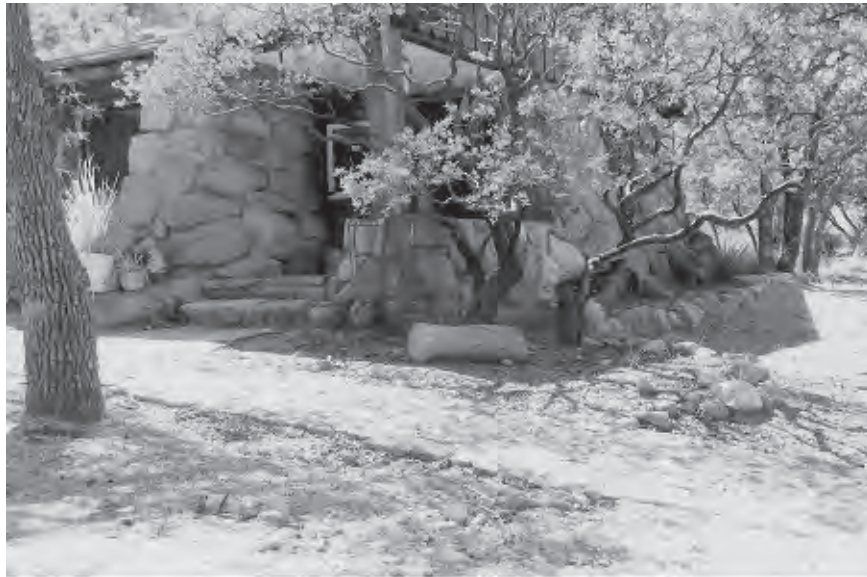
Figure 127. Porch entrance to Ranger Residence #1, 2002. Stonemasonry includes strongly battered walls constructed of large, uncut rubble. View looking south.

Figure 127. Porch entrance to Ranger Residence #1, 2002. Stonemasonry includes strongly battered walls constructed of large, uncut rubble. View looking south. R.L. Pinto.

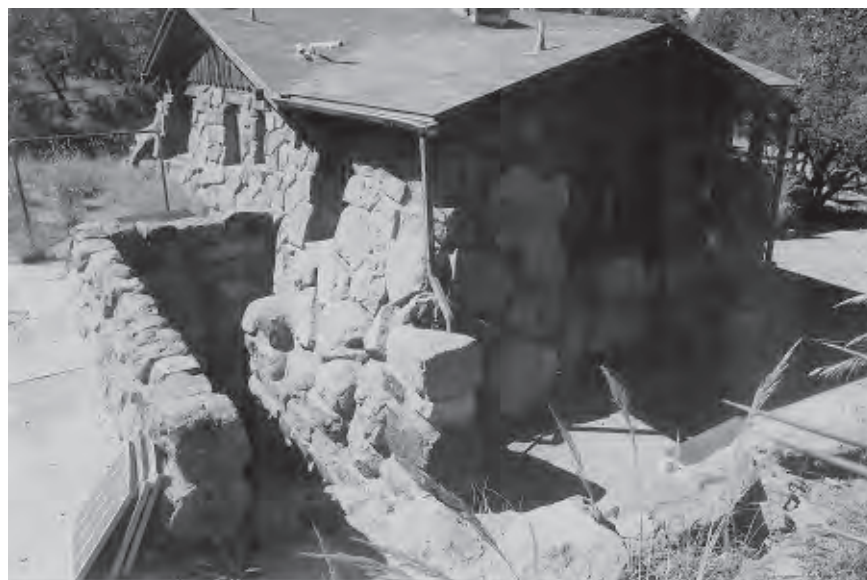
Figure 128. Basement entrance to Residence #1, 2002. View looking west.

Figure 128. Basement entrance to Residence #1, 2002. View looking west. R.L. Pinto.

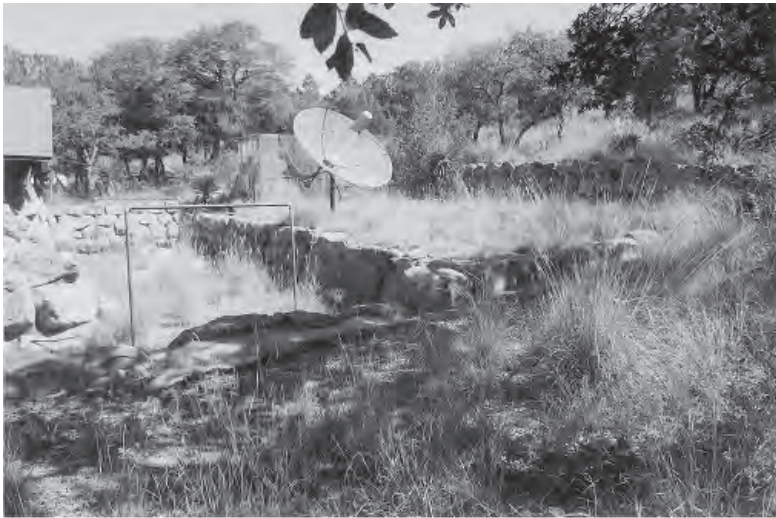
Figure 129. Terraced backyard for Residence #1 first constructed as children's play area, 2002. View looking east.

Figure 129. Terraced backyard for Residence #1 originally constructed as children's play area, 2002. View looking east. R.L. Pinto.

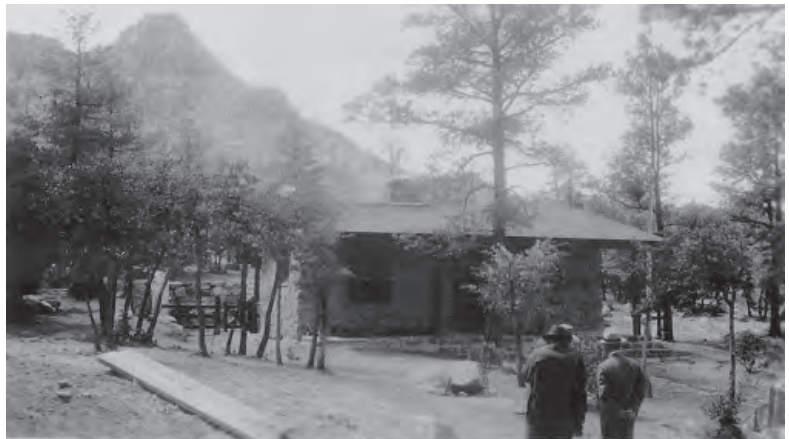
Figure 130. Residence #2, 1939. Note stone retaining wall at left. View looking southwest.

Figure 130. Residence #2, 1939. Note stone retaining wall at left. View looking southwest. Chiricahua National Monument Archives.

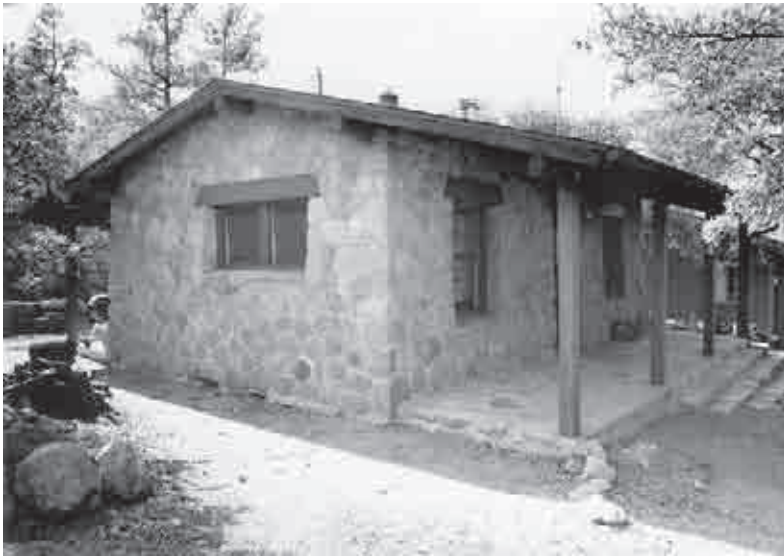
Figure 131. Stone-veneered front porch of Residence #2, 1993. View looking southwest.

Figure 131. Stone-veneered front porch of Residence #2, 1993. View looking southwest. Dewey Livingston. Chiricahua National Monument Archives.

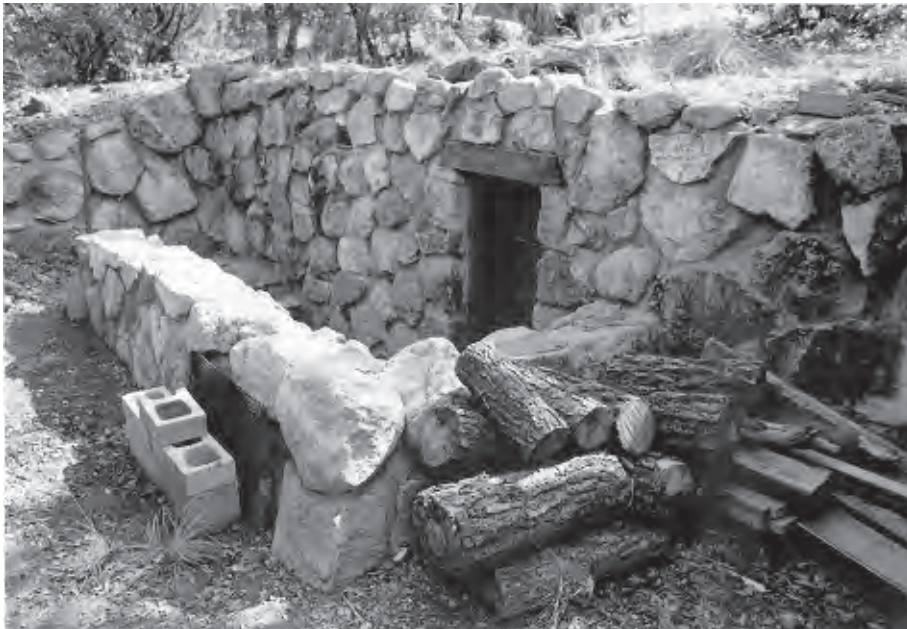
Figure 133. Root cellar in backyard of Residence #2, 1993. View looking south-east.

Figure 133. Root cellar in backyard of Residence #2, 1993. View looking southeast. Chiricahua National Monument Archives.

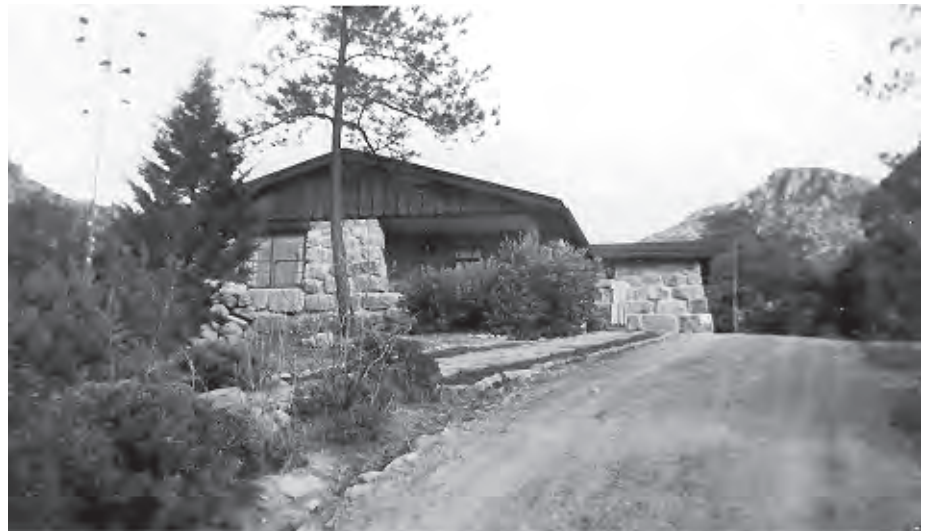
Figure 134. Front of Residence #3 shows stonemasonry with rectangular cut block and strongly battered walls, 1949. Note walkway and vegetation in front yard. View looking east.

Figure 134. Front of Residence #3 shows stonemasonry with rectangular cut block and strongly battered walls, 1949. Note walkway and vegetation in front yard. View looking east. Chiricahua National Monument Archives.

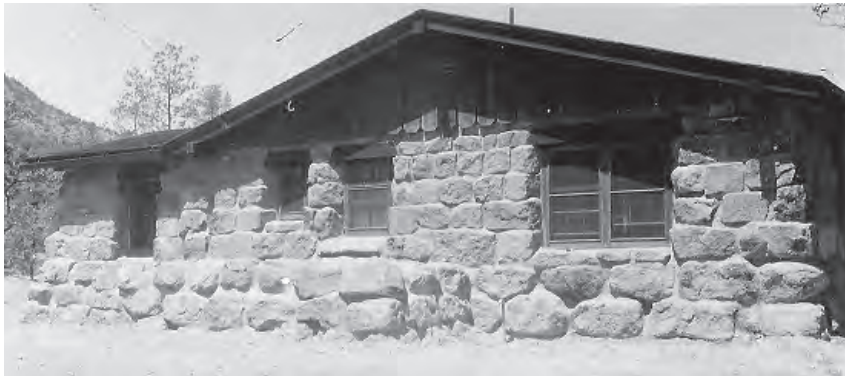
Figure 135. Basement entrance at rear of Residence #3, 1949. Note diminishing size of rock work from foundation up. View looking southwest.

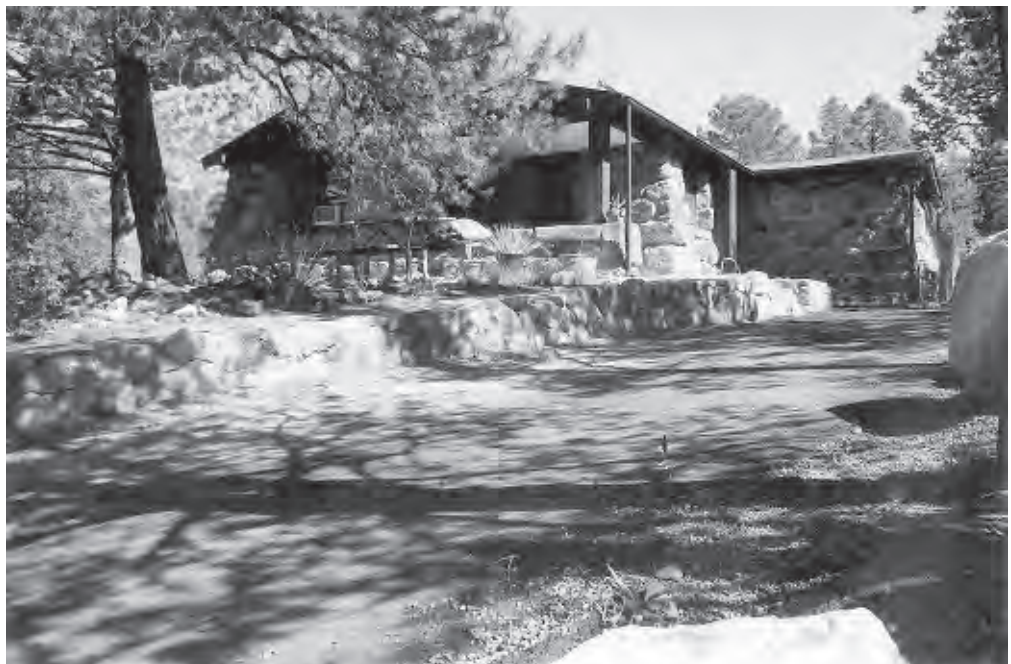
Figure 136. Recent image of Residence #3 illustrates changes to front yard including lowering of driveway and construction of retaining Wall, 2002. View looking east.

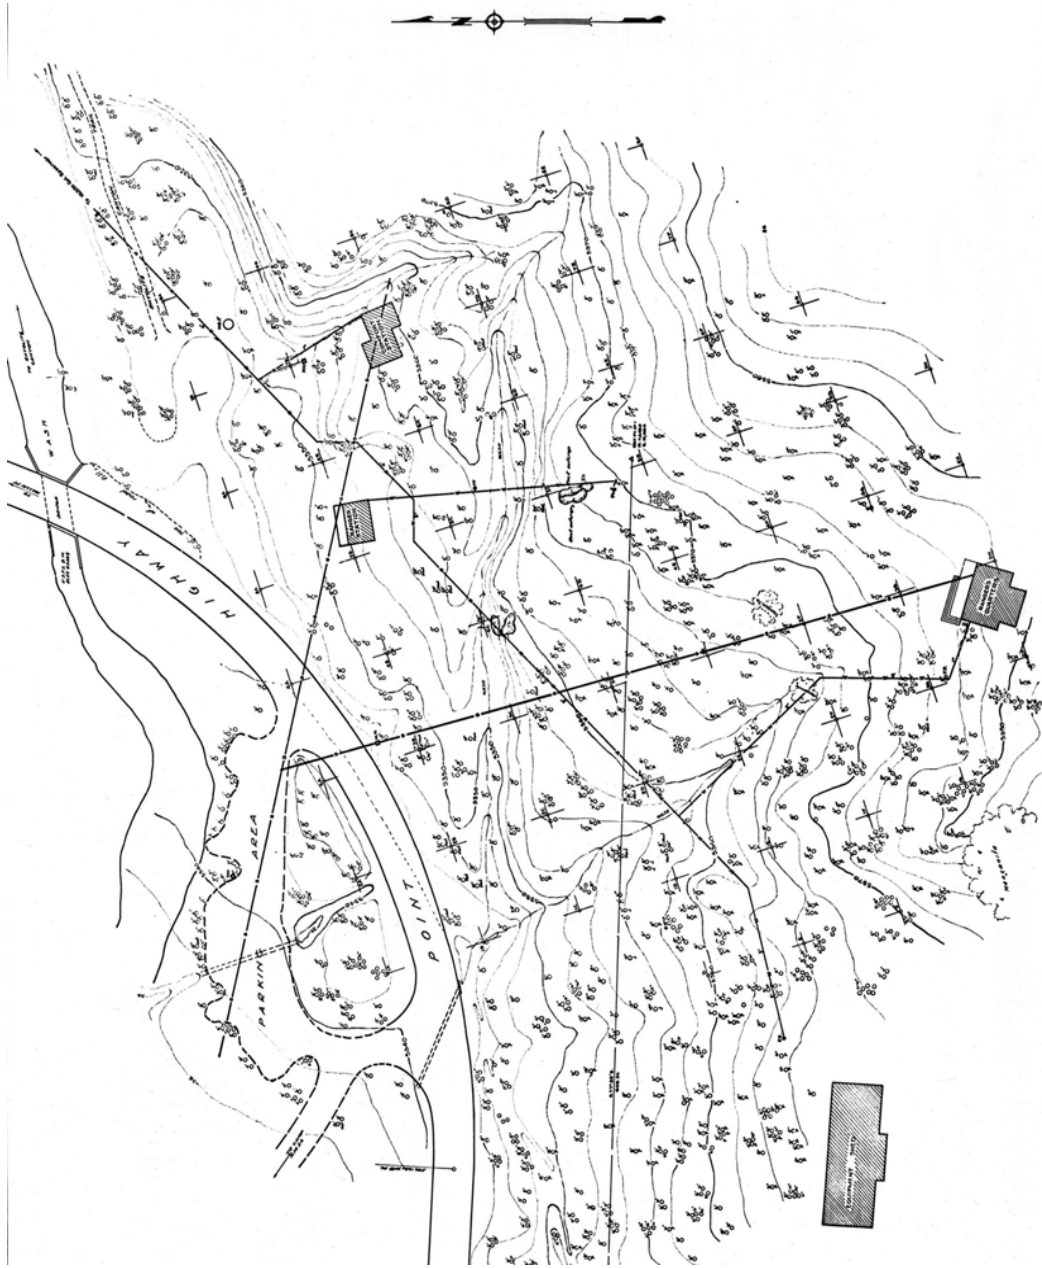
Map 7. Early survey of Administration Area with proposed locations for the Equipment Shed, Ranger Station, Comfort Station, and Ranger Residence #2, 1935.

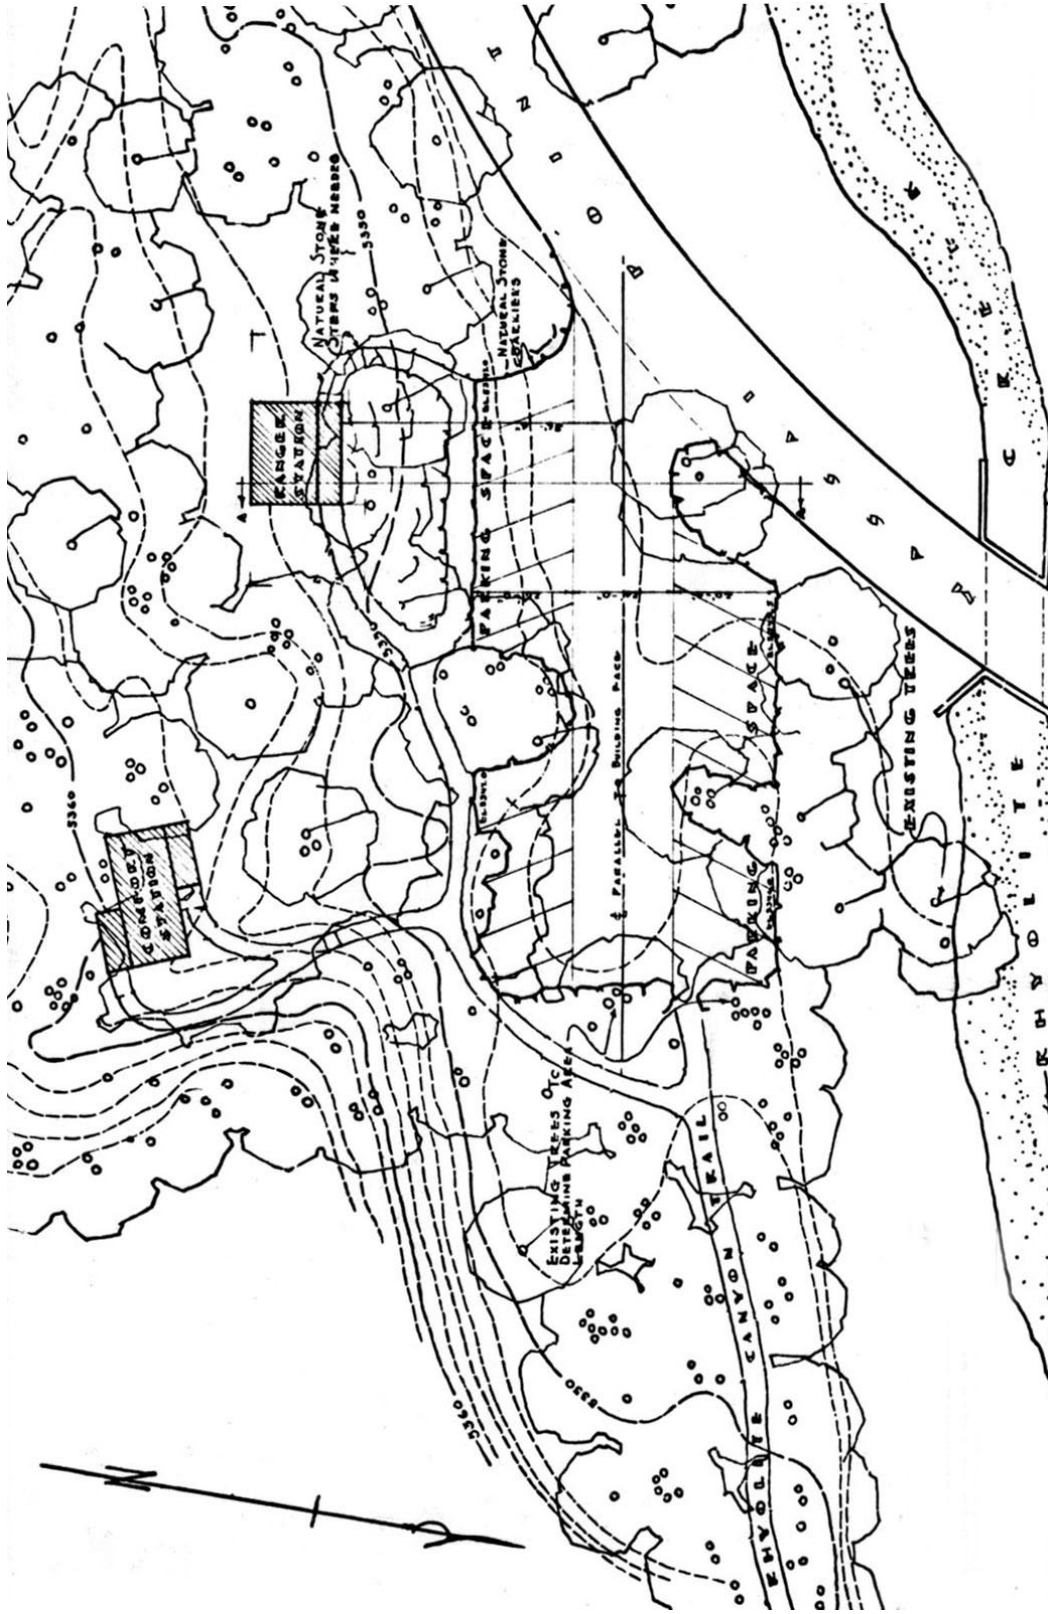
Map 8. Ranger Station and Comfort Station with pathway loop and parking area, 1936.

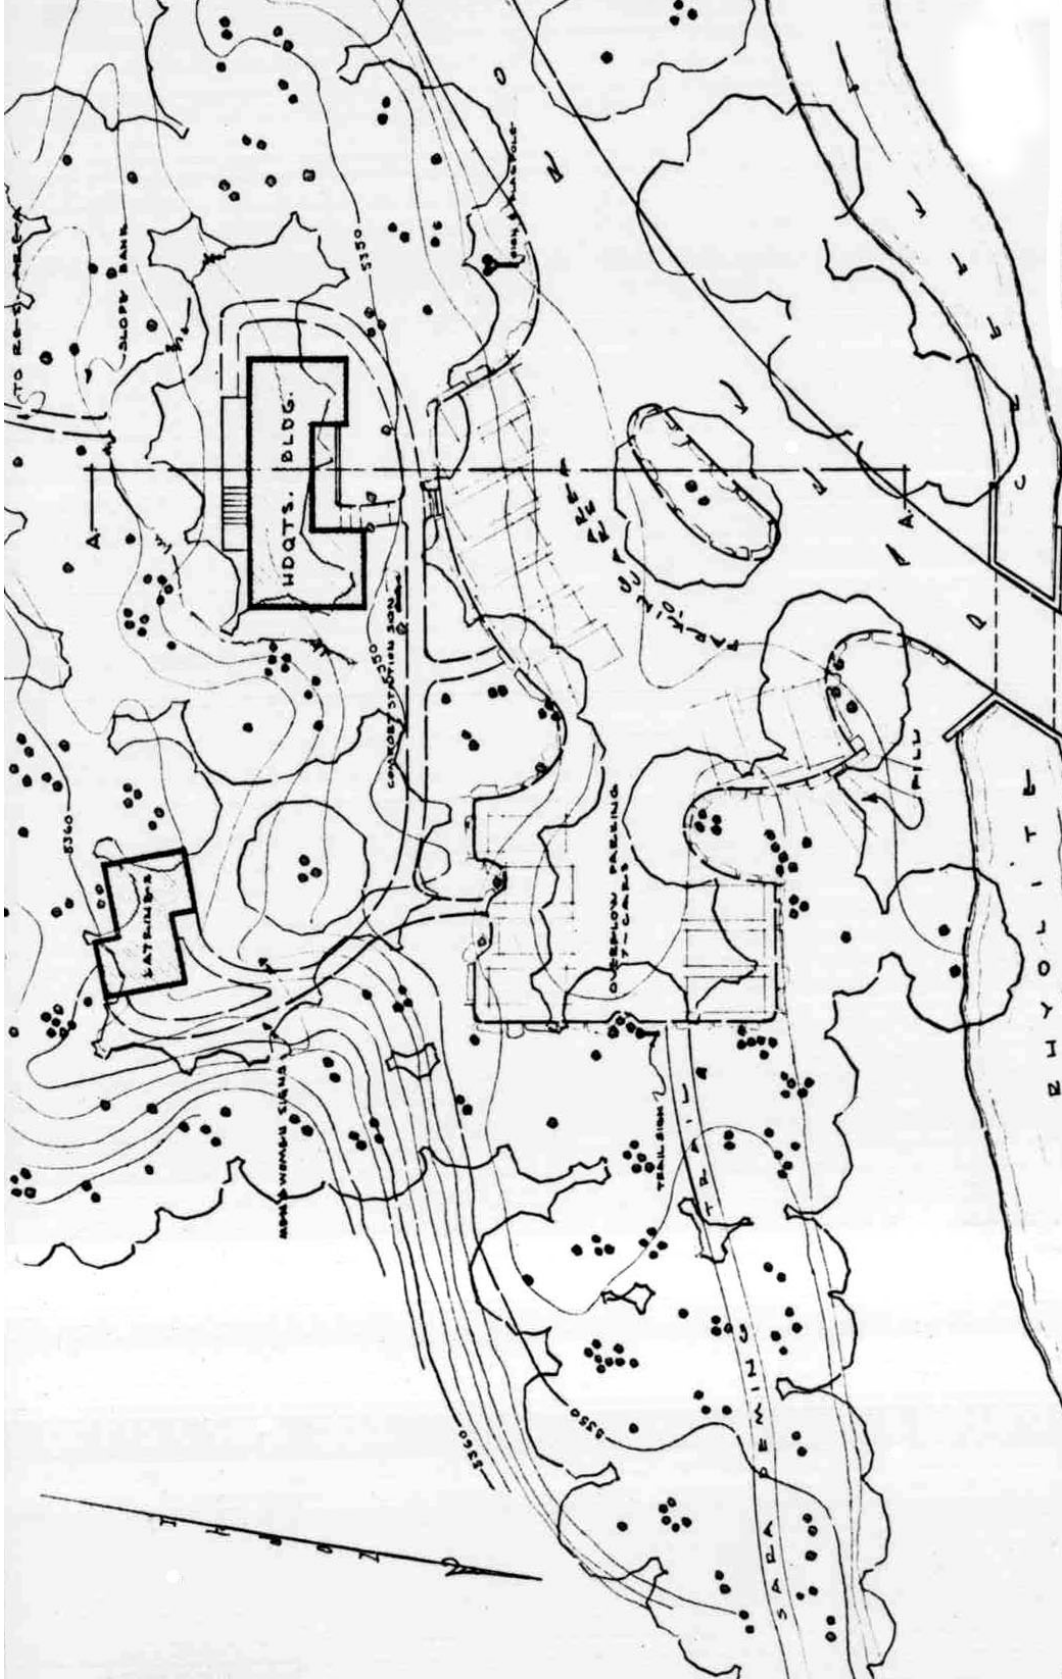
Map 9. Administration Building with pathway and parking area, 1938.
