National Park Service
U.S. Department of the Interior
Intermountain Region

Chiricahua National Monument – Faraway Ranch

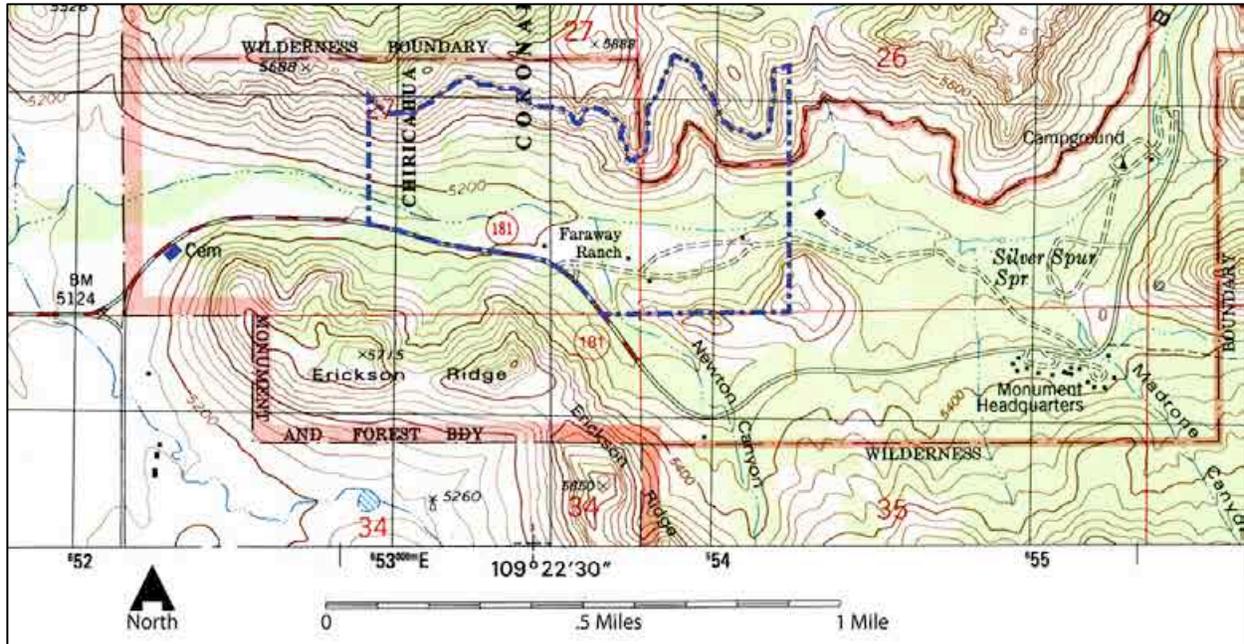
Figure 2 - 2. USGS Map of Faraway Ranch Historic District (USGS, 1996). The dashed blue outline indicates the boundary of the district and CLR study area.

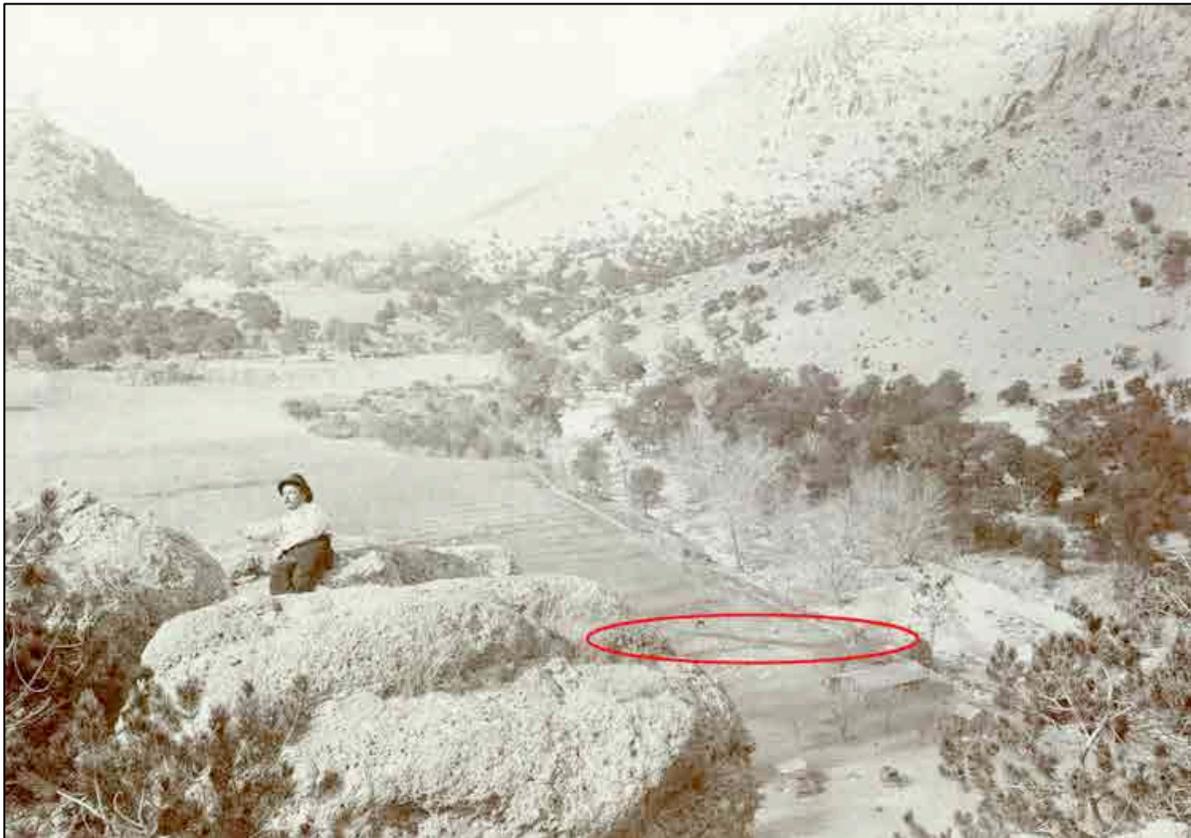
Figure 3 - 2. View of the valley around 1900. Irrigation ditch to the west of the Stafford Cabin is circled in red (CHIR 86:16:0856).

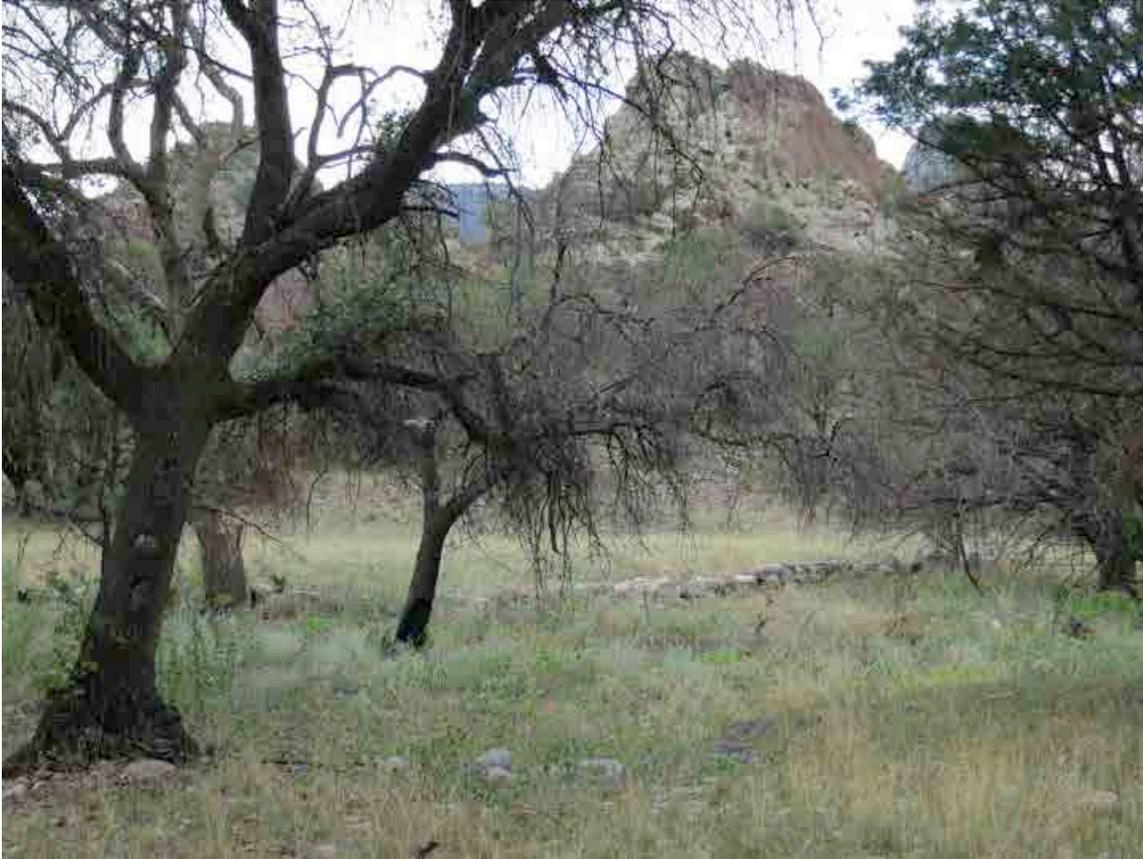
Figure 5 - 1. Fire damage along Newton's Wash, south of Ranch Road where it crosses the wash (Erickson, 2012).

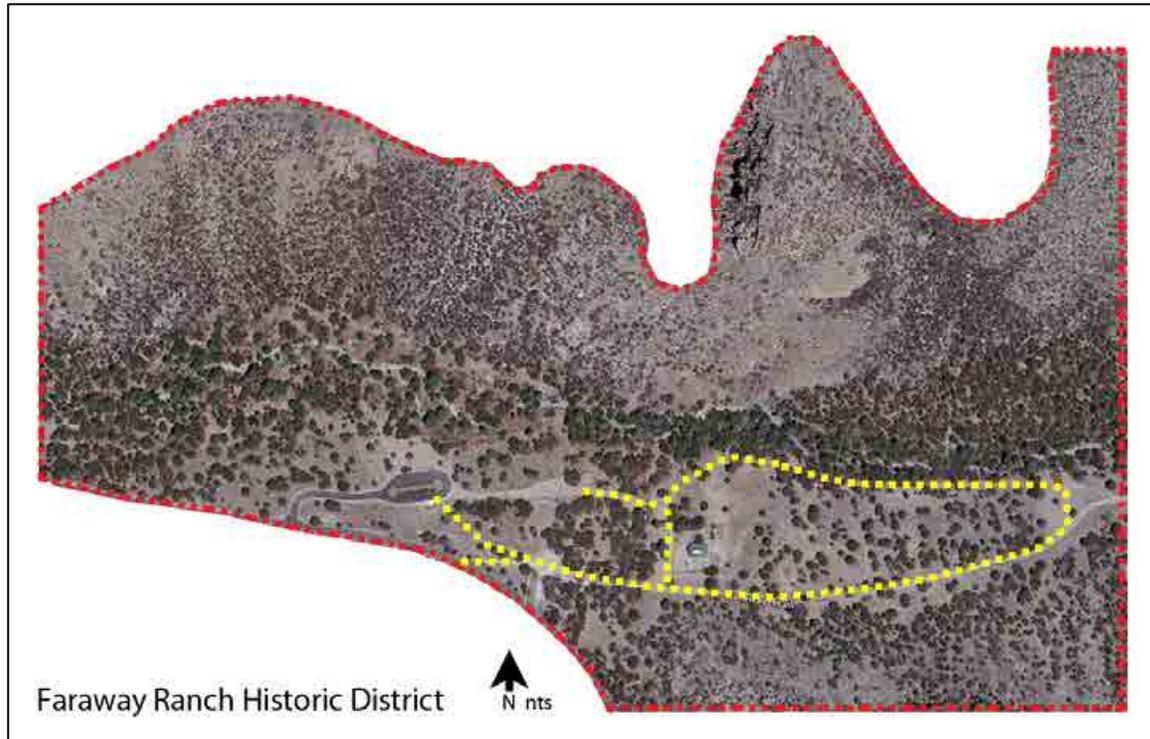
Figure 5 - 2. Recommended circulation routes for Faraway Ranch (adapted from Google Earth, 2012).

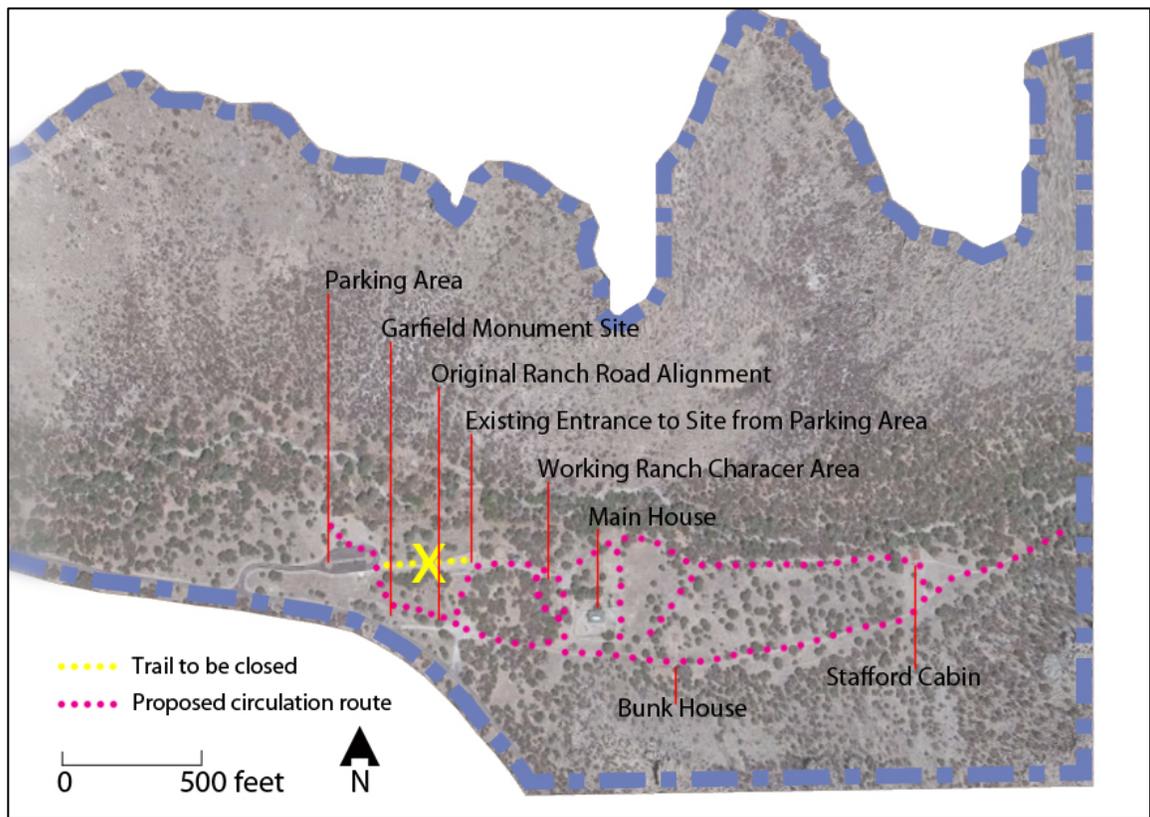
Figure 5 - 3. Proposed visitor circuits for Faraway Ranch (adapted from Google Earth, 2012).

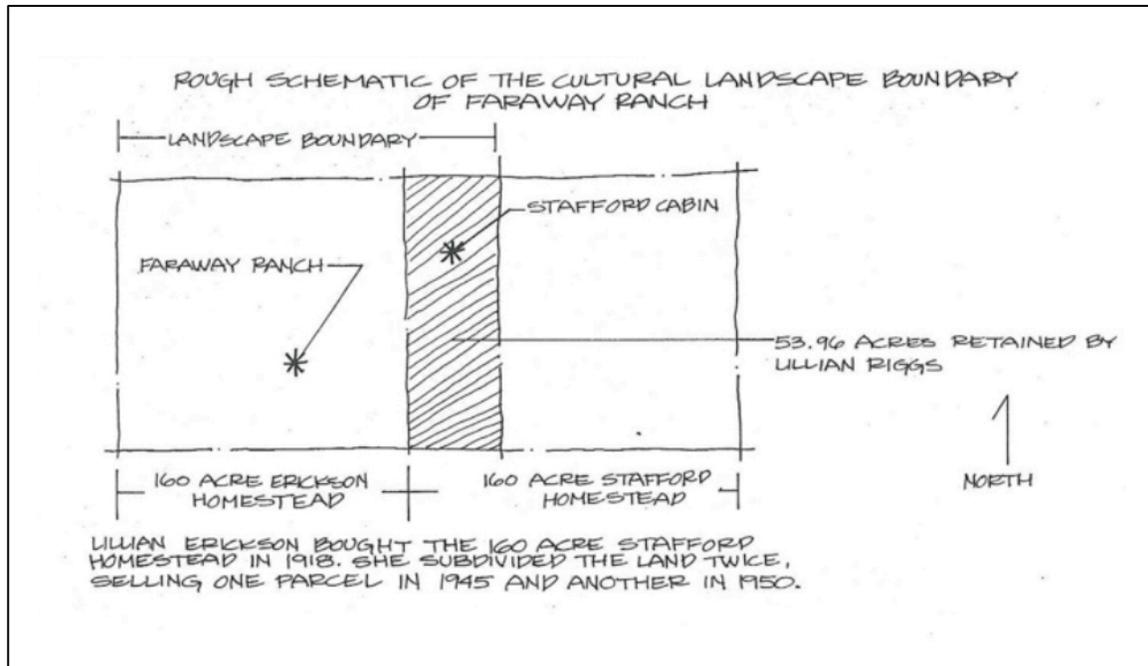
Figure 5A - 3. Boundary between Erickson and Stafford homesteads.³

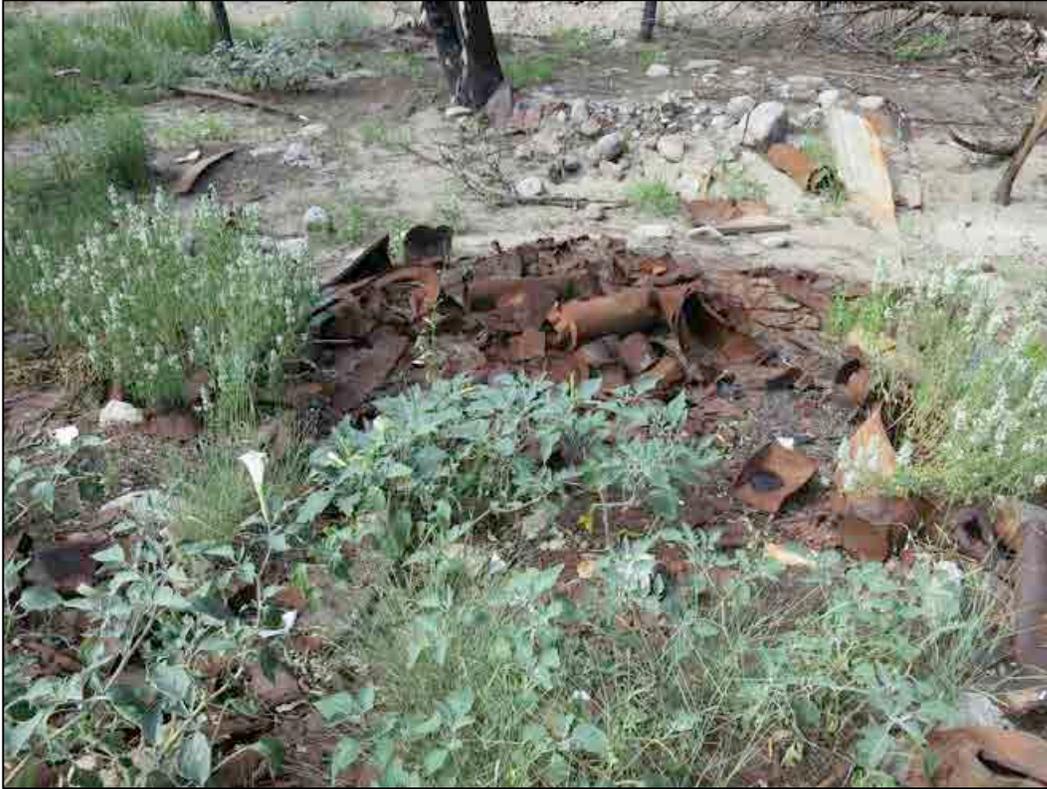
Figure 5A - 10. C.C.C. dump site (Erickson, 2012).

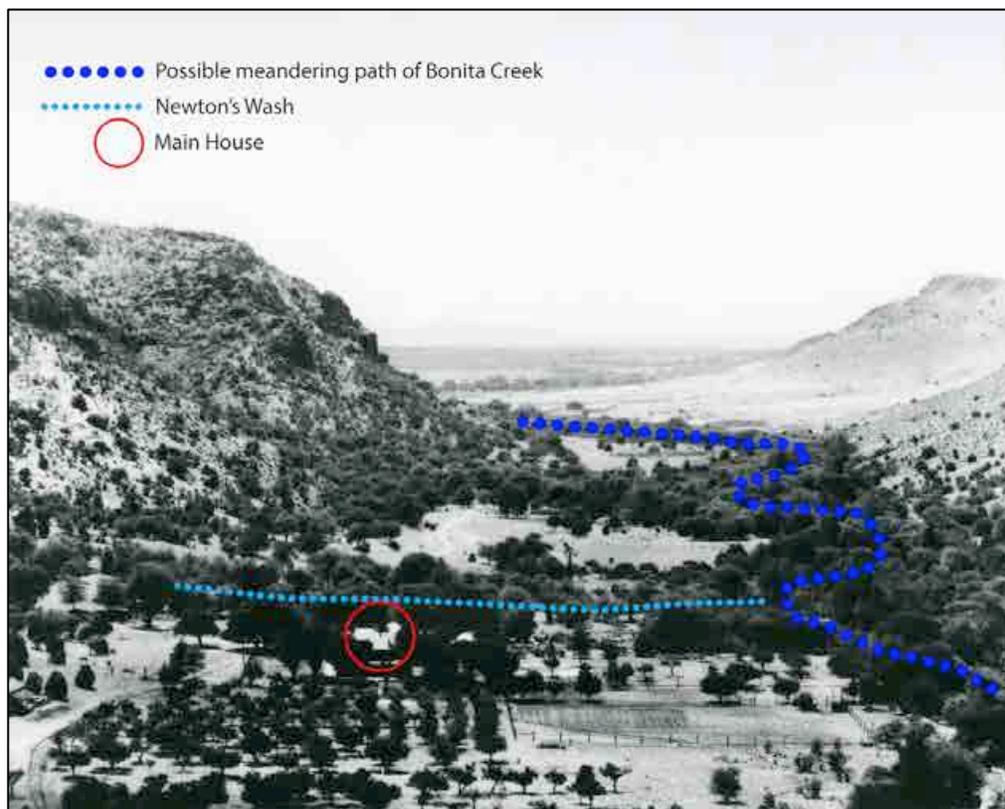
Figure 5B - 5. View of the valley from Neil's Rock, looking west, ca. 1908, showing Bonita Creek, right, and Newton's Wash, in center (CHIR 86:16:B2F8).

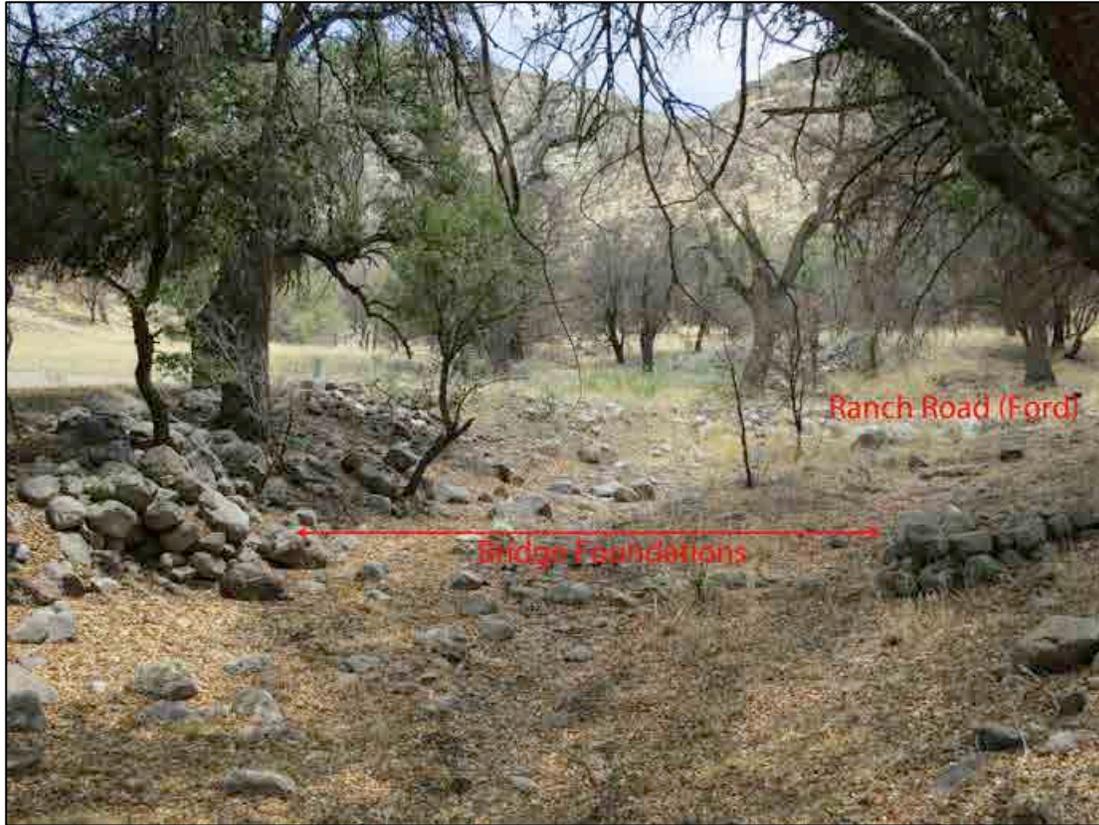
Figure 5B - 11. Old Bridge Foundations and ranch road ford across Newton's Wash, looking south from existing bridge (Erickson, 2012).

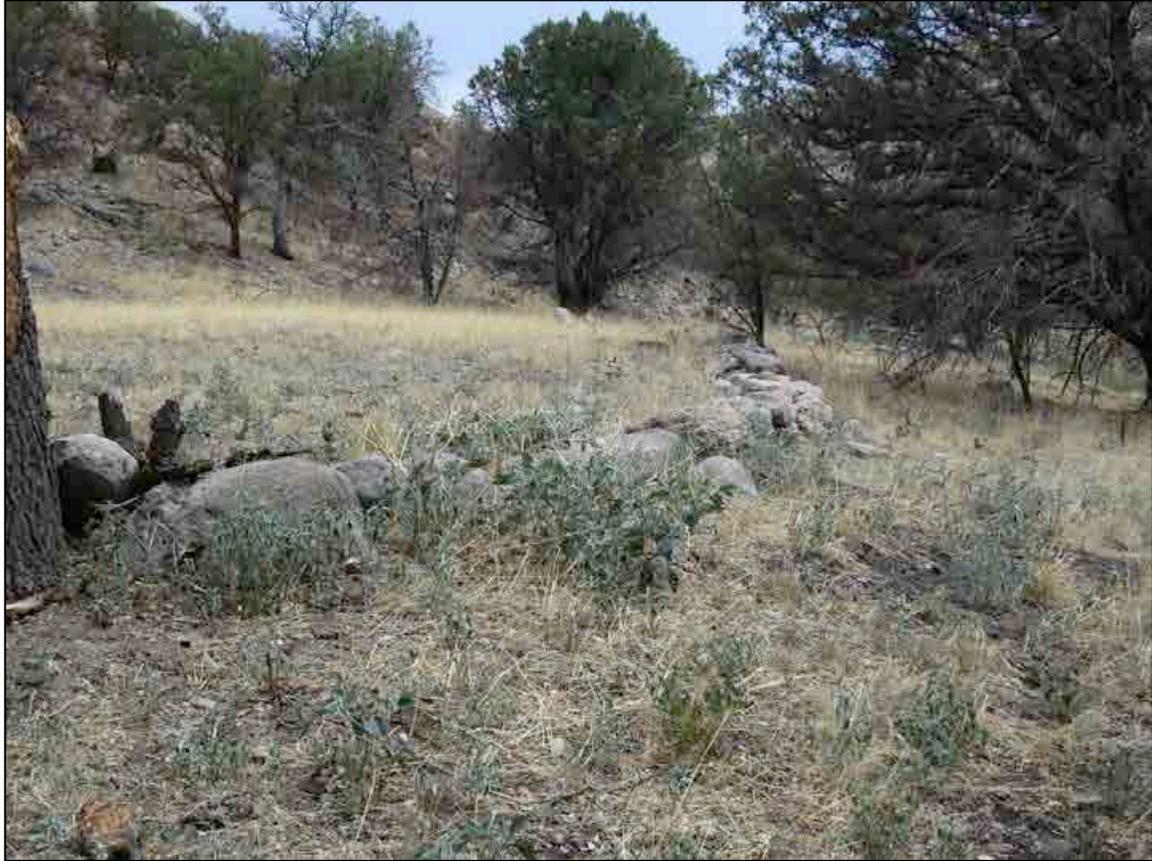
Figure 5B - 12. Stone embankment wall along Newton's Wash, south of ranch road, looking south (Erickson, 2012).

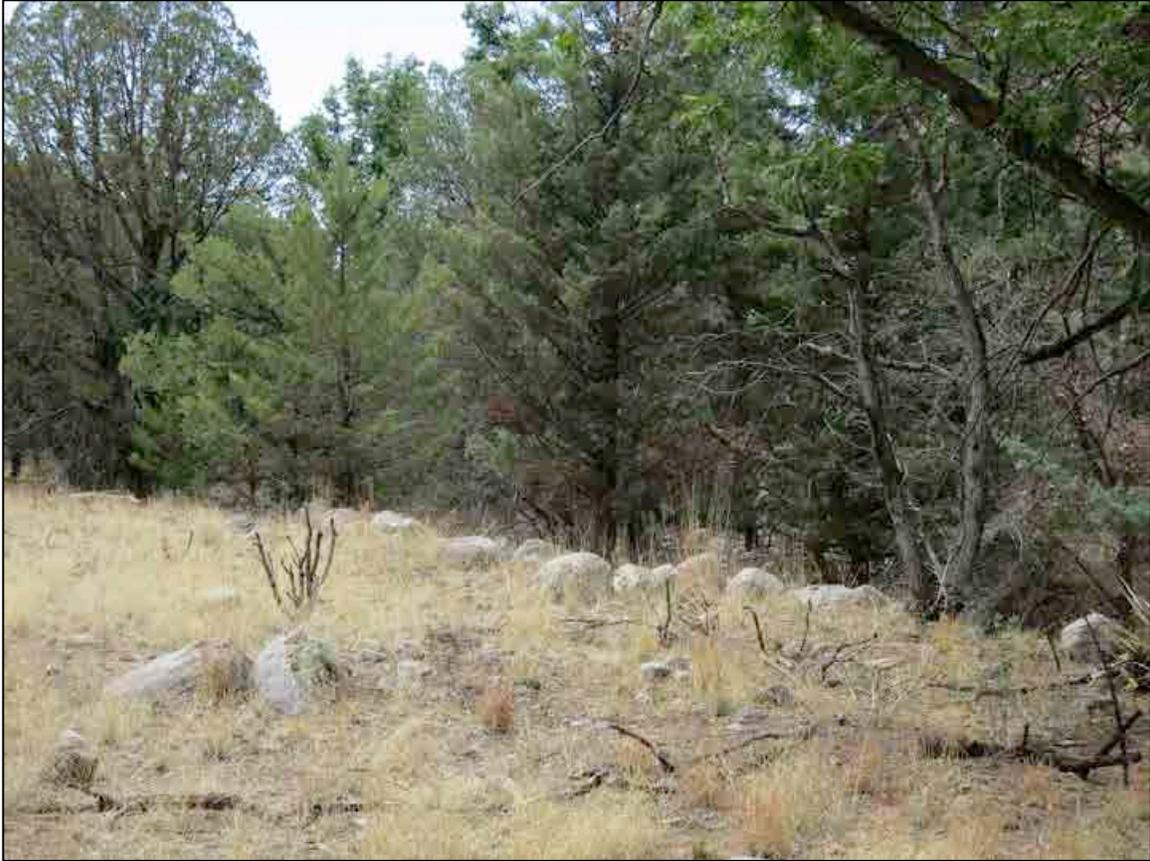
Figure 5B - 14. Bonita Creek retaining wall, Meadow area (Erickson, 2012).

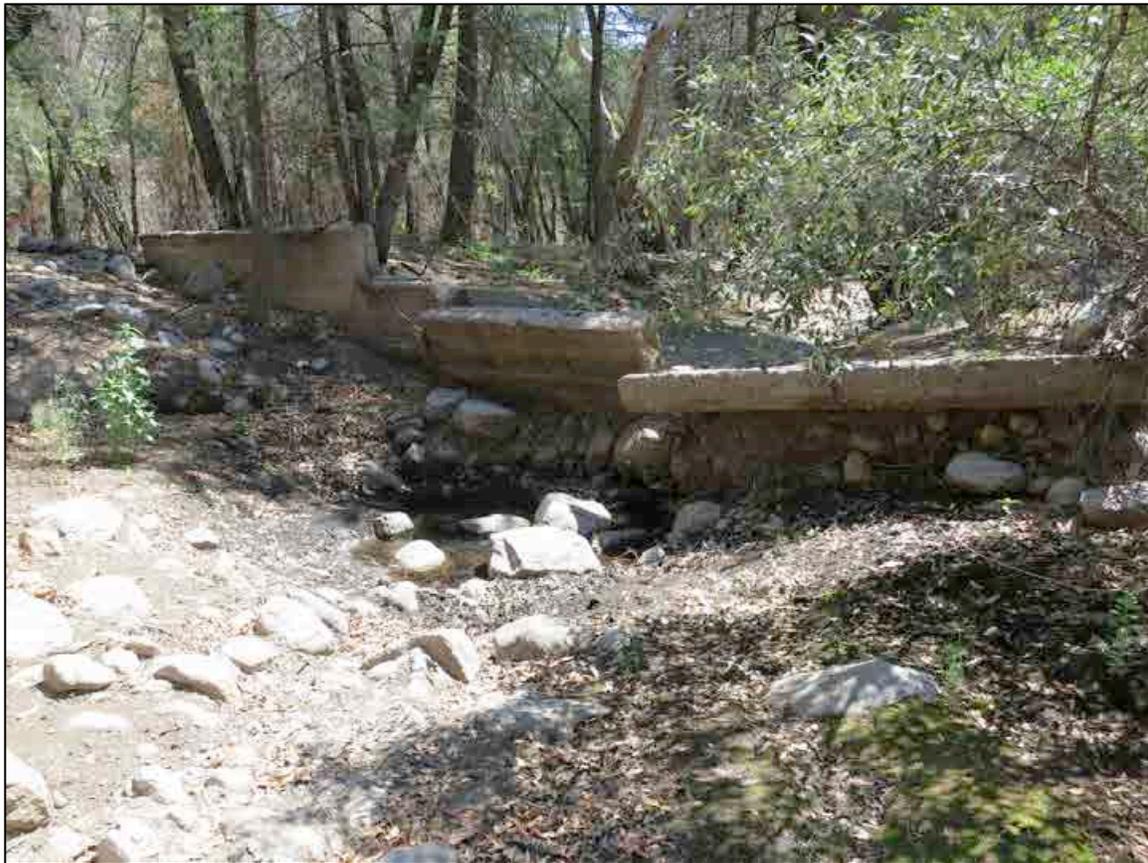
Figure 5B - 15. Concrete dam on Bonita Creek, east of Stafford Cabin (Erickson, 2012).

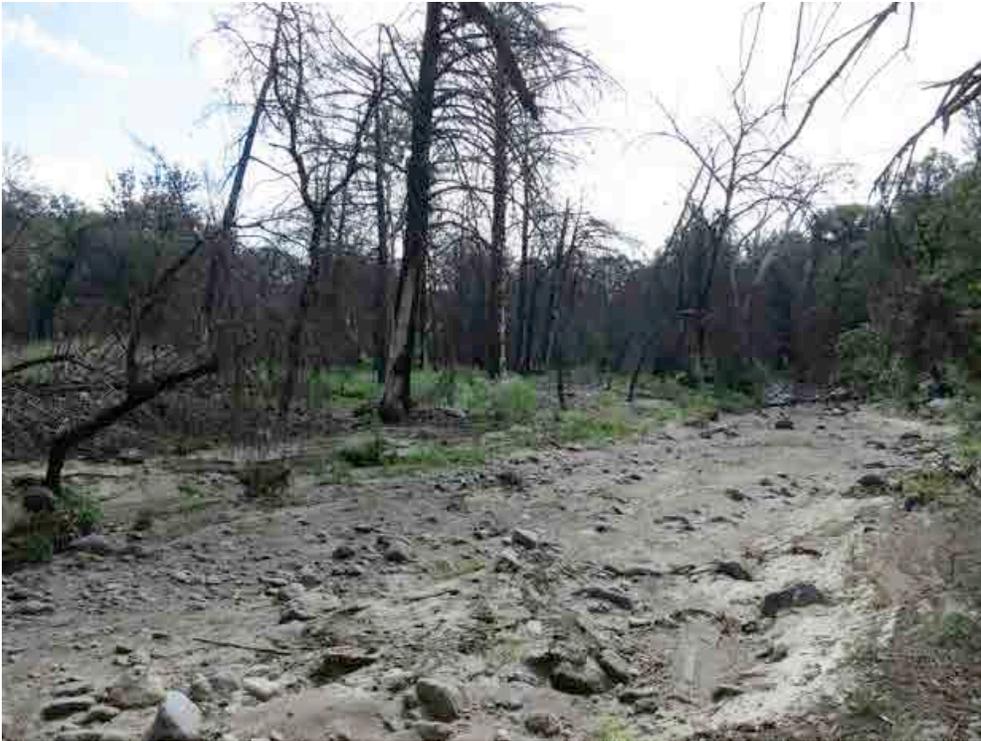
Figure 5B - 17. Fire-damaged vegetation along Bonita Creek, near Meadow area, looking northeast (Erickson, 2012).

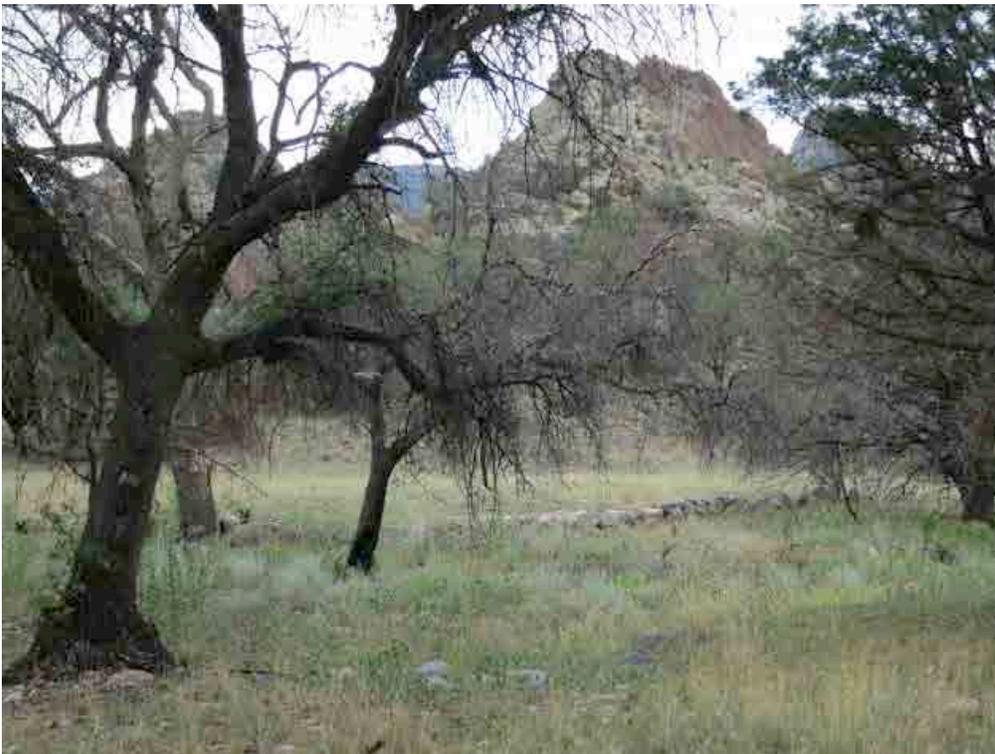
Figure 5B - 18. Fire-damaged vegetation, looking north along Newton's Wash from ranch road ford (Erickson, 2012).

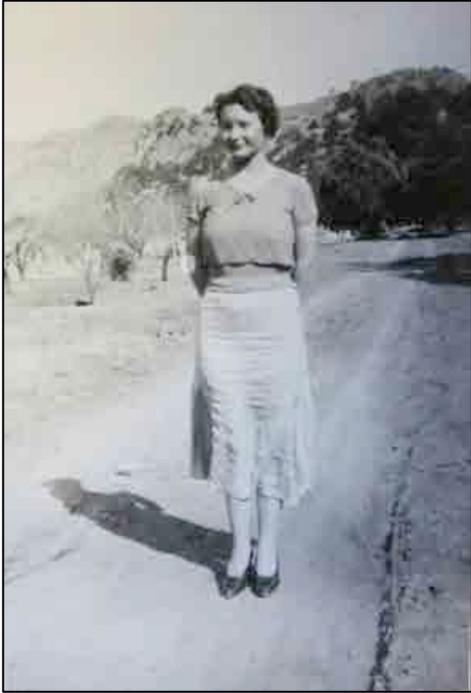
Figure 5C - 4. Anna McKay Riggs on Ranch Road, perhaps in the late 1940s, looking northwest (WACC 17:97:1352).

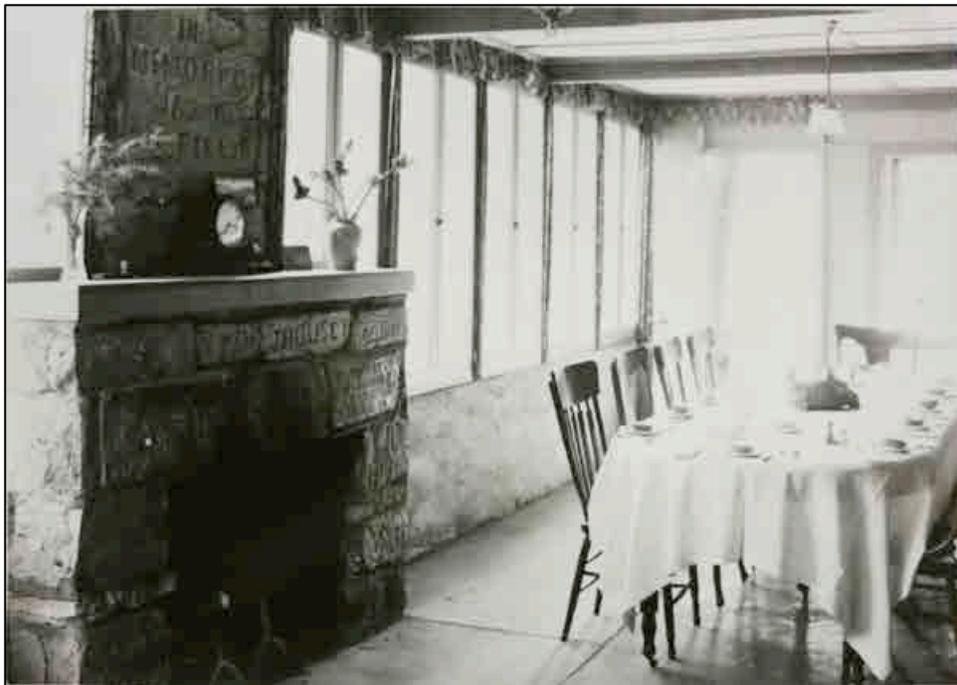
Figure 5C - 12. Garfield Fireplace, interior of Main House (CHIR 86:16:0852).

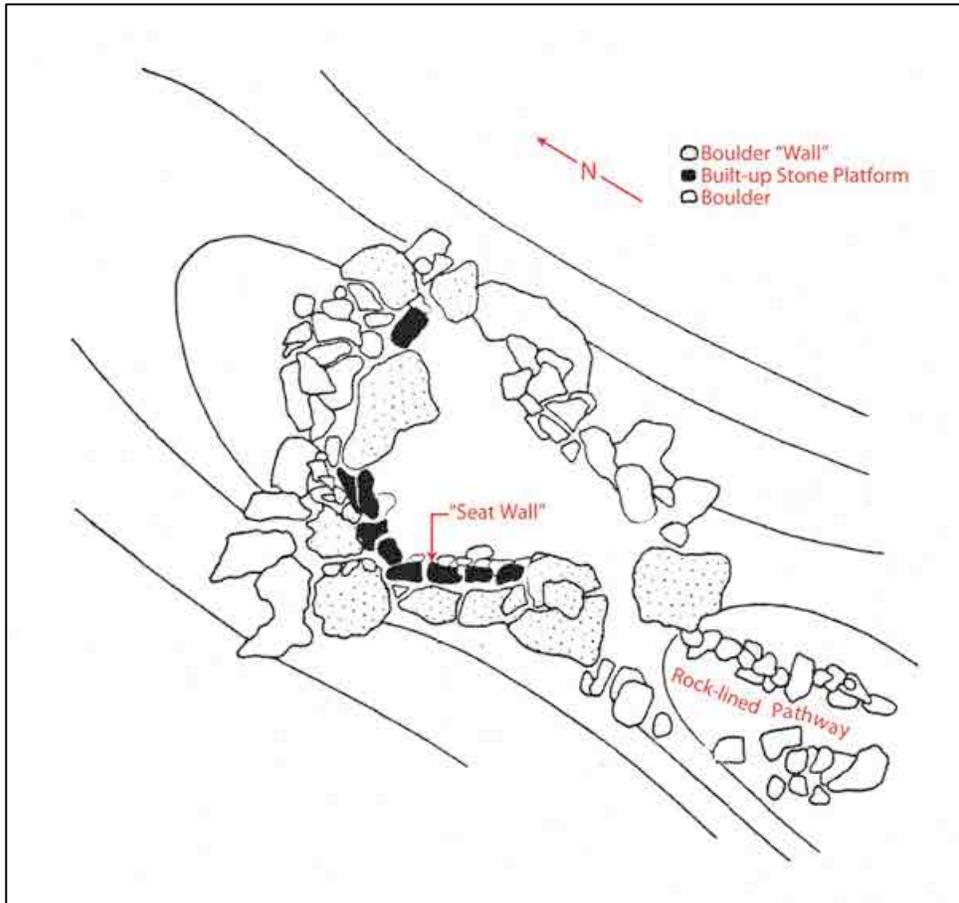
Figure 5C - 13. Drawing of Military Lookout (after Tagg).¹¹

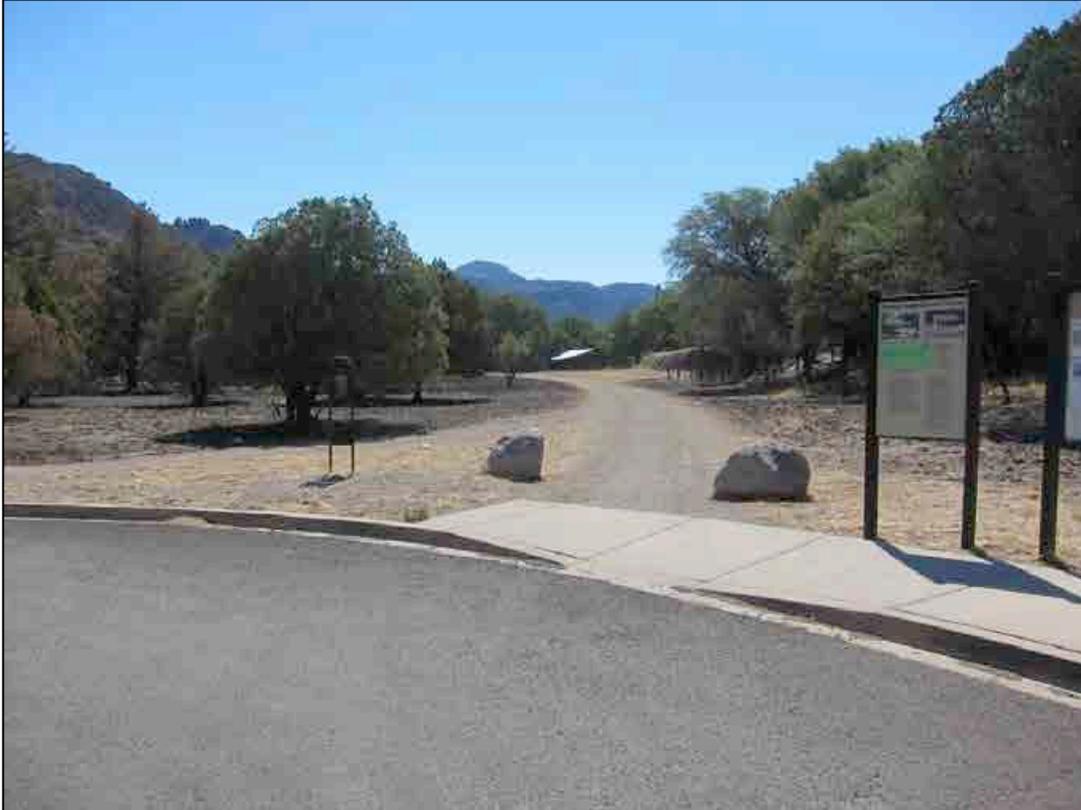
Figure 5D - 4. Entrance trail to Working Ranch from NPS parking lot (Erickson, 2011).

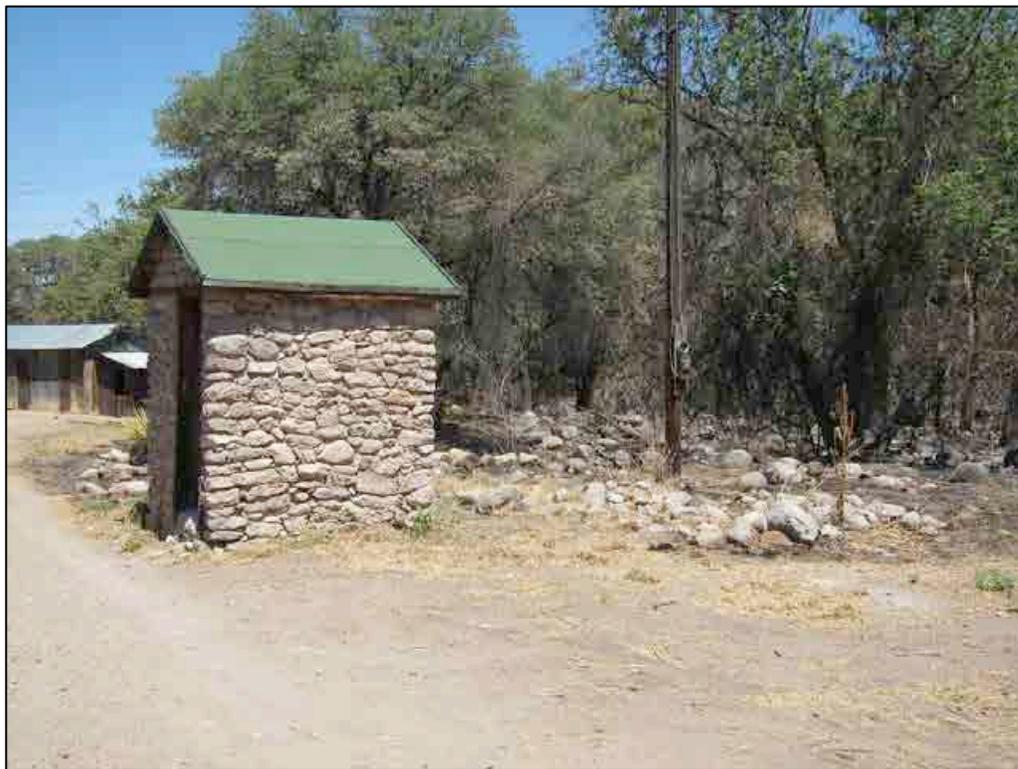
Figure 5E - 32. Generator House and possible Chicken Coop foundation (Erickson, 2011).

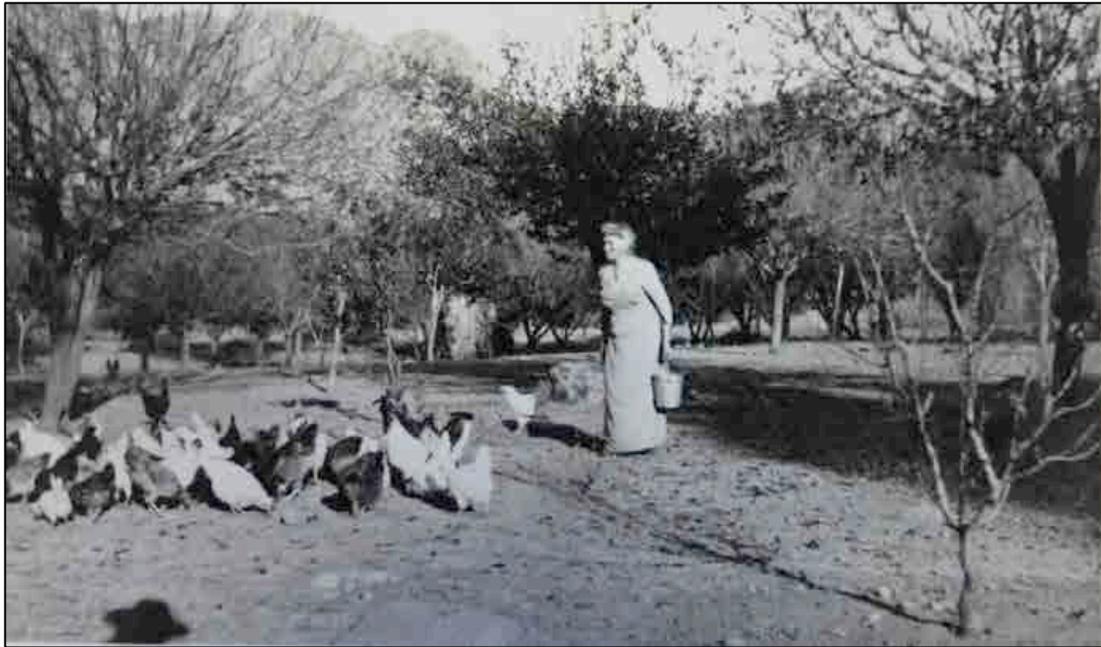
Figure 5E - 33. Woman (Emma?) feeding chickens north of Main House, looking north, n.d. (CHIR 86:16:0135).

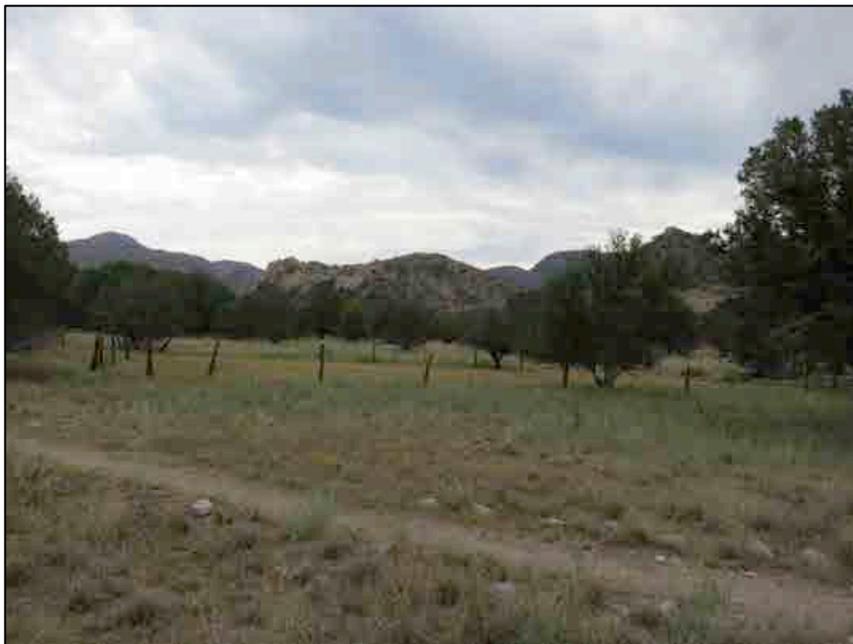
Figure 5E - 41. Garden behind Main House, looking east/southeast (Erickson, 2012).

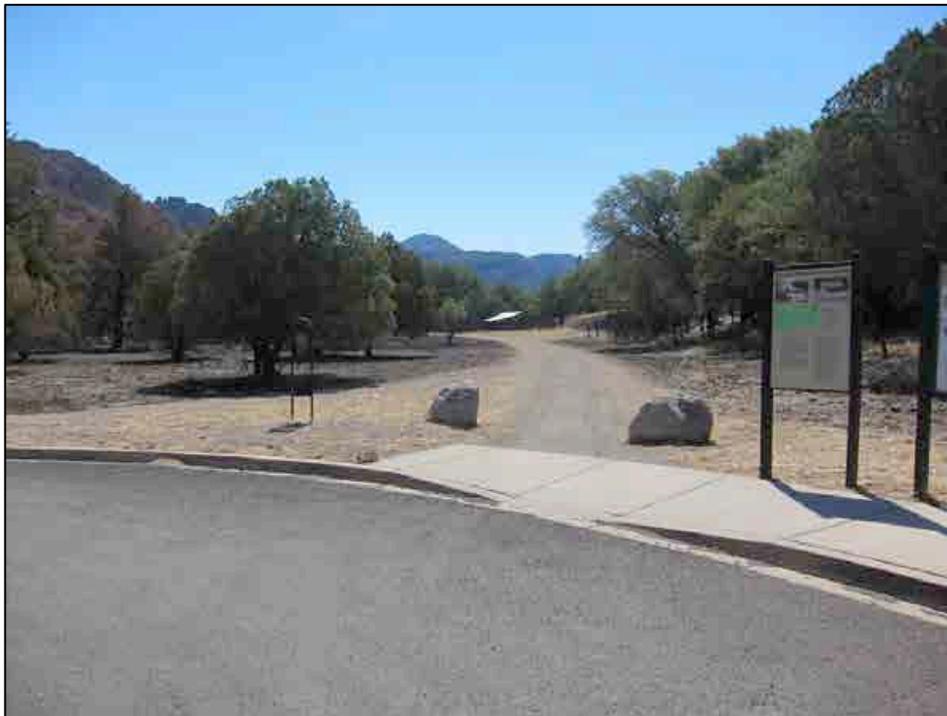
Figure 5E - 42. Trail to Main House through Working Ranch area (Erickson, 2011).

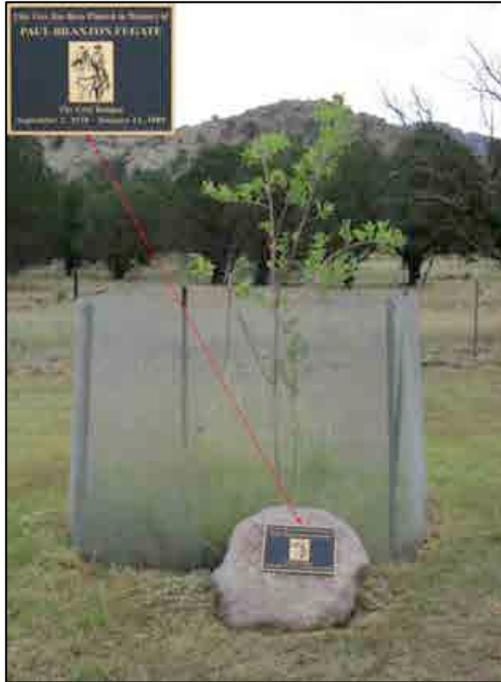
Figure 5E - 43. Memorial tree in front yard honoring lost Ranger Paul Braxton Fugate (Erickson, 2012).

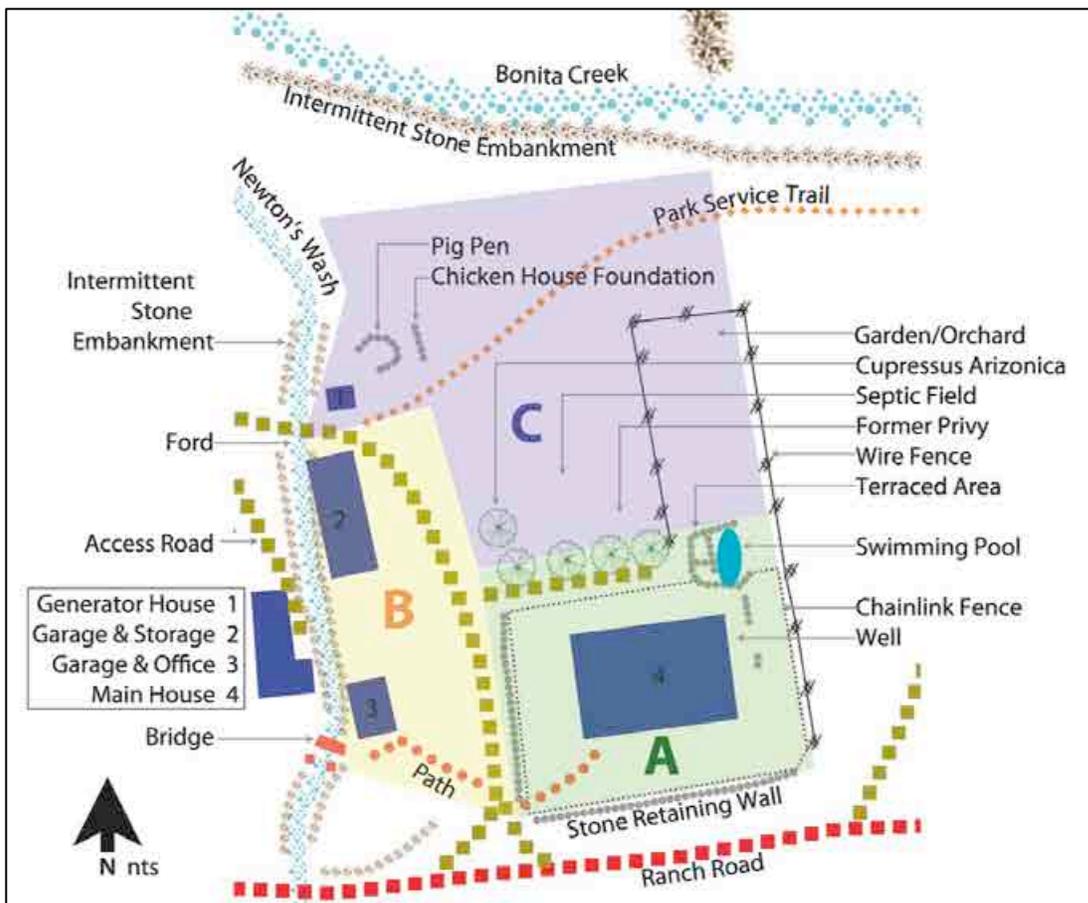
Figure 5E - 44. Functional Sections of the Main House Character Area (after Torres and Baumler, 1984).

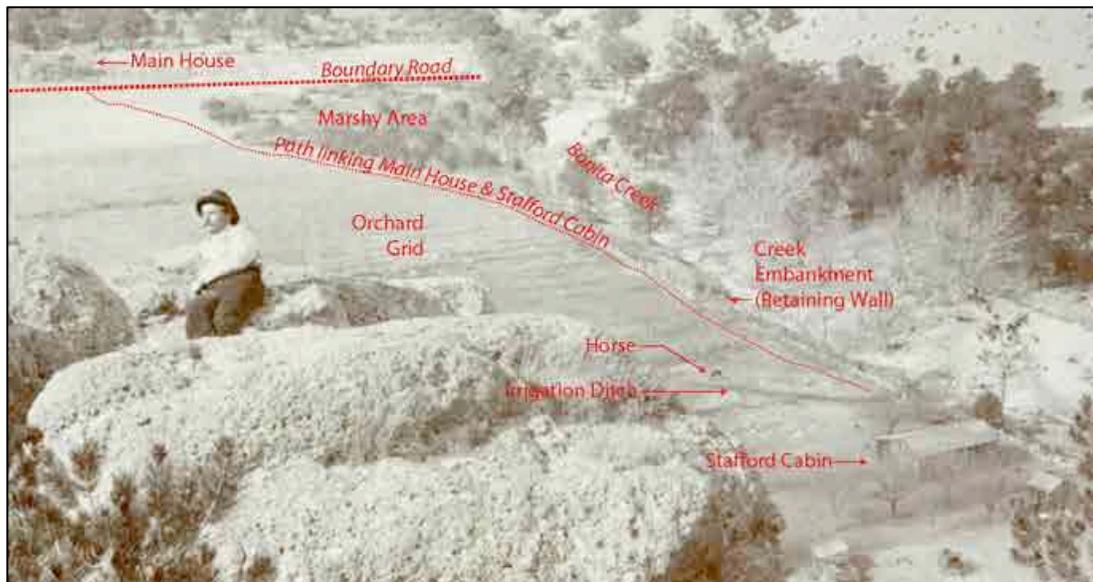
Figure 5F - 5. View of valley looking west from Neil's Rock, 1908 (WACC 17:95:0856).

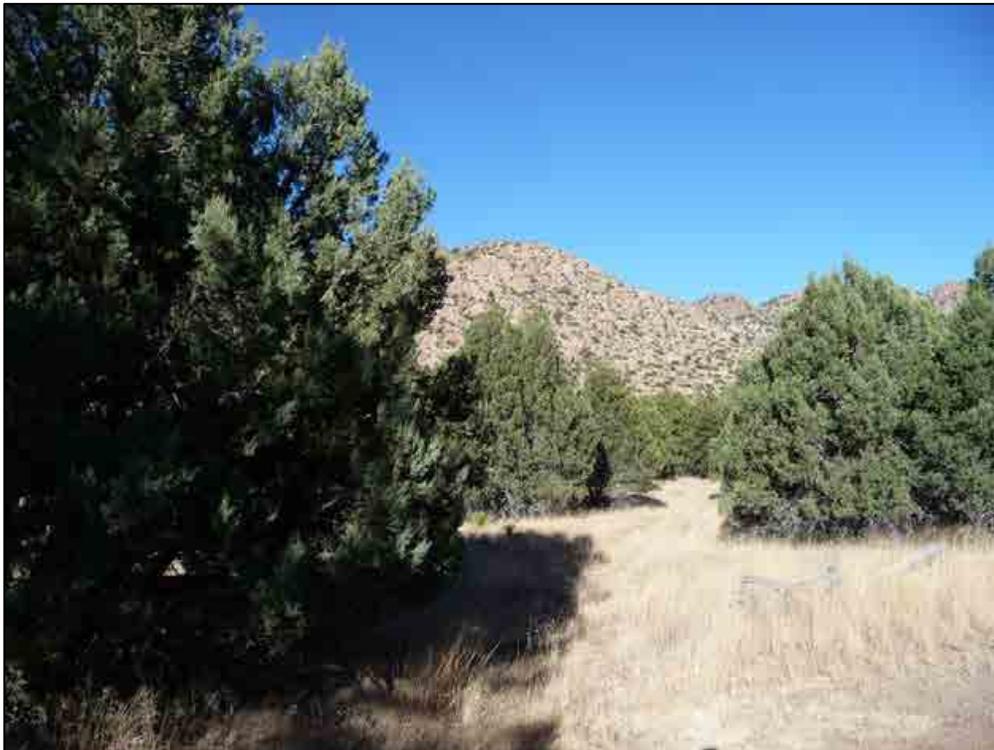
Figure 5F - 27. Clearing at diagonal pathway leading northeast to location of non-extant Martha Stark Cabin; typical condition of pathways (MB P1050138.JPG, 2010).

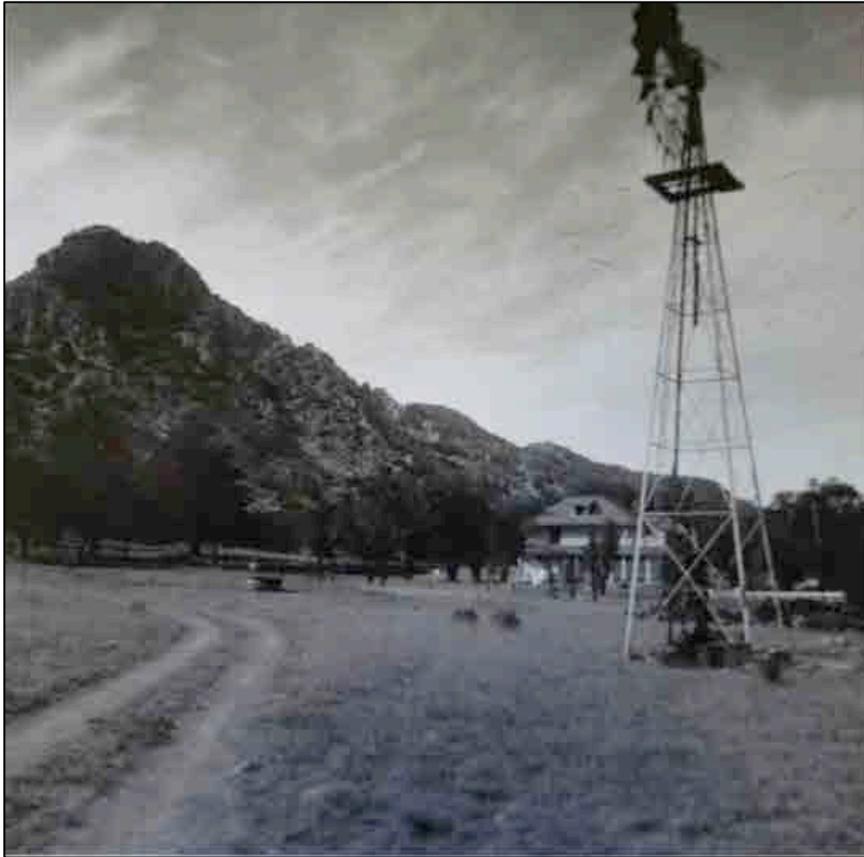
Figure 5F - 28. Windmill, looking west towards Main House, n.d. (CHIR 86:16:0873).

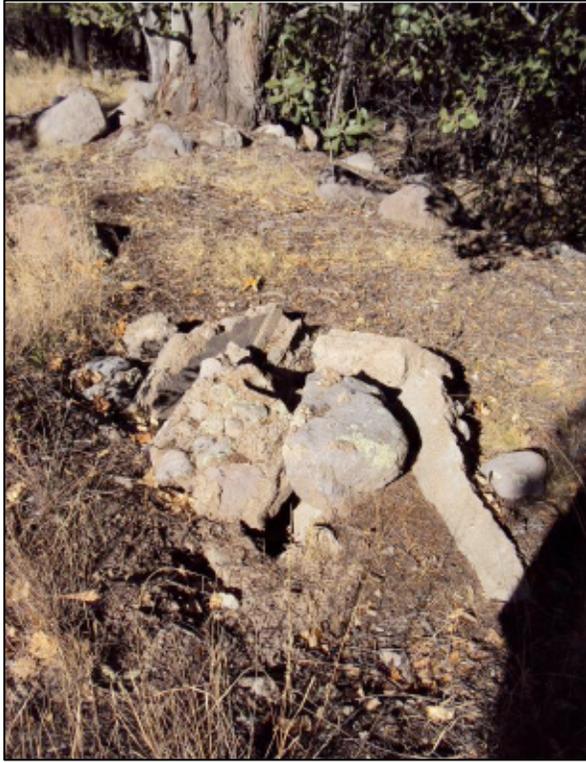
Figure 5F - 38. Rubble foundation remnants of Martha Stark cabin (MBDSC00640.JPG, 2010).

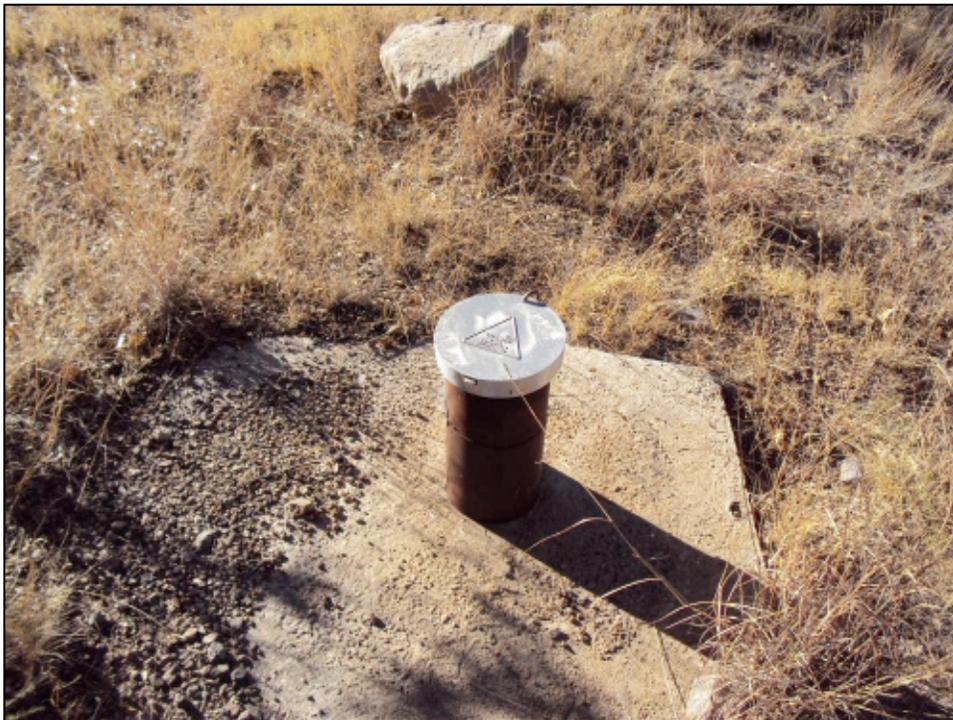
Figure 5F - 39. Monitoring well (MB DSC00604.JPG, 2010).
