National Park Service
U.S. Department of the Interior
Intermountain Region

Chiricahua National Monument – Faraway Ranch

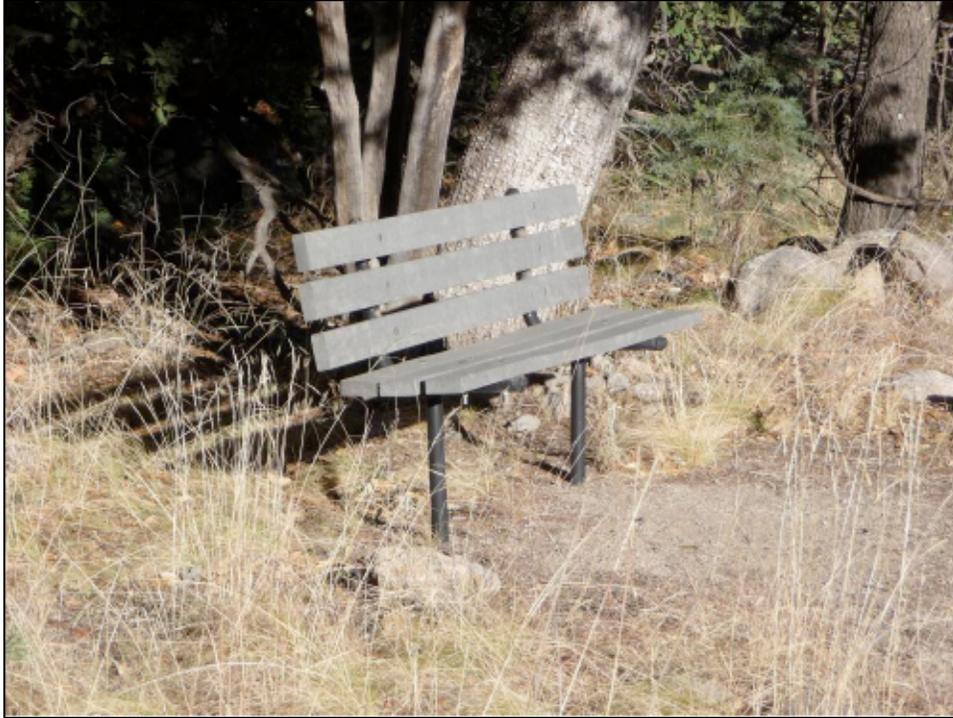
Figure 5F - 40. Bench near non-extant Martha Stark cabin (MB P1050209.JPG, 2010). A similar bench is located along the trail to the west of the cabin remnants.

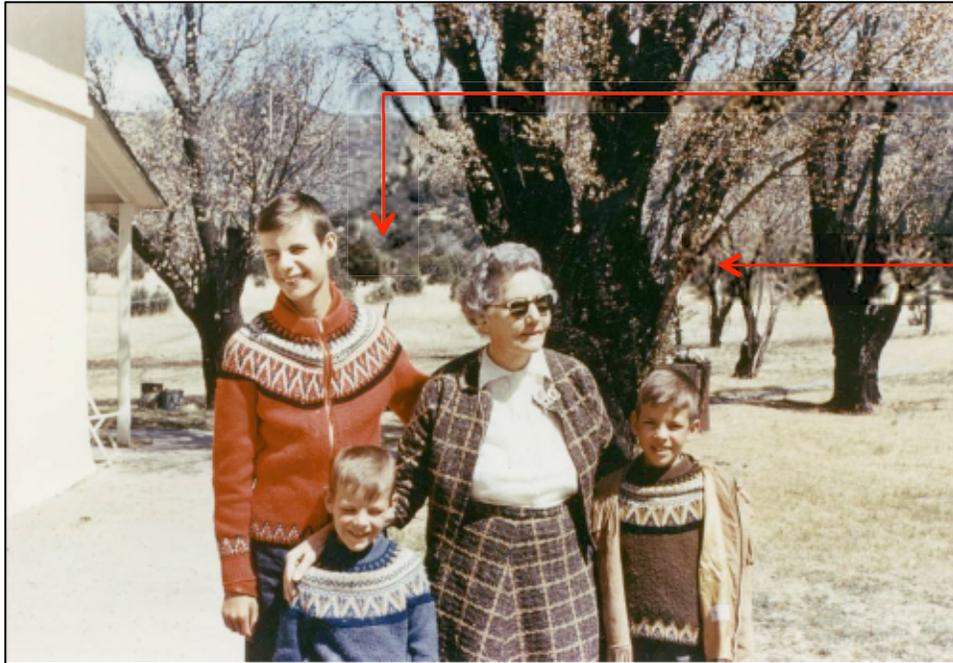
Height of junipers in 1973.

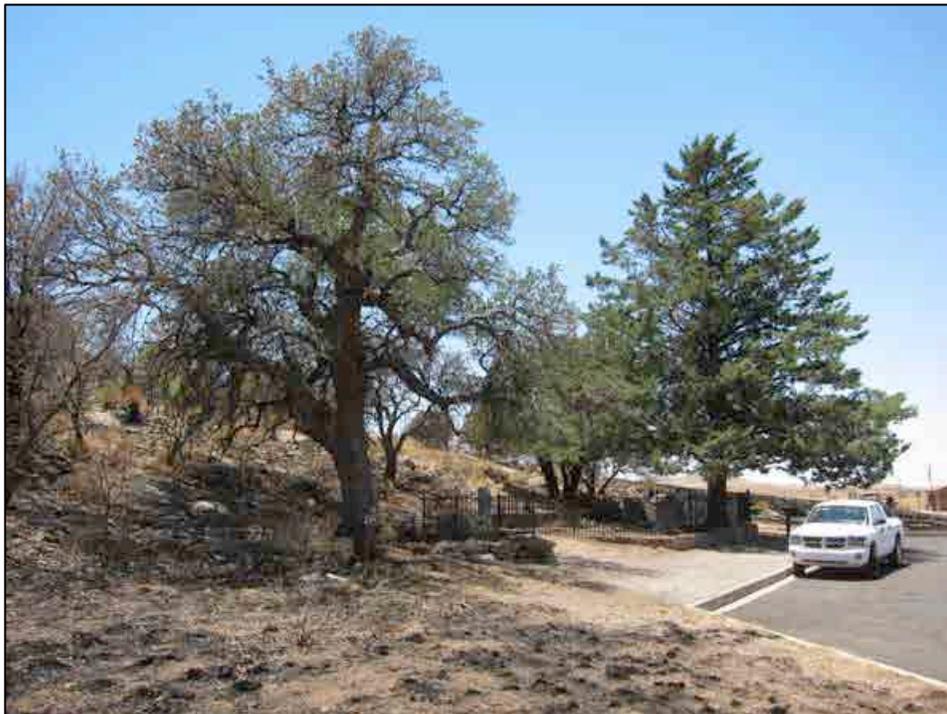
Figure 5H - 8. Cemetery area fire damage after Horseshoe 2 (Erickson, 2011).

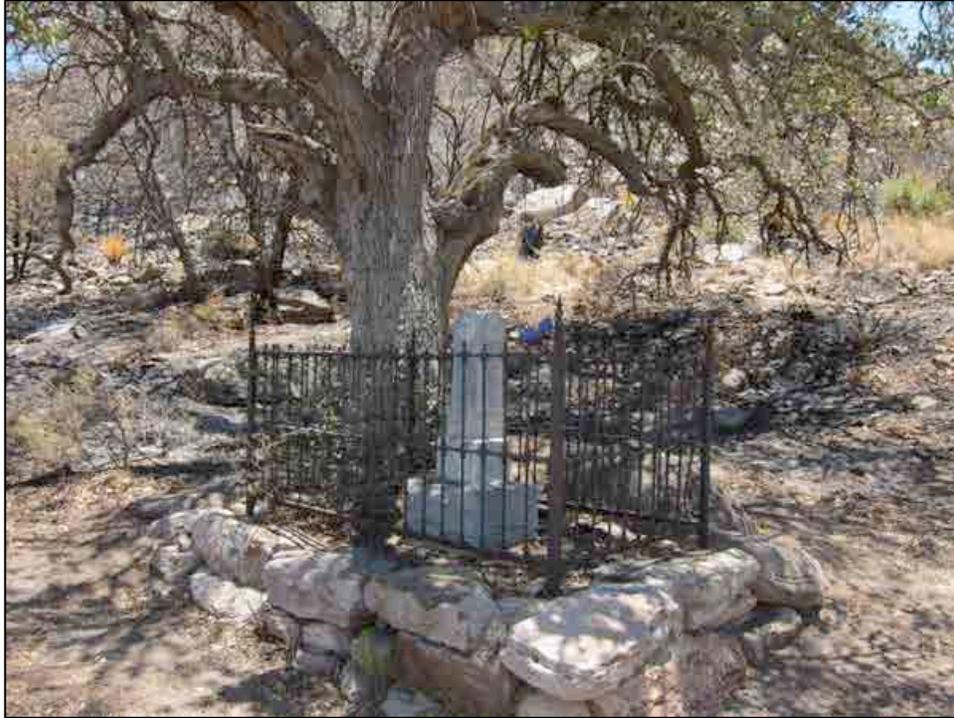
Figure 5H - 9. Fire damage to historic oak tree (*Quercus alba*) at Prue gravesite (Erickson, 2011). This photograph was taken immediately after the Horseshoe 2 Fire.

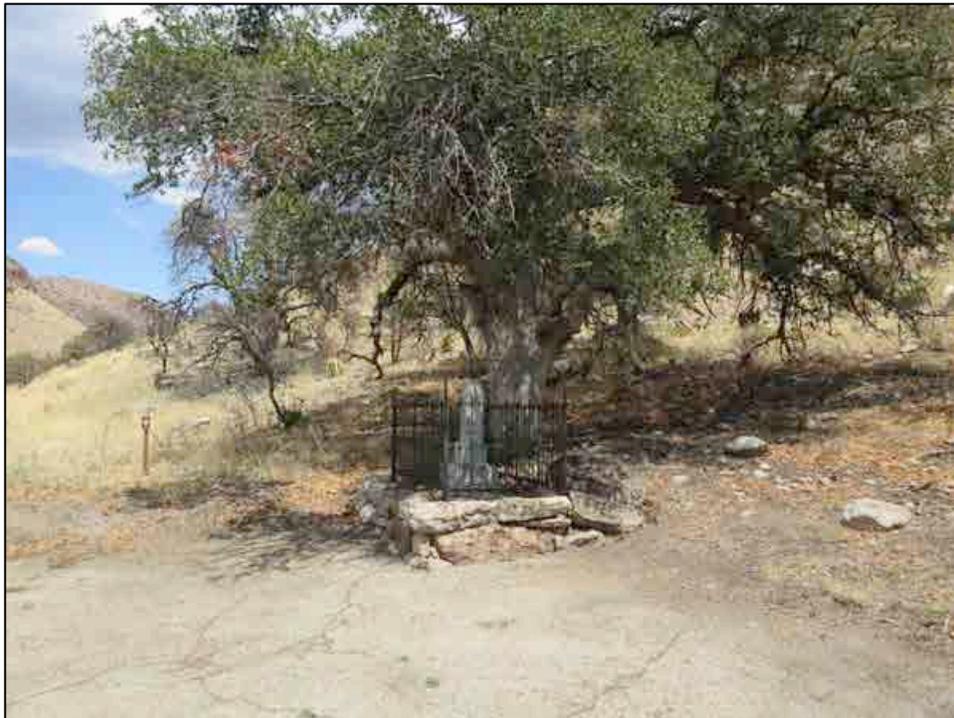
Figure 5H - 10. Historic oak tree at Prue gravesite one year after Horseshoe 2 Fire (Erickson, 2012).

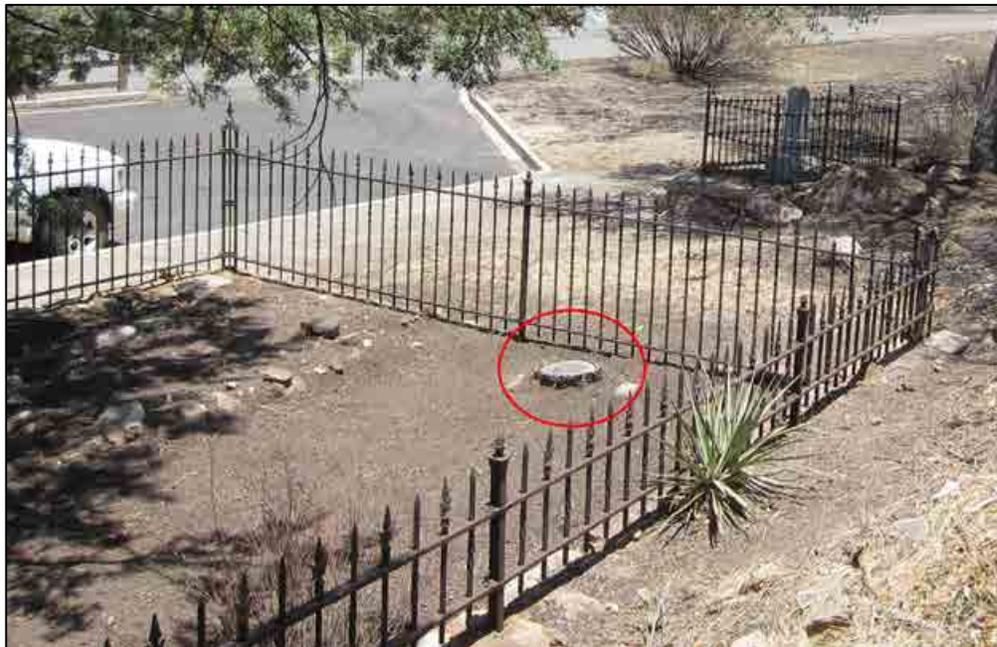
Figure 5H - 16. Missing Arizona cypress (*Cupressus arizonica*), circled in red, in Erickson Cemetery (Erickson, 2011).

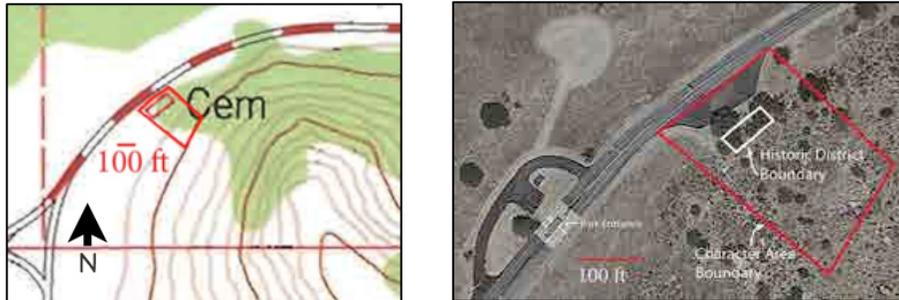
Figure 5H - 18. Proposed enlargement of Cemetery character area (USGS, 1996, and after Google Earth, 2011).

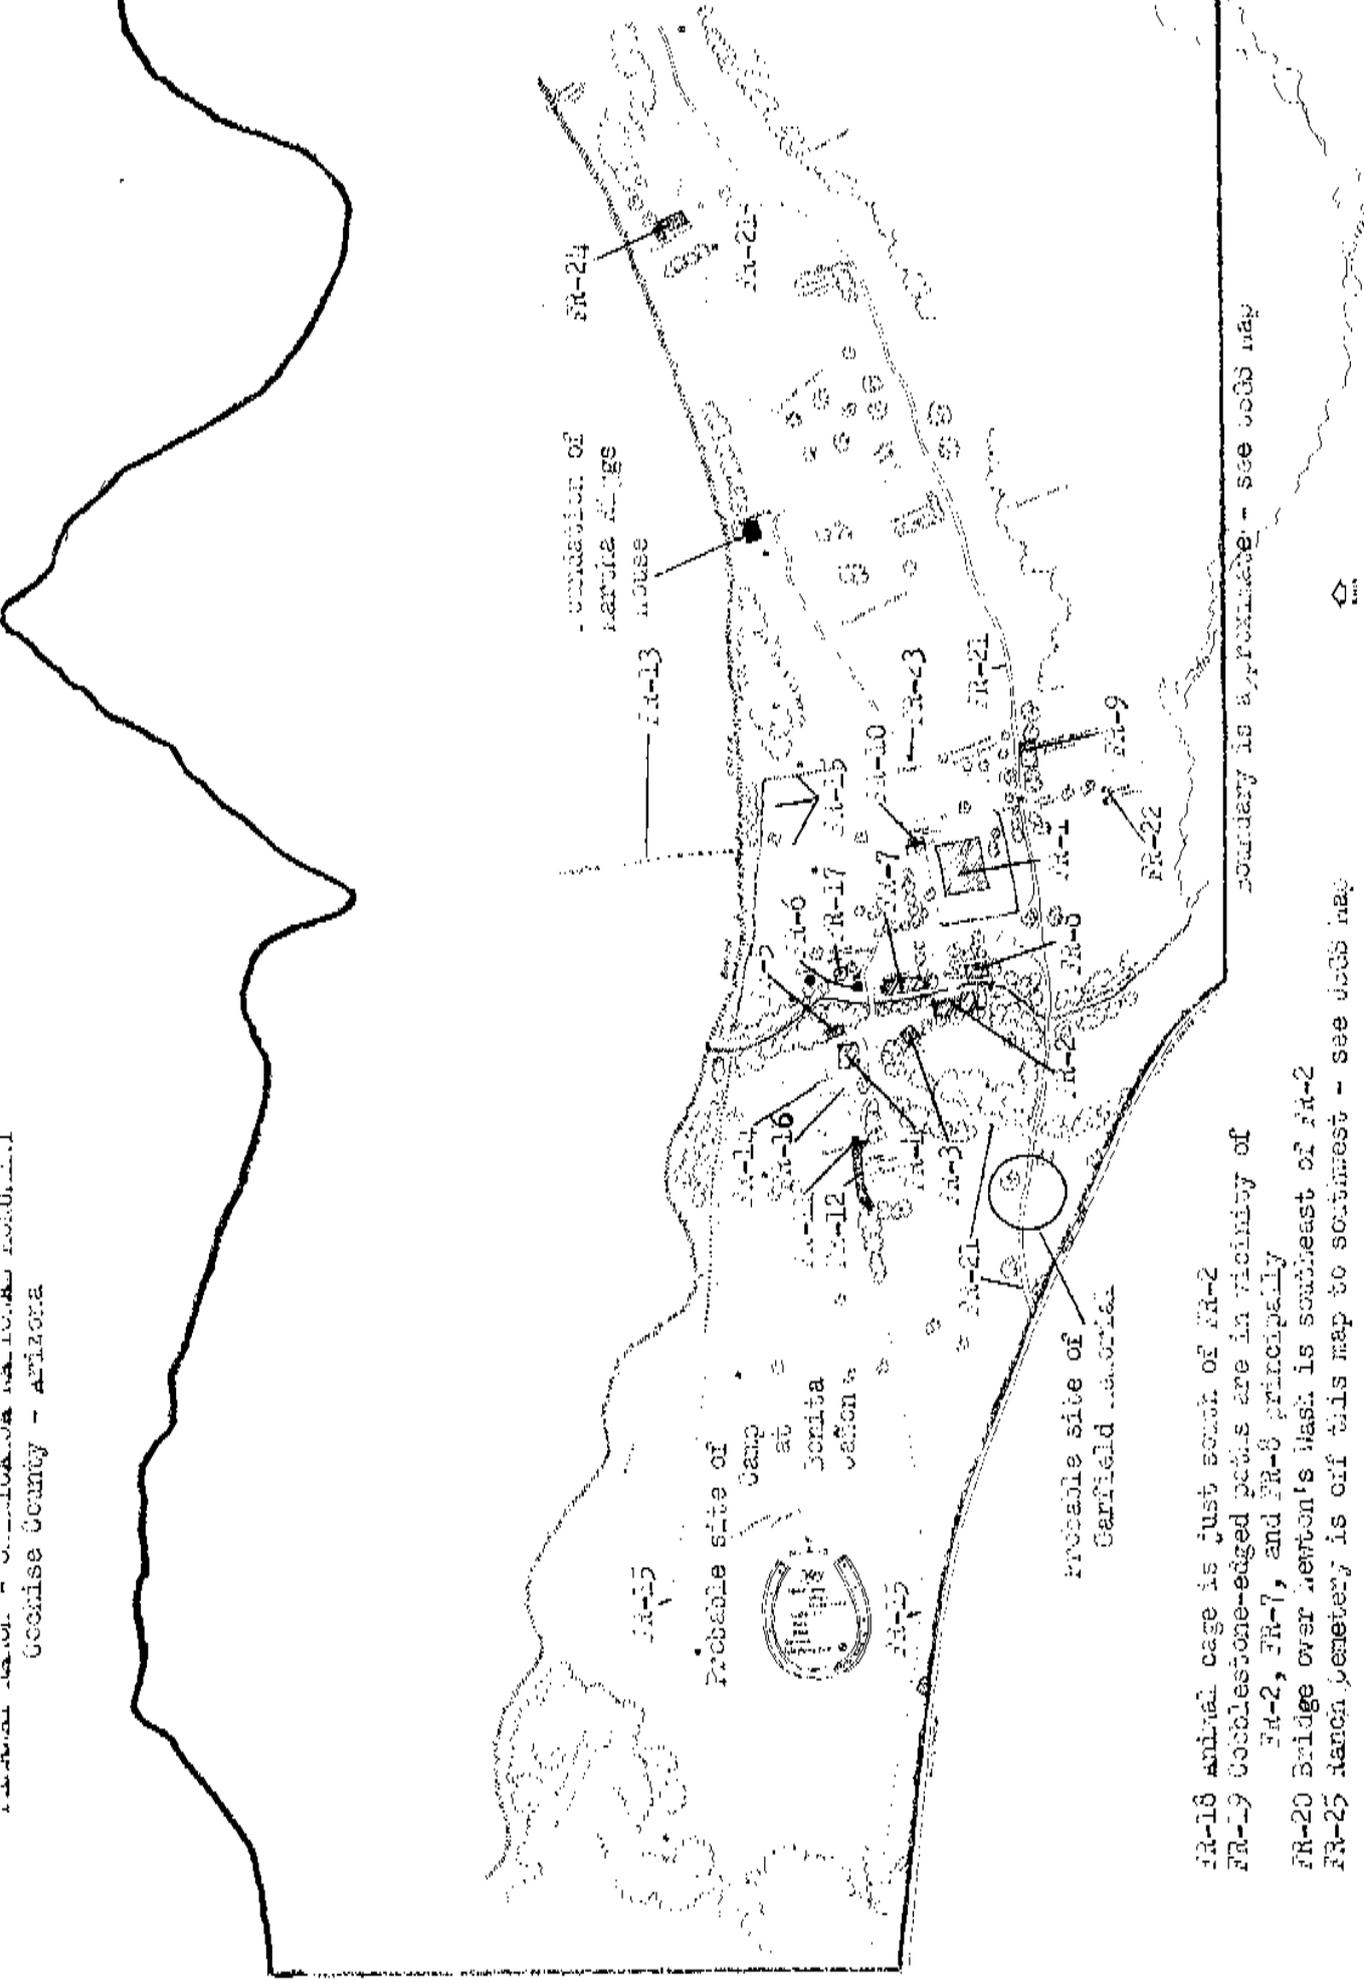
FR-18 animal cage is just south of FR-2
 FR-9 Cobblestone-edged paths are in vicinity of
 FR-2, FR-7, and FR-8 principally
 FR-20 Bridge over Newton's Wash is southeast of FR-2
 FR-25 ranch veterinary is off this map to southwest - see 6035 map

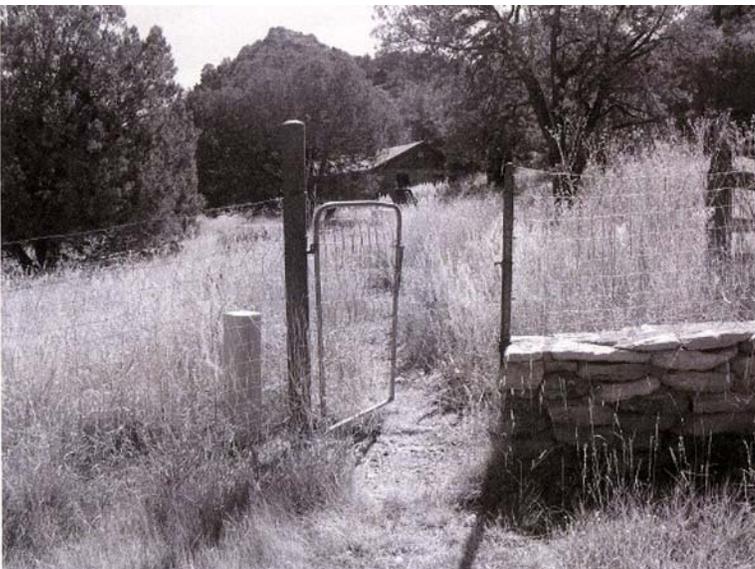
Fence and gate surrounding the ranch house
