Cannon/Douglass House Preservation Plan

***Preserving an Emblem of Scientific Research at
the University of Arizona***

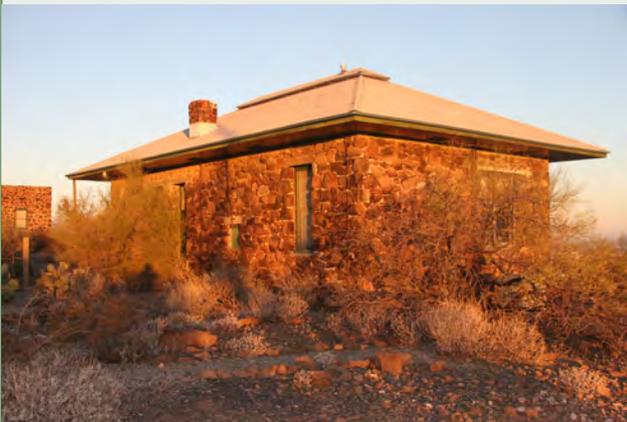
Source: Paul Weiner, Drachman Institute

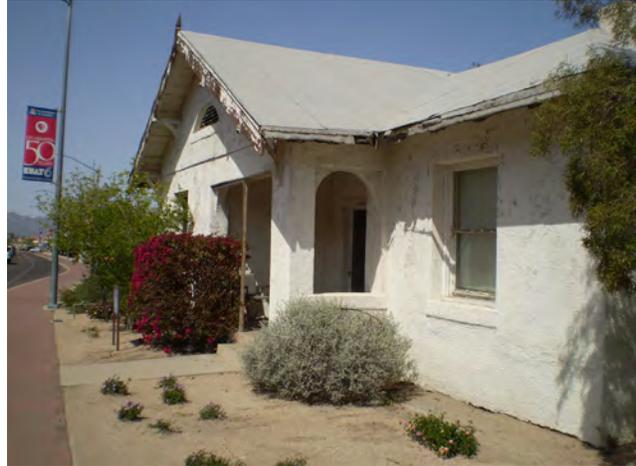
Identification of character defining features takes into account all aspects of the architecture and understands how they display the character of the building.

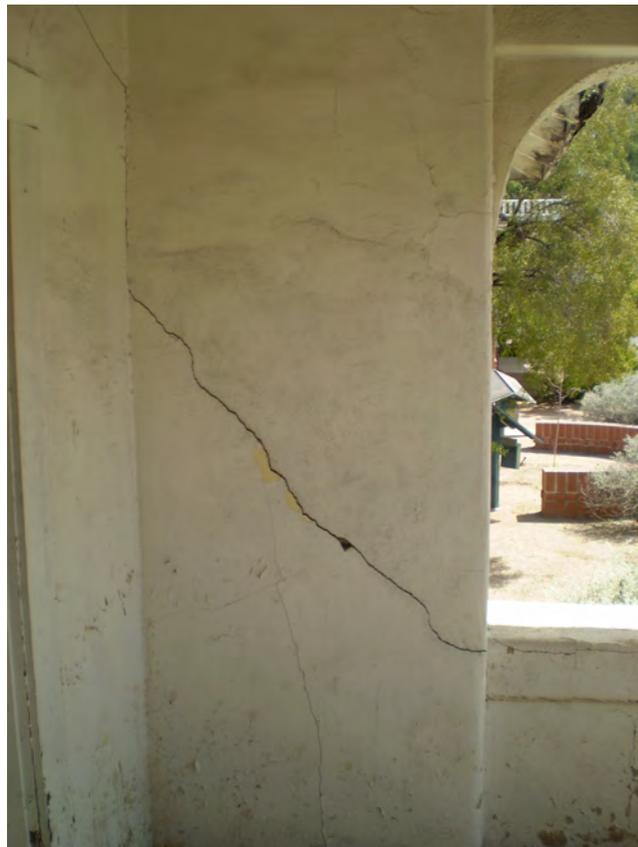
A large crack has permeated to the surface on the southern face of the house. A structural analysis will determine how to properly intervene.

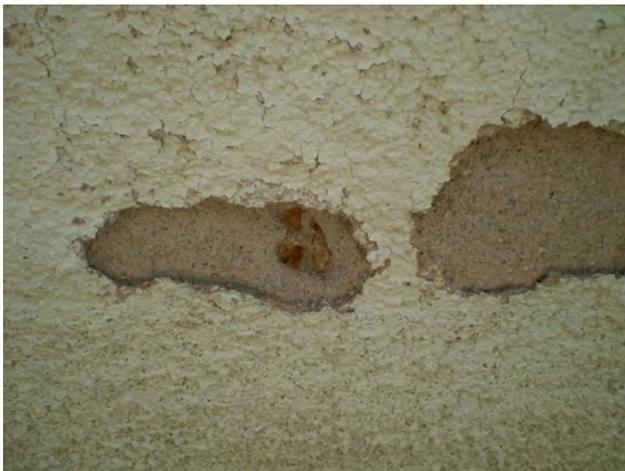
Spalling of the stucco may indicate other problems. Proper inspection is advised.

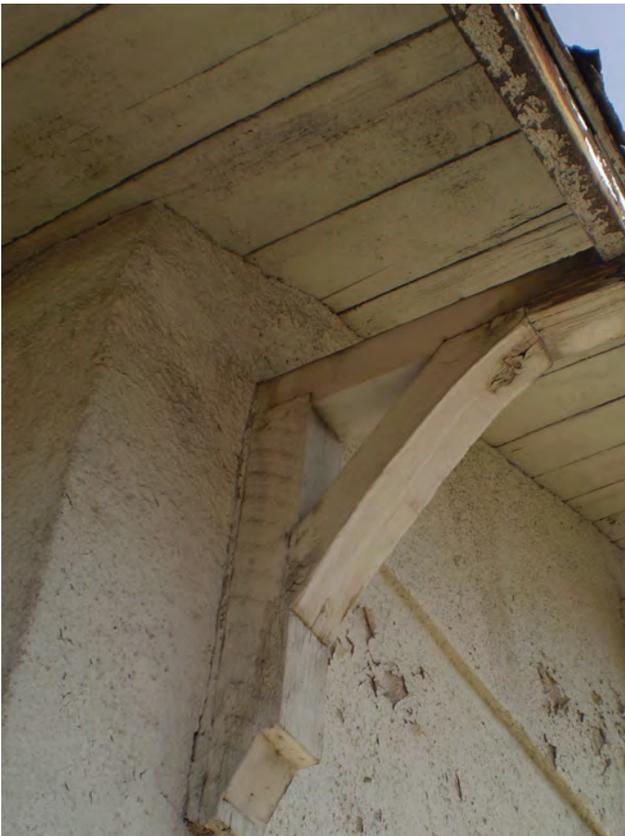
Wooden Brackets are a character defining feature.

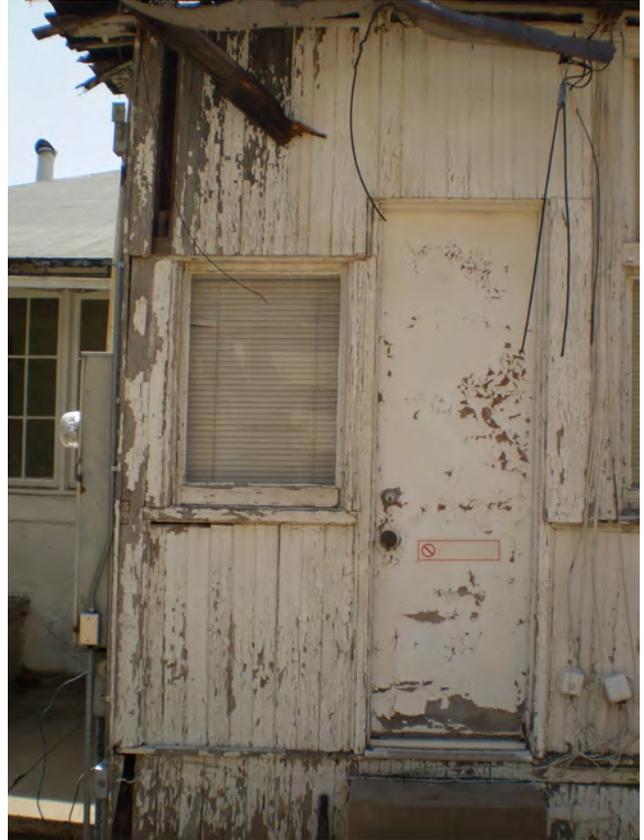
The wood on the covered porch is in poor condition; repair or replacement will be necessary.

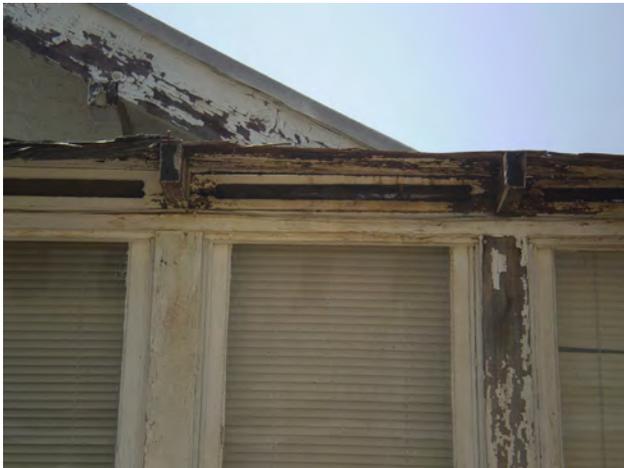
The exterior sleeping porch is constructed primarily of wood with a series of windows.

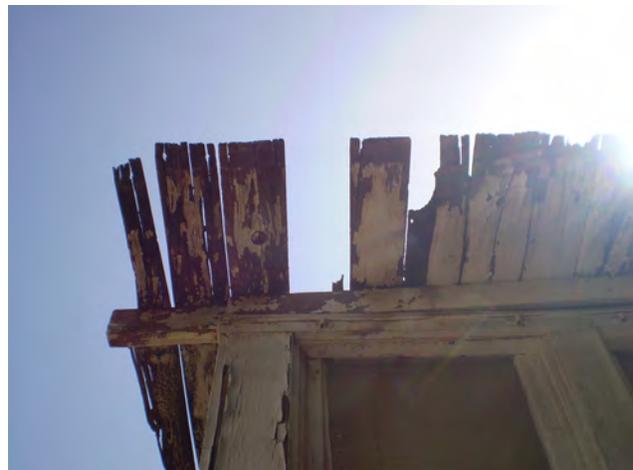
The roof of the covered porch has been severely compromised.

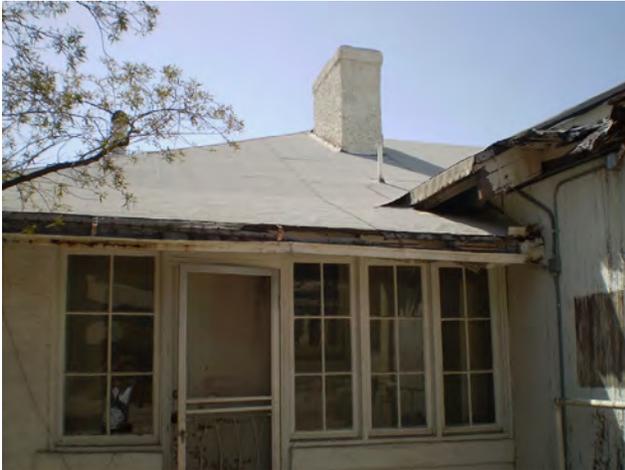
The wood on the covered porch is in poor condition; repair or replacement will be necessary.

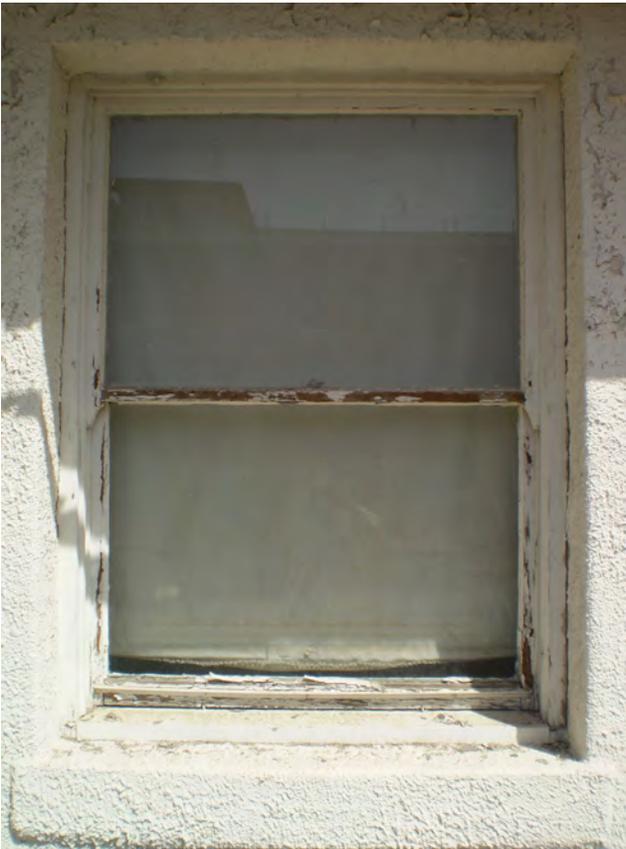
Some of the windows are in good repair and require only paint.

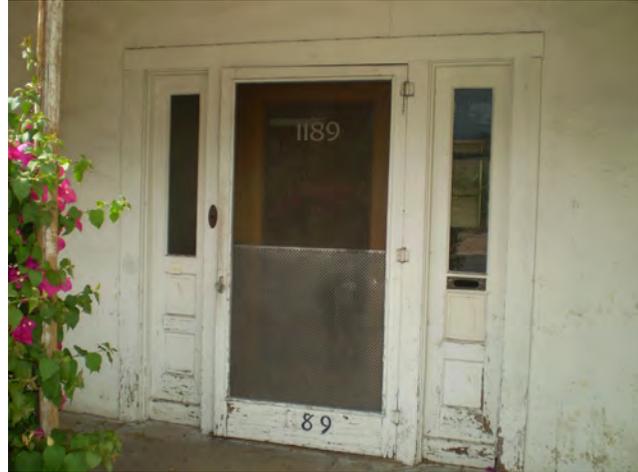
The front entrance to the Cannon/Douglass house is of simple design. A wide door flanked by half height side lites is trimmed with wooden planks.

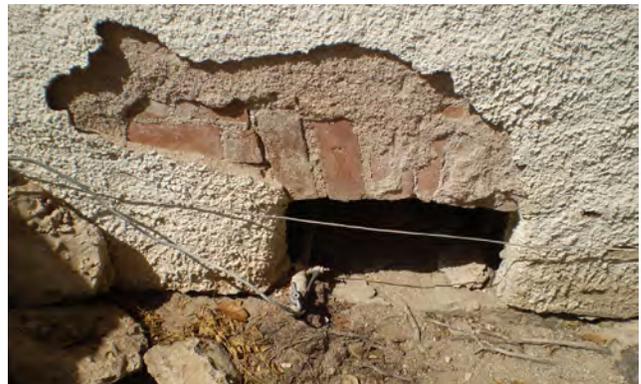
The brick exterior structure rests on a stone foundation which in turn rests upon a slightly graded ground plane.

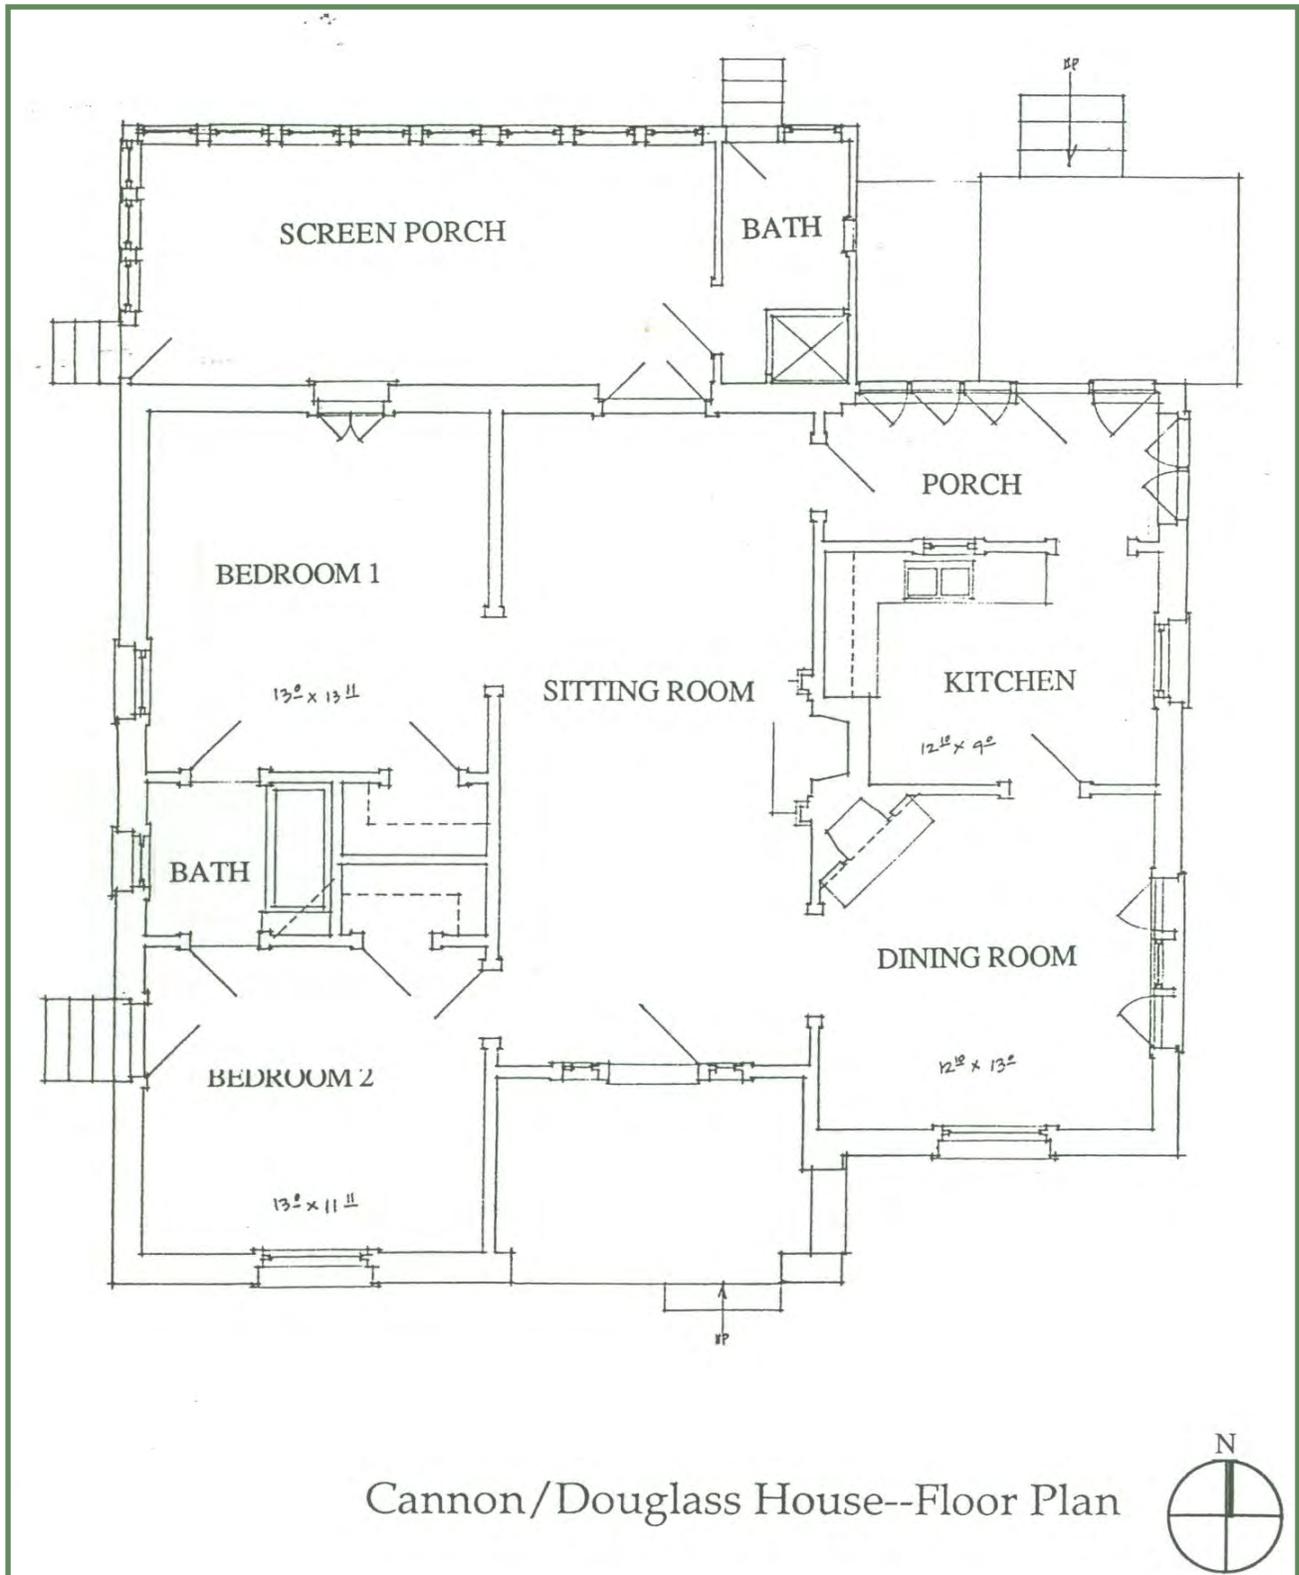
Cannon/Douglass House--Floor Plan

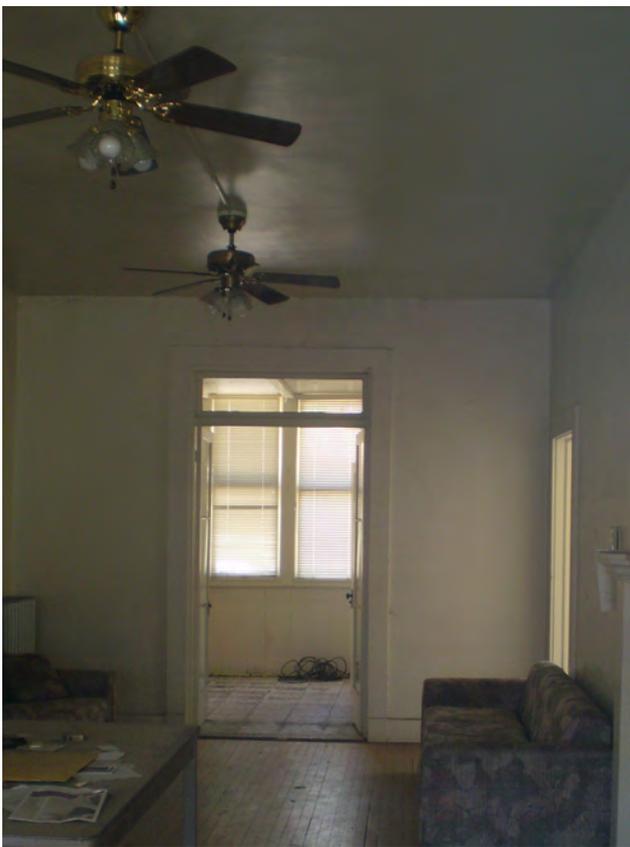
The pair of ceiling fans in the sitting room/zaguan are not original.

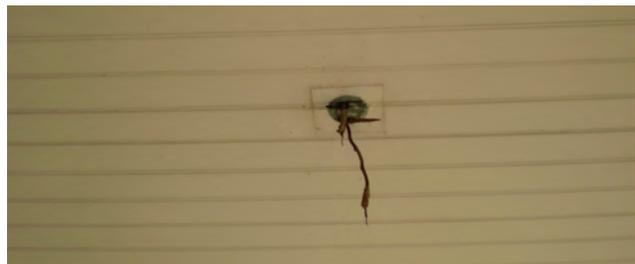
Loose wires are evident on the exterior of the building.

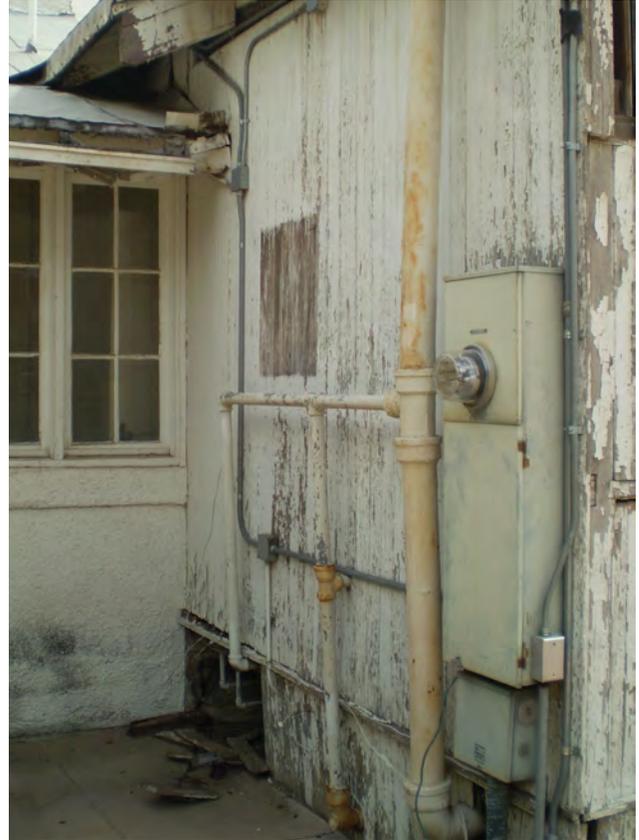
The electrical hookups and breaker box are on the side of the covered porch. If the porch is to be removed, a suitable location will need to be found for the breaker box.

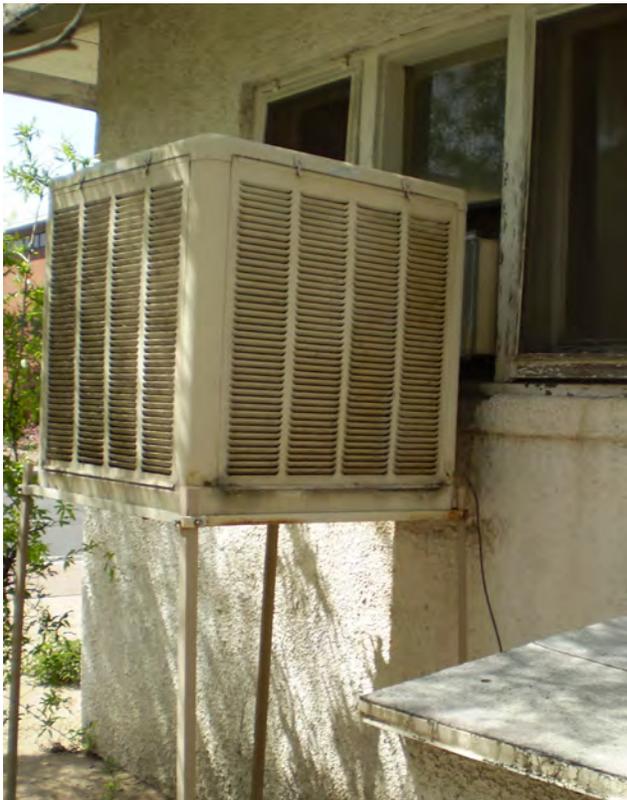
A pair of identical cooling units is affixed to windows on the east and west faces.

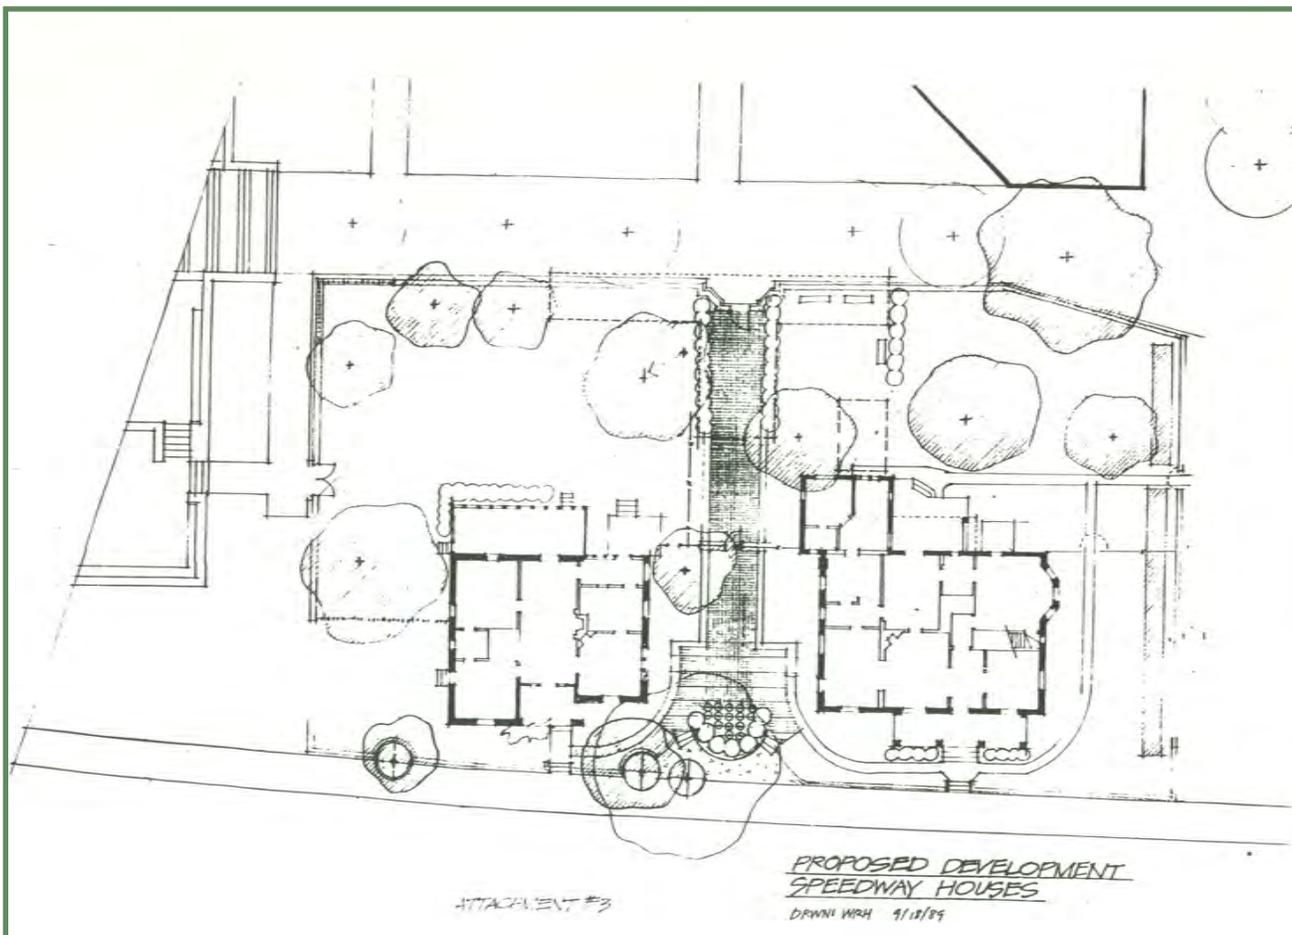
Site Plan for the Smith and Cannon/Douglass Houses
Source: CDA 1990 Preservation Project
