# **PRESERVATION PLAN**

## **ACEQUIA AND COMPUERTA**

### **TUMACÁCORI NATIONAL HISTORICAL PARK**

In conjunction with:  
Desert Southwest Cooperative Ecosystem Studies Unit (DS-CESU)  
June 2014

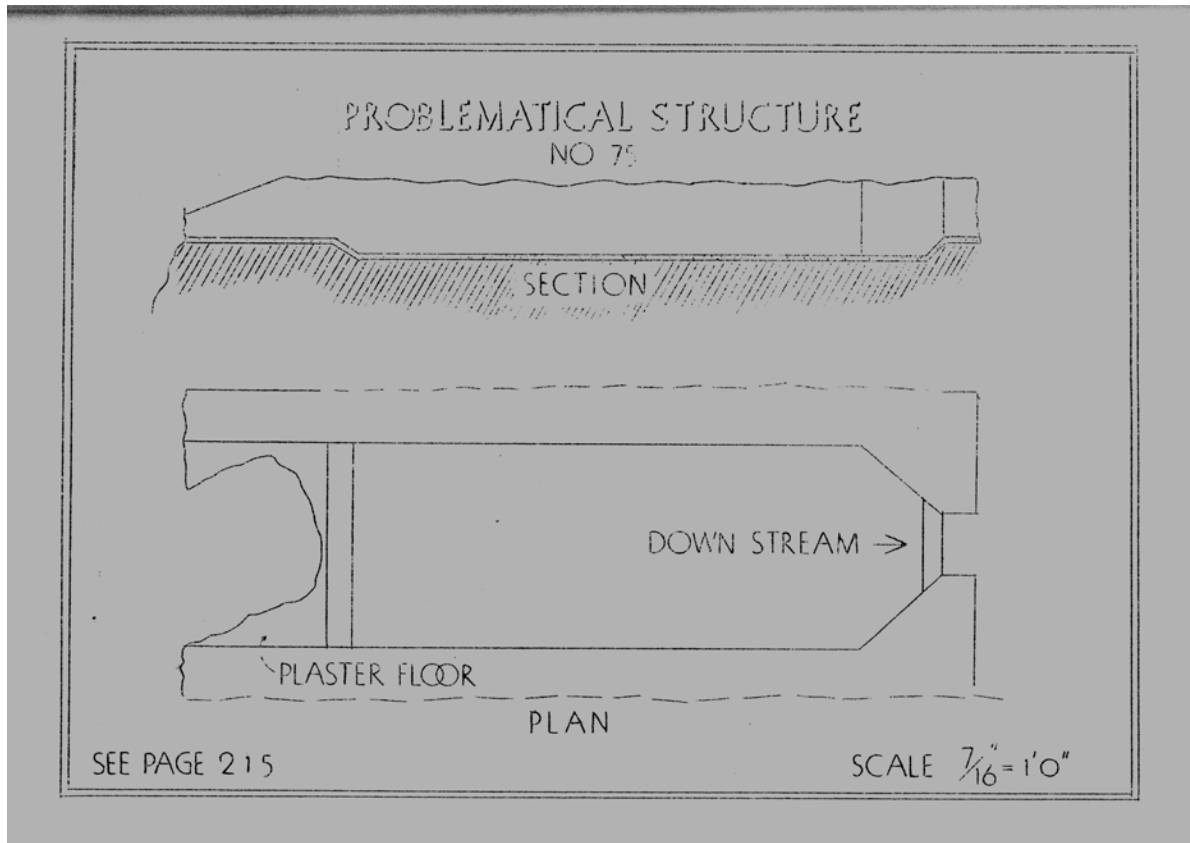
“a problematical structure of burned brick with plastered walls and floors. It was located in an irrigation ditch, about 14’ inside south wall of orchard. The constricted outlet would serve to raise the level of a stream slowing through this structure. The raise in water level might be desired to provide a “washing vat” or to introduce the water to another irrigation ditch. A 3” dip in the floor at the south end with a corresponding 3” rise at the north end suggests a secondary purpose for which I cannot account” (Beaubien 1935: 215).

Figure 1.4. Plan and cross section of compuerta (Area 75) from 1934 excavations directed by Paul Beaubien; compuerta described as a “problematical structure.” (Beaubien1935: 214).

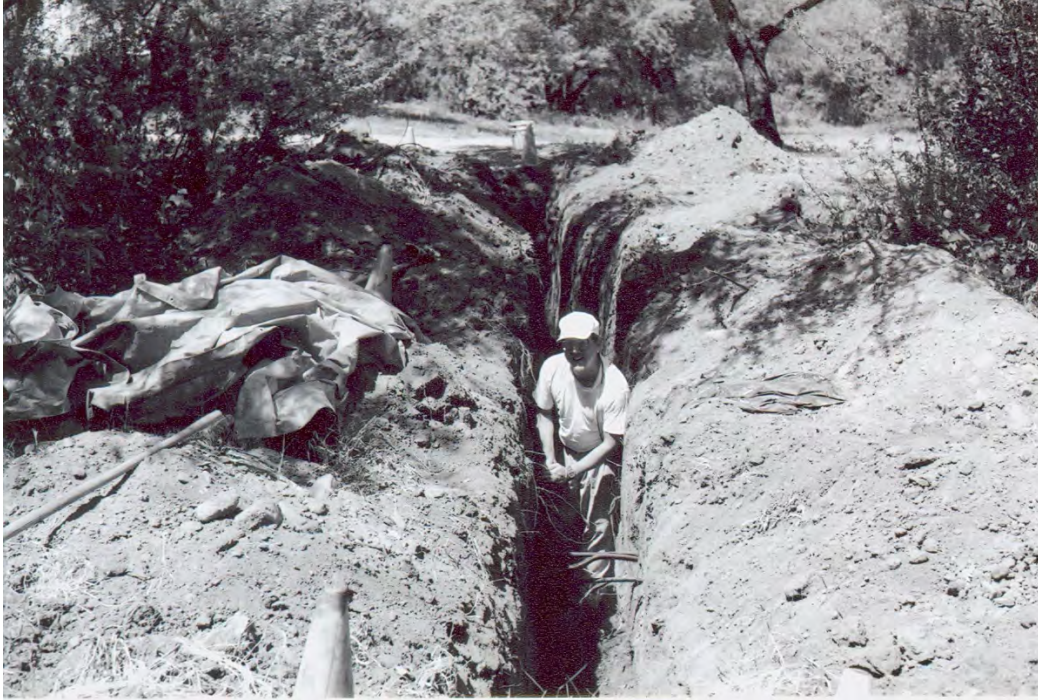
To further investigate the historic acequia feature, a backhoe trench (Unit 6) was excavated through the alignment approximately 6 m south of the compuerta. The trench measured 11.5 m in length and 1.5 m in depth. In a memo report to the WACC Division of Archaeology Chief, Burton describes a 1-m-wide basin-shaped stratum of laminated soils located just below the modern ground surface (see Figure 1.10). Burton suggests this may represent a modern channel due to the shallow nature of the feature in relation to the modern ground surface (1994:3). However, the profile drawn during the testing project shows a possible channel filled with grayish-brown silt with laminated clay inclusions located immediately below a slight dip in the topography that may represent the remnants of the acequia swale. The laminated soils may represent stratigraphy associated with use of the acequia.

Figure 1.6. Unit 6 from 1994 archaeological testing project directed by Jeffery Burton of WACC (NPS TNHP Archives).

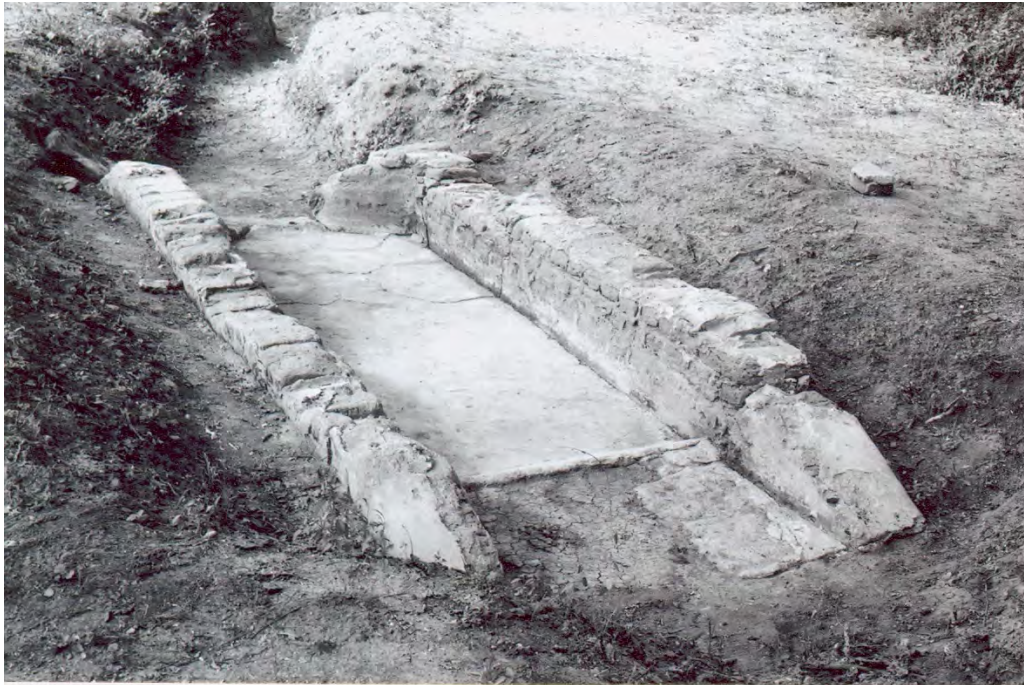
Figure 1.7. Photograph of compuerta during 1994 archaeological testing project directed by Jeffery Burton of WACC, looking northeast (NPS TNHP Archives).

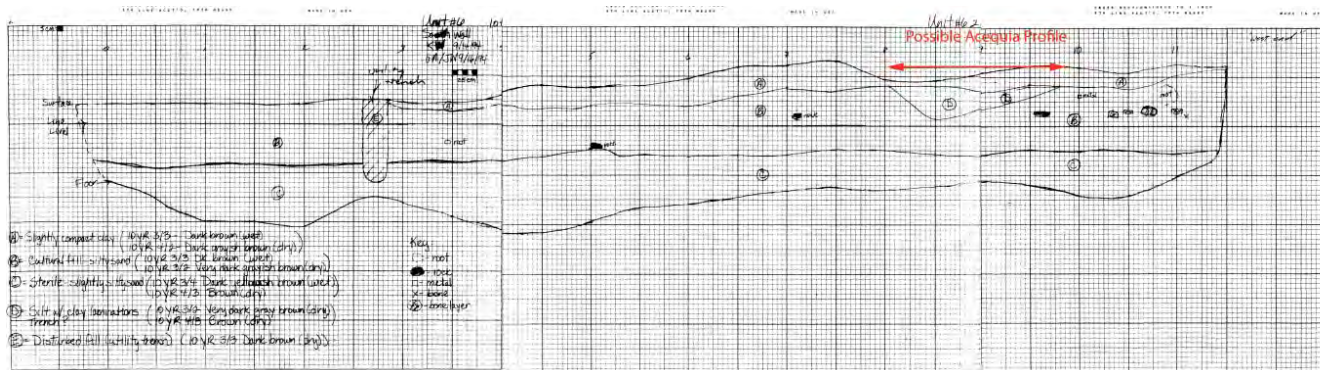
Figure 1.10. Profile of south wall of Unit 6, 1994 WACC archaeological testing project. Note location of laminated soils possibly representing acequia channel indicated in red (NPS TNHP Archives).

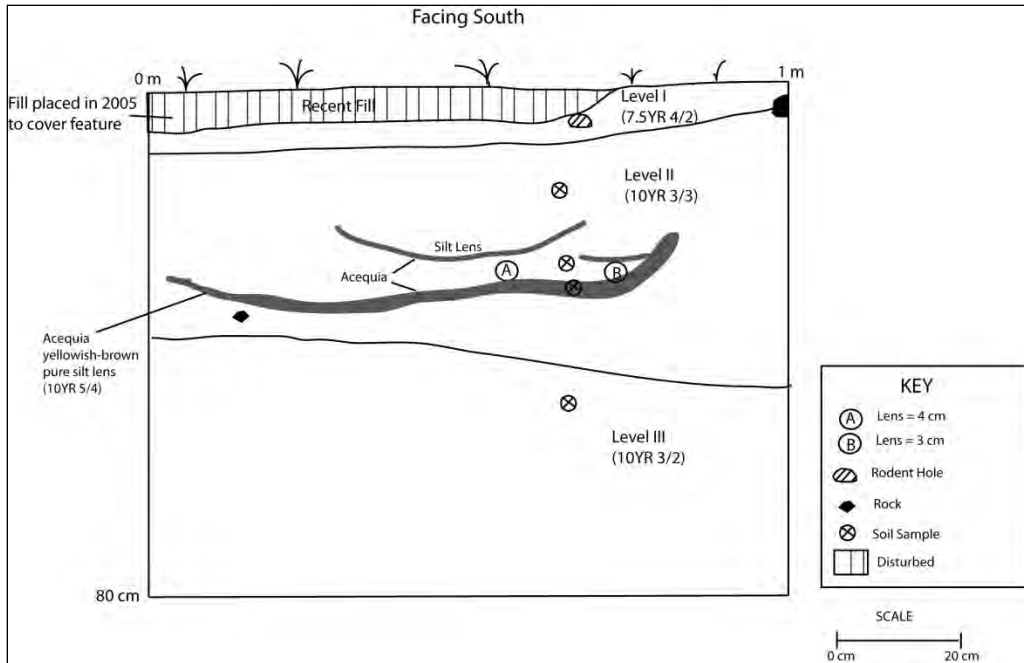
vicinity of the feature. This lens measured approximately 80 cm across and represents an early depositional event within the channel. A smaller, less distinct basin-shaped silt lens was observed at approximately 28 cm below the modern ground surface. This top lens was substantially smaller, measuring approximately 40 cm across. This lens appears to be from a later depositional event or a later iteration of the channel. The stratum between the two silt lenses was disturbed by rodent runs and roots, making it hard to distinguish from the surrounding matrix. Only one silt lens was recorded within the north profile of the test unit. Within the north profile, the acequia channel was delineated by a yellowish-brown silt lens that measured between 1 and 3 cm thick. The bottom of the silt lens was approximately 28 cm below the modern ground surface. This lens appeared to correspond to the lower, earlier lens within the south profile (the difference in elevation is attributed to the addition of modern fill, raising the ground surface on the south side of the unit). Bank deposits were not visible in either the north or south profiles and details on the feature's construction, maintenance and use require further investigation.

Figure 1.11. Profile of south wall from 2005 testing unit excavated south of the compuerta documenting acequia stratigraphy (reproduced in Conyers and Moss 2013).

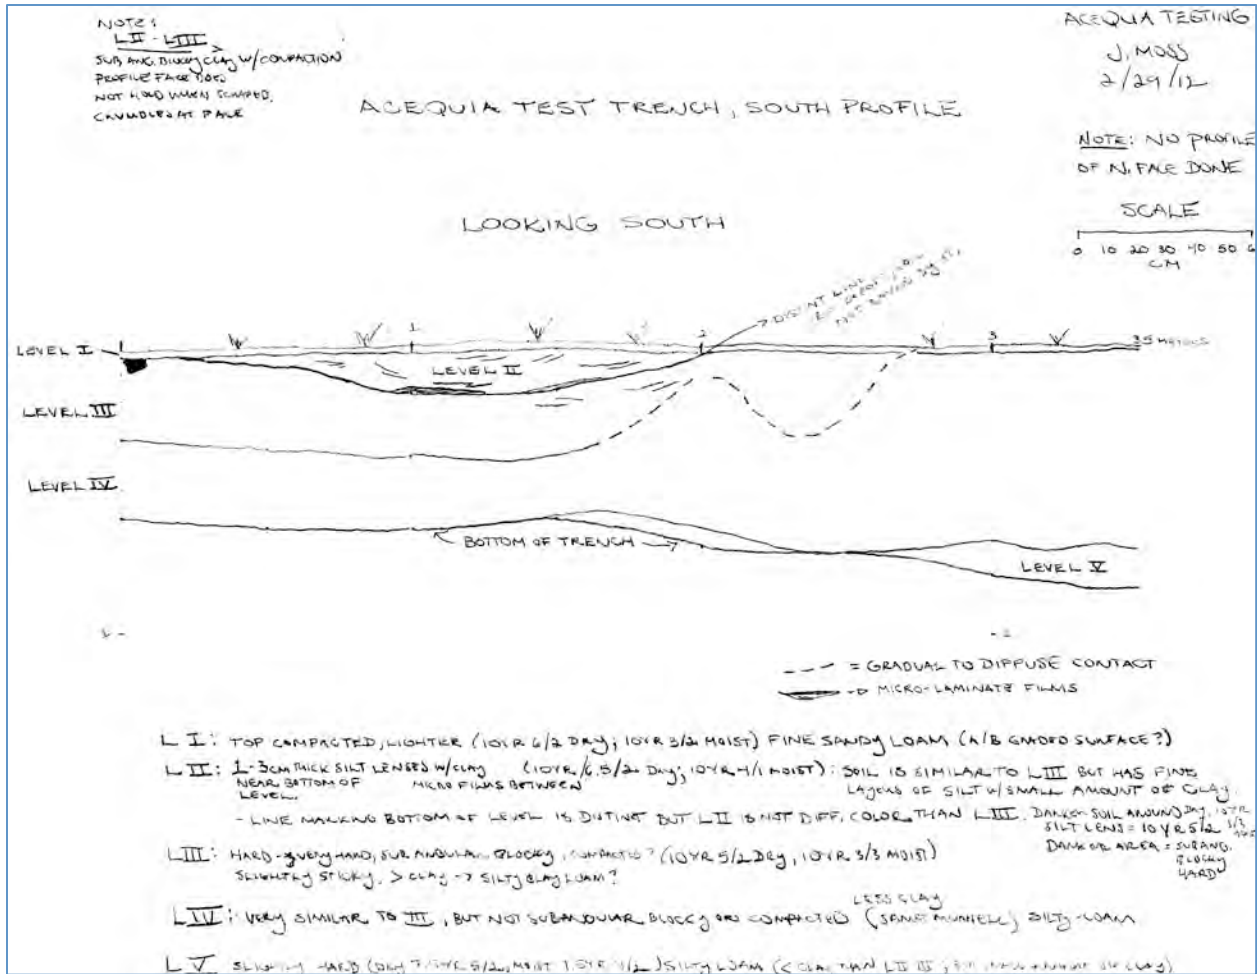
The top of the channel appeared to be truncated and was capped by a shallow (less than 5 cm in depth) stratum of light grayish-brown fine sandy loam at the modern ground surface. The acequia channel was defined by a basin-shaped, 1-to-3 cm thick lens of light yellowish-gray to pale brown fine laminated silt with clay films. The channel above the silt lens was filled with grayish-brown silty clay loam with subangular blocky texture and hard to very hard compaction (Level II). The channel fill was similar in color and texture to the underlying stratum into which it was excavated (Level III); however, there were fine silt lenses and clay microfilms throughout the channel fill that were not present throughout Level III. Level III consisted of a band of hard to very hard compacted medium gray-brown silty clay loam that was approximately 30 cm thick. The bottom contact of Level III with the underlying stratum (Level IV) sloped upward below the western edge of the channel and became irregular and less distinct, terminating just below the modern ground surface approximately 70 cm west of the acequia edge. Level IV was similar in color to Level III, but contained less clay, was less compact, and was not blocky in structure. A thin band of slightly hard medium brown silty loam (Level V) was exposed at the bottom of the trench in the western end of the unit.

The bottom of the channel exposed in the southern profile of TT2 was 23 cm below the modern ground surface (993.003 meters above sea level). The bottom of the channel was found to be slightly higher (0.055 m) higher than the bottom surface of the compuerta (992.948 meters above sea level). Because the elevation of the acequia base should decrease in the downstream direction, it is possible that the profile exposed in TT2 reflects a later iteration of the channel. Alternatively, the canal may have been constructed in such a manner as to maintain a relatively slow flow of water when a head gate within the compuerta was opened, releasing water downstream. The top of the acequia appears to be truncated within the southern profile in TT2 as a result of ground surface modification through grading and/or erosion (see discussion in Progression of Condition below), removing the berms on both sides of the channel.

Figure 1.15. Profile map documenting the acequia stratigraphy exposed in the south wall of Test Trench 2 during 2012 test excavations (Moss and Burghardt 2012).

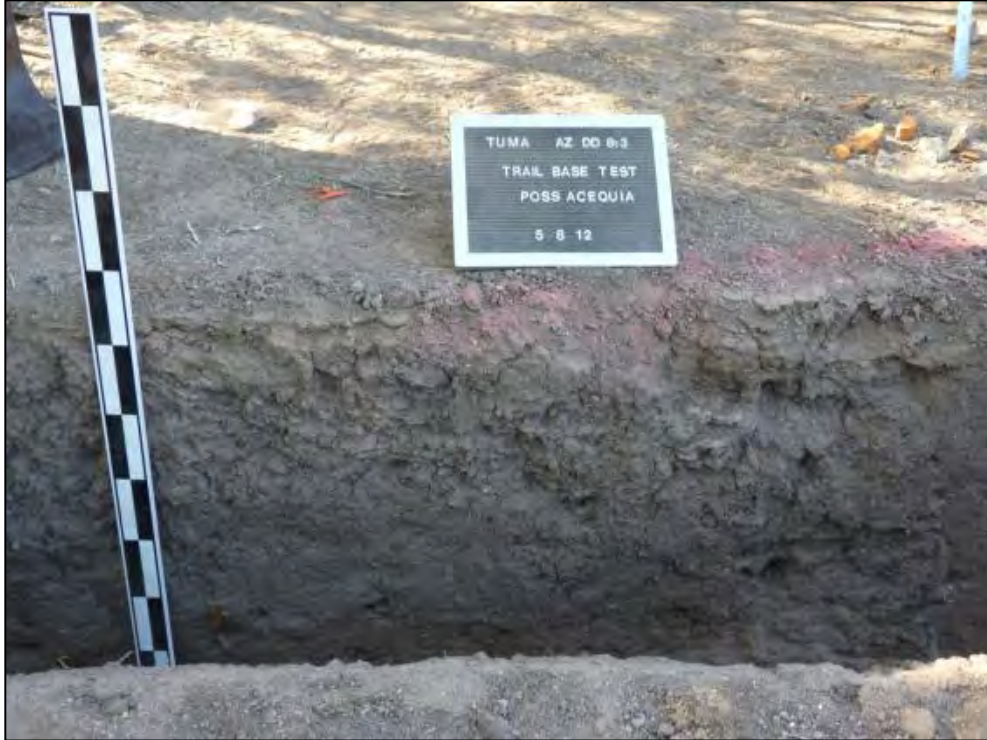
Figure 1.16. Acequia profile in south wall of Test Trench 2 during 2012 test excavations (Moss and Burghardt 2012).

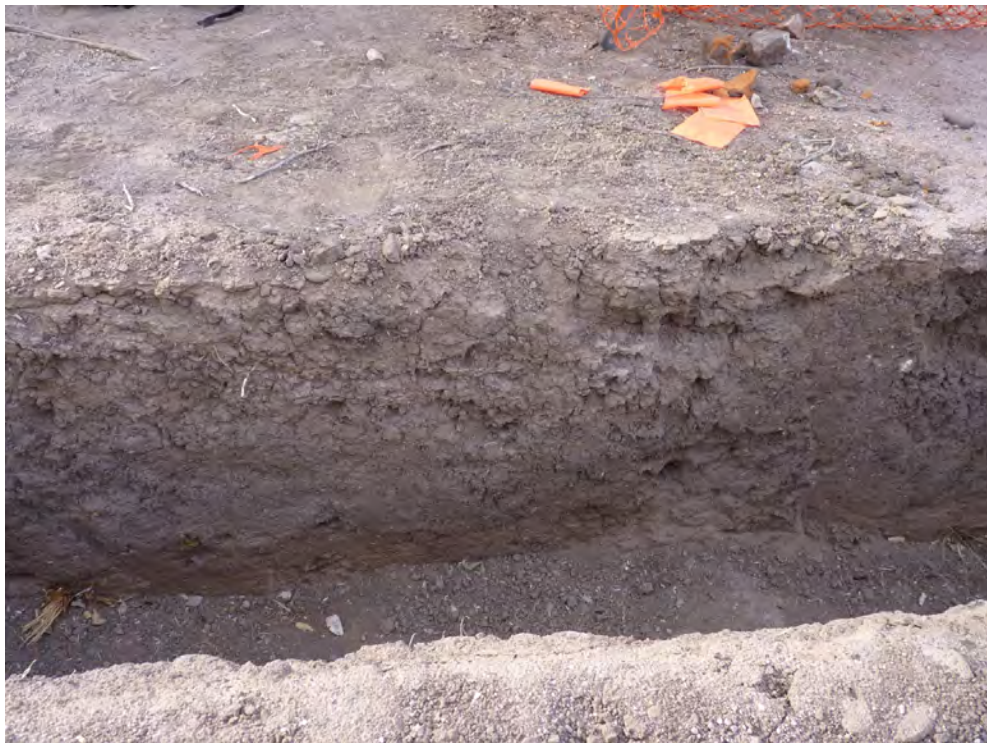
Figure 1.17. Additional view of acequia profile in Test Trench 2 during 2012 test excavations (Moss and Burghardt 2012).

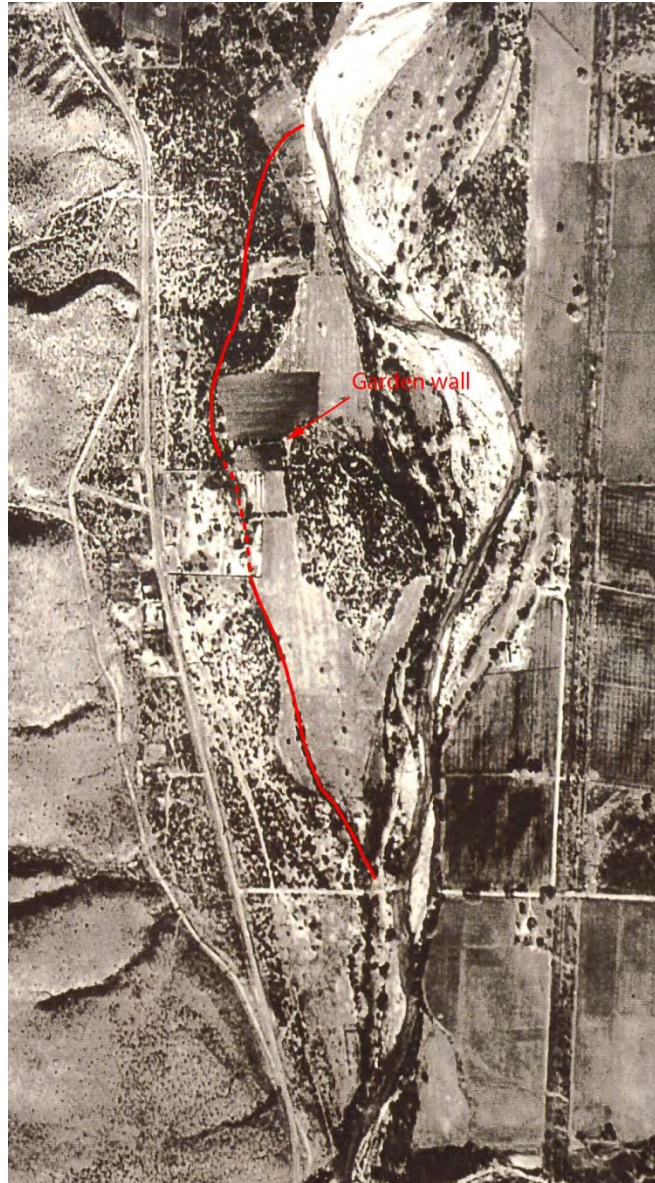
Figure 2.2. Detail of 1936 aerial photo; red line indicates approximate location of acequia alignment.

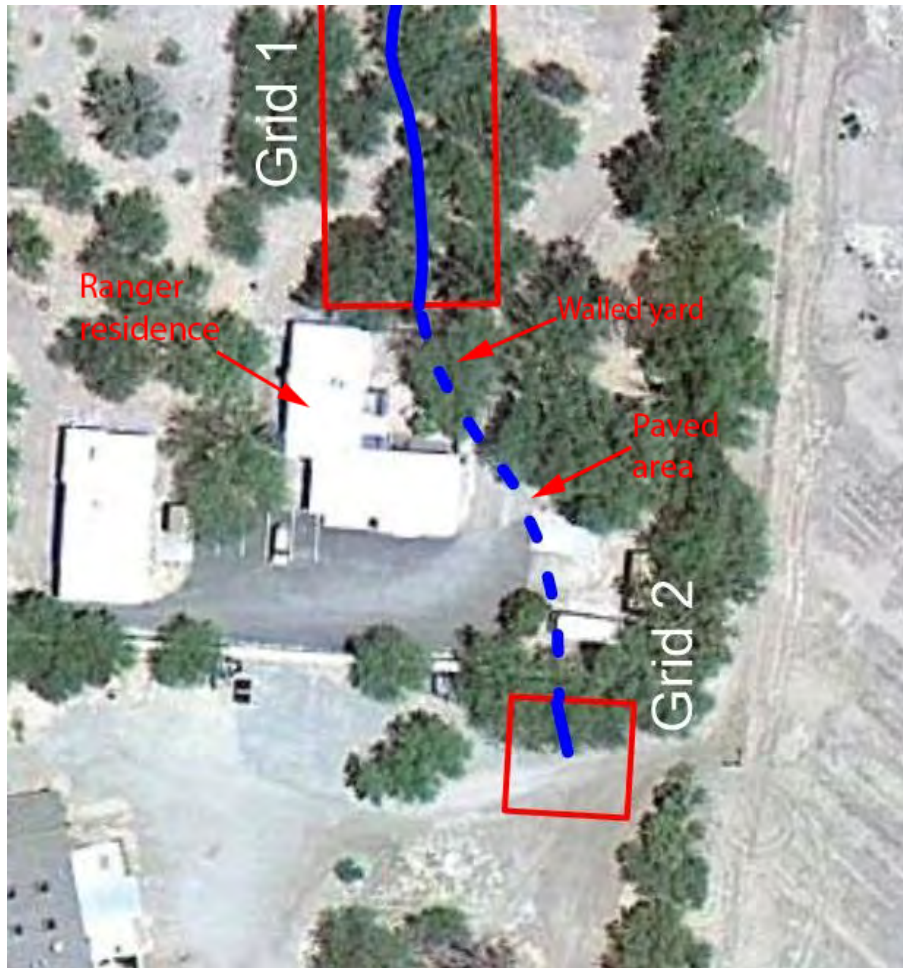
extending from the northeast corner of the building were likely built over the acequia alignment (see Figure 2.4).

Figure 2.4. 2012 aerial photo depicting the amended footprint of combined ranger’s residence and garage, as well as walled yard and paved parking area, in relation to the projected acequia alignment (denoted with blue line segment). Red boxes with grid designations denote units from ground-penetrating radar study discussed below (amended after Moss and Conyers 2013:16).

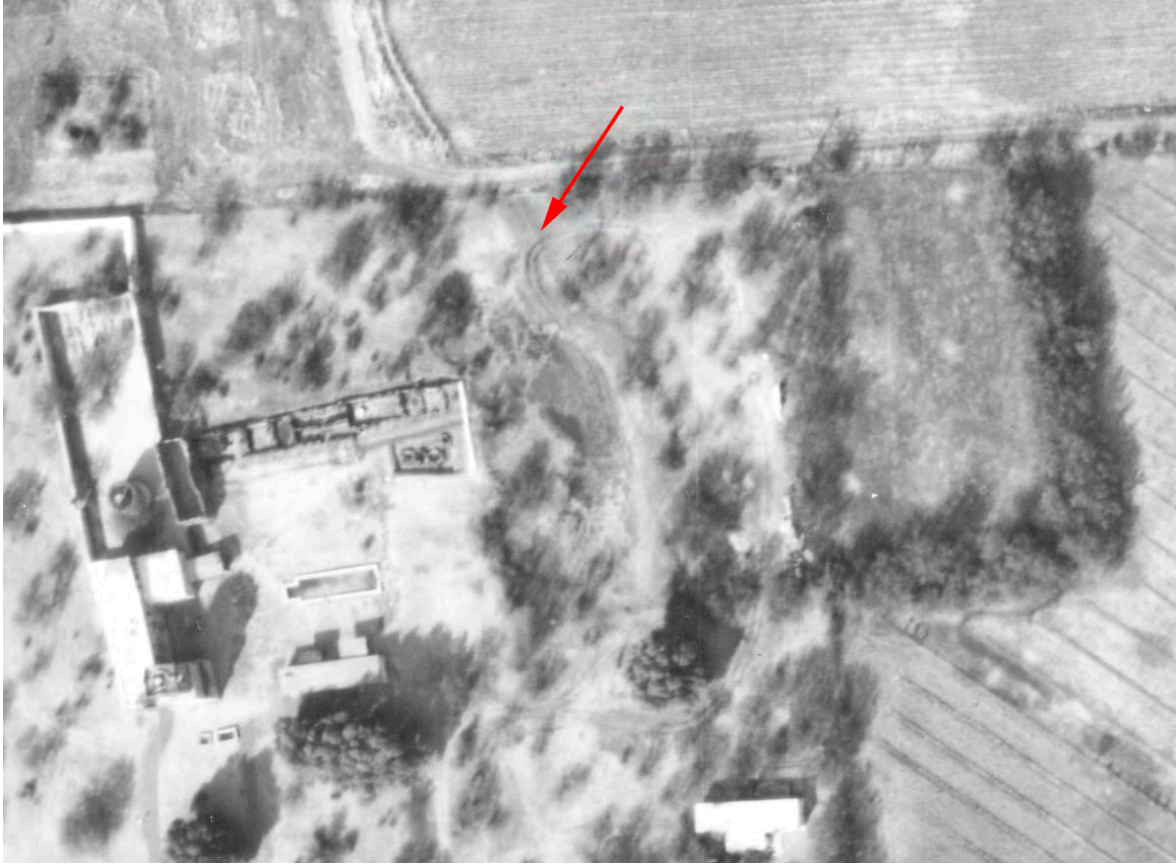
Figure 2.6. Detail of 1967 aerial photograph showing location of remaining acequia alignment indicated with red arrow. Note two-track road trace over feature (NPS TNHP Archives).

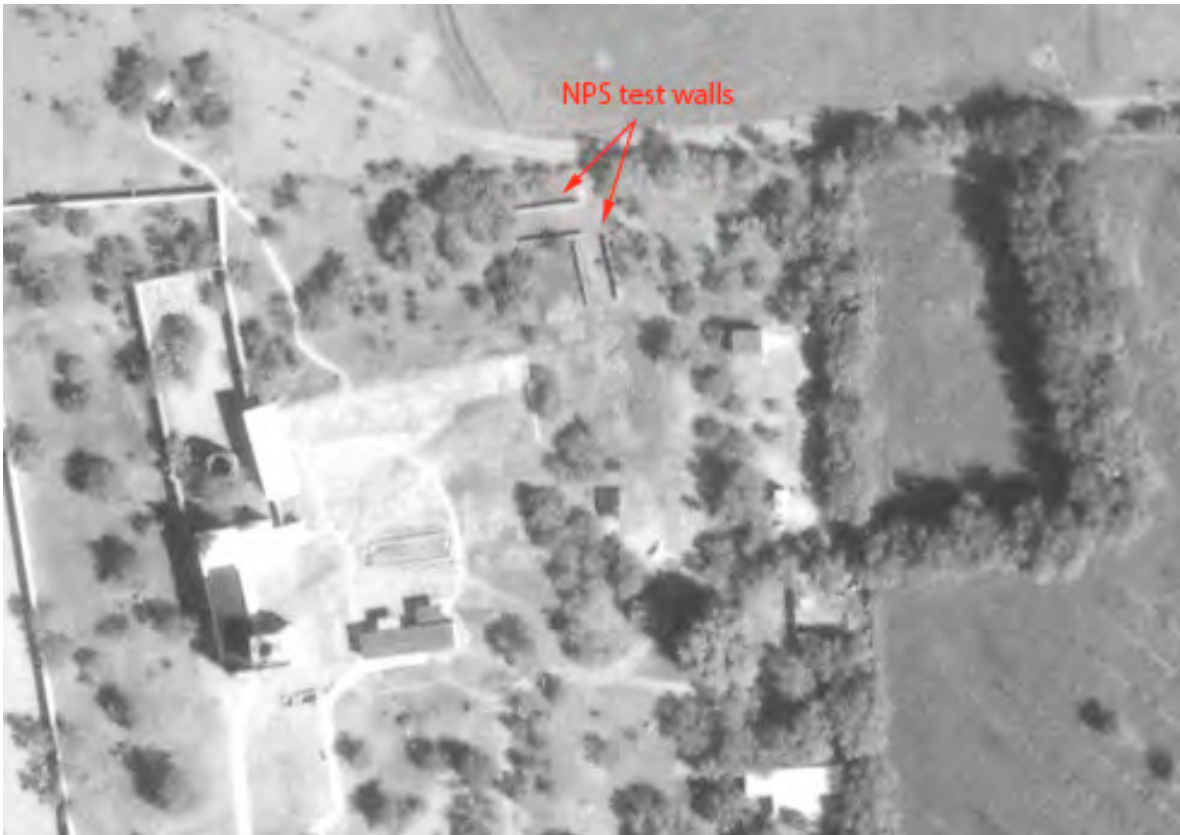
By 1977, the area of the historic acequia had been flattened and increased vegetation had accumulated over the alignment. NPS had built a series of adobe test walls over the feature just south of the dirt road paralleling the northern garden wall (Figure 2.7). Vegetation encroachment increasingly affected the visibility of the feature in the 1980s, including the straightened and cemented portion of the feature north of the mission core. An aerial photograph taken in 1983 (Figure 2.8) shows that a dirt road had been built over the feature, roughly following a segment of the alignment through the adobe test walls to the fiesta grounds. The fields to the south of the mission continued to be cultivated, while the fields to the north had been allowed to naturalize.

Figure 2.7. Detail of 1977 aerial photograph showing the condition of the acequia and the alterations within the mission landscape (NPS TNHP Archives).

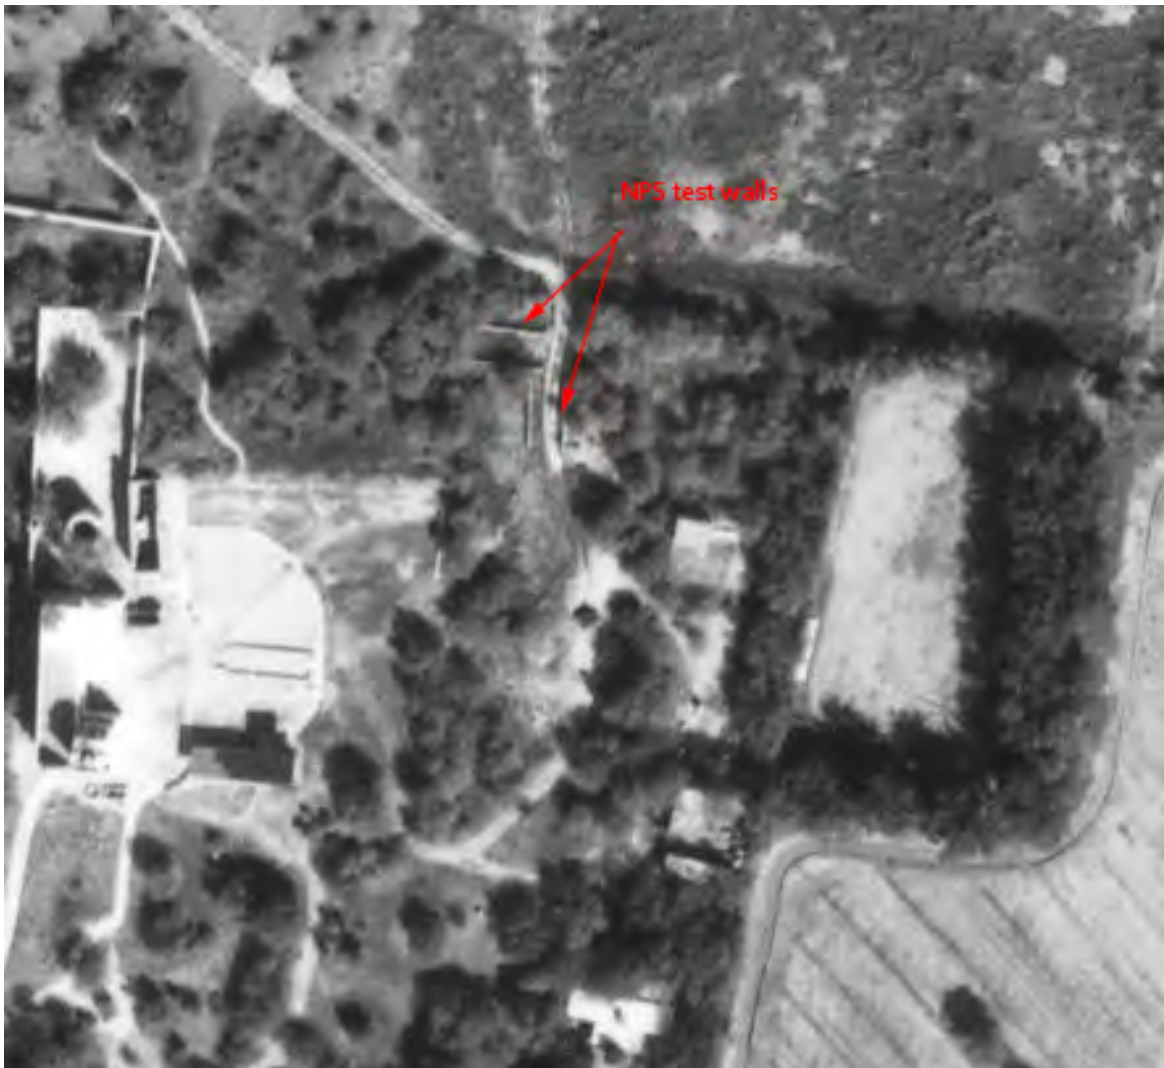
Figure 2.8. 1983 aerial photo illustrating the development of the landscape and the condition of the acequia adjacent to the mission core complex. Red arrows indicated road trace between NPS test walls follows approximate acequia alignment south of the raised dirt road to the fiesta grounds (NPS TNHP Archives).

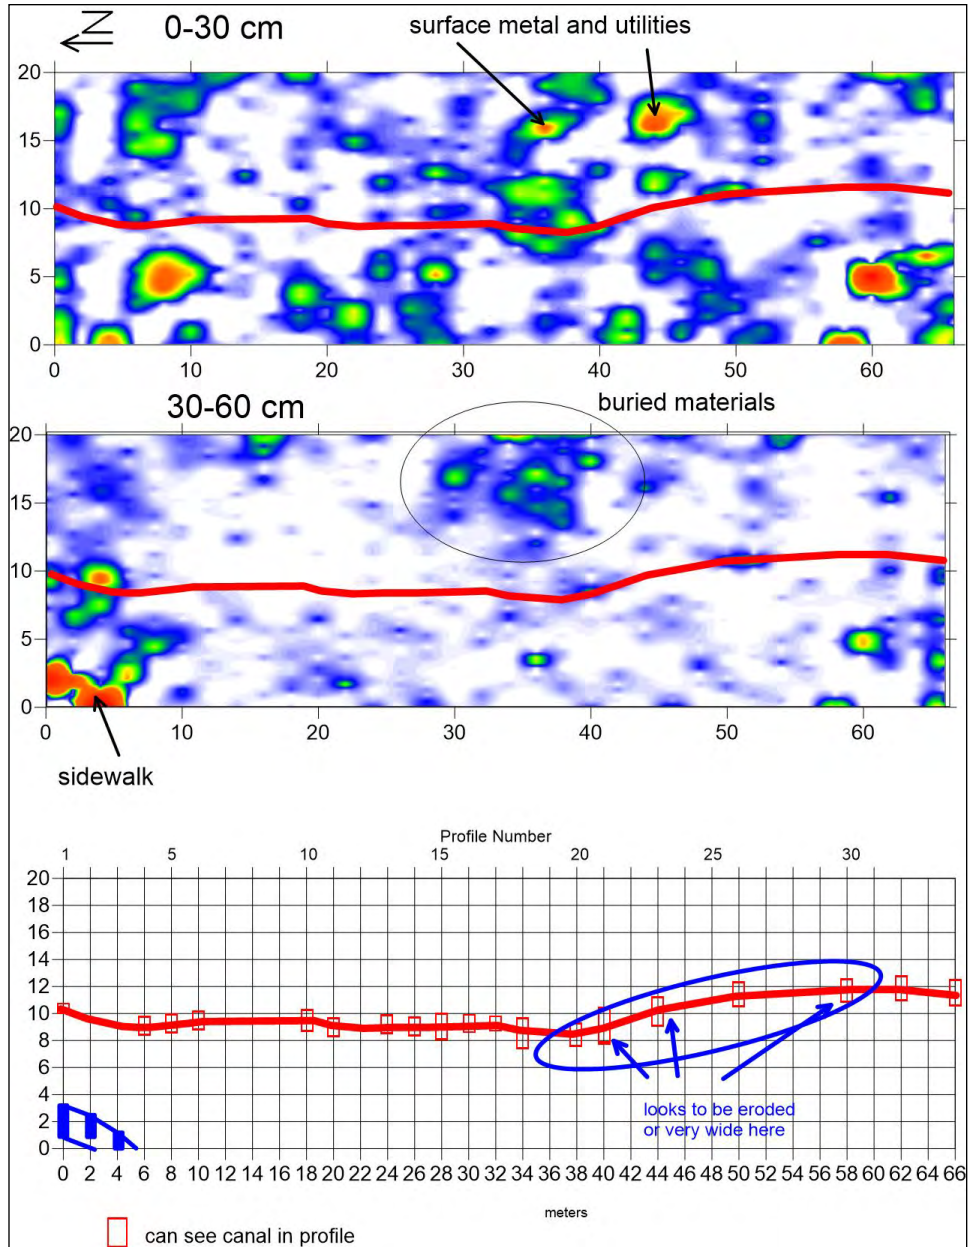
Data were collected from 34 transects within this unit. However, only 18 transect produced visible reflection profiles (Figure 2.14). Reflection profiles indicate the channel is located approximately 15 cm below the modern ground surface and is approximately 40 cm in depth. The horizontal amplitude maps and manual interpretation of profile alignments produced from data collected in this unit suggested that the channel alignment is fairly straight within this segment, with slight undulations. Multiple disturbances, including metal pipes were detected in this unit. The margins appear to be much wider along a portion of the channel in the in the southern half of the unit, indicating possible erosion or disturbance (Figure 2.15).

Figure 2.15. Horizontal amplitude maps (top and middle) and alignment map (bottom) showing the plan view location of the channel within Grid 1. Note location of potentially disturbed or eroded section in southern half of the unit (from Conyers and Moss 2013:11).

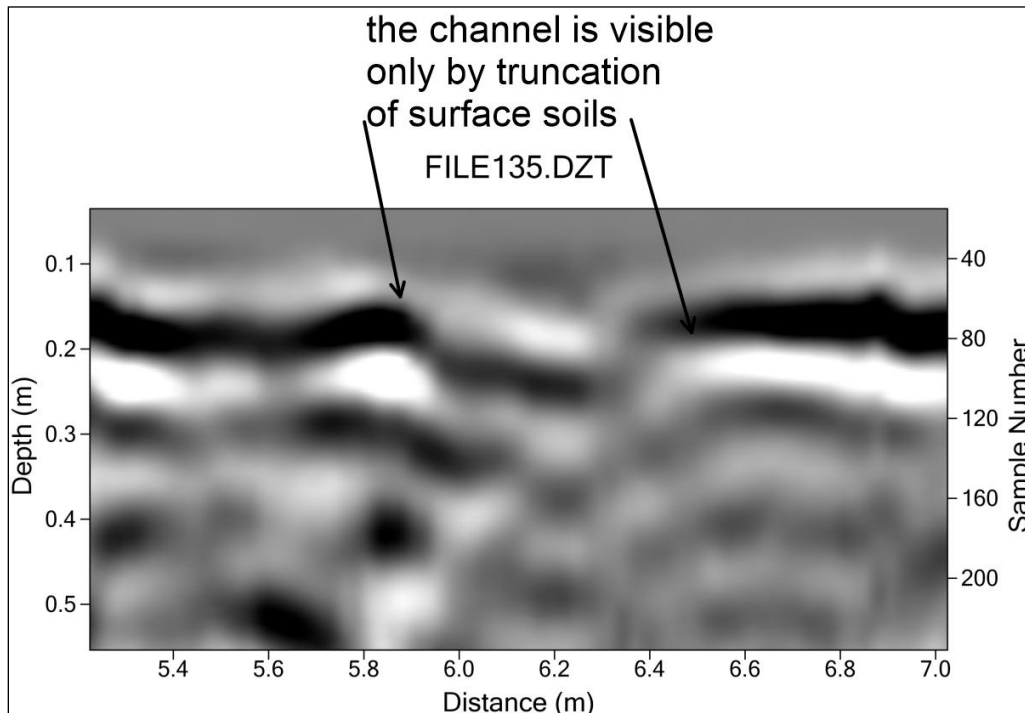
Data were collected from a total of eight transects within this unit. Less than half (three out of eight) of the reflection profiles from transects within this unit showed evidence of the acequia channel. The top of the feature appears to be truncated in this area, with intact portions of the channel located immediately below the modern ground surface (Figure 2.16). This unit is located adjacent to a paved parking area and is transected by a dirt road trace. The development of both modern features may have impacted the acequia, truncating the top of the feature. The base of the

Figure 2.16. Representative reflection profile from Grid 2, showing the channel truncating the stratum just below the modern ground surface (from Conyers and Moss 2013:12).

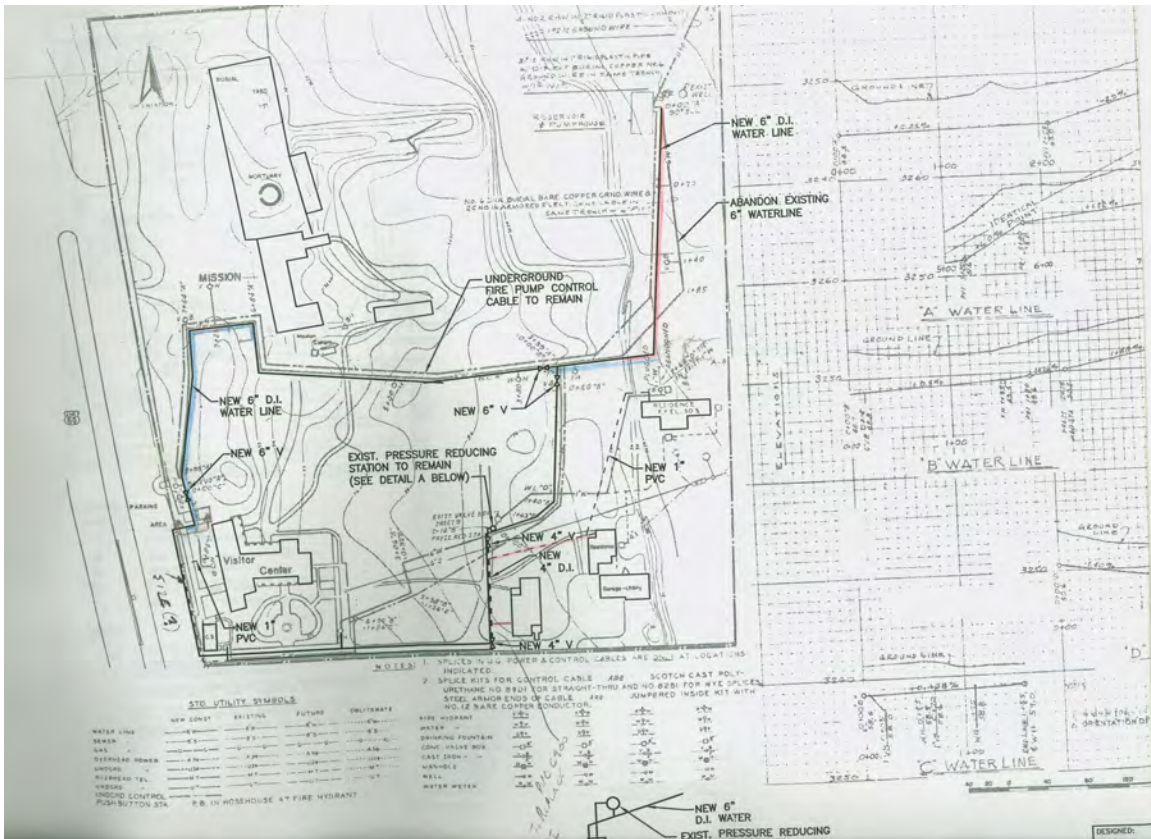
NPS Additions/Modifications. An approximately 2.5 m wide concrete path has been paved over the acequia alignment 10.5 m north of the compuerta. Archaeological testing prior to the construction of the path showed that the acequia alignment in this location is extremely shallow and the top portion of the feature was likely adversely affected during construction of the concrete path. Furthermore, the concrete path interrupts the visually linear nature of the feature. Additionally, a dirt road trace has been constructed over the acequia alignment south of the compuerta, further obscuring the linear feature. The addition of Park infrastructure, including a 6-inch water line and a buried fire pump control cable, may have damaged buried portions of the acequia (see Figure 3.6).

Figure 3.6. Schematic map of Park utility infrastructure produced in 2001. Note existing 6-inch waterline and underground fore pump control cable in vicinity of acequia alignment (NPS TNHP Archives).

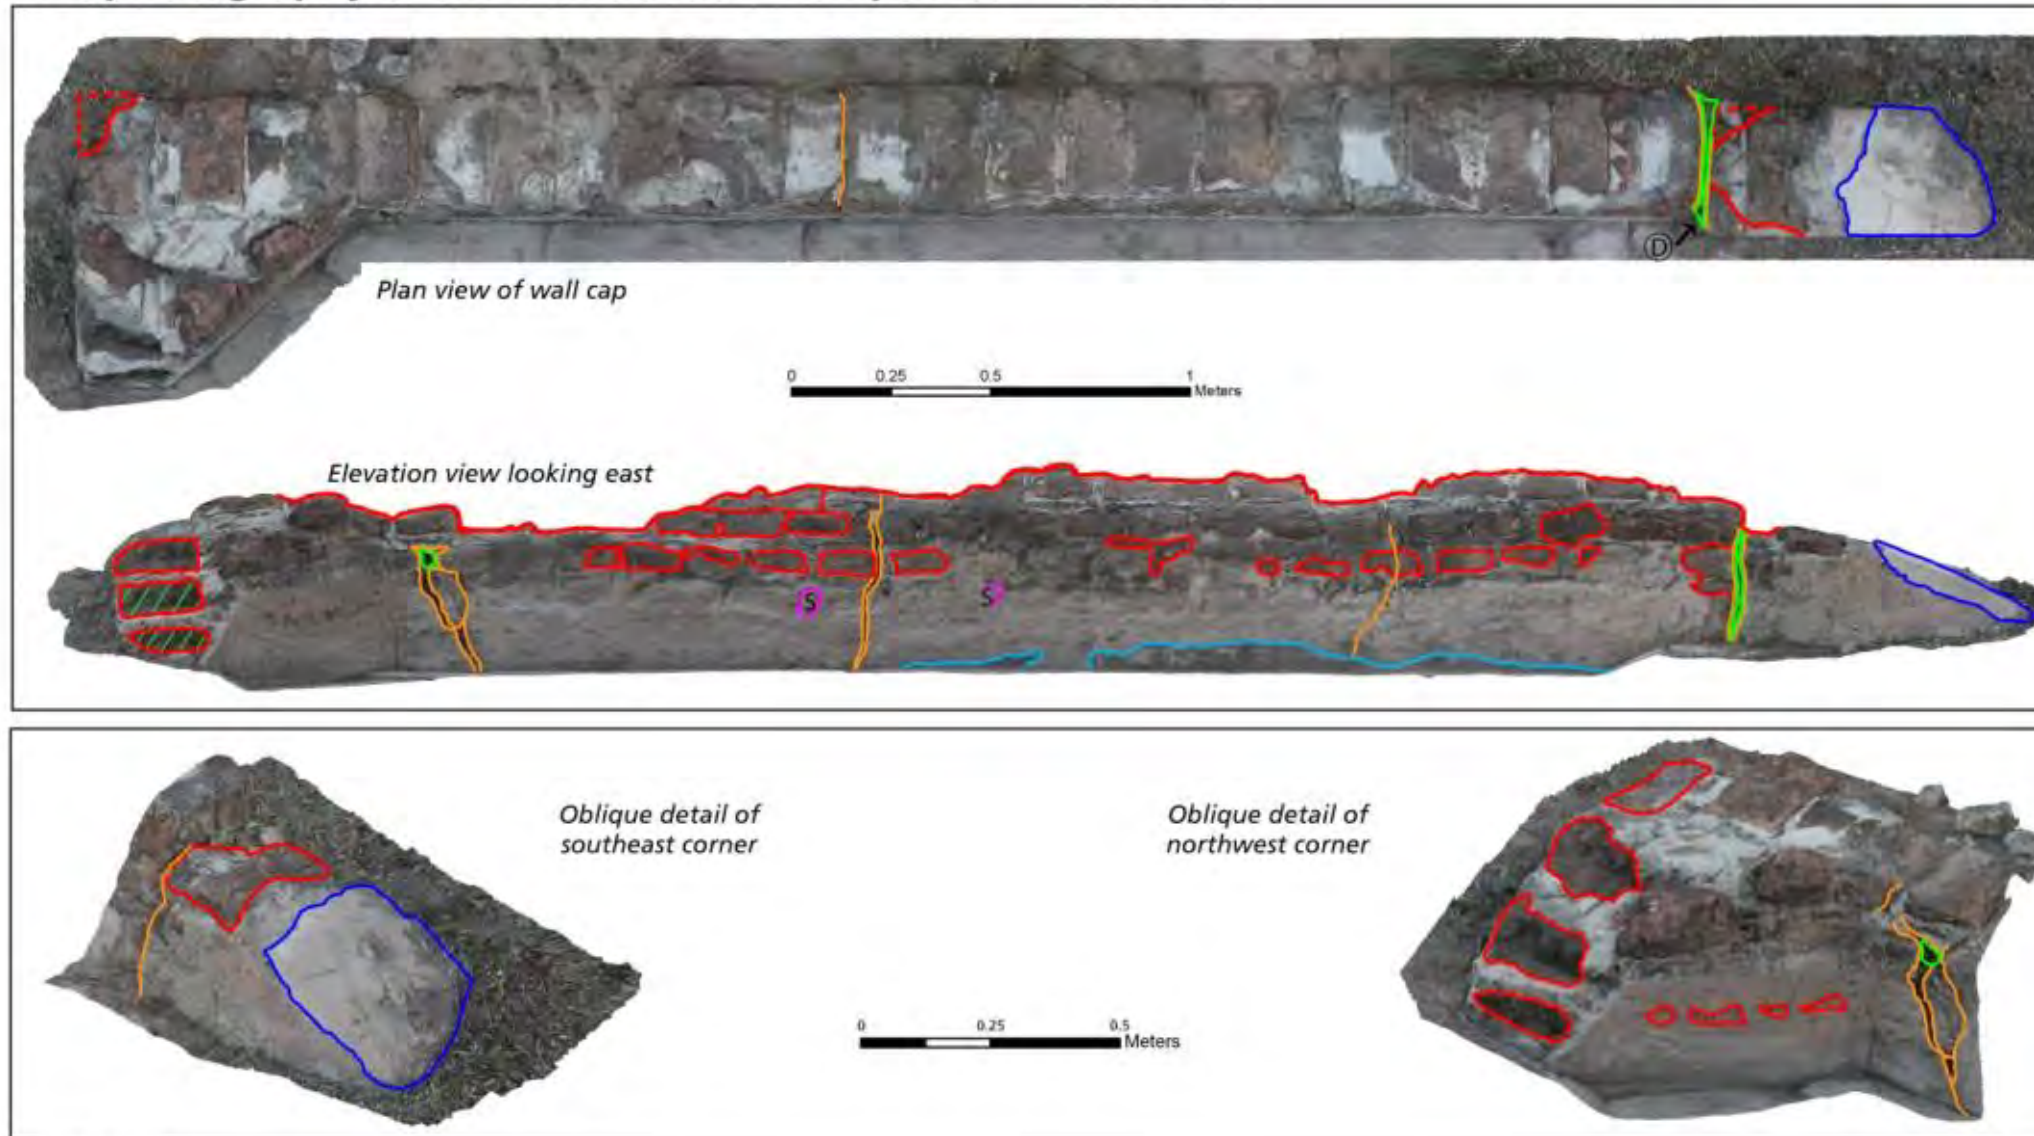
### Orthophotography of the Tumacacori Compuerto - East Wall

Figure 3.8. Annotated photomontage illustrating comprehensive condition assessment evaluation for the east compuerta wall.

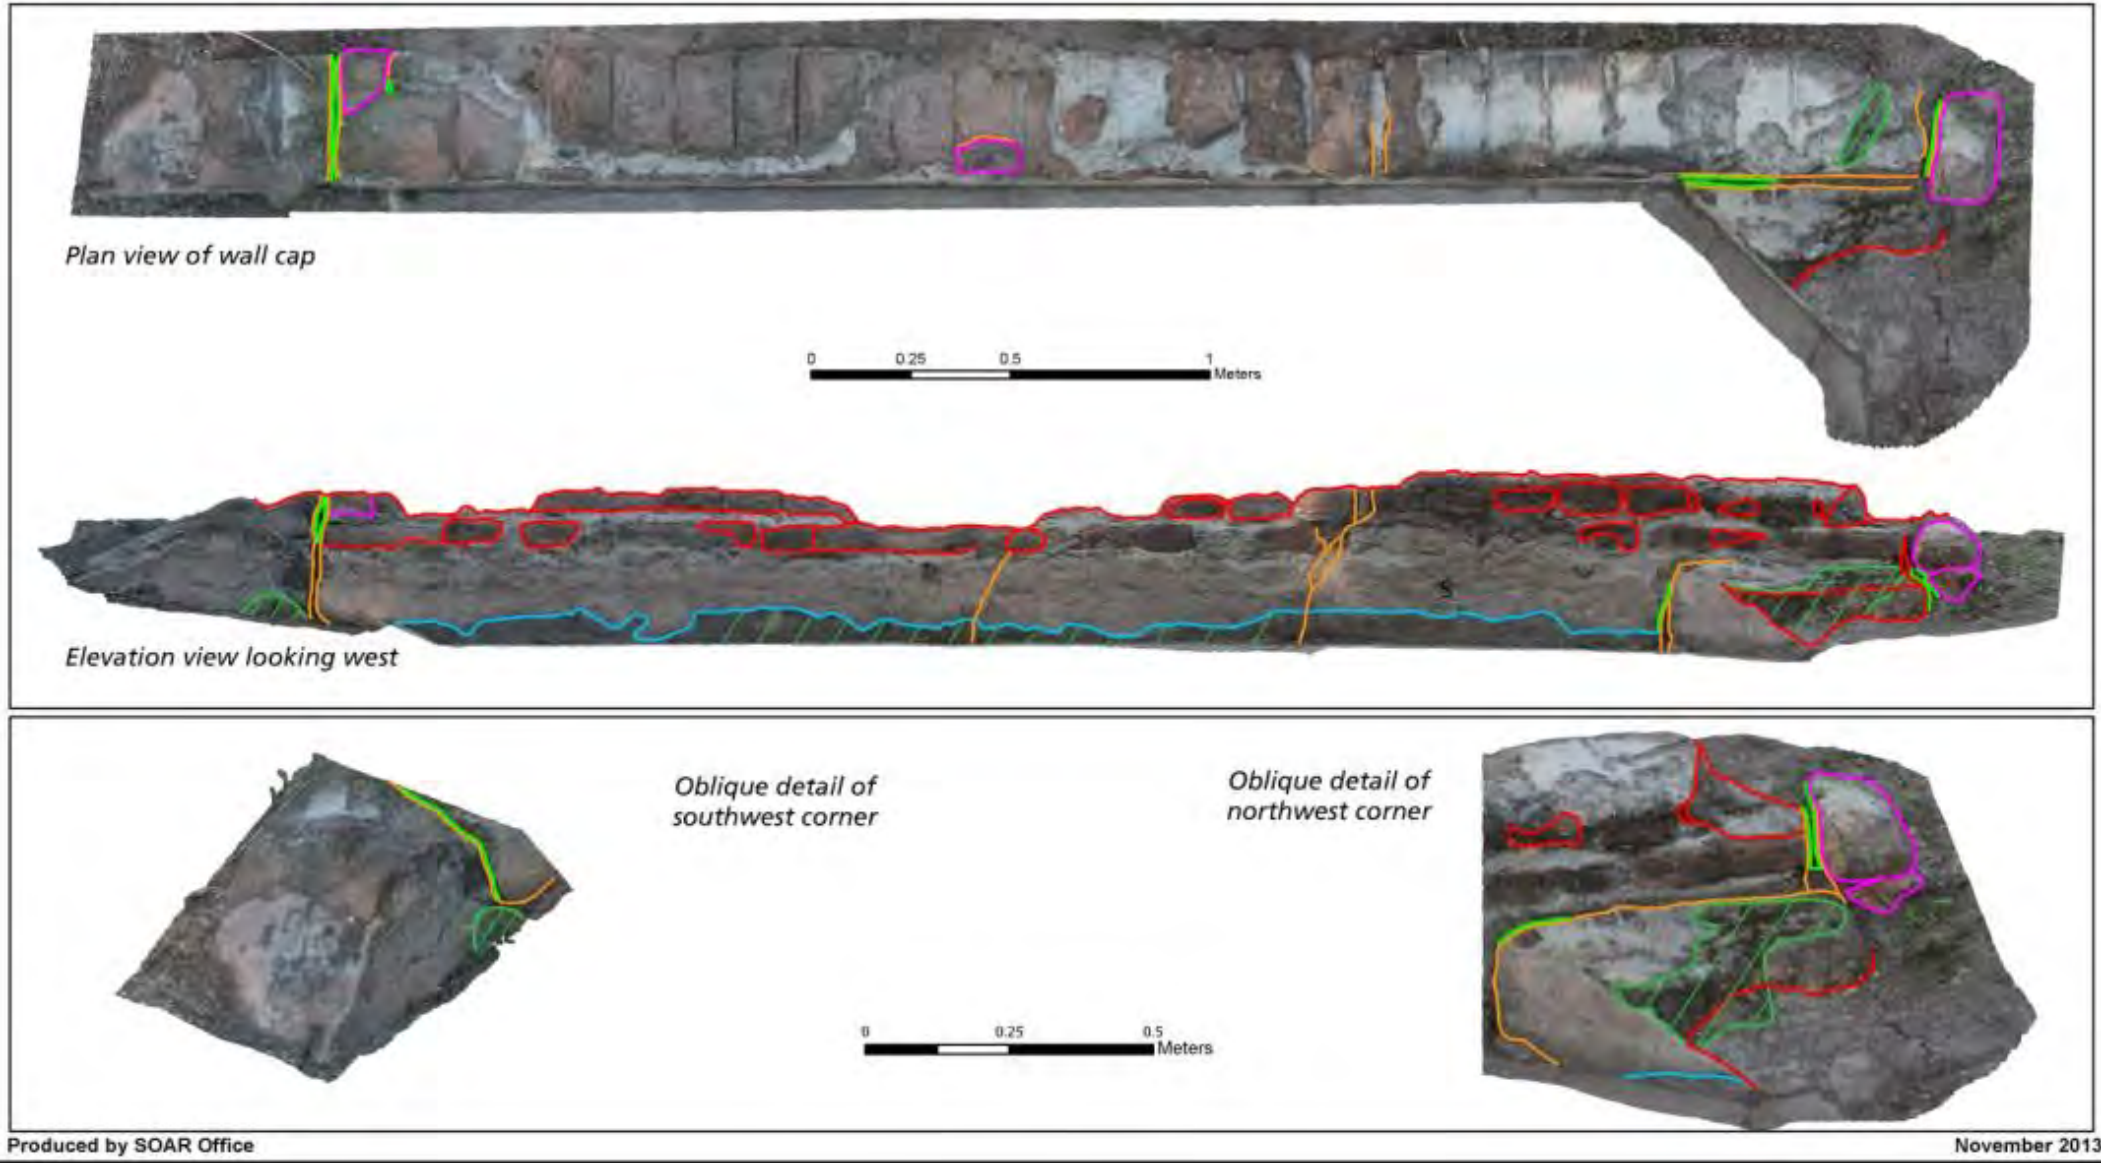
### Orthophotography of the Tumacacori Compuerto - West Wall

Figure 3.9. Annotated photomontage showing comprehensive condition assessment evaluation for the west compuerta wall.

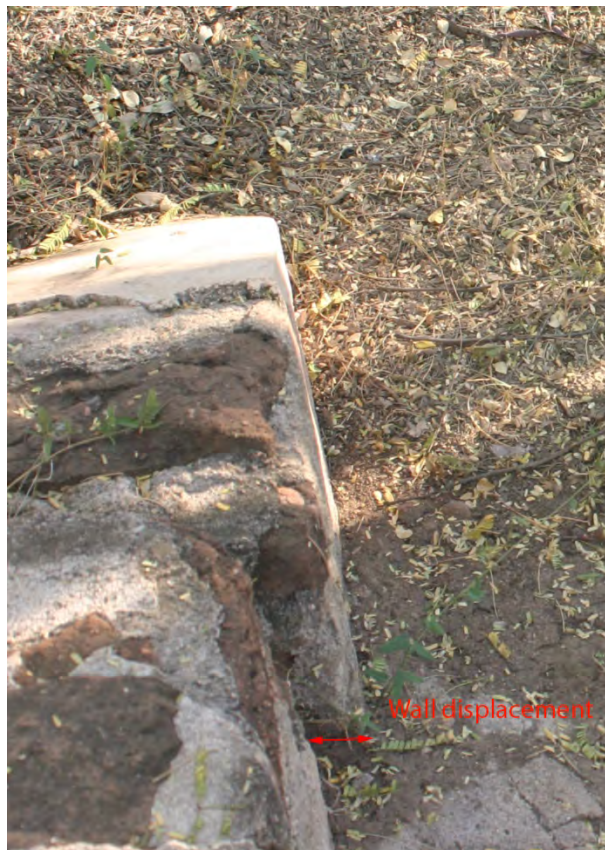
Slight displacement of the southern end of the eastern wall was noted, with movement of this section of wall toward the west. The displacement may be a result of disturbance factors such as root encroachment (Figure 3.14).

Figure 3.14. Detail of southern end of east wall with displacement of section of wall toward the west (photographed November 19, 2013).
