# **PRESERVATION PLAN**

## **ACEQUIA AND COMPUERTA**

### **TUMACÁCORI NATIONAL HISTORICAL PARK**

In conjunction with:  
Desert Southwest Cooperative Ecosystem Studies Unit (DS-CESU)  
June 2014

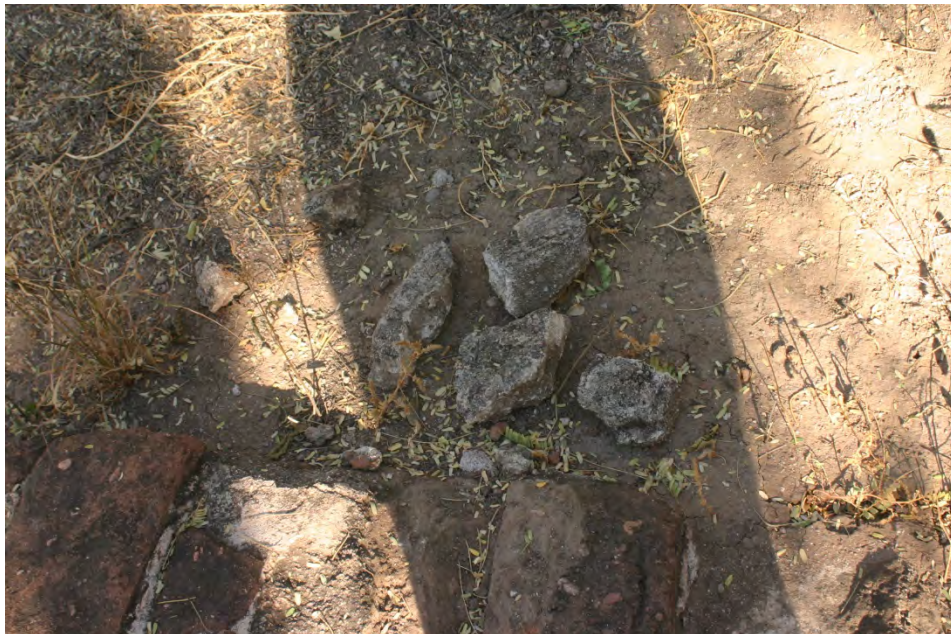
Cracking within the bedding mortar has resulted in localized material losses between the brick joints (Figure 3.20). Brick and mortar fragments associated with the compuerta are piled in two areas, which may represent both recent losses (Figure 3.21) and loose materials that were found during the initial excavation that uncovered the compuerta in 1994 (Figure 3.22).

Figure 3.21. Bedding mortar fragments piled near the eastern wall of the compuerta (photograph facing east, November 19, 2013).

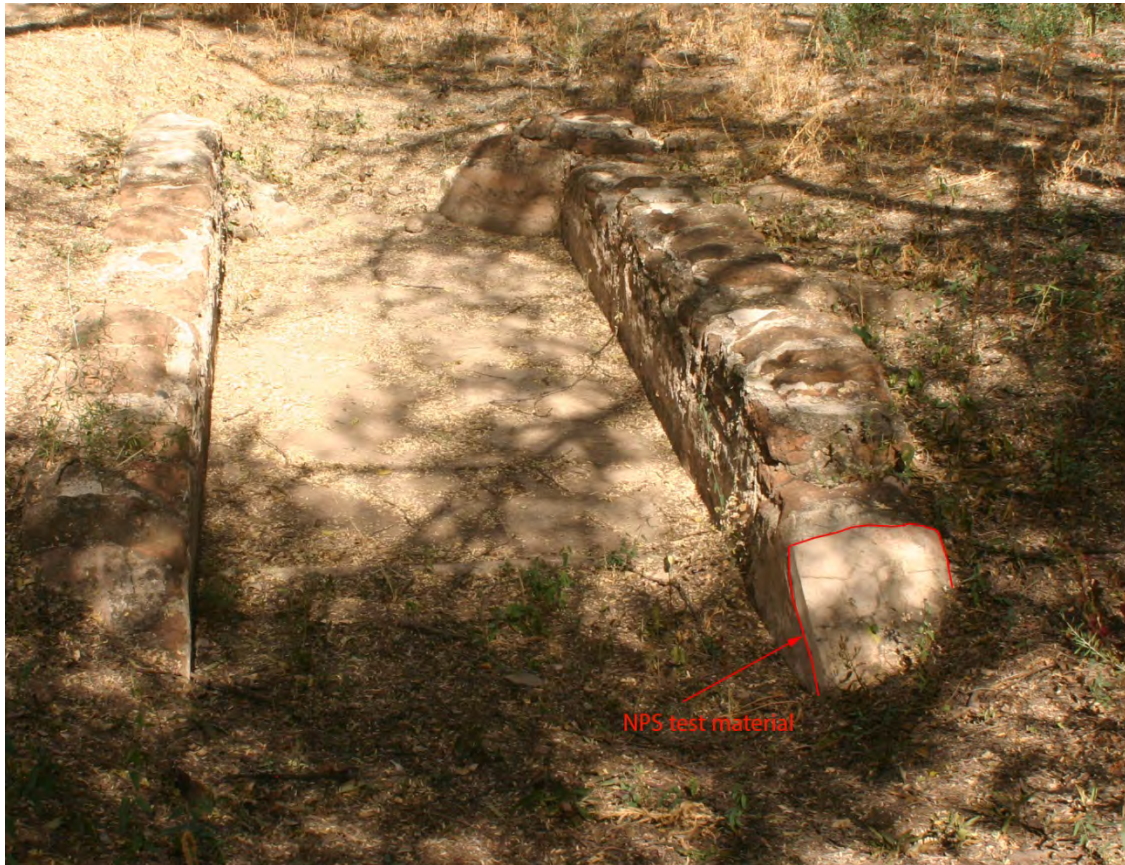
NPS Repairs. A hydraulic lime plaster coating was added in 2010 on the southern end of the east wall, capping the top surface of the wall as it curves down toward the ground surface. The plaster coating was added as a test to evaluate the material and its effects on the historic fabric of the compuerta. The test material is composed of St. Astier 3.5 moderately hydraulic lime (Jeremy Moss, personal communication, April 2014).

Figure 3.27. Natural hydraulic lime plaster test material at southern end of east compuerta wall (photograph looking north November 19, 2013)

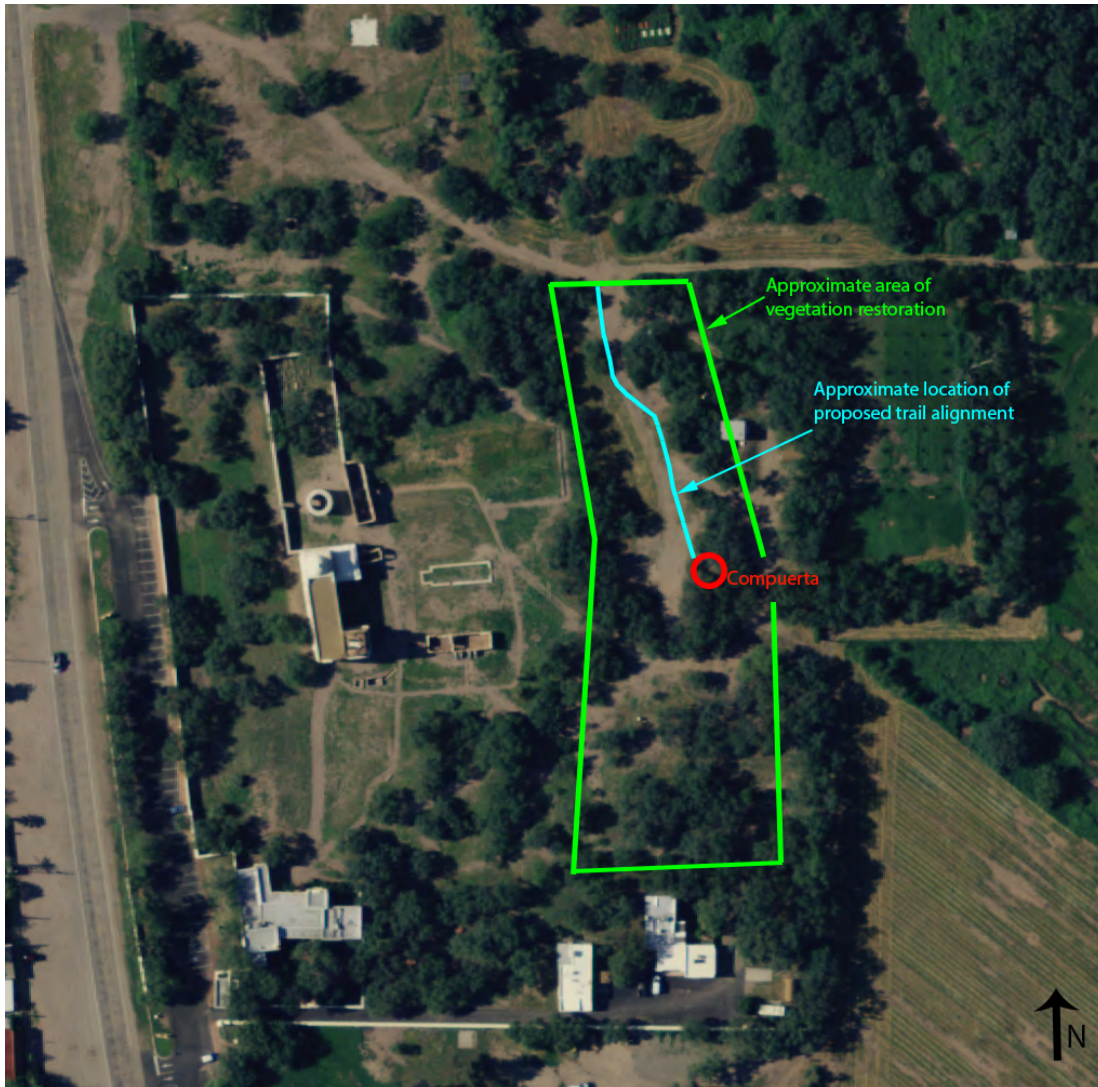
Figure 5.1. Overview of general area within the Park included in recommended cultural landscape rehabilitation. The area delineated in green represents the reseeding area associated with the acequia; the blue line represents the approximate location for the portion of the acequia alignment recommended for development as an interpretive trail.

While trail development along the acequia alignment south of the compuerta is not recommended at this time due to staffing limitations, similar preservation maintenance strategies should be employed to maintain the archaeological integrity of this feature. This includes regular vegetation maintenance to reduce root disturbance, along with use of plant species with low-impact root systems for any future vegetation restoration, within the vicinity of the acequia alignment to the south of the compuerta.

Trail development and implementation should incorporate strategies that limit hazards to the public and adverse effects on Park resources. Initial strategies include maintaining a buffer zone on the periphery of the trail to limit exposure of Park visitors' and staff to hidden wildlife, such as snakes. Further, the fine floodplain sediments that may be exposed on the trail alignment could become slick and muddy during rains. Muddy conditions could render the trail hazardous and potentially adverse effects on the shallowly buried channel could be sustained by pedestrian or small vehicular traffic during muddy conditions. In addition to considering drainage patterns along the trail alignment, the feasibility of preparing the trail with gravel or decomposed granite should be assessed to reduce the potential for muddy conditions (see Alternatives below).

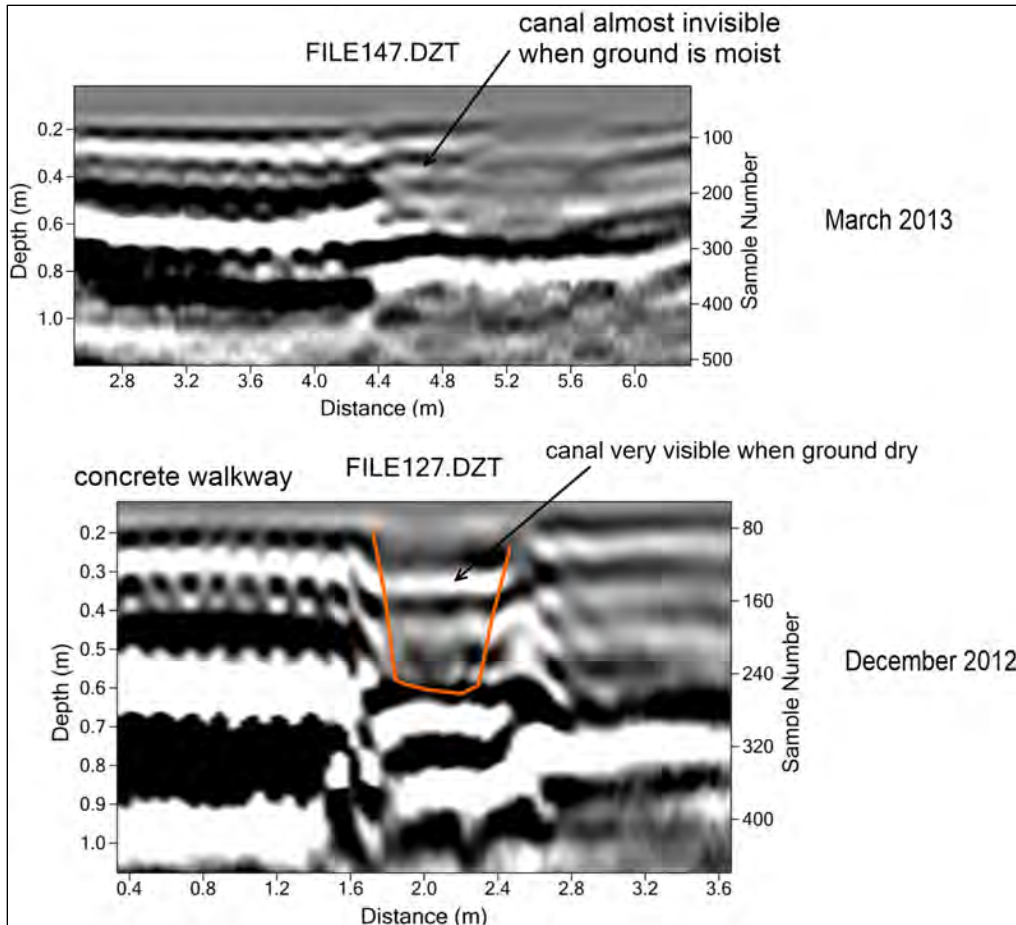
The lower reflection contrast in radar waves in the March, 2013 is exactly what can be seen in profiles. In Figure 4 a comparison of two reflection profiles in these two moisture regimes shows how the edges of the canal and its bottom produced high amplitude reflections in December, 2012 with the same feature is almost invisible in March, 2013.

**Figure 4:** Comparison of March and December reflection profiles over the same feature in Grid 3. The canal is quite visible (especially its base) in Dec. but is almost invisible in March.

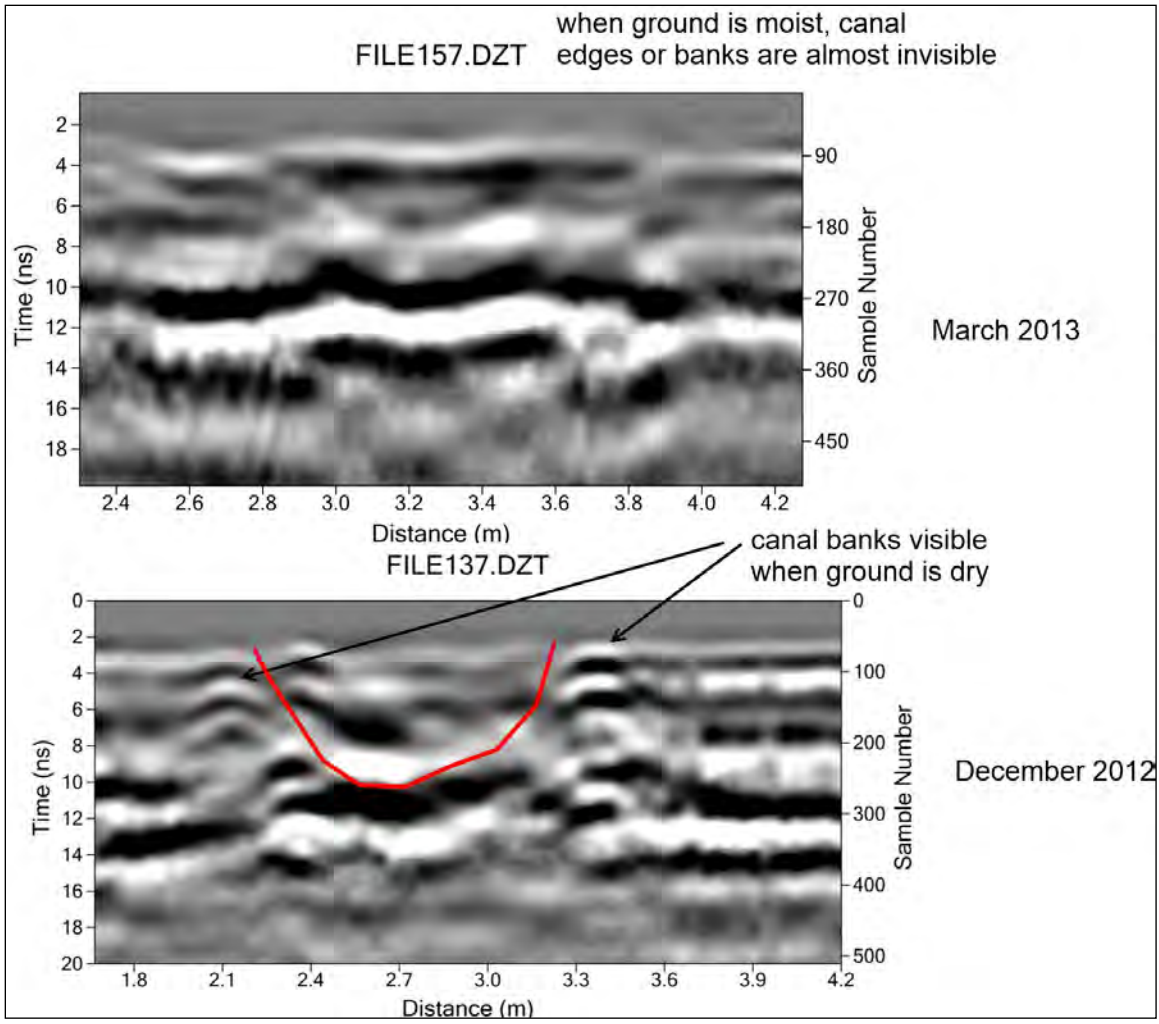
The canal edges are also more visible in reflection profiles collected in December (Figure 5). This is likely caused by clay in the “clean out” sediments deposited on the margins of the canals, which retains more moisture. While there is little sediment analysis at the site, canals usually contain finer-grained sediment deposition, which needs to be cleaned out periodically. That finer-grained material has a much lower permeability, and therefore retains more water. With more water retention in the clays layers, and less in the interbedded coarser grained sediment, the variation in the physical and chemical constituents that are responsible for radar wave reflection are more pronounced (Conyers 2012). The canal edges are therefore more pronounced in the December data. This is visible in many of the profiles. More analysis of sediments may help with interpretation of the GPR data.

**Figure 5:** Comparison of profiles where the edges of the canals are more visible in December than in March. This is likely caused by the contrast in water saturation between canal clean-out sediments after 3 months of no rain.

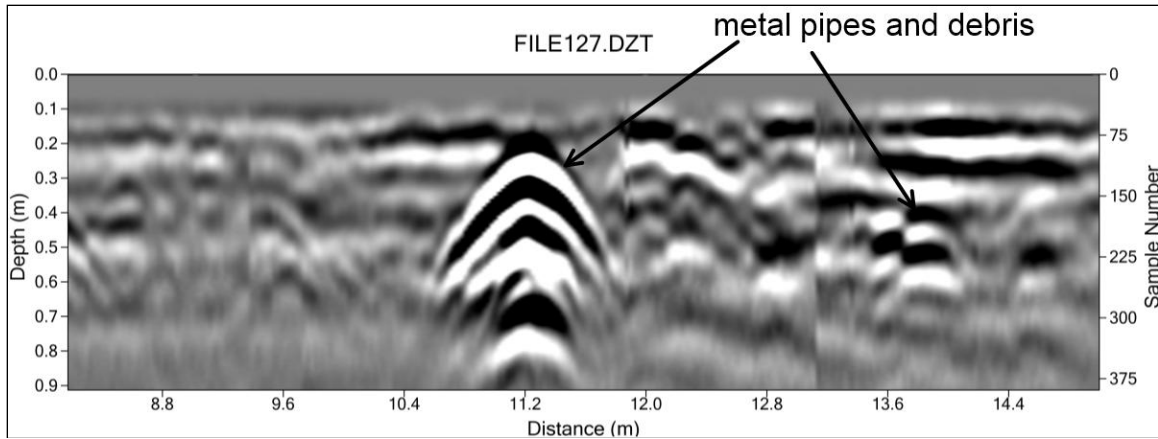
**Figure 7:** Example of buried metal pipes and other debris that obscures the canal in some of these profiles in Grid 1.

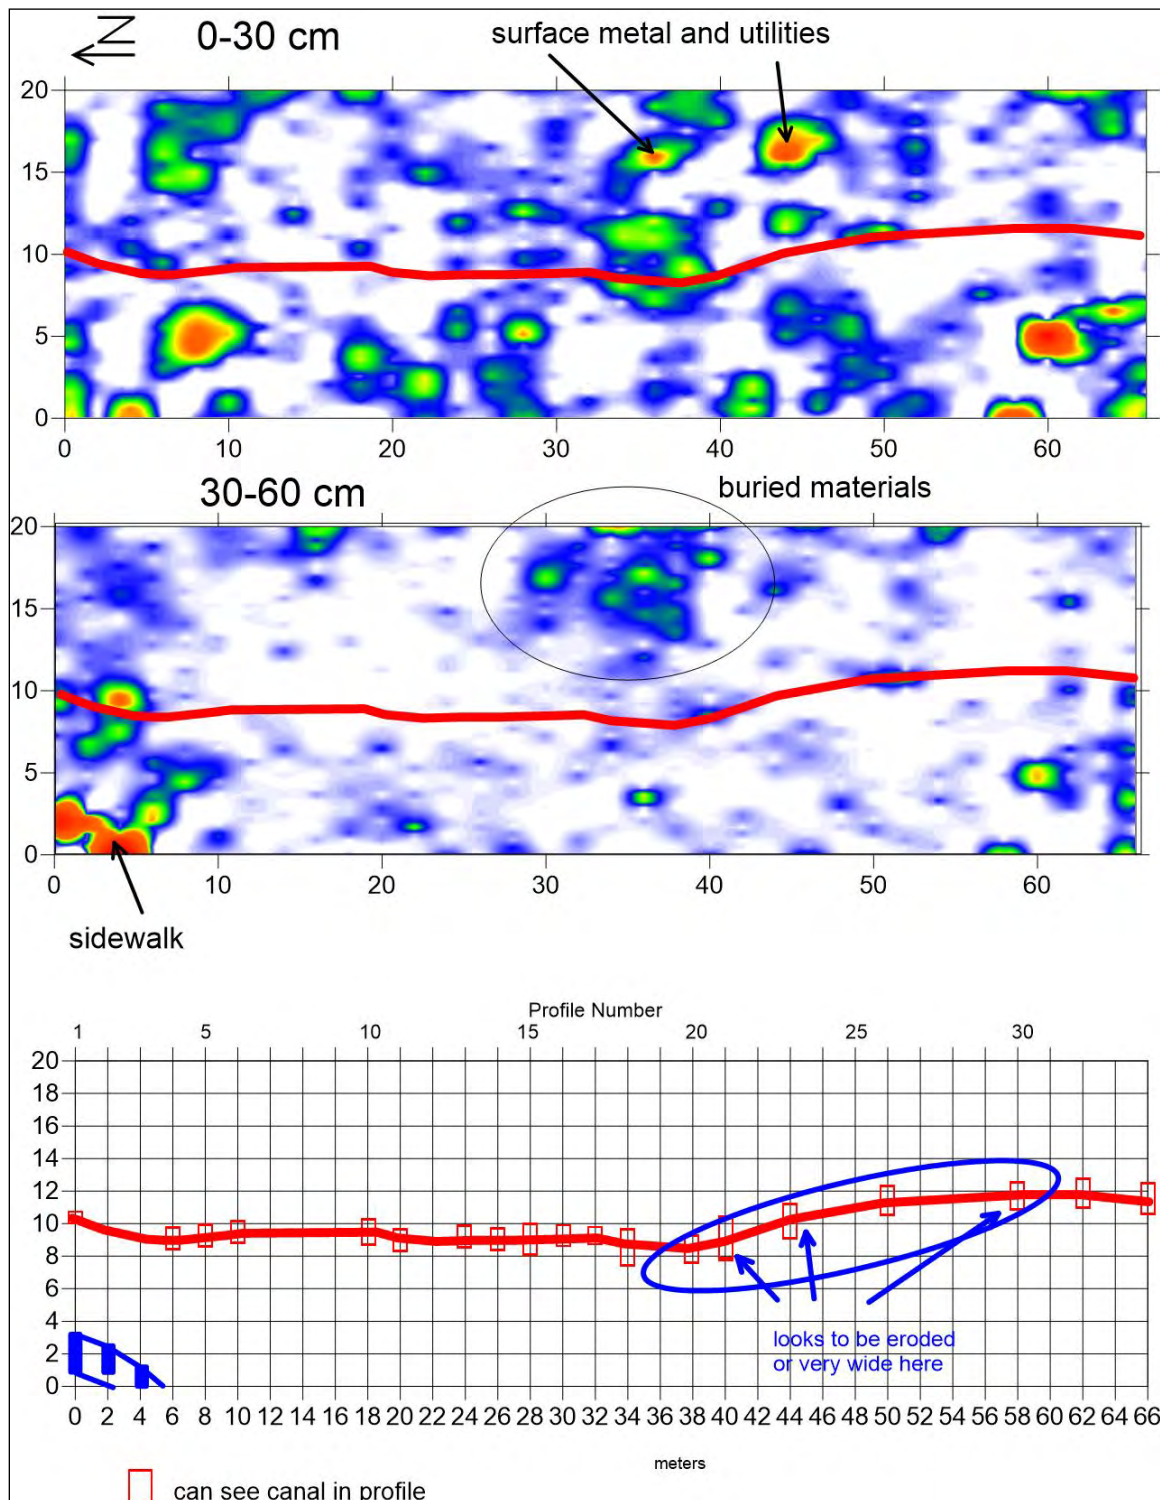
In the vicinity of the metal debris and other disruptions, the canal appears to be wider than elsewhere (Figure 9). Perhaps it was partially eroded here? Or am I seeing the results of digging and other excavations that have partially destroyed the canal in this area? It is difficult to know which. In Grid 1 the canal appears to be almost straight, and is only disturbed in the area where there is a good deal of metal and buried pipes (Figure 9). It trends directly into the walled backyard of the residence.

**Figure 9:** Amplitude maps and manual interpretation of profiles in Grid 1. The interpreted canal trend is shown in red.

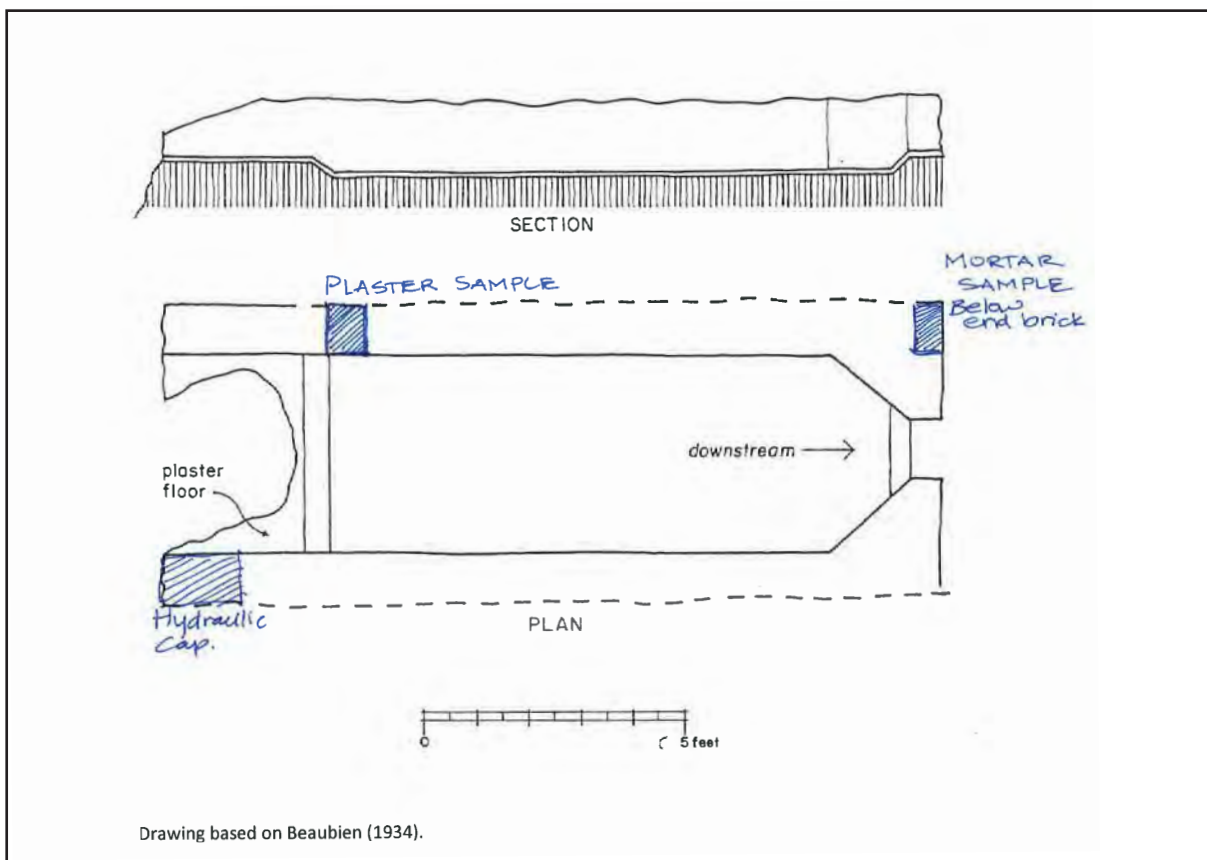
Figure 3: Plan of compuerta showing locations of samples and previous repair. (Map courtesy of NPS.)

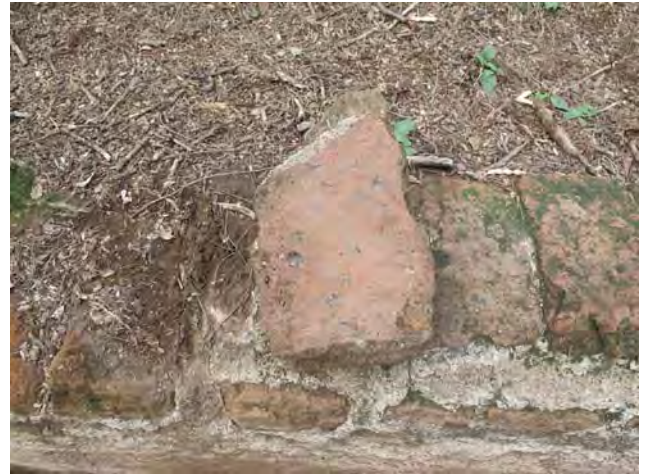
**Figure 5A:** Photo of plaster sample after turning it over to expose the plaster finish.

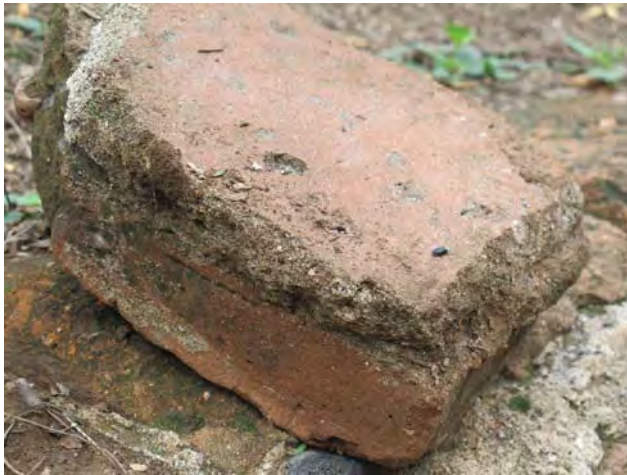
**Figure 5B:** Close-up photo of plaster sample.

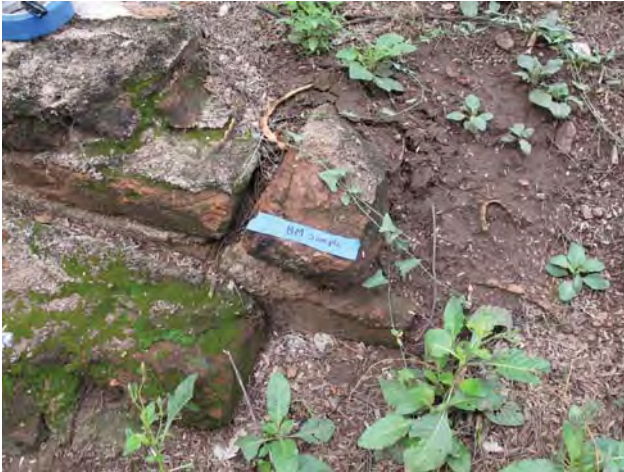
**Figure 6:** Photo of compuerta wall prior to removing the bedding mortar sample.

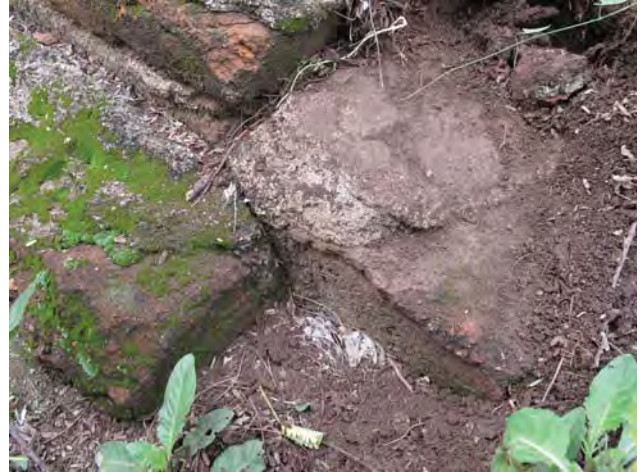
**Figure 7:** Photo of exposed bedding mortar after removing the brick above.

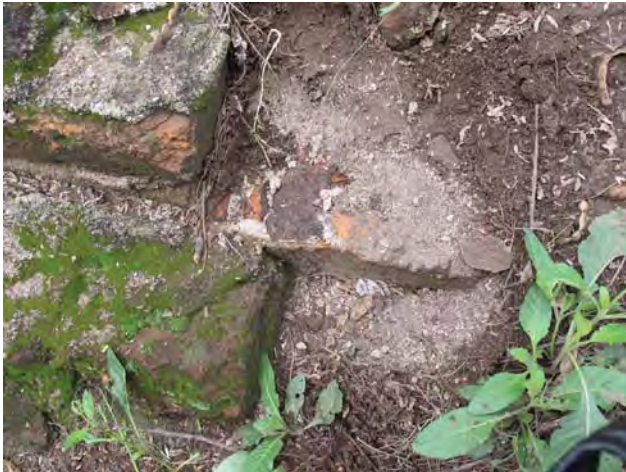
**Figure 8:** Photo of the bedding mortar extraction site after removal of the sample.

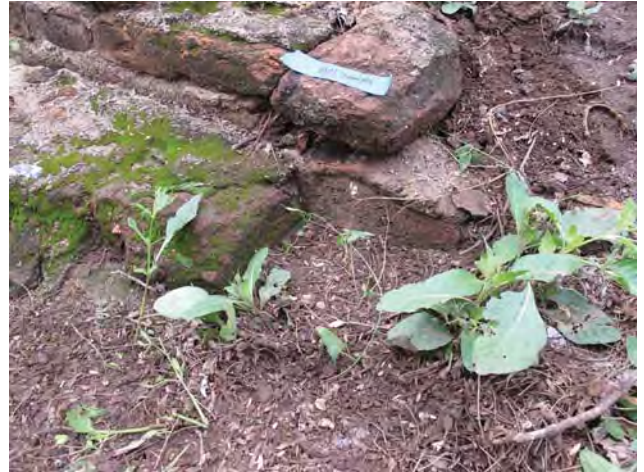
**Figure 9:** Photo of the compuerta wall after the mortar sample was removed.

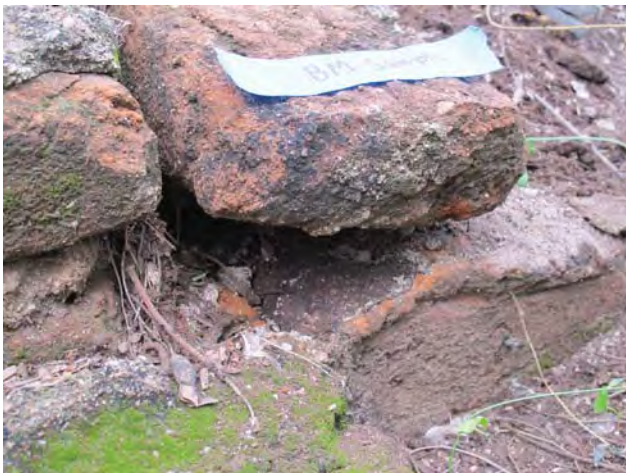
**Figure 10:** Close-up photo of extraction site.

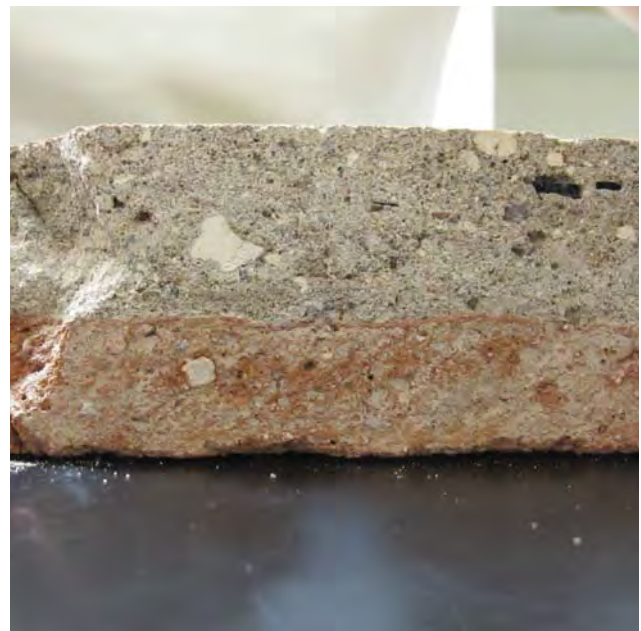
**Figure 22:** Original plaster with embedded brick surface finish (bottom)

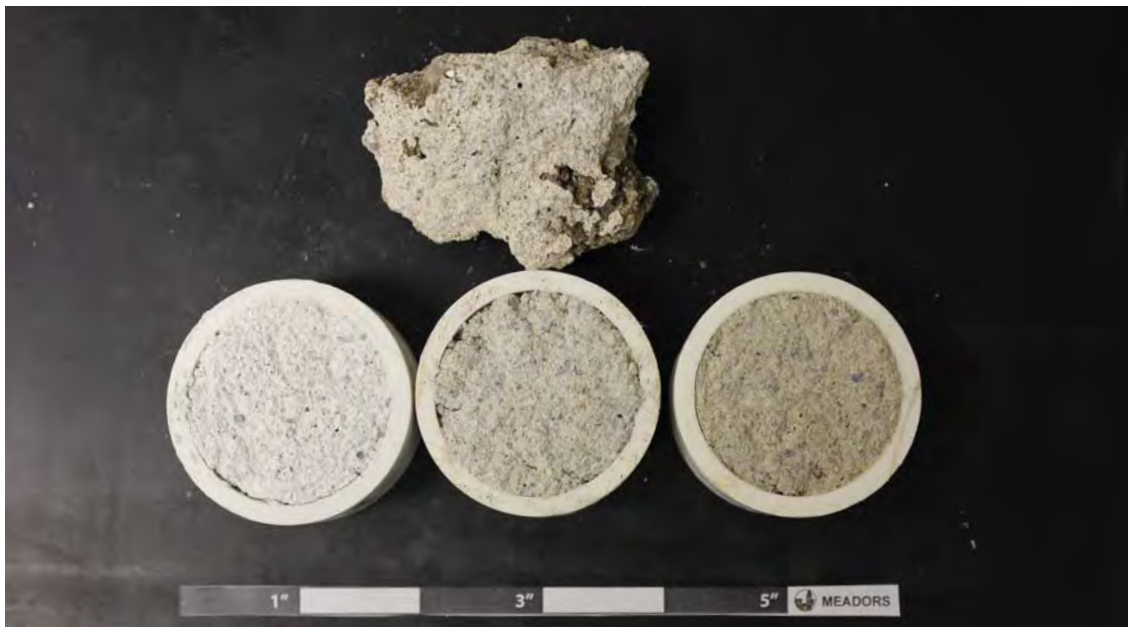
1-1/2 inch circular sample discs were made of Formulation B with varying amounts of yellow iron oxide pigment (red shade). Due to the buff to gray color of the Formulation B aggregate, very small proportions of pigment were selected for replication trials which included samples made with 1/256, 1/512, and 1/1024 parts pigment. The samples were left to cure for several days and then visually compared to the original material in order to obtain the following recommendations. Laitance was removed from the replication discs prior to color matching using a bristle brush.

**Figure 39:** Original mortar (top) with unpigmented replication mortar (left), 1/1024 parts pigmented mortar (middle), and 1/512 parts pigmented mortar (right).

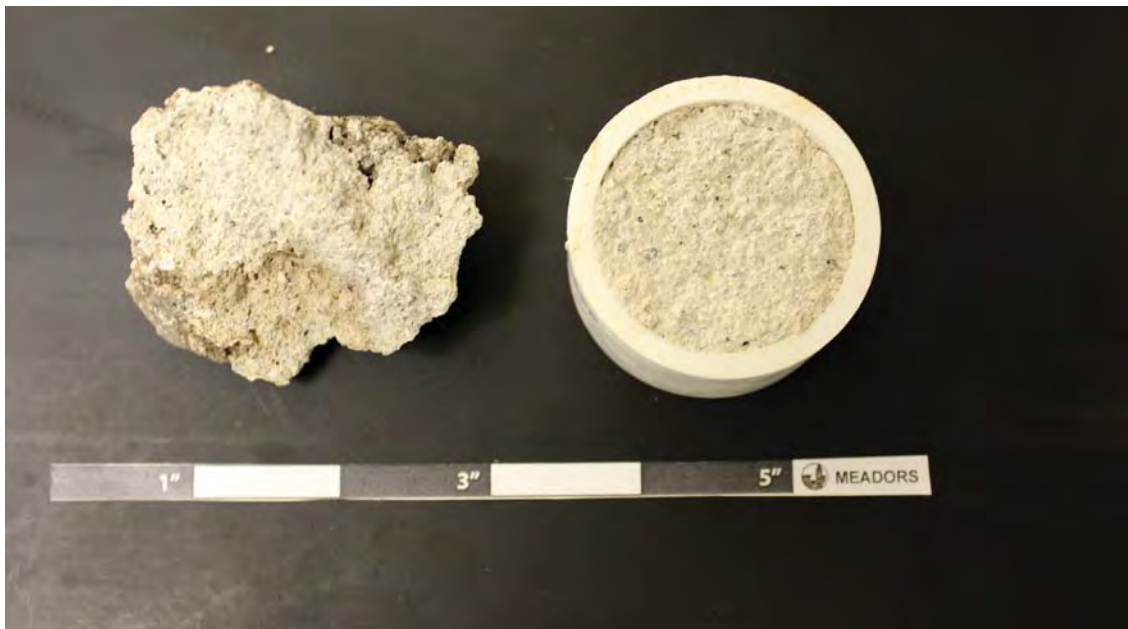
**Figure 40:** Original mortar with selected 1/512 parts pigment replication mix.

- 1/512 Parts Yellow Oxide Pigment-Red Shade (Yellow 6940 Pigment) (Bayferrox 940)  
Available from Edison Coatings in 1 lb. and 5 lb. containers as Dry Color Pak, 3 Northwest Drive, Plainville, CT 06062 (860-747-2220), <http://www.edisoncoatings.com/store/>

The required volume of pigment necessary to achieve the desired color may vary when combined with the aggregate. Cured samples should be compared to the original to ensure an aesthetic match. All parts for each specified mortar mix should be mixed by volume and not by weight. Dry ingredients should be well mixed prior to the addition of a water.

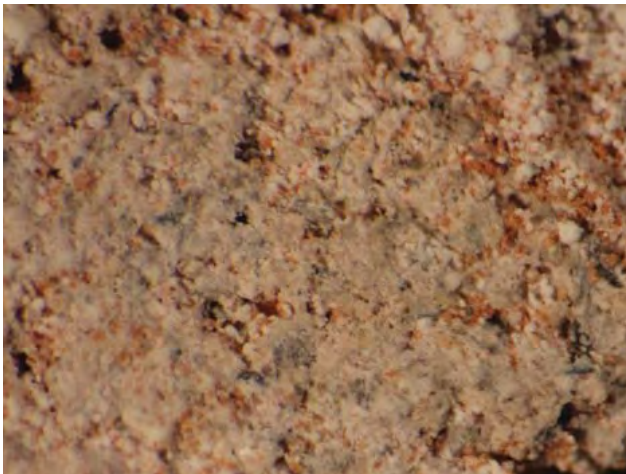
After 6 applications, it was apparent that all the limewashes imparted color to the original mortar to a varying degree. As expected, the wash with the highest proportion of brick dust caused the greatest change in chroma for both brick dust types. The 20% limewash formulation for brick dust A, the modern Mexican brick, was light pink in color and had a Munsell color code approximately 5YR 8/1 "white". The 20% limewash formulation of brick dust B, the historic Franciscan era brick, was also light pink in color and had a Munsell color code of 5YR 8/1 "white" (Figure 43). The applied washes did not match the original color of the plaster, which is light reddish brown in color with a Munsell color code approximately 2.5YR 6/3.

**Figure 43:** Formulation B plaster with 20% Historic Franciscan period brick dust limewash applied after 5 applications. Samples using either brick were identical in color (Munsell color code of 5YR 8/1 “white”) and texture. Note: Light dispersion of brick dust with inconsistent deposition (upper right). (30x magnification, Reflected/Quartz Halogen)

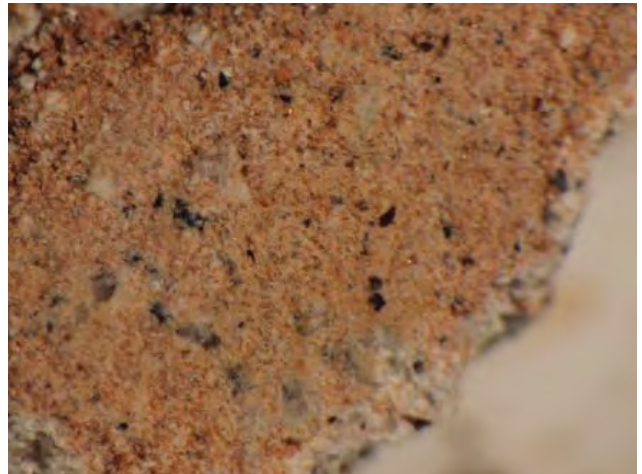
Based upon the available evidence and test samples prepared in the laboratory it is likely that the pigmented finish along the plaster surface was a burnished brick wash finish applied in a fresco fashion (Figure 44). The following recommendations are based upon historic research texts currently available and have not been extensively tested in the laboratory. However, locally based research not readily available to Meadors may provide more appropriate insight into historic surface finish techniques and regionally used application methods.

**Figure 44:** Mexican brick fresco sample. Samples using either brick were identical in color (Munsell color code of 5YR 7/4 “pink”) and texture. Note: Even distribution of brick dust and darker appearance than limewash. (30x magnification, Reflected/Quartz Halogen)

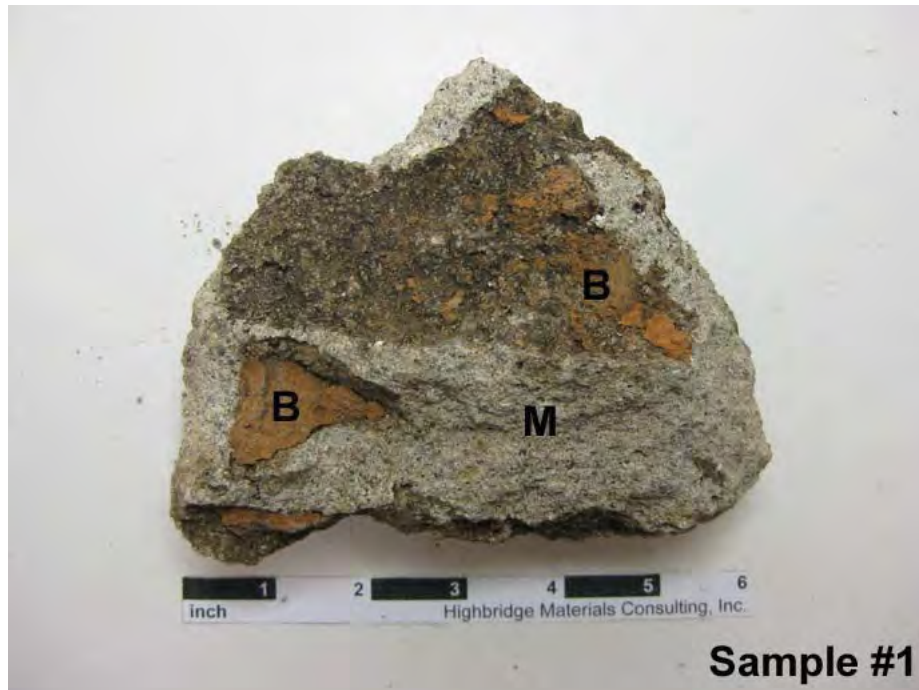
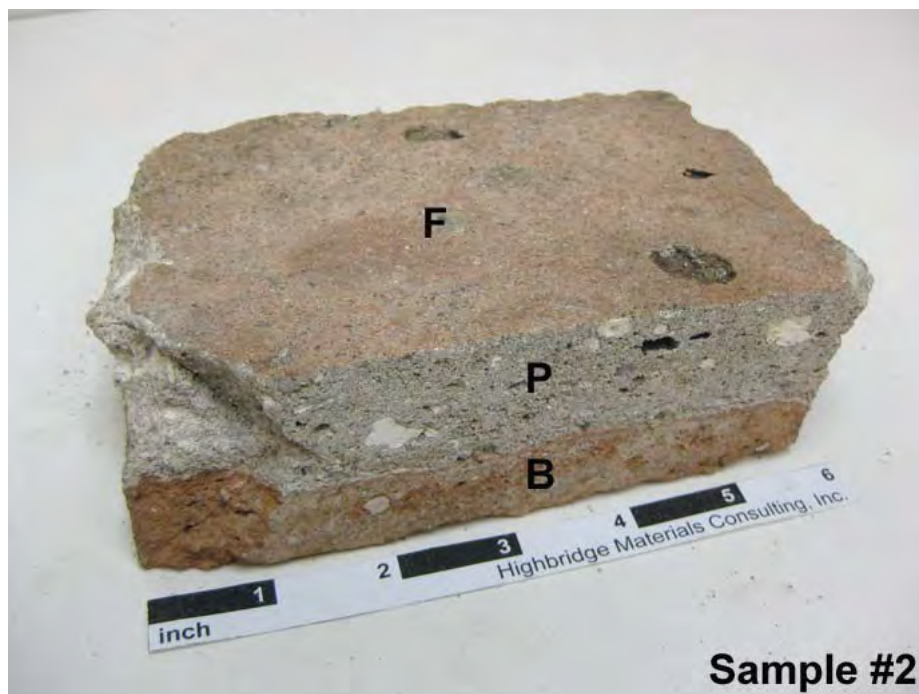
**Figure 1:** Photographs of the two as received by Highbridge for examination. Sample #1 consists of mortar (M). Several pieces of adherent brick (B) are included with the sample. Sample #2 consists of a thick plaster (P) well compacted against a brick substrate (B). The plaster has a float-type finish (F) and a pinkish pigmentation.

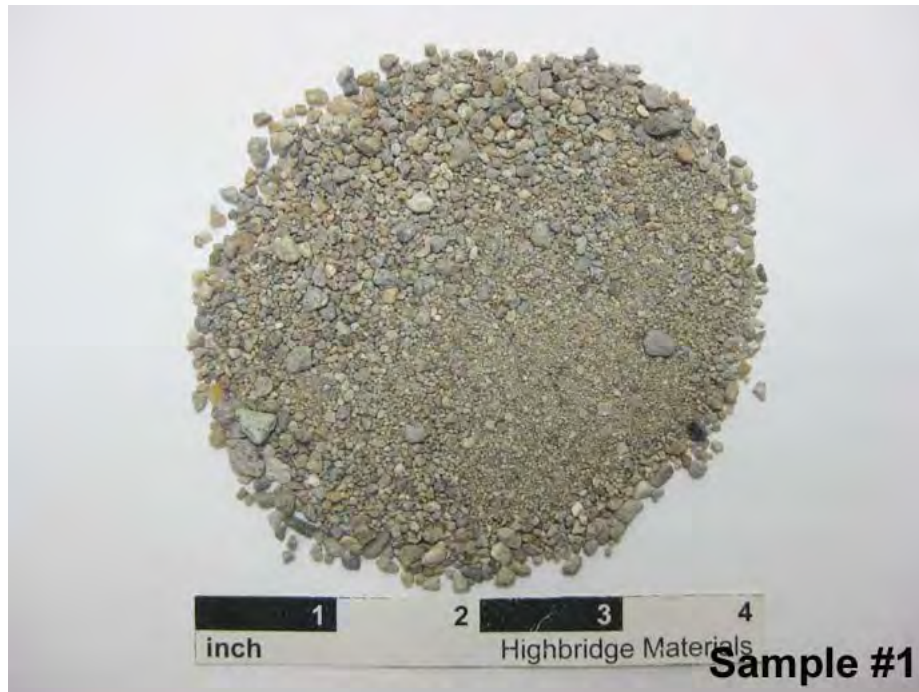
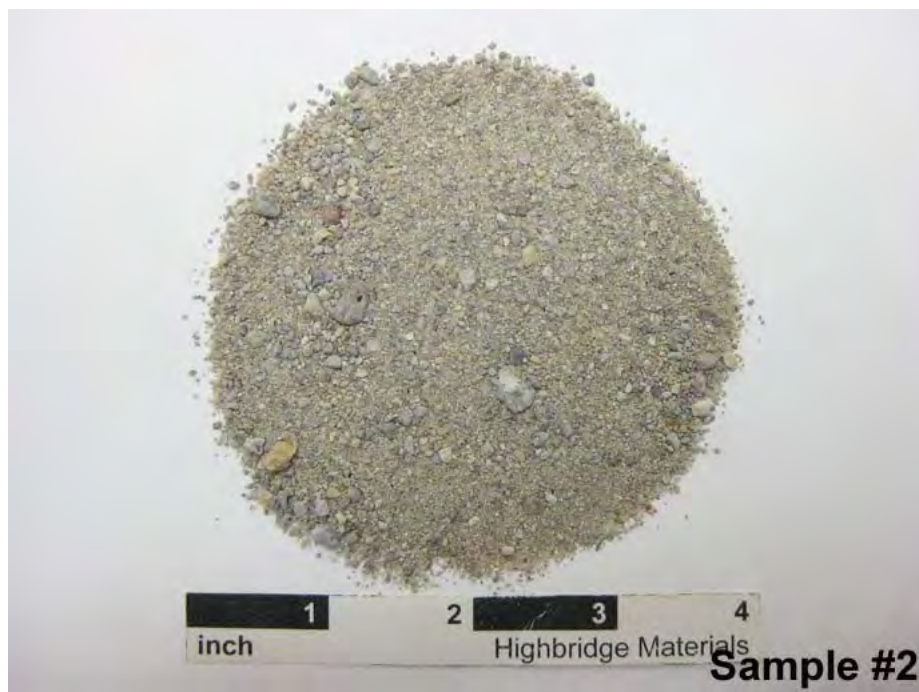
**Figure 2:** Photographs of the sand extracted from the two samples by acid digestion. Both are dull-lustered and opaque with a reddish gray color. The sand is composed largely of volcanic particles. The original sand may have been somewhat darker assuming that the surfaces have been etched due to reaction with the lime binder.

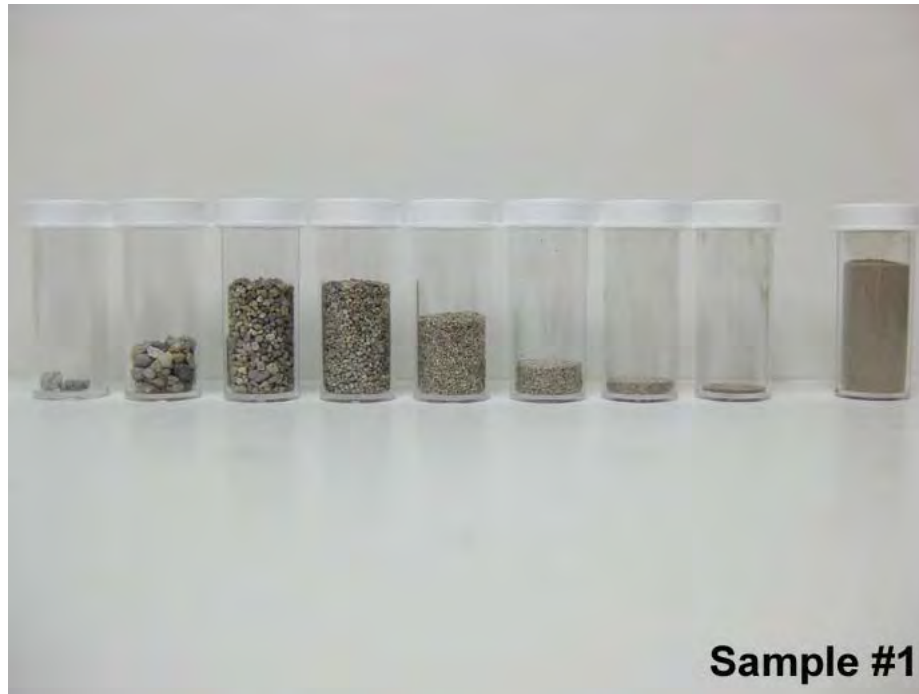
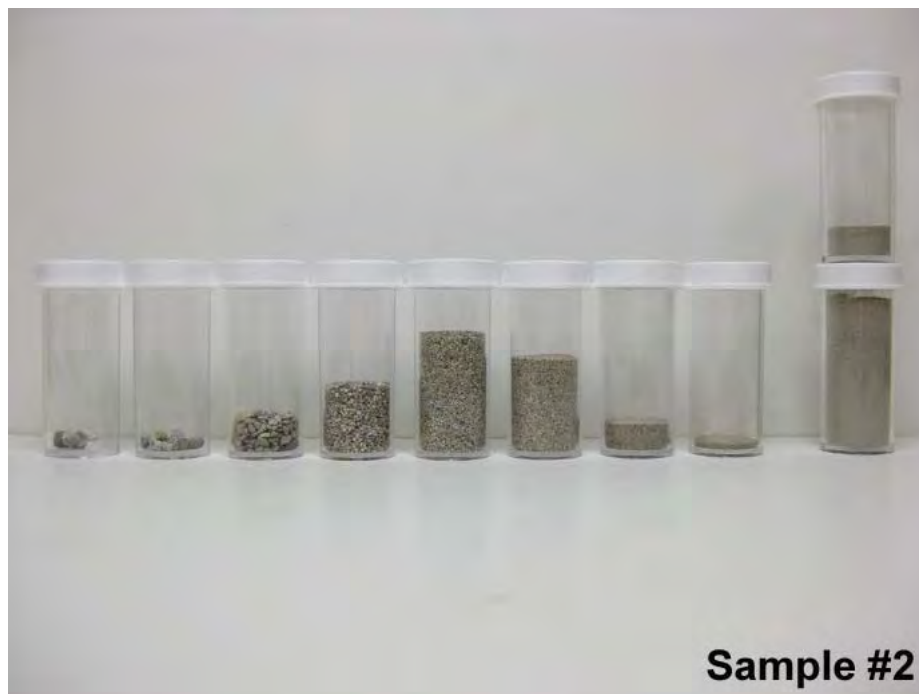
**Figure 3:** Photographs of the sand extracted from the two samples by acid digestion after gradation through a standard sieve stack. Particle size distributions are broad for both though the sand in Sample #1 is coarser-grained. The vials set aside to the right in each image represent fines passing a No. 325 sieve. Though some of this may represent undigested silica from the binder, much of it is volcanic rock fragments and glass. This may simply represent unwashed clay-sized fines from the sand source. Alternatively, these may represent a separate natural trass addition.

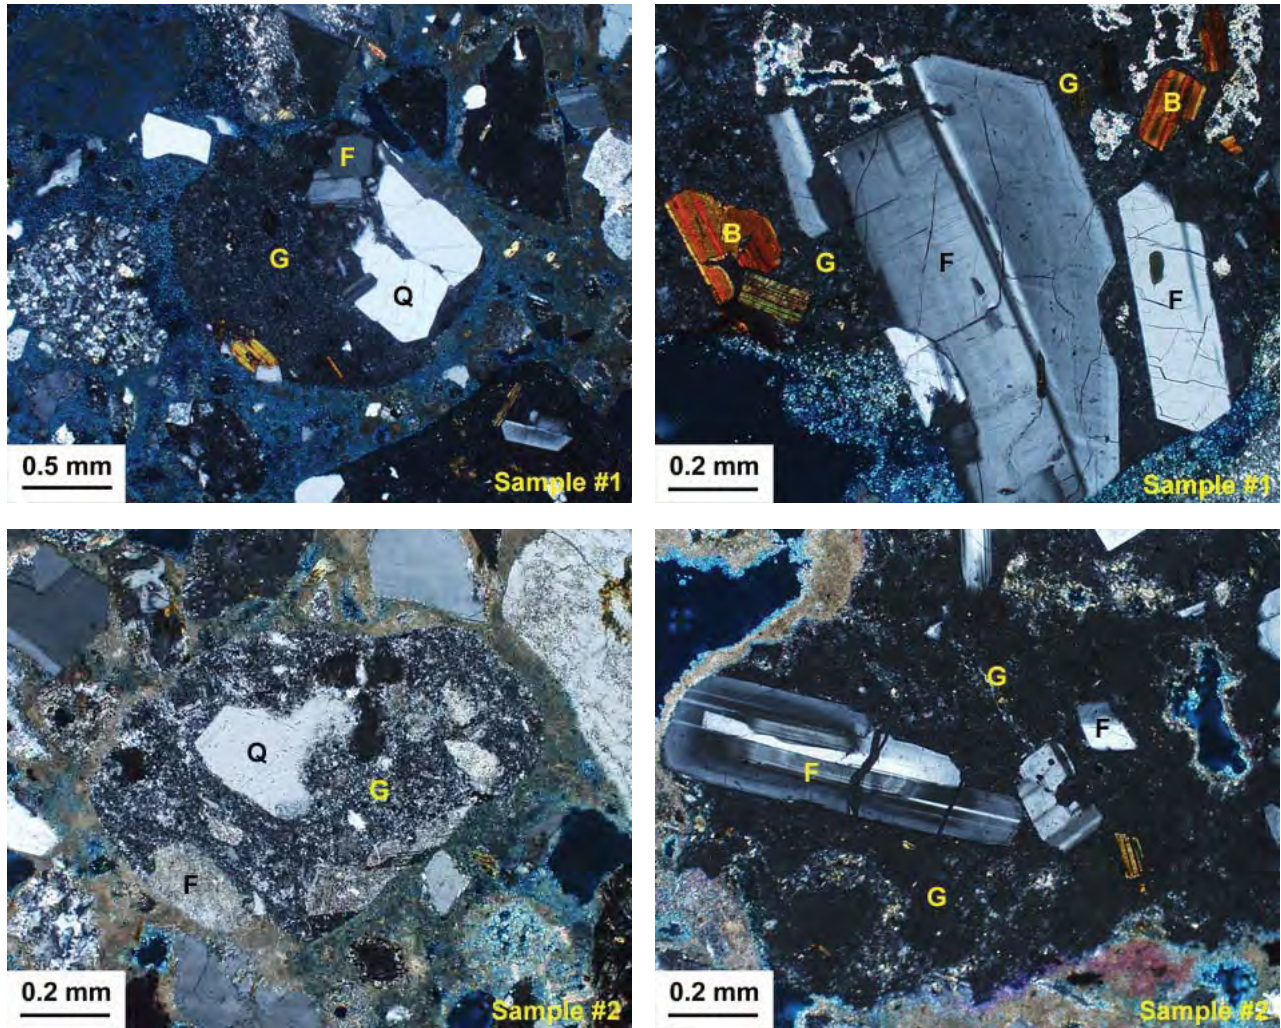
**Figure 4:** XPL photomicrographs. The sand in both samples is highly varied though most represent sediments derived from intermediate to somewhat acidic volcanic rocks. Dacite grains are shown at upper and lower left for each sample. The groundmass (G) consists mostly of very fine-grained feldspar though some glass is likely present. Phenocrysts include quartz (Q) and plagioclase feldspar (F). An andesite grain is shown at upper right for Sample #1. Again, a groundmass (G) of fine-grained feldspar is predominant. Phenocrysts include plagioclase feldspar (F) and biotite mica (B). The grain shown at lower right may also be andesitic rather than dacitic with feldspar (F) as the primary phenocrysts. In this case, the groundmass (G) is composed almost entirely of glass.

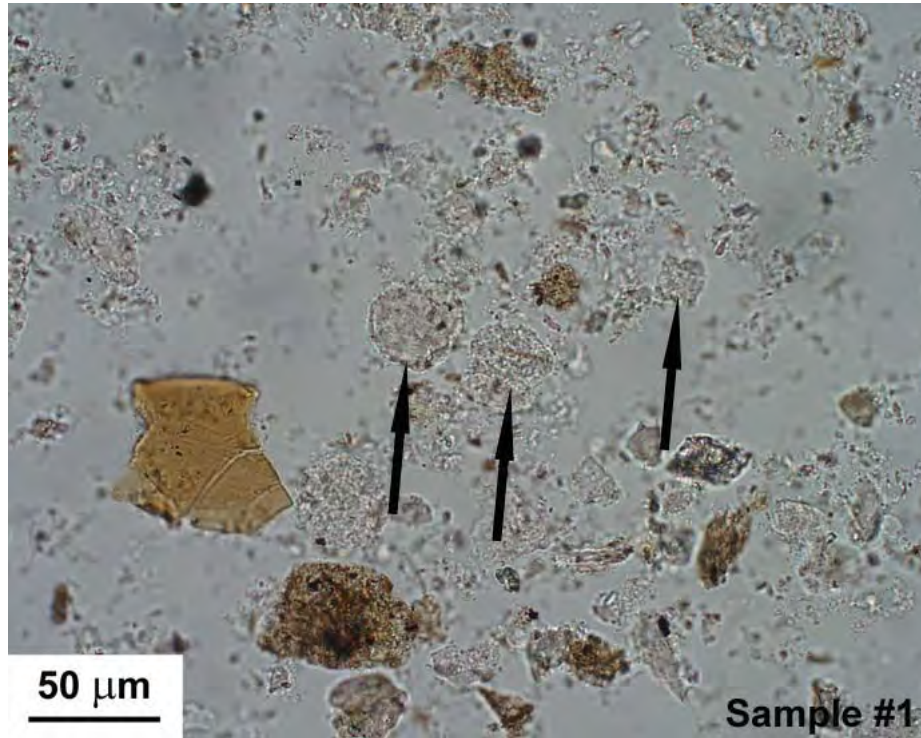
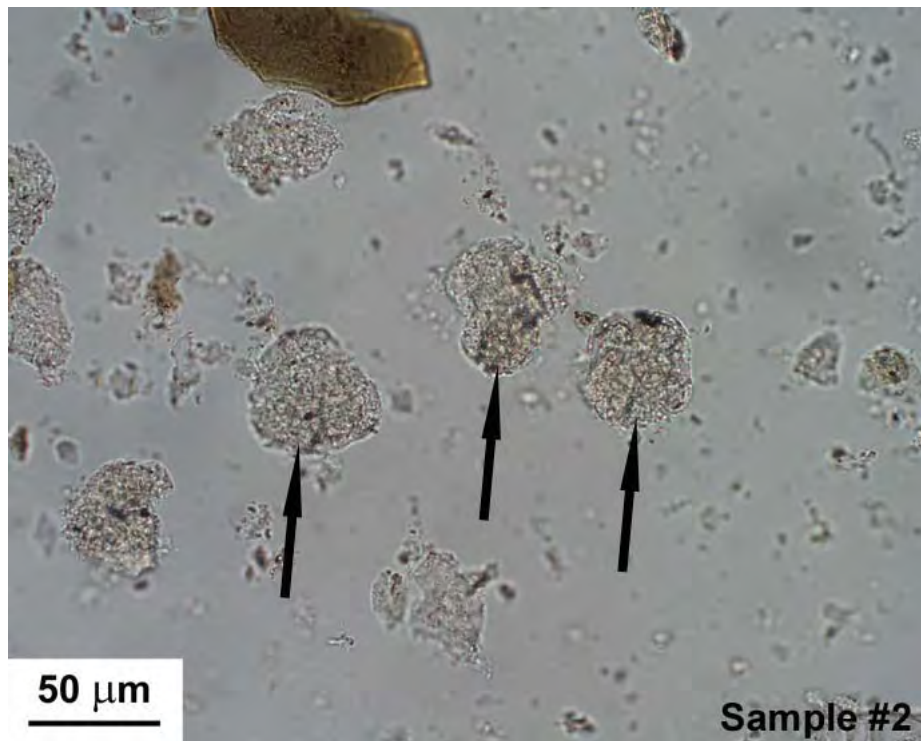
**Figure 5:** PPL photomicrographs of powder mount specimens prepared from the fines extracted through acid digestion. The arrows indicate fine particles of volcanic glass that represent a major portion of the finest fraction. Refractive indices are approximately 1.50 indicating a high silica content and this would be expected to result in a higher pozzolanic potential.
