# **PRESERVATION PLAN**

## **ACEQUIA AND COMPUERTA**

### **TUMACÁCORI NATIONAL HISTORICAL PARK**

In conjunction with:  
Desert Southwest Cooperative Ecosystem Studies Unit (DS-CESU)  
June 2014

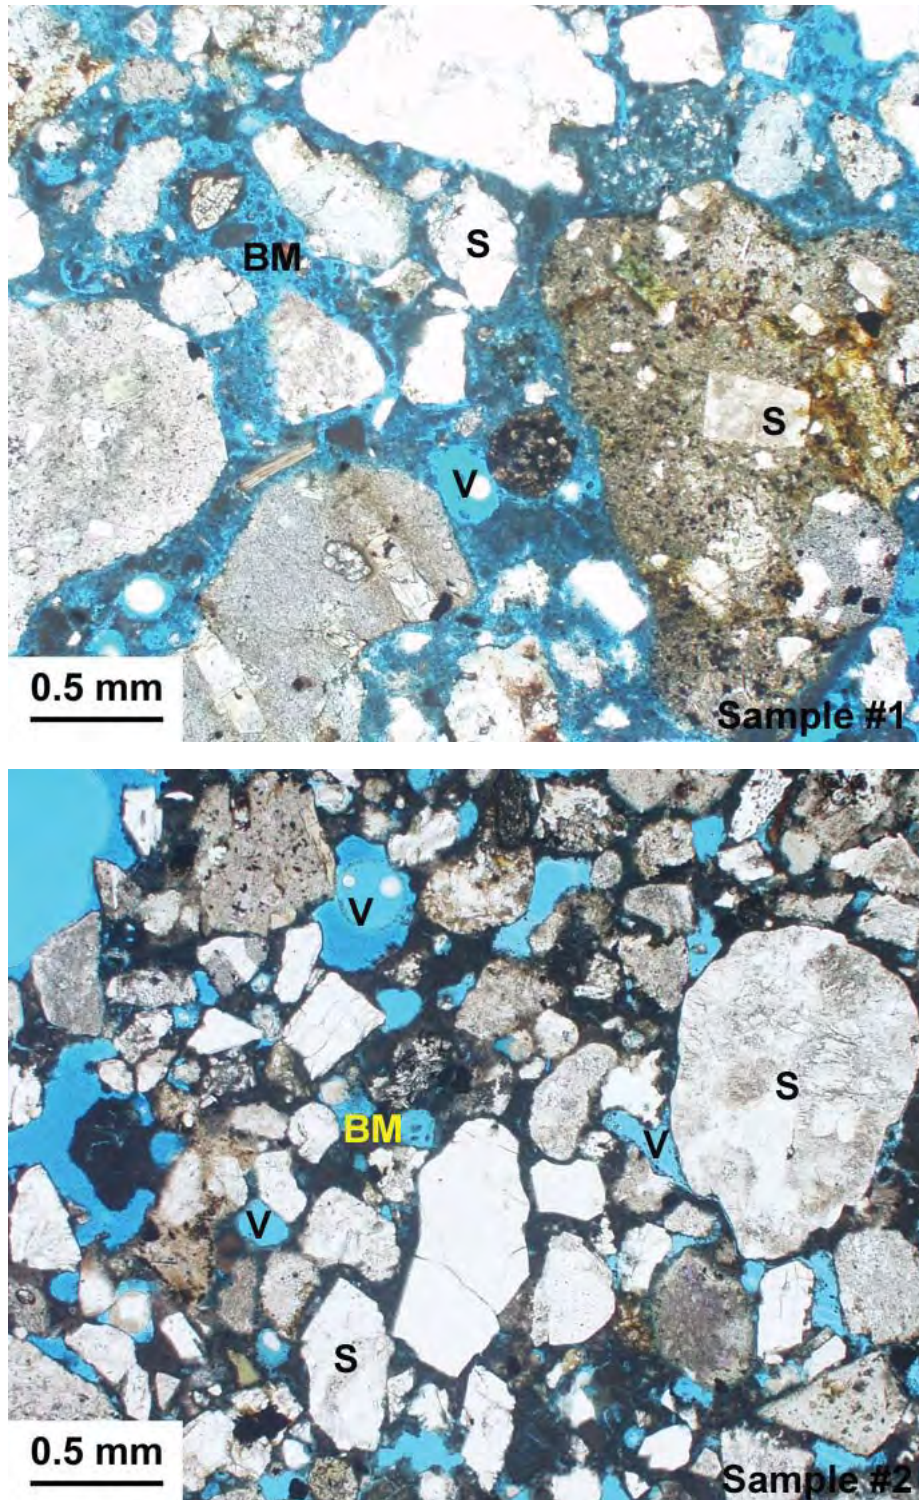
**Figure 6:** PPL photomicrographs illustrating the overall microtexture of the two examined samples. Both samples are impregnated with a low-viscosity, blue-dyed epoxy in order to highlight cracks, pores, and voids. The capillarity porosity of the binder matrix (BM) may be judged by the intensity of absorbed epoxy. Note that both have higher porosities typical of high lime mortars though Sample #2 is somewhat denser. Sand grains (S) are densely distributed in both samples reflecting the higher sand contents. Note the coarser grain size in Sample #1. The tight packing in Sample #2 leaves air-voids (V) at the interstitial space between some sand particles. Consolidation is not as well achieved in this sample. Voids are well distributed and not deformed between sand particles in Sample #1. The consolidation is more complete in this sample.

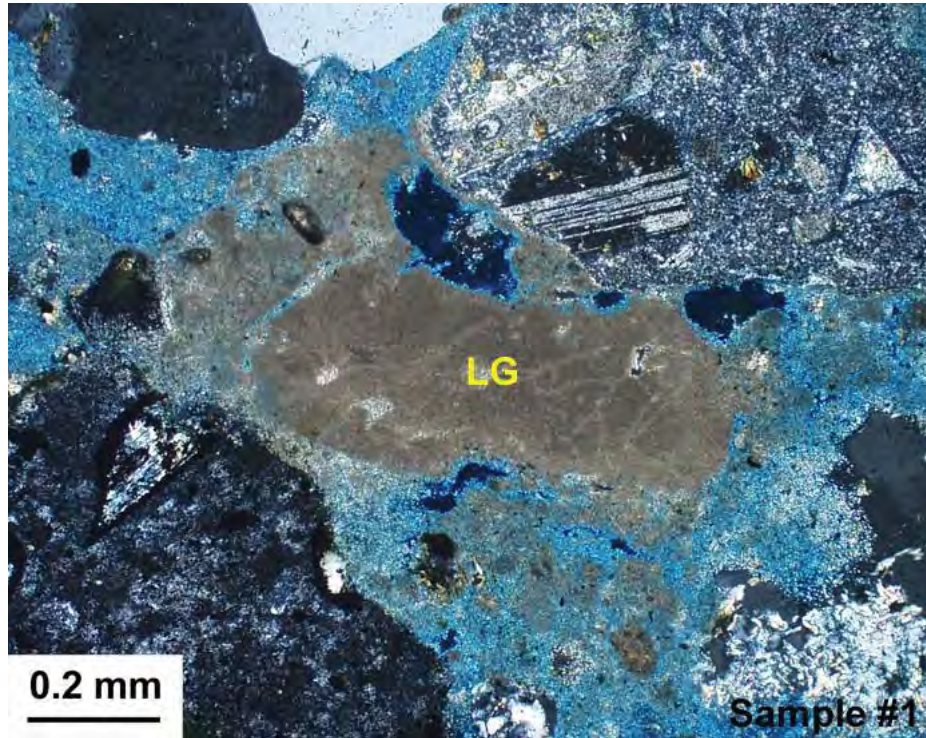
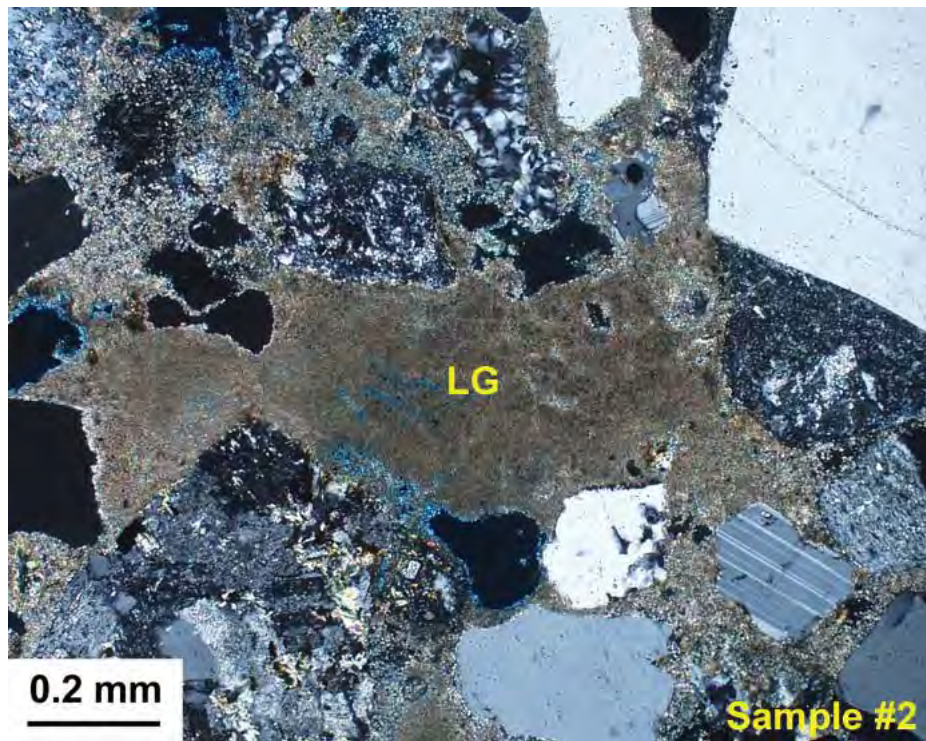
**Figure 7:** XPL photomicrographs illustrating the texture of most lime grains (LG) in both samples. The golden color indicates full carbonation of the lime. Most particles are non-descript and relatively fine-grained. The source of the lime is not revealed in these more abundant grains.

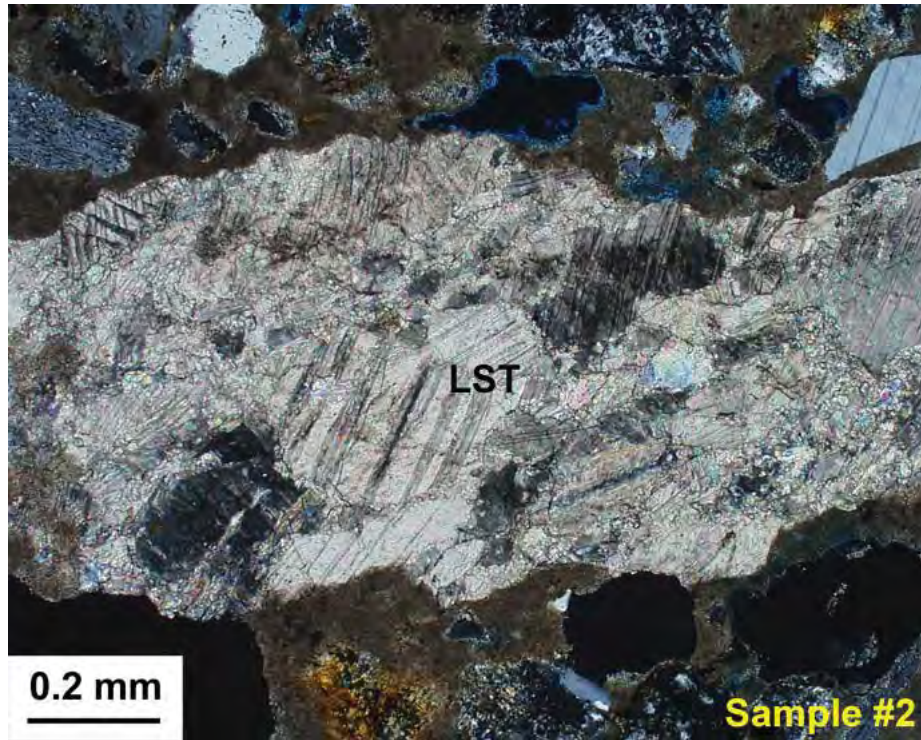
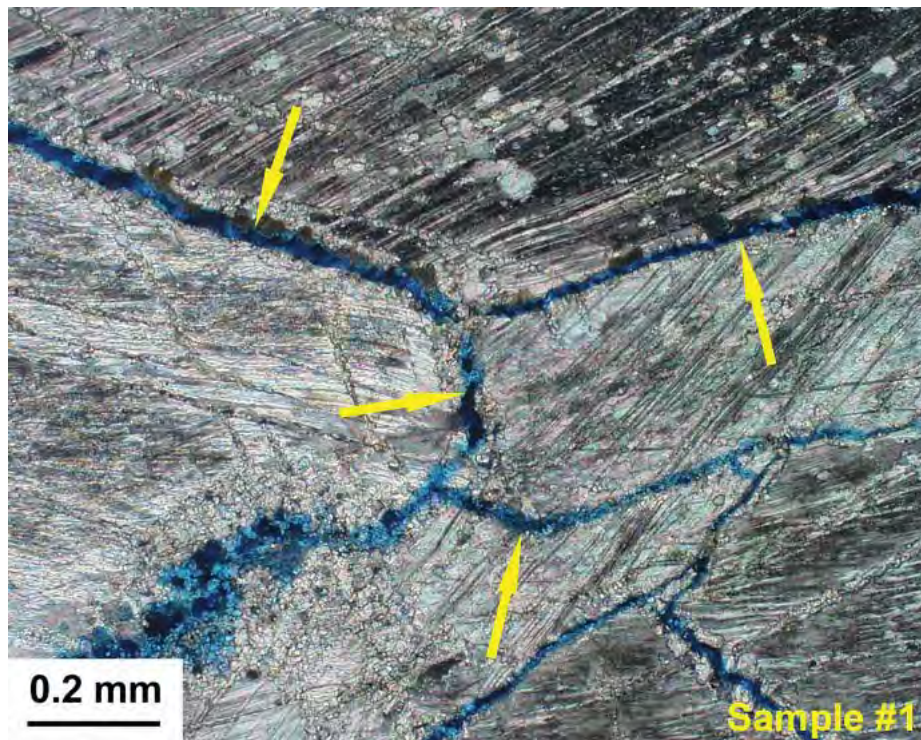
**Figure 8:** XPL photomicrographs illustrating grains revealing the lime source in both samples. (Upper image) A limestone particle (LST) is interpreted to represent an unburned portion of the lime. No burn texture is identified in this particular grain. The limestone consists primarily of calcite with trace quartz. The texture is indicative of mild geological deformation. (Lower image) A similar limestone grain is shown for Sample #1. Bent twin planes and subgrains along shear bands are again features related to geological strain. In this case, disaggregation has begun along grain boundaries and shear bands (arrows). This is produced by thermal expansion and this particular grain is determined to have been lightly burned.

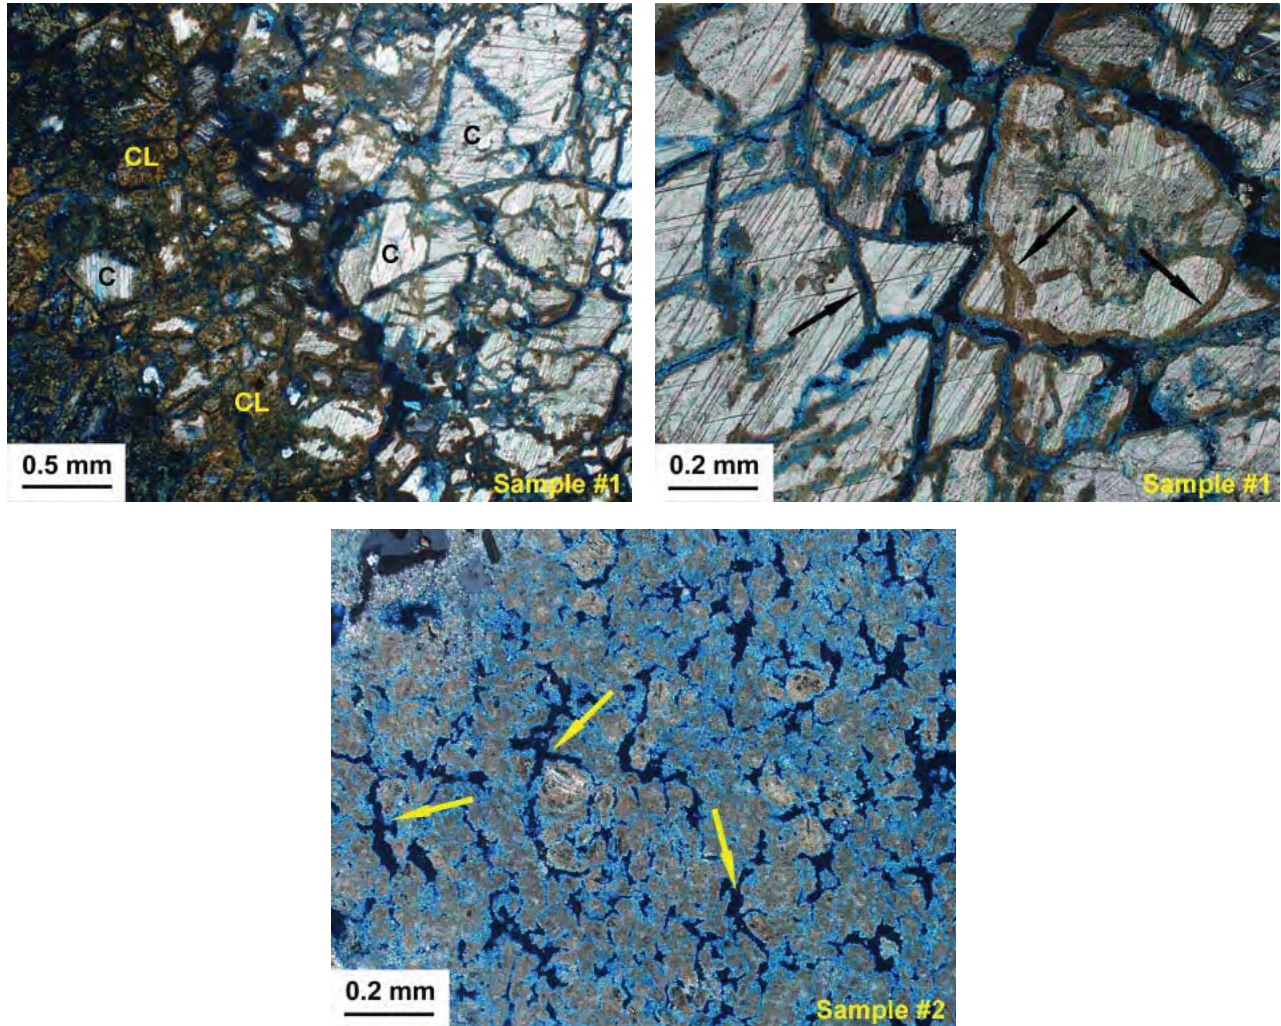
**Figure 9:** XPL photomicrographs illustrating lime grains that have undergone a greater degree of calcination than those shown in the last figure. (Upper left) The interior is shown of a large lime particle. Unburned calcite (C) appears cream-colored and carbonated lime (CL) appears a darker brown. Note that the left side of the grain was more completely calcined and this represents the outer core of the lime particle. Free lime was originally developed and this has since carbonated in situ. (Upper right) A close-up is shown of the less burned interior of the same grain. The arrows indicate disaggregation fractures formed during calcination along pre-existing grain boundaries and shear bands. Note that these fractures are lined with carbonated lime. Calcination has occurred first along the fracture openings. (Lower image) A completely burned and carbonated lime grain is shown. However, the original disaggregation fractures can still be observed (arrows). No unburned calcite is left within this particular grain.

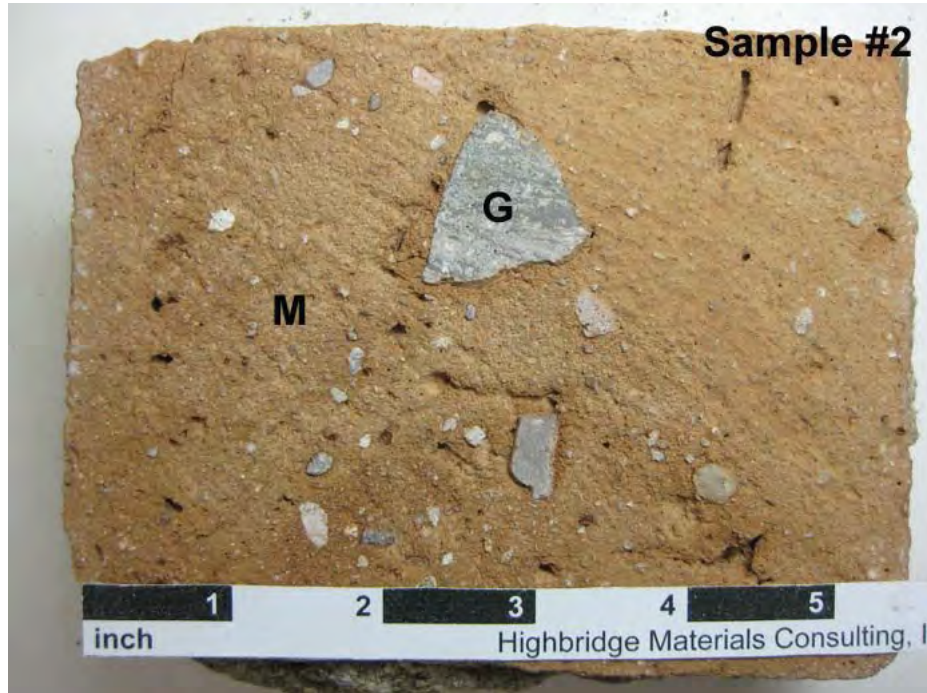
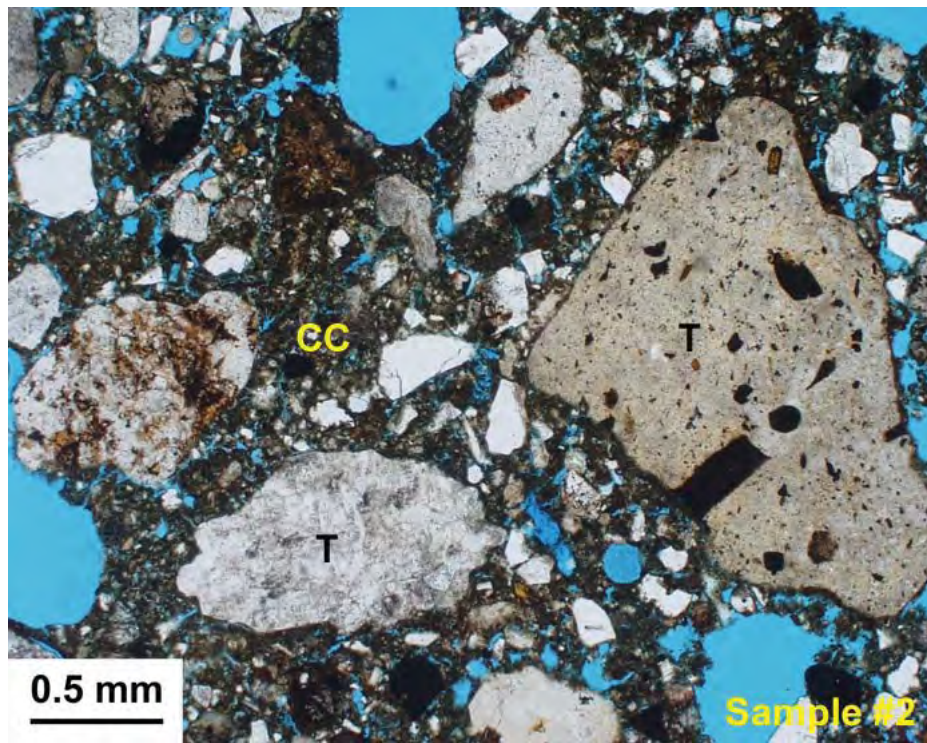
**Figure 10:** (Upper image) The saw-cut brick surface underlying the plaster sample is shown. The brick has a reddish clay matrix (M) and a minor amount of coarse grog (G). (Lower image) PPL photomicrograph illustrating the brick microtexture in Sample #2. The brick contains an abundance of volcanic temper (T) encased in a matrix of calcined clay (CC). The volcanic grains are mostly similar to those observed in the mortar aggregate.

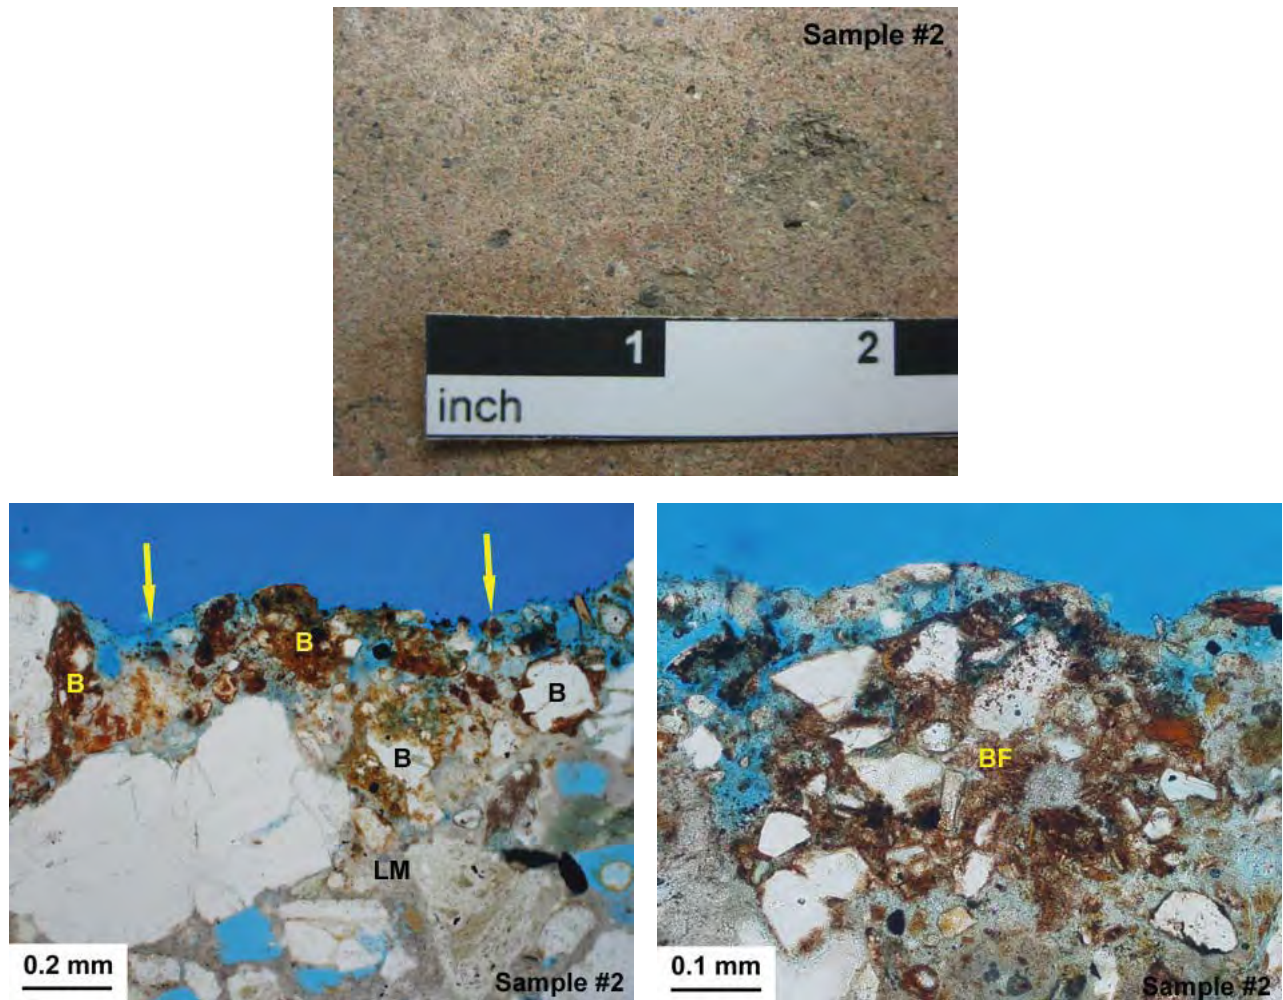
**Figure 11:** (Upper image) A close-up photograph illustrates the plaster finish surface. The finish has a slightly sandy, float-type texture and a pink pigmentation. (Lower left) PPL photomicrograph taken with a condenser lens inserted in the light path. The arrows indicate the outer surface of the plaster. Brick dust and fine fragments (B) are embedded in the lime mortar (LM). These brick fragments are responsible for the pigmentation and may also provide some weather-resistance assuming they have a pozzolanic property. (Lower right) PPL photomicrograph. A close-up is shown of one the coarser-grained brick fragments (BF) used for the plaster finish.
