**HERMIT'S REST
GRAND CANYON NATIONAL PARK**

THE UNIVERSITY OF ARIZONA
PRESERVATION STUDIES PROGRAM
COLLEGE OF ARCHITECTURE AND
LANDSCAPE ARCHITECTURE

DECEMBER 2007

ROOF PLAN
DEFICIENCIES

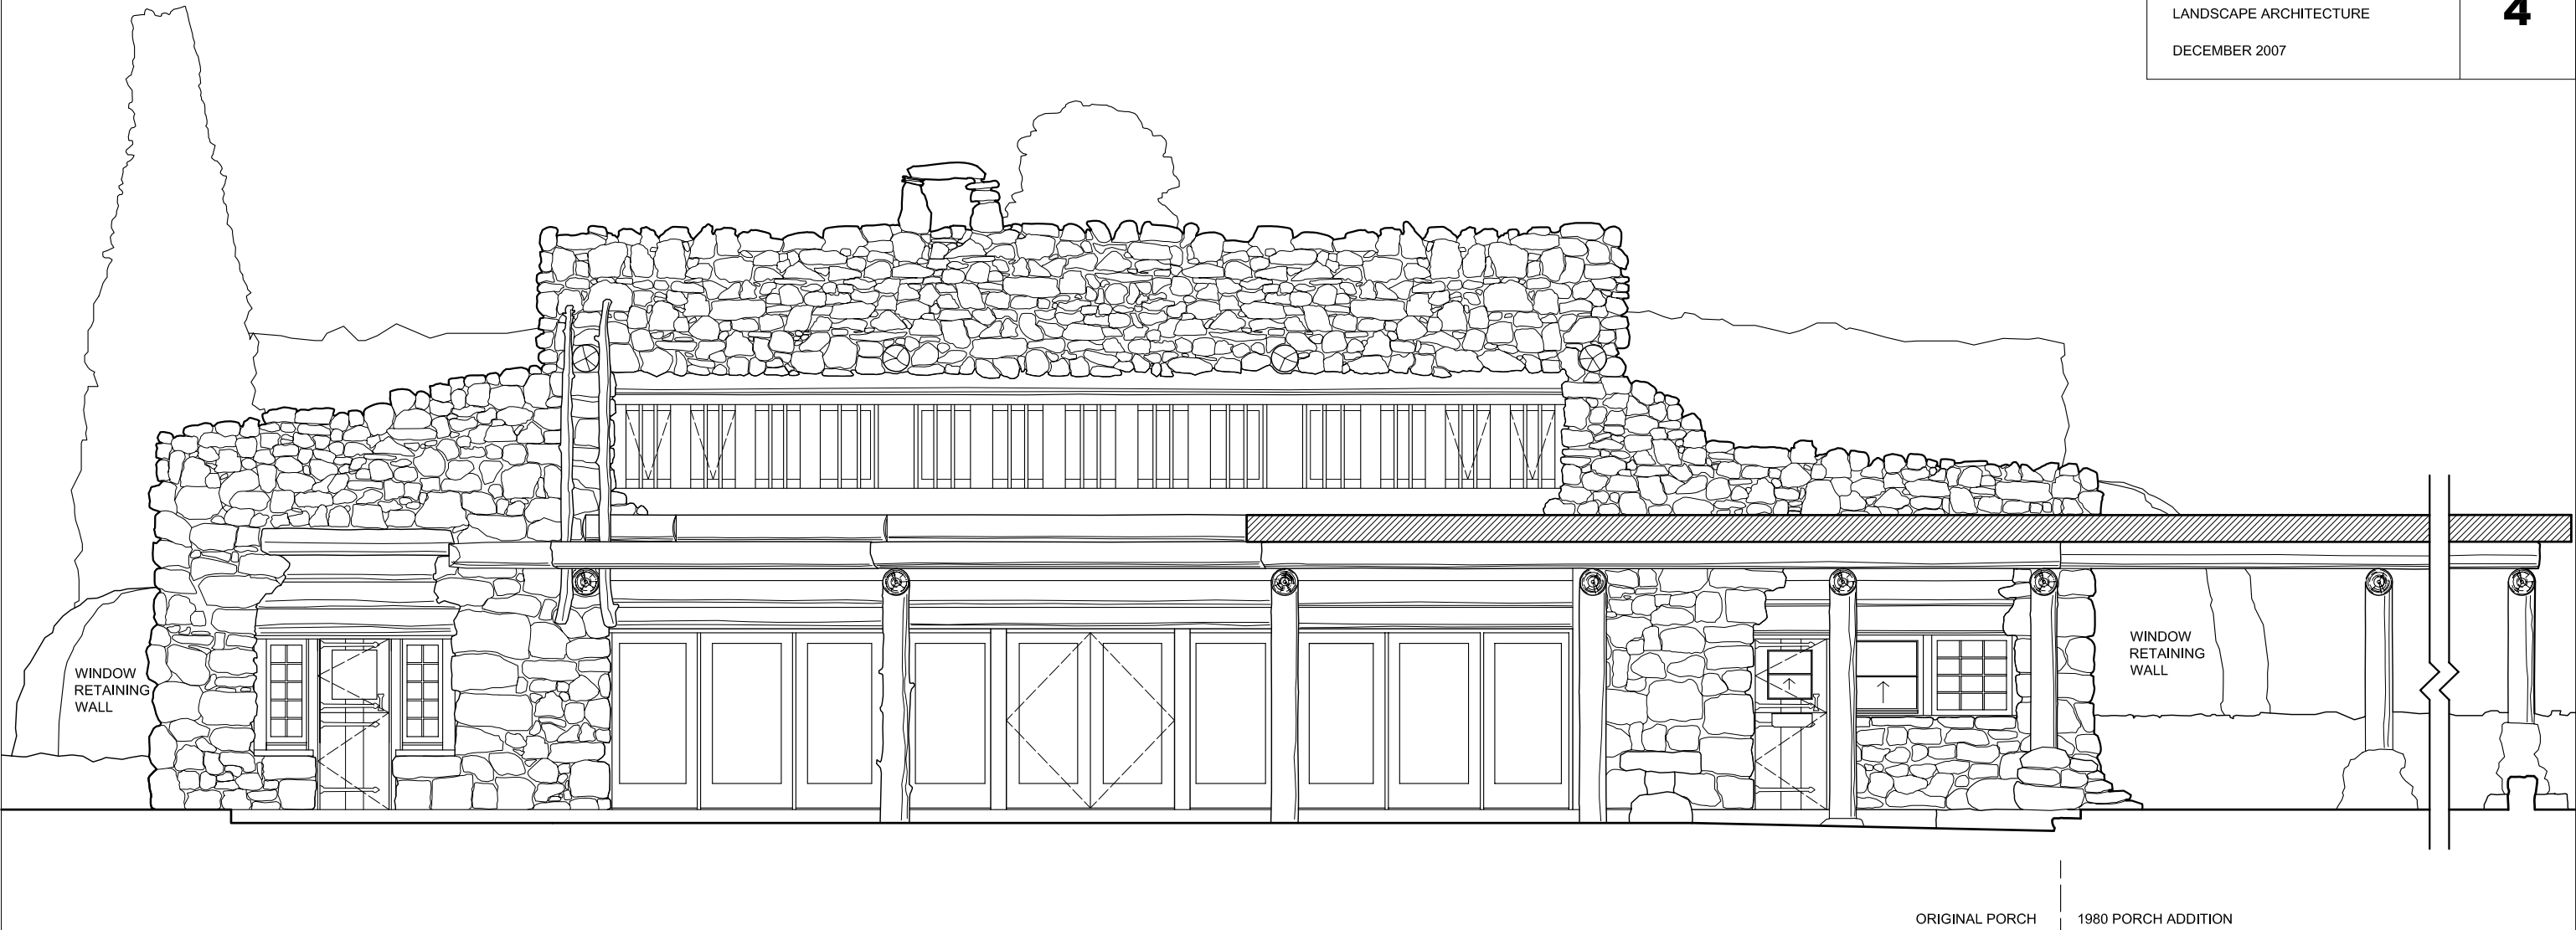
EAST ELEVATION

①	Tar applied between stones under clerestory windows. See FIG. E34.
②	Excessive and/or incompatible mortar applied to stone. See FIGS. E10, E18, E19, E32.
③	Excessive epoxy applied at ends of porch roof beams. See FIG. E23.
④	Porch posts and stone bases not anchored. See FIG. E16.
⑤	Excessive putty between mullion and glass on east window. See FIG. E51.
⑥	Historic bark beetle damage to fascia on porch roof. See FIG. E23.
⑦	Lichen present on stone. See FIG. E6.
⑧	Displaced stones at the base of the north retaining wall. See FIGS. E16, E17.
⑨	Decayed wood members, including vigas and porch beams, caused by moisture. See FIGS. E23, E24, E36.
⑩	Sheet metal installed over wood vigas and porch beams likely traps moisture. See FIG. E36.

⑪	Paint worn on wood members. See FIGS. E48, E54.
⑫	Porch posts do not rest on above-grade footings. See FIGS. E5, CD3 in Chronology of Development section.
⑬	Mortar applied on top of stone roof lookout with unknown purpose. See FIGS. E12, E13.
⑭	Secondary Room chimney missing stones/mortar creating holes. See FIG. E10.
⑮	Lack of animal-proof screen on Great Room chimney (unless present inside chimney). See FIG. E11.
⑯	Unsecured wire mesh over Secondary Room chimney. See FIG. E10.
⑰	Improper drainage channels, unsightly and in poor condition. See FIG. E52.

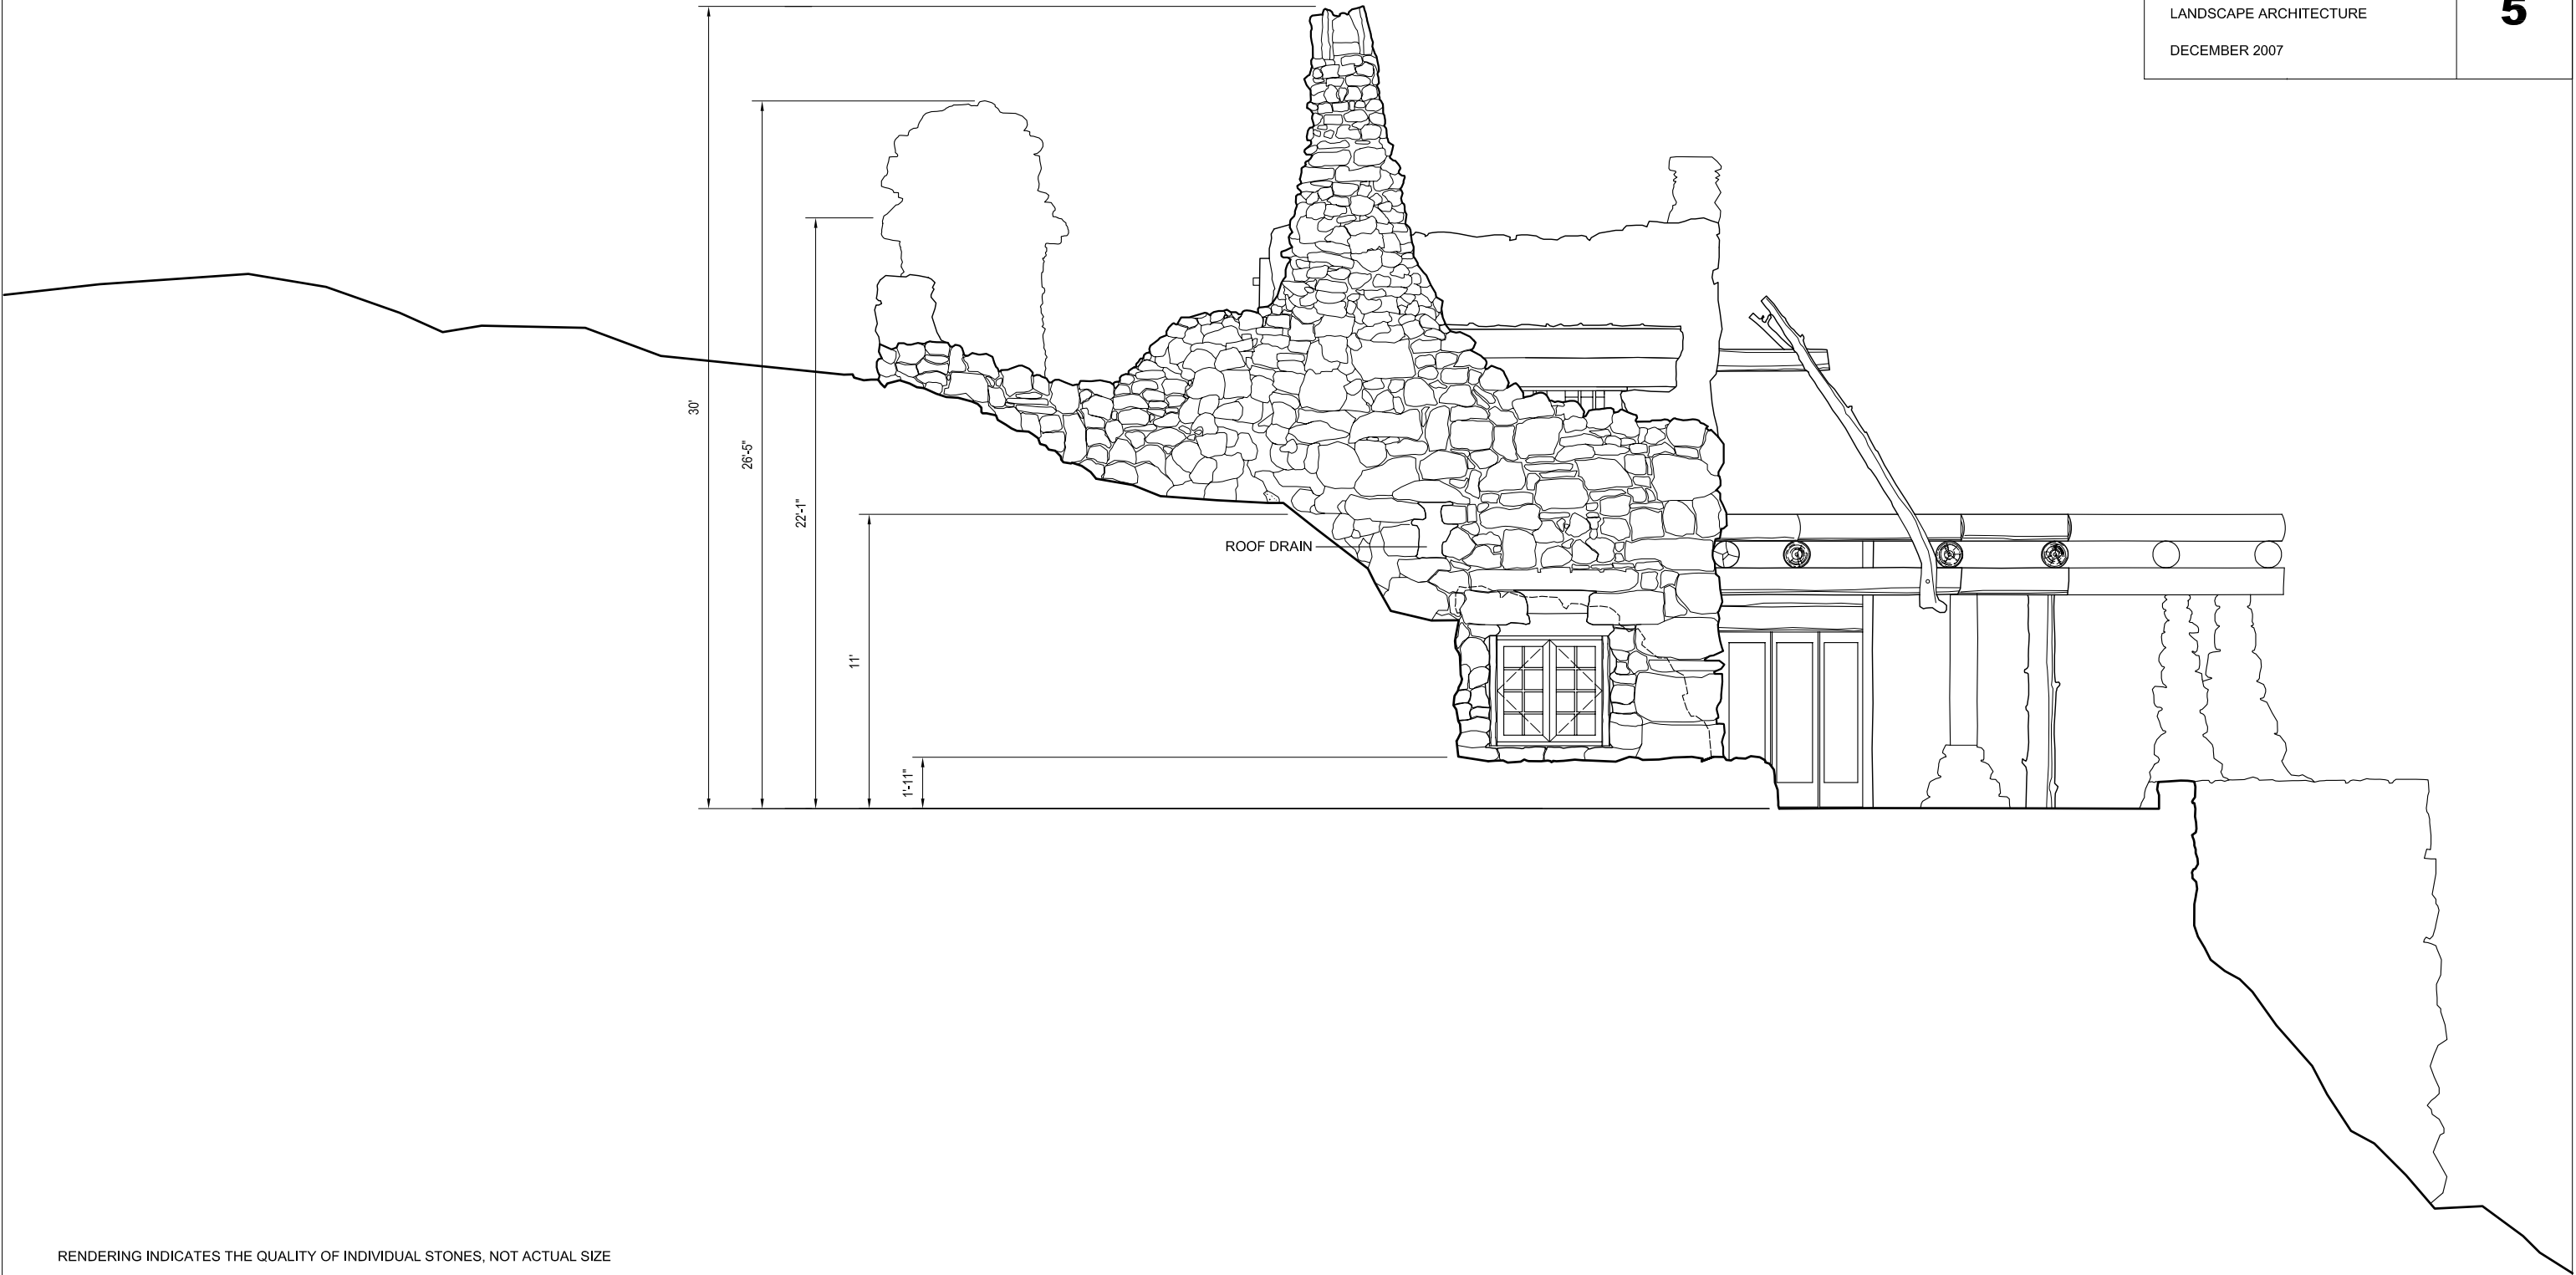
WEST ELEVATION

①	Displaced stone causing hole in stone wall. See FIG. E14.
②	South section of Office window in poor condition with the bottom right pane missing and replaced with board, and the mullion trim missing in places. See FIG. E57.
③	Paint worn on wood members. See FIGS. E48, E54.
④	Gaps between building materials allowing rodent access to the interior. See FIGS. E14, E15.
⑤	Reflective film applied to west Kitchen windows. Film is creased and bubbly. See FIG. E55.
⑥	Vents installed in west Kitchen windows. See FIGS. E55, E56.
⑦	Grey water pipe installed through the window trim and on a west elevation drainage channel. See FIG. E56.
⑧	Damaged 2 x 4 attached to Office window trim. See FIG. E58.
⑨	Propane / electrical conduit installed through window trim. See FIGS. E53, E58.
⑩	Duct tape and plastic applied to Office window trim. See FIG. E57.
⑪	Porch posts and stone bases not anchored. See FIG. E16.
⑫	Displaced stones at the base of the north retaining wall. See FIGS. E16, E17.

⑬	Decayed wood members, including vigas and porch beams, caused by moisture. See FIGS. E23, E24, E36.
⑭	Sheet metal installed over wood vigas and porch beams likely traps moisture. See FIG. E36.
⑮	Porch posts do not rest on above-grade footings. See FIGS. E5, CD3 in Chronology of Development section.
⑯	Mortar applied on top of stone roof lookout with unknown purpose. See FIGS. E12, E13.
⑰	Elastomeric roofing material applied on stone walls. See FIGS. E31, E32.
⑱	Secondary Room chimney missing stones/mortar creating holes. See FIG. E10.
⑲	Lack of animal-proof screen on Great Room chimney (unless present inside chimney). See FIG. E11.
⑳	Unsecured wire mesh over Secondary Room chimney. See FIG. E10.
㉑	White elastomeric roof treatment visually distracting and impairs view of the Hermit's Rest. See FIGS. E7, E31.

㉒	Porch extended westward. See FIGS. E22, E26, E35, CD2, CD4, CD5, CD21, CD22 in Chronology of Development section.
㉓	Kitchen window replacements on west elevation. See FIG. E55.
