HISTORIC STRUCTURE REPORT

UTAH PARKS COMPANY SERVICE STATION BRYCE CANYON NATIONAL PARK

A Service Learning Project of the
Preservation Studies Program
College of Architecture and Landscape Architecture
The University of Arizona

November 2005

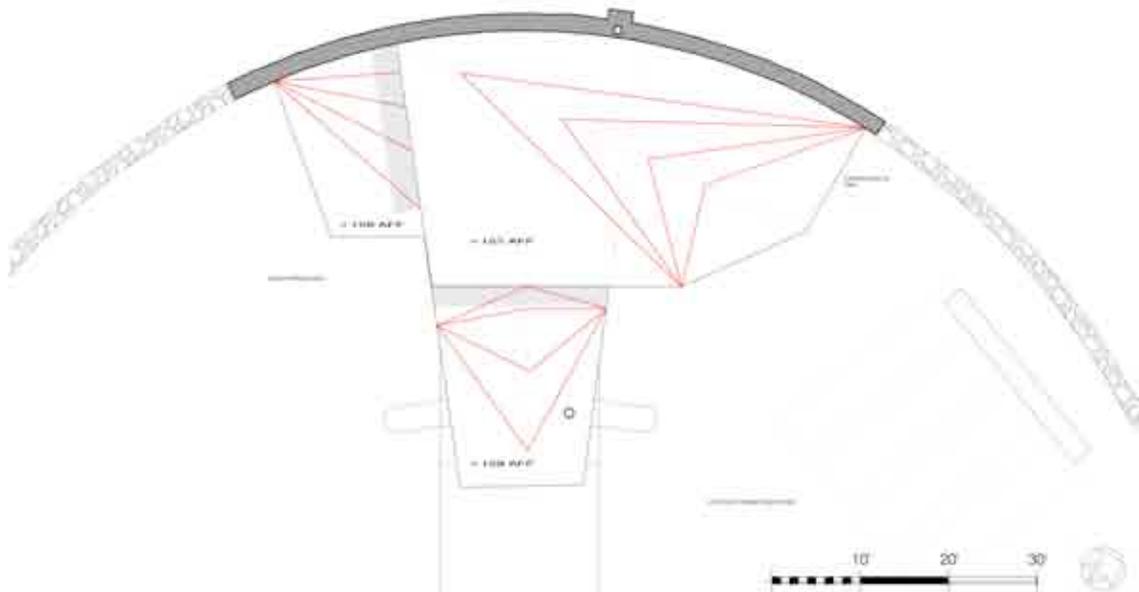
Figure 4 - Roof plan with existing drainage patterns.

The drainage system for the Utah Parks Company Service Station includes all systems employed to carry water away from the building and off the site. Currently, there is no drainage system in place, nor was there one designed as part of the original intent of the architect. Water leaks into the structure from the planar roof at the junction of the roofline and the rear stone wall, causing damage to the roof supports and to the stone wall. There are also exterior drainage problems at all corners of the roofline, where the water ponds and drips down the fascia and exterior walls of the building at unintentional places causing significant damage to building elements. Additionally, once the water reaches the ground, poor site drainage causes the water to flow back toward the building, causing damage to the concrete slab and exterior walls, in the form of undercutting at the corners of the Sales Office and other parts of the building perimeter.

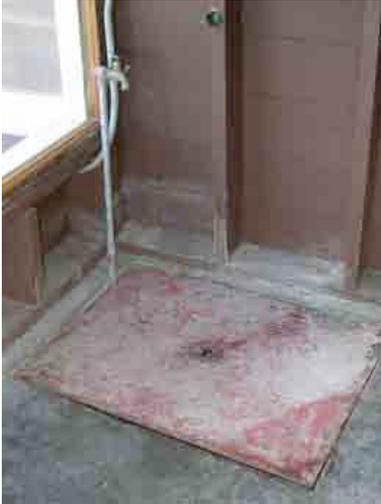
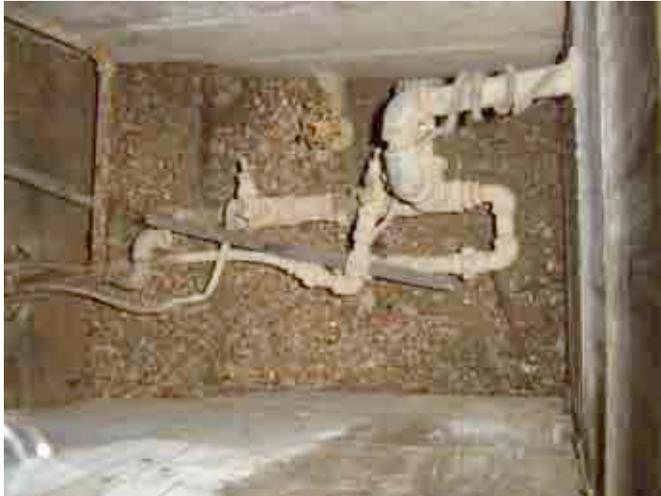
Figure 22 & Figure 23 - Manhole cover in Repair Shop and old water supply and air piping system, within the manhole.

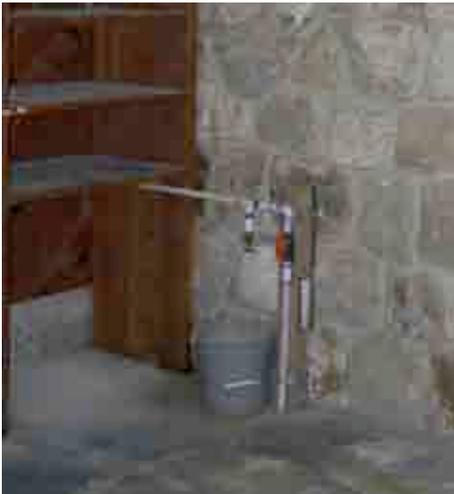
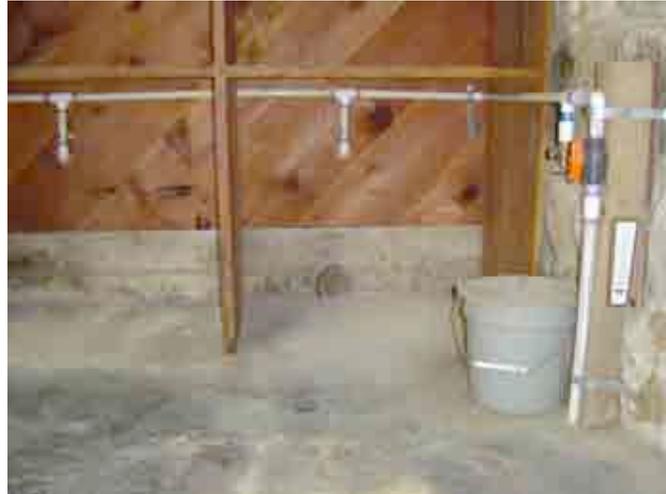
Figure 24 & Figure 25 - Current PVC water supply system as it enters the building in the Utility Room (left) and is distributed to the restrooms (right).

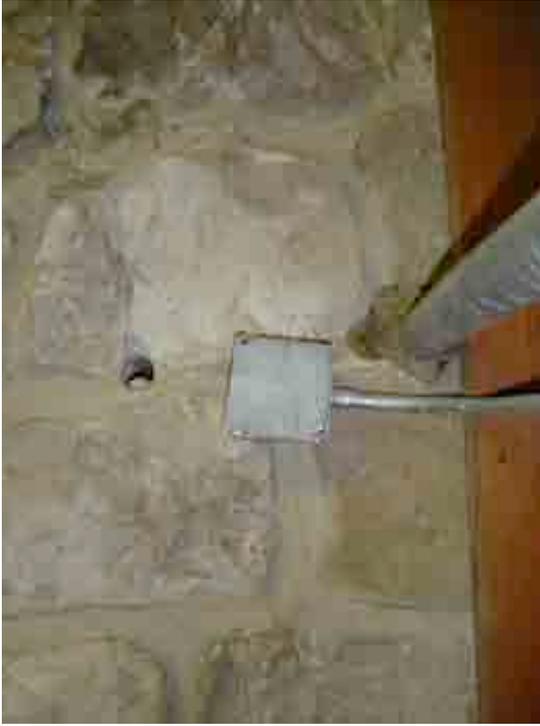
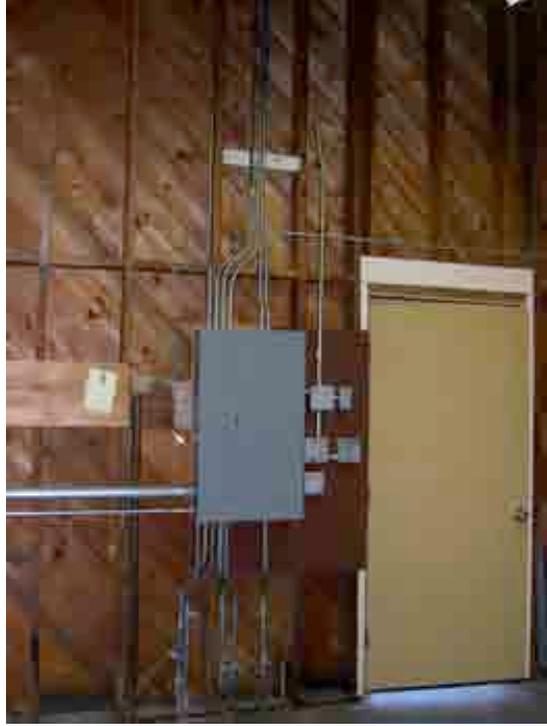
Figure 28 & Figure 29 - Upgraded electrical system enters building through stone wall (left) to the panel distribution box in the Utility Room (right).

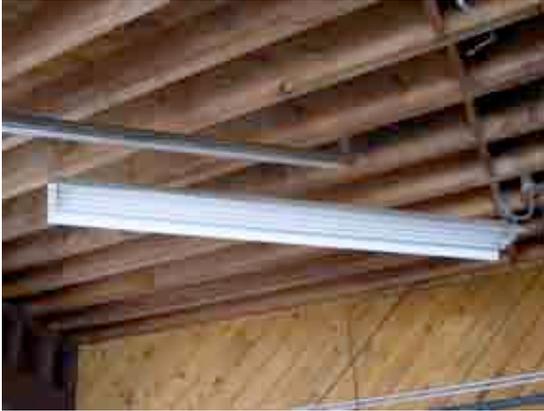
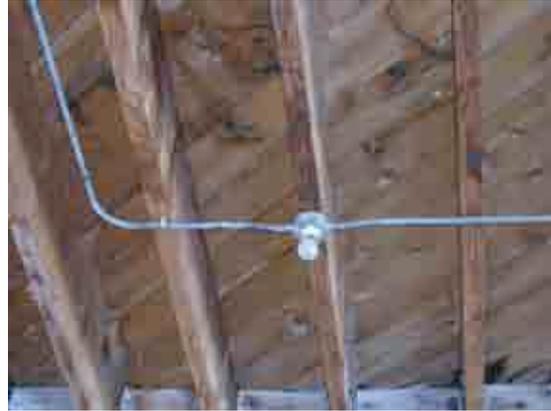
Figure 32 & Figure 33 - Florescent (left) and incandescent (right) lighting fixtures on interior.

Deficiency	Treatment Recommendation	Priority
Current electrical system is ungrounded except for the restrooms.	Upgrade to grounded service throughout entire service station.	Serious
Florescent lighting fixtures in Repair Shop and Sales Office.	Replace florescent fixtures in Repair Shop and Sales Office with fixtures appropriate for future use of the building.	Minor
Location of electrical meter against the stone wall detracts from the visual quality of the west façade.	Move electrical meter away from the wall.	Minor

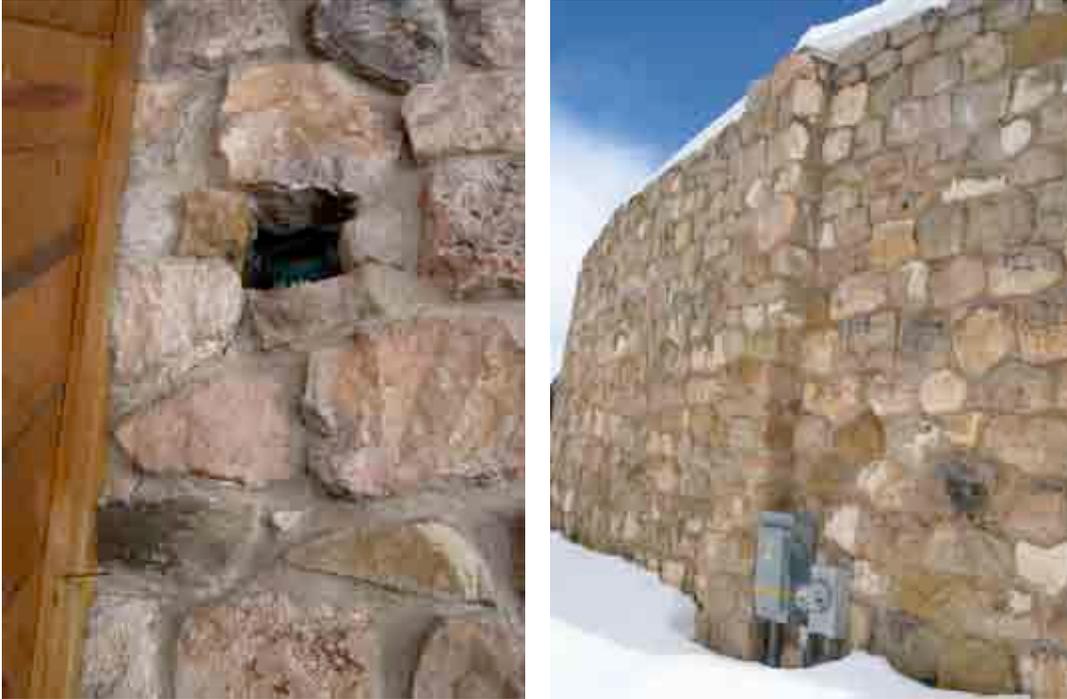
Figure 36 & Figure 37 - Location of flue hole on the interior of the Repair Shop (left) and the protruding chimney form on the exterior of the west wall (right).

Deficiency	Treatment Recommendation	Priority
Outdated heater wall unit in Sales Office is potential fire danger and detracts from the visual quality of the wood paneling.	Remove and replace with portable space heater; not one that is permanently attached to the wall.	Serious
No heat in Repair Shop or Utility Room	Utilize portable space heaters as needed that are not permanently attached to the wall.	Serious
Original heater in Lift Room has been removed. Flue opening contains coffee can to prevent air conveyance.	Remove coffee can and block air with insulation material that is non-intrusive and maintain the original flue opening.	Minor

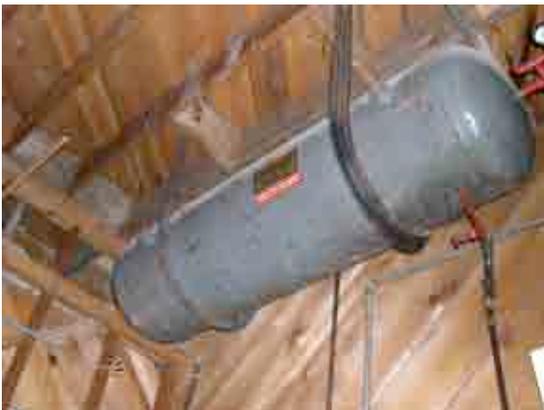
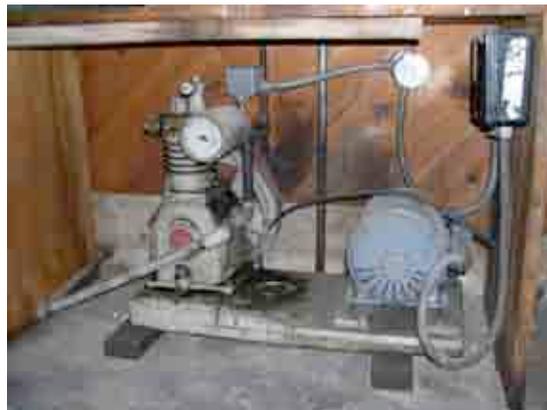
Figure 39 & Figure 40 - Compressed air tank (left) and pump (right) located in the Utility Room.

Deficiency	Treatment Recommendation	Priority
Operability of compressed air system.	Verify operability of compressed air system; if system is not functional, replace with new system in the original location to accommodate future use or preserve/interpret automobile lift.	Serious
	Preserve placement of existing compressed air system including air tank, pump (both in Utility Room), manifold, automobile lift (both in Repair Shop) and air dispensers (Pump Island).

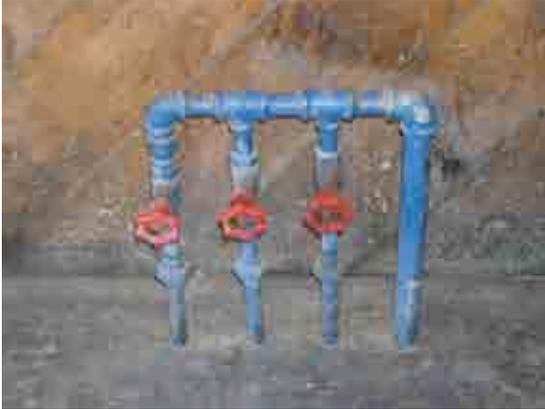
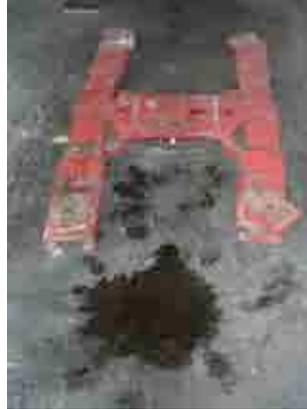
Figure 41 & Figure 42 - Air manifold (left) and automobile lift mechanism (right) in Repair Shop.

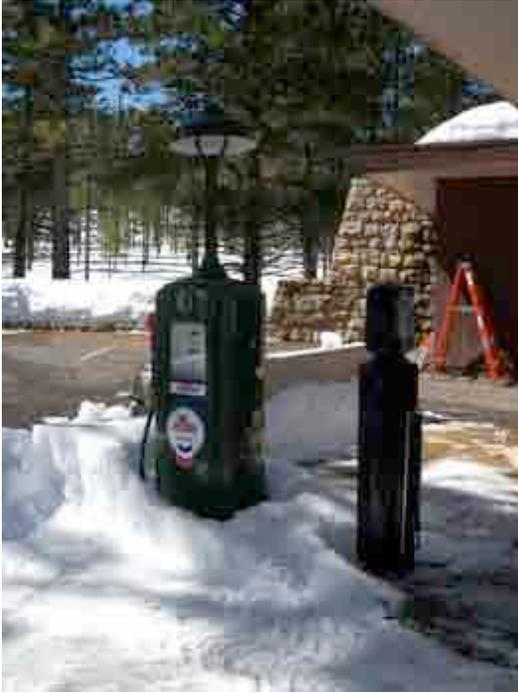
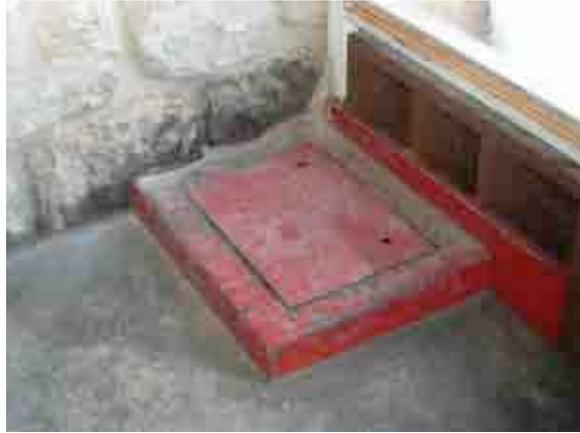
Figure 44 & Figure 45 - Non-operational, non-original gasoline pump at the Pump Island representing the period of significance (left) and the waste oil disposal area, northwest corner of Repair Shop (right).

Deficiency	Treatment Recommendation	Priority
No documentation of waste oil tank removal.	Determine whether the waste oil tank is still present underground at the north end of the building. If tank is still present, consult with Utah Department of Environmental Quality to determine its appropriate disposal. Maintain waste oil disposal area in Repair Shop for its association with the system's historic use.	Serious
No documentation of Blazo tank location/removal	Verify tank removal through excavation of area designated for the tank on architectural drawings (Kelly Shakespear believes it has been removed).	Serious

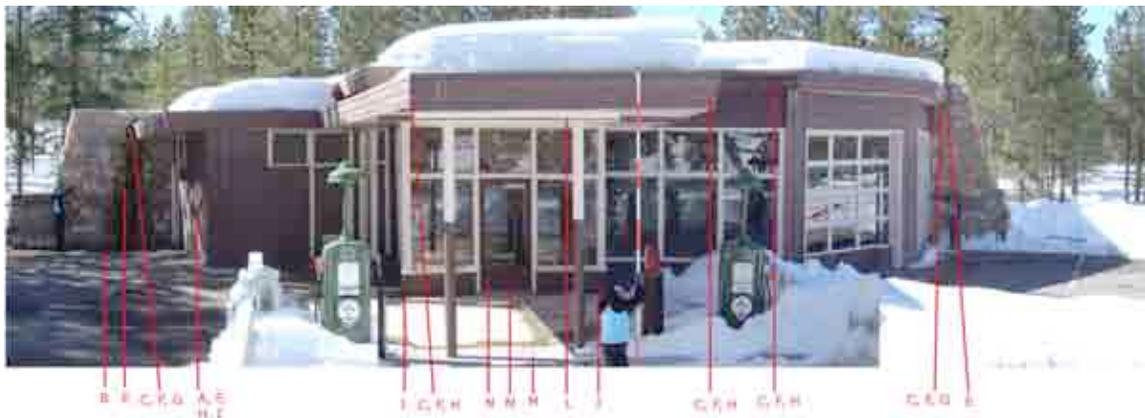
Figure 49 - East façade composite documentation photograph (letters refer to notes in condition assessment table below).

K. Wood rot and paint peeling on the windowsills.	Replace wood sills where necessary;	Serious
	Repaint to match original color.

L. Rusting on exterior fluorescent light fixtures.	Replace with lighting system appropriate for period of significance and future use.	Serious
M. Cracking and loss of concrete slab at base of main entrance, garage door, and around Pump Island.	Repair with like materials	Minor
N. Scuffing/scarring of front and restroom doors.	Repair and refinish.	Minor
O. High profile vehicle damage in the form of scraped beaded board paneling on both north and south sides of the underside, fascia and metal flashing of Pump Island canopy	Repair and repaint. Replace concrete barricades with deterrent less visually intrusive and more appropriate to future use (e.g. outdoor seating). Replace metal flashing where necessary and repaint to match original.	Serious

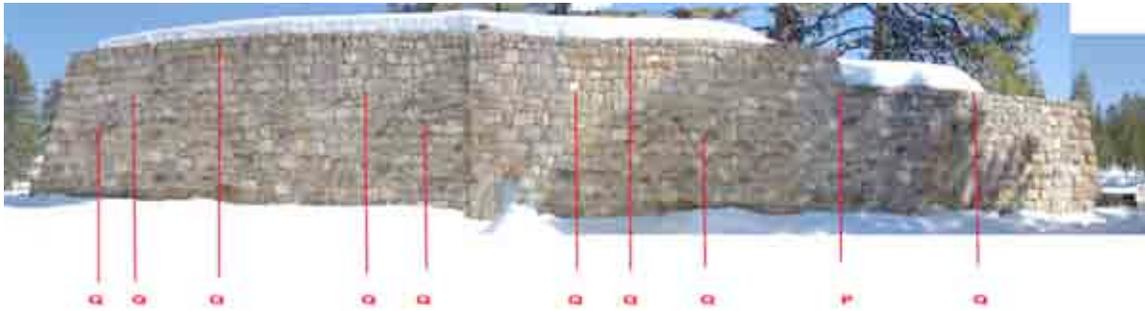
Figure 52 - West façade composite documentation photograph (letters refer to notes in condition assessment table below).

Deficiencies	Recommended Treatments	Priority
P. Vertical crack running from base of wall to the top.	Repoint and install crack monitors to assess long-term separation.	Critical
Q. Mortar loss, stone erosion, efflorescence, and biological growth on rock wall.	Implement maintenance schedule that includes gentle cleaning and mortar repointing.	Serious

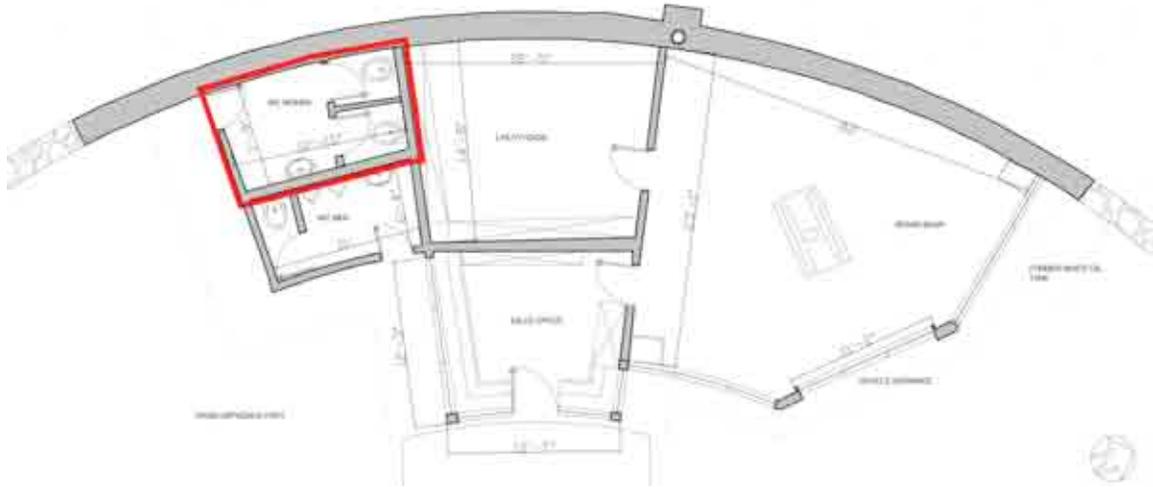
Figure 53 - Reference floor plan showing location of the Women's Restroom.

The Women's Restroom is accessed from the outside through a door on the south wall. The room contains two toilets and one sink. These are the original plumbing fixtures and are in good condition. The stalls are original, sheathed in stained fir verneer, and are in good condition. The ceiling is white plasterboard and has two cracks, one extending from the east wall and one extending from the west wall. Each crack reaches approximately halfway across the ceiling. The west wall is formed of locally quarried fieldstone. The stone wall has a vertical crack that is visible on the exterior and is also visible on the interior of the Women's Restroom. The crack was previously repaired but this repair is failing. The connection between the rock wall and ceiling is poor and there are a few areas where roofing tar leaked through the ceiling onto the stone. The remaining three walls are white plasterboard on the upper half and stained pine wood on the bottom half and are in good condition. The floors are stained red concrete that turn up at the base of the wall to form an integrated base molding. There is general wear and tear to the concrete and a band of residue at the base of the wood paneling and concrete base along the north wall. Communication with Kelly Shakespear indicated that there has been termite infestation through the stone wall but there is no visible evidence of current activity.

Deficiency	Treatment Recommendation	Priority
Poor connection where the rock wall meets the roof/ceiling causing water damage.	Implement Proposed Drainage Plan (see <i>Ultimate Treatment</i>) and seal the joint between the rock wall and the roof/ceiling.	Critical
Roofing tar has leaked onto the stone through the joint between the ceiling and rock wall.	Clean tar off rock wall.	Minor
Vertical crack in rock wall running from floor to ceiling.	Repoint and install crack monitor to assess movement.	Critical
Cracking in ceiling plasterboard.	Repair and repaint ceiling.	Minor
Wear and tear along the base of the wood paneling and top of concrete trim along the north wall.	Clean residues from wood and concrete and refinish.	Minor
General wear and tear to concrete floors.	Refinish and restain surface with appropriate red color or reseal.	Serious
Previous termite activity.	Evaluate infestation and existing damage to wood elements.	Critical

Consult pest control specialist for treatment options.	
	Replace any structural members damaged beyond repair.

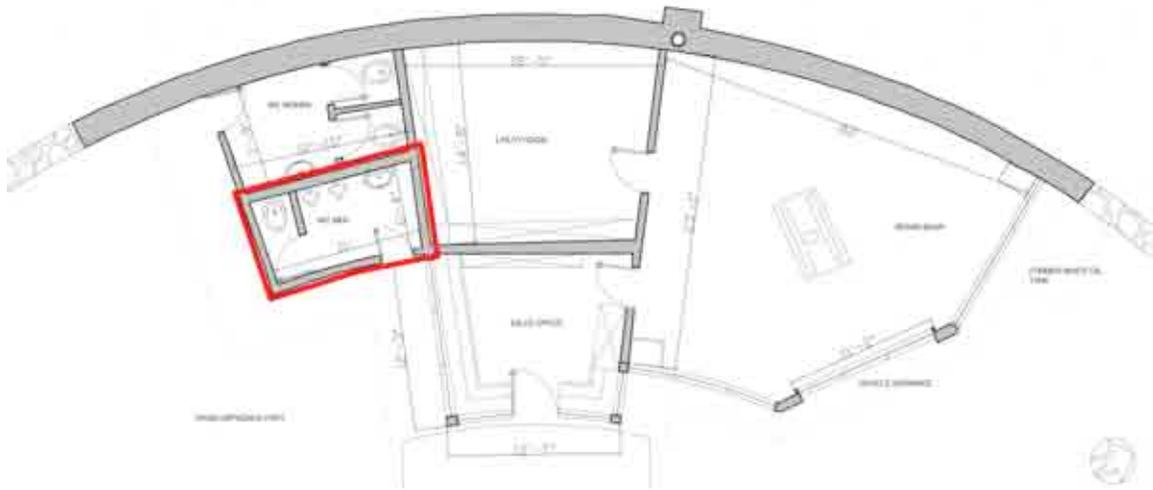
Figure 58 - Reference floor plan showing location of the Men's Restroom

The Men's Restroom is accessed from the outside through a door on the east wall. The room contains two urinals, one toilet, and one sink. These are the original plumbing fixtures and are in good condition. The partition stalls are original, sheathed in fir veneer, and are in good condition. The ceiling is white plasterboard and has one crack extending from the east wall approximately halfway across the ceiling. The four walls are white plasterboard on the upper half and stained pine wood on the bottom half and are in good condition. The floors are red-stained concrete that turn up at the base of the wall to form an integrated base molding. There is general wear and tear to the concrete.

Deficiency	Treatment Recommendation	Priority
Cracking in ceiling plasterboard.	Repair and repaint ceiling.	Minor
General wear and tear to concrete floors.	Refinish concrete floors paint with appropriate color.	Serious

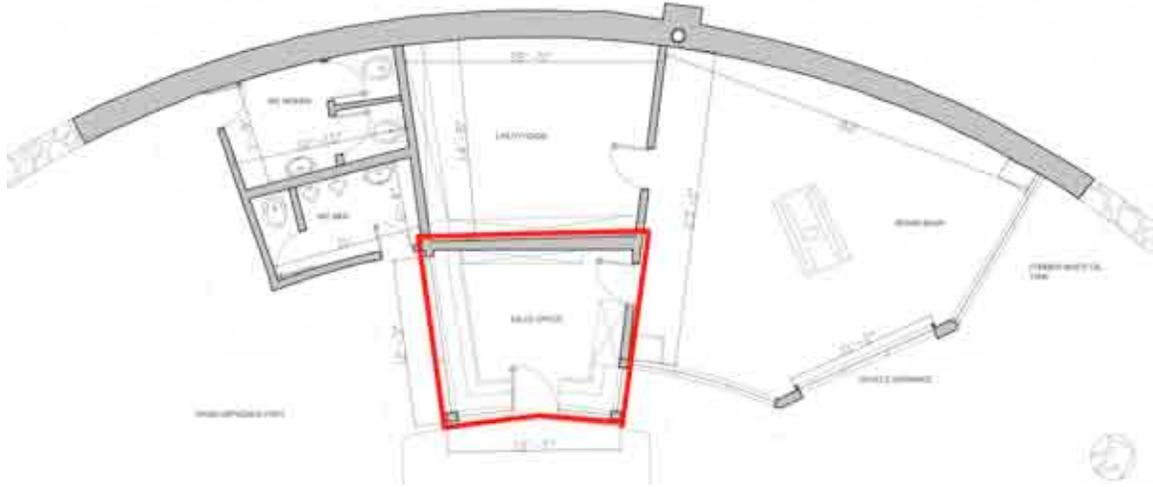
Figure 61 - Reference floor plan showing location of the Sales Office.

The main entrance to the Sales Office is located on the east wall and accessed from underneath the Pump Canopy. The walls facing the exterior of the Sales Office consist of rectangular, wood-framed windows paired with smaller windows above. Two of the upper windows are operable awning-type windows and the rest are fixed pane. A wood door with one large glass pane provides access to this sales area. The west wall and ceiling are sheathed with stained and varnished pine bead-board paneling in a distinctive chevron pattern. Additionally, a wall-unit heater has been installed on this wall that appears not to be original. The wood shelving along the west wall and the sales counter along the north wall are original. These are showing normal wear and tear. The display shelving along the north, east, and south windows was reconstructed in 2000 based on similar display shelving from the Service Station's sister facility at the North Rim of Grand Canyon National Park. The floors are unfinished concrete and are showing normal wear and tear along with some oil staining. A non-original fluorescent light fixture is located in the center of the ceiling that detracts from the chevron-patterned paneled ceiling.

There is water damage to the pine bead-board ceiling, including staining and cracking as well as to the trim along the north wall. This damage is particularly noticeable in the northeast corner of the ceiling. There is a small area of loss to the bead-board near the fluorescent light fixture that is located in the center of the ceiling. There is also some soiling along the base of the west wall paneling, especially in the northwest corner.

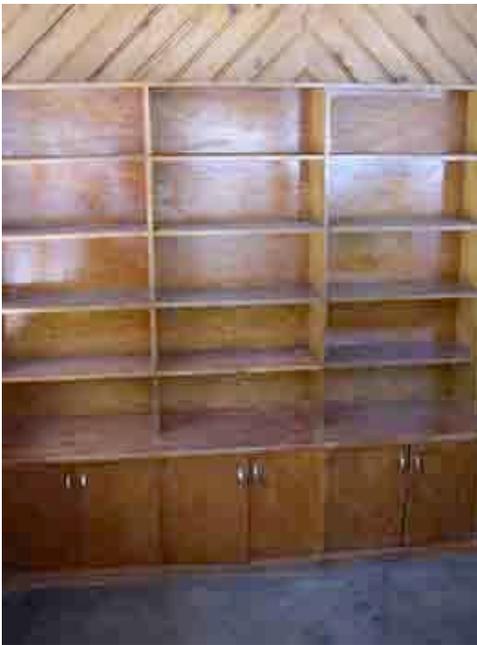
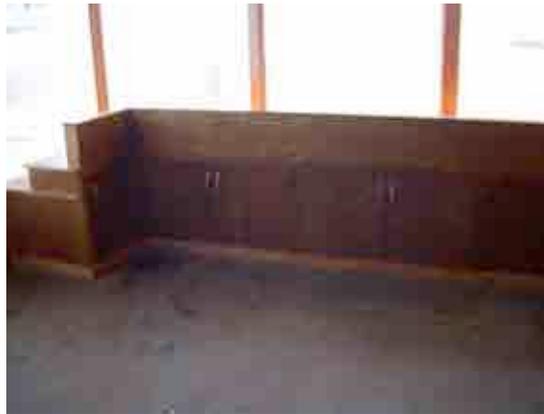
Figure 64 & Figure 65 - Original wood shelving on west wall (left) and reconstructed display cabinet (right).

Deficiency	Treatment Recommendation	Priority
Wear and tear to original shelving units and sales counter.	Refinish original shelving units.	Minor
Fluorescent fixture obscures chevron pattern of ceiling.	Remove fluorescent lights and replace with lighting system more appropriate for the period of significance and future use.	Serious
Water damage to beaded board ceiling and wood trim.	Repair source of water damage.	Critical
	Replace and refinish wood where necessary to match original.	
Small area of loss in beaded board near light fixture.	Repair area of loss.	Minor
Wear and tear to east entrance door and hardware.	Refinish door and repair/replace hardware.	Serious

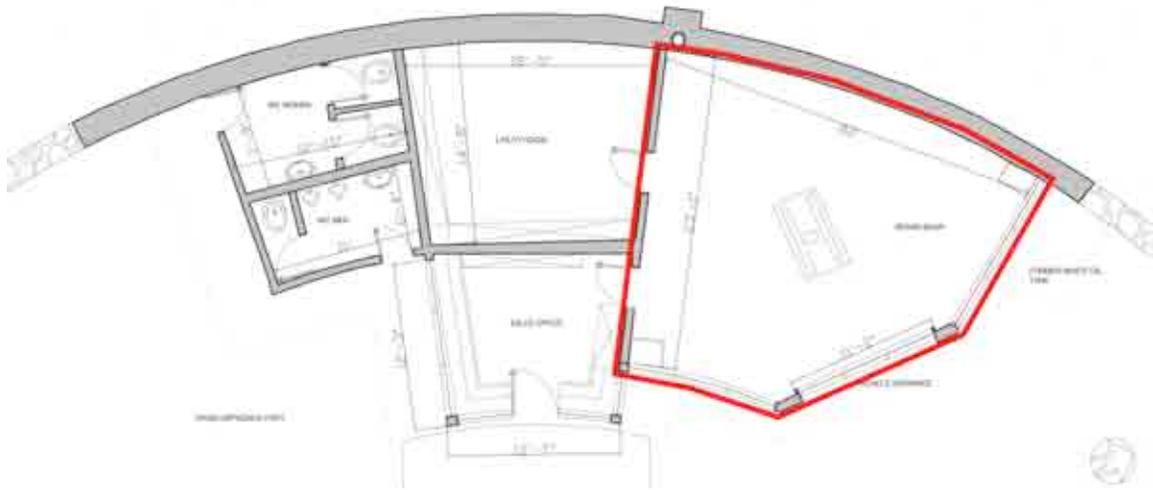
Figure 66 - Reference floor plan showing location of the Repair Shop.

The Repair Shop can be accessed from the interior through the Sales Office or from the exterior through the garage door. The door from the Sales Office and its hardware show normal wear and tear. The garage door is operational and appears to be in good condition. There are two operable windows along the top of the north wall whose hardware appears to be in good condition. The north, northeast, and east walls are primarily wood-framed windows. There is water damage to the wood (warping and wood rot) and paint (bubbling and peeling) along the base of the north and east walls, especially in the northeast corner. This is most likely from puddling and back-splash of water due to poor site water drainage on the exterior in these areas. The south wall is partly composed of windows shared with the Sales Office and half composed of a wood framed and paneled wall with a non-original door/door frame leading into the Utility Room. The Utility Room originally had only an opening (without a door) to the Repair Shop. A doorframe and door were installed in 1990 and are in good condition. Also on the south wall are three incandescent bulbs aligned vertically whose original purpose is unclear.

The west wall is formed of locally quarried fieldstone that forms the arcing rear wall of the room. On the north side of the stone wall is a workbench painted blue that is in poor condition. The workbench probably dates close to the construction date but is not original. There is a fluorescent fixture above the bench that drops down and obscures the stone wall. On the south side of the stone wall there is a flue opening that was formerly connected to the original oil-burning heater that has since been removed. The flue opening leads to a chimney that protrudes from the exterior of the stone wall. There is a crack in the stone wall at the south end of the room beginning at the lower left corner of the flue opening and continuing down into the Utility Room. This crack is only visible from the interior and may have been caused by drilling in the Utility Room when the electrical service was upgraded. There is dark soiling and staining along the base

of the west and south walls, particularly in the southwest corner that may be from the residues of mechanical fluids or from the original oil-burning heater.

The wooden roof joists and diagonally-laid roof decking of the ceiling are exposed. The connection between the stone wall and the Repair Shop roof is poor. There is considerable water damage to the ceiling joists including staining, warping, and rot. There is a significant band of efflorescence and areas of biological growth on the stones just below the ceiling. Both the original incandescent lighting and the later florescent light fixtures remain on the ceiling along with the garage door mechanisms.

The floors are unfinished concrete and are cracked in some areas but are not structurally deficient. In the center of the Repair Shop floor is an automobile lift that appears to be original. When folded up, the lift is 3 feet wide, 5 feet long and has a 14 inch round center. This round center allows the arms to move in any direction. There are 4 arms total that can be extended to approximately twice their original length. Its operability was not verified. There is also evidence that there was a subterranean service pit in the floor, but there are no records to indicate when it was filled in.

In addition to normal wear on the floor, there are numerous oil stains throughout the room with fresh oil puddles around the lift mechanism. At the northwest corner of the room, there is a waste oil disposal pit used as part of the original waste oil system. The pit edge and cover is raised a few inches off the floor and is currently removable. There is another covered pit in the southeast corner of the room that houses valves of the old water compressed air systems. This steel plate cover is flush with the floor and is currently removable.

Deficiency	Treatment Recommendation	Priority
Crack in rock wall beginning at lower corner of flue opening and continuing down into Utility Room (see <i>Structural System</i> section for image)	Repoint mortar and insert crack monitor to assess movement.	Critical
Poor connection between the rock wall and ceiling.	Implement Proposed Drainage Plan (see <i>Ultimate Treatment</i>) to seal the joint between the rock wall and the roof.	Critical
Water damage to roof joists.	Replace wood where necessary.	Critical
Areas of efflorescence, biological growth, and dark staining on stone.	Clean with gentle methods and implement regular maintenance schedule of monitoring and cleaning.	Minor
Water damage to the wood frame and paint along the bottom of north and east walls.	Replace wood and/or repaint where necessary.	Critical
Testing indicates brown paint on walls contains lead.	Remove lead paint using appropriate abatement standards and repaint to match original color.	Serious

Fresh oil puddles and stains on floor.	Clean concrete floors, fill in cracks in slab, and seal leaving patina.	Critical
Concrete slab is cracked in some areas

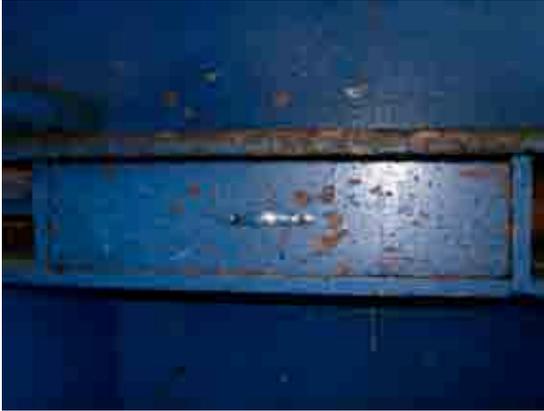
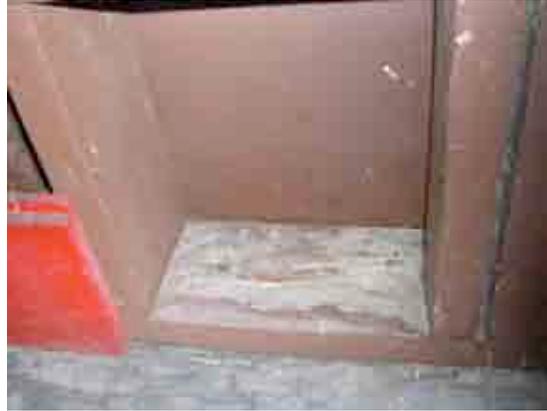
Figure 68 & Figure 69 - Workbench and north wall, both of which have paint containing lead.

Wear and tear on workbench.	Document, remove, and dispose of workbench using lead abatement standards, to expose entire stone wall.	Serious
Testing indicates blue paint contains lead.		
Lighting	Remove fluorescent lights and replace with lighting fixtures appropriate to the period of significance and future use.	Minor
Oil disposal pit.	Remove remaining waste oil fill and seal.	Serious
Automobile lift	Adapt lift for future use or interpretation.	Serious

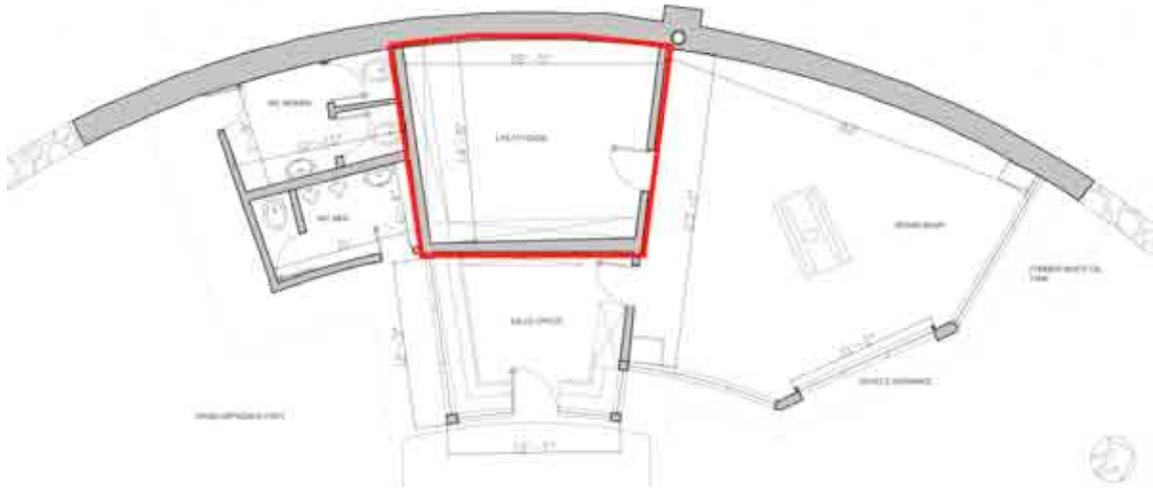
Figure 72 - Reference floor plan showing location of the Utility Room

The Utility Room is entered from the north through the adjacent Repair Shop. The Utility Room originally had only an opening to the Repair Shop. A doorframe and door were installed in 1990 and are in good condition. The north, east, and south walls are wood frame with diagonal wood paneling on the south wall and exposed frame on the east and north walls. The Service Station's electric breaker box is located on the north wall, adjacent to the door. A large electrical conduit, installed in 2002 penetrates the stone wall connecting the electrical meter on the exterior with the electric breaker panel on the interior of the Utility Room.

There is a cabinet and shelving along the east wall and shelving along the south wall. At the top of the east and south walls is access to the intersticiary space between the roof and ceiling of the Restrooms/Sales Office/Pump Island canopy roof plane which is lower than the upper roof plane over the Utility Room/Repair Shop. The wood paneling beneath this space is cut in an irregular, jagged manner. Currently, there are pieces of cardboard and other scraps stored in the intersticiary space; the size of the crawl space prevented access. There is handwritten graffiti in yellow chalk on the cabinetry and on some areas of the north and south walls. The cabinets appear to be contemporaneous with the building's construction (they are similar in construction to those in the Sales Office). During the years the building functioned as a service station, graffiti accumulated from the various employees of Utah Parks Company, many of whom still live in the Bryce Canyon area. This graffiti represents a continuum of historic artifacts that should be preserved as tangible evidence of the people who worked there.

The west wall is composed of locally quarried fieldstone that forms part of the arcing west wall. There is a crack in the rock wall at the north end of the room that begins in the Repair Shop and moves into the Utility Room. This crack is only visible from the interior and may have been caused by drilling into the stone wall to install the electrical conduit in 2002.
