Volume IV  
Commercial Corridors  
Profile of Existing Conditions:

Commercial Corridor Profile of Existing Conditions, Volume IV

Prepared for:  
Department of Community Development  
and Neighborhood Conservation  
Pima County, Arizona

April 2013

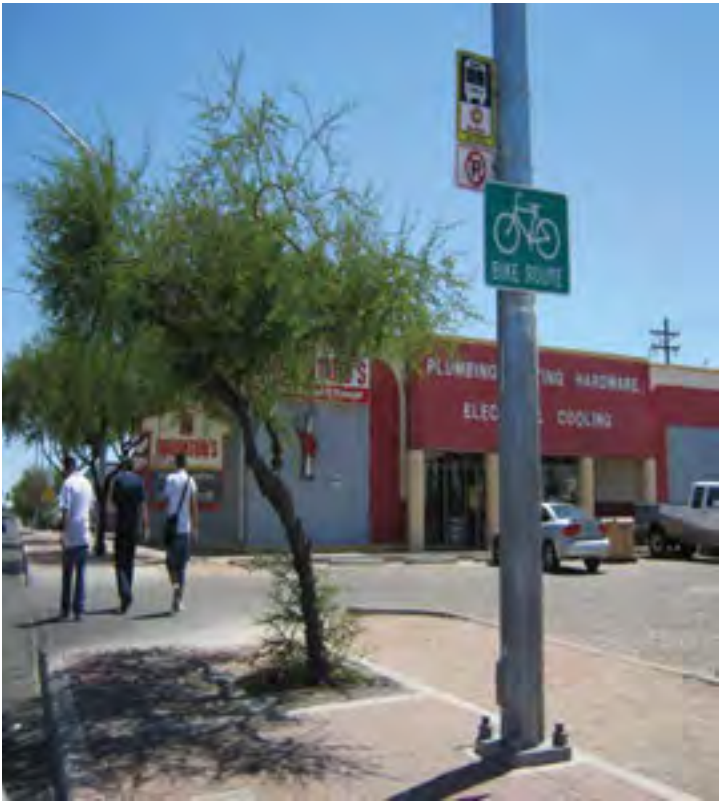
An un-sheltered bus stop on South 6th Avenue

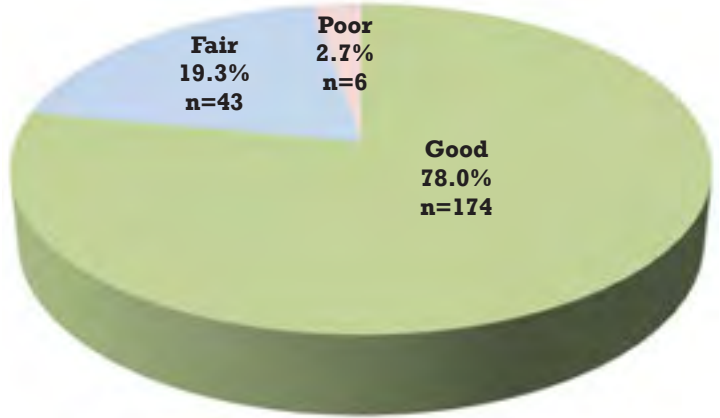
The majority (78.0 percent) of business properties on the South 6th Avenue Corridor are in ‘Good’ condition (see Figure 3.19). Approximately 19.3 percent are in ‘Fair’ condition requiring between \$5,000 and \$15,000 in repairs. Six structures are in ‘Poor’ condition, indicating a need for repairs on the order of \$15,000 to \$50,000.

**Figure 3.19: Condition of All Business Properties-South 6th Avenue Commercial Corridor**  
*Excludes parking lots, vacant lots, residential, and four parcels that were unable to be assessed.*

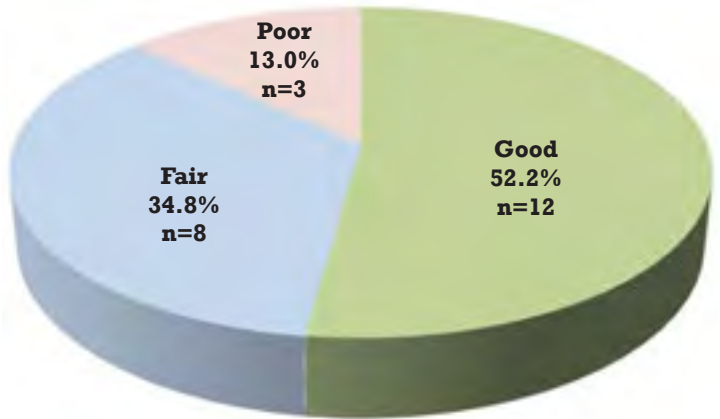
Twenty-three business properties on the corridor are vacant. Of these vacant businesses, almost half are in ‘Fair’ or ‘Poor’ condition.

**Figure 3.20: Condition of Vacant Business Properties-South 6th Avenue Commercial Corridor**

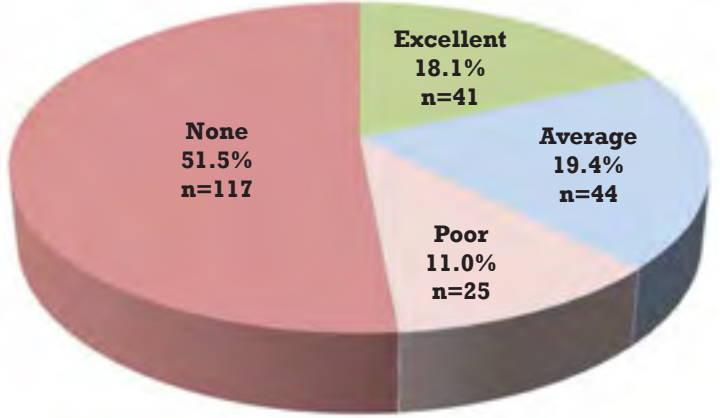
More than half of business properties on the South 6th Avenue Corridor do not have landscape or grounds to assess (Figure 3.21). Approximately 18.4 percent of business properties have grounds assessed as ‘excellent,’ which means that landscape is both intentional and maintained.

**Figure 3.21: Landscape Condition of All Business Properties- South 6th Avenue Commercial Corridor**  
*Excludes parks, parking lots, vacant lots, and residential.*

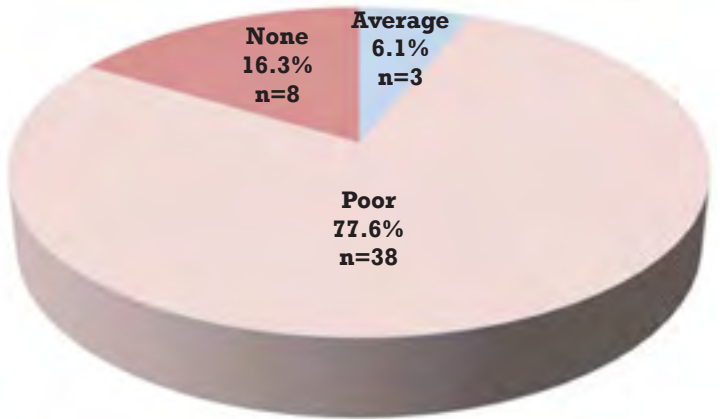
Of note is the condition of vacant lots on the corridor. Thirty-eight of the forty-nine vacant lots had grounds in poor condition and all forty-nine had litter at the time of the windshield survey (Figure 3.22).

**Figure 3.22: Landscape Condition of Vacant Lots-South 6th Avenue Commercial Corridor**  
*Note: All 49 vacant lots had litter and 14 of the 49 parcels had graffiti at the time of the windshield survey.*

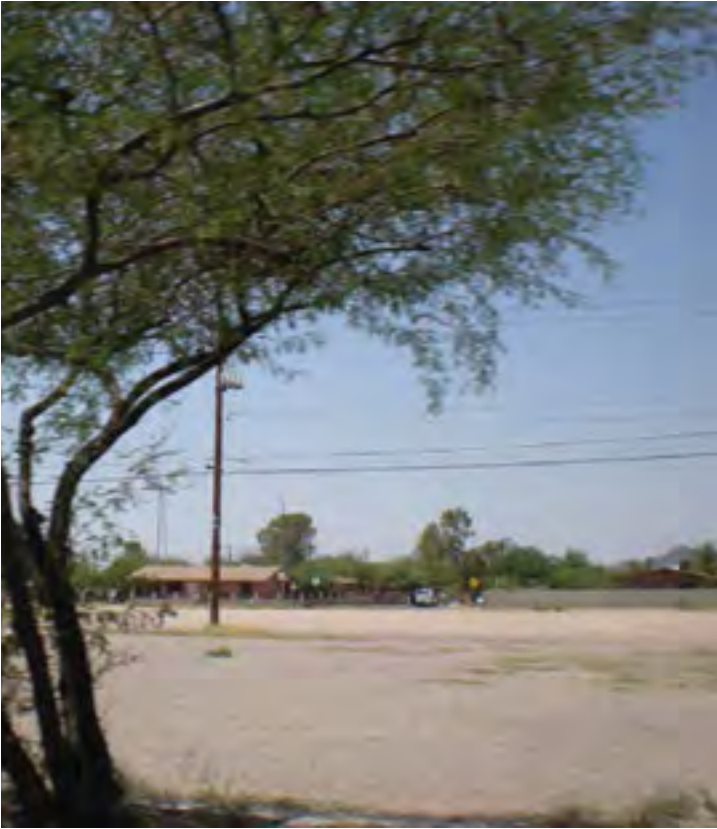
Drachman Institute identified 49 out of 283 parcels (17.3 percent) on the South 6th Avenue Commercial Corridor as vacant (see Figure 3.23). Litter is a problem on vacant land as all forty-nine vacant parcels had litter at the time of the windshield survey.

A vacant parcel on the South 6th Avenue Commercial Corridor

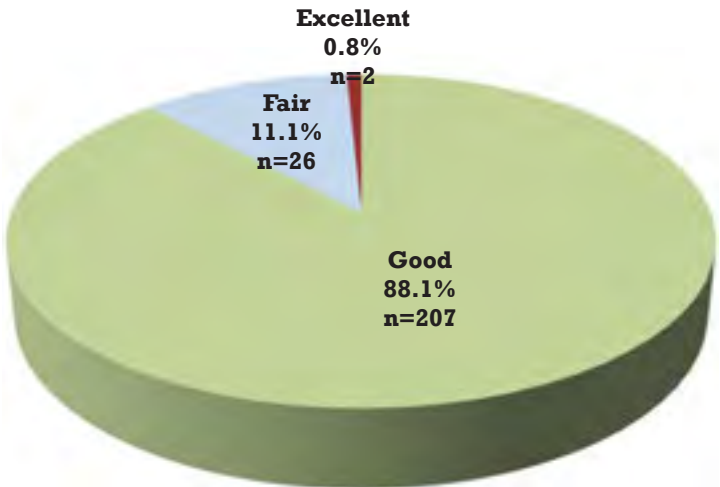
**Figure 4.20: Condition of All Business Properties-South 12th Avenue Commercial Corridor**  
*Excludes parking lots, vacant lots, residential, and parcels that were unable to be assessed.*

The majority (88.1 percent) of business properties on the South 12th Avenue Corridor are in ‘Good’ condition (see Figure 4.20). Approximately 11.1 percent are in ‘Fair’ condition requiring between \$5,000 and \$15,000 in repairs.

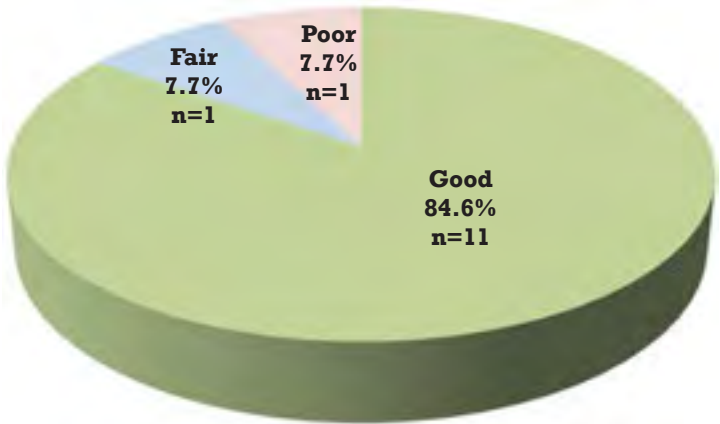
**Figure 4.21: Condition of Vacant Business Properties-South 12th Avenue Commercial Corridor**

Thirteen business properties on the corridor are vacant. Of these vacant businesses, eleven are in ‘Good’ condition (Figure 4.21).

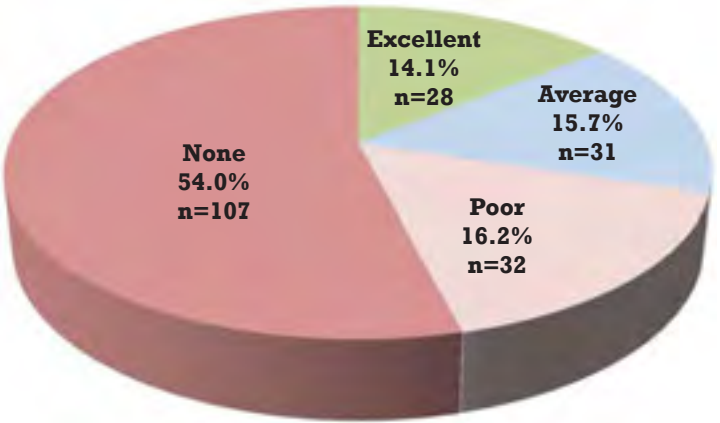
**Figure 4.22: Landscape Condition of All Business Properties- South 12th Avenue Commercial Corridor**  
*Excludes parking lots, vacant lots, vacant buildings, and residential.*

More than half of business properties on the South 12th Avenue Corridor do not have landscape or grounds to assess (Figure 4.22). Approximately 14.1 percent of business properties have grounds assessed as ‘excellent,’ which means that landscape is both intentional and maintained.

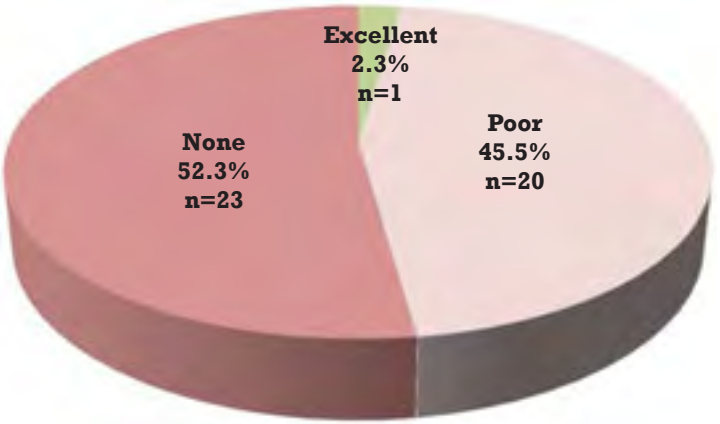
**Figure 4.23: Landscape Condition of Vacant Lots-South 12th Avenue Commercial Corridor**  
*Note: Half of the vacant parcels had litter and ten of the 44 parcels had graffiti at the time of the windshield survey.*

Of note is the condition of vacant parcels on the corridor. Twenty of the forty-four vacant parcels had landscapes in poor condition and litter at the time of the windshield survey (Figure 4.23).

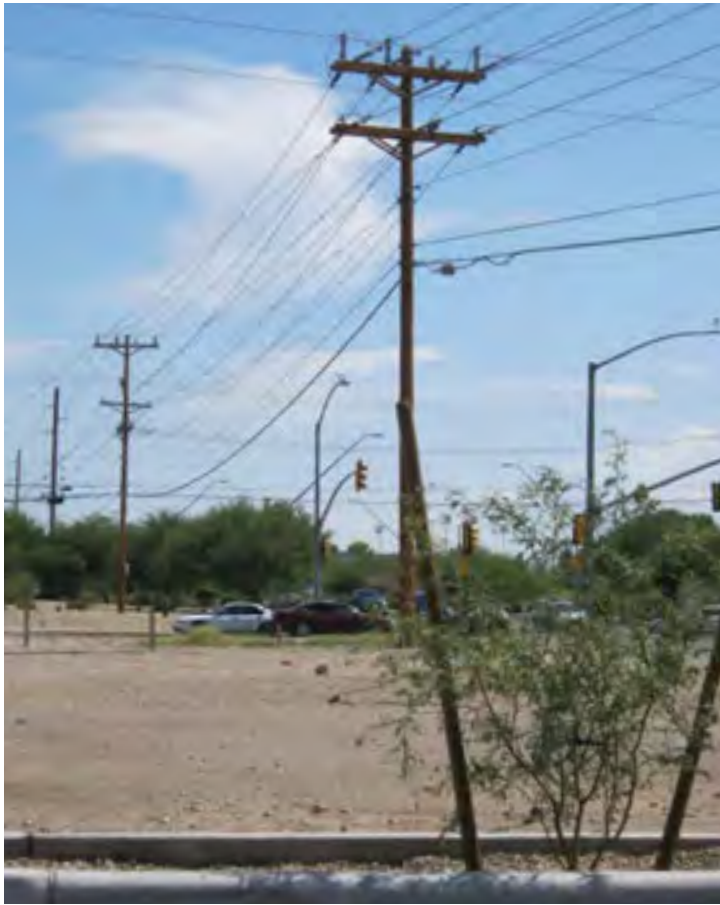
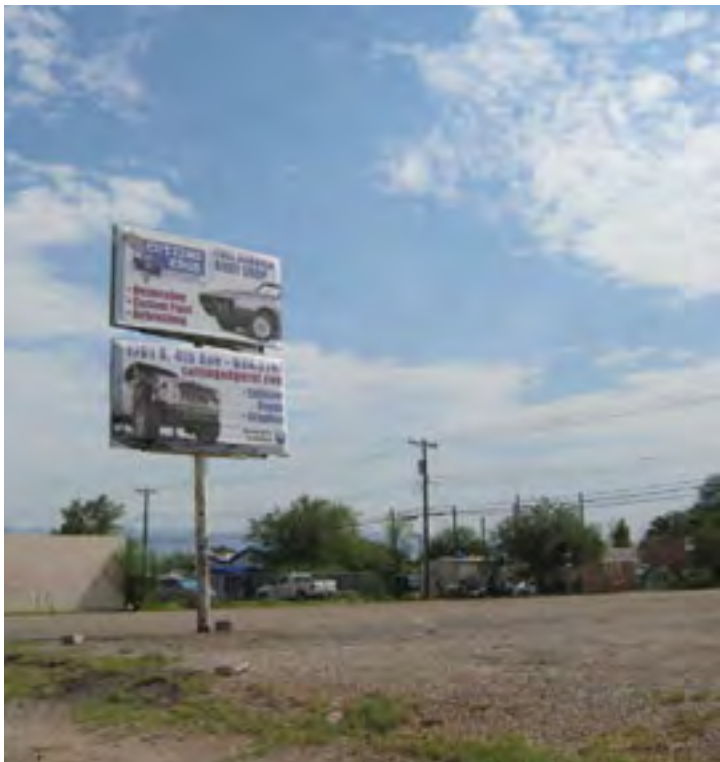
Photos above show vacant lots within the South 12th Avenue Commercial Corridor. In August 2012, 16.9 percent of parcels were vacant.

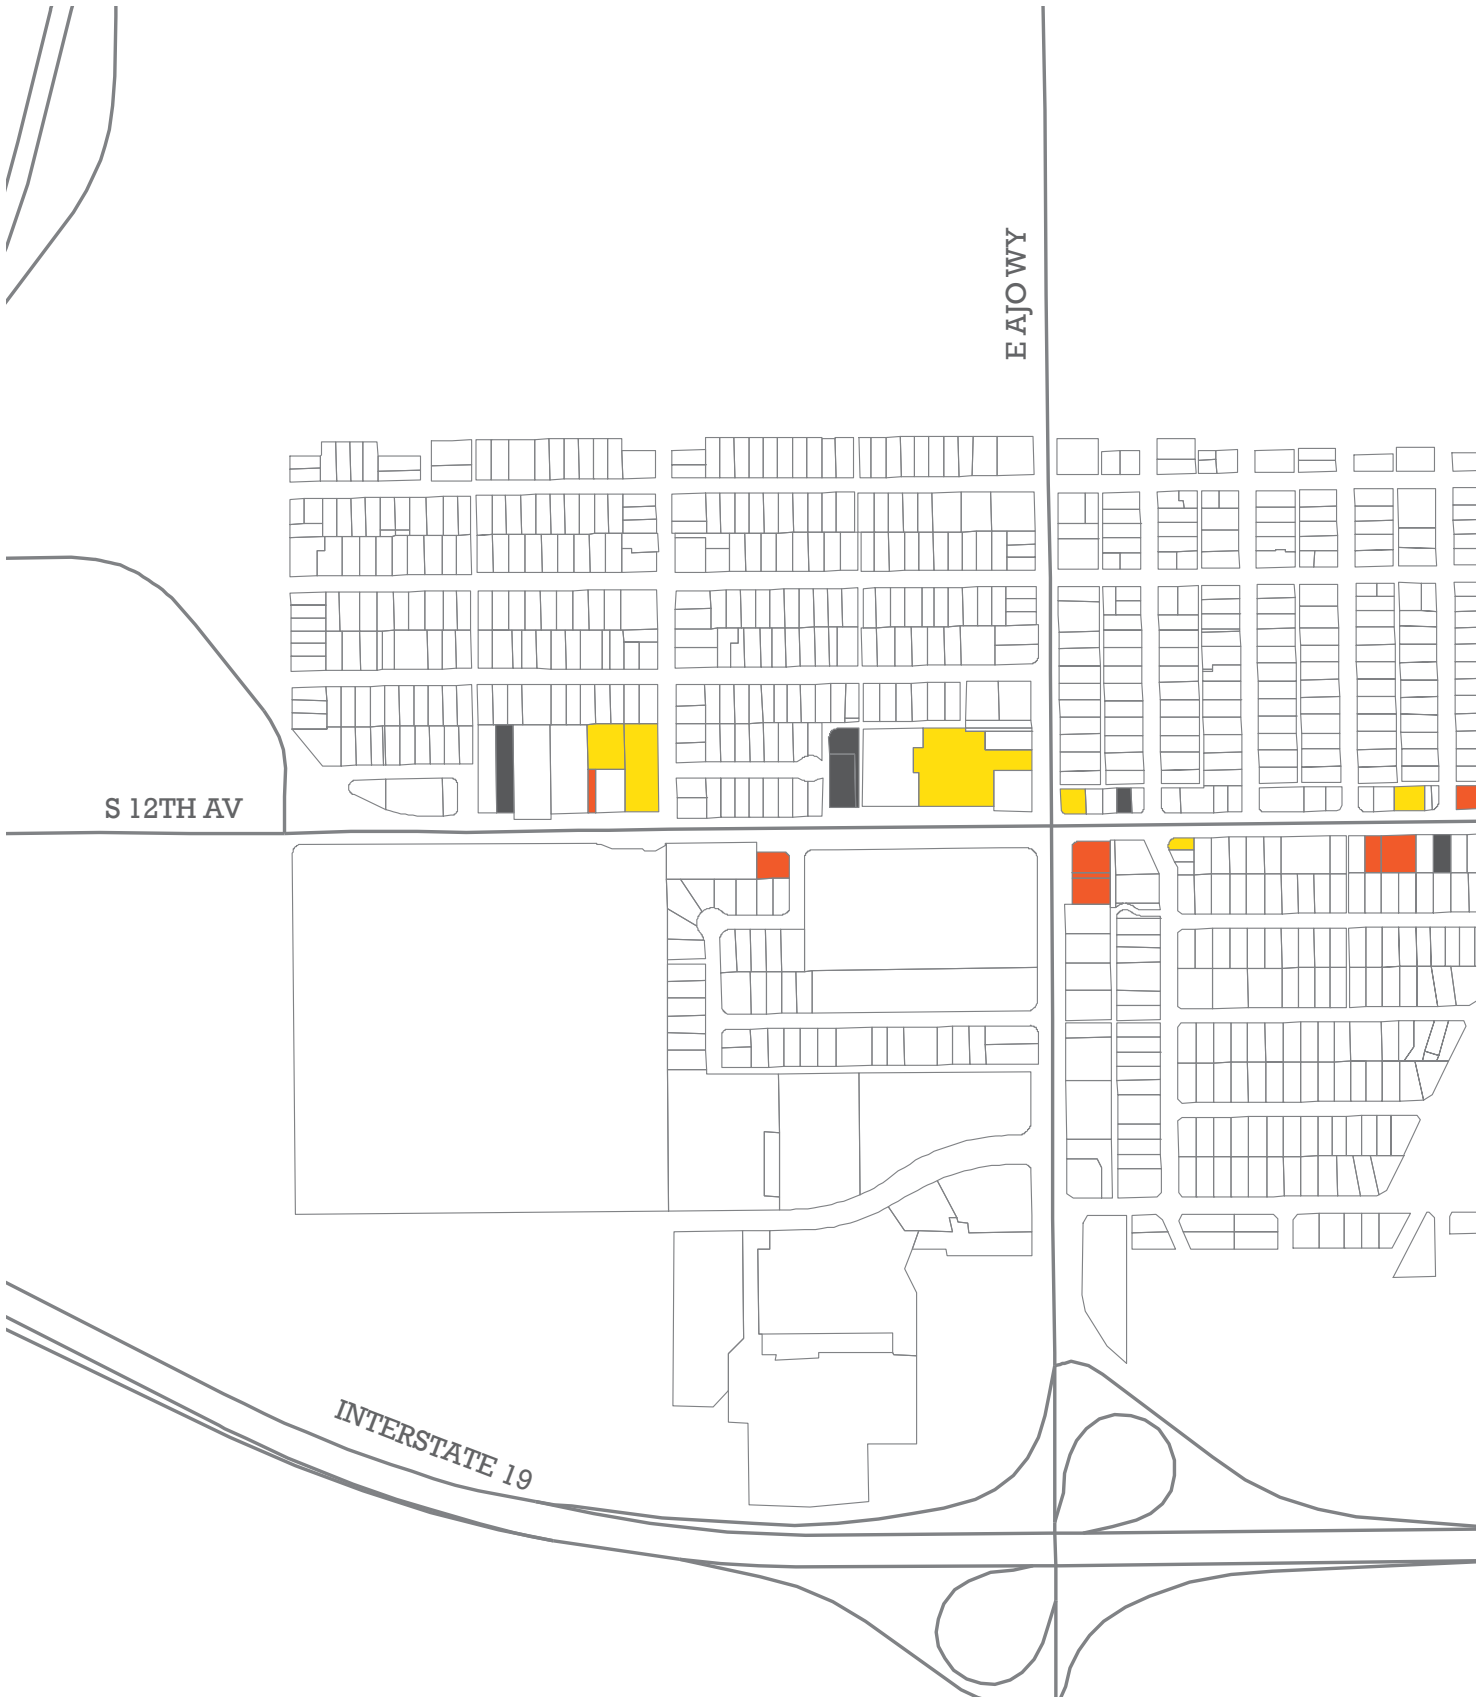
Figure 4.24: Parking Lots, Vacant Business Properties, and Vacant Parcels-South 12th Avenue Commercial Corridor. Source: Drachman windshield survey, 2012.

Drachman Institute identified 44 out of 260 parcels (16.9 percent) on the South 12th Avenue Commercial Corridor as vacant (see Figure 4.24).

An additional 21 out of 260 parcels (8.1 percent) are identified as surface parking lots (see Figure 4.24).

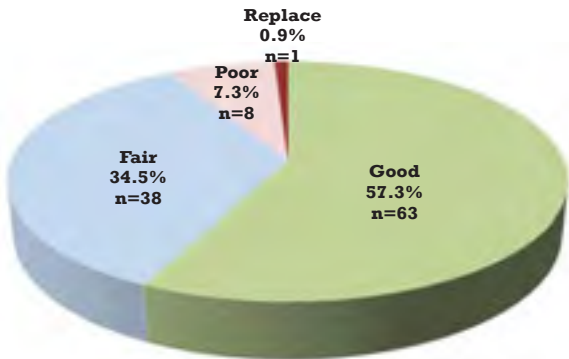
**Figure 6.20: Condition of All Business Properties- Benson Highway Commercial Corridor**  
*Excludes parking lots, vacant lots, residential, and parcels that were unable to be assessed.*

More than half (57.3 percent) of business properties on the Benson Highway Corridor are in ‘Good’ condition (see Figure 6.20). Approximately 34.5 percent are in ‘Fair’ condition requiring between \$5,000 and \$15,000 in repairs. Eight structures are in ‘Poor’ condition, indicating a need for repairs on the order of \$15,000 to \$50,000.

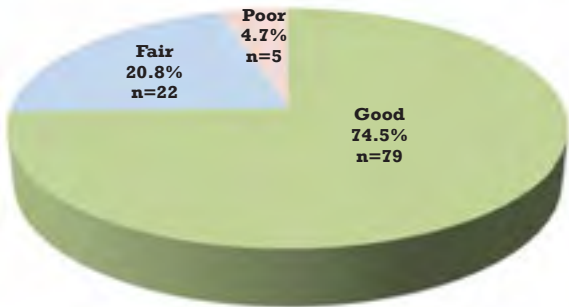
**Figure 6.21: Condition of Residences- Benson Highway Commercial Corridor**

The majority of residences on the corridor are also in ‘Good’ condition (Figure 6.21).

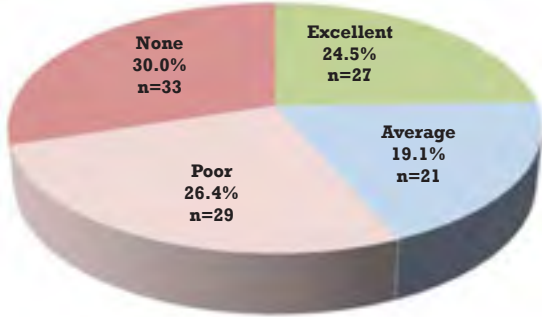
**Figure 6.22: Landscape Condition of All Business Properties- Benson Highway Commercial Corridor**  
*Excludes parking lots, vacant lots, vacant buildings, and residential.*

Approximately 30.0 percent of business properties on the Benson Highway Corridor do not have landscape or grounds to assess (Figure 6.22). Almost one-quarter of business properties have grounds assessed as ‘excellent,’ which means that landscape is both intentional and maintained.

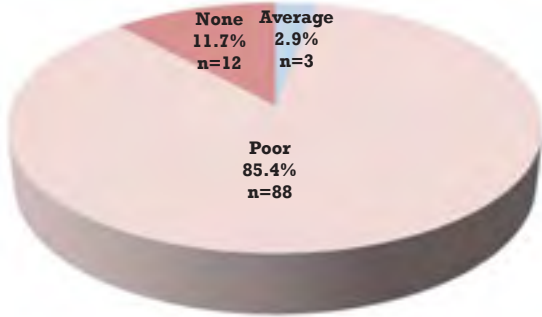
**Figure 6.23: Landscape Condition of Vacant Lots- Benson Highway Commercial Corridor**  
*Note: 95/103 vacant lots had litter and 14 had graffiti at the time of the windshield survey.*

Of note is the condition of vacant lots on the corridor. More than 85 percent of vacant lots had grounds in poor condition and 95/103 lots had litter at the time of the windshield survey (Figure 6.23).

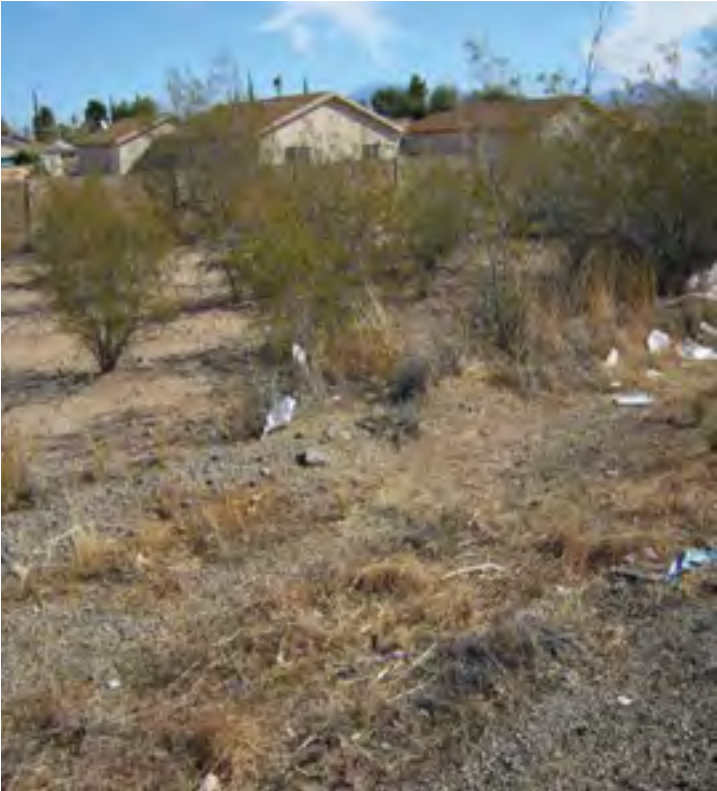
Drachman Institute identified 103 vacant parcels on the corridor.

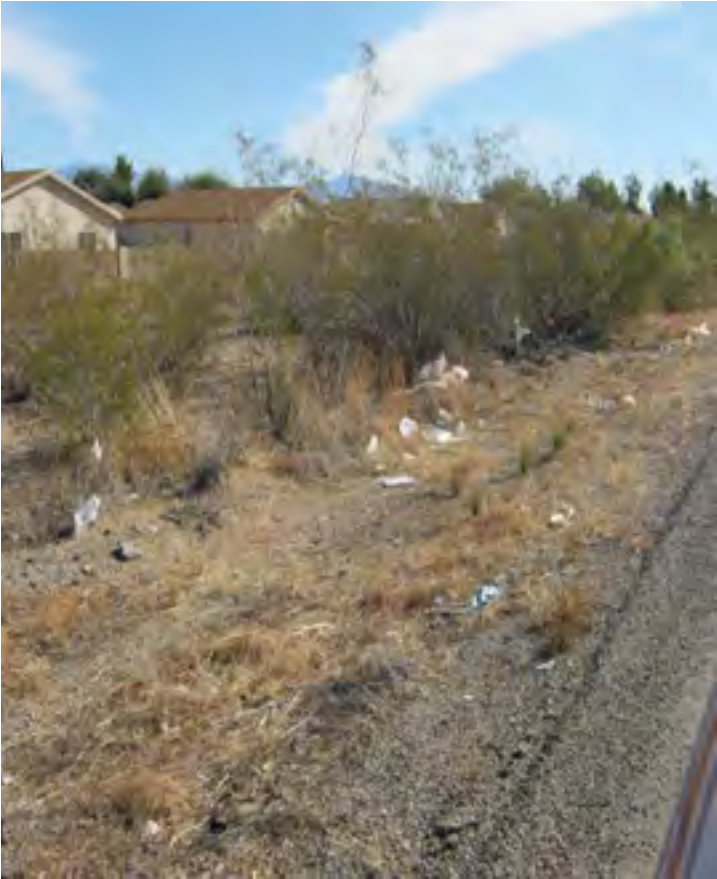
Drachman Institute identified 103 out of 335 parcels (30.7 percent) on the Benson Highway Commercial Corridor as vacant (see Figure 6.24). Litter is a problem on vacant land as 92.2 percent of vacant parcels had litter at the time of the windshield survey.

Litter is a problem on vacant land along the corridor.

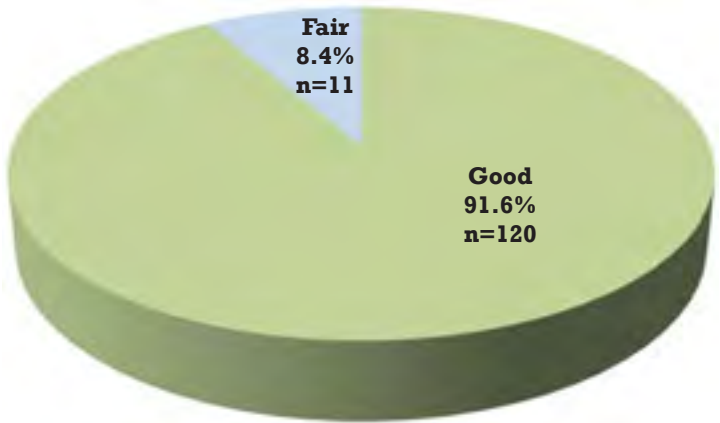
**Figure 7.20: Condition of All Business Properties-Irvington Road Commercial Corridor**  
*Excludes parking lots, vacant lots, residential, and parcels that were unable to be assessed.*

The majority (91.6 percent) of business properties on the Irvington Road Corridor are in ‘Good’ condition (see Figure 7.20). Approximately 8.4 percent are in ‘Fair’ condition requiring between \$5,000 and \$15,000 in repairs.

Seven business properties on the corridor are vacant. Of these vacant businesses, all are in ‘Good’ condition.

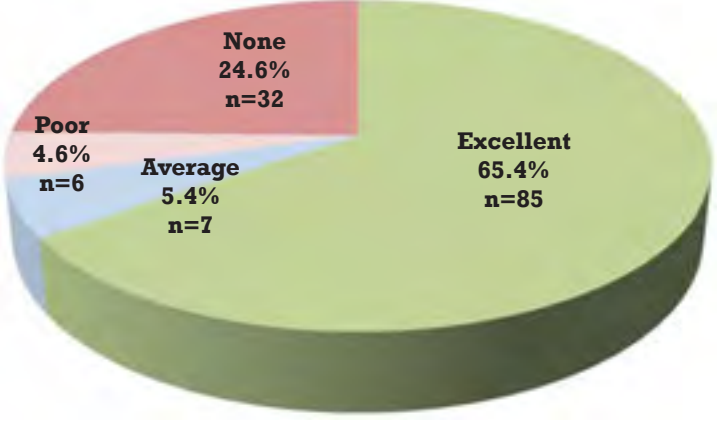
**Figure 7.21: Landscape Condition of All Business Properties-Irvington Road Commercial Corridor**  
*Excludes parks, parking lots, vacant lots, vacant buildings, and residential.*

Approximately one-quarter of business properties on the Irvington Road Corridor do not have landscape or grounds to assess (Figure 7.21). Approximately 65 percent of business properties have grounds assessed as ‘excellent,’ which means that landscape is both intentional and maintained.

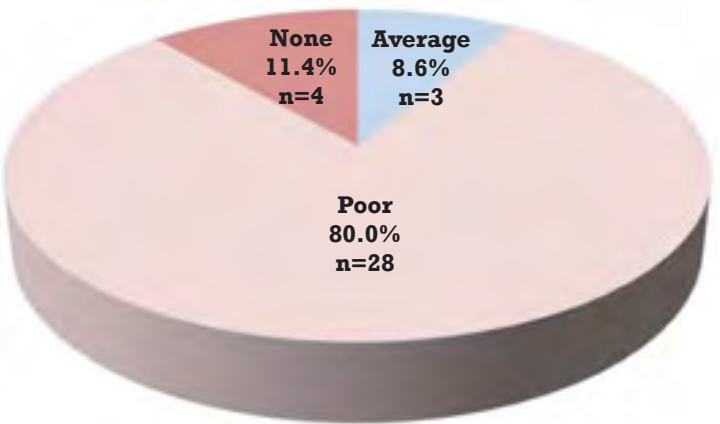
**Figure 7.22: Landscape Condition of Vacant Lots-Irvington Road Commercial Corridor**  
*Note: All 35 vacant lots had litter and 27 of the 35 parcels had graffiti at the time of the windshield survey.*

Of note is the condition of vacant lots on the corridor. Twenty-eight of the thirty-five vacant lots had landscapes in poor condition and all thirty-five had litter at the time of the windshield survey (Figure 7.22).

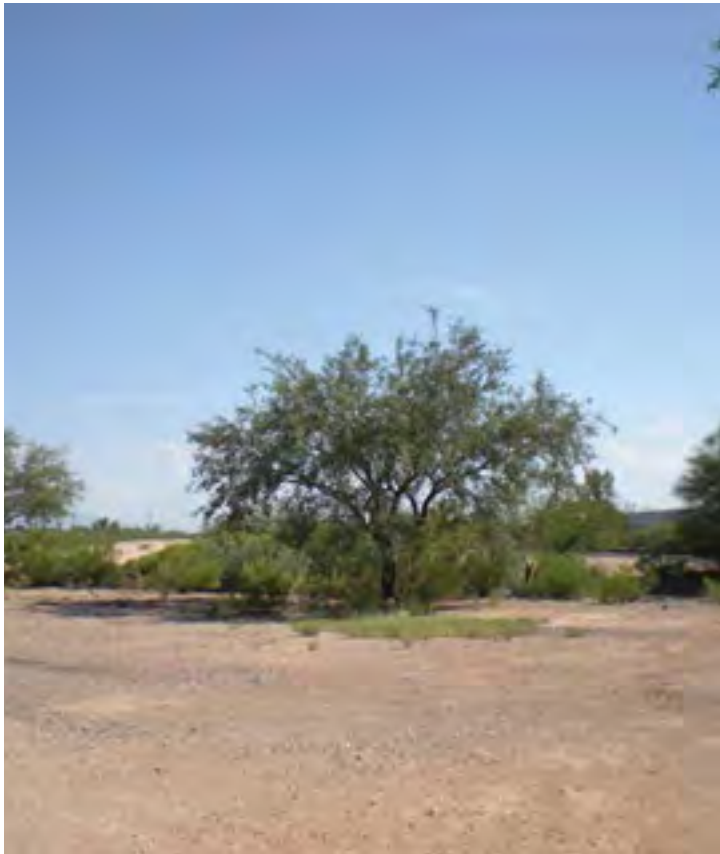
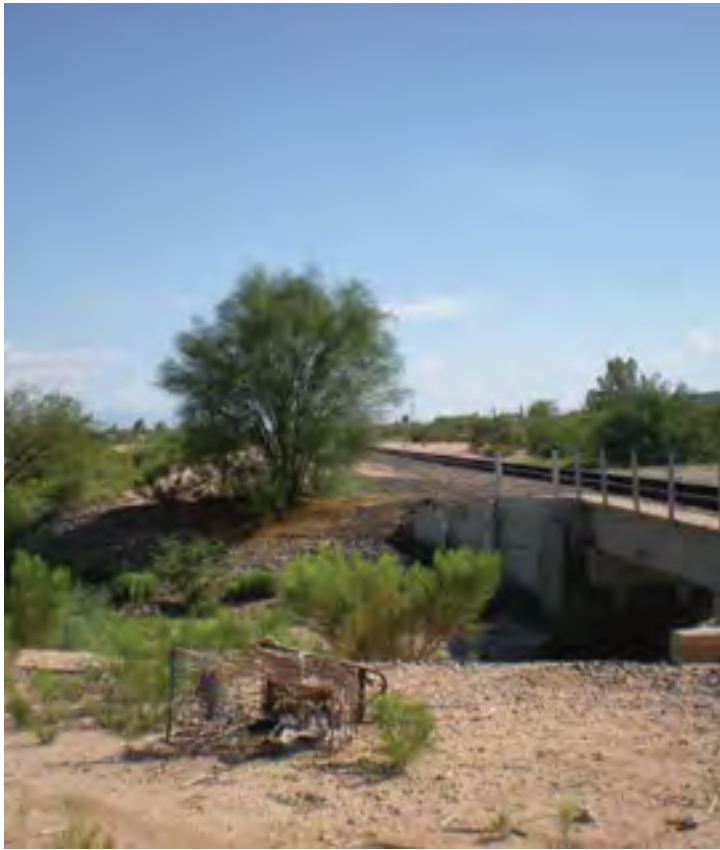
Drachman Institute identified 35 out of 233 parcels (15.0 percent) on the Irvington Road Commercial Corridor as vacant (see Figure 7.23). Litter is a problem on vacant land as all thirty-five vacant parcels had litter at the time of the windshield survey.

Litter is a problem on vacant land on Irvington Road.
