# HISTORIC STRUCTURES REPORT

## **BATES WELL RANCH ORGAN PIPE NATIONAL MONUMENT**

A Service Learning Project of the  
Preservation Studies Program  
College of Architecture and Landscape Architecture  
The University of Arizona

May 2006

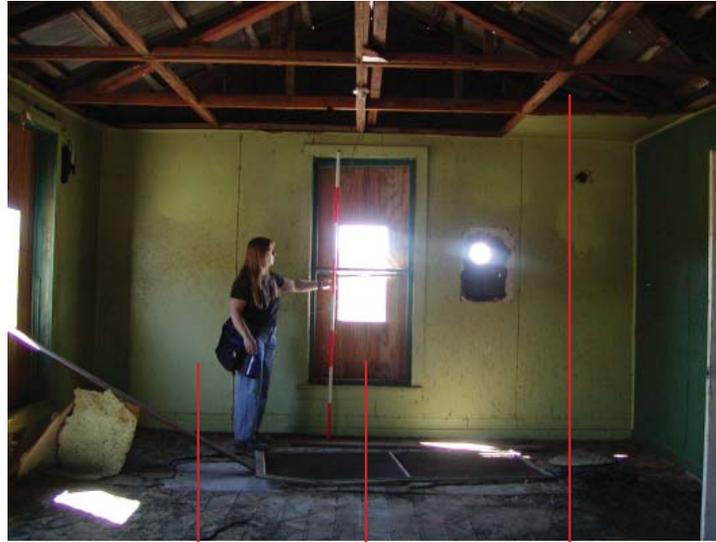
Fig. 7 - Interior Large Room of the Main Residence (letters refer to notes in condition assessment table below)

D F, E D

<b>Deficiencies</b>	<b>Recommended Treatments</b>	<b>Priority</b>
A	Corrugated Steel rusted through	Replace or seal roof from further water damage	Serious
B	Rotted/termite infested Wood	Application of biocides where severe damage.	Critical
C	Missing Components	Replace lost components	Serious
D	Water Damage	Repair/repalce roof and reinstall damaged material.	Serious
E	Broken Window Framing/ glazing	Replace and repair as needed	Serious
F	Items added after period of significance	Remove and return to original state	Critical

At the very least the roof should be sealed to prevent further infiltration of water into the exterior.

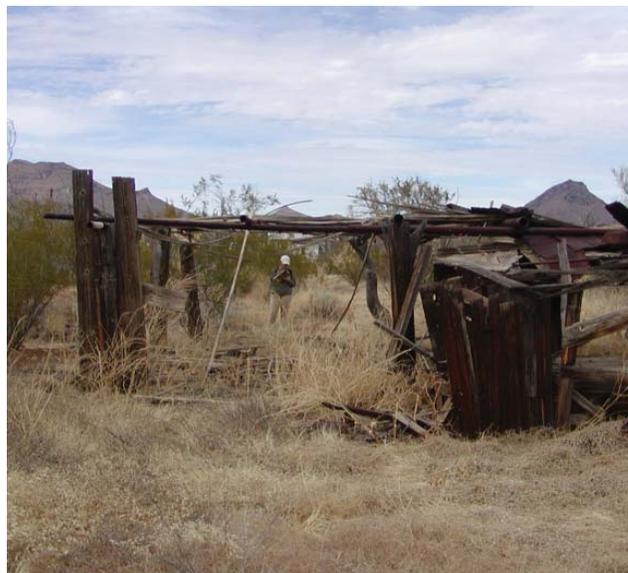
The Ramada is intact but it is difficult to complete an evaluation of the structure because we do not know the original intent of the builder. The material placed on top is composed of dimensional lumber, saguara ribs, and more steel pipe. There is many pieces of this material laying on the ground below the structure and it is assumed that this material at one time sat on top of the ramada. Structurally the ramada is ridge possibly having more to do with being tied on a grid system with the steel piping than the columns' foundations.

*Fig. 7 -South Elevation of the Ramada with Blacksmith Shop to the right.*

Overall condition of each structure is very poor and without proper intervention the structures should be expected to collapse. Shoring up the southwest corner of the building and elements of the ramada should be undertaken until a final determination is made on the site. Additionally, trees and grasses growing in, under and within 20 feet of the building should be removed to prevent possible fire damage.

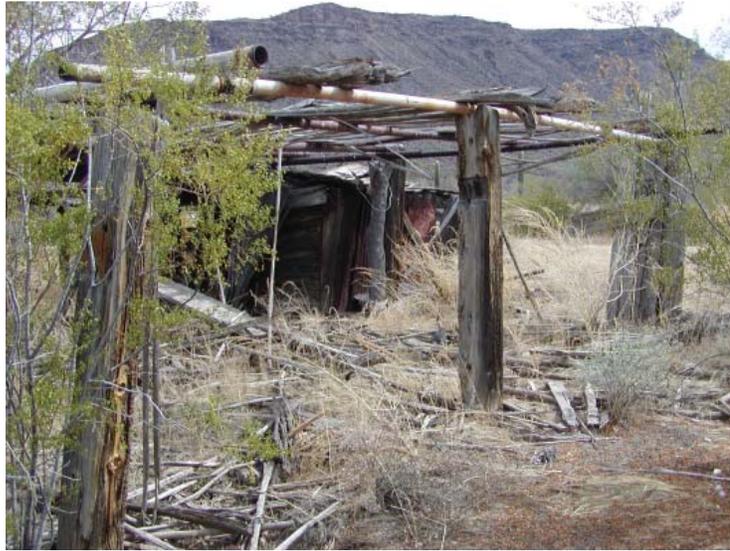
*Fig. 8 -West Elevation of the Ramada with Blacksmith Shop behind.*

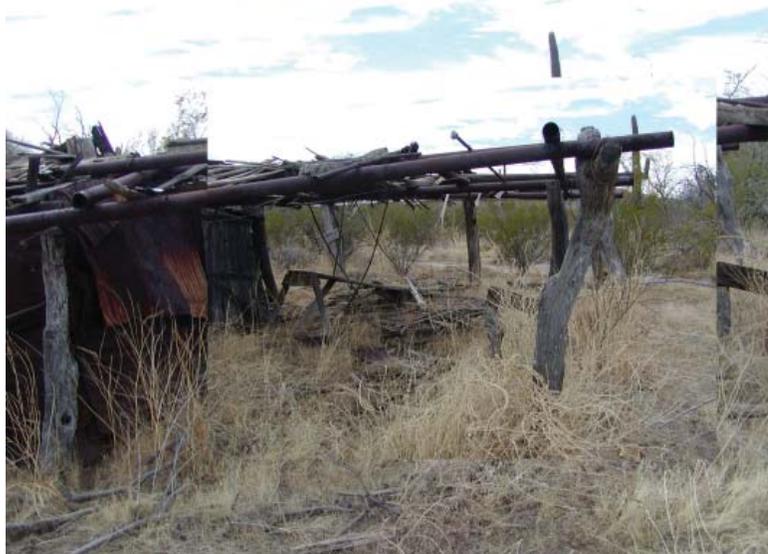
*Fig. 8 -East Elevation of the Ramada with Blacksmith Shop to the left.*

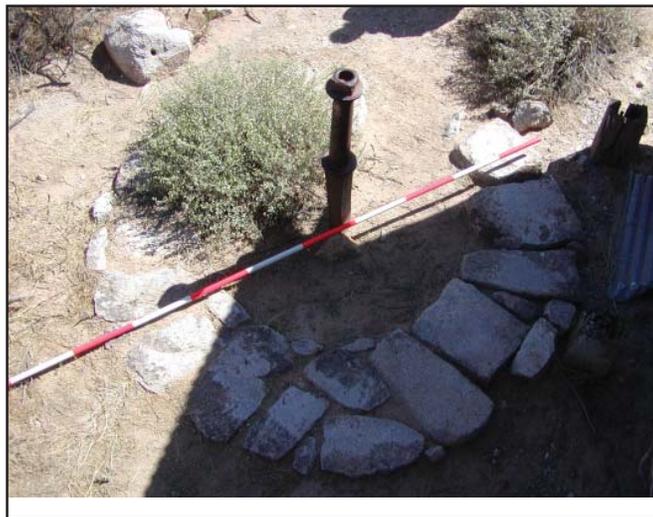
The arrastra is approximately eight feet in diameter and constructed of flat-topped granitic stones set at grade; several of the support stones forming the base are missing. A 3' 9" tall machined metal axle is inset in the center of the structure and would have provided support for the grinding wheels or drag stones. Based on the material used to construct the support axle, it is likely that the feature is Anglo in origin. The arrastra is in fair condition, although there is some minimal sheetwash erosion and disturbance from vegetation growth.

*Fig. 1 - View of the Arrastra from the north*

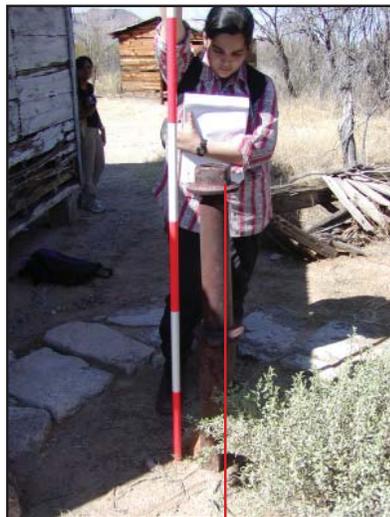
*Fig. 3 - Center axle of Arrastra (letters refer to notes in condition assessment table below)*

<b>Deficiencies</b>	<b>Recommended Treatments</b>	<b>Priority</b>
A	Missing Granite Stones	Replace with same	Serious
B	Missing arm and wheel	Replace if period becomes part of significance.	None

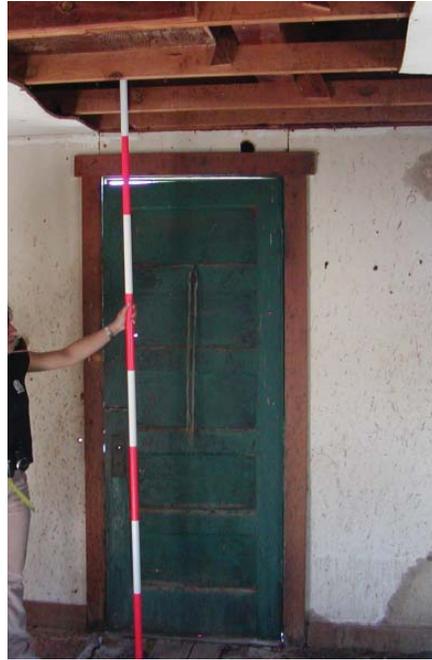
*M, A, B. Detail view of window on west elevation. Note the wire mesh screen coming off & new board above*

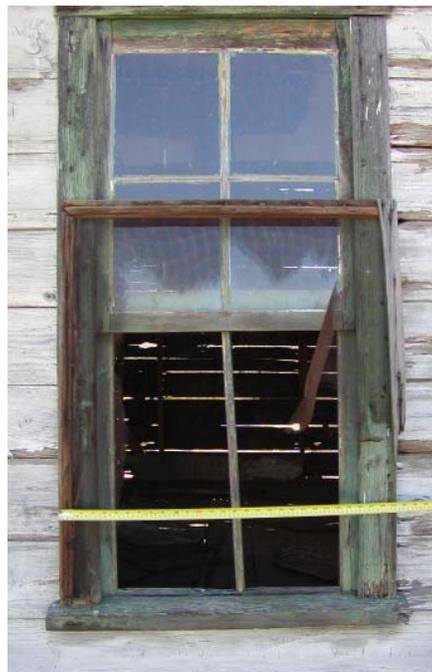
*M. View of the window on north wall. Note the new frame nailed on top .*

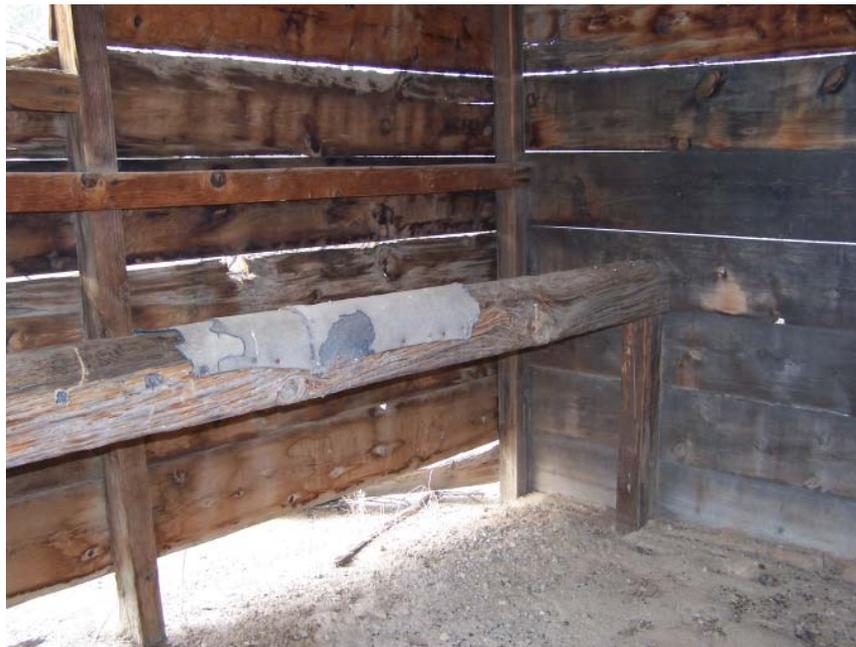
*Fig. 2 - View of the saddle bar in the interior*

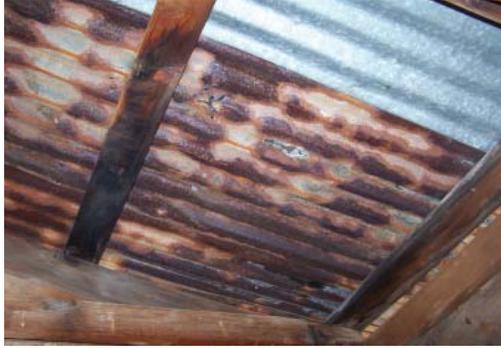
*E. Rusting of the corrugated metal roof due to water damage*

<b>Deficiencies</b>	<b>Recommended Treatments</b>	<b>Priority</b>
A	Water damage to wood paneling and fascia including warping and splintering.	Correction of the source of water Replace the wooden planks where severely damaged; match the size & type of wood to existing.	Serious
B	Rotting of wood due to microorganisms/ pests (also termite) infestation.	Application of biocides where severe damage.	Critical
C	Missing parts from wood planks	Replace entire plank where substantial parts missing or structural stability is endangered.	Serious
D	Corrosion and deterioration of wood around iron nails on edges.	Apply anti-rust coating on nails before replacement planks are installed.	Serious
E	Rusting of the corrugated metal roof due to water damage	Replace the sheets which are severely rusted.	Serious
F	Falling apart of the metal sheets on the roof esp. the central ridge	Replace/reattach the portions that are coming apart. Use identical sheeting for replacement	Critical

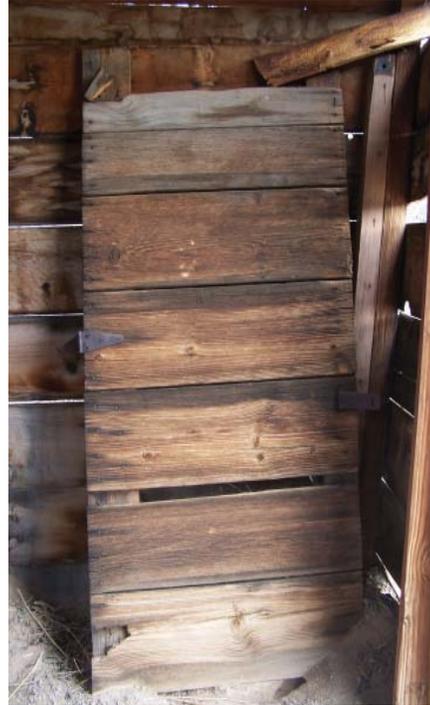
*H. Dis-hinged entrance door lying inside the structure.*

G	Staining of wood due to water damage.	Correction of the source of water; pay attention to roof leaks & holes in wall panels.	Serious
H	Dis-hinged entrance door	Reattach the door.	Critical
I	Tilting of the structural wooden posts leading to de-stability & bending of the shed sideways.	Stabilise the structure by realigning the main structural posts. If necessary reassess the condition of the tie-beam and strengthen it to bind the structure	Critical
J	Falling apart of the wooden planks near the base of the structure.	These pieces should be nailed back to the structure.	Critical

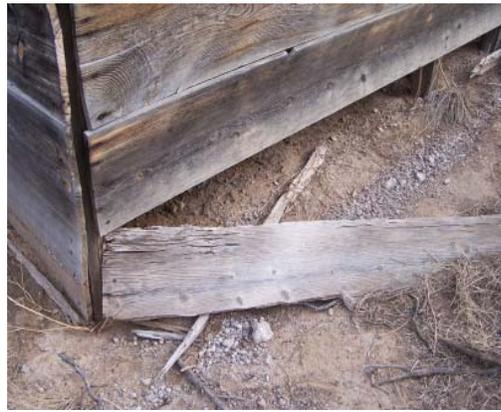
*J. Falling apart of the wooden planks near the base of the structure.*

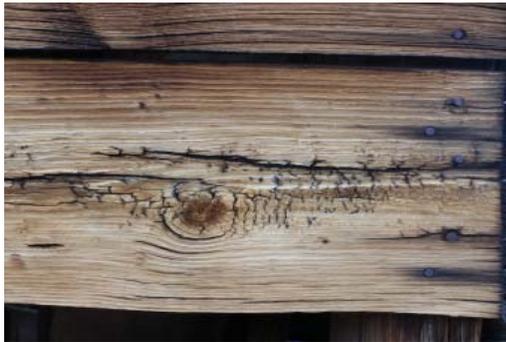
*B. Rotting of wood due to microorganisms/ pests (also termite) infestation.*

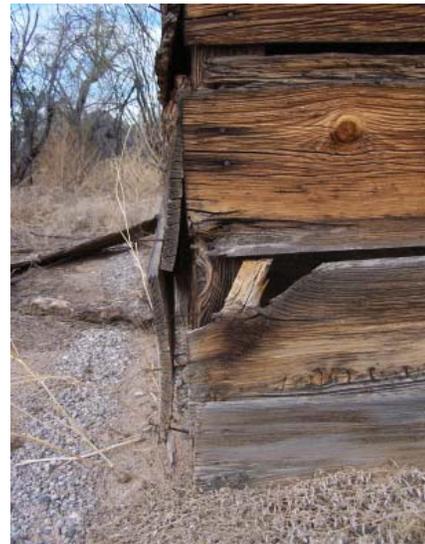
*A,B,C. Water damage to wood paneling and fascia including warping and splintering & rotting due to microorganisms/ pests.*

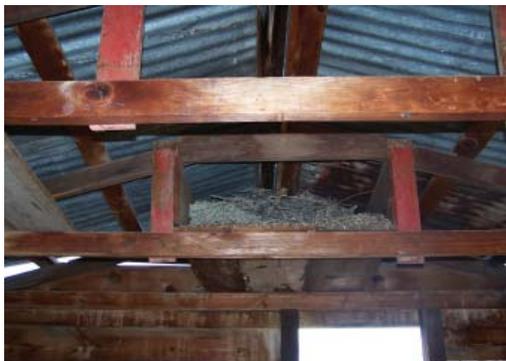
*Bird nests in the roof platform inside the structure*

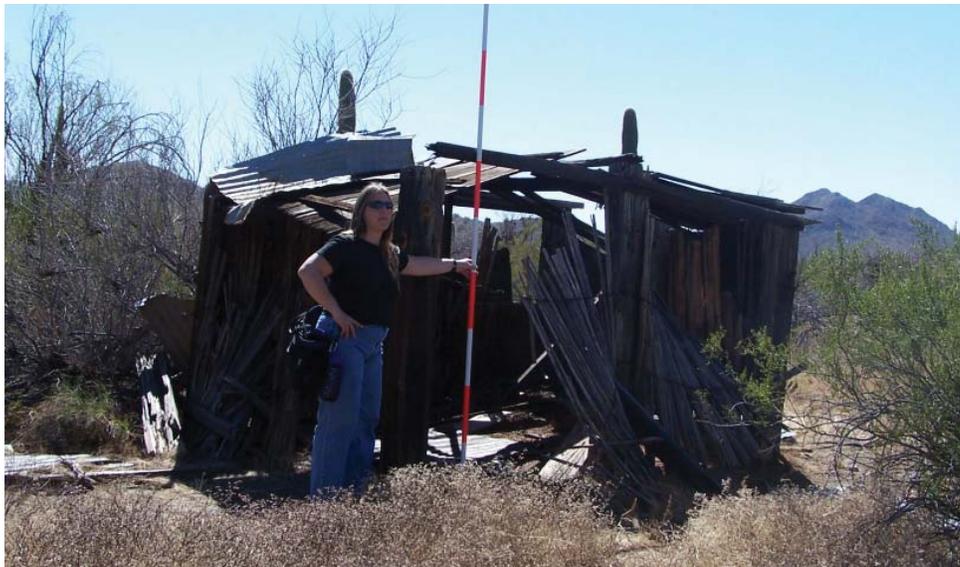
*Fig. 1 - View of the north elevation of the Ocotillo Shed*

At present, the condition of the structure has been assessed as poor relative to the other ranch structures on site. This is primarily because of the severe structural damage that it has suffered. The walls are all falling apart with the fallen pieces all lying around the site. The causes for this are the biodeterioration of the saguaro ribs as well as the coming off of the barbed wire that was holding them together. Also the metal sheets that formed parts of the wall are all coming apart. In addition the roof of the structure is in very bad shape and the covering material is almost absent. If immediate steps to stabilize this structure are not taken, it may very soon be reduced to a heap of materials lying on the ground.

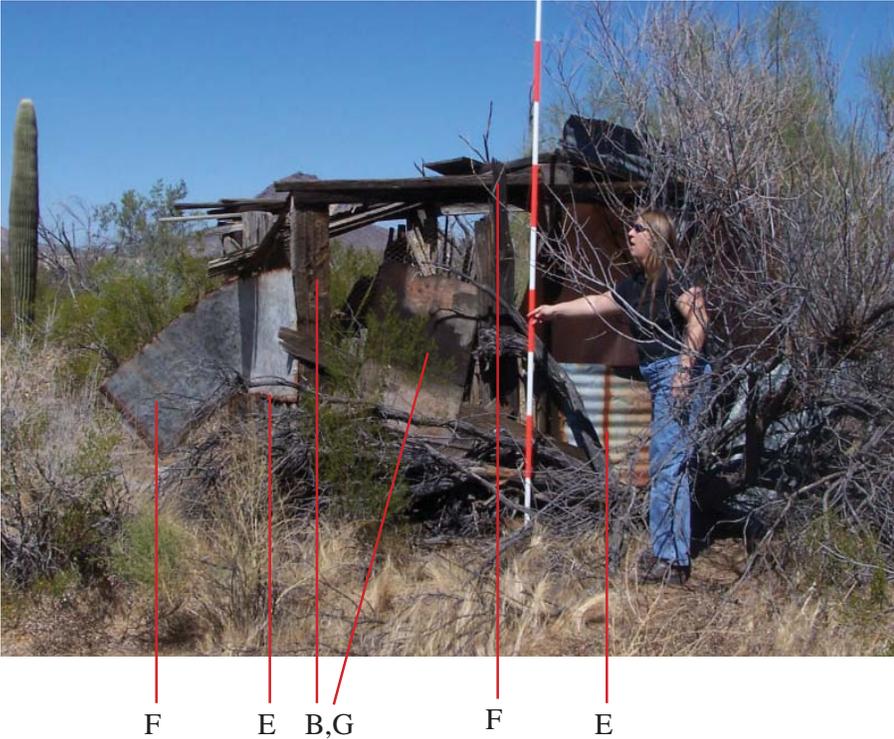
*Fig. East elevation of the Ocotillo Shed  
(Letters refer to notes in condition assessment table ahead)*

<b>Deficiencies</b>	<b>Recommended Treatments</b>	<b>Priority</b>
B	Rotting of wood due to microorganisms/ pests (also termite) infestation.	Application of biocides where severe damage.	Serious
C	Missing parts from wood planks	Replace entire plank where substantial parts missing or structural stability is endangered.	Critical
D	Corrosion and deterioration of wood around iron nails on edges.	Apply anti-rust coating on nails before replacement planks are installed.	Serious
E	Rusting of the corrugated metal roof due to water damage	Replace the sheets which are severely rusted.	Serious
F	Falling apart of the metal sheets on the roof and walls	Replace/reattach the portions that are coming apart. Use identical sheeting for replacement	Critical
G	Staining of wood due to water damage.	Correction of the source of water; pay attention to roof leaks & holes in wall panels.	Serious
I	Tilting of the structural wooden posts leading to de-stability & bending of the shed sideways.	Stabilise the structure by realigning the main structural posts. If necessary reassess the condition of the tie-beam and strengthen it to bind the structure	Critical

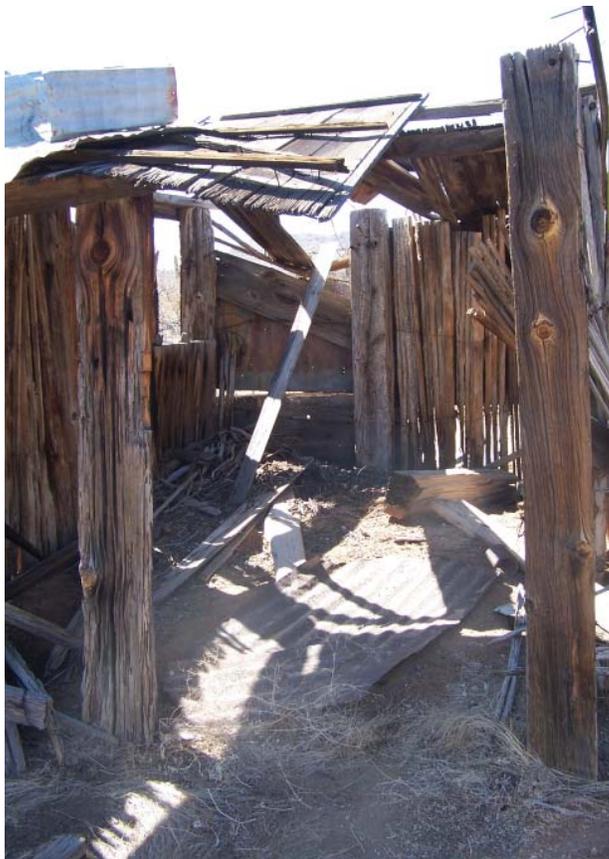
*View of the inside of the Ocotillo shed*

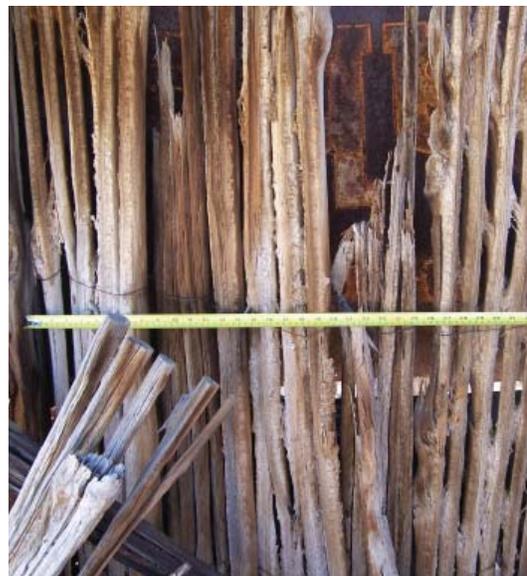
*View of the saguaro ribs tied with barbed wire that make up the walls of the shed.*

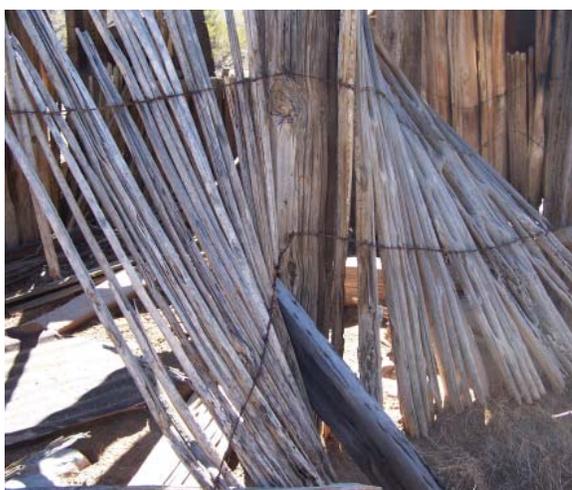
*View showing the tilting of the walls*

Q	The tilting of rib - walls	Replace the saguaro/ ocotillo ribs that are missing or damaged and re-attach them using barbed wire, then prop up the wall again	Critical

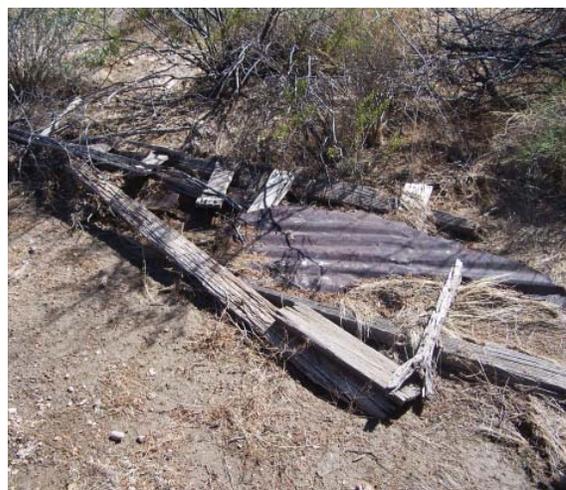
*View of the parts of the structure lying scattered around on the site*

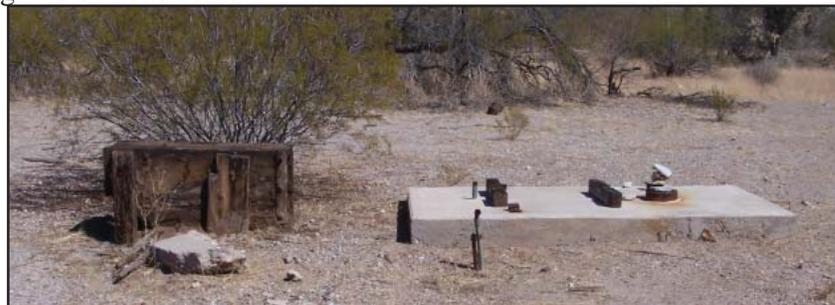
At present, the condition of the structure has been assessed as fair relative to the condition of the other ranch structures on site. There are few visual clues however to associate the individual pieces with what was once a critical element of daily ranch life for the Bates Well Ranch. More than just their adjacency is required to help visitors understand its importance. The unknown state of the well shaft itself ought then to be assessed and the possibility of reinstating the function of the well ought to be considered.

*Fig. 1 - View of concrete slab of covered well and wooden generator platform*

<b>Deficiencies</b>	<b>Recommended Treatments</b>	<b>Priority</b>
A	Material displacement	Reorganize elements into a more cohesive cluster: rebuild water tank platform, orient with concrete slab	Critical
B	Corrosion of iron due to water	Chemically treat or replace elements whose integrity is damaged by corrosion	Critical
C	Convexity caused by structural damage	Reform the tank bottom	Serious
D	Concavity in metallic sheeting	Reform the tank sides	Serious
E	Vegetable overgrowth	Trim or remove vegetation that obscures visibility and orientation of elements into a cohesive grouping	Serious
F	Staining of material due to water	Allow to occur naturally	Low

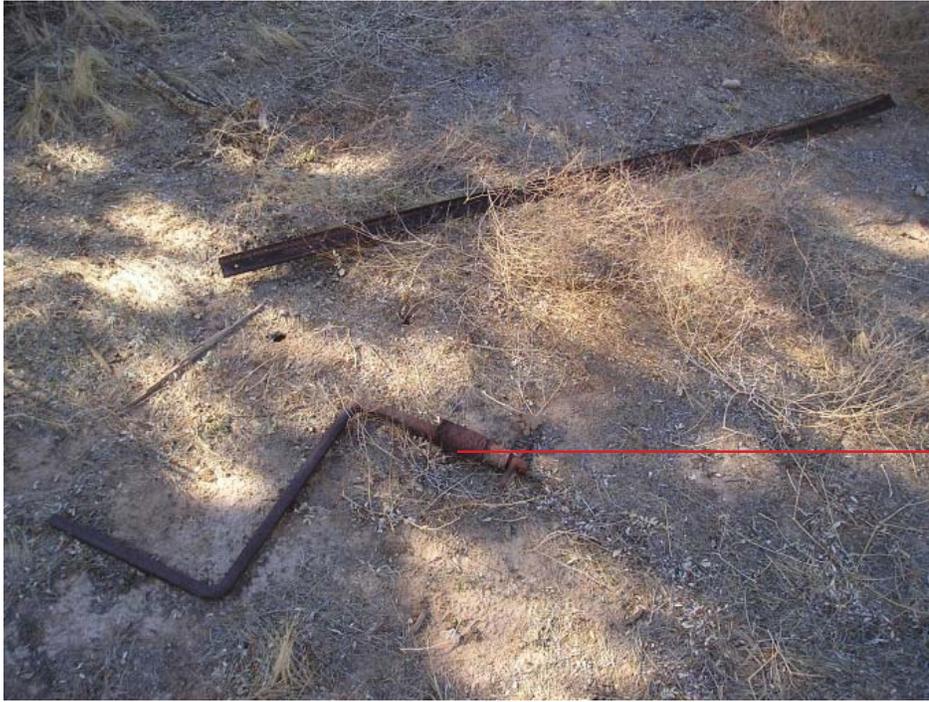
The pipes the water from the well to the southern corral are disconnected, broken and pieces of it lie around the base of the structure. The concrete pad is in good shape

Fig 4. Bits of the pipe that fed water from Windmill #1 to the trough at Southern Corral.. (letters refer to notes in condition assessment table below)

<b>Deficiencies</b>	<b>Recommended Treatments</b>	<b>Priority</b>
A	Detached and/or missing components. Windmill Blades missing, Connector between rotor and well pump detached. Horizontal member detached at base of windmill frame. Pipes to Southern Corral detached, missing and rusted	Repair and Reattachment of existing members if possible. Replacement of damaged/missing members.	Critical
B	Rusting of metal parts Well cap, pipe, diagonal bracing of windmill frame	Chemically treat or replace elements whose integrity has been damaged by corrosion	Critical
C	Vegetation Overgrowth around Structure	Trim or remove vegetation that obscures visibility and orientation of elements into a cohesive grouping	Serious
D	Staining of material due to water	Allow to occur naturally	Low
E	Cracking in Concrete Pad	Stitch crack or replace pad	Low

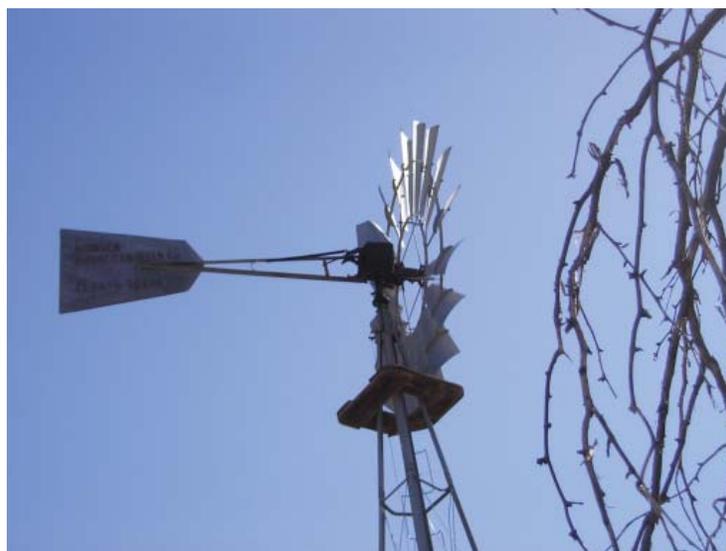
Windmill #2 is in best shape among the three windmills on site, with its blades and vane intact and the capacity for turning action when there is a breeze. It is nearest to the Eastern Corral. Its frame is in good shape, with none of the members missing or badly deteriorated. There is not a significant amount of rust. The connection between the rotor and the pump is broken and hence the windmill does not serve its function. Both the windmill and the adjacent water tank have suffered deterioration due to weathering. There is some rusting seen in the body of the water tank, as well as in the cylindrical corrugated metal casing for the pump. The platform of the water tank, constructed out of railroad ties, needs to be stabilised as some of the wooden members as well as the connections that keep them together are deteriorating. The ladder to the tank platform is missing.

*Fig 2. View of Windmill #2 - blades and vane from the north side.*

The windmill can be left as is.

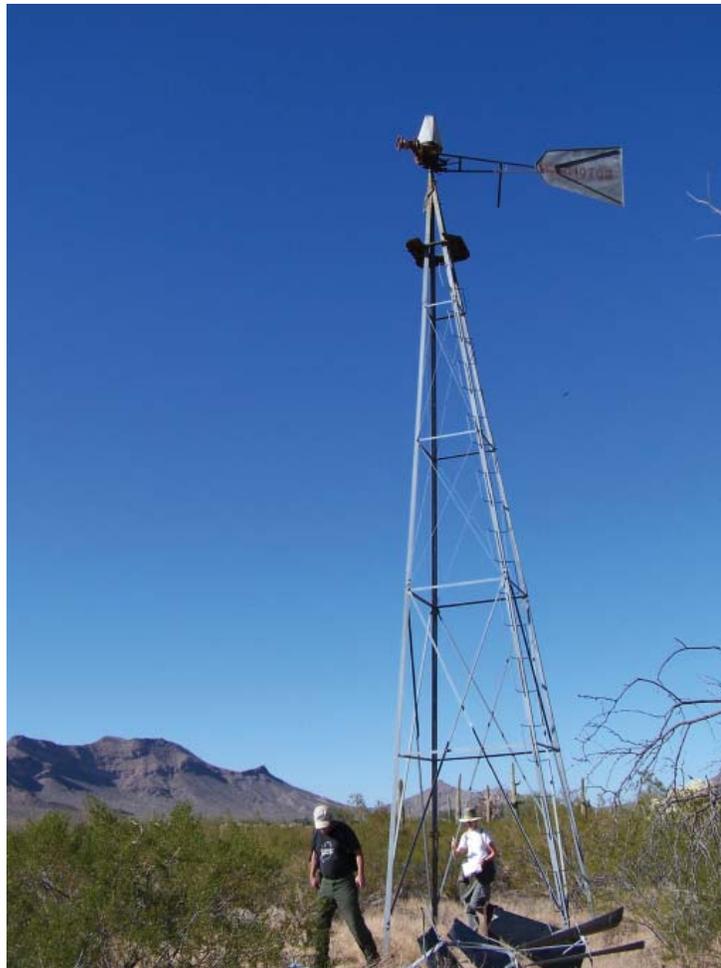
*Fig 1. Photograph of Windmill#3 taken from the south-west direction.*

The Windmill#3 is the most isolated among the three windmills and is the north-most structure in the Bates Well Ranch complex. The blades have fallen to the ground, and lie near the base of the windmill. They are in somewhat less of a damaged state than those of Windmill#1. The connection between the rotor and the pump is broken. The windmill has suffered deterioration due to weathering.

The windmill can be left as is.

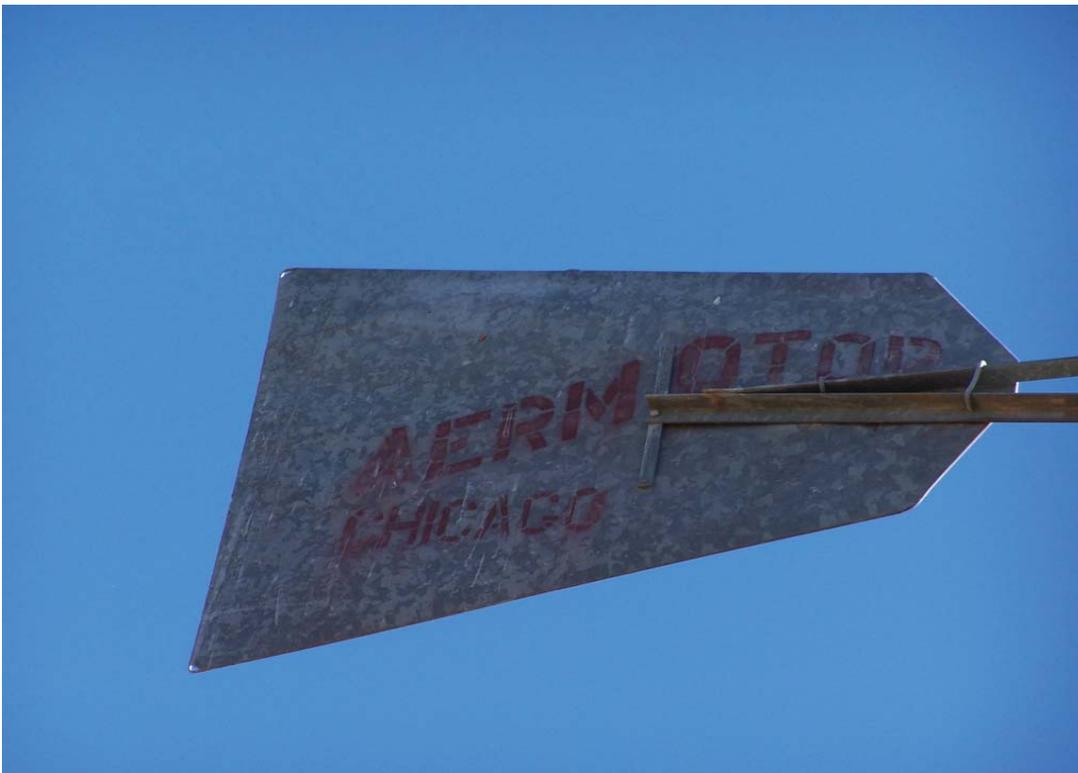
*Fig 2. View of vane - windmill#3*

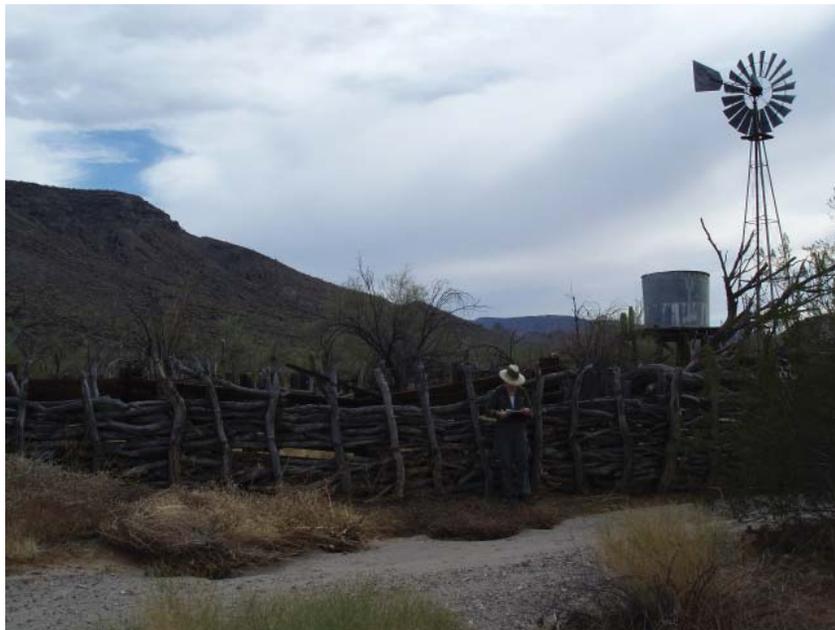
*Fig. 1 - View of the north most wall of East Corral*

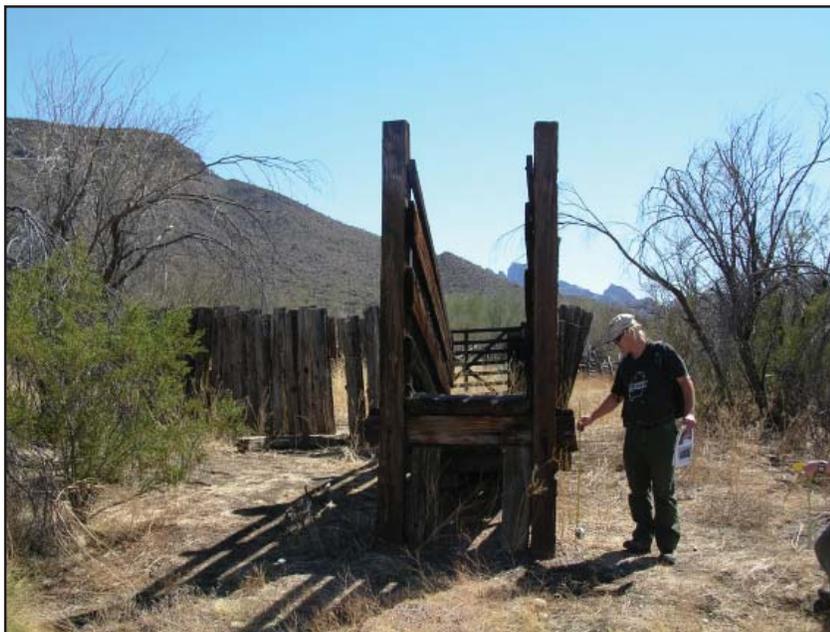
*Fig. 1 - View of the cattle chute & northmost fence of the South Corral*

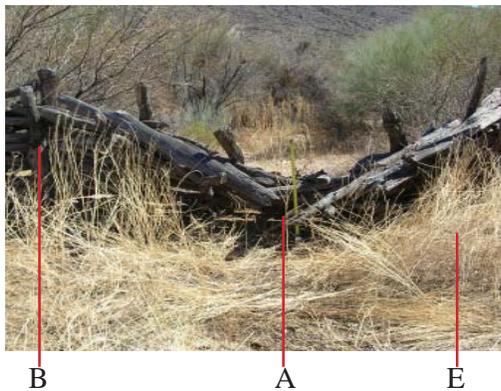
3: Collapsed portion of mesquite stacked fence
