HISTORIC STRUCTURE REPORT

FIRST ADMINISTRATION BUILDING

GRAND CANYON NATIONAL PARK

June 2008

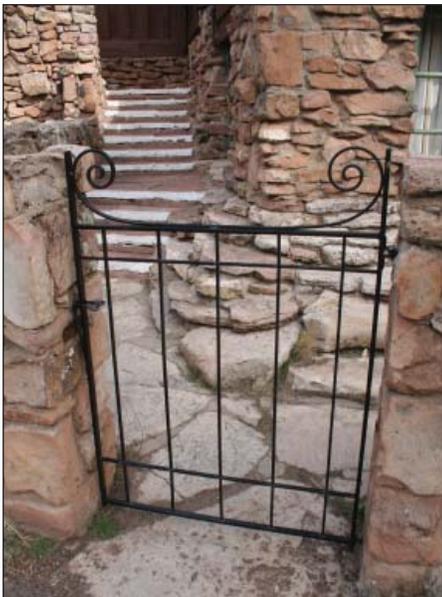
FIG. S7: Iron gate in the stone patio wall. Note lack of handrails on stair in the background, 2007.

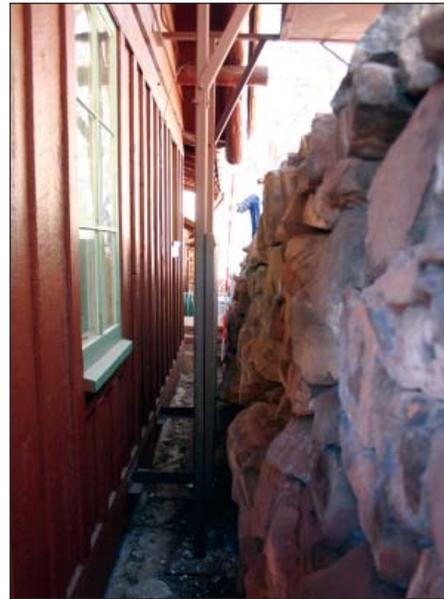
FIG. S10: Buckled stone retaining wall on the north side of the building, 2007.

The site should be assessed and re-graded in consultation with a landscape architect. The weathered paving stones should be re-set with compatible mortar and the buckling retaining walls repaired. Handrails should be installed in a manner sympathetic to the character of the building.

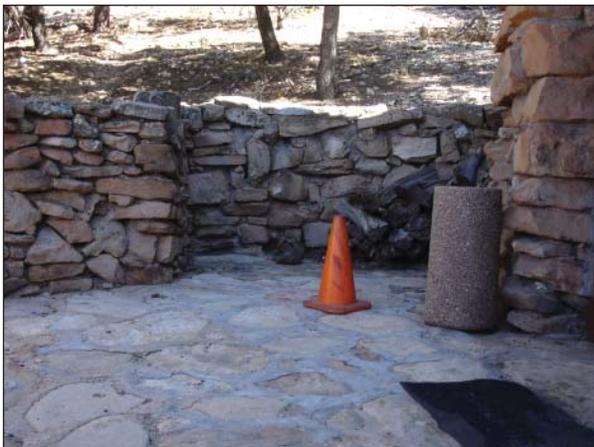
FIG. S11: Uneven paving near the entrance to Room One due to differential weathering of materials. Note the north stone retaining wall in the background, 2007.

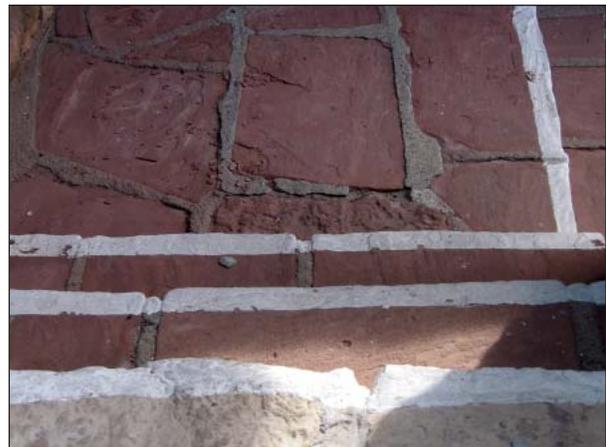
FIG. S12: Uneven pathway and steps due to differential weathering of materials, 2007.

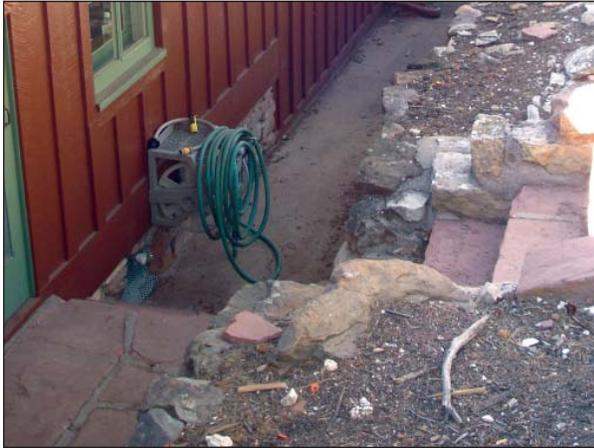
FIG. S13: View of the north stair showing site slope that directs water toward the north side of the building, 2007.

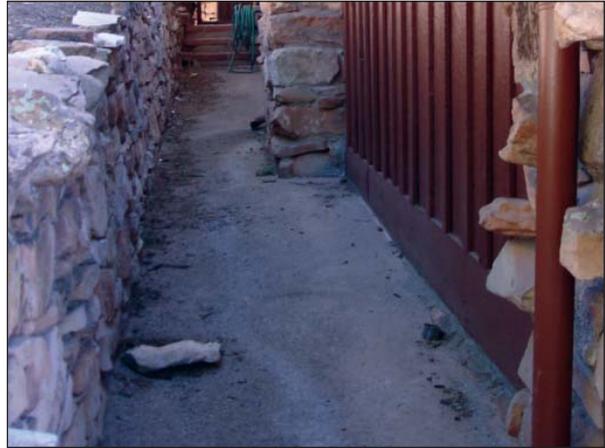
FIG. S14: View facing west showing the concrete walkway that directs water toward the building, 2007.

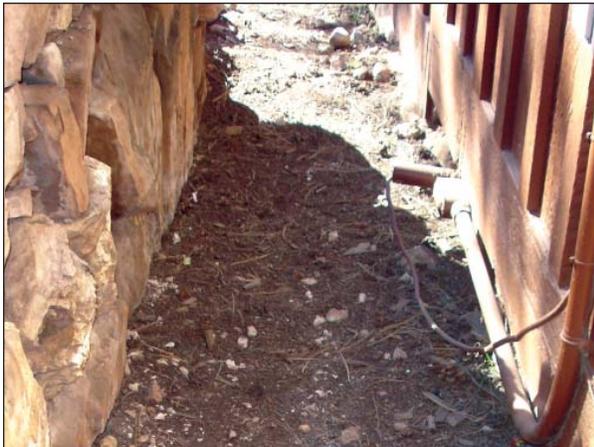
FIG. S15: Debris-filled walkway near the northeast retaining wall that directs water toward the foundation, 2007.

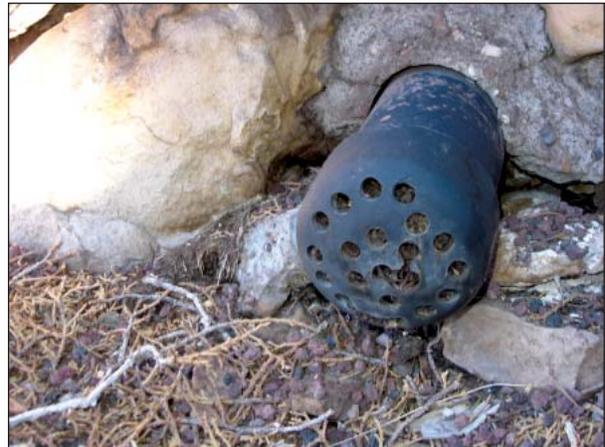
FIG. S16: Debris-filled drainage pipe on the south stone patio wall, 2007.

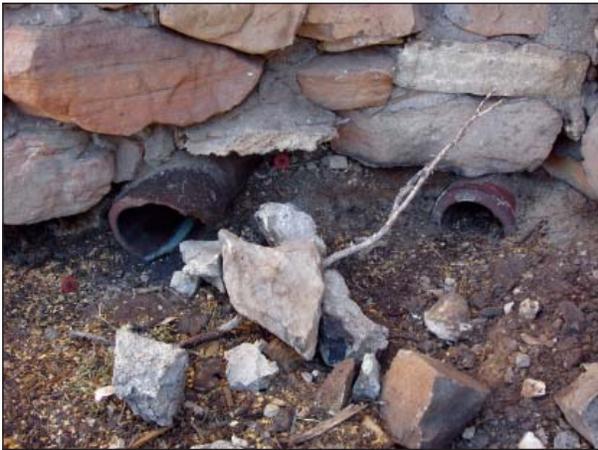
Blocked clay drain pipes near the west porch wall. See FIG. S17.	Remove debris and clean drainage pipe. Replace pipe if necessary.	Moderate
Trees in close proximity to building. See FIG. S18.	Trim trees that pose a potential fire hazard to the building.	Moderate
Blocked drainage pipe under the north stair landing.	Remove debris and clean drainage pipe. Replace pipe if necessary.	Moderate

FIG. S17: Blocked drain pipes from the west porch, 2007.

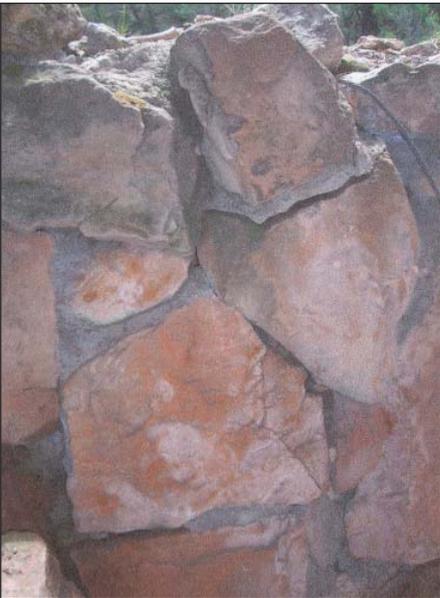
FIG. S19: Loose stone and cracked mortar in buckling east stone retaining wall, 2007.

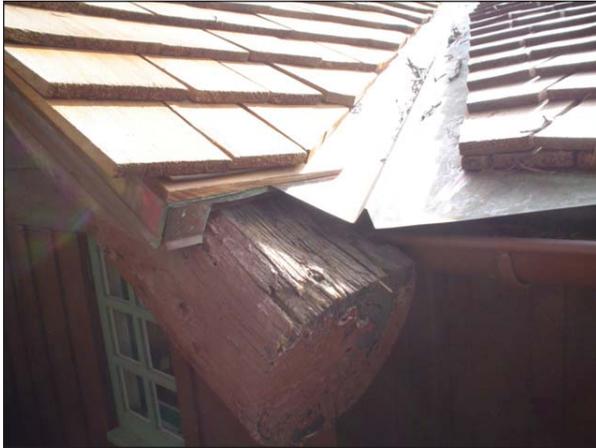
FIG. E7: Water directed onto a rafter from the roof valley on the north wall, 2008.

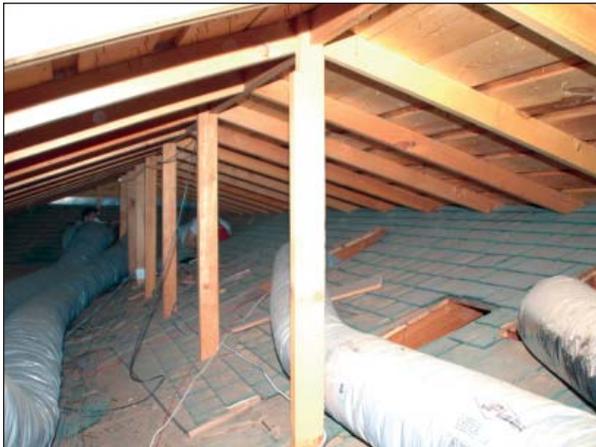
FIG. E9: View into the attic where a roof was superimposed over an earlier pitched roof showing the web of flexible duct and potentially hazardous asphalt shingles on the earlier roof, 2007.

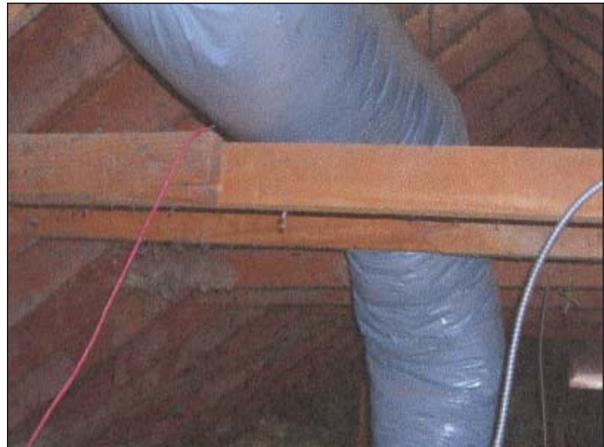
Insufficient attic collar ties and displaced foundation post supports are severe structural issues. The building does not meet accessibility code, has egress-related deficiencies and is not protected from fire. Additionally, fire, security and electrical systems were damaged by a nearby lightning strike.

FIG. E10: Insufficient and damaged collar ties in the attic, 2007.

The attic has damaged and inadequate collar tie framing.

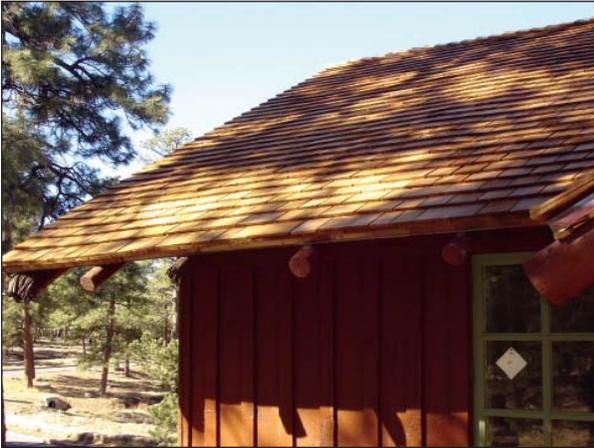
FIG. E11: Missing gutter on the south side of the east wall, 2007.

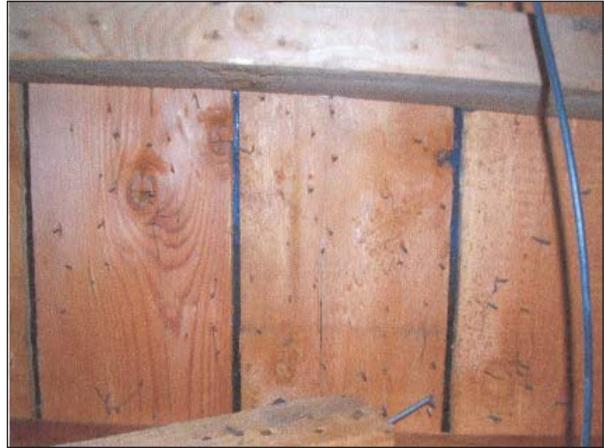
FIG. E12: Gaps between the roof decking boards, 2007.

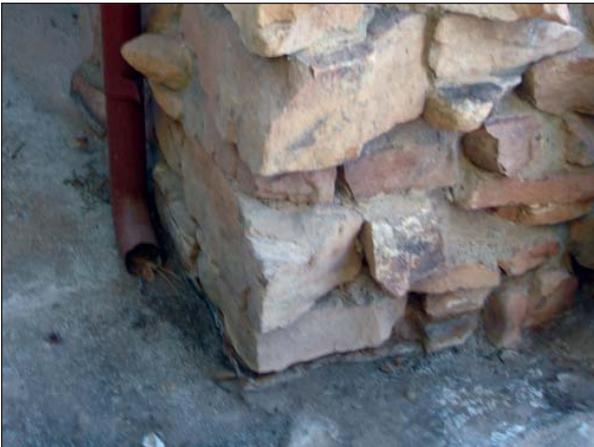
Exterior Deficiency/Alteration	Recommended Treatment*	Impact
Deflected roof over Room Eight. See FIG. E5.	Adjust ridge board and rafters to remove deflection, replacing specific members as required. Resheath and shingle roof.	Severe
Decayed rafters and outriggers. See FIGS. E6, E8.	Remove decayed area. Patch with wood splice. Where rot is more than 50% of the log section, replace the entire rafter tail or outrigger back into the structure. Paint to match existing.	Severe
Water directed onto rafter from roof valley. See FIG. E7.	Install gutter to match existing. Trim back rafter if necessary.	Severe
Insufficient and/or damaged collar ties in attic. See FIG. E10.	Remove damaged collar tie framing. Install collar tie at every rafter with screw connections.	Severe
Water directed toward foundation due to improperly placed leader on the west corner of the north elevation. See FIG. E13.	Move leader away from the building to direct water away from the foundation.	Severe

FIG. E13: Downspout on the northwest corner of the building that drains water onto the patio floor and toward the building foundation, 2007.

placed leader on the northwest corner of the building directs water toward the building foundation. Where necessary, connecting pipes direct runoff toward Village Loop Drive.

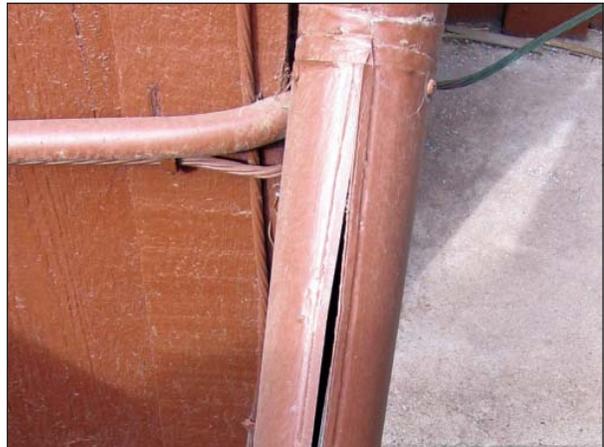
FIG. E14: Split downspout on the east wall, 2007.

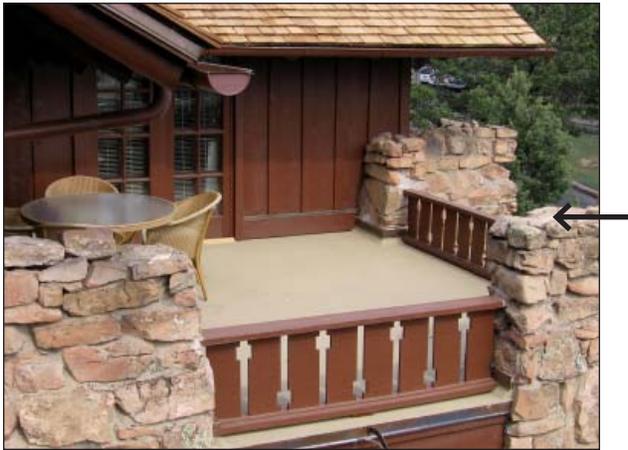
FIG. E15: View of the patio facing southeast showing the structural stone corners, wood railing and liquid-applied, waterproofing membrane flooring. Note birdbath location at arrow and low railing height, 2007.

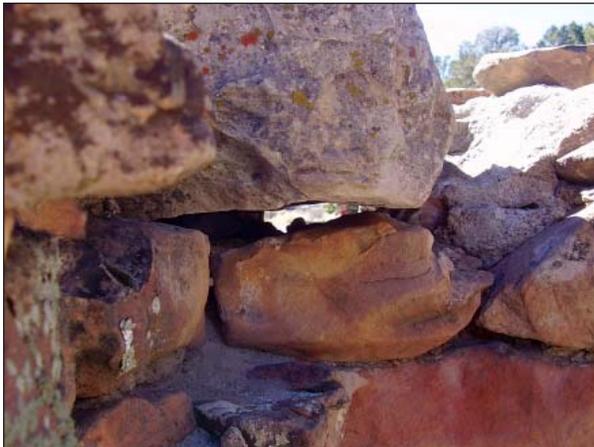
FIG. E17: Gaps in the southwest corner of the patio stone support, 2007.

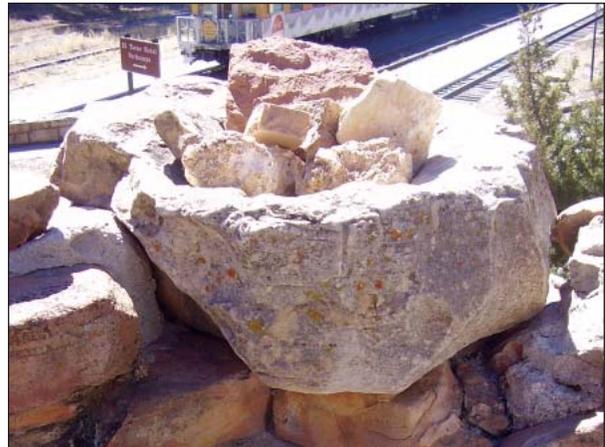
FIG. E18: Unsecured birdbath in the southwest corner of the patio stone support, 2007.

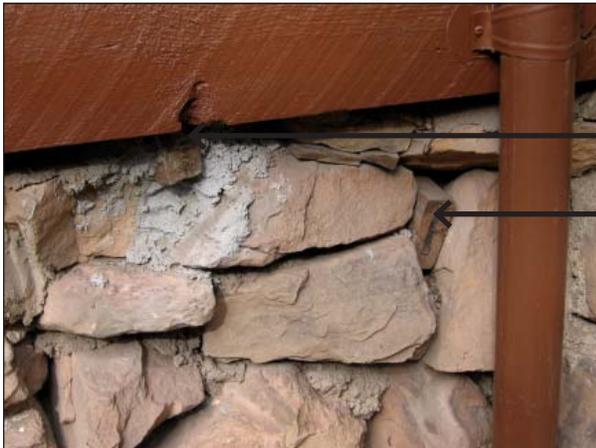
FIG. E19: Wood in-fill in the stone wall on the south wall at arrows, 2007.

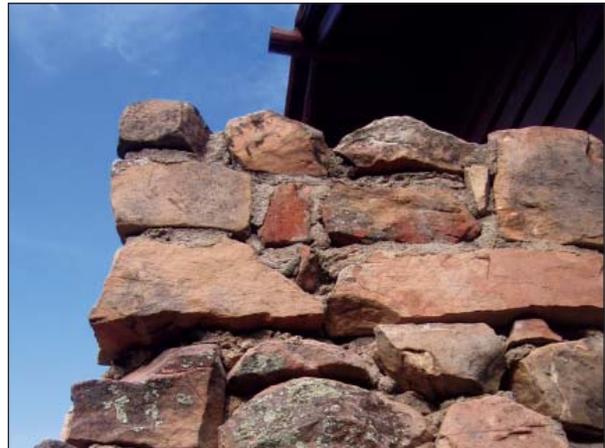
FIG. E20: Lichen on the stone on the east wall, 2007.

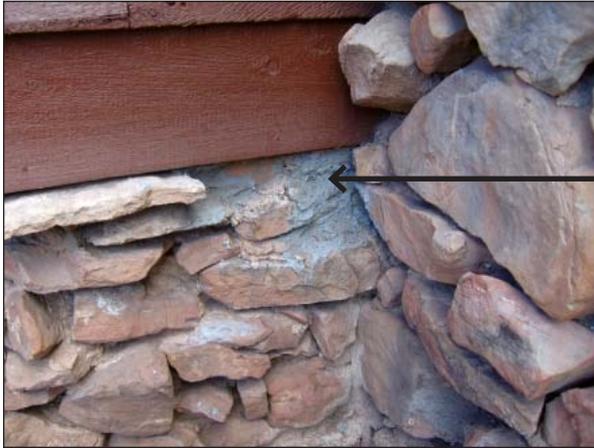
Inappropriate repair including excessive and/or incompatible mortar. See FIGS. E23, E25.	Carefully remove excess mortar from stone. If necessary, apply compatible mortar. Compatible mortar should match the historic mortar in composition, texture, color and placement within the joints.	Moderate

FIG. E23: Inappropriate mortar repair on the south wall at arrow, 2007.

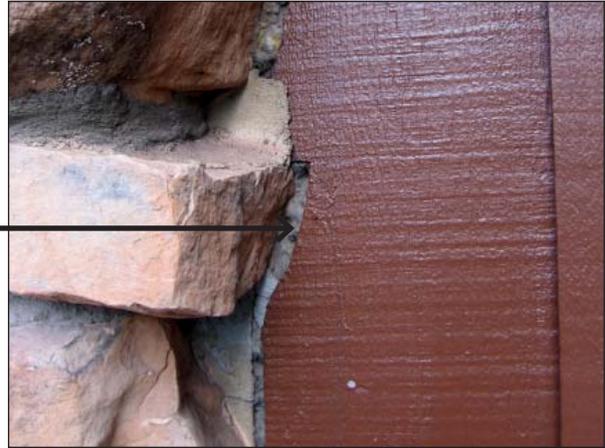
FIG. E24: Exposed insulation on the south wall at arrow, 2007.

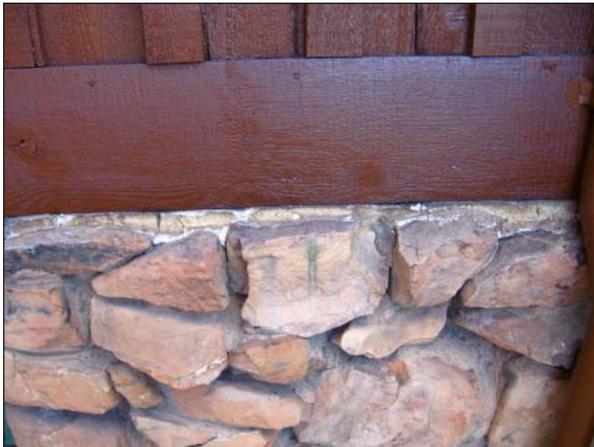
FIG. E25: Discolored mortar on the west wall, 2007.

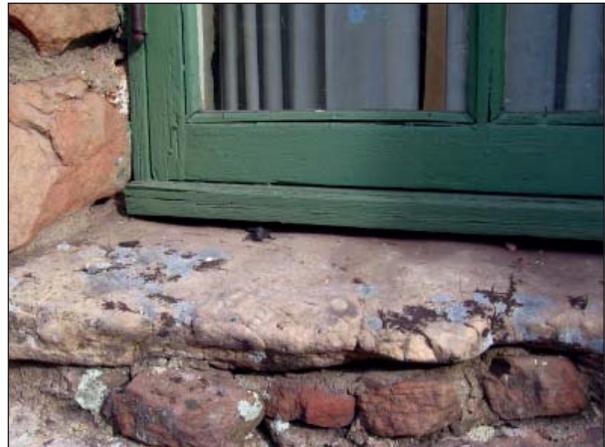
Exterior Deficiency/Alteration	Recommended Treatment*	Impact
Gaps between building materials, potentially allowing rodent access into the building. See FIGS. E26, 21.	Fill gaps with material appropriate to location (for example, stone or wood) in consultation with the park historical architect. If necessary, paint to match existing.	Moderate
Cracked wood beam. See FIG. E27.	Replace in-kind. Paint to match.	Moderate
Warped window frame and sill. See FIG. E28.	Remove window. Repair window frame and sill. Reinstall.	Moderate
Damaged wood siding and/or roof sheathing. See FIGS. E29, E34 and E35.	Where possible, repair wood siding/roof sheathing with wood splice and paint to match existing. If necessary, remove damaged wood siding/roof sheathing and replace in-kind. Paint to match existing.	Moderate
Decayed garage door at ground level. See FIG. E31.	Remove decayed area and patch with epoxy or with wood splice if necessary. Paint to match existing.	Moderate

FIG. E26: Gap between the window and stonework on the south wall, 2007.

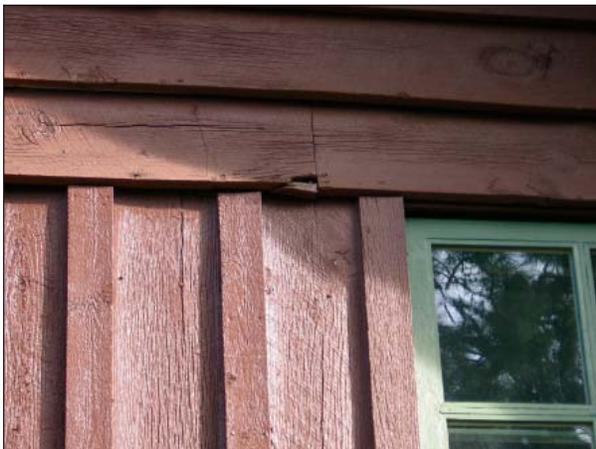
FIG. E29: Damaged wood siding on the south wall, 2007.

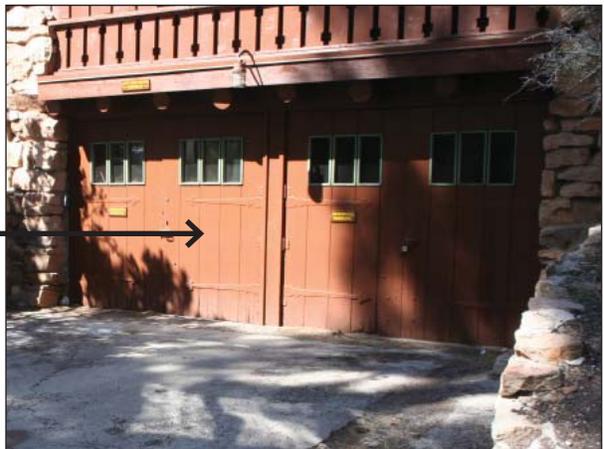
FIG. E30: Historic garage doors. Note the door at arrow opens to access a sliding glass door into Room Seventeen, 2007.

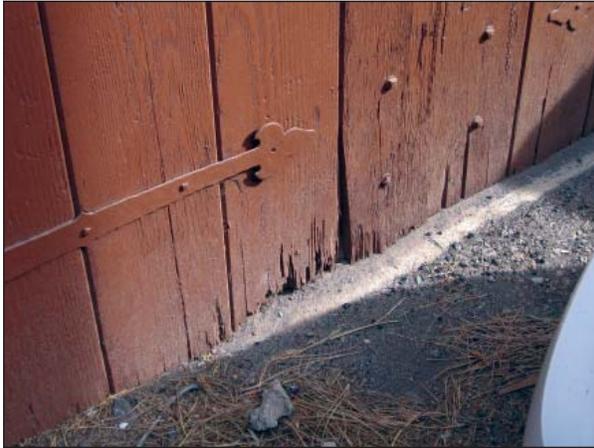
FIG. E31: Decayed wood garage door on the south wall, 2007.

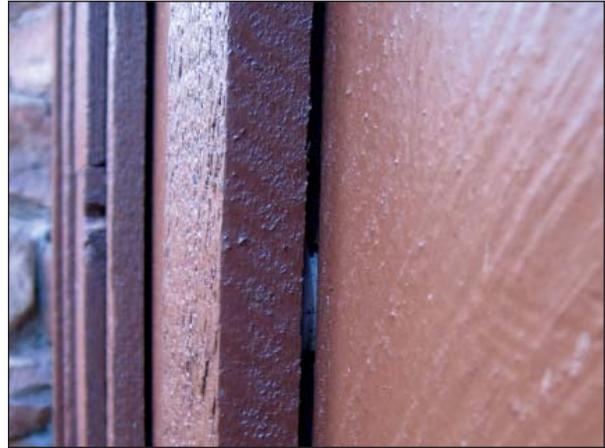
FIG. E32: Separation of the siding on the north wall, 2007.

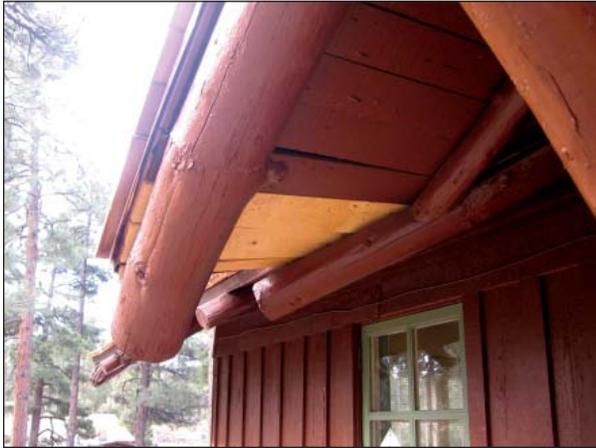
FIG. E35: Unpainted wood roof sheathing on the east wall, 2007.

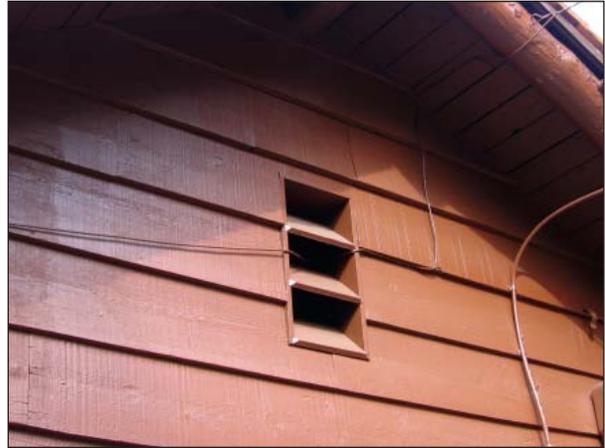
FIG. E36: Exposed wire on the east gable, 2007.

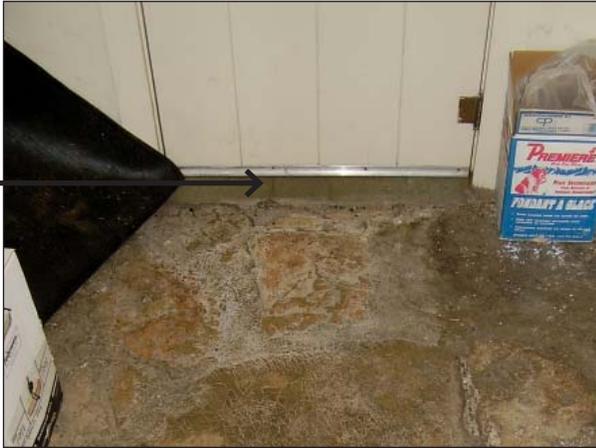
FIG. R1.4: Original stone floor cracking at joints. Note cracked threshold at arrow, 2007.

Room One Deficiency/Alteration	Recommended Treatment*	Impact
Cracked stone threshold at exterior door. See FIG. R1.4.	Fill cracks with compatible mortar. Compatible mortar should match the historic mortar in composition, texture, color and placement within the joints. Finish to match existing.	Moderate
Cracked stone floor. See FIG. R1.4.	Fill cracks with compatible mortar. Compatible mortar should match the historic mortar in composition, texture, color and placement within the joints. Finish to match existing.	Moderate
Lack of handrails at stair. See FIG. R1.2.	Assess the need for a handrail. If necessary, install a handrail with an appropriate design in a manner appropriate to the character of the building.	Low
Plaster cracks at ceiling. See FIG. R1.5.	Patch and repair plaster. Paint to match existing.	Low
Modern carpet over stair to Room Two.	No treatment required. Remove carpet and restore stair if appropriate for future use.	Low

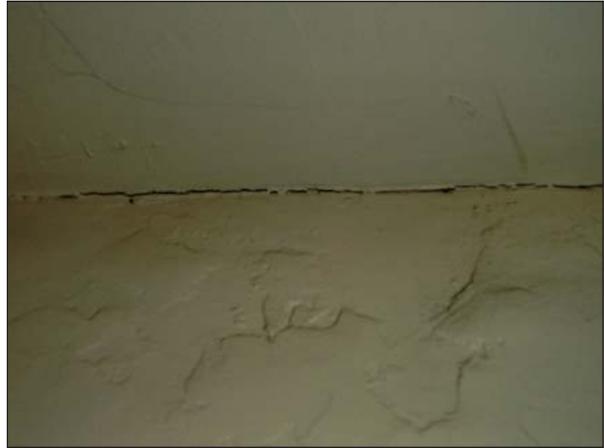
FIG. R1.5: Plaster cracks at junction of wall and ceiling, 2007.

The walls are plastered gypsum board painted white. The plaster is cracked at the junction of the ceiling and walls. A built-in wood closet occupies the entire north wall and is accessed through two wood doors. On the east wall, three risers provide access into Room Two.

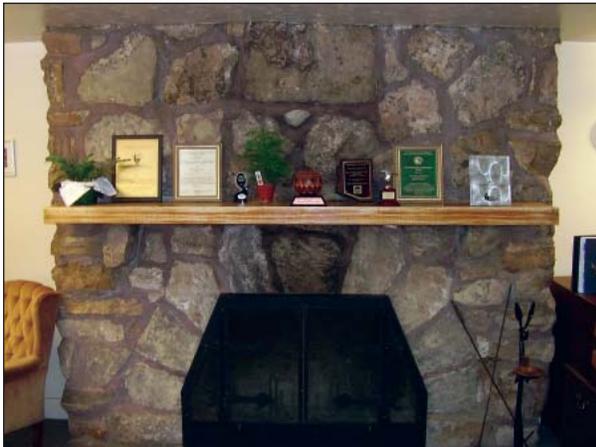
FIG. R2.4: Stone fireplace with inappropriate modern screen and faux-wood painted mantel, 2007.

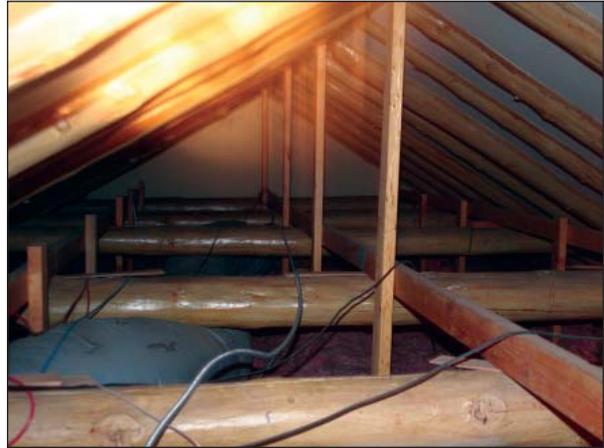
FIG. R2.7: Concealed rustic pitched ceiling above the suspended ceiling (accessed through a vent), 2007.

Room Two Deficiency/Alteration	Recommended Treatment*	Impact
Modern suspended ceiling conceals original rustic ceiling and pitch of opening into Room One. See FIGS. R2.2, R2.7.	Remove suspended ceiling in conjunction with the installation of a modern split system heat pump. Restore the original rustic ceiling.	Moderate
Modern fireplace screen of inappropriate design and shape. See FIGS. R2.4, R2.5.	Remove screen. Clean fireplace. Install free-standing fireplace screen that allows visibility of the arched opening.	Moderate
French doors to patio currently blocked by furniture. See FIG. R2.3.	Remove furniture currently blocking doors to patio.	Low
Faux-painted wood fireplace mantel. See FIG. R2.4.	Remove paint and refinish wood mantel.	Low
Modern carpet. See FIG. R2.8.	No treatment required. Remove carpet and restore wood floor if appropriate for future use.	Low
Modern electric heaters. See FIG. R2.9.	Remove electric heaters in conjunction with the installation of a modern split system heat pump.	Low

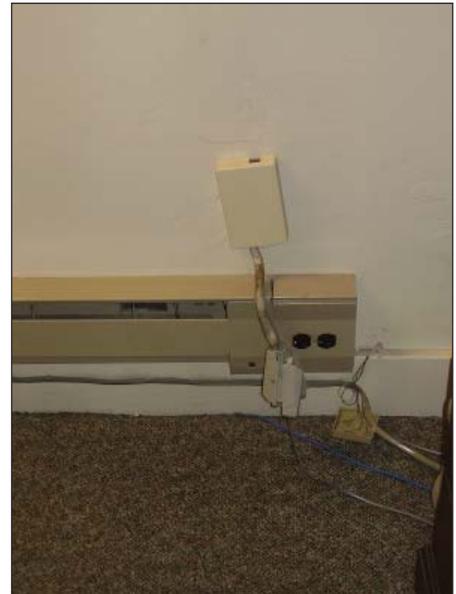
FIG. R2.9: Modern electric heater, 2007.

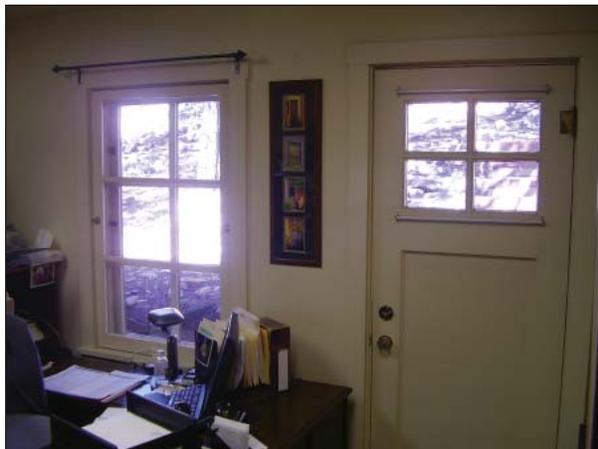
FIG. R3.2: View of Room Three facing northwest showing the exterior door and concealed picture rail, 2007.

Room Three Deficiency/Alteration	Recommended Treatment*	Impact
Concealed picture rail on the north wall. See FIG. R3.2.		Low
Modern carpet. See FIG. R3.3.	No treatment required. Remove carpet and restore wood floor if appropriate for future use.	Low
Modern electric heaters. See FIG. R3.6.	Remove electric heaters in conjunction with the installation of a modern split system heat pump.	Low
In-filled opening to Room Four. See FIGS. CD2 and CD3 in the <i>Chronology of Development & Use</i> section, and FIG. R3.4.	No treatment required. A doorway into Room Four is not necessary at this time.	Low
* Note: Please see <i>Requirements for Treatment</i> for additional information on each recommendation.

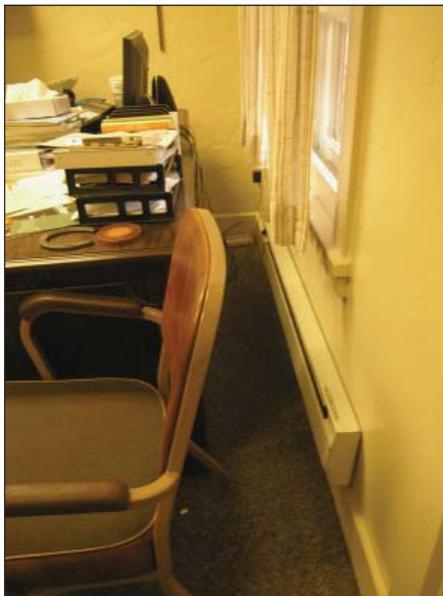
FIG. R3.6: Modern electric heater and carpet, 2007.

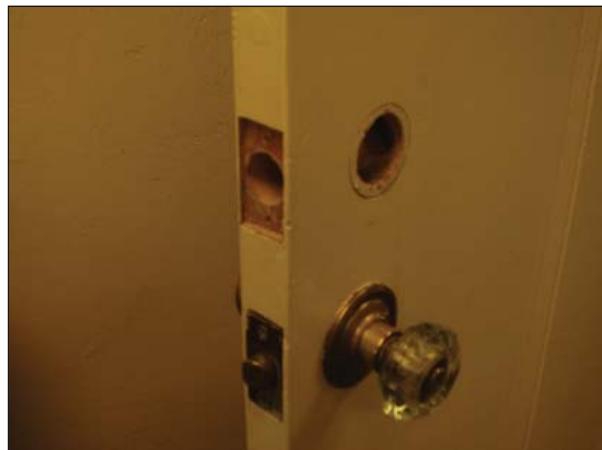
FIG. R4.3: Door missing deadbolt, 2007.

Room Four Deficiency/Alteration	Recommended Treatment*	Impact
Missing deadbolt in door. See FIG. R4.3.	Install deadbolt if necessary. Alternatively, patch hole with wood splice and paint to match existing.	Low
Removed north-south partition wall. See FIG. R4.4.	No treatment required. Partitioning of Room Four is not necessary at this time.	Low
Exposed wiring on the north side of the structural remnant of a north-south ceiling partition. See FIG. R4.4.	Re-route wiring so as to conceal it or to be more consistent with the architectural features.	Low
Modern carpet. See FIG. R4.5.	No treatment required. Remove carpet and restore wood floor if appropriate for future use.	Low
Modern electric heaters. See FIG. R4.5.	Remove electric heaters in conjunction with the installation of a modern split system heat pump.	Low
In-filled opening to Room Three. See FIGS. CD2 and CD3 in the <i>Chronology of Development & Use</i> section, and FIG. R3.4 in the <i>Room Three</i> section.	No treatment required. A doorway into Room Three is not necessary at this time.	Low

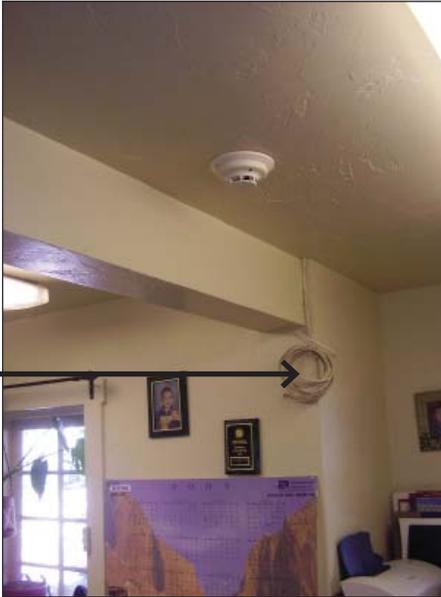
FIG. R4.4: View facing north showing the structural remnant of the removed partition wall. Note exposed wiring at arrow, 2007.

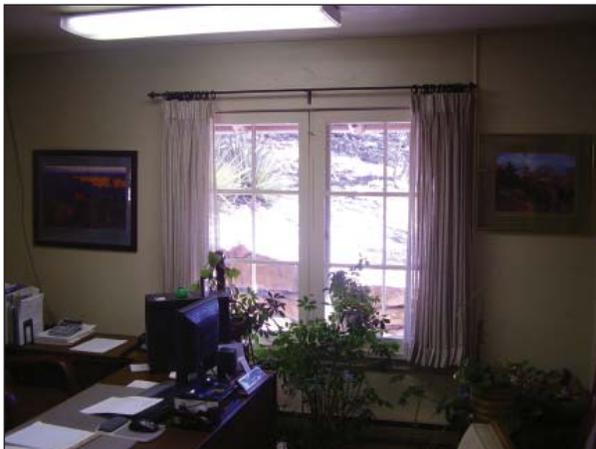
FIG. R5.2: View of Room Five facing east showing the double six-lite wood casement windows and concealed picture rail, 2007.

Room Five Deficiency/Alteration	Recommended Treatment*	Impact
Concealed picture rail on the north and east walls. See FIG. R5.2.		Low
Missing closet doors. See FIGS. R5.3.	No treatment required. Install wood doors if appropriate for future use.	Low
Exposed wiring in the northeast corner. See FIG. R5.4.	Re-route wiring so as to conceal it or to be more consistent with the architectural features.	Low
Improper junction of picture rail. See FIG. R5.5.	Remove and re-install picture rail for proper junction.	Low
Modern electric heaters. See FIG. R5.6.	Remove electric heaters in conjunction with the installation of a modern split system heat pump.	Low
Modern carpet. See FIG. R5.6.	No treatment required. Remove carpet and restore wood floor if appropriate for future use.	Low
Damaged weather-stripping on north window. See FIG. R5.7.	Replace weather-stripping.	Low

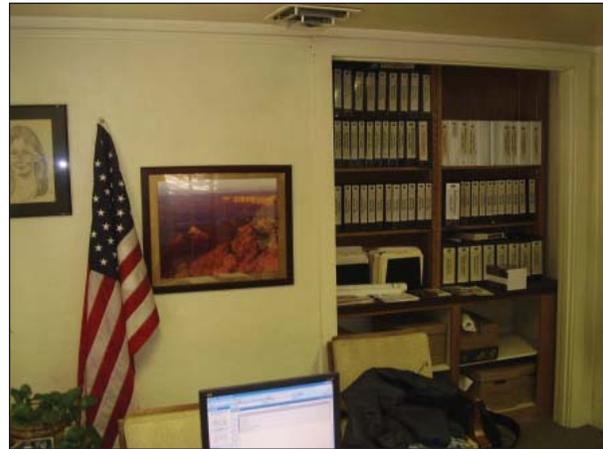
FIG. R5.3: View of Room Five facing southwest showing shelving in the closet and lack of closet doors, 2007.

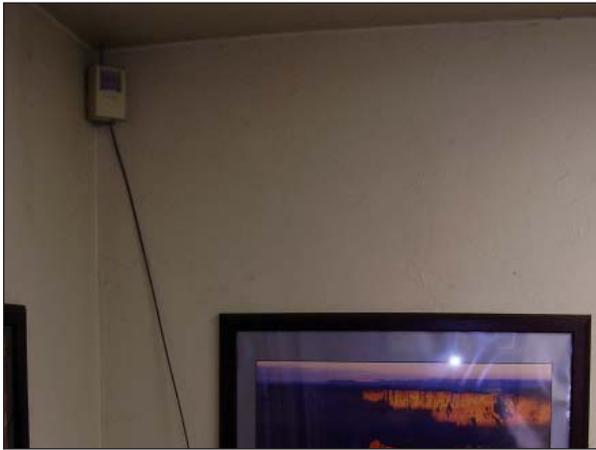
FIG. R5.4: Exposed, loose wiring connected to the motion sensor, 2007.

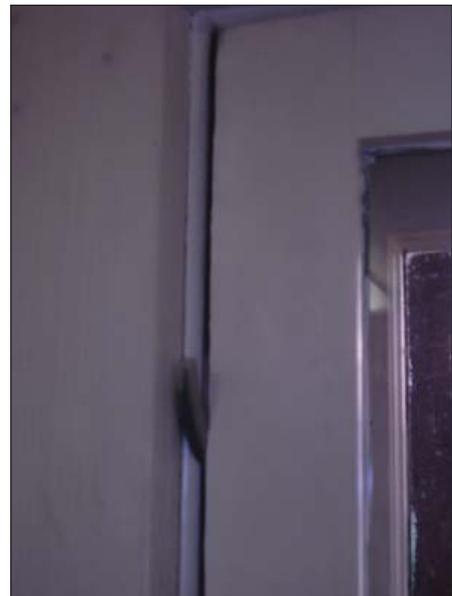
FIG. R5.7: Damaged weatherstripping on the north window, 2007.

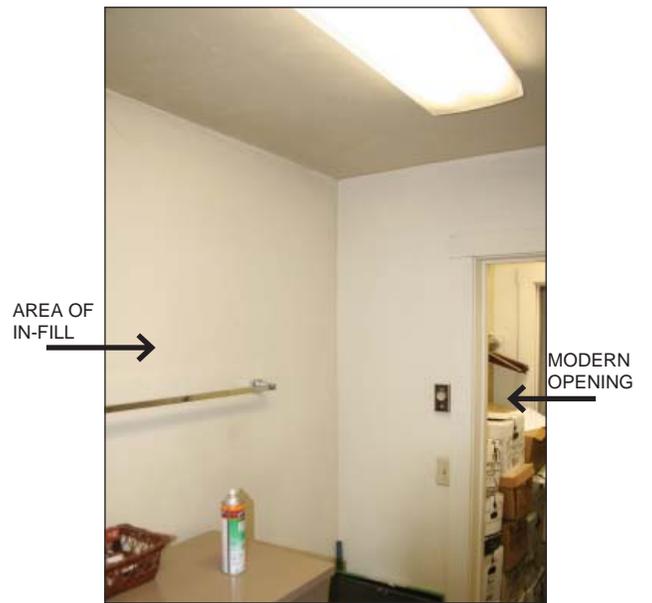
Room Seven Deficiency/Alteration	Recommended Treatment*	Impact
Removed partition wall. See FIGS. R7.3, R7.4 and FIGS. CD2 and CD3 in the <i>Chronology of Development & Use</i> section.	No treatment required. Partitioning of Room Seven is not necessary at this time.	Low
In-filled opening to Room Eight. See FIG. R7.3. and FIGS. CD2 and CD3 in the <i>Chronology of Development & Use</i> section.	No treatment required. A doorway into Room Eight is not necessary at this time.	Low
Modern tile floor. See FIG. R7.5.	No treatment required.	Low
Modern electric heaters. See FIG. R7.5.	Remove electric heaters in conjunction with the installation of a modern split system heat pump.	Low

FIG. R7.3: View of Room Seven facing southwest showing the area of in-fill to Room Eight at left arrow, and modern opening at right arrow, 2007.

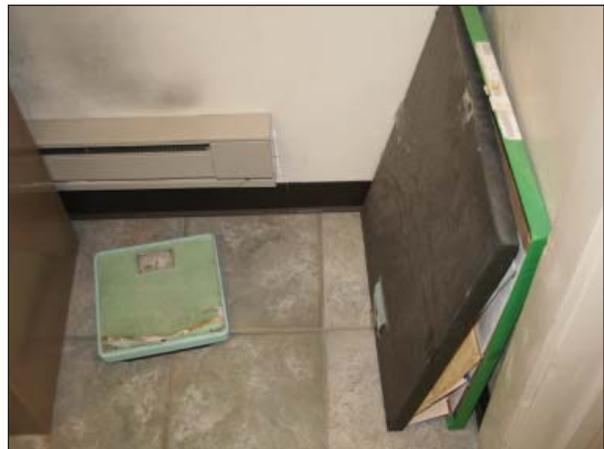
FIG. R7.5: Modern electric heater and tile flooring, 2007.

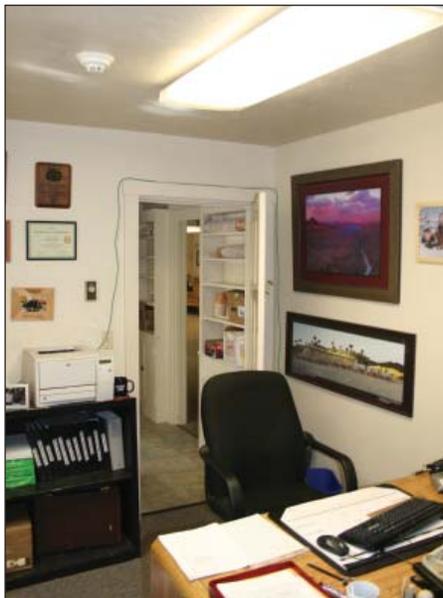
Room Nine Deficiency/Alteration	Recommended Treatment*	Impact
Modern carpet. See FIG. R9.2.	No treatment required. Remove carpet and restore wood floor if appropriate for future use.	Low
Modern windows. See FIG. R9.3.	No treatment required.	Low
Altered wall configuration on the east side of the room. See FIG. R9.5 and FIGS. CD2 and CD3 in the <i>Chronology of Development & Use</i> section.	No treatment required. This minor modification provides adequate space within both Room Nine and the adjacent hallway at this time.	Low
Modern electric heaters. See FIG. R9.6.	Remove electric heaters in conjunction with the installation of a modern split system heat pump.	Low
Removed kitchen cabinets and fixtures. See FIG. CD13 in the <i>Chronology of Development & Use</i> section.	No treatment required. Kitchen cabinets and fixtures are not necessary at this time.	Low

FIG. R9.2: View of Room Nine facing northwest showing the modern carpet, 2007.

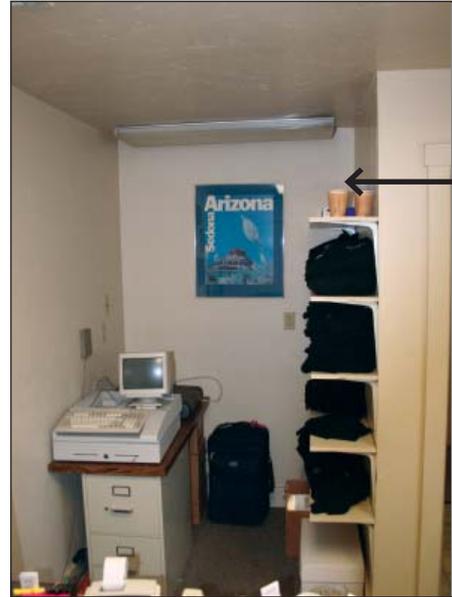
FIG. R9.5: View of the east wall of Room Nine which is used as storage space. Note the area to the right which was once part of a hallway coat closet at arrow, 2007.

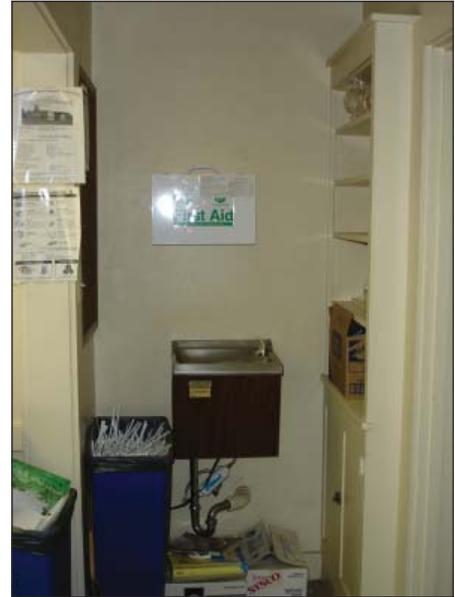
Room Ten Deficiency/Alteration	Recommended Treatment*	Impact
Modern windows. See FIG. R10.2.	No treatment required.	Low
In-filled opening to Room Eleven. See FIG. R10.5 and FIGS. CD2 and CD3 in the <i>Chronology of Development & Use</i> section.	No treatment required. A doorway into Room Ten is not necessary at this time.	Low
Modern wall-mounted drinking fountain. See FIG. R10.5.	No treatment required. Remove drinking fountain if not necessary for future use.	Low
Modern tile floor. See FIG. R10.6.	No treatment required.	Low
Light switch mounted on door trim. See FIG. R10.7.	No treatment required.	Low
* Note: Please see <i>Requirements for Treatment</i> for additional information on each recommendation.

FIG. R10.5: View of Room Ten facing west showing the modern drinking fountain. Note this area was historically open into Room Eleven, 2007.

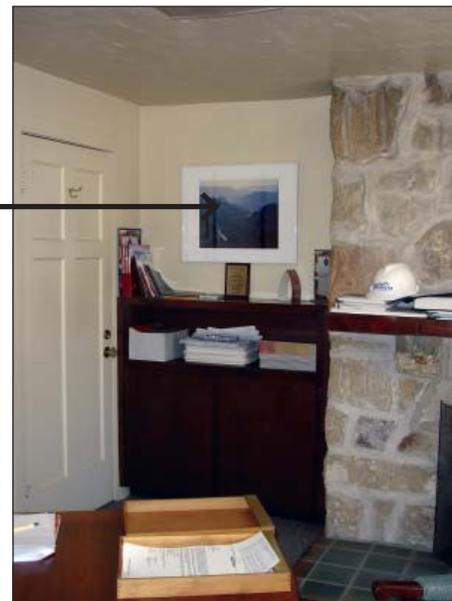
Room Eleven Deficiency/Alteration	Recommended Treatment*	Impact
Modern built-in bookshelves. See FIG. R11.3.	No treatment required.	Low
In-filled opening to Room Ten. See FIG. R11.3 and FIGS. CD2 and CD3 in the <i>Chronology of Development & Use</i> section.	No treatment required. An opening into Room Ten is not necessary at this time.	Low
Modern carpet. See FIG. R11.4.	No treatment required. Remove carpet and restore wood floor if appropriate for future use.	Low
Modern electric heaters. See FIG. R11.6.	Remove electric heaters in conjunction with the installation of a modern split system heat pump.	Low
* Note: Please see <i>Requirements for Treatment</i> for additional information on each recommendation.

FIG. R11.3: Modern built-in bookshelf flanking the fireplace. Note in-filled area to Room Ten at arrow, 2007.

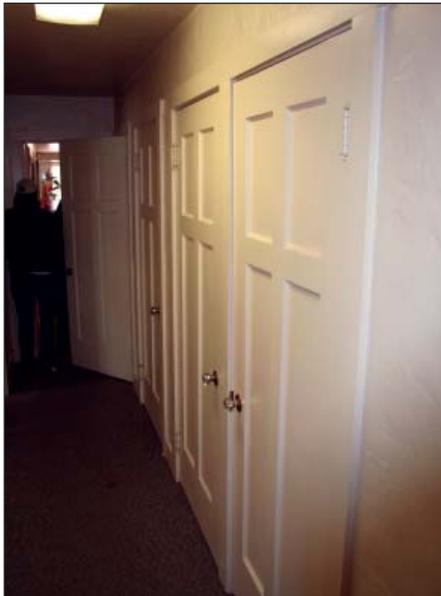
Hallways and Closets Deficiency/Alteration	Recommended Treatment*	Impact
Door to lower level stair blocks upper level hallway when open. See FIG. UH4.	Keep door in closed position.	Severe
Sloped floor at the south side of the north-south hallway. See FIG. UH6.	Evaluate the structural sufficiency of the floor and repair as necessary.	Moderate
Inaccessible fuse box. See FIG. UH7.	Confirm that the panel has been abandoned. Inspect and correct as necessary.	Moderate
Modern carpet. See FIG. UH2.	No treatment required. Remove carpet and restore wood floor if appropriate for future use.	Low
Altered wall configuration at southwest entrance. See FIG. UH8.	No treatment required. These minor modifications provide adequate space within the hallway and Rooms Eight and Nine at this time.	Low
Modern tile floor. See FIG. UH9.	No treatment required.	Low

FIG. UH4: View facing west showing the closet doors in the east-west hallway. Note the open door to the lower level stair, 2007.

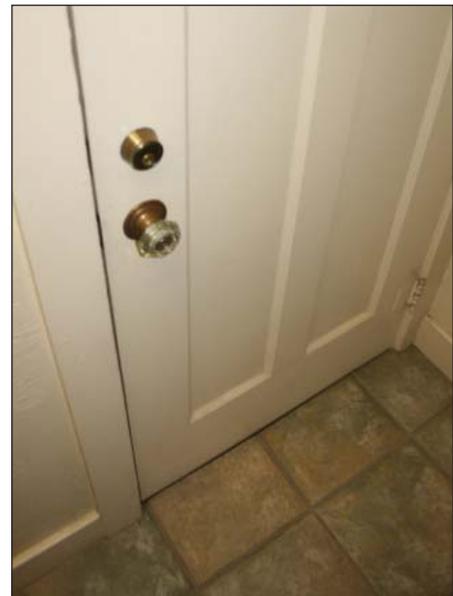
FIG. UH9: Ceramic tile flooring in the entrance vestibule, 2007.

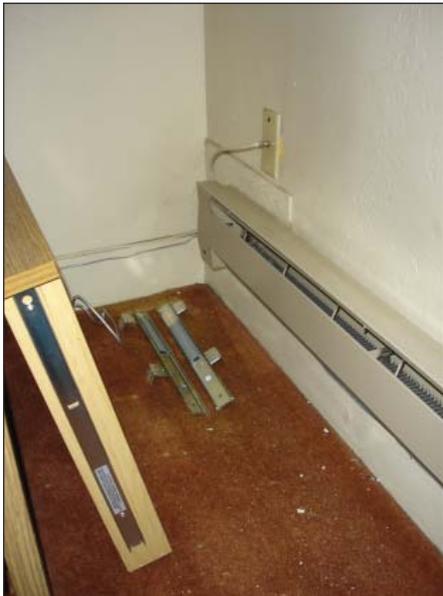
Modern electric heaters. See FIG. R12.6.	Remove electric heaters in conjunction with the installation of a modern split system heat pump.	Low
* Note: Please see <i>Requirements for Treatment</i> for additional information on each recommendation.

FIG. R12.6: Modern electric heater, 2007.

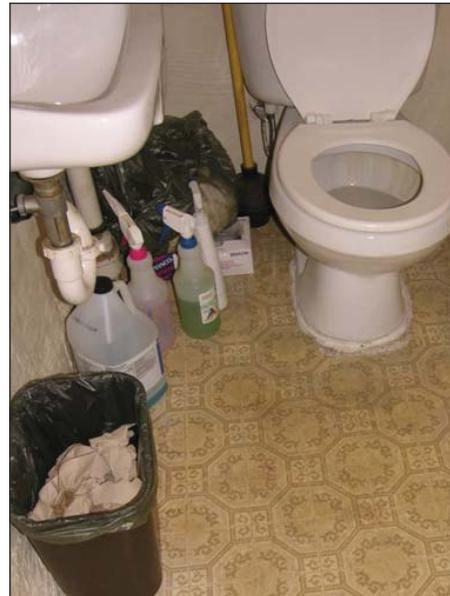
Room Thirteen Deficiency/Alteration	Recommended Treatment*	Impact
Modern seamless resilient flooring damaged by moisture penetration. See FIG. R13.3.	Remove flooring. Identify and repair source of water infiltration. Install new floor.	Severe
Ceiling plaster covers door frame. See FIG. R13.4.	No treatment required.	Low
Split door rail and stile. See FIGS. R13.5, R13.6.	Install in-kind wood splices. Paint to match existing.	Low
* Note: Please see <i>Requirements for Treatment</i> for additional information on each recommendation.

FIG. R13.3: Modern resilient flooring, 2008.

Room Thirteen has modern seamless resilient flooring that is damaged by moisture penetration into the building at the approximate center of the north wall, near the concrete walkway above. Baseboard trim is not present.

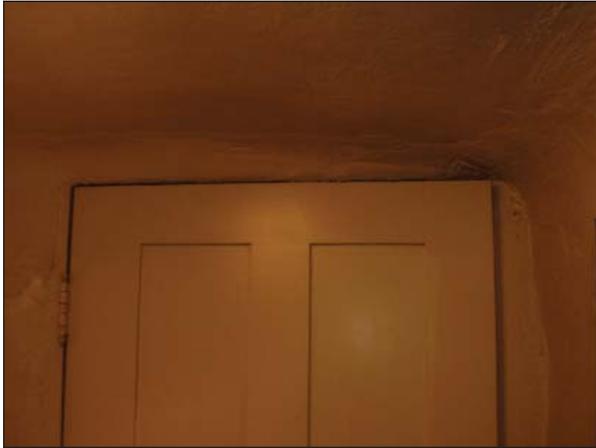
FIG. R13.4: Plastered door frame. Note coloration in photograph is due to flash photography, not actual appearance, 2007.

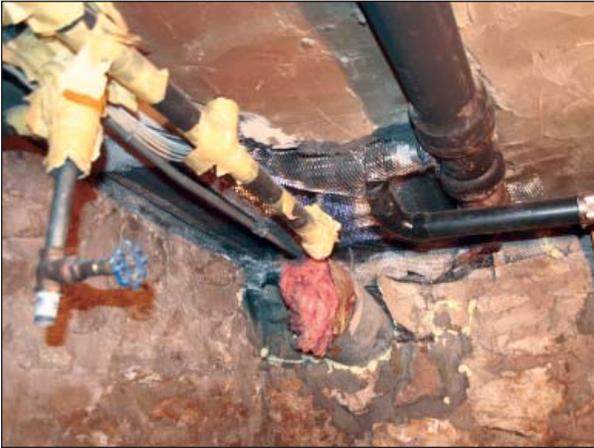
Room Fourteen Deficiency/Alteration	Recommended Treatment*	Impact
Gaps between building materials allow rodent access into interior. See FIGS. R14.4, R14.5.	Seal gaps in consultation with park historical architect.	Severe
Room is not fully sheathed to prevent fire spread into the wall and ceiling structure. See FIG. R14.3.	Install fire-rated material on the ceiling and walls.	Moderate
Alteration of wall configuration. See FIGS. CD2 and CD3 in the <i>Chronology of Development & Use</i> section.	No treatment required. The current use benefits from modern partition walls.	Low
* Note: Please see <i>Requirements for Treatment</i> for additional information on each recommendation.

FIG. R14.4: Insulation and wire mesh around pipes, 2007.

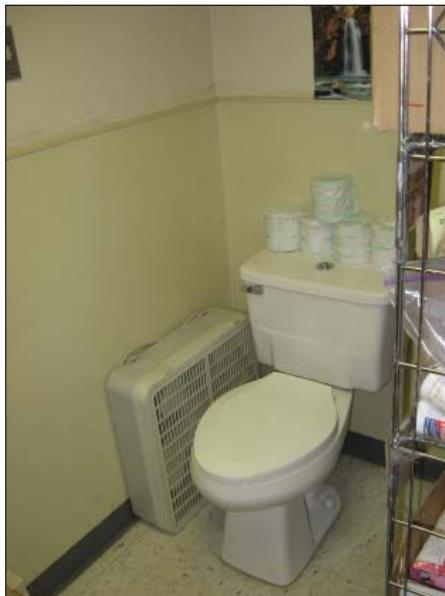
FIG. R15.2: View of Room Fifteen facing northeast, 2007.

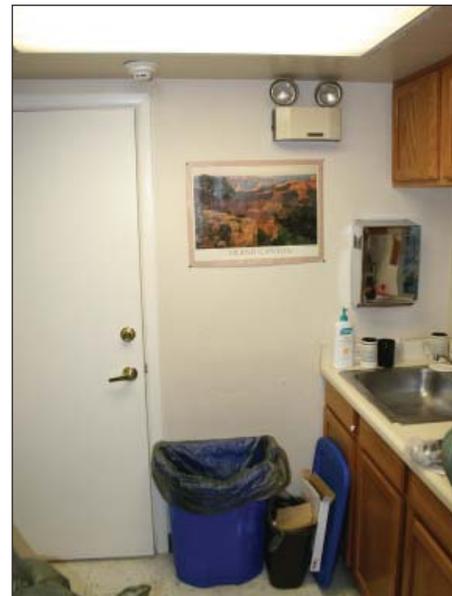
FIG. R16.1: View of Room Sixteen facing north showing the modern partition wall and door into Room Fifteen, 2007.

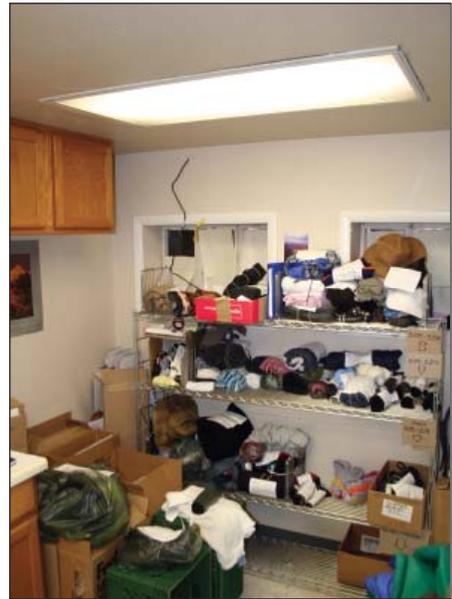
FIG. R16.3: View of Room Sixteen facing southeast. Note the blocked and covered windows, 2007.

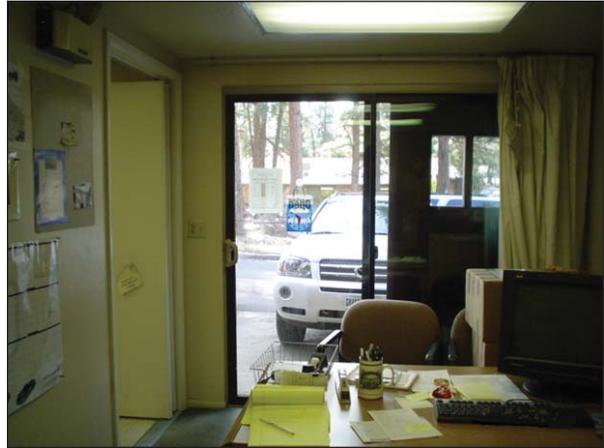
Modern sliding glass door in Room Seventeen. See FIG. R17.1.	See <i>Alternatives for Treatment</i> for recommendations on wheelchair accessibility in this area. Limit parking in front of the historic garage doors to handicapped parking. Construct and install a temporary ramp over the threshold of the sliding glass exterior door to allow wheelchair access into Room Seventeen.	Low

FIG. R17.1: View of Room Seventeen facing south showing the modern partition wall at left and the sliding glass doors to the exterior at center. Note the historic garage door on the outside of the sliding glass door at right. See FIG. E31 for the configuration of the historic garage doors from the exterior, 2008.

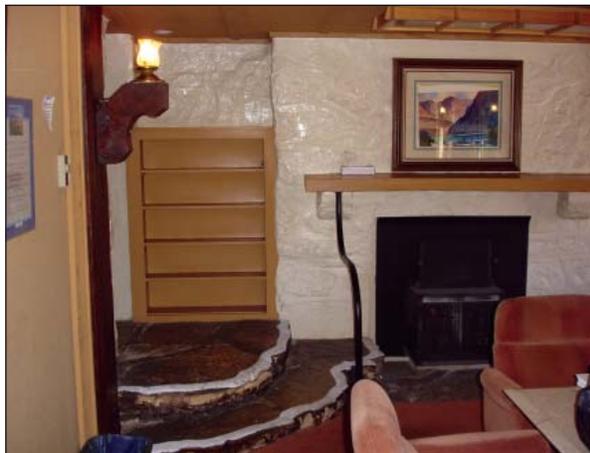
Modern iron handrail at staircase. See FIG. R18.2.	Remove handrail. If handrail is determined necessary, install new handrail with appropriate design.	Low
Modern electric heaters. See FIG. R18.11.	Remove electric heaters in conjunction with the installation of a modern split system heat pump.	Low

FIG. R18.2: View of Room Eighteen facing east showing the stone steps, built-in bookshelf, fireplace and mantel, 2007.
