HISTORIC STRUCTURE REPORT

FIRST ADMINISTRATION BUILDING

GRAND CANYON NATIONAL PARK

June 2008

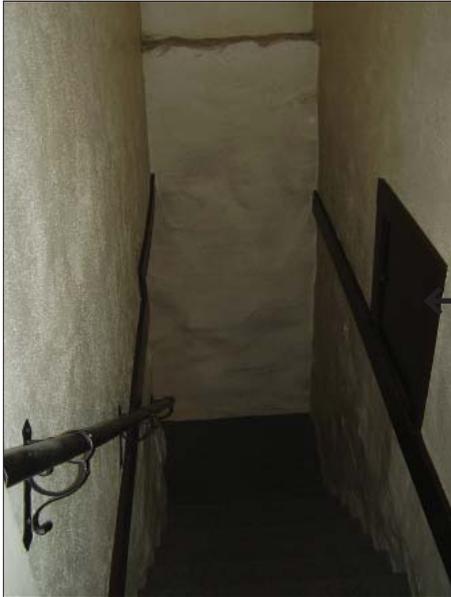
Lower Hallway & Stairwell Deficiency/Alteration	Recommended Treatment*	Impact
Loose handrail on west stairwell wall. See FIGS. LH2, LH3.	Secure handrail in place.	Severe
Water damage on the north exposed stone stairwell wall. See FIG. LH5.	Repair source of moisture penetration. Clean stone wall and repaint.	Severe
Missing beam support in crawlspace. See FIG. LH11.	Install concrete base beam support.	Severe
Displaced stones in crawlspace. See FIG. LH11.	Remove all stone supports in crawlspace. Install concrete bases for posts supports.	Severe
Downward-sloping floor toward Room Eighteen. See FIG. LH7.	Evaluate the structural sufficiency of the floor and repair as necessary.	Moderate
Insufficient hallway width for egress-compliance.	No treatment required.	Moderate
Dead-end hallway created when interior door to Room Seventeen locked.	Install no-exit signage.	Moderate
Modern carpet stained. See FIG. LH7.	Remove modern orange carpet and replace with blue carpet to match. Remove all carpet and restore historic floor if appropriate for future use.	Low

FIG. LH2: View facing north showing the stair to the lower level. Note the exposed stone walls and the crawlspace access at arrow, 2007.

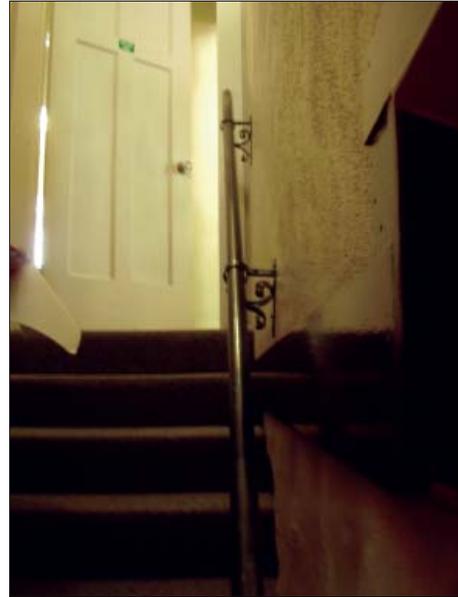
FIG. LH3: View of the stair facing south showing handrail and iron support, 2007.

An iron handrail is mounted on the west side of the stairwell and is supported on iron brackets. The handrail is currently loose.

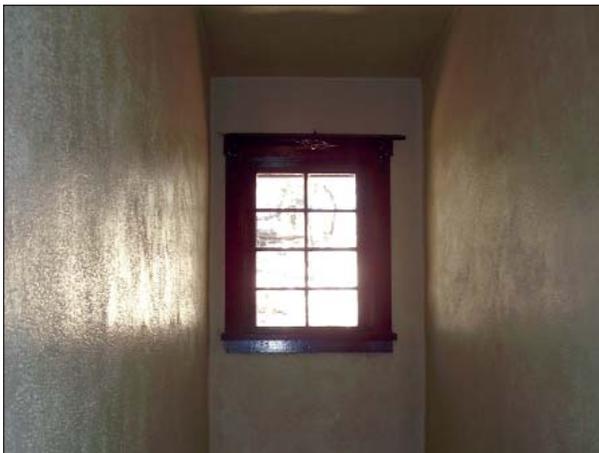
FIG. LH4: Eight-lite wood casement window on the north stairwell wall, 2007.

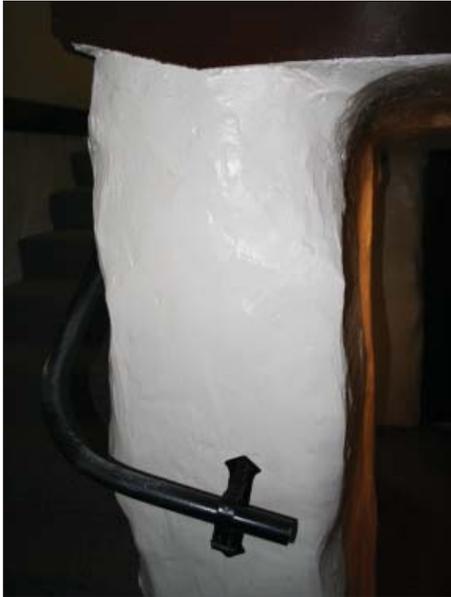
FIG. LH6: Stair handrail termination at the lower level, 2007.

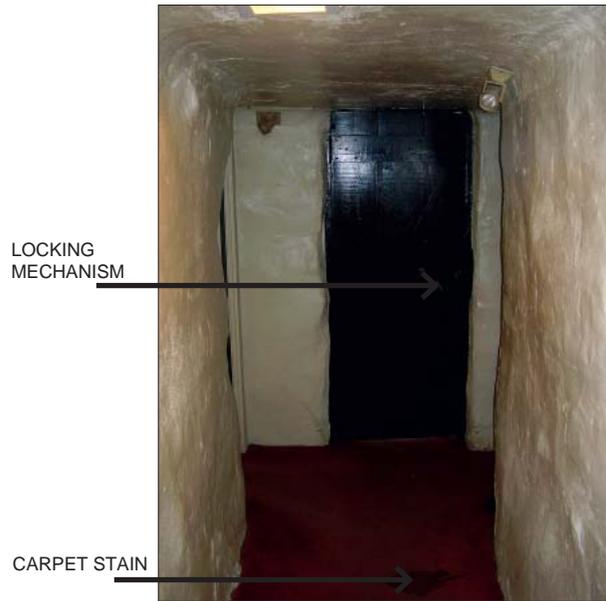
Hallway dimly lit. See FIG. LH7.	Install additional light fixtures in the hallway.	Low
Faux-painted door to closet under the stair. See FIG. LH12.	Remove door and replace with wood door to match other interior doors.	Low

FIG. LH7: View of the dimly-lit hallway facing south showing the historic wood door to Room Eighteen and floor deflection. Note locking mechanism on the hallway-side of the door and carpet stain at arrows, 2007.

The original wood flooring of the lower level hallways is concealed with modern orange carpet on the west side and modern tight-weave blue carpet on the east side; the orange carpet is stained. The hallway floor slopes downward toward Room Eighteen.

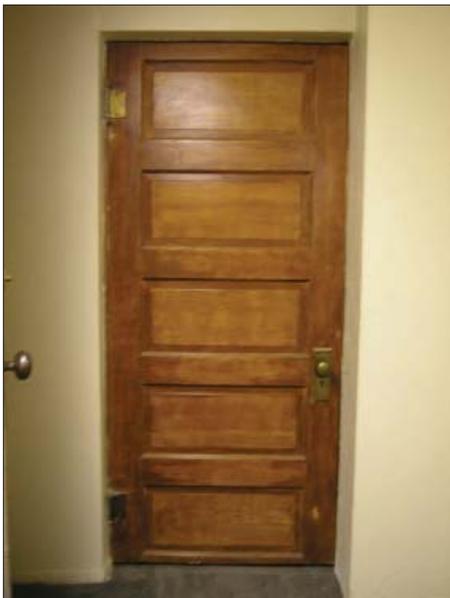
FIG. LH12: Faux-painted door to the closet under the stair, 2008.

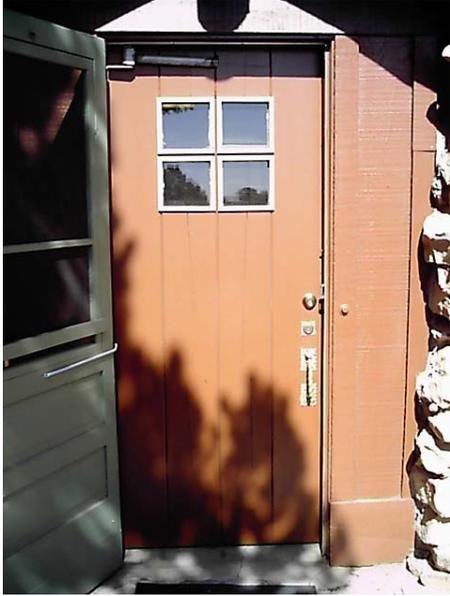
There is no accessible entrance into the building	Remove 2.5" ht. threshold and replace with maximum 1/2" threshold at West Entrance on upper level (alternate: raise floor in R1 vestibule and exterior); modify or replace door as necessary; remove and replace exterior stone pavers and re-grout flush with top of stone; positive drainage away from door is critical to allow removal of tall threshold	Exterior door and stone pavers are character-defining features of the building; of limited value if accessible route from a site access point to the building is not provided
There is no accessible route on the main level	Install a mechanical lift at stair in R1 vestibule; widen upper level corridor door at R2 and R7/8 to 32" clear; widen doors into offices R6 and R8, bath R7 to 32" clear; replace all knob handles with door hardware that meets accessibility requirements in rooms R2, and R6 thru R11; alternate: none	Of minimal value if accessible route from a site access point to the building is not provided

Figure 1: West Entrance, upper level

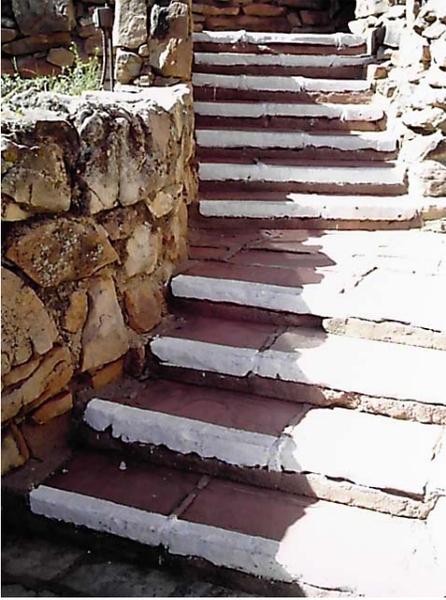
Deficiency	Recommended Treatment	Impact
Exterior		
There is no handrail for the exterior stairway at the West Entrance, upper level (outside R1)	Install new handrail, one side only	Handrail should be easily removable, visibility of handrail should be minimized, and installation should minimize permanent damage to substrate

There is no handrail for the exterior stairway at the South Entrance, upper level	Install new handrail, one side only	Handrail should be easily removable, visibility of handrail should be minimized, and installation should not do permanent damage to substrate
There is no handrail for exterior stairway (outside R3) at the North Entrance, upper level	None	Stair receives little use; other access is provided
Walking surfaces on the exterior of the building near the upper level West Entrance (at R1 door) and on the adjacent stairway have eroded posing trip hazard; stairs are not slip resistant, and walking surfaces do not drain properly	Remove existing stone where necessary and install new stone pavers; grind existing grout flush with stone or re-grout with mortar that is compatible with stone hardness; provide slip resistant texture on stair treads; provide positive drainage and install new drains as necessary	Stone paving is a character-defining feature; slip-resistant texture might be attained by cutting small grooves into the stone near the outside edge of the tread (avoid applying new slip-resistant material over stone, if possible); consider underground heating system for stairs to minimize freeze--thaw damage to stone

Walking surfaces on the exterior of the building near the upper level South Entrance door and on the adjacent stairway have eroded posing a trip hazard; stairs are not slip resistant	Remove existing stone where necessary and install new stone pavers; grind existing grout flush with stone or re-grout with mortar that is compatible with stone hardness; provide slip resistant texture on stair treads; provide positive drainage and install new drains as necessary	Stone paving is a character-defining feature; slip-resistant texture can be attained by cutting small grooves into the stone near the outside edge of the tread (avoid applying new slip-resistant material over stone, if possible); consider underground heating system for stairs to minimize freeze--thaw damage to stone
Walking surfaces on the exterior of the building near the North Entrance (at R3 door) and on the adjacent stairway have eroded posing a trip hazard; stairs are not slip resistant	Grind existing grout flush with stone or re-grout with mortar that is compatible with stone hardness	Stair receives little use; other access is provided

Figure 3: Stairs to West Entrance, upper level Figure 4: Stairs to South Entrance, upper level

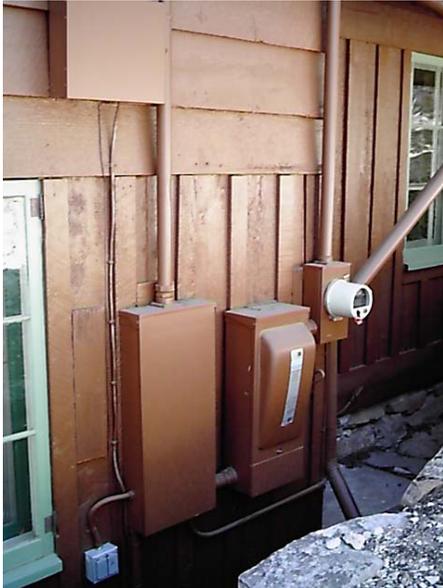
Deficiency	Recommended Treatment	Impact
No evaporative cooling in Basement	None; not required	would be nearly impossible to install because of low ceiling heights in basement; small air conditioner may be alternate option
Electrical fuse box at South Entrance on upper level is plastered shut and inaccessible	Confirm that panel has been abandoned; inspect and correct as necessary	
There is no exterior light at South Entrance on upper level	Repair existing light; confirm adequate illumination for exiting

Figure 6: Electrical service entrance on exterior east wall

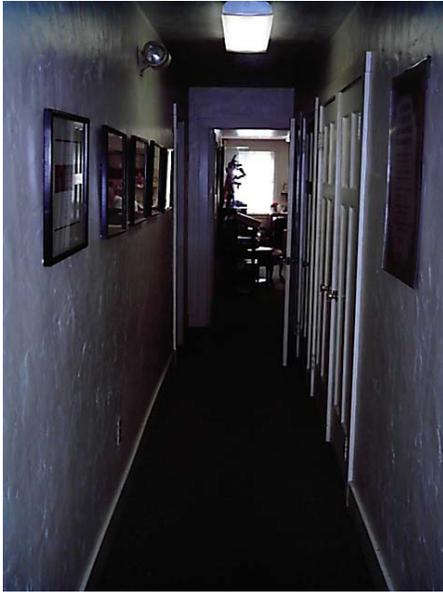
Figure 8: Upper level corridor showing emergency lighting in upper left corner

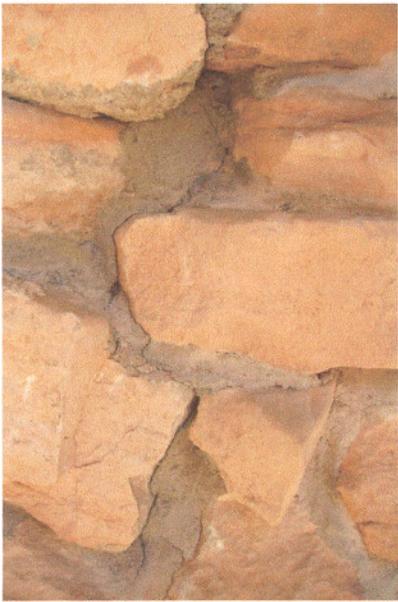
1. Chimney – exterior north side; some minor cracks in the mortar (refer to photo 1); also the metal flue protruding from the top of the stone masonry chimney appears to be skewed (refer to photo2).

1. Minor cracks in stone masonry chimney

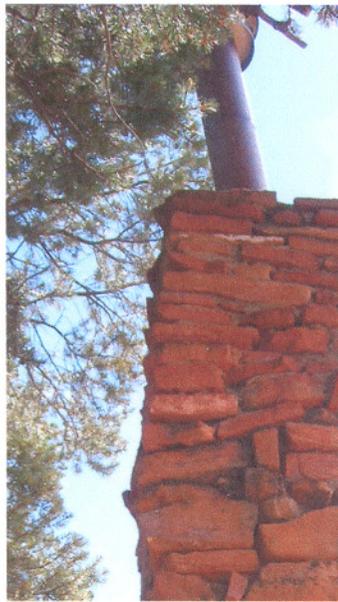
2. Skewed Metal Flue Chimney

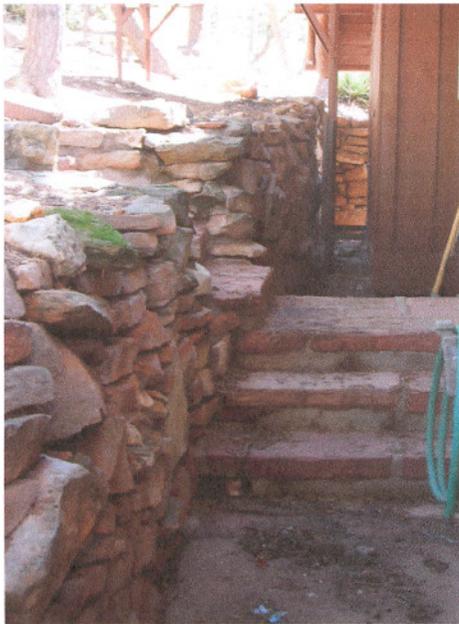
2. Gap between retaining wall and building – northeast corner; area does not appear to drain adequately; area run-off from slope above retaining wall drains into gap (refer to photo 3).

3. Gap between wall and building

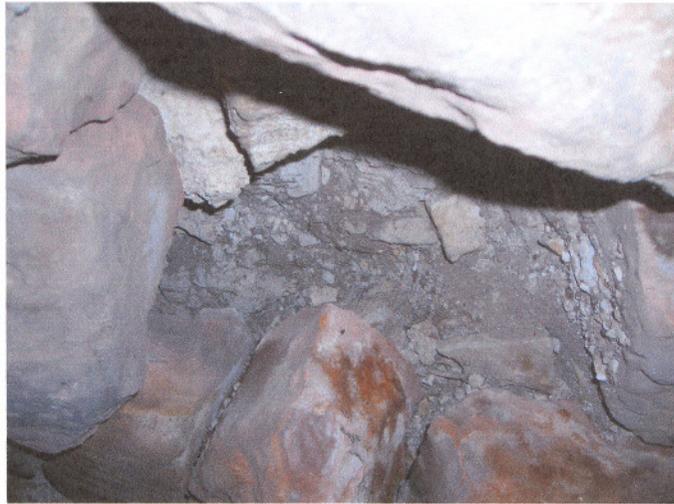
3. Retaining wall at evaporative cooler location – north east corner; the wall has partially failed; there is some stone bulging out of place; there is a gap behind some of the stone (refer to photo 4); a large stone has pushed out and is nearly touching the wood board stiffener that is part of the new supports for the evaporative cooler refer to photo 5 and 6); the stone wall at this location is retaining approximately 5.5 feet of sloping earth fill.

4. Gap behind the stones in wall

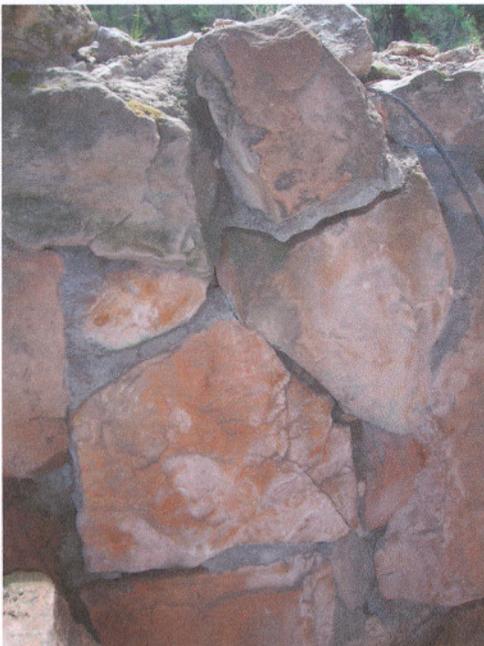
4. Retaining wall on east side just south of jog in the retaining wall; stone masonry wall is retaining approximately 5 feet of earth at this location; stone is bulging out; wall is coming apart; loose stone; displaced stone; cracks in the mortar (refer to photo 7).

7. Bulge in wall – mortar separating from stone

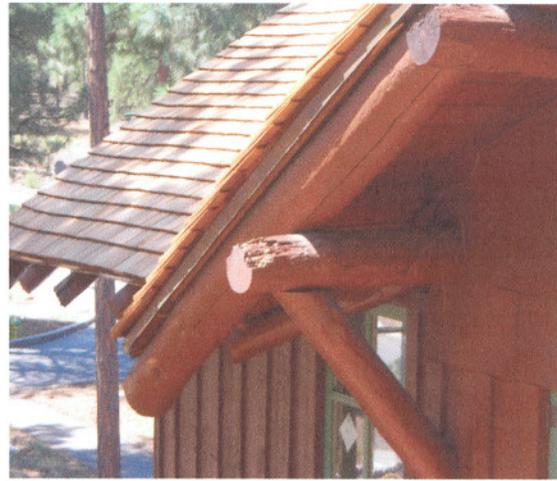
10. Braced and sagging gable end

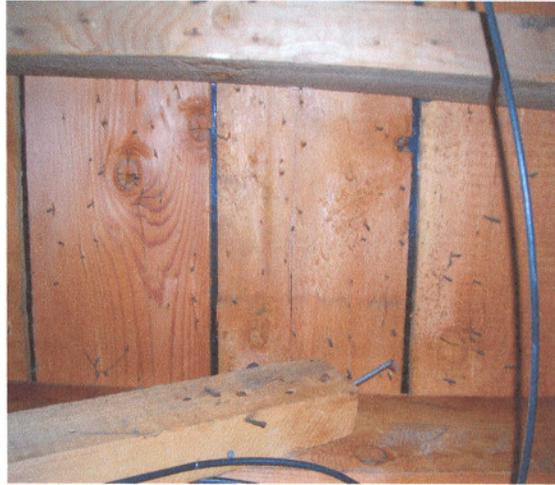
12. The wood plank roof decking has gaps between the adjacent boards (refer to photo 14).
13. Floor support beams at crawl space areas: floor beams are typically supported on a wood stub post bearing on stacked rocks; in several locations the stacked rocks have fallen apart and the support is gone (refer to photo 15).
14. Floor support beams at crawl space areas: the floor beams at the exterior wall are supported on stone rubble (refer to photo 16).
15. The plaster on the interior face of the interior stairwell has discolored and is flaking off, due to moisture penetration thru the below grade wall.

14. Gaps visible in wood plank roof decking
